Expertise

Protocol number: 46347201
Order No. / Reference: 26184134
Inspection date: 30 Jun 2026

Model: Vito 116 CDI Extralang HA Aut. PRO

VIN: W1VVLCEZ9T4566878

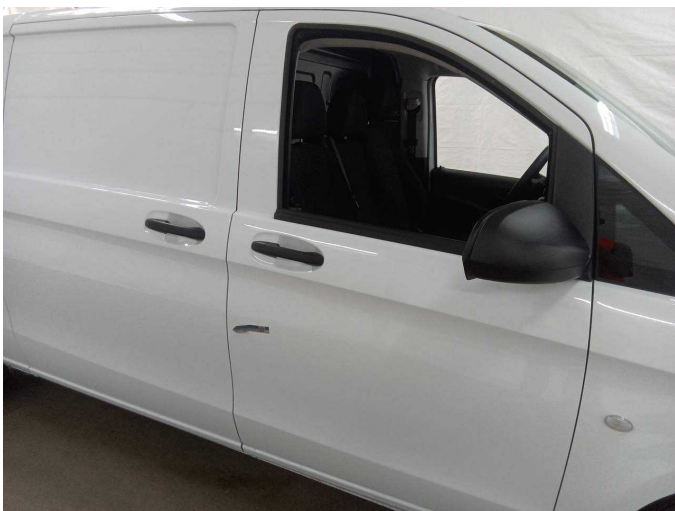
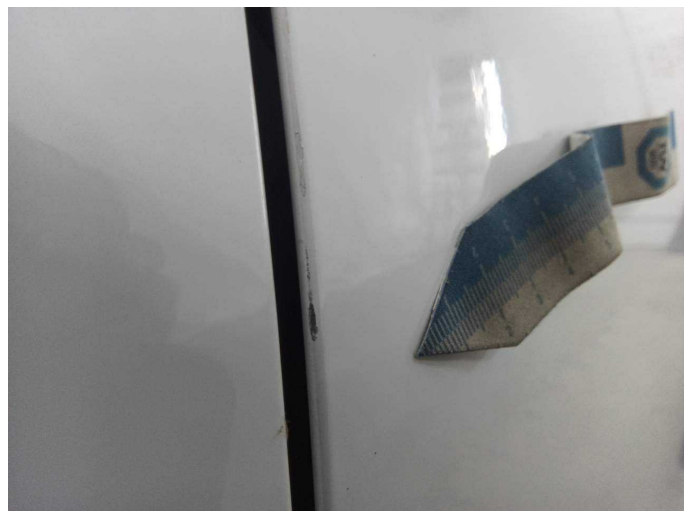
| No. | Component group | Description |
|---|---|--|
| 1 | Door - front right side | Door edge - Scratch(es) - Smart repair |

Damage 1: Door - front right side: Door edge - Scratch(es) - Smart repair

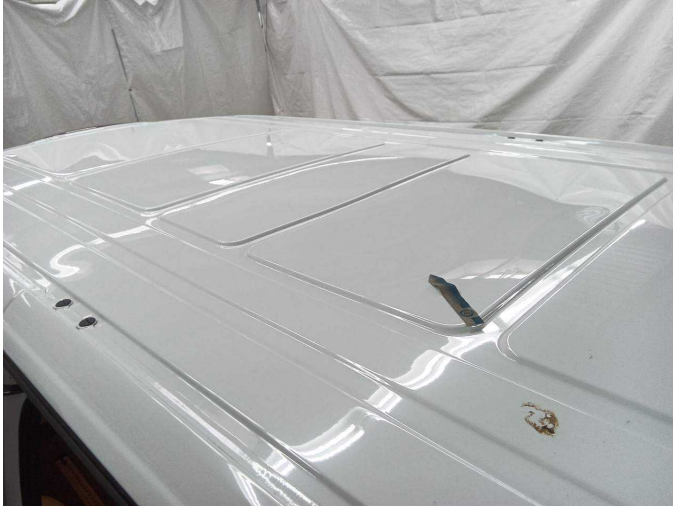
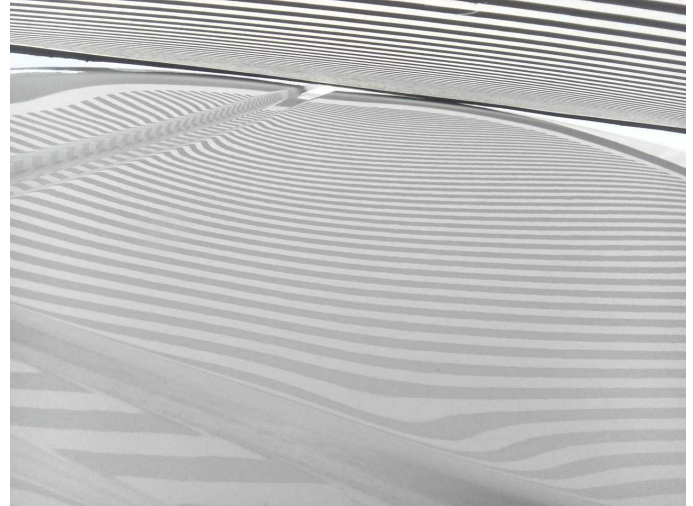
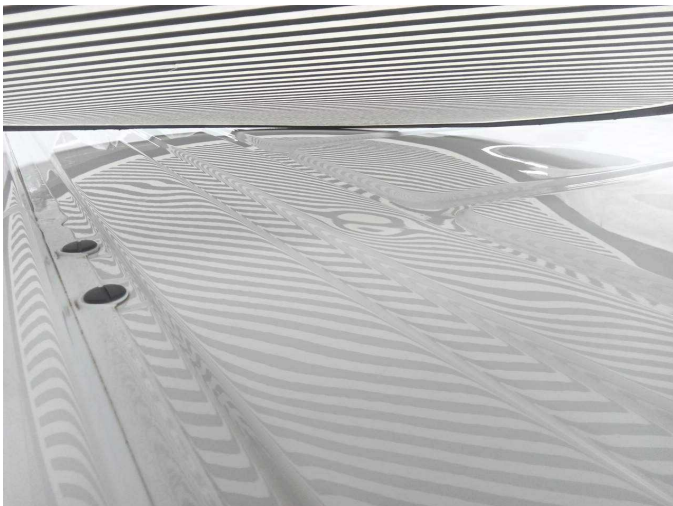
| No. | Component group | Description |
|---|---|--|
| 2 | Roof | Roof (Grosse dellen gedrückt) - Deformed - Smooth repair work |

Damage 2: Roof: Roof (Grosse dellen gedrückt) - Deformed - Smooth repair work

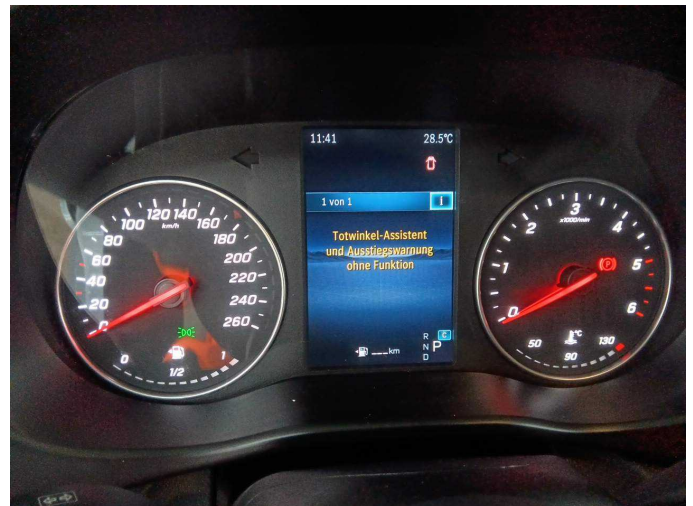
| No. | Component group | Description |
|---|---|--|
| 3 | Instrument panel | Indicator light (Totwinkelassistent + Ausstiegswarnung) - on - Perform diagnosis |

Damage 3: Instrument panel: Indicator light (Totwinkelassistent + Ausstiegswarnung) - on - Perform diagnosis

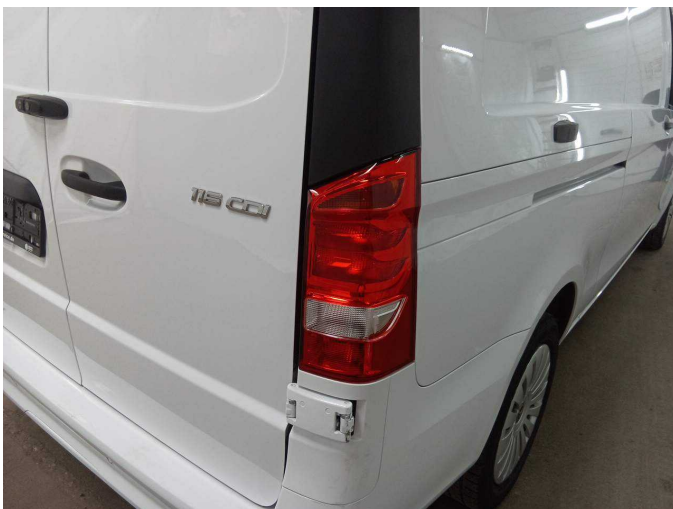
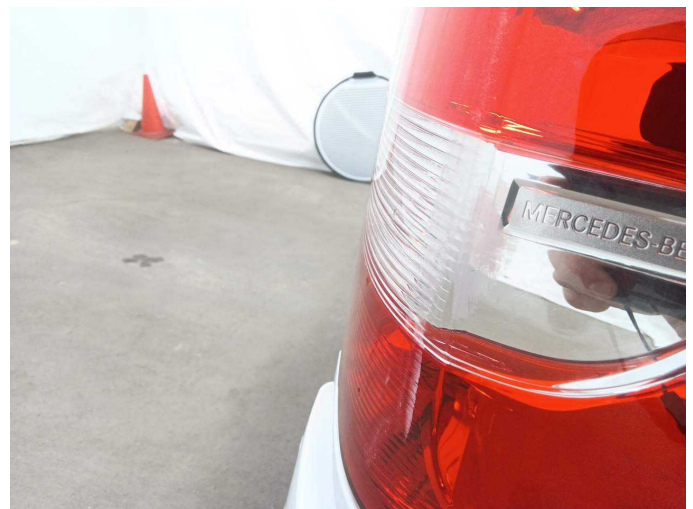
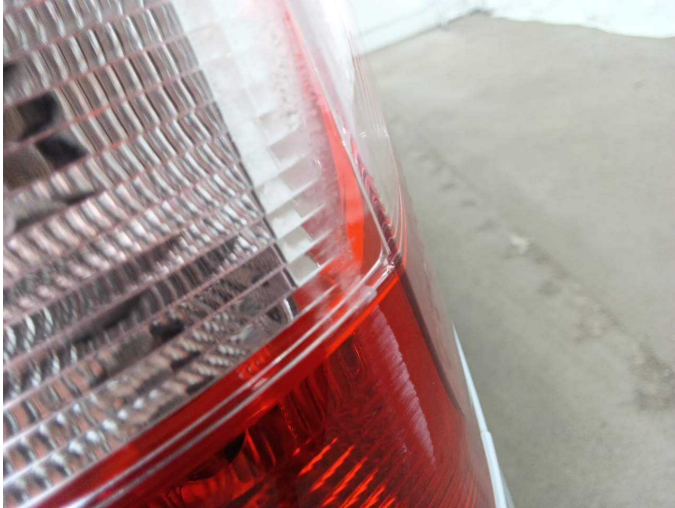
| No. | Component group | Description |
|---|---|--|
| 4 | Tail light | Tail lamp - right side - Scratch(es) - Replace |

Damage 4: Tail light: Tail lamp - right side - Scratch(es) - Replace

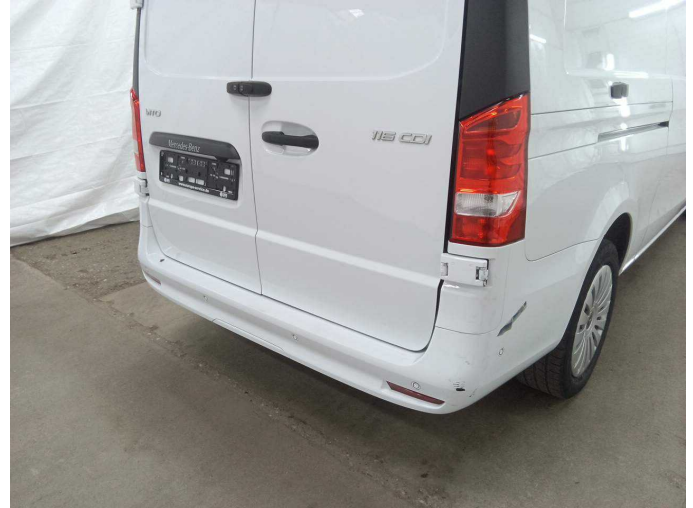
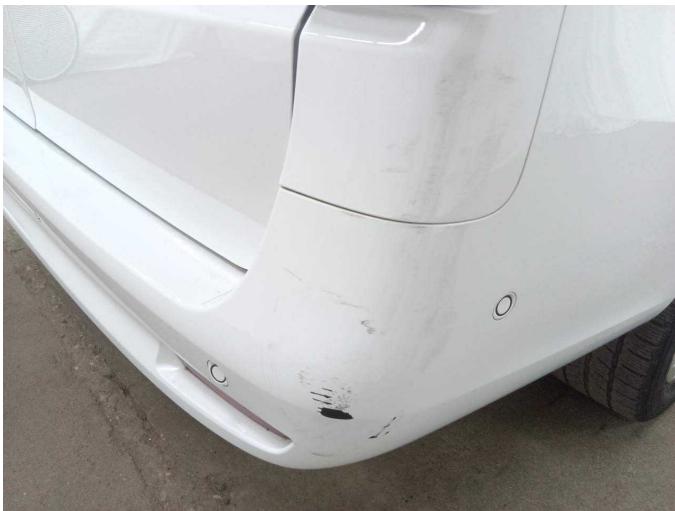
| No. | Component group | Description |
|---|---|--|
| 5 | Rear bumper | Rear bumper - Scratch(es) - Paint |

Damage 5: Rear bumper: Rear bumper - Scratch(es) - Paint

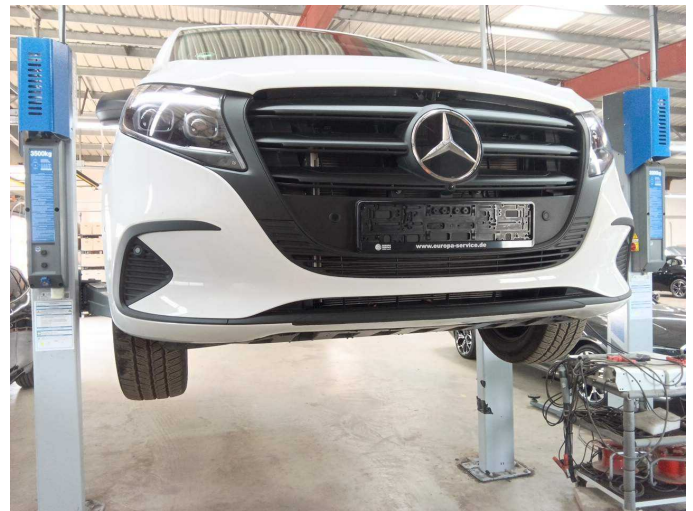
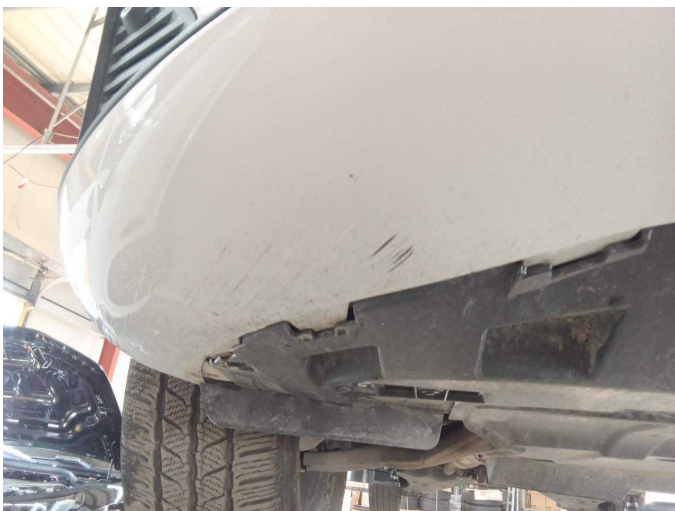
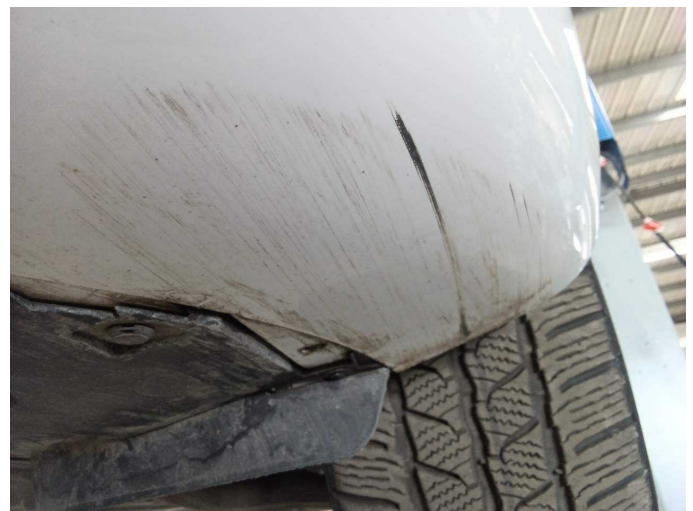
| No. | Component group | Description |
|---|---|--|
| 6 | Front bumper | Front bumper - Scratch(es) - Paint |

Damage 6: Front bumper: Front bumper - Scratch(es) - Paint

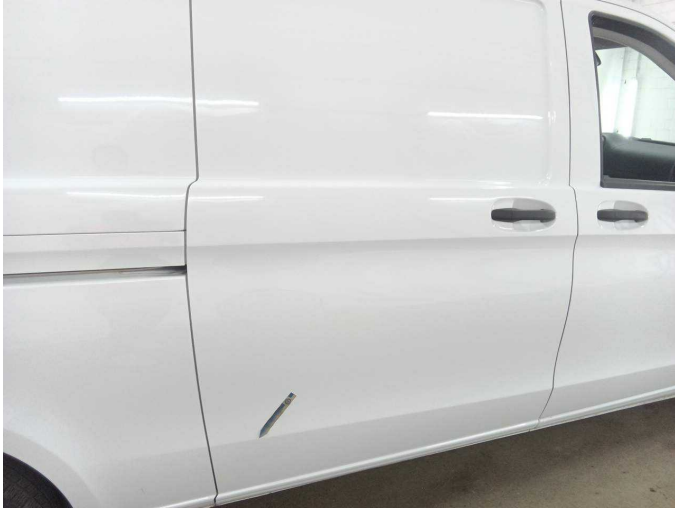
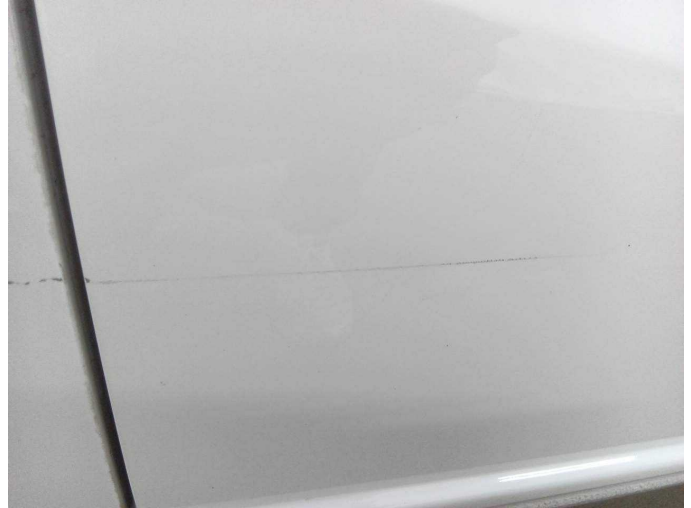
| No. | Component group | Description |
|---|---|--|
| 7 | Sliding door, right | Sliding door - Scratch(es) - Paint |

Damage 7: Sliding door, right: Sliding door - Scratch(es) - Paint

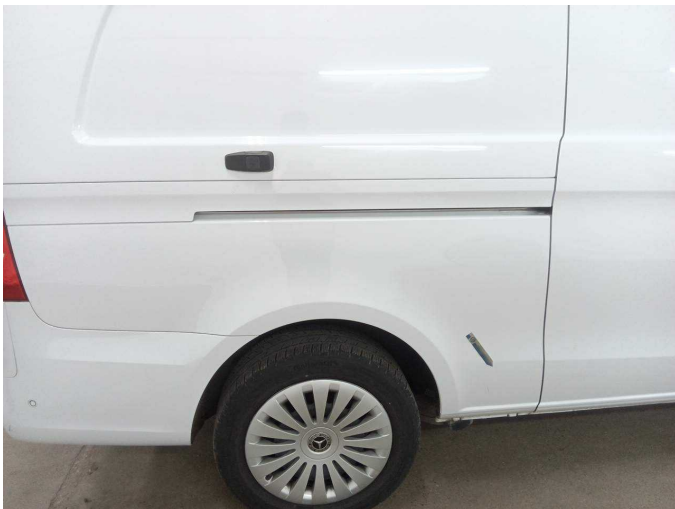
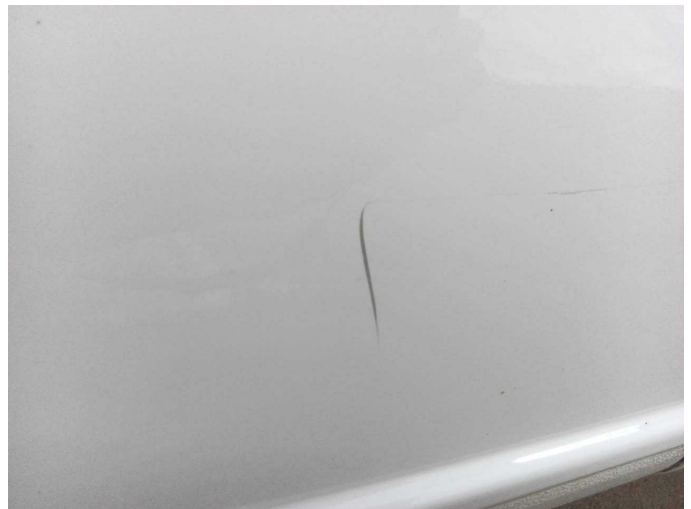
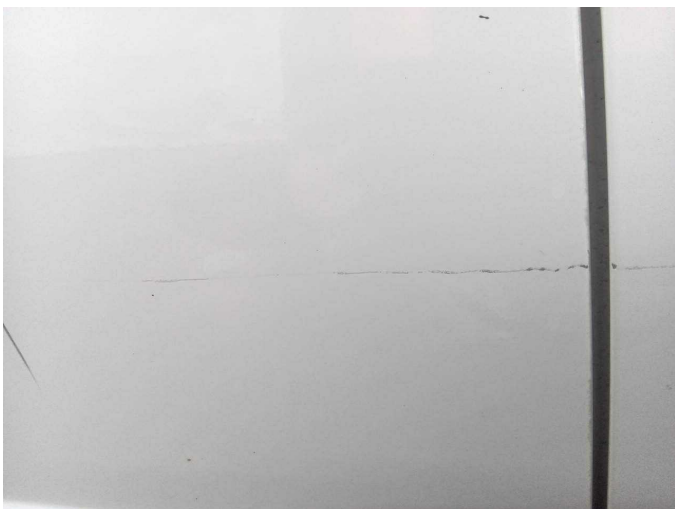
| No. | Component group | Description |
|---|---|--|
| 8 | Side panel - rear right side | Side panel - Scratch(es) - Paint |

Damage 8: Side panel - rear right side: Side panel - Scratch(es) - Paint

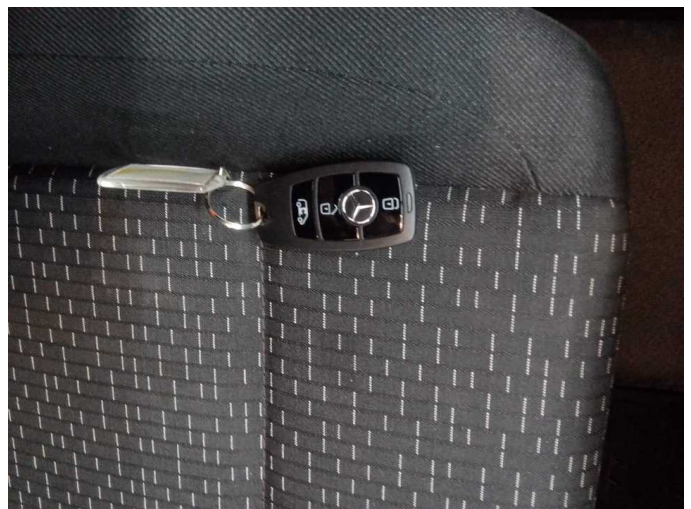
Missing part 2: Equipment: Vehicle key - Missing - Replace
