Expertise

Protocol number: 46368534
Order No. / Reference: 26545768
Inspection date: 2 Jul 2026

Model: Arona 1.0 TSI OPF Style

VIN: VSSZZKJZNR043124

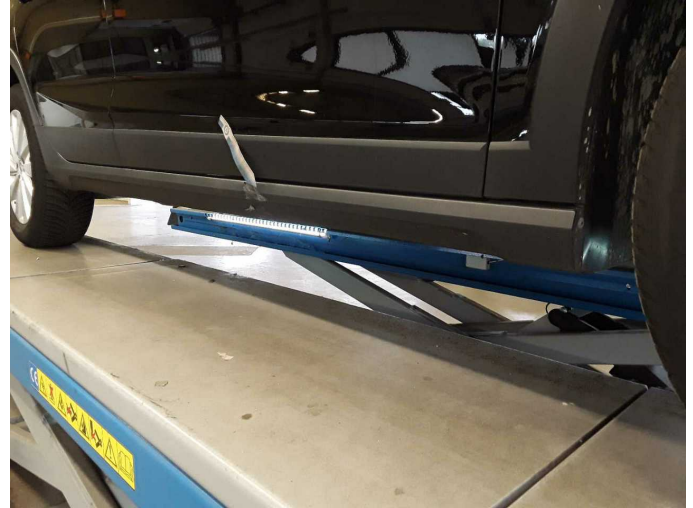
Damage 2: Sill - right side: Trim - Scratched - Replace

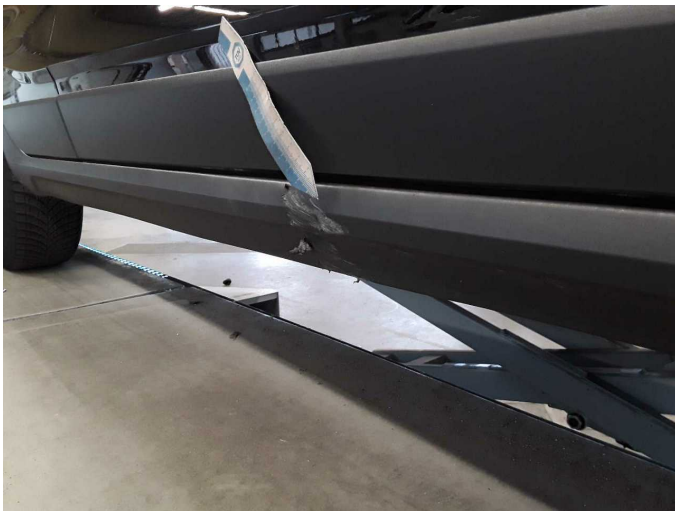
Damage 2: Sill - right side: Trim - Scratched - Replace

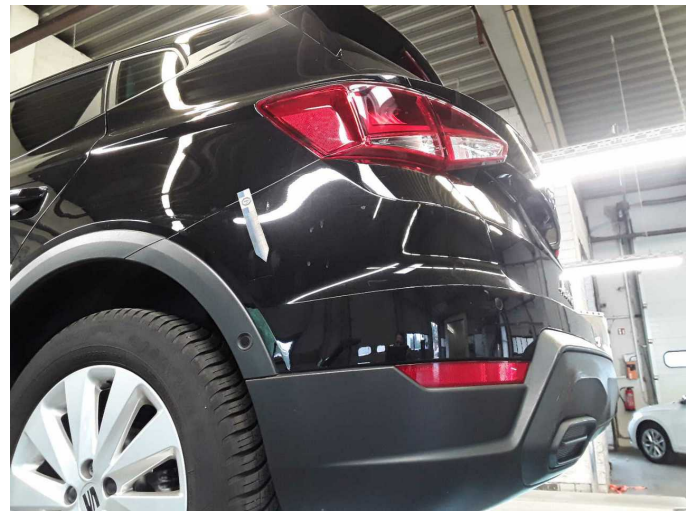
Damage 3: Rear bumper: Rear bumper - Scratch(es) - Smart repair

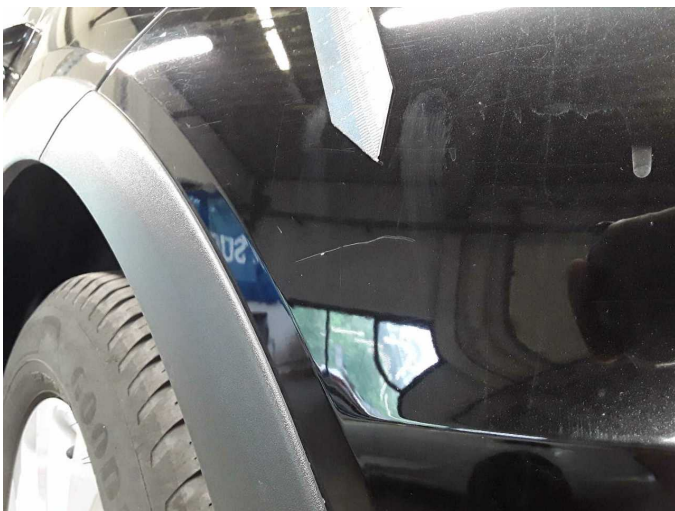
Damage 3: Rear bumper: Rear bumper - Scratch(es) - Smart repair

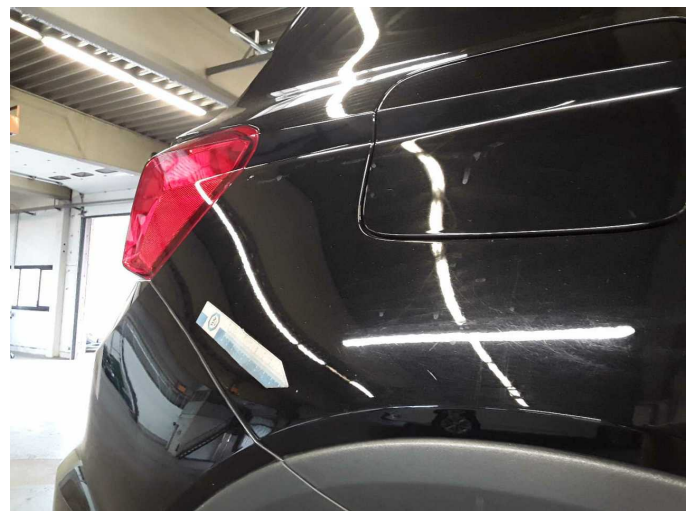
Damage 4: Side panel - rear right side: Side panel - Dent / paintcoat damage - Smart repair

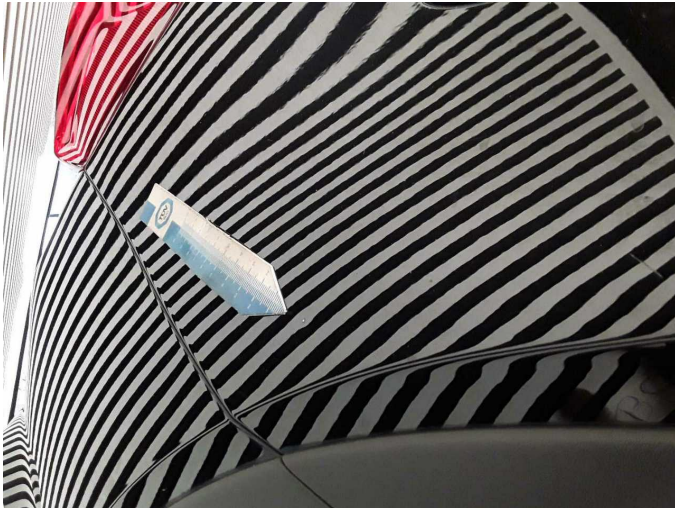
Damage 4: Side panel - rear right side: Side panel - Dent / paintcoat damage - Smart repair

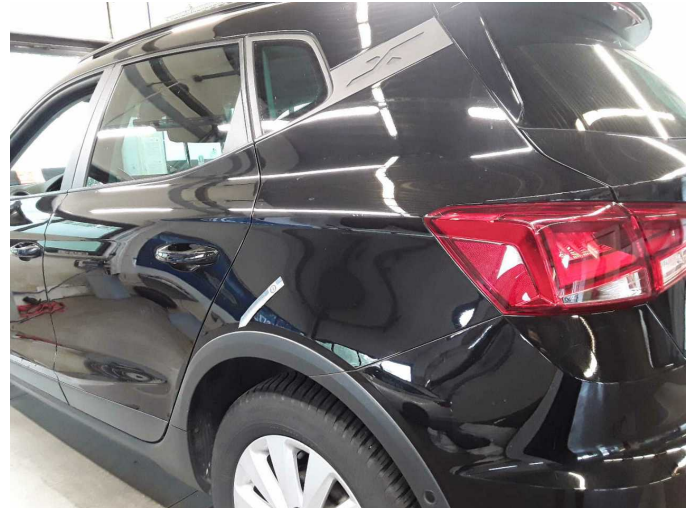
Damage 5: Side panel - rear left side: Side panel - Dent / paintcoat damage - Smart repair

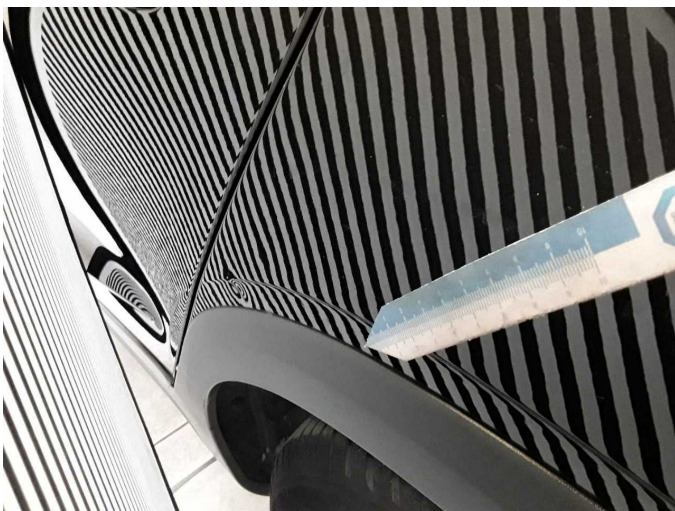
Damage 5: Side panel - rear left side: Side panel - Dent / paintcoat damage - Smart repair

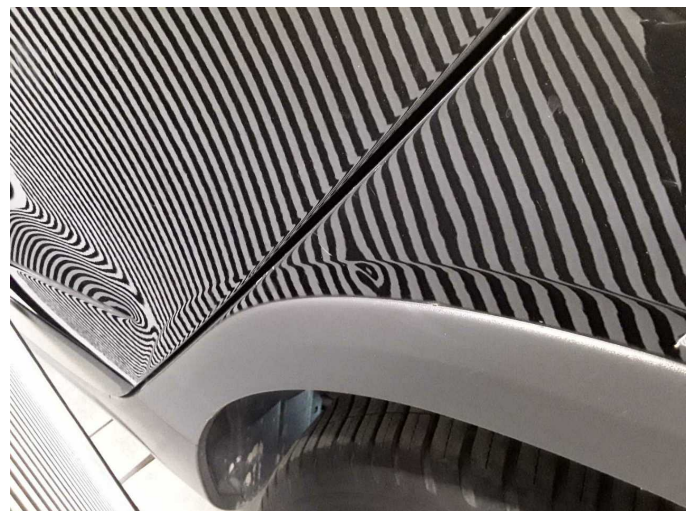
Damage 5: Side panel - rear left side: Side panel - Dent / paintcoat damage - Smart repair

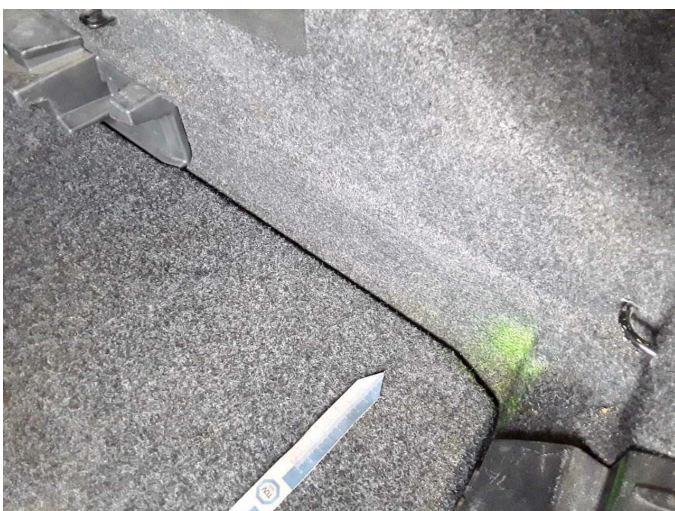
Damage 6: Interior: Interior (Farbe) - Soiled - Conditioning

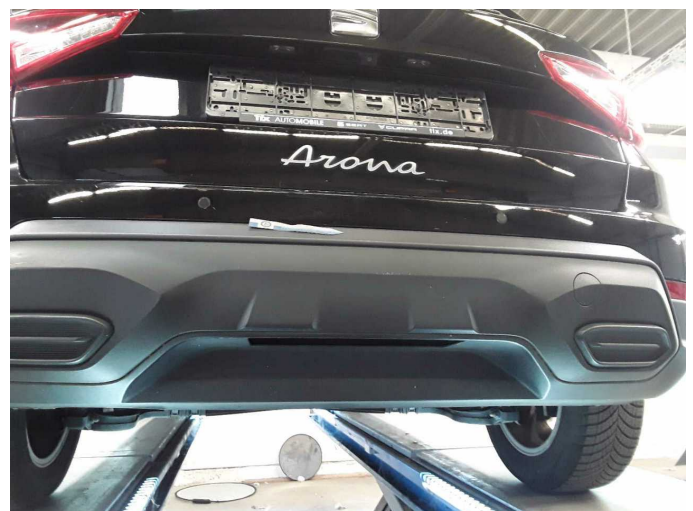
Damage 7: Rear bumper: Spoiler - Scratch(es) - Replace

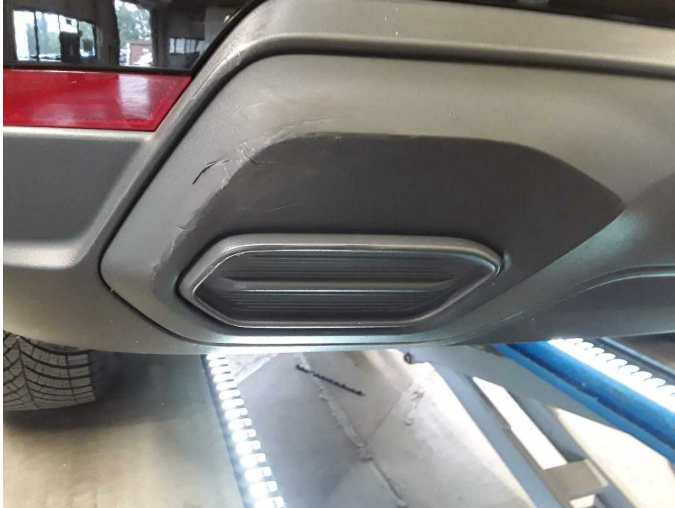
Damage 7: Rear bumper: Spoiler - Scratch(es) - Replace

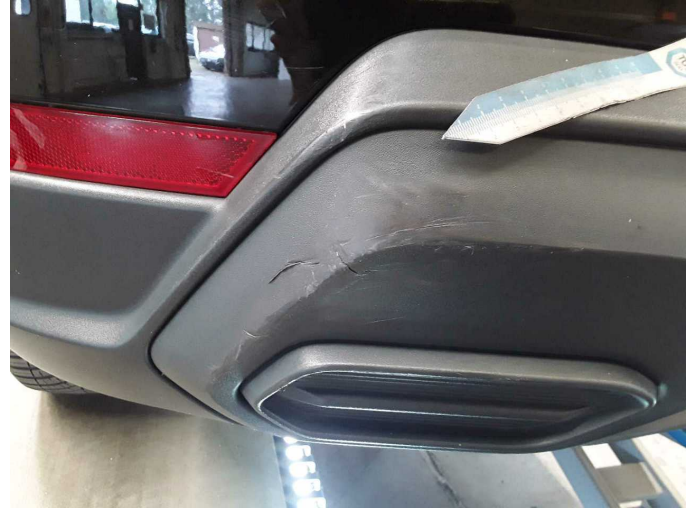
Damage 7: Rear bumper: Spoiler - Scratch(es) - Replace

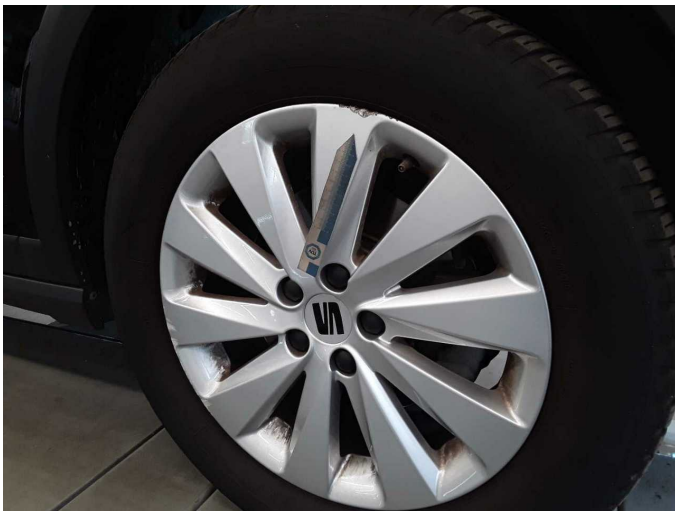
Damage 8: Wheel / tyres: Alloy rim - front right side - Scratched - Replace

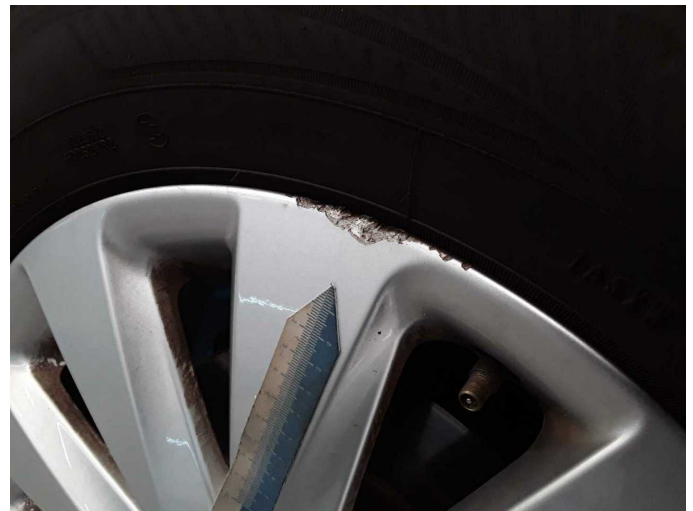
Damage 8: Wheel / tyres: Alloy rim - front right side - Scratched - Replace

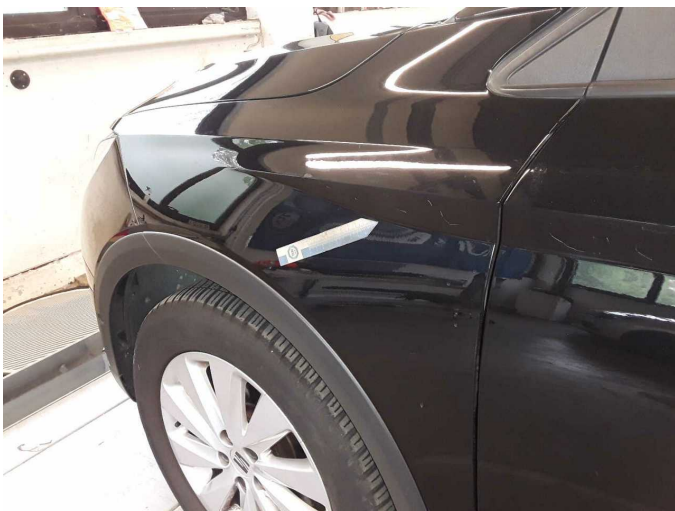
Damage 9: Mudguard - left side: Mudguard - left side - Scratch(es) - Paint

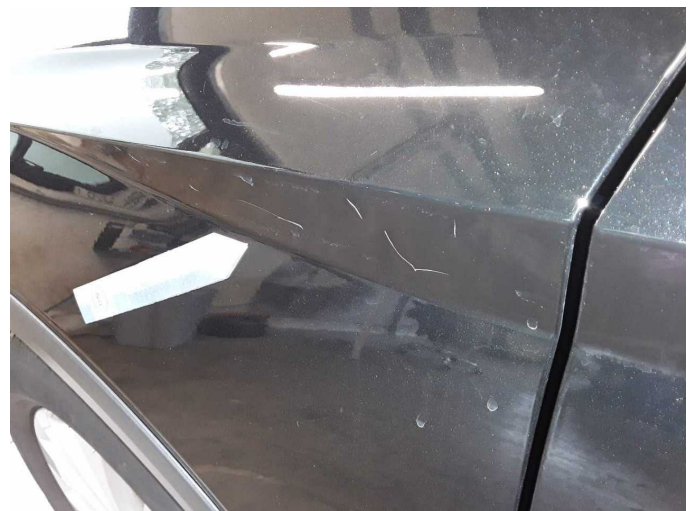
Damage 9: Mudguard - left side: Mudguard - left side - Scratch(es) - Paint

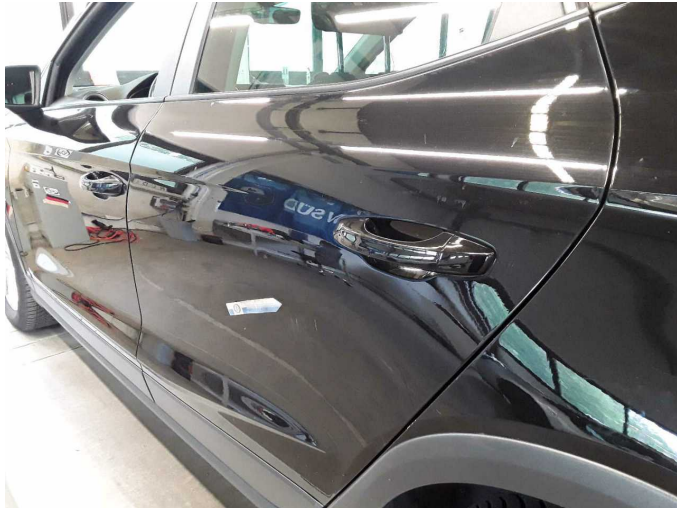
Damage 10: Door - rear left side: Door - Scratched - Paint

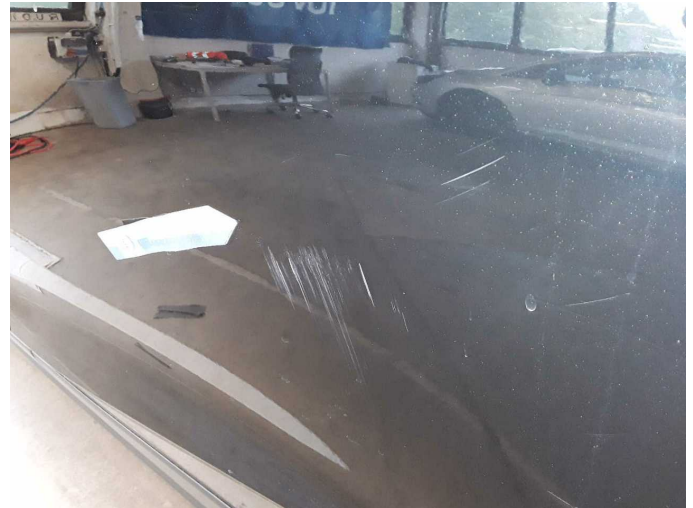
Damage 10: Door - rear left side: Door - Scratched - Paint

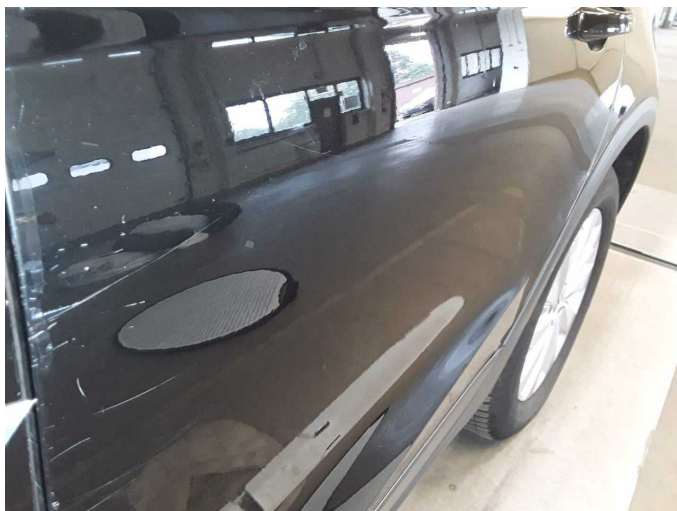
Damage 10: Door - rear left side: Door - Scratched - Paint

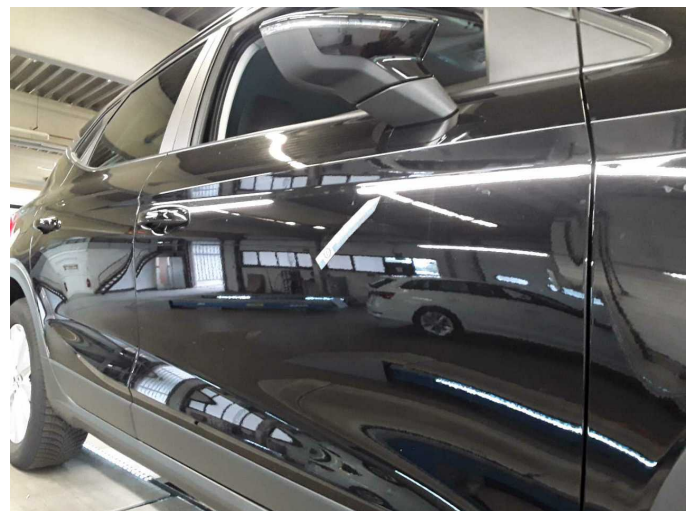
Damage 11: Door - front right side: Door - Scratch(es) - Paint

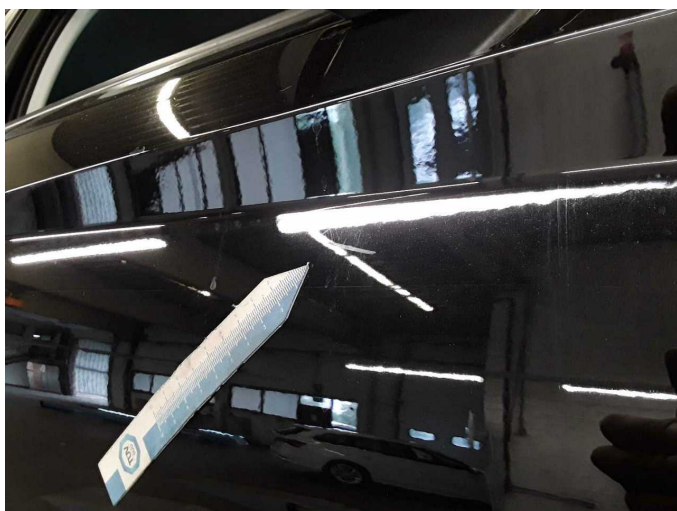
Damage 11: Door - front right side: Door - Scratch(es) - Paint

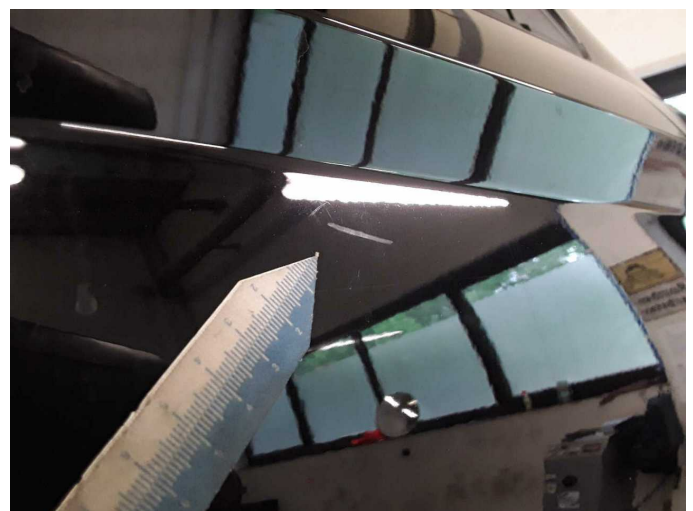
Damage 11: Door - front right side: Door - Scratch(es) - Paint

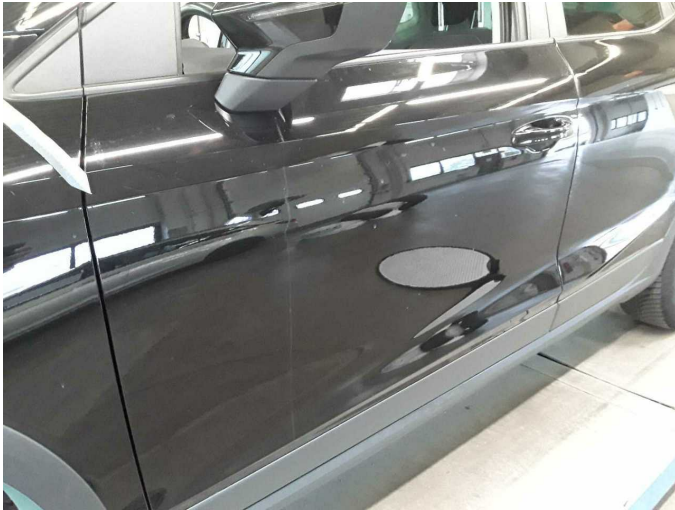
Damage 12: Door - front left side: Door - Scratch(es) - Paint

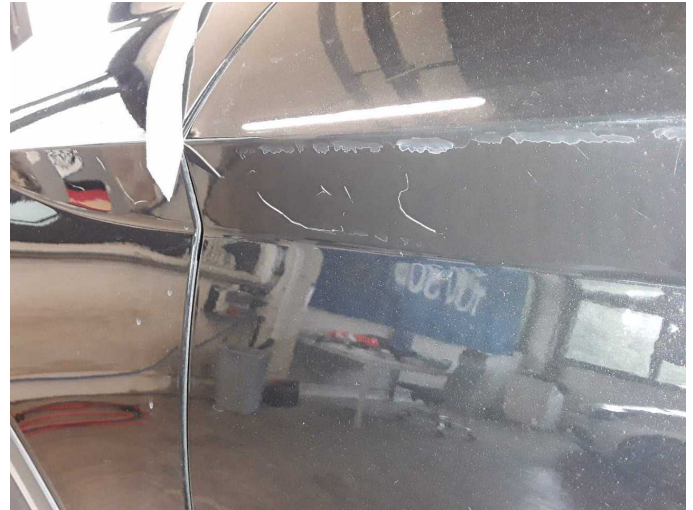
Damage 12: Door - front left side: Door - Scratch(es) - Paint

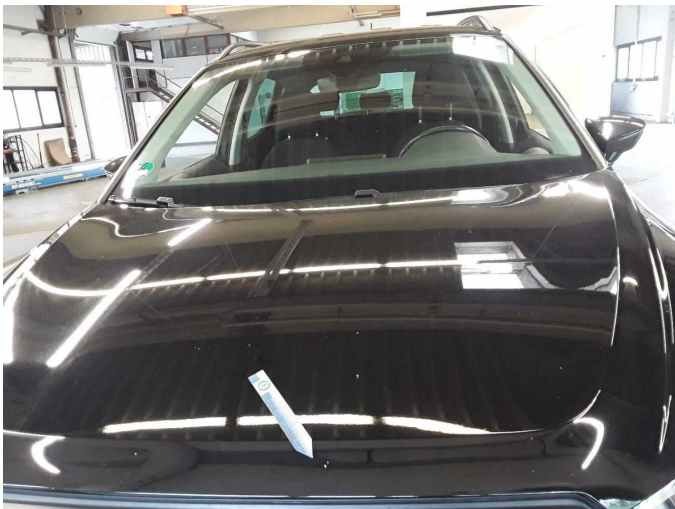
Damage 13: Bonnet: Bonnet - Dent / paintcoat damage - Repair and paint

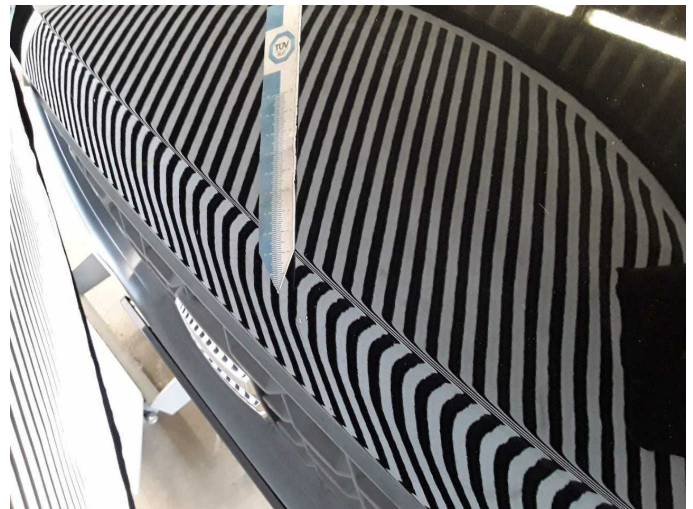
Damage 13: Bonnet: Bonnet - Dent / paintcoat damage - Repair and paint

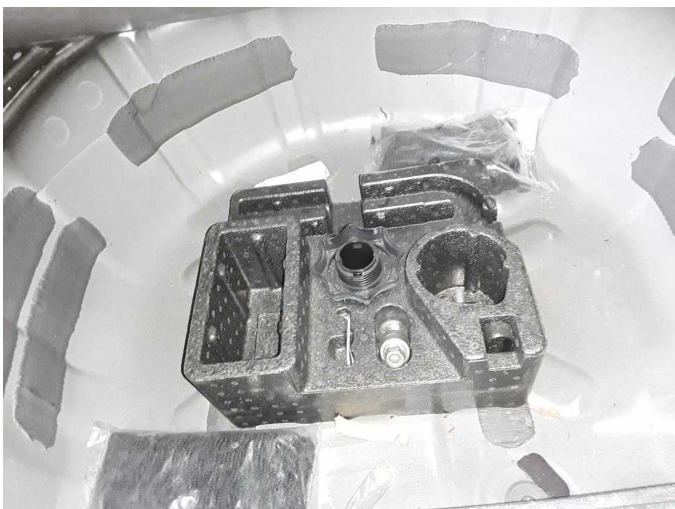
Missing part 1: Equipment: Tirefit compressor - Missing - Replace
