## Expertise

Protocol number: 46206874  
Order No. / Reference: 26509895  
Inspection date: 19 Jun 2026

Manufacturer: Mercedes-Benz

Model: 315 CDI Sprinter Standard VA

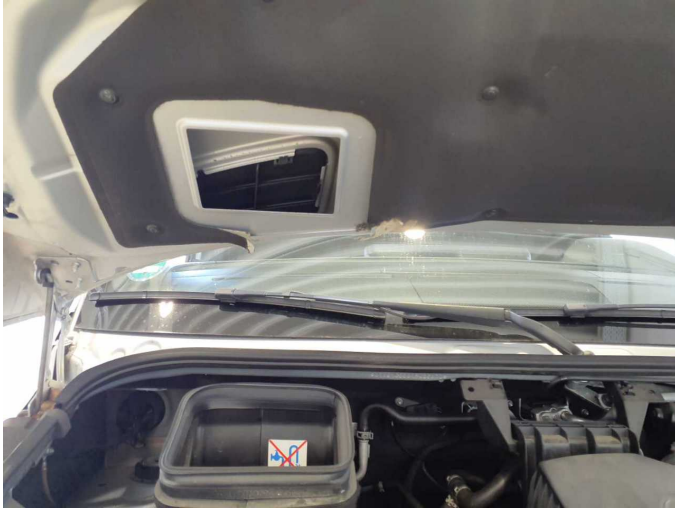
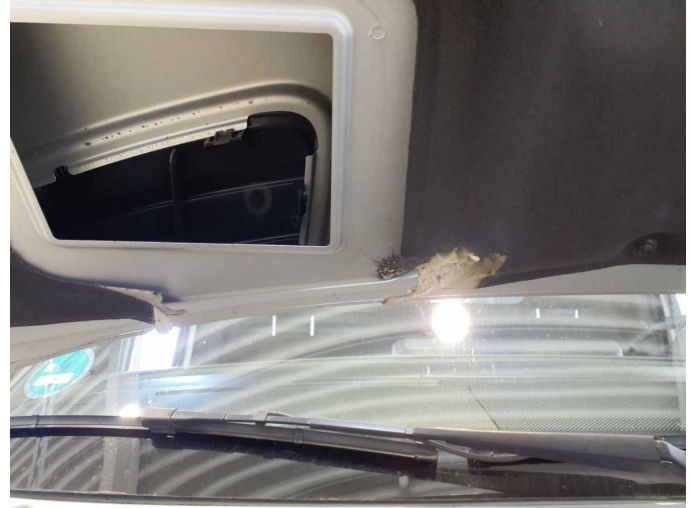
**Damage 1:** Bonnet: Insulation lining - Damaged - Replace

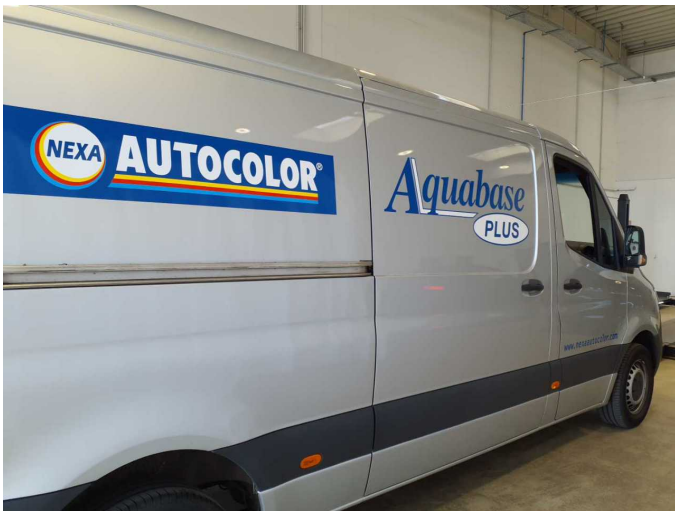
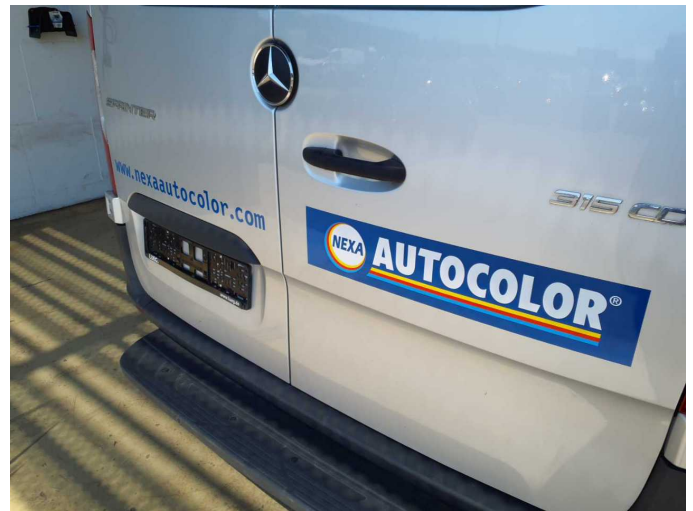
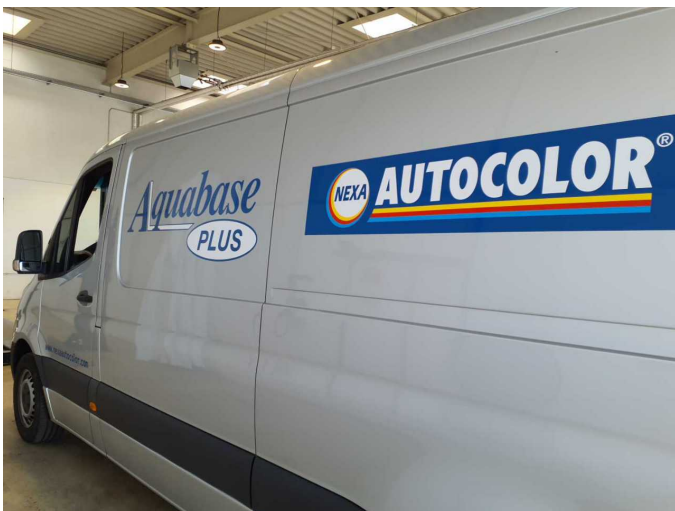
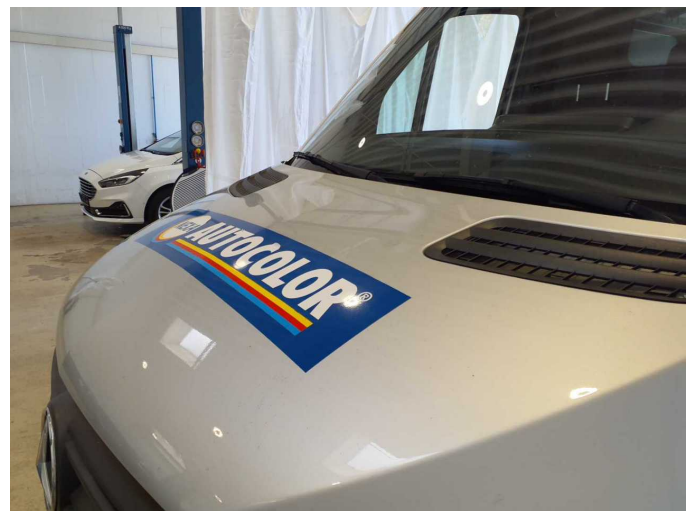
**Damage 2:** Body: Body - Glued / labelled - De-glug / neutralise

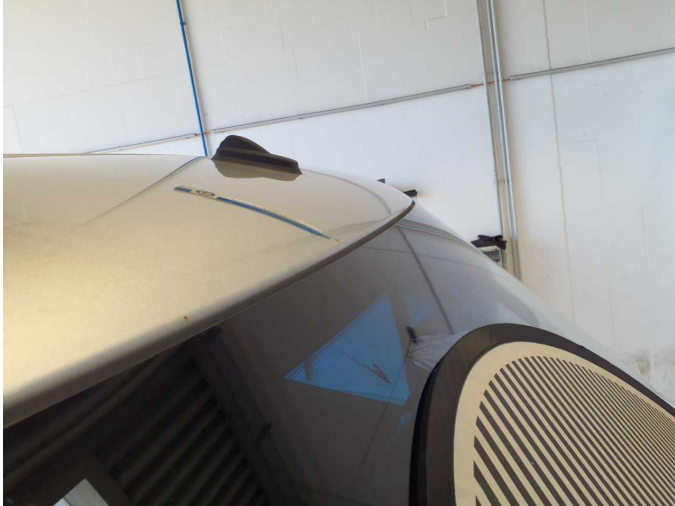
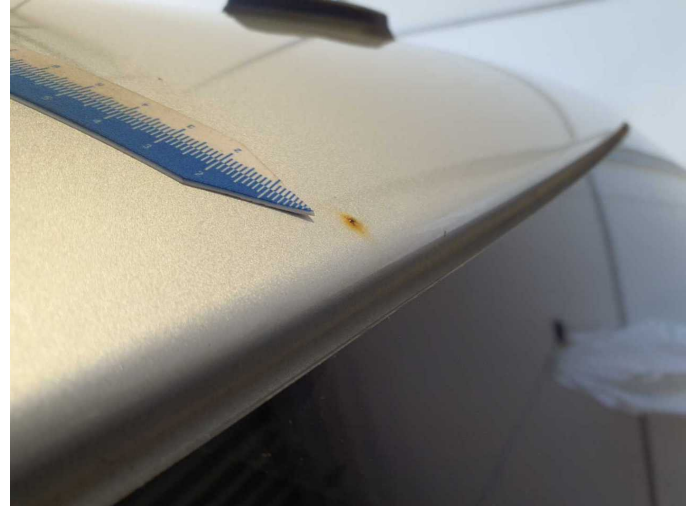
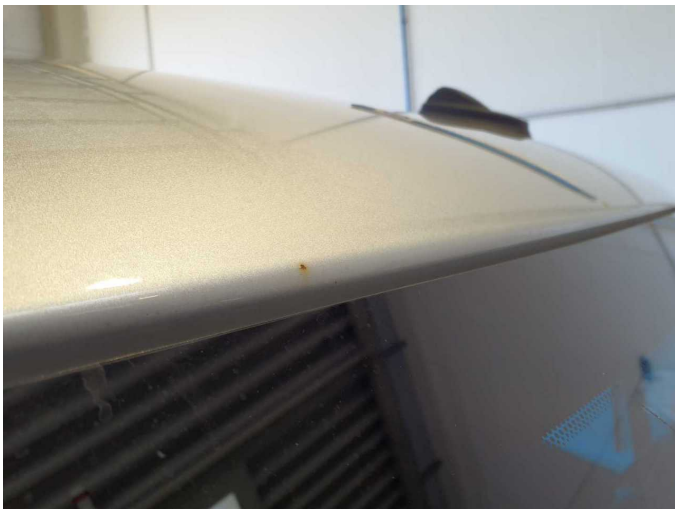
**Damage 3:** Roof: Roof - Corrosion - Repair and paint

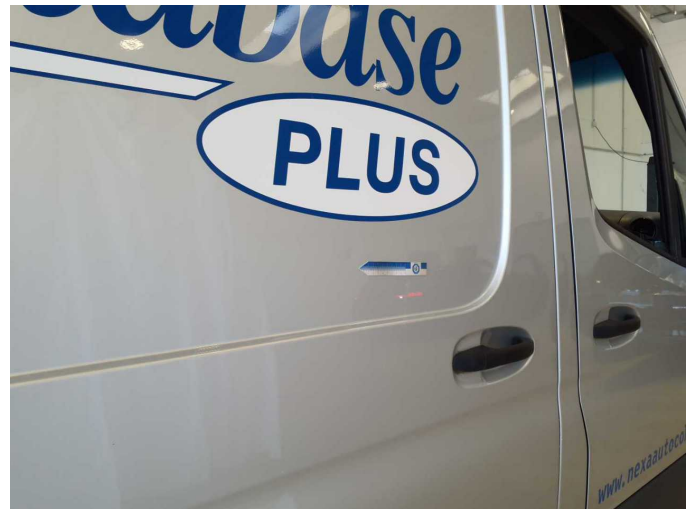
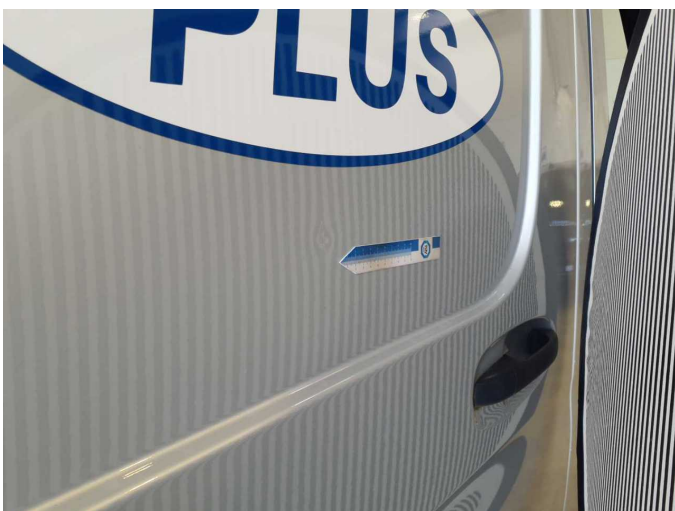
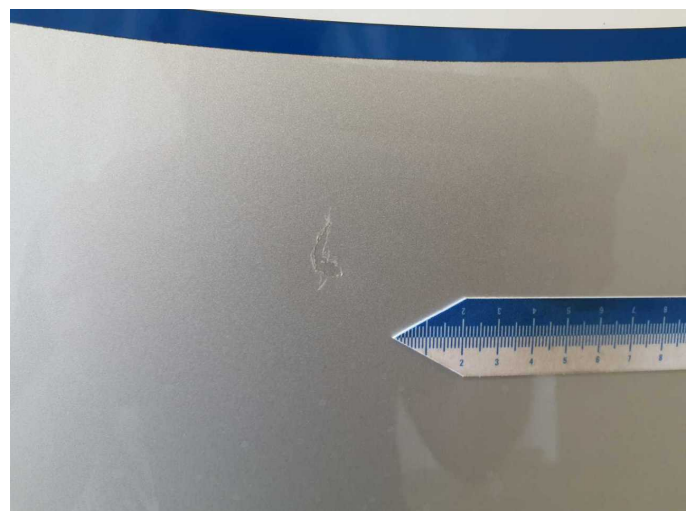
**Damage 4:** Sliding door, right: Sliding door - Dent / paintcoat damage - Repair and paint

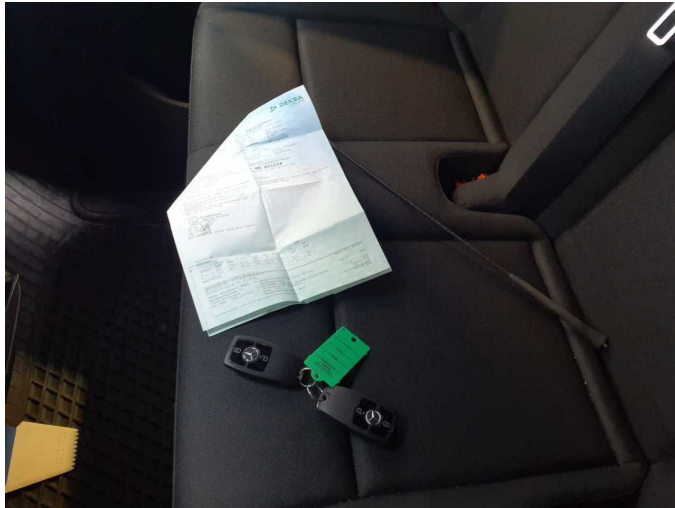
**Missing part 1:** Documents: Log book - Missing - Replace
