Expertise

Protocol number: 46887938  
Order No. / Reference: 26782891  
Inspection date: 4 Aug 2026

Manufacturer: Opel

Model: Astra 1.5 D Start/Stop Sports Tourer Elegance

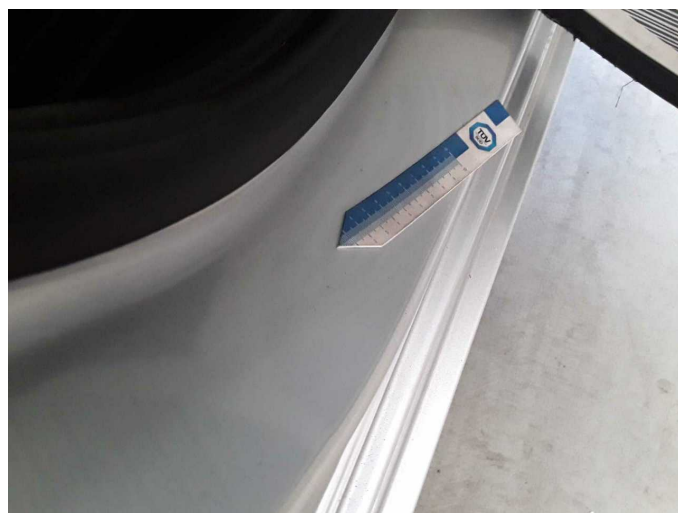
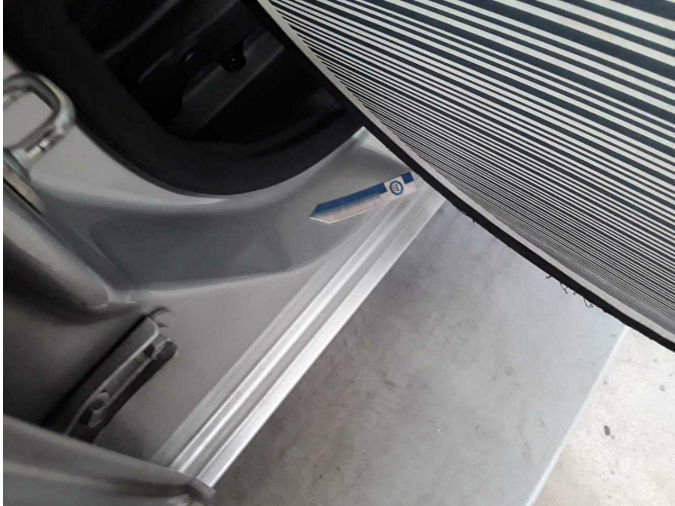
| No. | Component group | Description |
|---|---|---|
| 1 | Sill - right side | Sill - dent(s) - Smooth repair work |

Damage 1: Sill - right side: Sill - dent(s) - Smooth repair work

**Damage 1:** Sill - right side: Sill - dent(s) - Smooth repair work

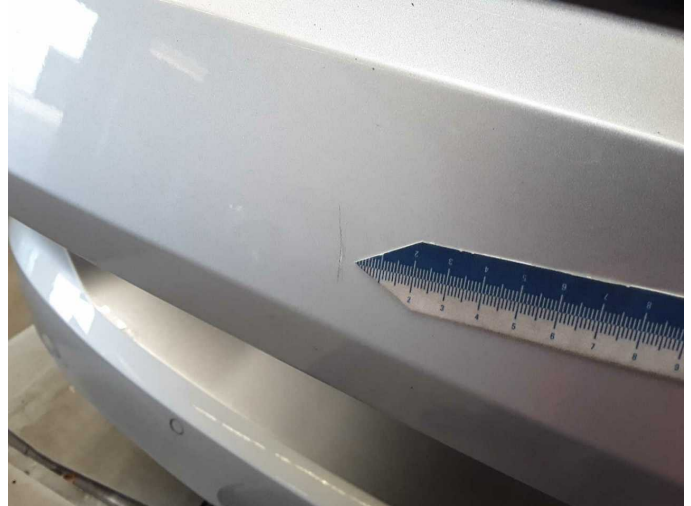
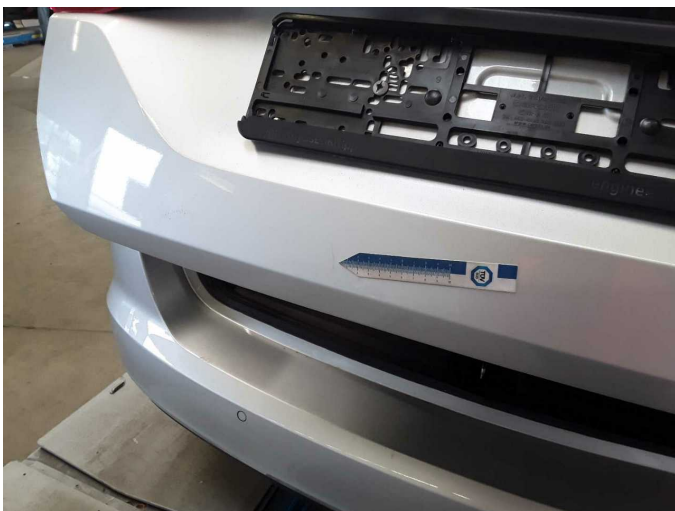
| No. | Component group | Description |
|---|---|---|
| 2 | Boot lid / rear door | Boot lid - Scratch(es) - Smart repair |

**Damage 2:** Boot lid / rear door: Boot lid - Scratch(es) - Smart repair

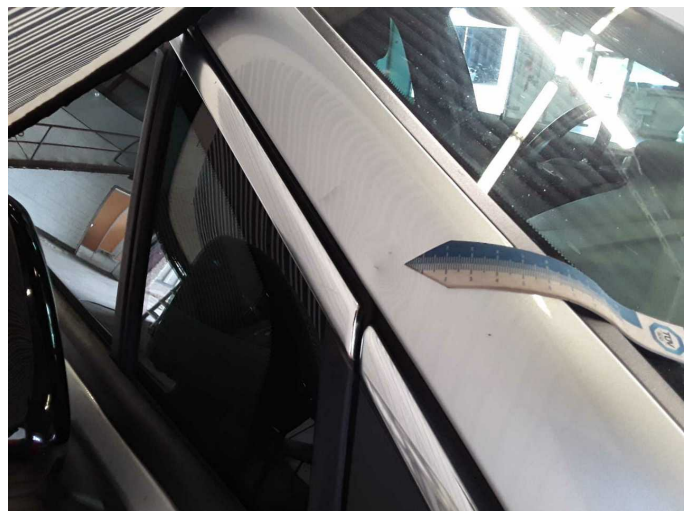
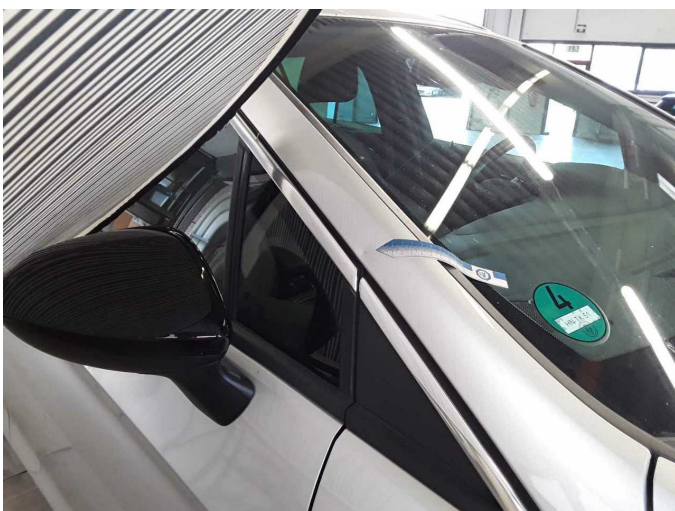
| No. | Component group | Description |
|---|---|---|
| 3 | Body | A-pillar - right side - dent(s) - Smart repair |

**Damage 3:** Body: A-pillar - right side - dent(s) - Smart repair

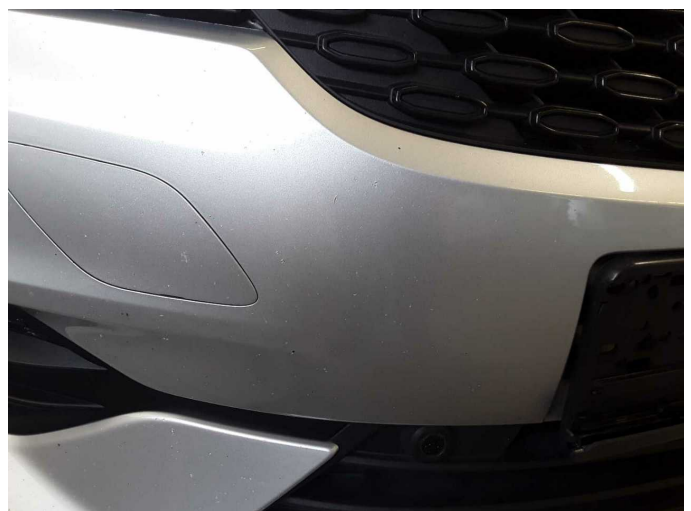
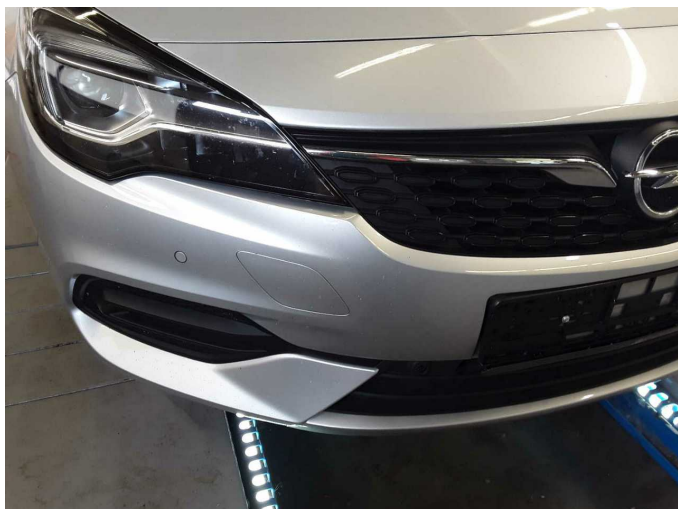
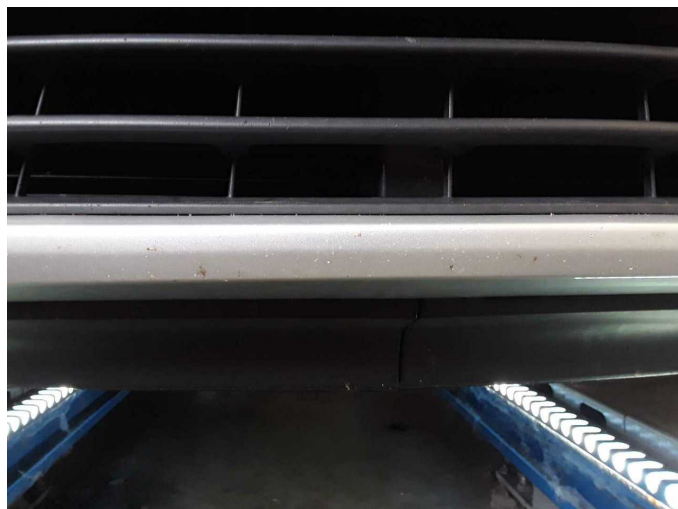
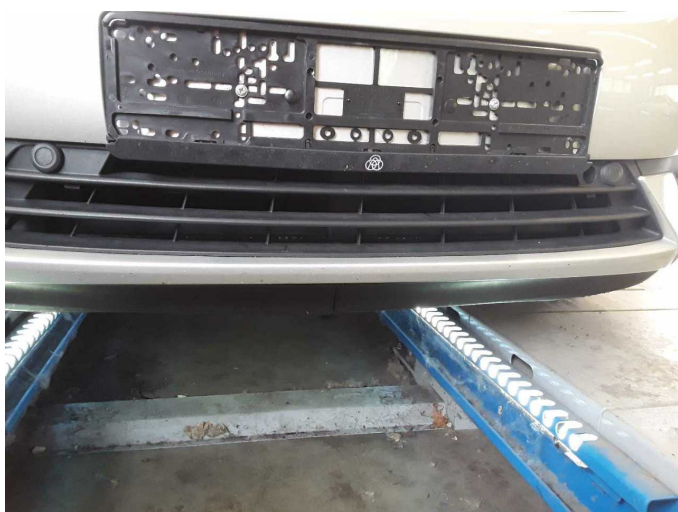
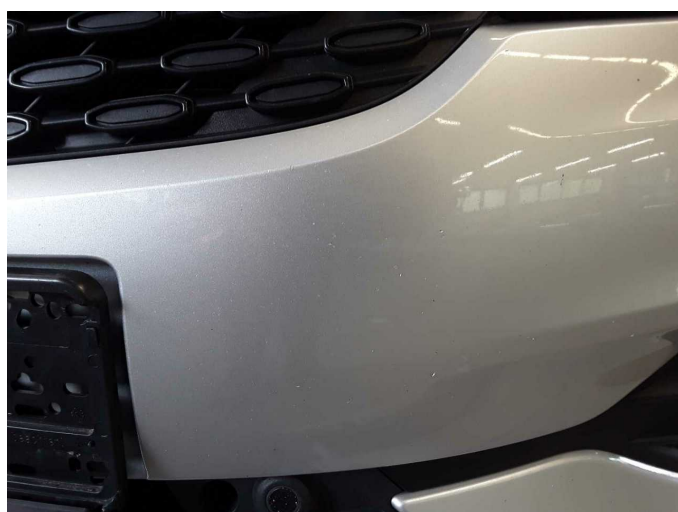
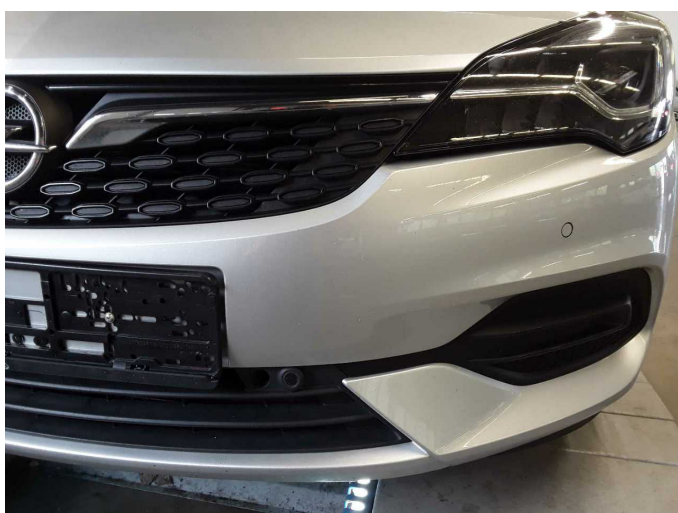
| No. | Component group | Description |
|---|---|---|
| 4 | Front bumper | Front bumper - Stone chips - Paint |

**Damage 4:** Front bumper: Front bumper - Stone chips - Paint

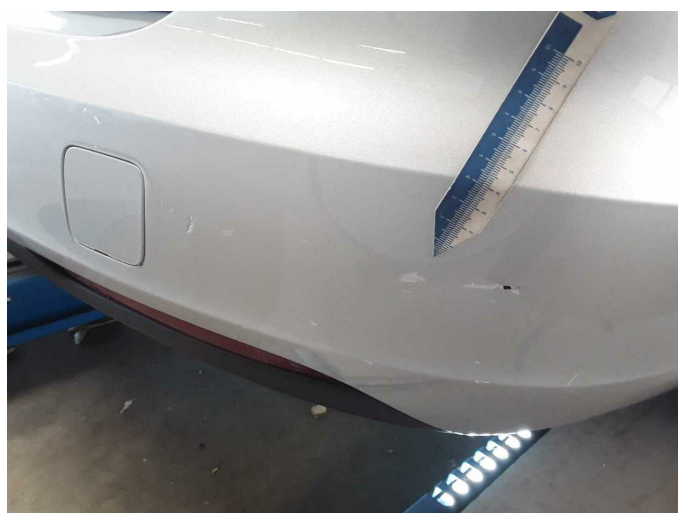
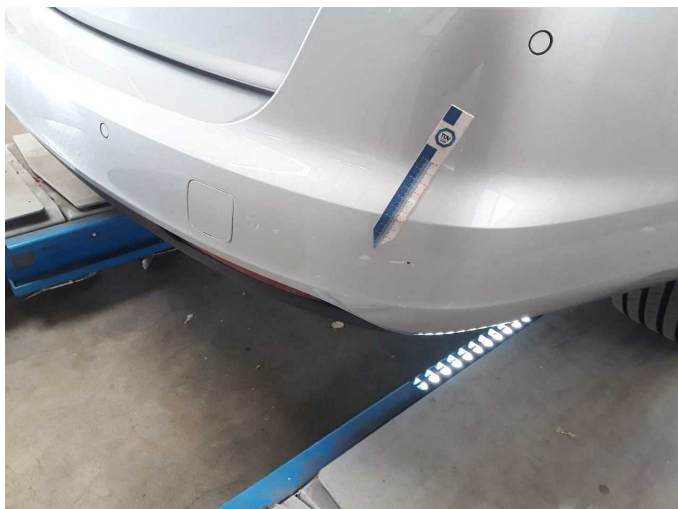
| No. | Component group | Description |
|---|---|---|
| 5 | Rear bumper | Rear bumper - Scratched - Paint |

**Damage 5:** Rear bumper: Rear bumper - Scratched - Paint

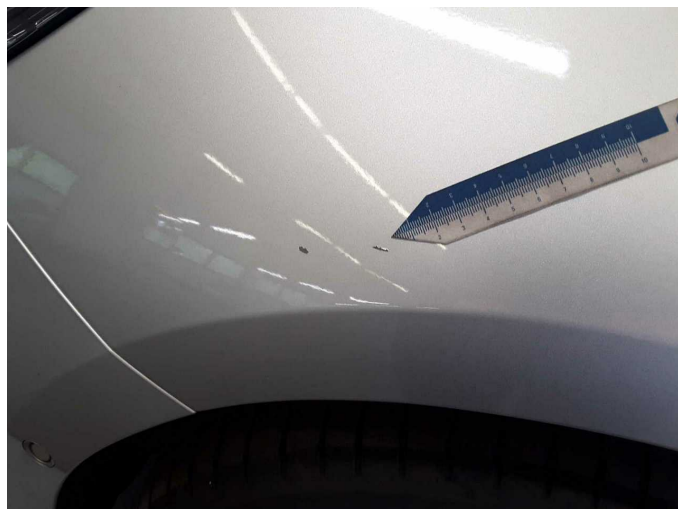
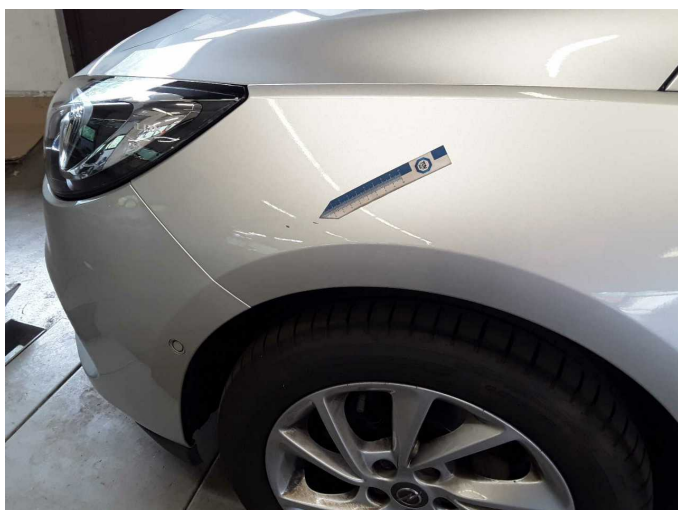
| No. | Component group | Description |
|---|---|---|
| 6 | Mudguard - left side | Mudguard - left side - Scratch(es) - Paint |

**Damage 6:** Mudguard - left side: Mudguard - left side - Scratch(es) - Paint

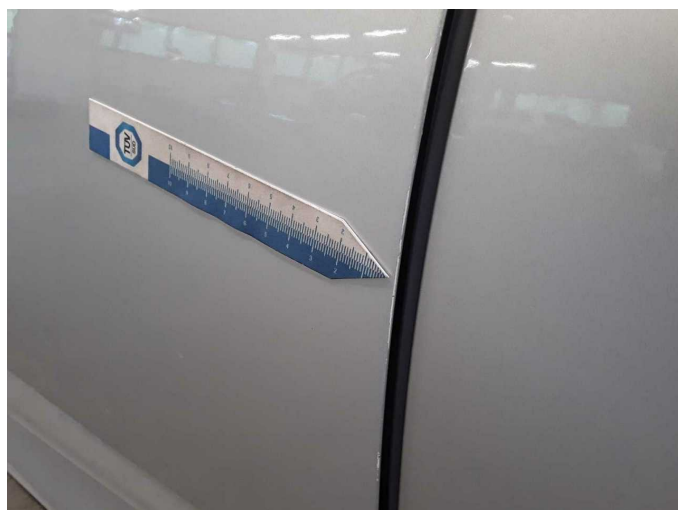
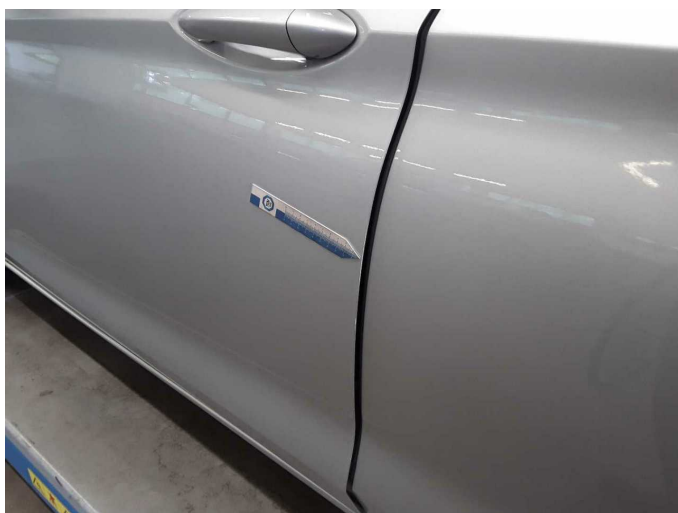
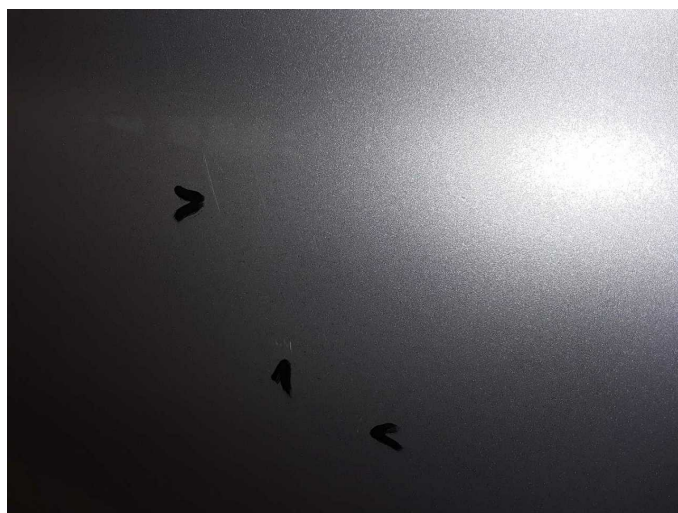
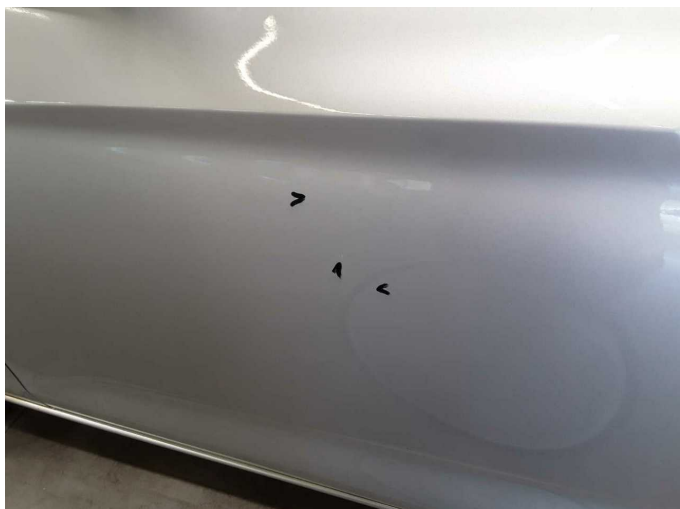
| No. | Component group | Description |
|---|---|---|
| 7 | Door - front left side | Door - Scratch(es) - Paint |

**Damage 7:** Door - front left side: Door - Scratch(es) - Paint

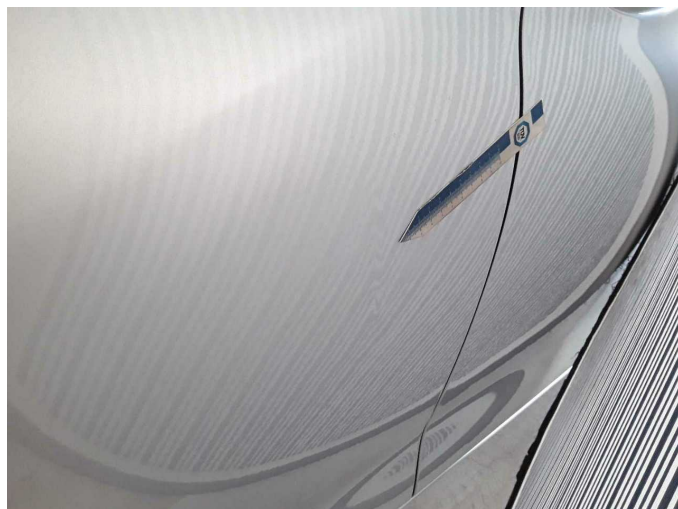
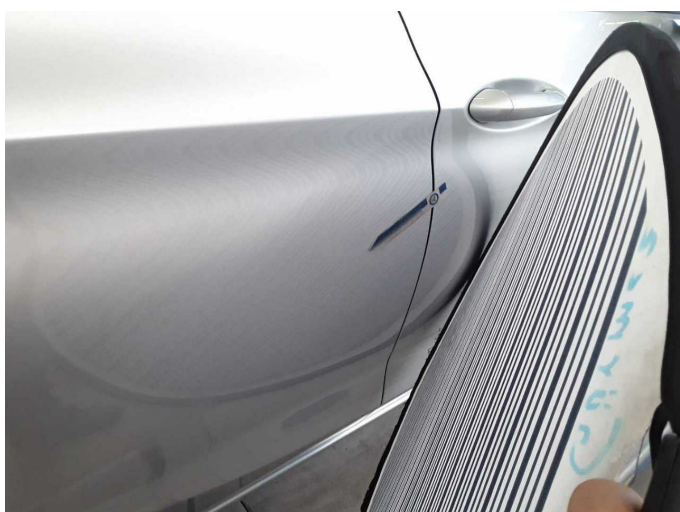
| No. | Component group | Description |
|---|---|---|
| 8 | Door - rear right side | Door - dent(s) - Repair and paint |

**Damage 8:** Door - rear right side: Door - dent(s) - Repair and paint

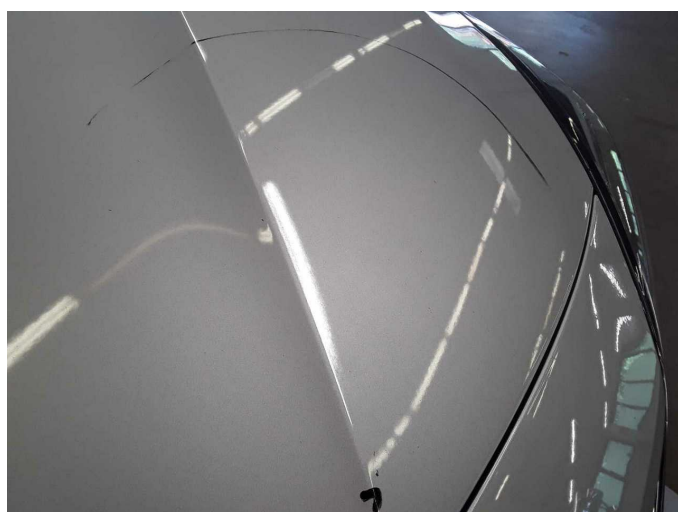
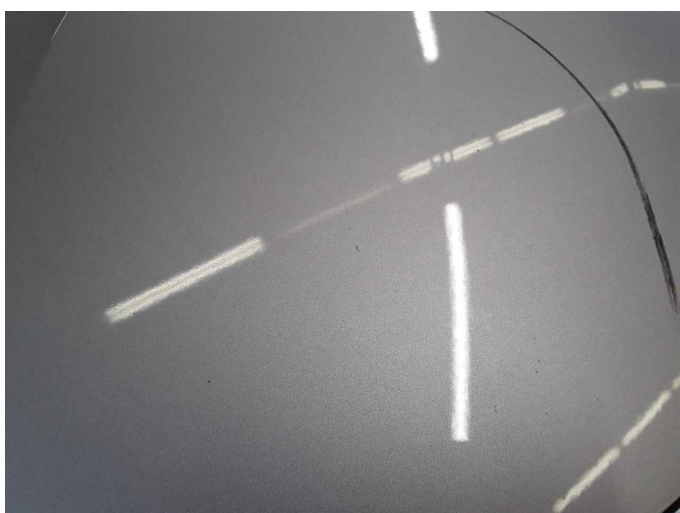
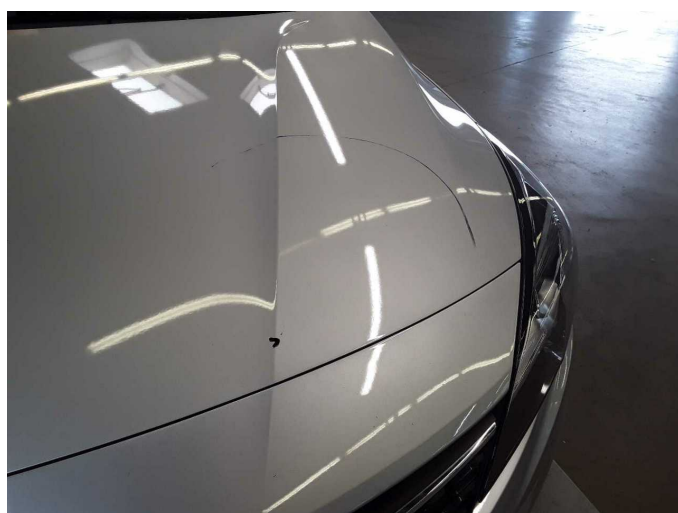
| No. | Component group | Description |
|---|---|---|
| 9 | Bonnet | Bonnet - Stone chips - Paint |

**Damage 9:** Bonnet: Bonnet - Stone chips - Paint

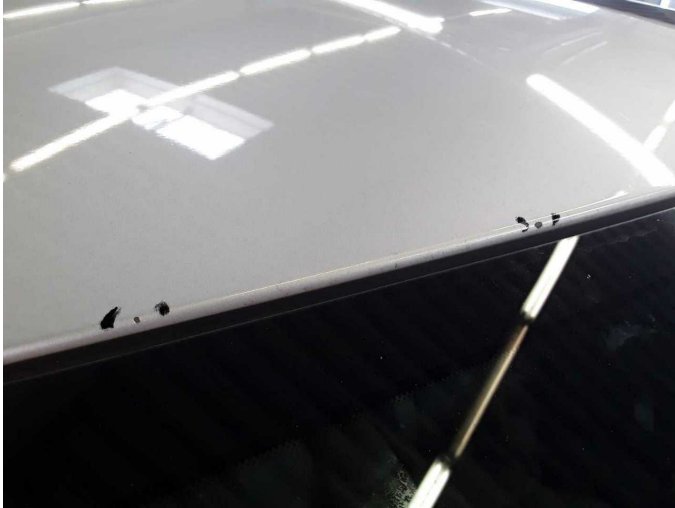
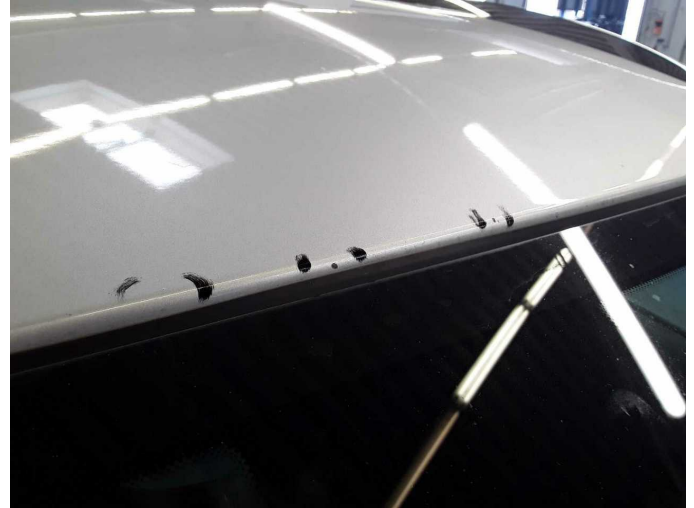
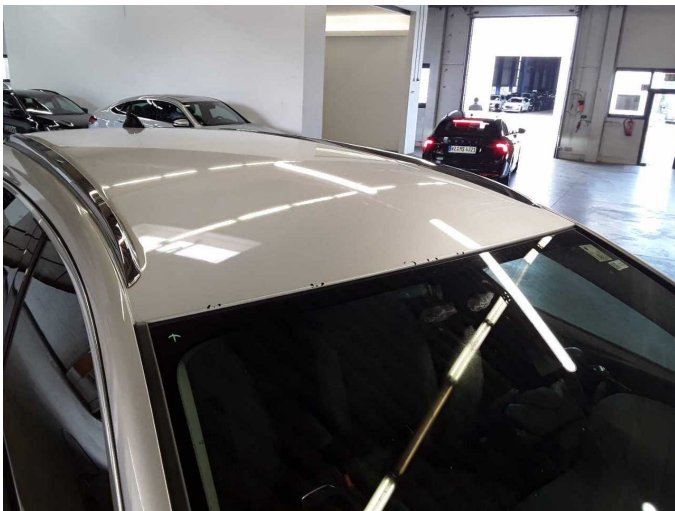
| No. | Component group | Description |
|---|---|---|
| 10 | Roof | Roof - Stone chips - Paint |

**Damage 10:** Roof: Roof - Stone chips - Paint

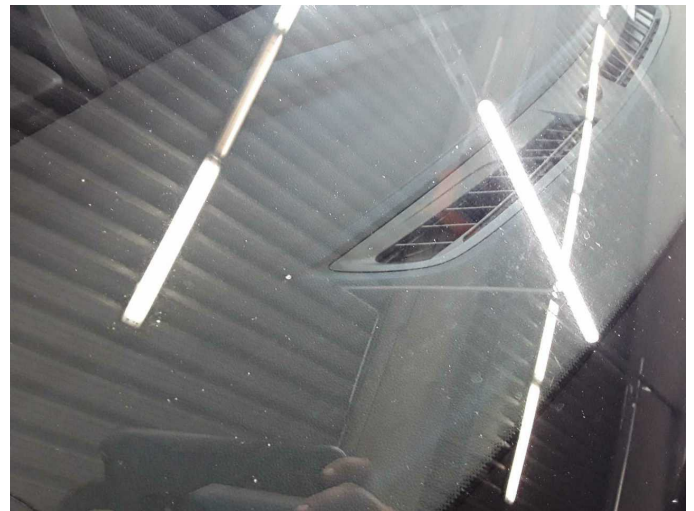
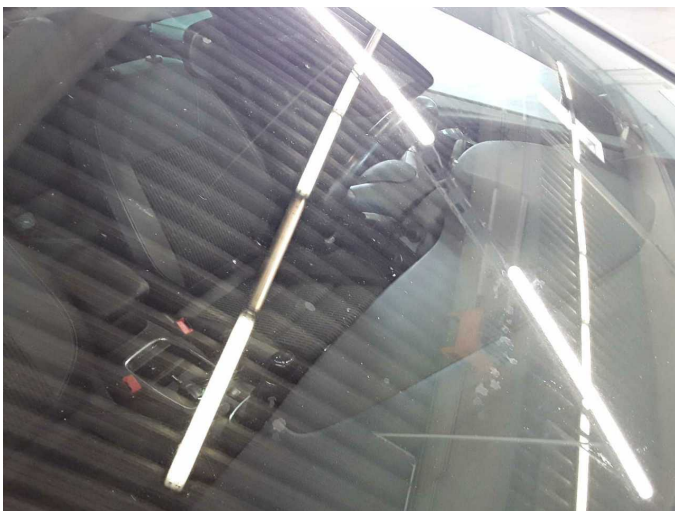
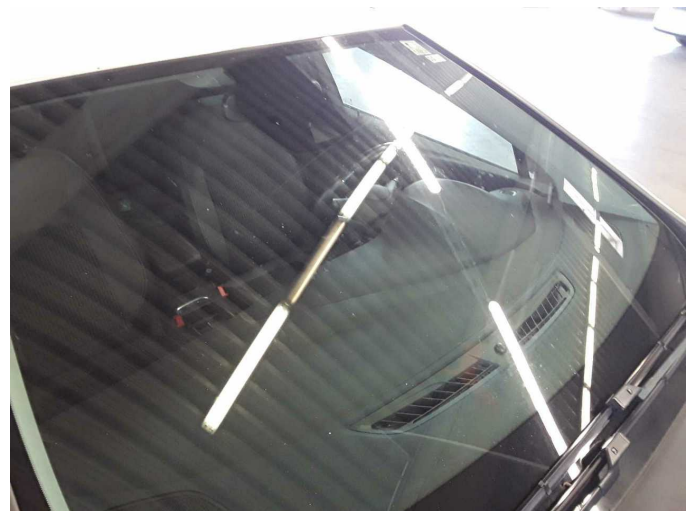
| 1 | Vehicle glazing | Windscreen (Steinschläge) - Stone chips - No deduction |

**Wear and tear 1:** Vehicle glazing: Windscreen (Steinschläge) - Stone chips - No deduction

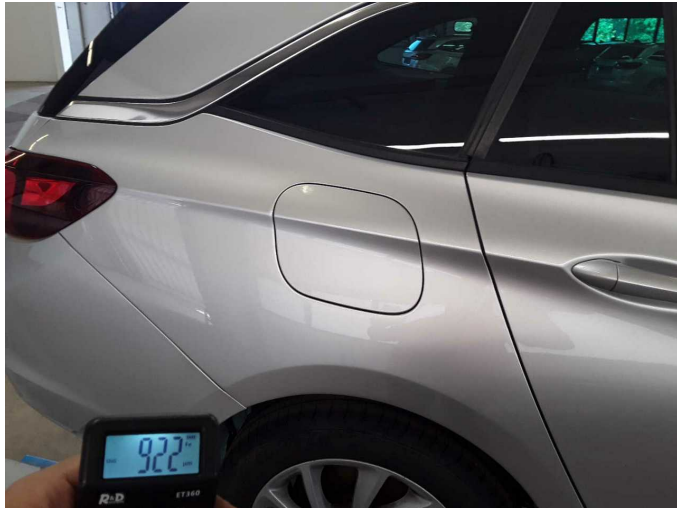
| 1 | Side panel - rear right side, Door - rear right side, Door - front right side, Professionally carried out |

| Side panel - rear right side | 922 µm | Door - rear right side | 205 µm |

Side panel - rear right side: 922 µm

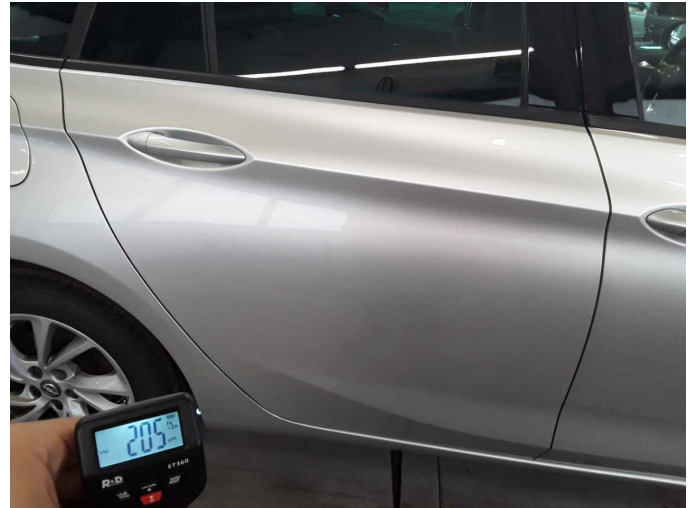
Door - rear right side: 205 µm

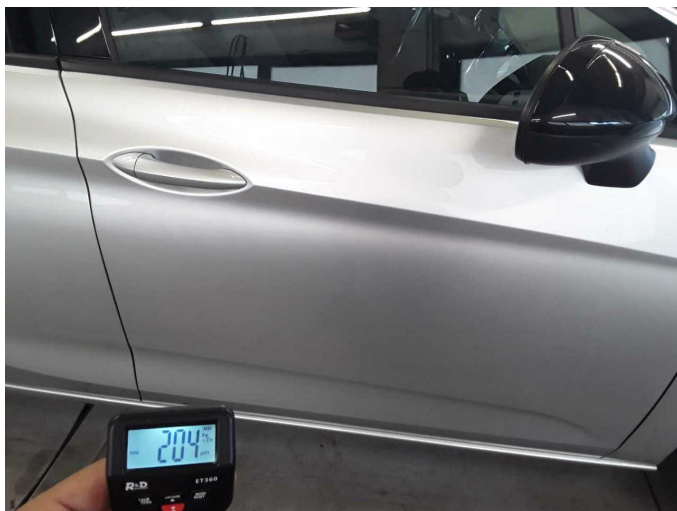
| Door - front right side | 204 µm | | |

Door - front right side: 204 µm
