Expertise

Protocol number: 46594656  
Order No. / Reference: 26712362  
Inspection date: 15 Jul 2026

Manufacturer: Volkswagen

Model: Caddy 2.0 TDI BMT (7-Si.) Caddy Maxi

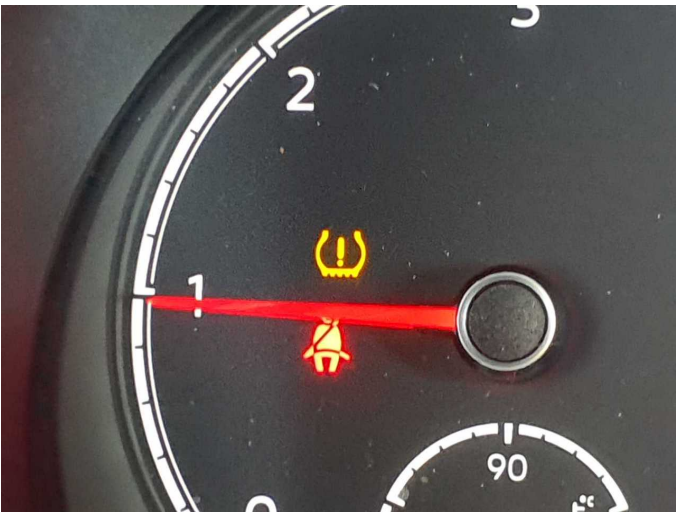
| No. | Component group | Description |
|---|---|---|
| 2 | Instrument panel | Indicator light (Reifendruck) - on - Perform diagnosis |

Damage 2: Instrument panel: Indicator light (Reifendruck) - on - Perform diagnosis

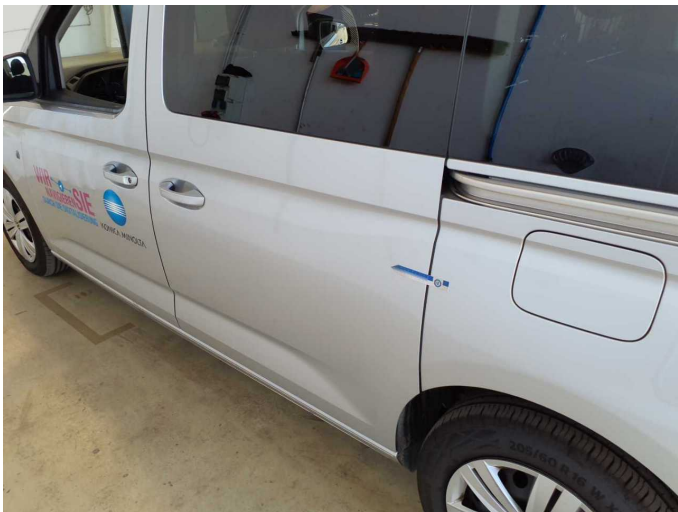
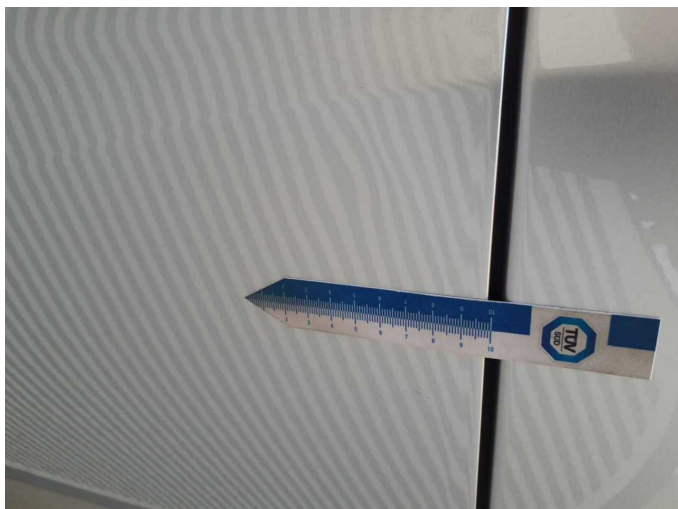
| No. | Component group | Description |
|---|---|---|
| 3 | Sliding door - left side | Sliding door - dent(s) - Smooth repair work |

Damage 3: Sliding door - left side: Sliding door - dent(s) - Smooth repair work

**Damage 3:** Sliding door - left side: Sliding door - dent(s) - Smooth repair work

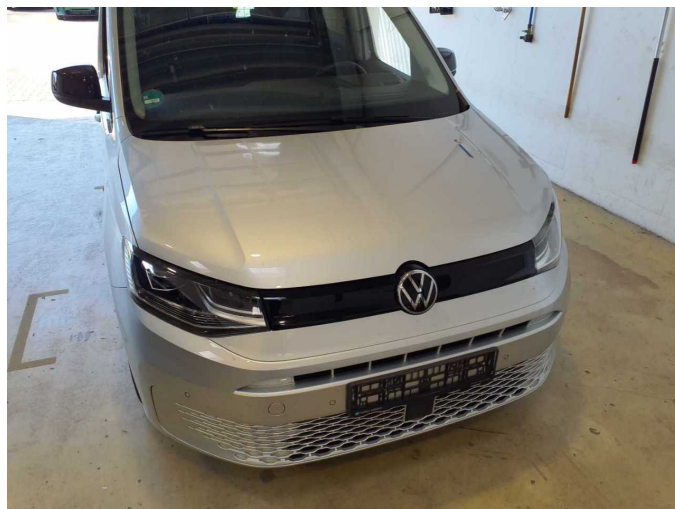
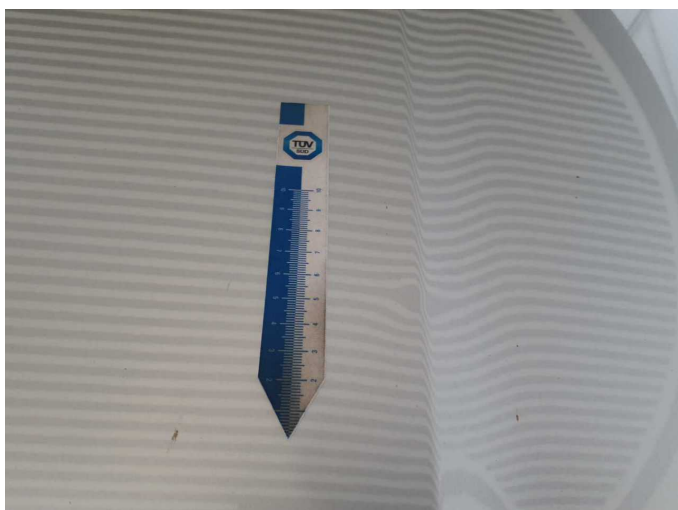
| No. | Component group | Description |
|---|---|---|
| 4 | Bonnet | Bonnet - dent(s) - Smart repair |

**Damage 4:** Bonnet: Bonnet - dent(s) - Smart repair

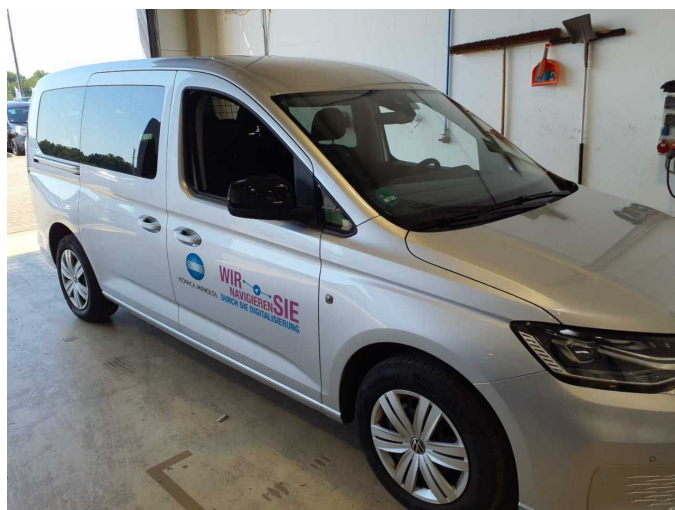
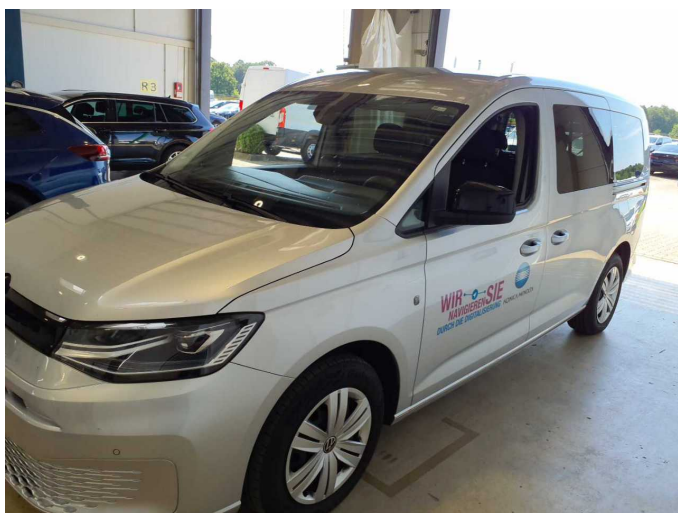
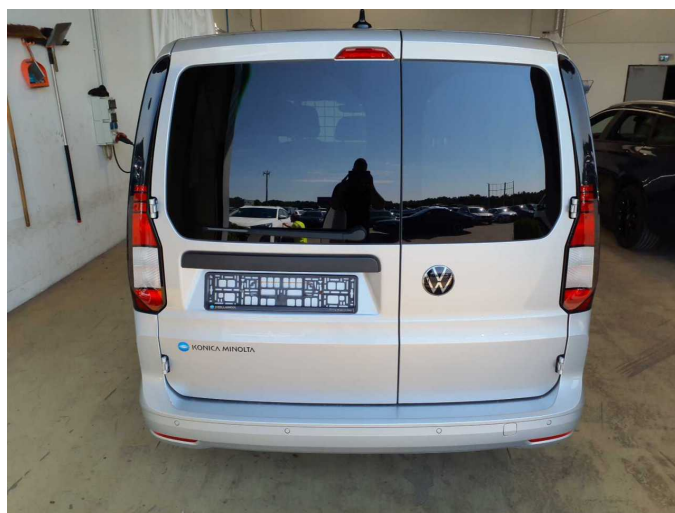
| No. | Component group | Description |
|---|---|---|
| 5 | Body | Body - Glued / labelled - De-glue / neutralise |

**Damage 5:** Body: Body - Glued / labelled - De-glue / neutralise

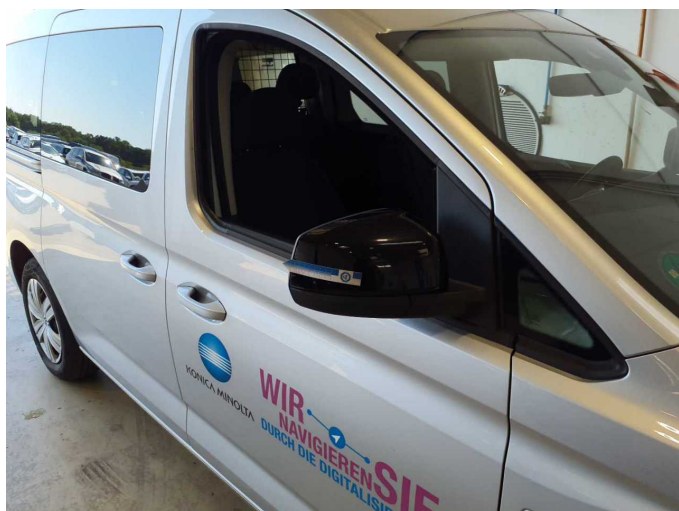
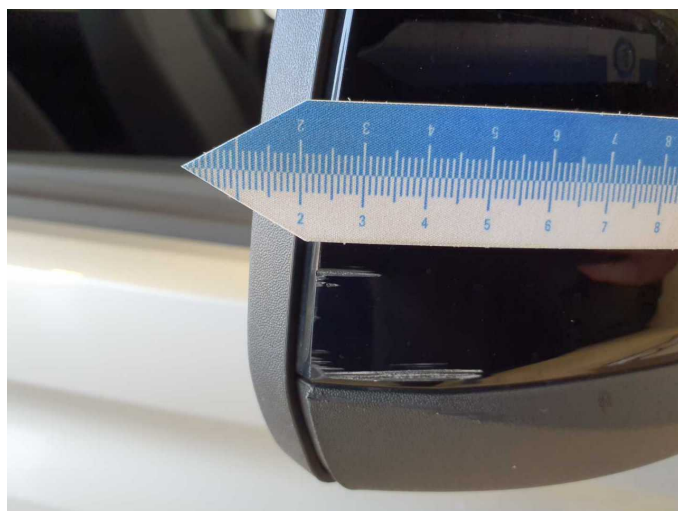
| No. | Component group | Description |
|---|---|---|
| 7 | Wing mirror - right side | Cap - Scratch(es) - Paint |

**Damage 7:** Wing mirror - right side: Cap - Scratch(es) - Paint

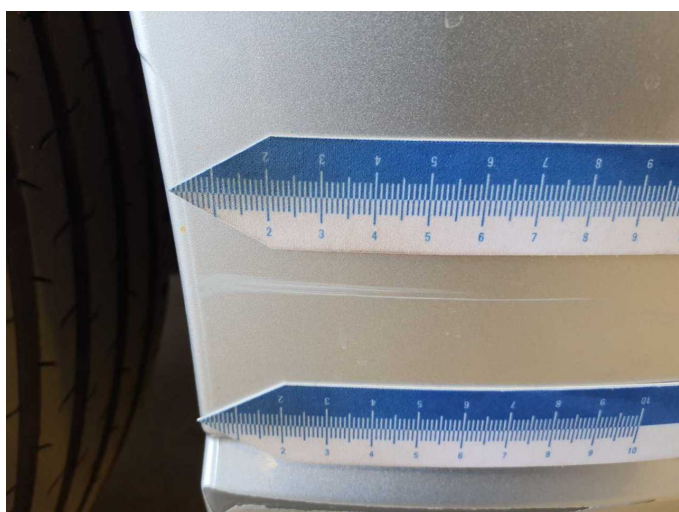
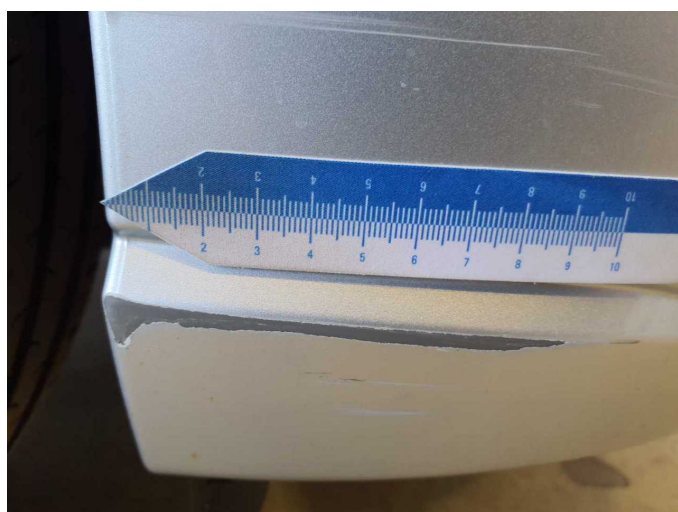
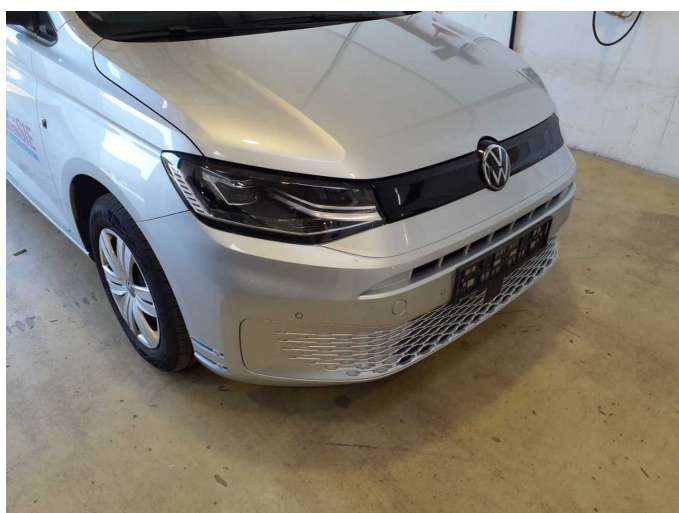
| No. | Component group | Description |
|---|---|---|
| 8 | Front bumper | Front bumper - Scratch(es) - Paint |

**Damage 8:** Front bumper: Front bumper - Scratch(es) - Paint

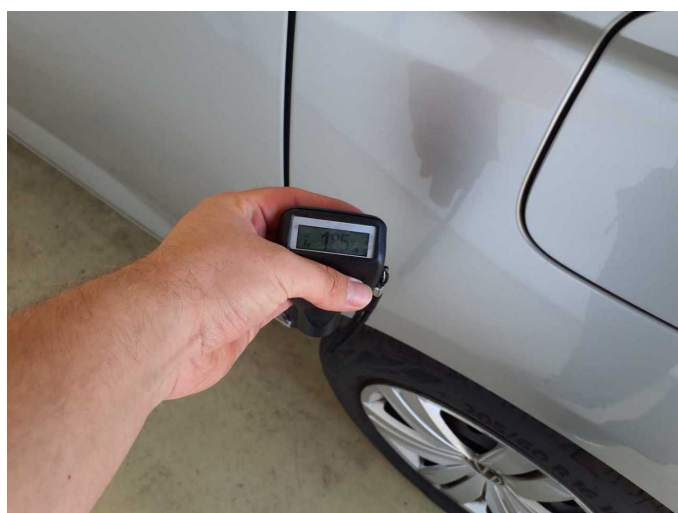
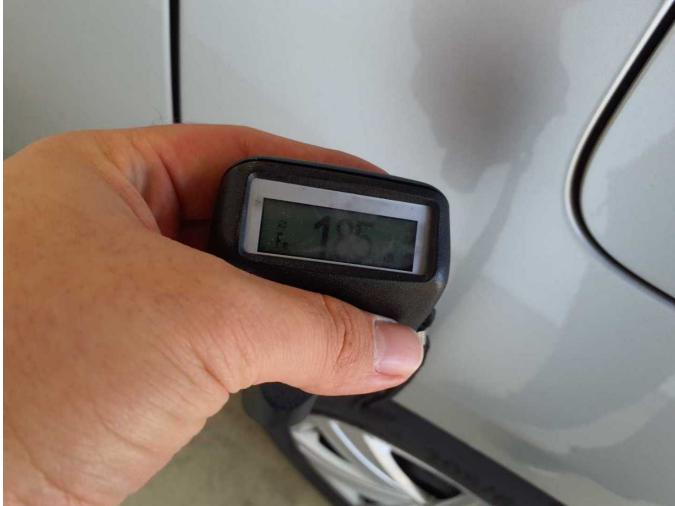
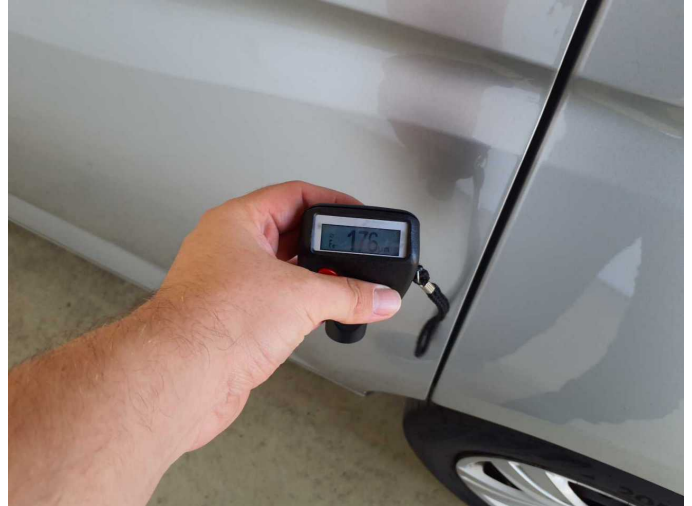
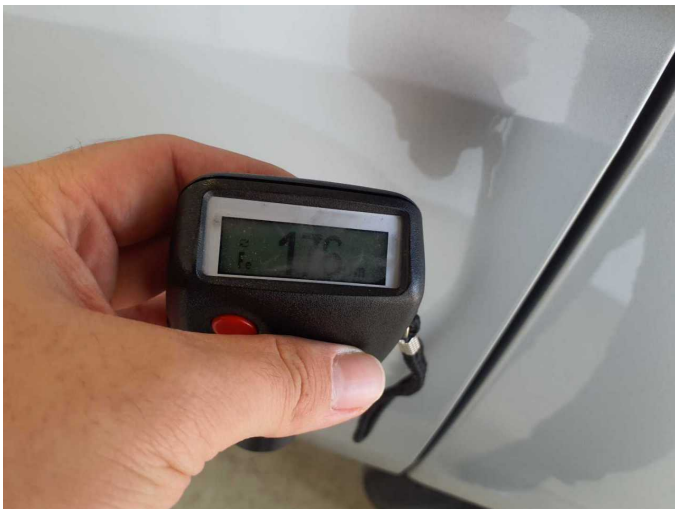
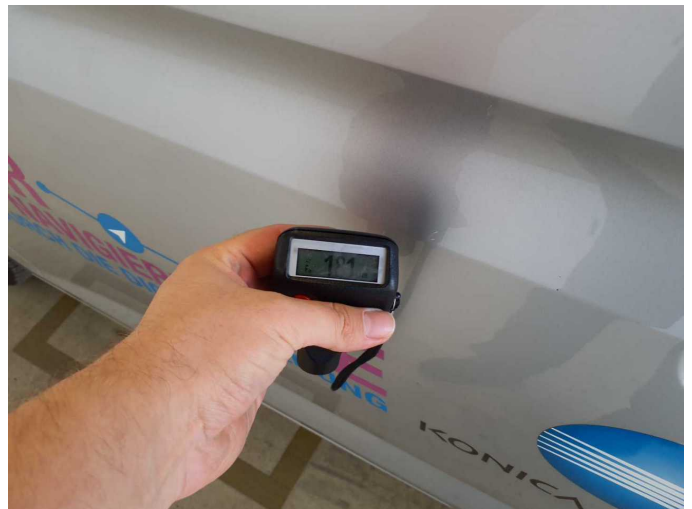
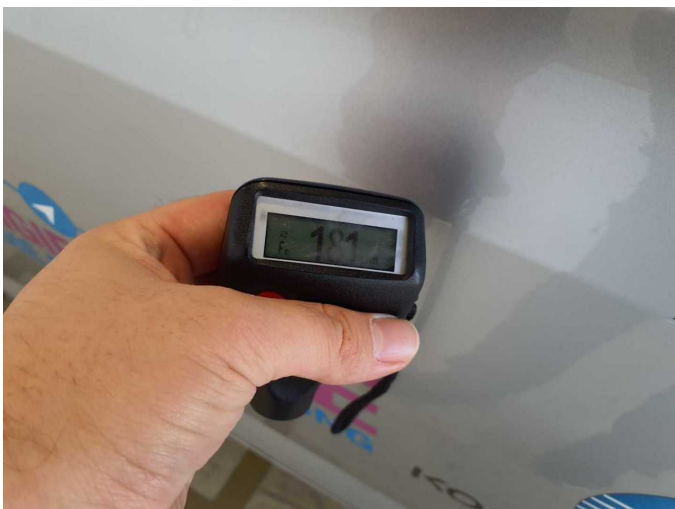
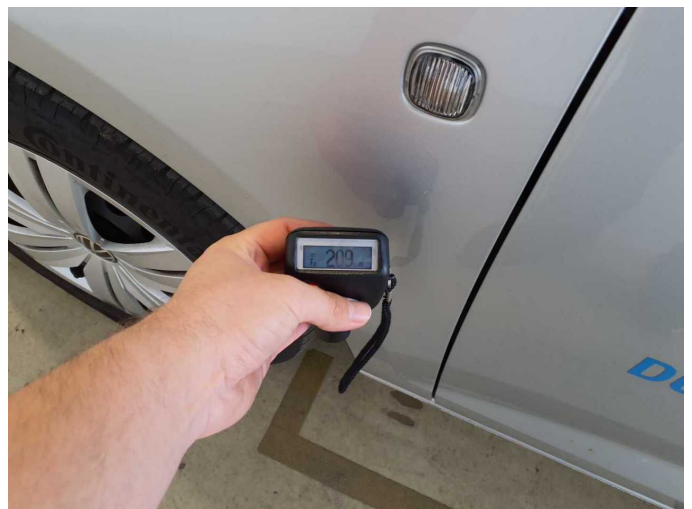
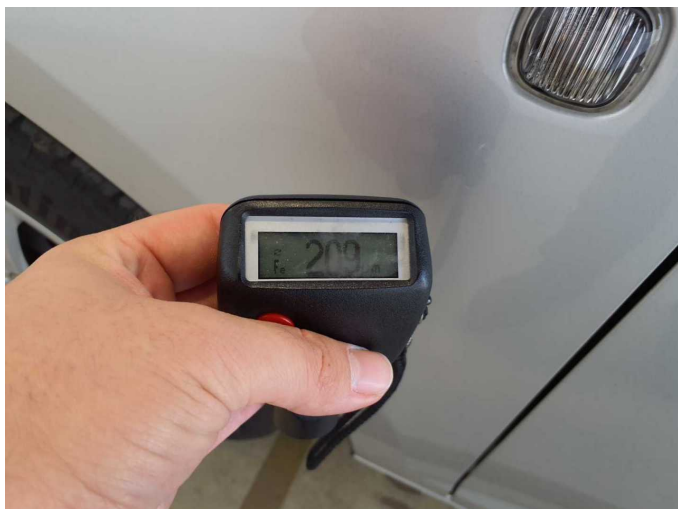
1 Mudguard - left side, Side panel - rear left side, Door - rear left side, Door - front left side, Professionally carried out

| Mudguard - left side | 209 µm | Side panel - rear left side | 185 µm |
| Door - rear left side | 176 µm | Door - front left side | 181 µm |

**Repainting 1:** Mudguard - left side, Side panel - rear left side, Door - rear left side, Door - front left side
