Expertise

Protocol number: 46520930  
Order No. / Reference: 26546968  
Inspection date: 7 Jul 2026

Manufacturer: Ford

Model: Galaxy 2.5 Duratec FHEV VIGNALE

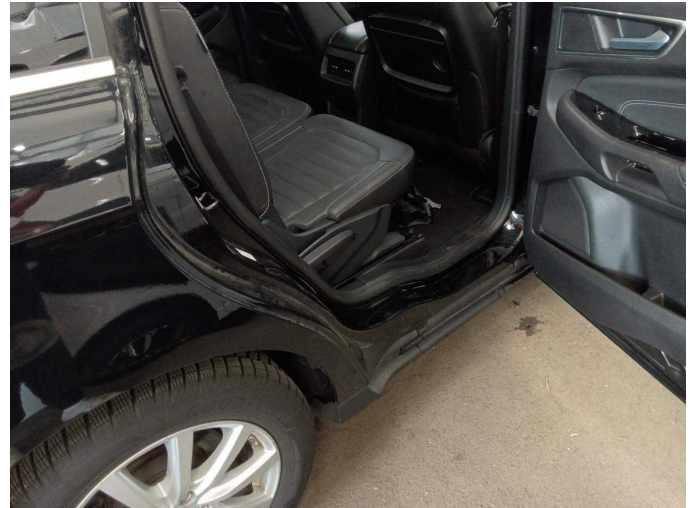
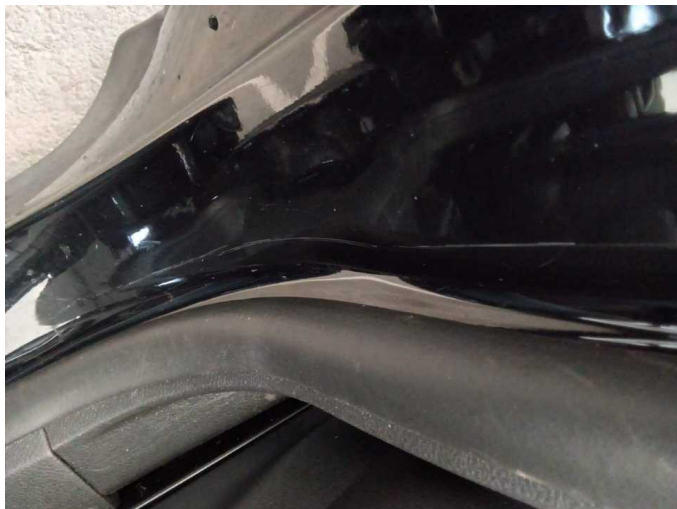
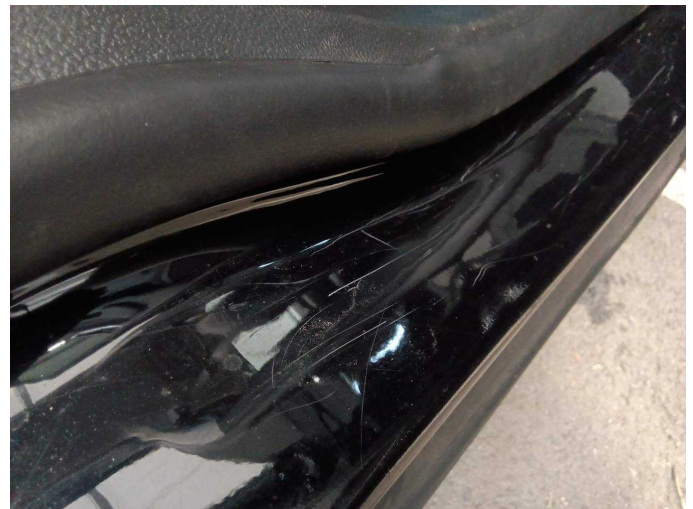
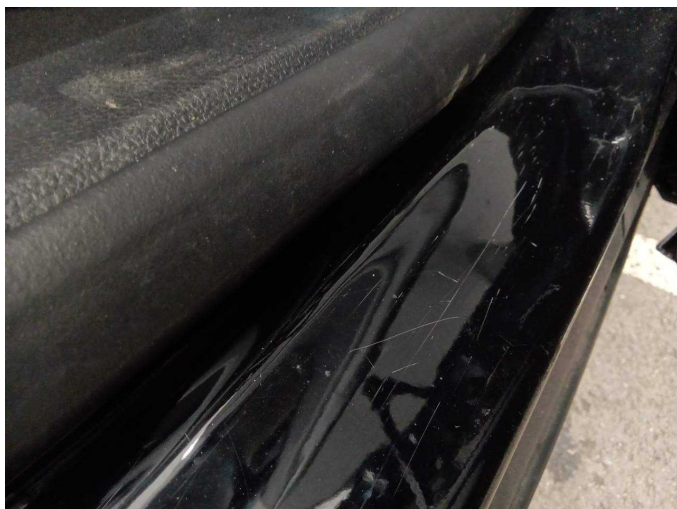
| No. | Component group | Description |
|---|---|---|
| 1 | Side panel - rear right side | Sill - Scratch(es) - Smart repair |

**Damage 1:** Side panel - rear right side: Sill - Scratch(es) - Smart repair

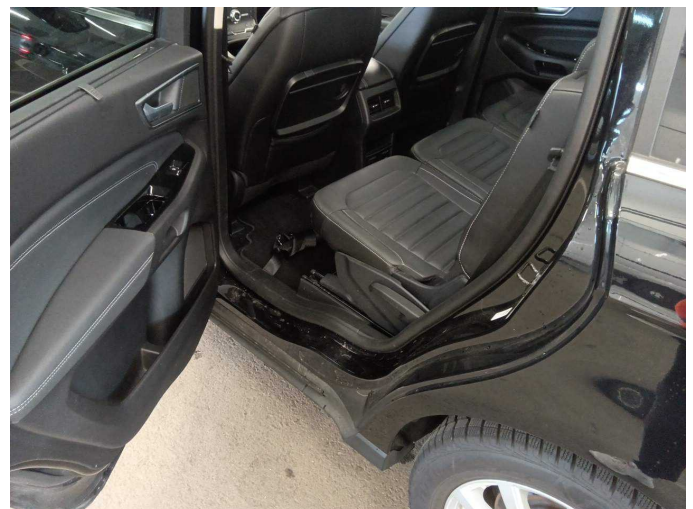
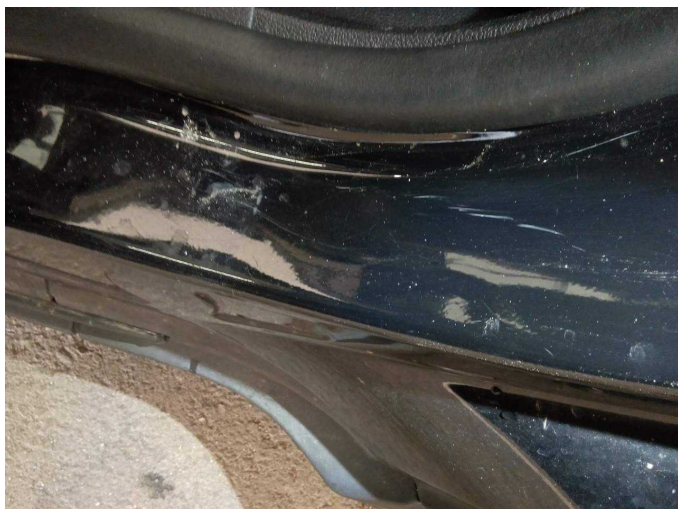
| No. | Component group | Description |
|---|---|---|
| 2 | Side panel - rear left side | Sill - Scratch(es) - Smart repair |

**Damage 2:** Side panel - rear left side: Sill - Scratch(es) - Smart repair

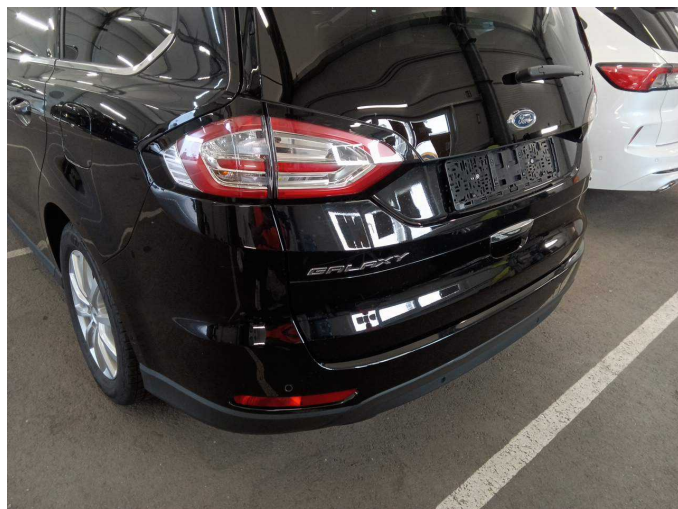
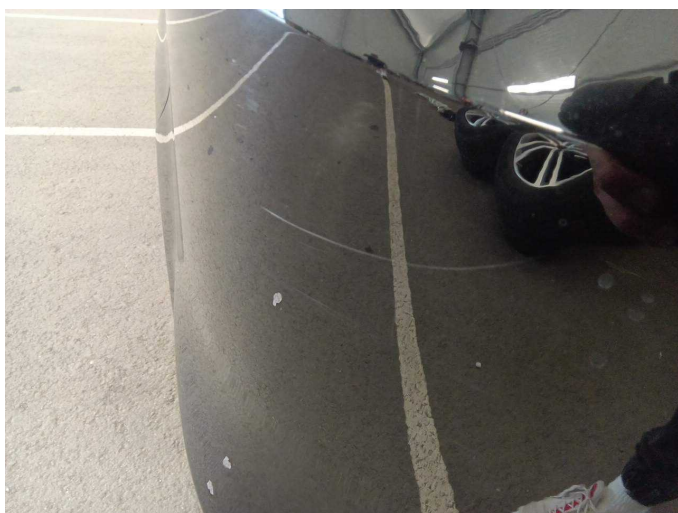
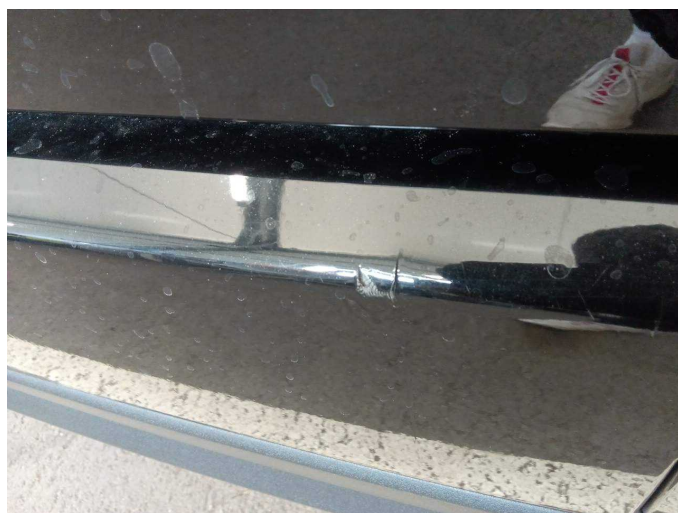
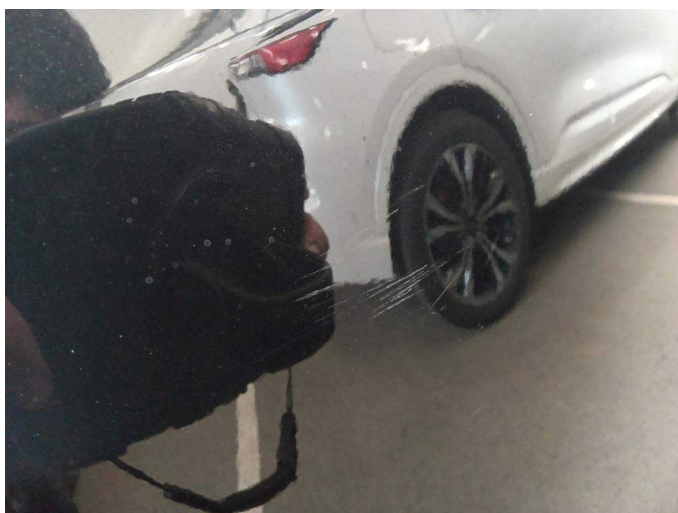
| No. | Component group | Description |
|---|---|---|
| 4 | Rear bumper | Rear bumper - Scratch(es) - Paint |

**Damage 4:** Rear bumper: Rear bumper - Scratch(es) - Paint

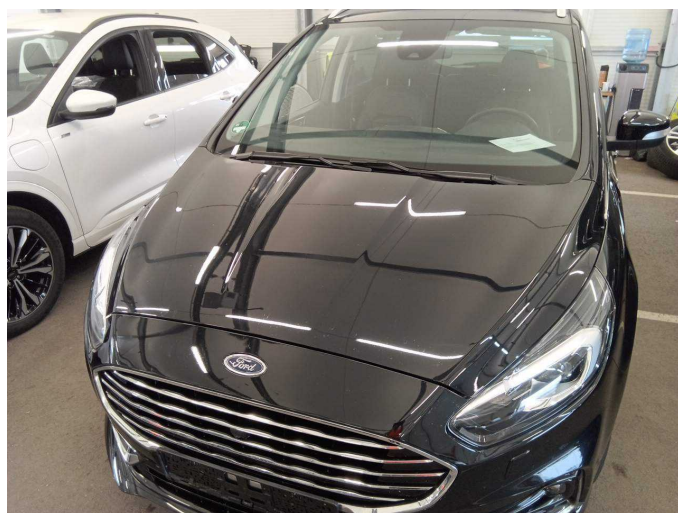
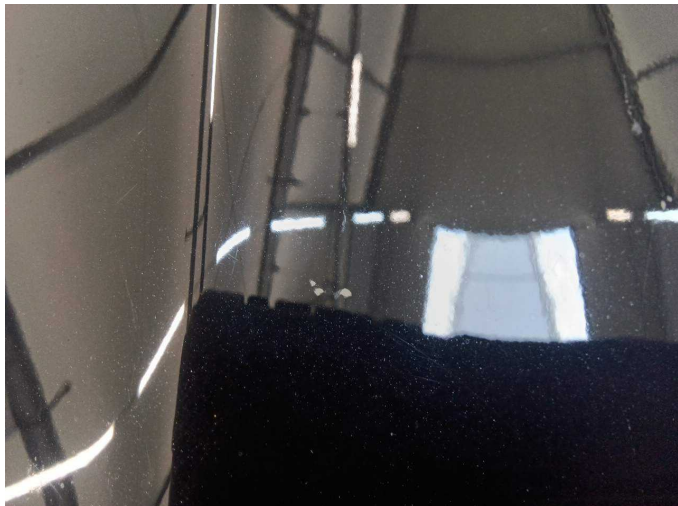
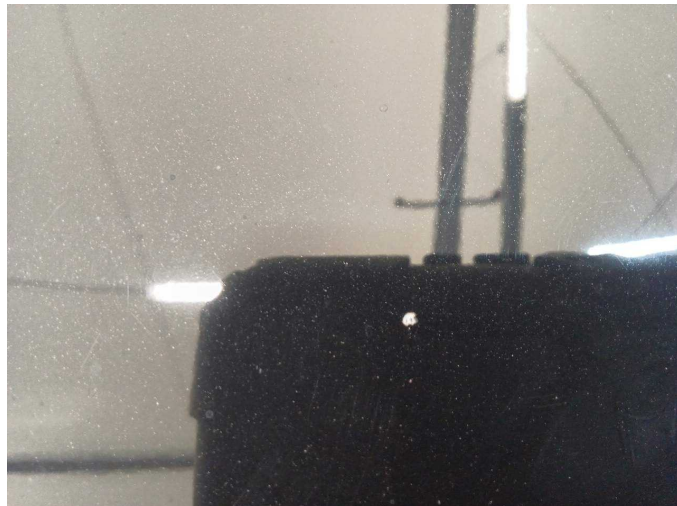
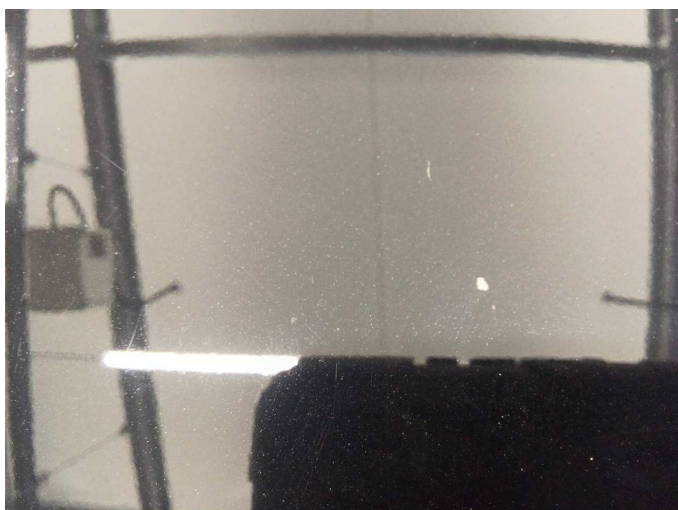
| No. | Component group | Description |
|---|---|---|
| 5 | Bonnet | Bonnet (Übermäßige Steinschläge) - Stone chips - Paint |

**Damage 5:** Bonnet: Bonnet (Übermäßige Steinschläge) - Stone chips - Paint

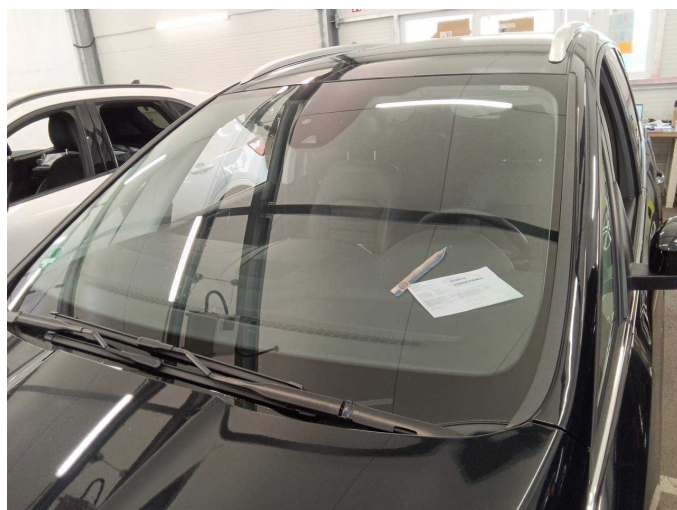
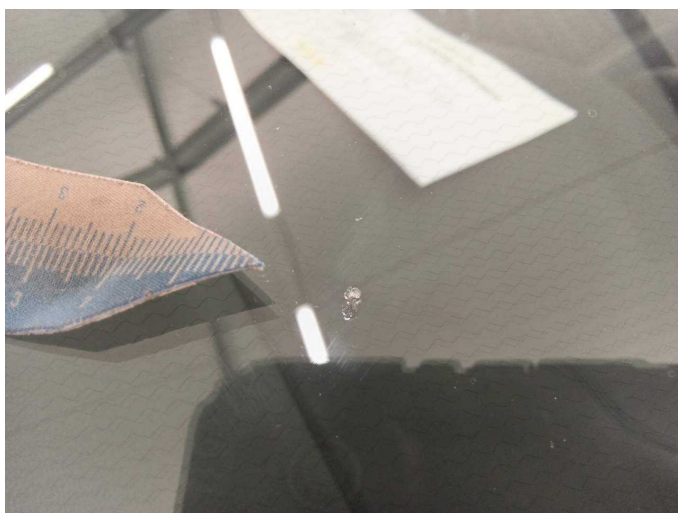
| No. | Component group | Description |
|---|---|---|
| 6 | Vehicle glazing | Windscreen, heated (Großer Abplatzer im Fahrersichtfeld, Sichtbeeinträchtigung) - Stone chips - Replace |

**Damage 6:** Vehicle glazing: Windscreen, heated (Großer Abplatzer im Fahrersichtfeld, Sichtbeeinträchtigung) - Stone chips - Replace

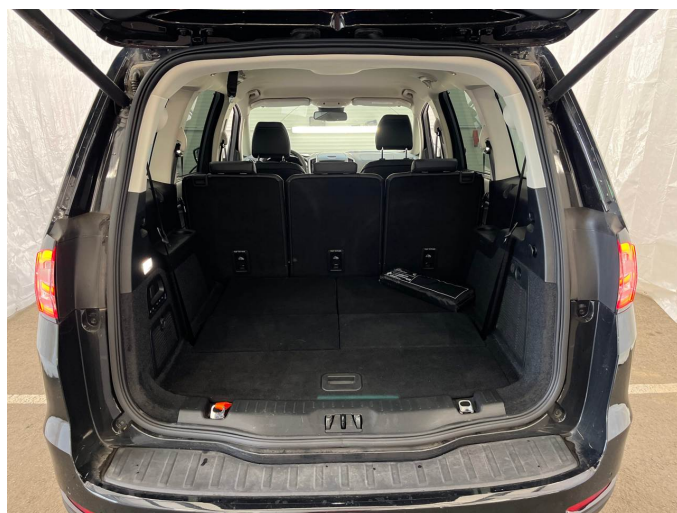
Interior - Separation net

**Missing part 1:** Interior: Separation net - Missing - Replace
