Expertise

Protocol number: 46398412
Order No. / Reference: 26571317-1
Inspection date: 24 Jun 2026

Manufacturer: Ford

Model: Transit 350 L3H3 Lkw VA Trend

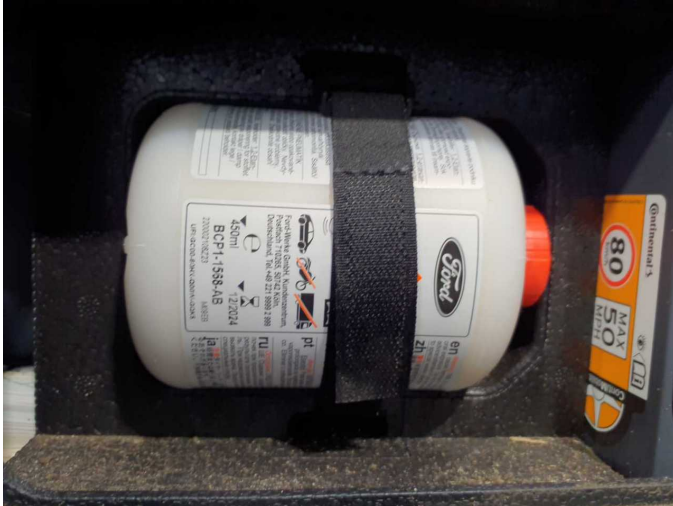
Damage 1: Equipment: Tirefit filler - Expired - Replace

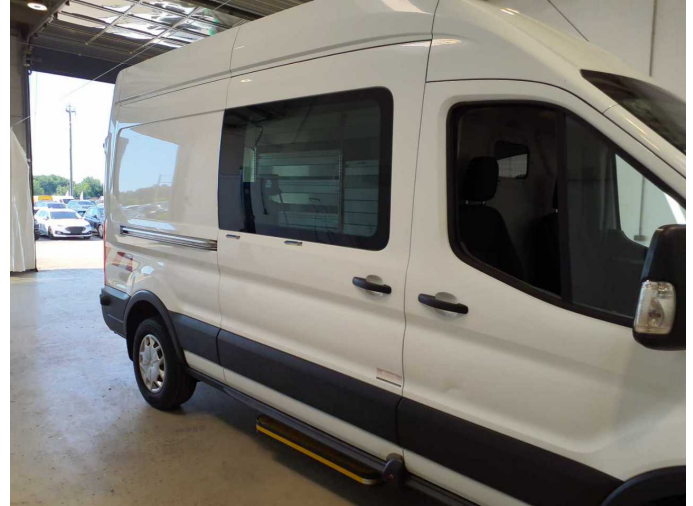
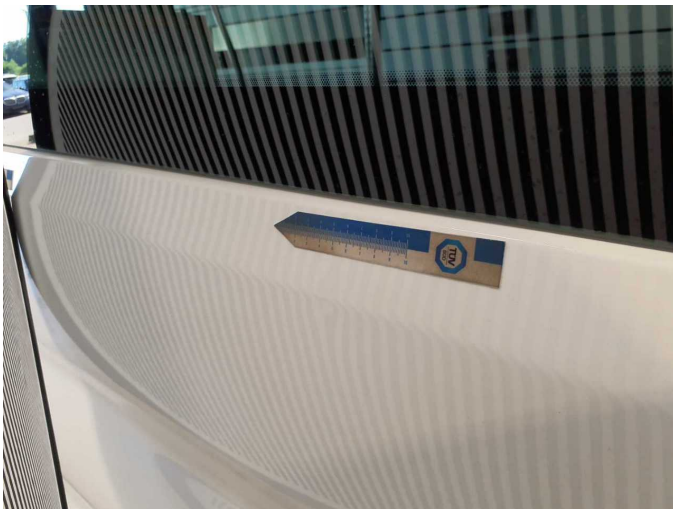
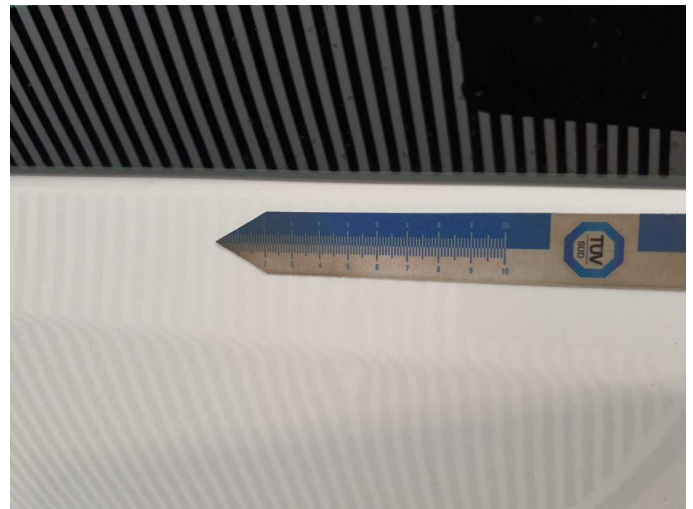
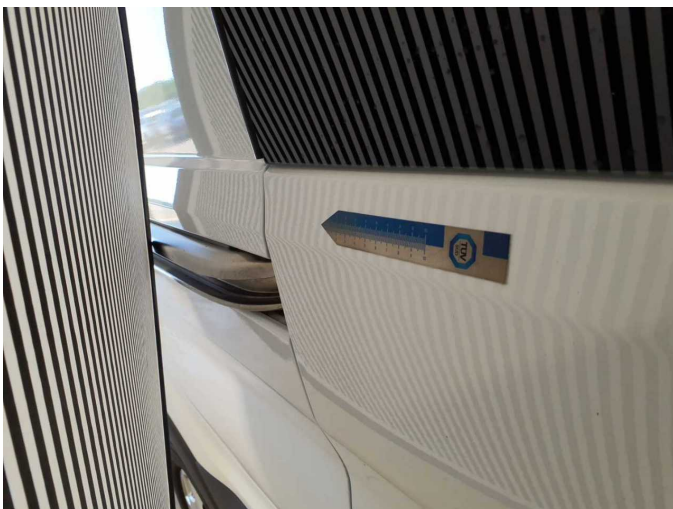
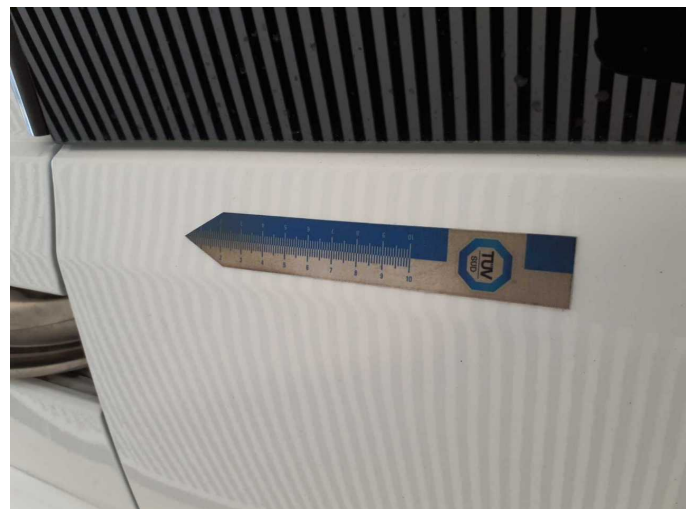
Damage 2: Sliding door, right: Sliding door - dent(s) - Smart repair

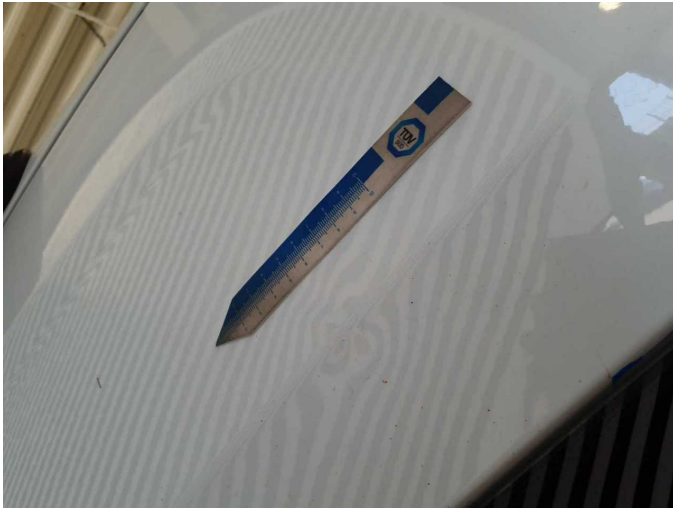
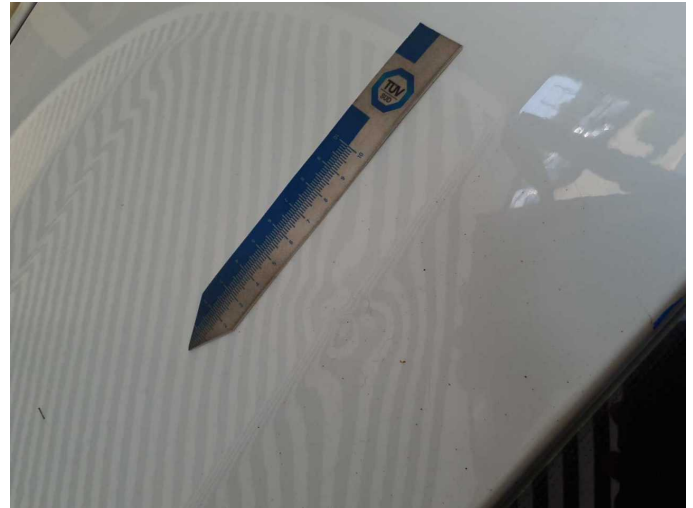
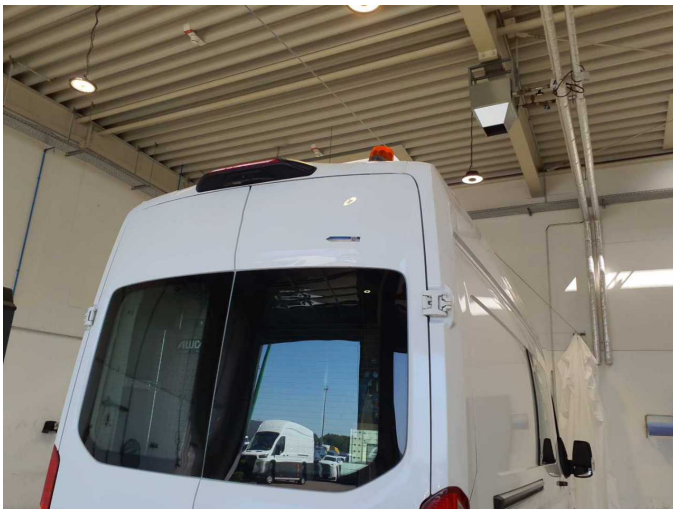
Damage 3: Boot lid / rear door: Rear door - right side - dent(s) - Smart repair

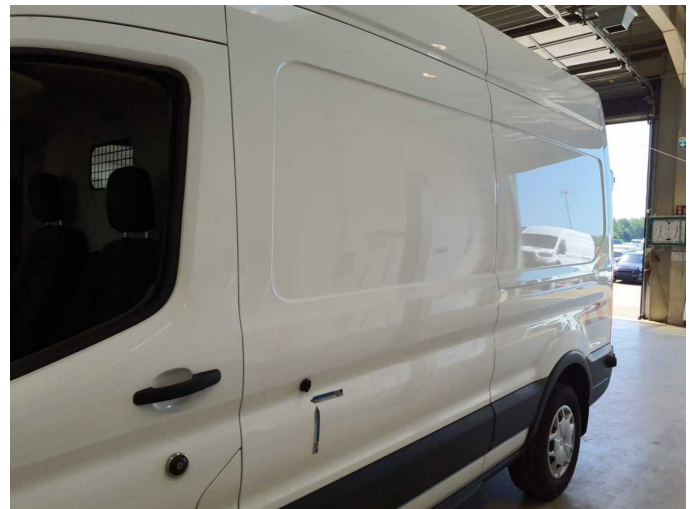
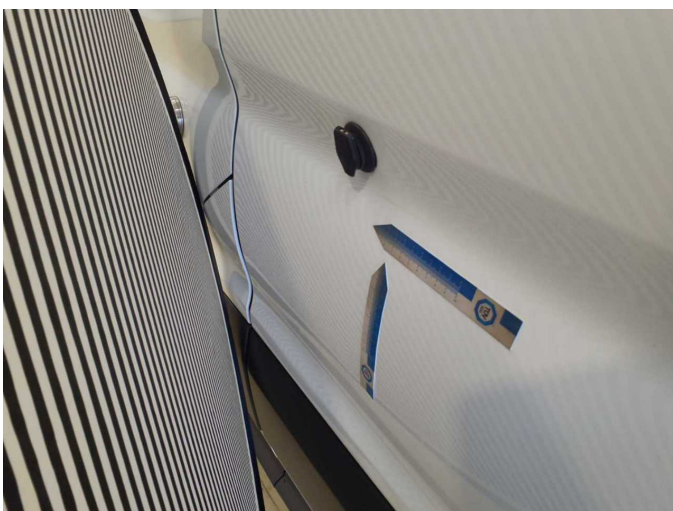
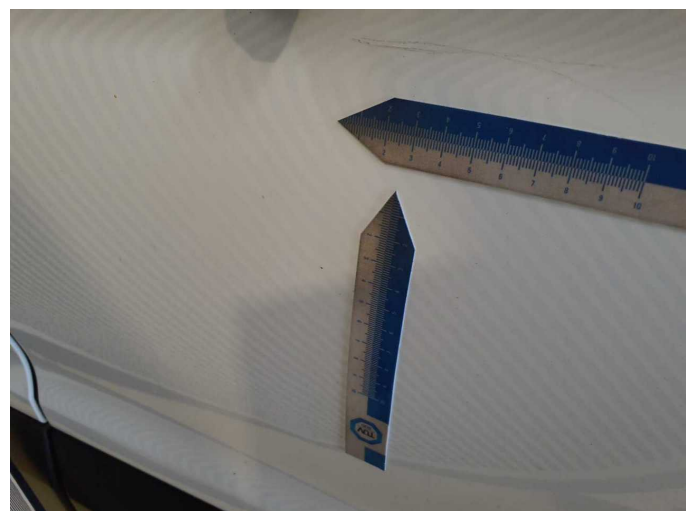
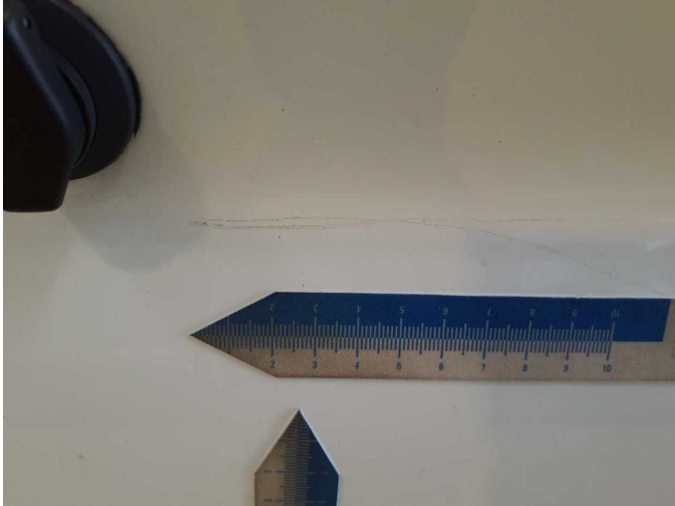
Damage 4: Side panel - rear left side: Side panel - Dent / paintcoat damage - Smart repair

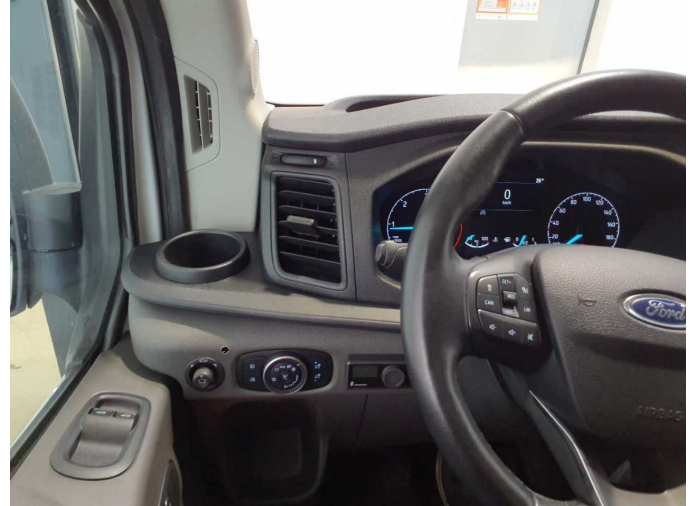
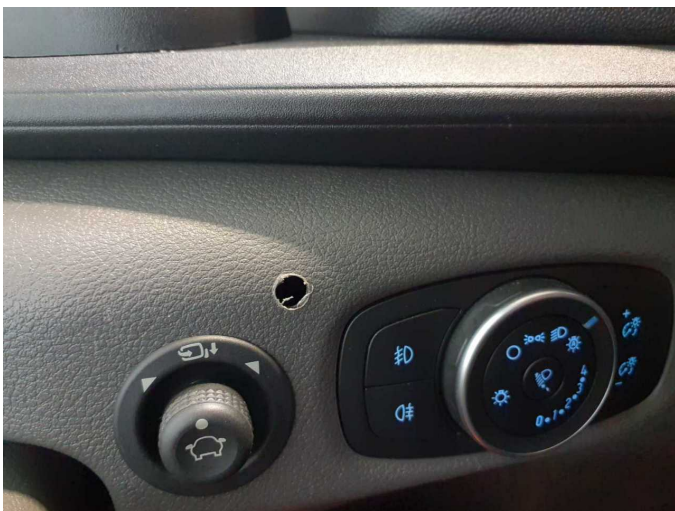
Damage 5: Instrument panel: Instrument panel (Links) - Holes - Replace

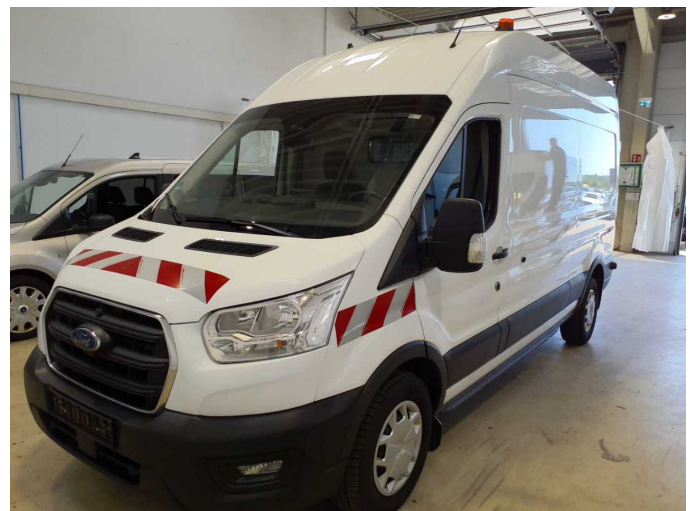
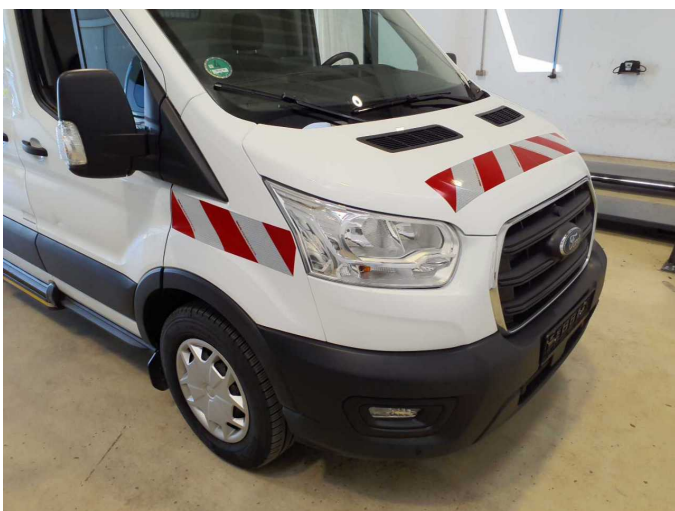
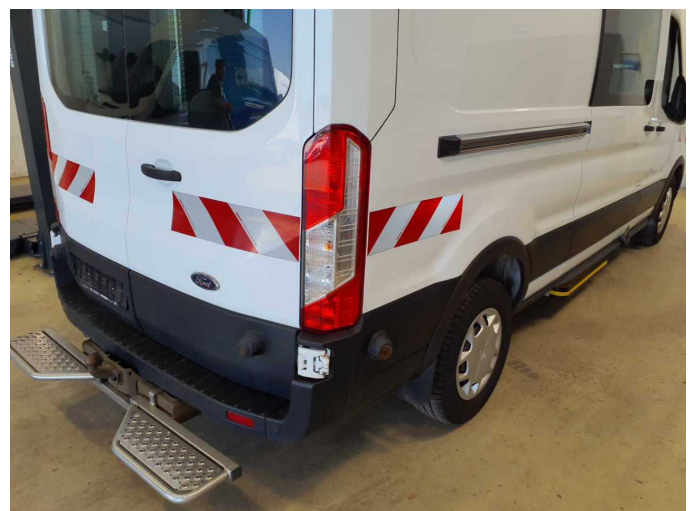
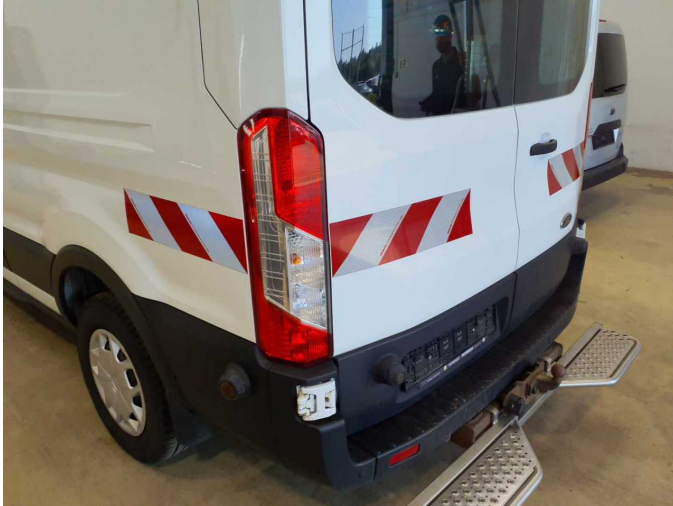
Damage 6: Body: Body - Glued / labelled - De-glug / neutralise

Damage 6: Body: Body - Glued / labelled - De-glue / neutralise

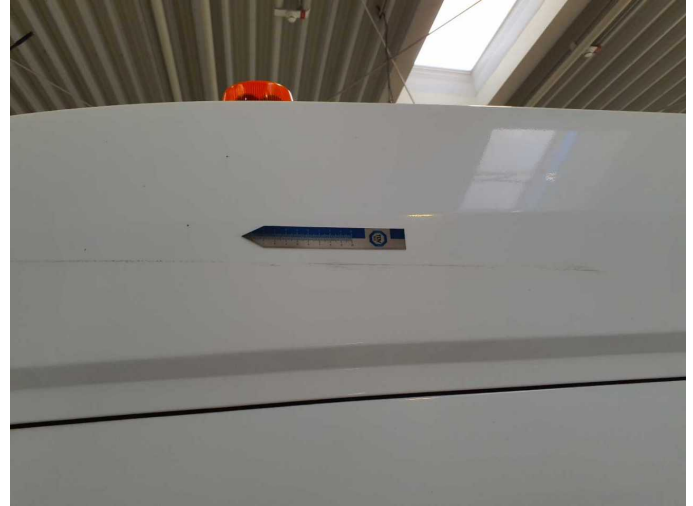
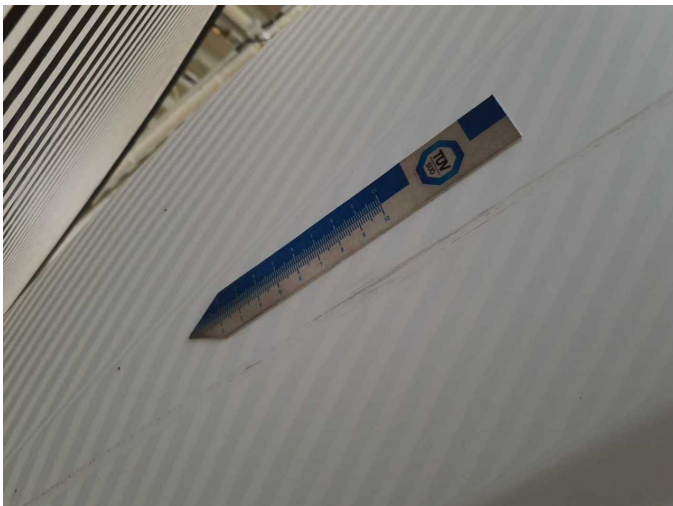
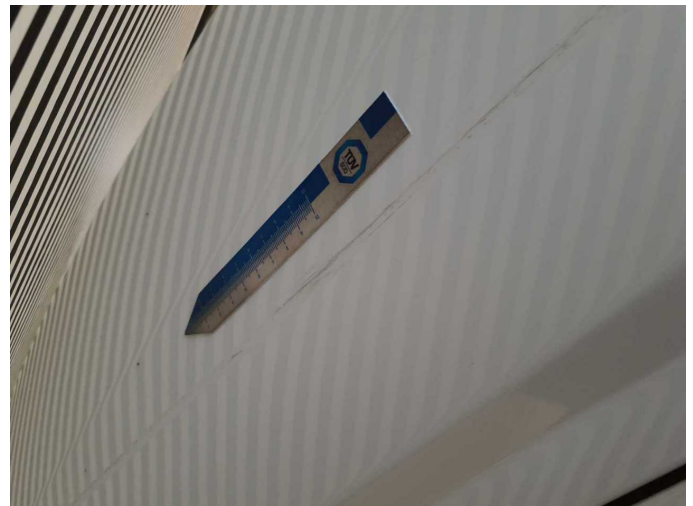
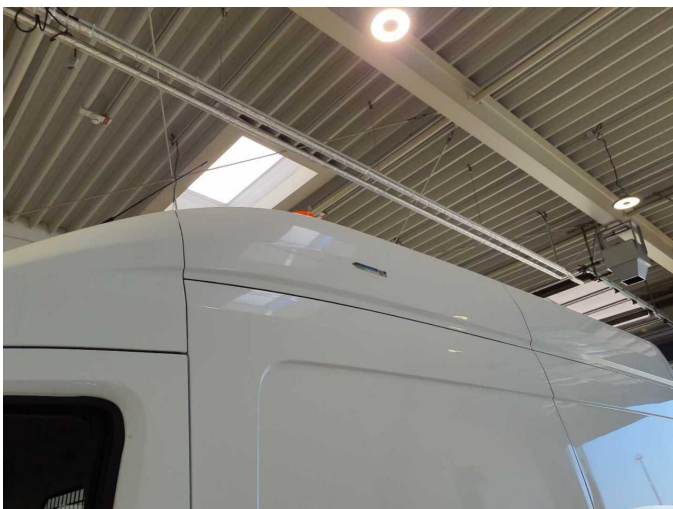
Damage 7: Roof: Roof rail - left side - Dent / paintcoat damage - Paint

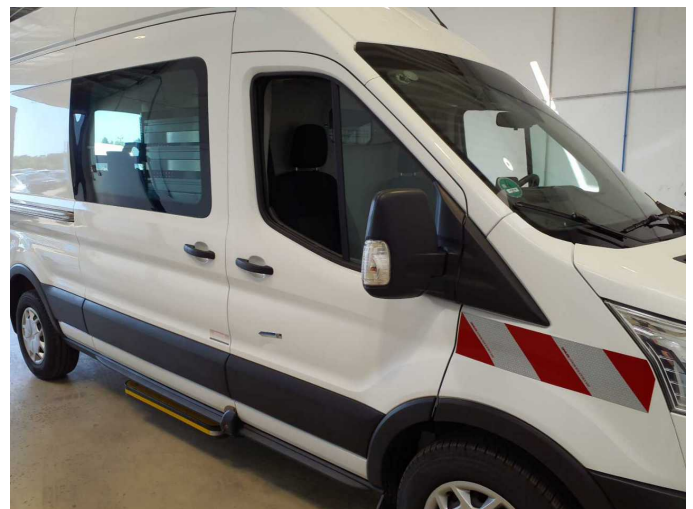
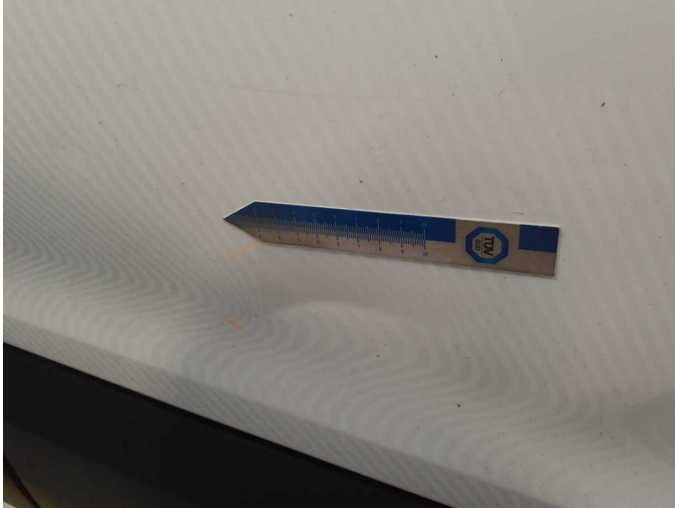
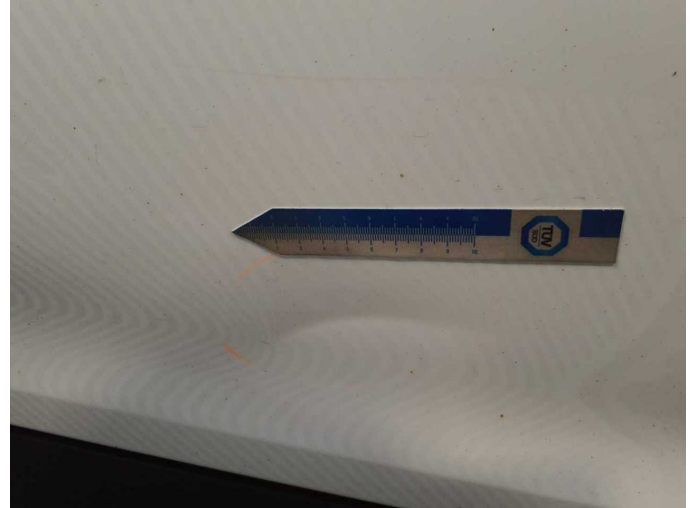
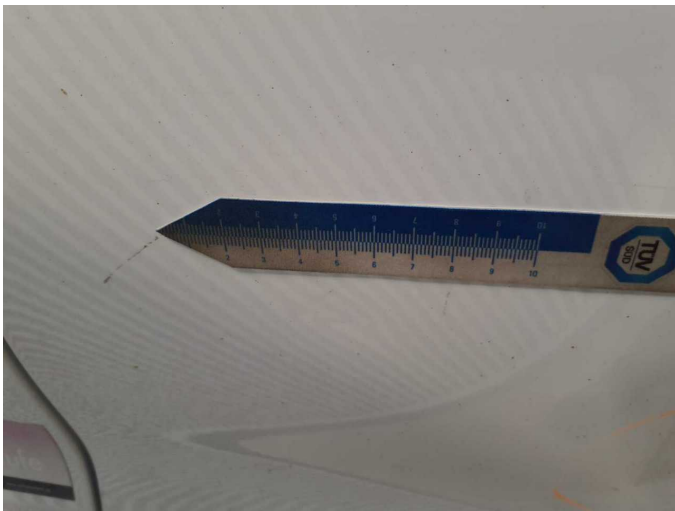
Damage 8: Door - front right side: Door (unterhalb) - Deformed - Repair and paint

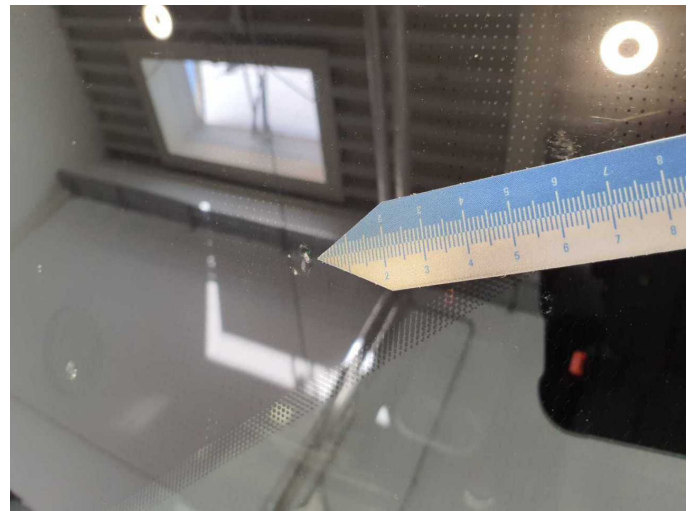
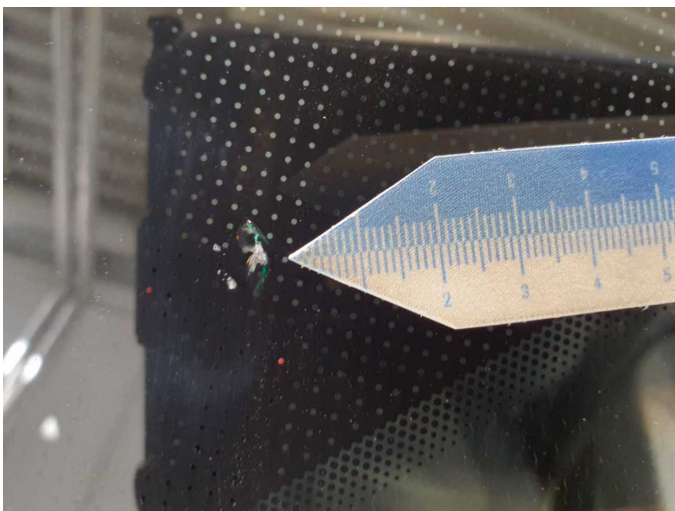
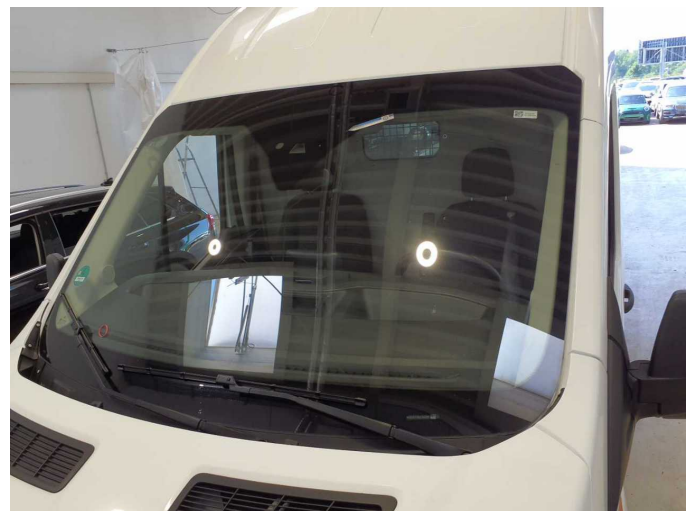
Damage 9: Vehicle glazing: Windscreen - Broken / torn - Replace

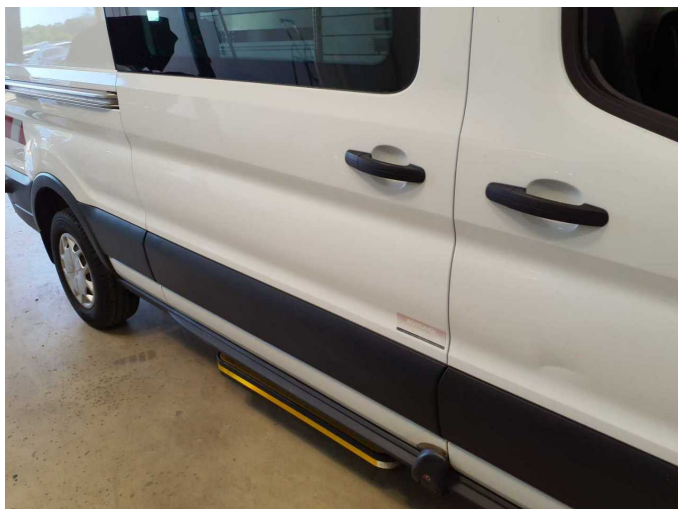
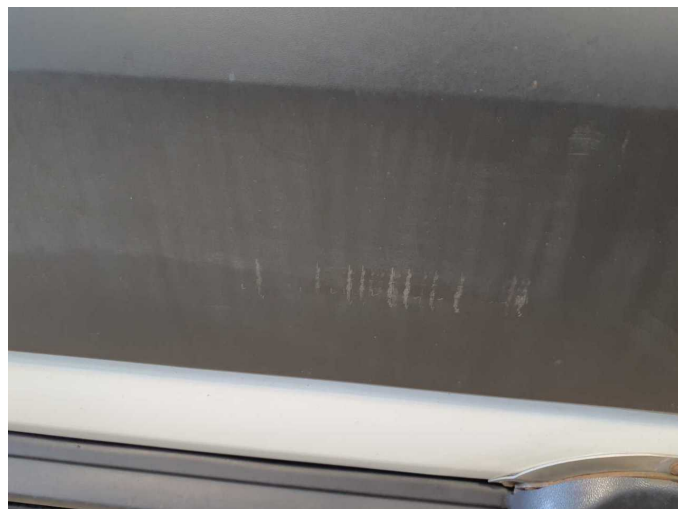
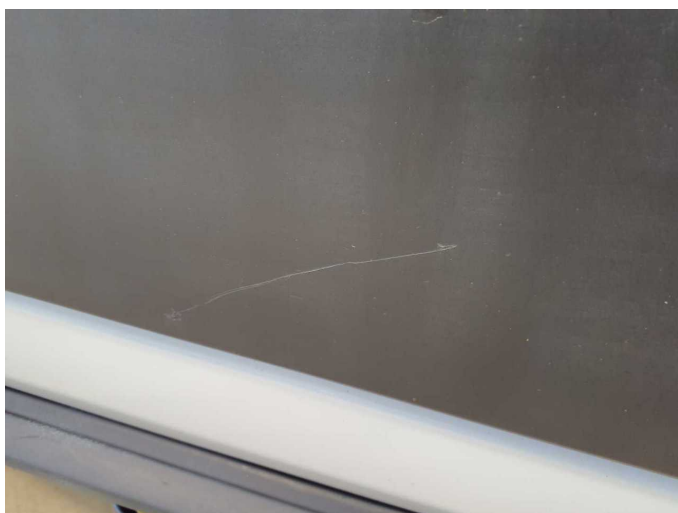
Wear and tear 4: Sliding door, right: Sliding door (Zierleiste) - Scratch(es)
- No deduction
