## Expertise

Protocol number: 46182040  
Order No. / Reference: 26520481  
Inspection date: 24 Jun 2026

Model: C 200 d T 9G-TRONIC

VIN: W1KAH0DB4PF090985

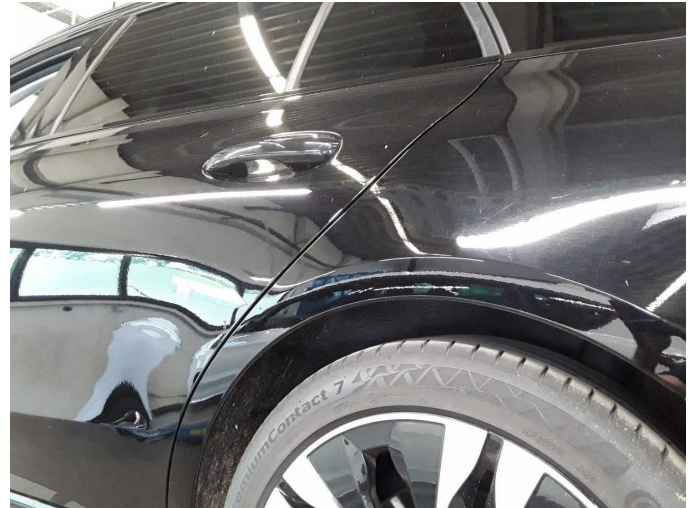
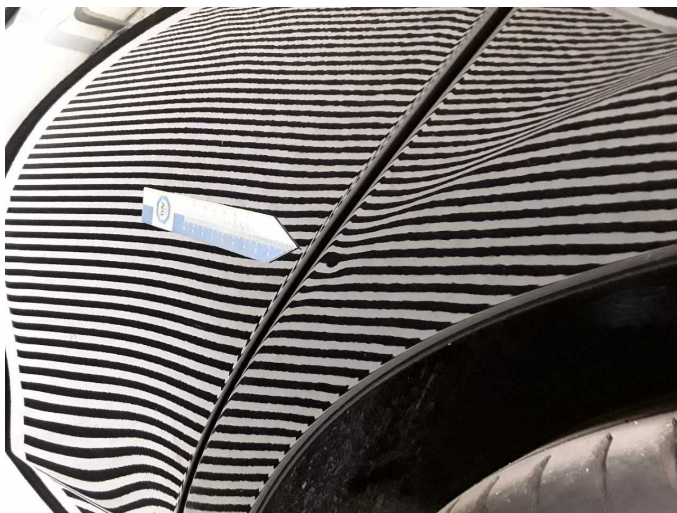
| No. | Component group | Description |
|---|---|---|
| 1 | Side panel - rear left side | Side panel - dent(s) - Smooth repair work |

Damage 1: Side panel - rear left side: Side panel - dent(s) - Smooth repair work

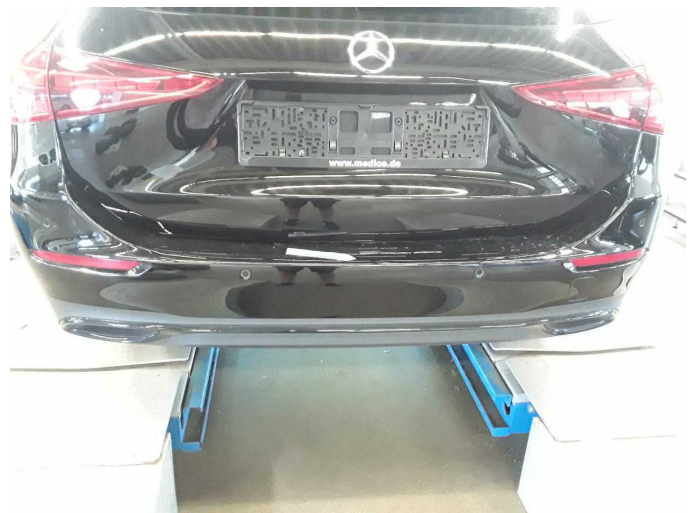
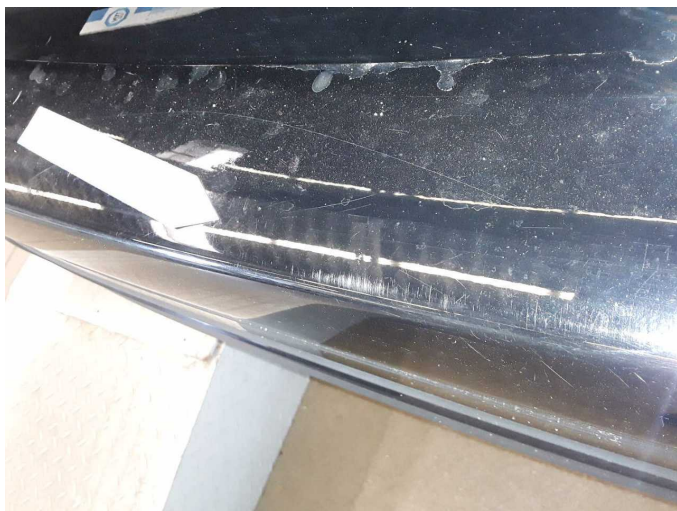
| No. | Component group | Description |
|---|---|---|
| 2 | Rear bumper | Rear bumper - Scratch(es) - Smart repair |

Damage 2: Rear bumper: Rear bumper - Scratch(es) - Smart repair

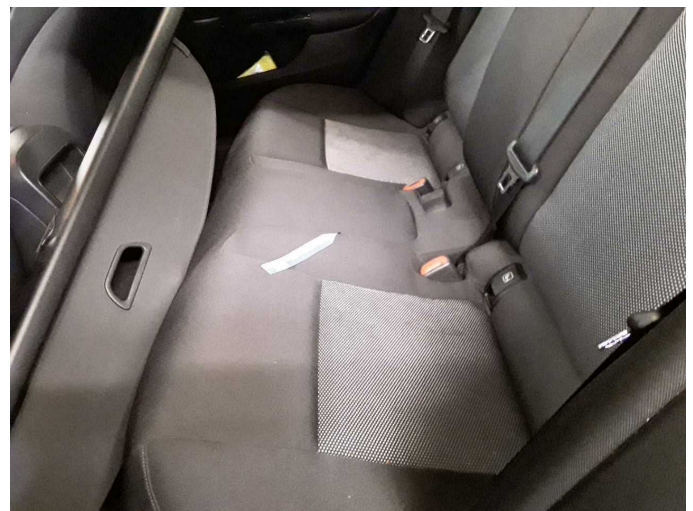
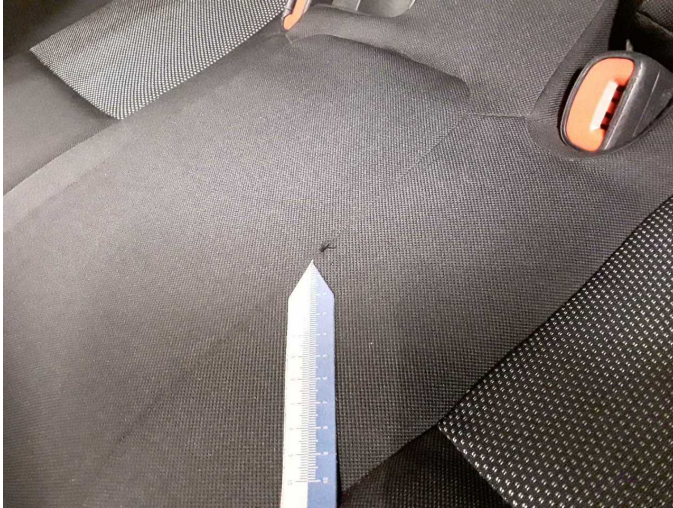
| No. | Component group | Description |
|---|---|---|
| 3 | Seat - rear | Back seat - Porous / cracked - Smart repair |

Damage 3: Seat - rear: Back seat - Porous / cracked - Smart repair

**Damage 3:** Seat - rear: Back seat - Porous / cracked - Smart repair

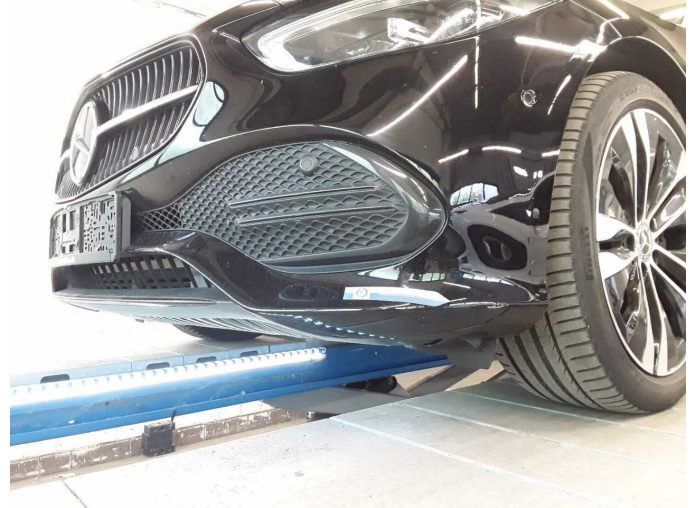
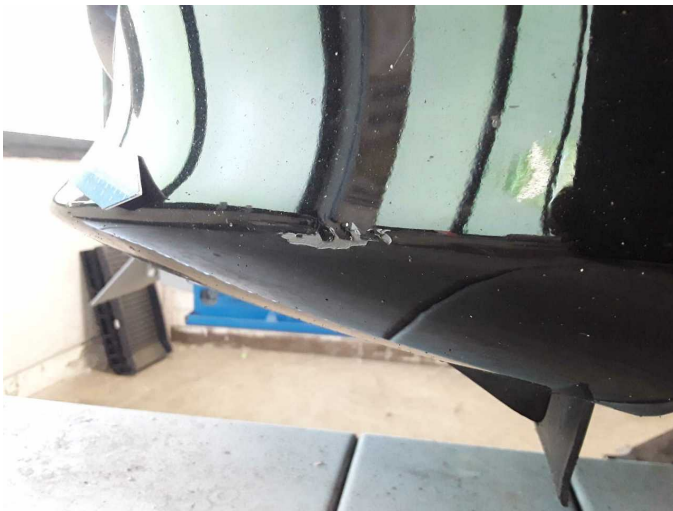
| No. | Component group | Description |
|---|---|---|
| 4 | Front bumper | Front bumper - Scratch(es) - Smart repair |

**Damage 4:** Front bumper: Front bumper - Scratch(es) - Smart repair

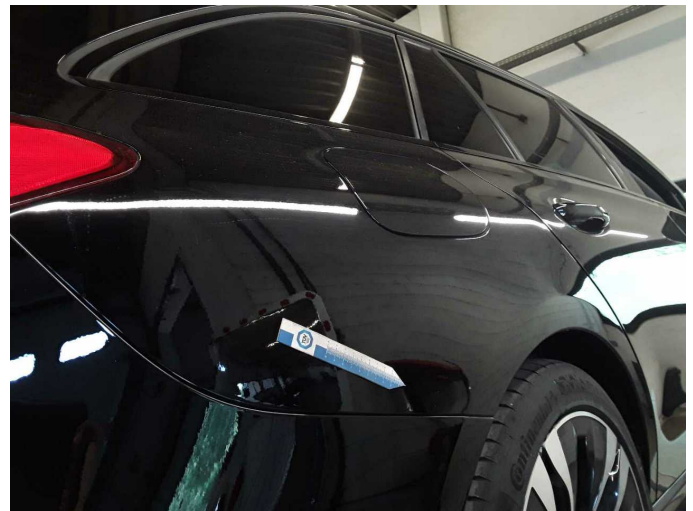
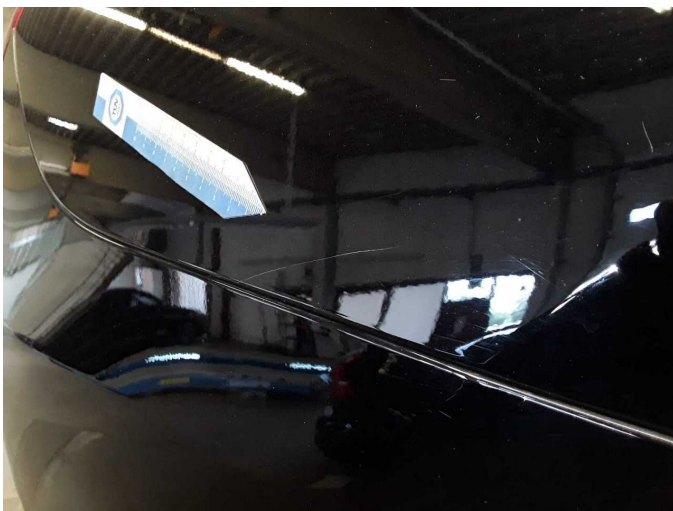
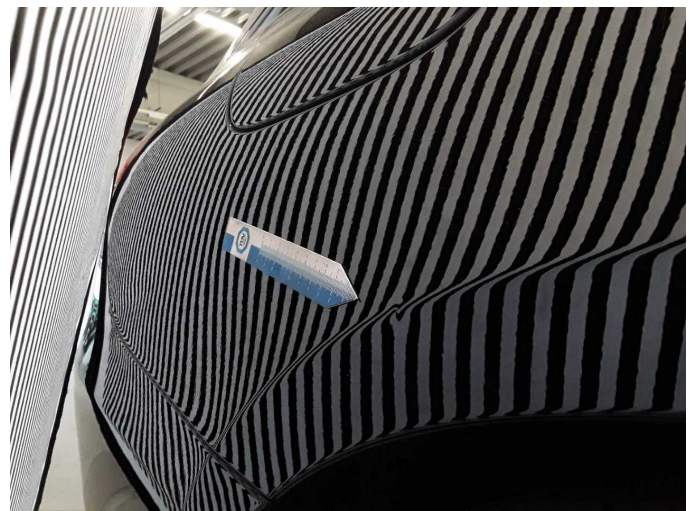
| No. | Component group | Description |
|---|---|---|
| 5 | Side panel - rear right side | Side panel - Dent / paintcoat damage - Repair and paint |

**Damage 5:** Side panel - rear right side: Side panel - Dent / paintcoat damage - Repair and paint

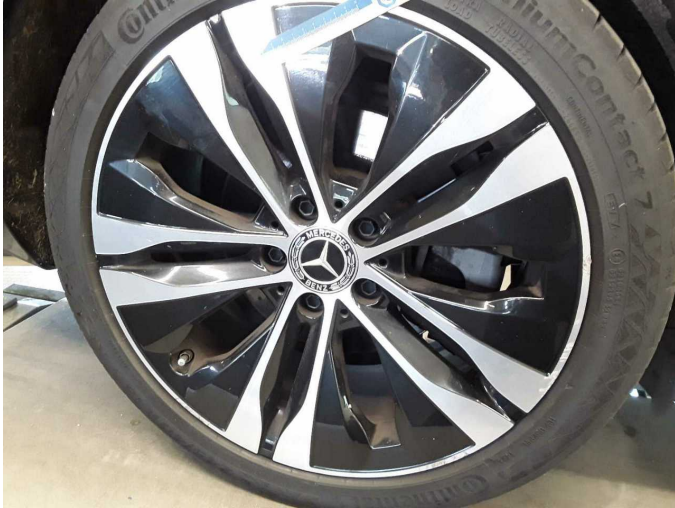
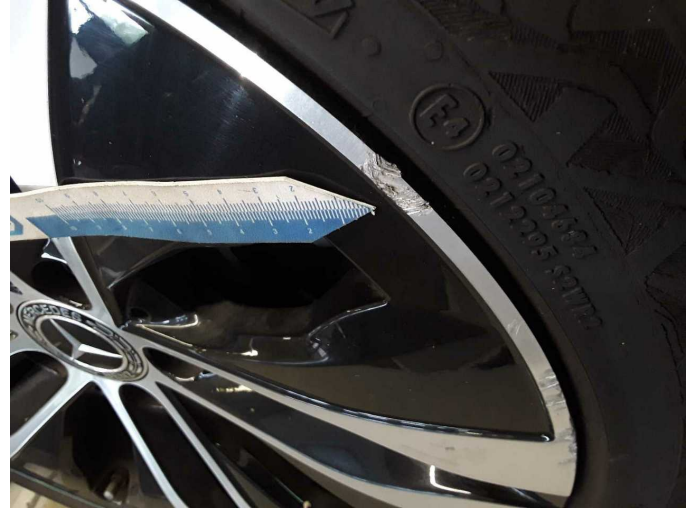
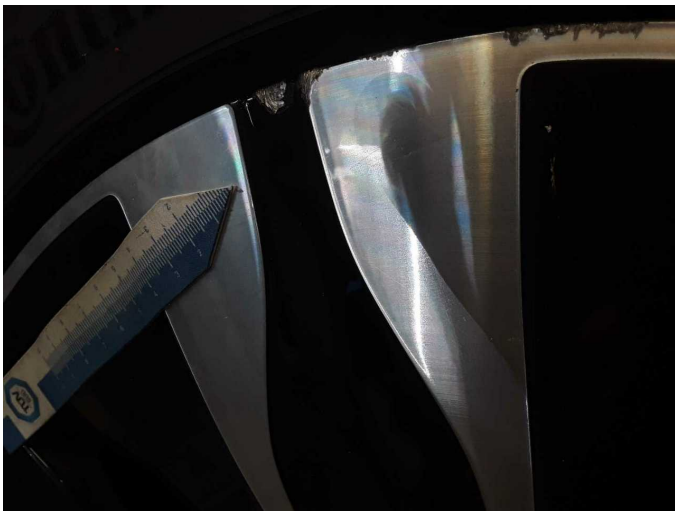
| No. | Component group | Description |
|---|---|---|
| 6 | Wheel / tyres | Alloy rim - rear right side - Scratched - Replace |

**Damage 6:** Wheel / tyres: Alloy rim - rear right side - Scratched - Replace

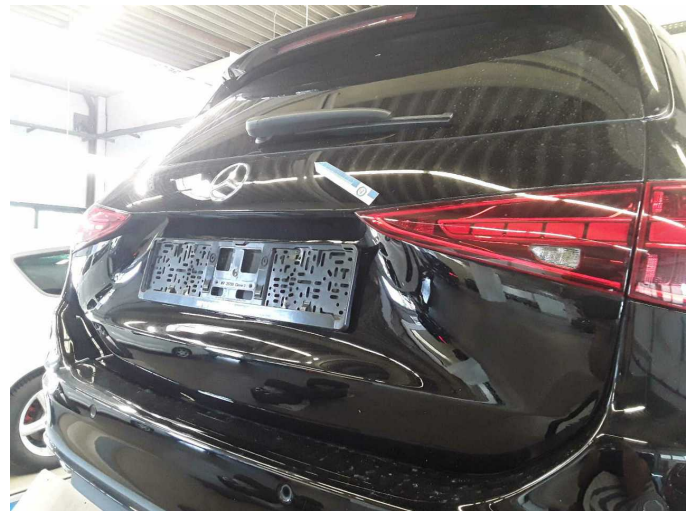
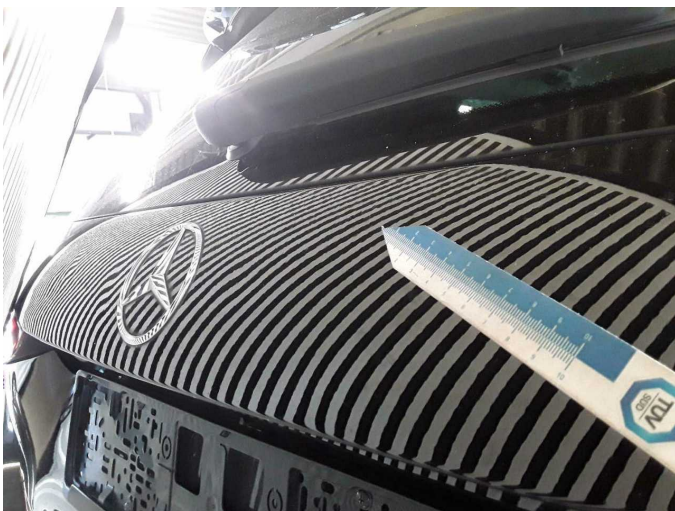
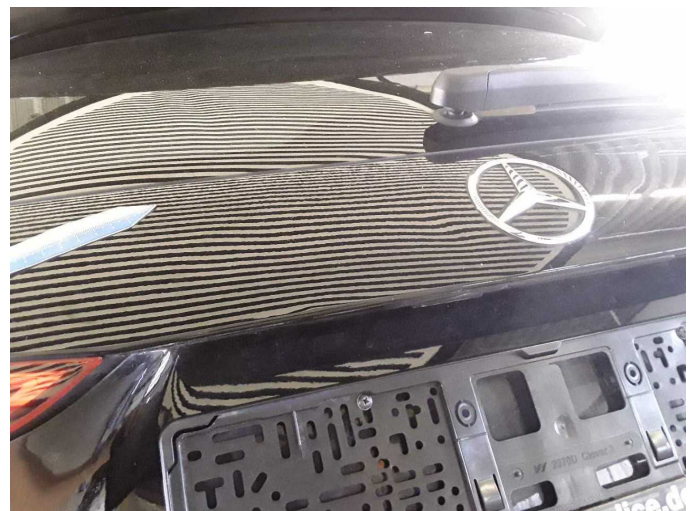
| No. | Component group | Description |
|---|---|---|
| 7 | Boot lid / rear door | Boot lid - Deformed - Repair and paint |

**Damage 7:** Boot lid / rear door: Boot lid - Deformed - Repair and paint

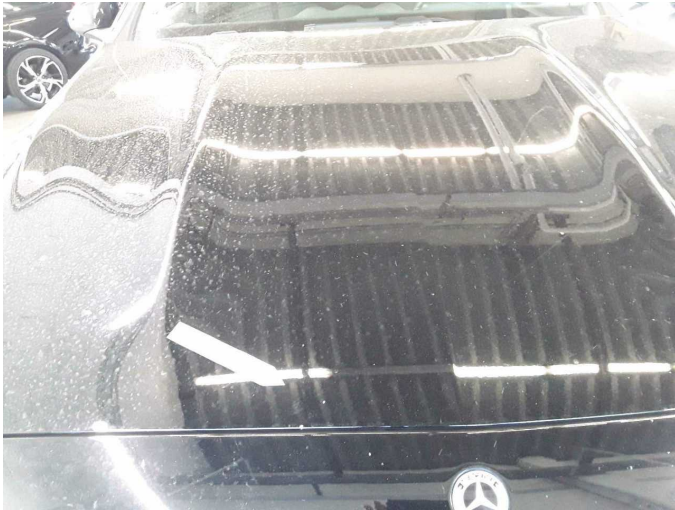
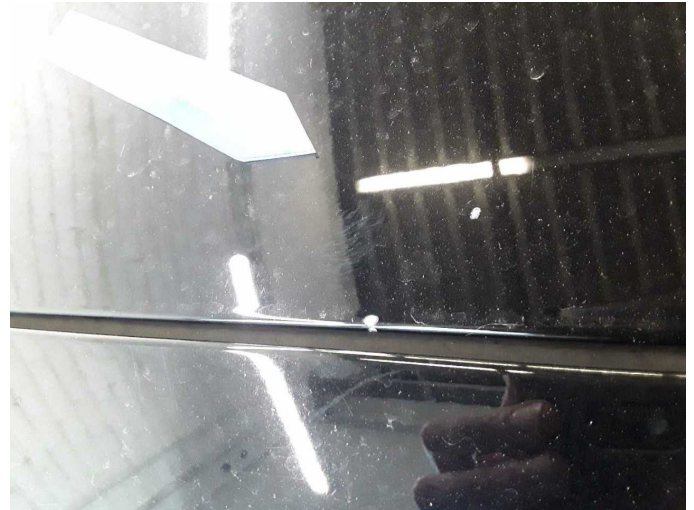
| No. | Component group | Description |
|---|---|---|
| 1 | Bonnet | Bonnet - Stone chips - No deduction |

**Wear and tear 1:** Bonnet: Bonnet - Stone chips - No deduction

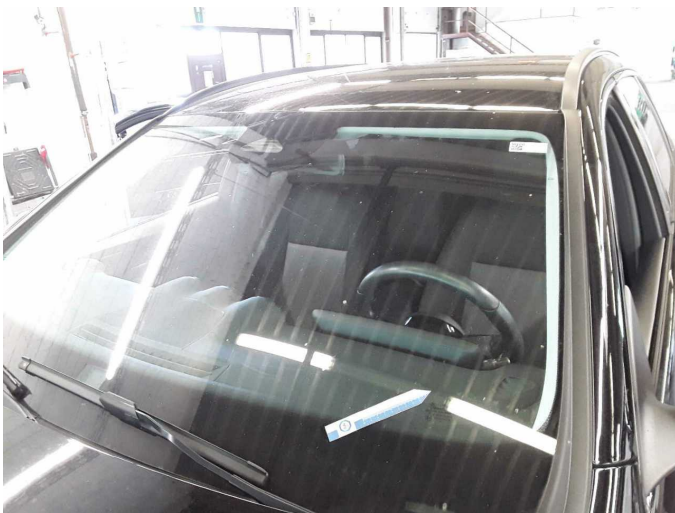
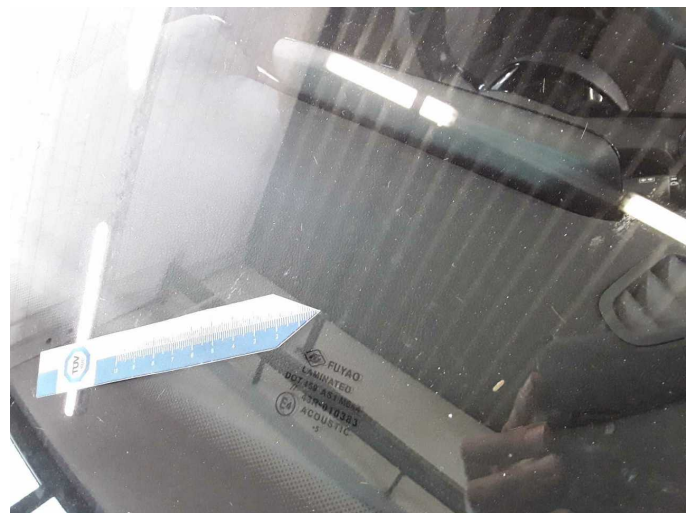
| No. | Component group | Description |
|---|---|---|
| 2 | Vehicle glazing | Windscreen - Stone chips - No deduction |

**Wear and tear 2:** Vehicle glazing: Windscreen - Stone chips - No deduction

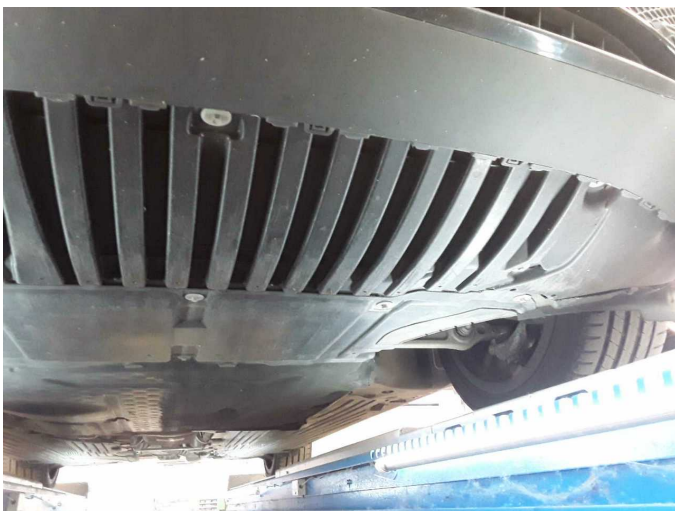
| No. | Component group | Description |
|---|---|---|
| 3 | Body | Underbody panelling - Scratched - No deduction |

**Wear and tear 3:** Body: Underbody panelling - Scratched - No deduction
