## Expertise

Protocol number: 46021827  
Order No. / Reference: 26417537  
Inspection date: 18 Jun 2026

Manufacturer: Ford

Model: Transit Connect 200 L1 S&S Trend

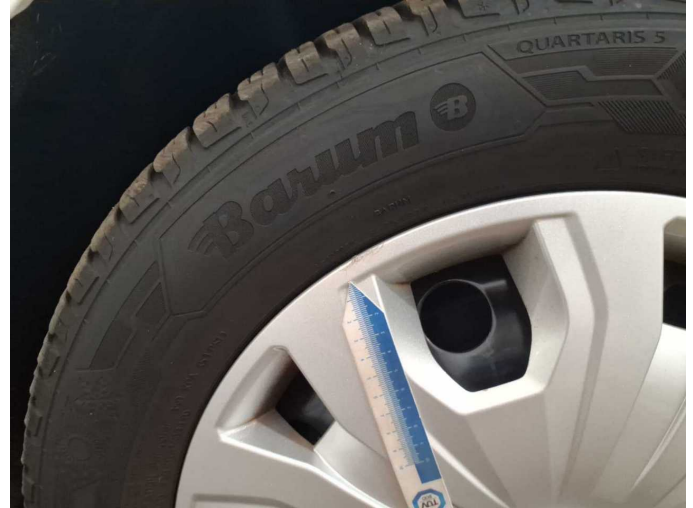
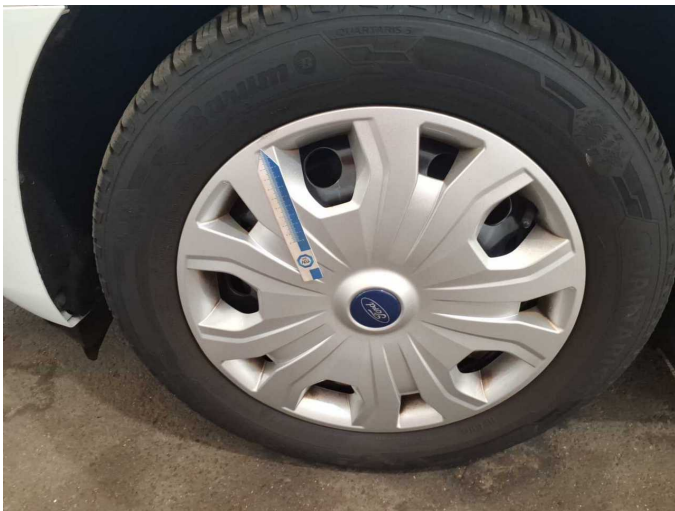
Damage 1: Wheel / tyres: Wheel cover - front left side - Scratch(es) - Replace

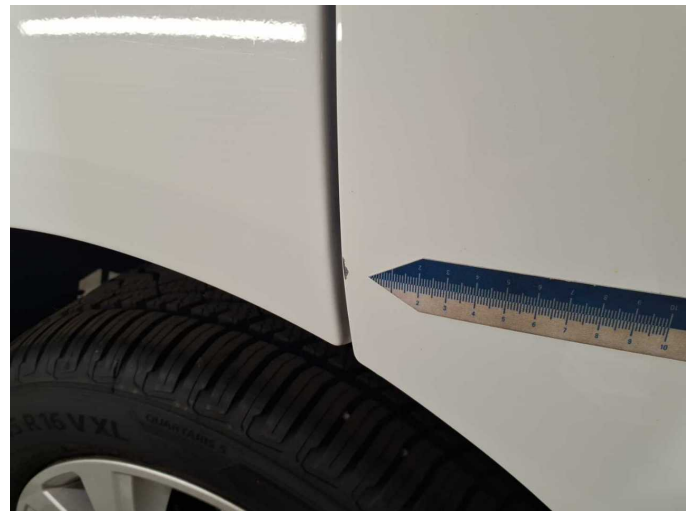
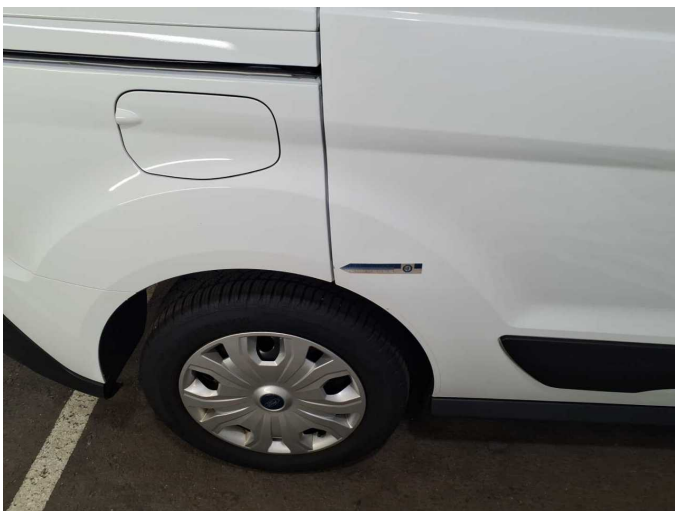
Damage 2: Door - rear right side: Door edge - Scratch(es) - Smart repair

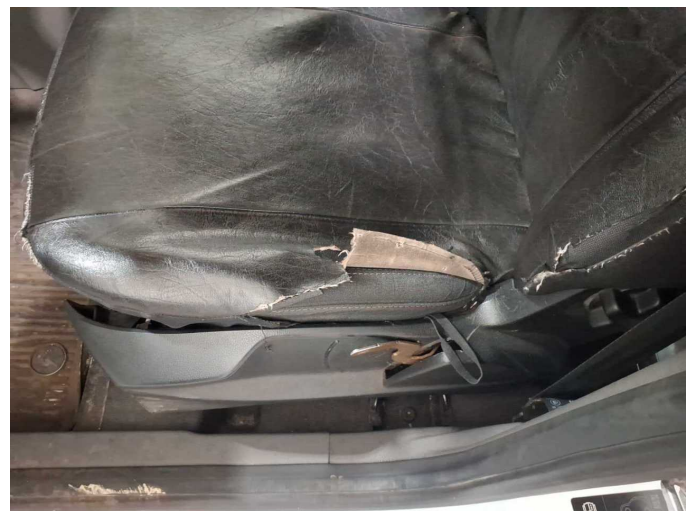
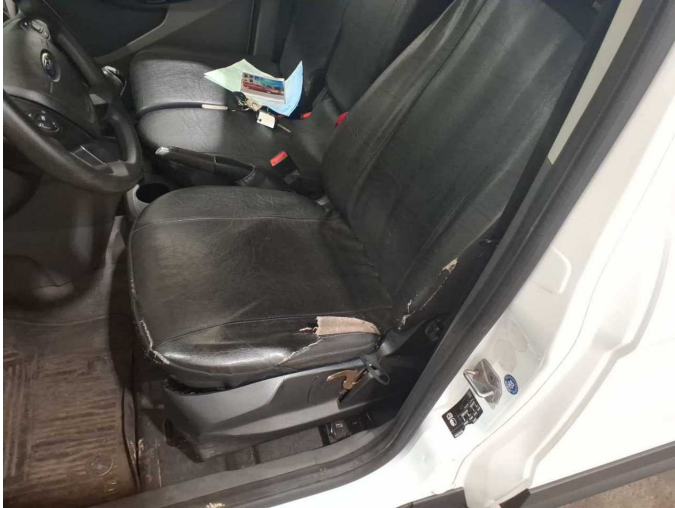
Damage 3: Seat - front: Protective Cover - left side - Broken / torn - Replace

**Damage 3:** Seat - front: Protective Cover - left side - Broken / torn - Replace

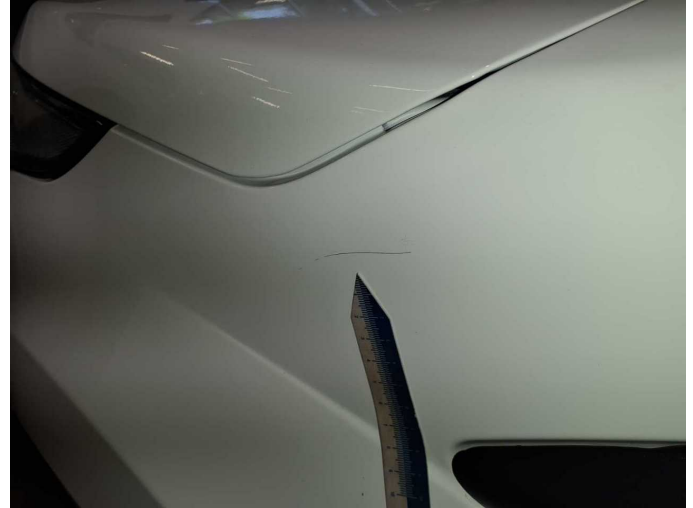
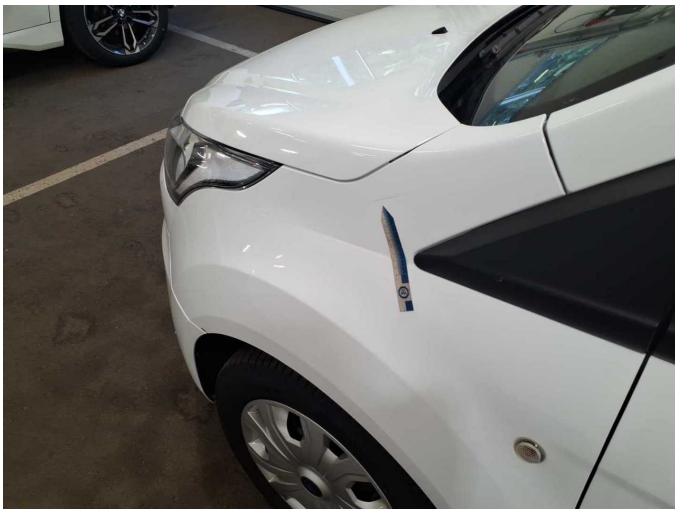
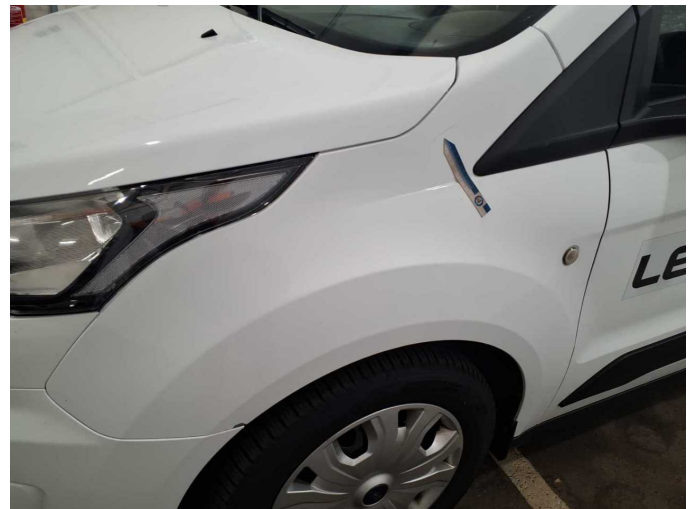
**Damage 4:** Mudguard - left side: Mudguard - left side - Scratch(es) - Paint

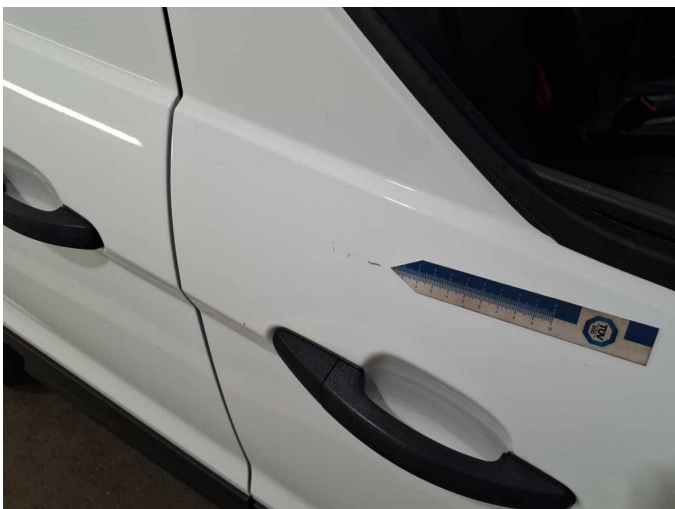
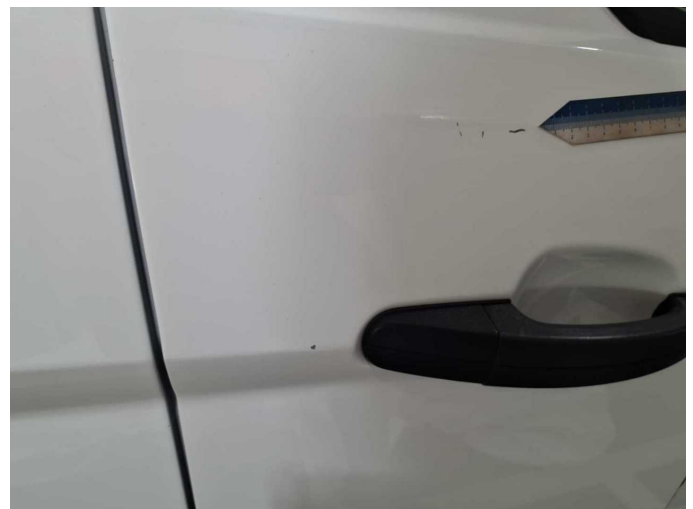
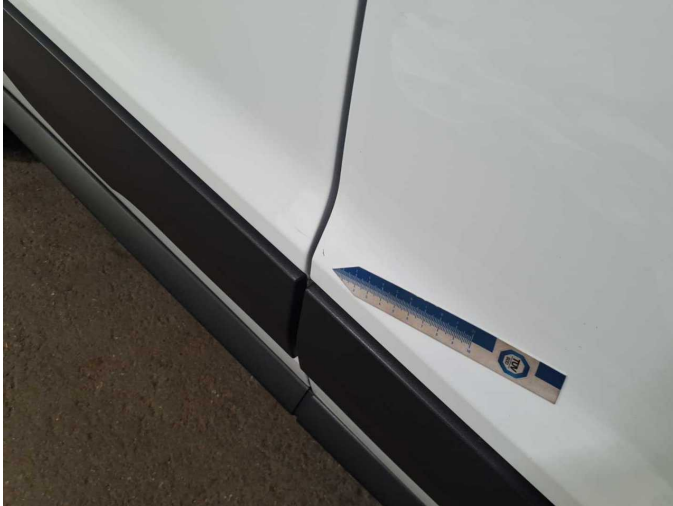
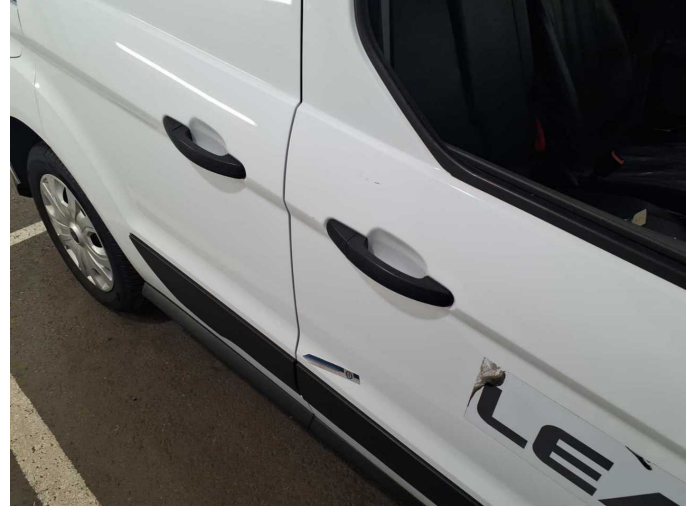
**Damage 5:** Door - front right side: Door - Scratch(es) - Paint

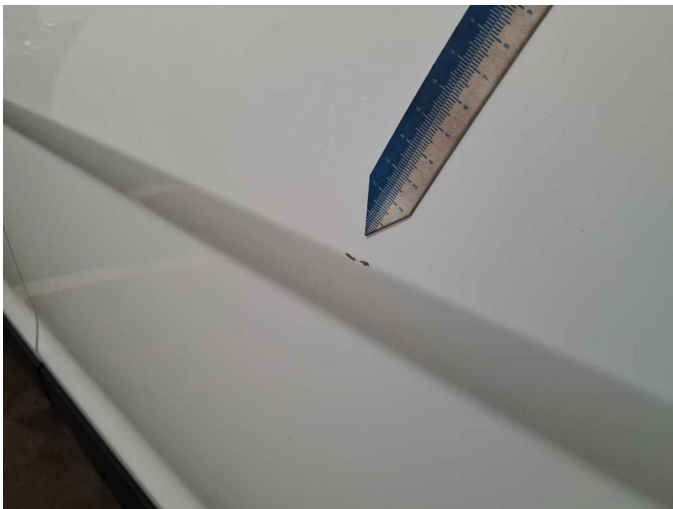
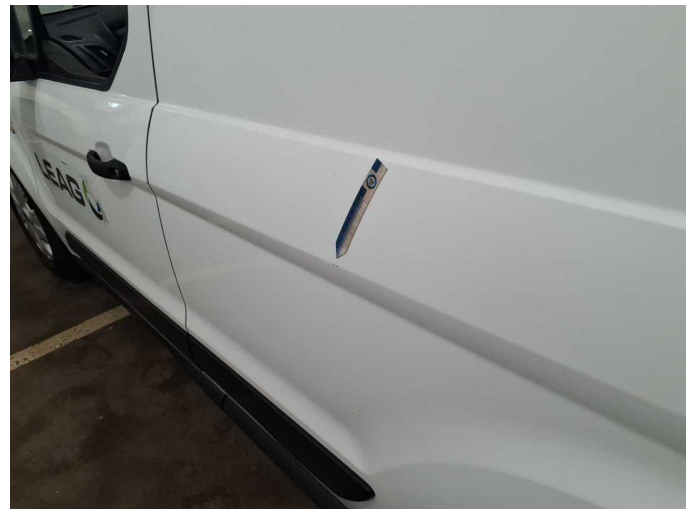
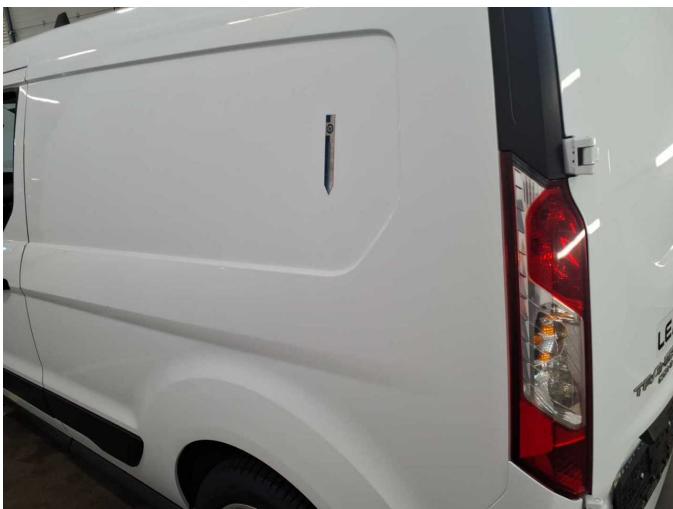
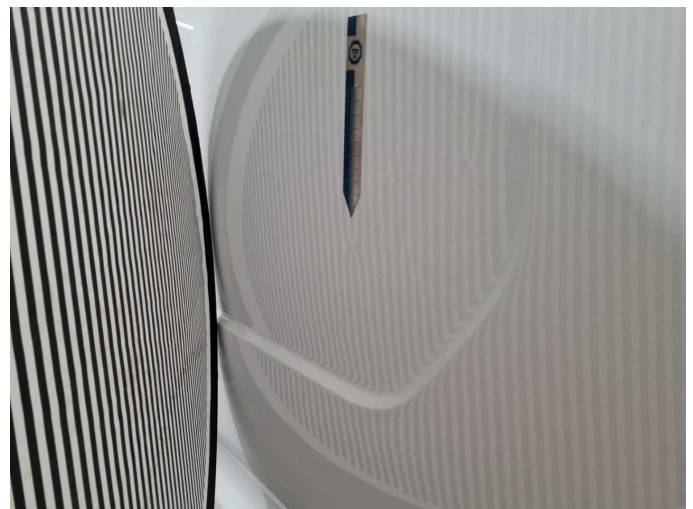
**Damage 6:** Side panel - rear left side: Side panel - Dent / paintcoat damage - Repair and paint

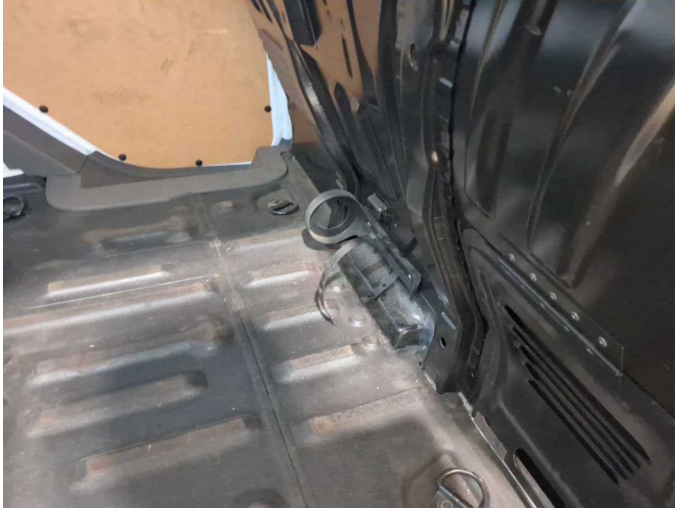
**Missing part 1:** Equipment: Fire extinguisher - Missing - Replace
