Expertise

Protocol number: 46341473
Order No. / Reference: 26438115
Inspection date: 25 Jun 2026

Model: e-Spacetourer XL (75 kWh) Feel

VIN: VF7VZZKXZPZ093098

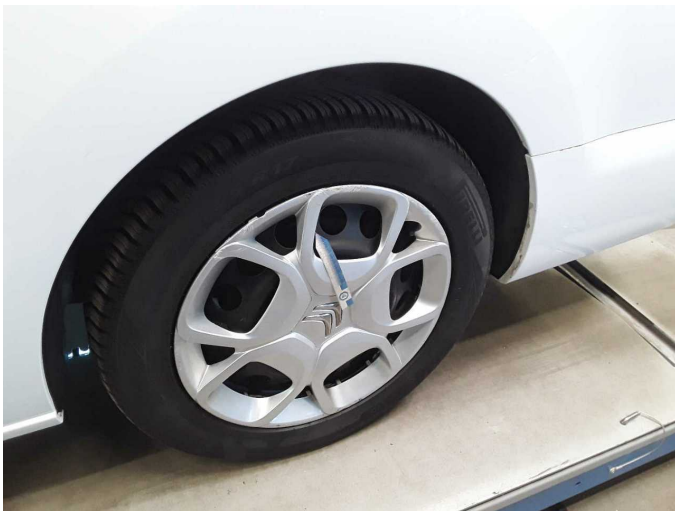
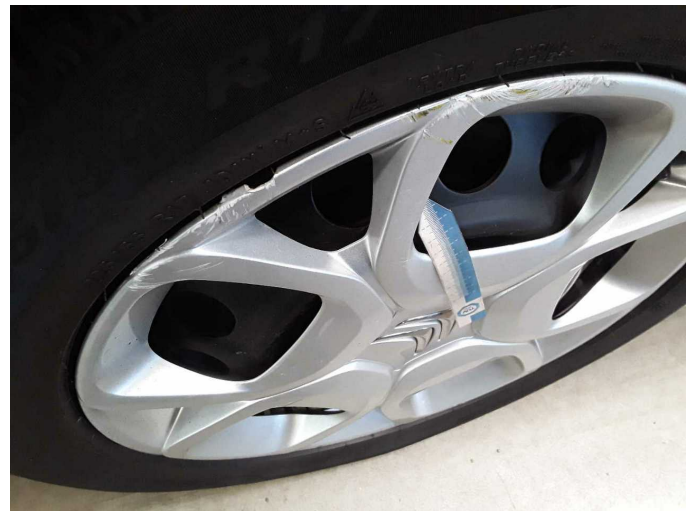
Damage 1: Wheel / tyres: Wheel cover - rear left side - Damaged - Replace

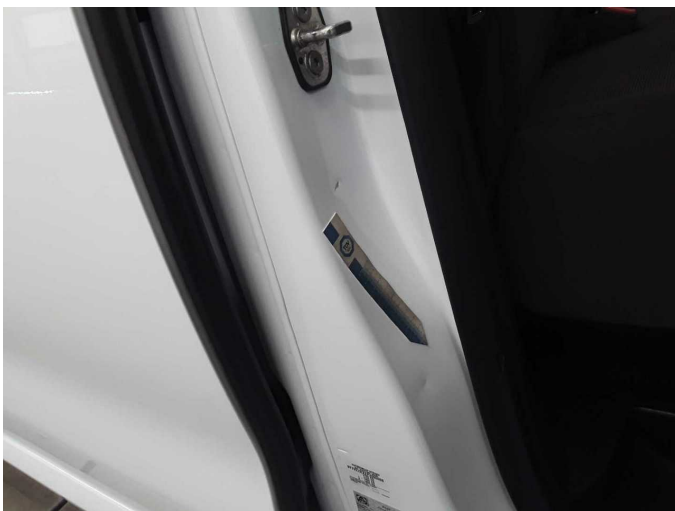
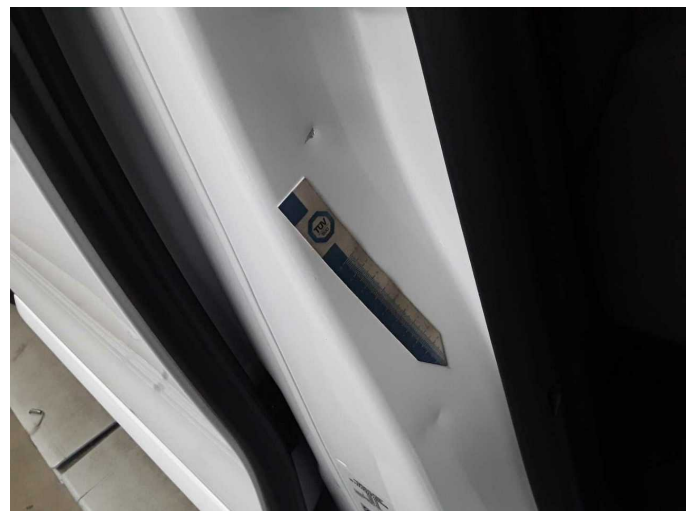
Damage 2: Sill - right side: Sill - Dent / paintcoat damage - Smart repair

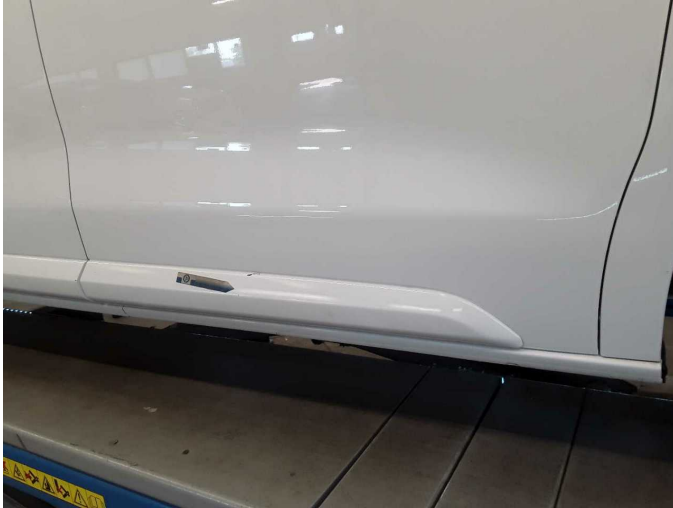
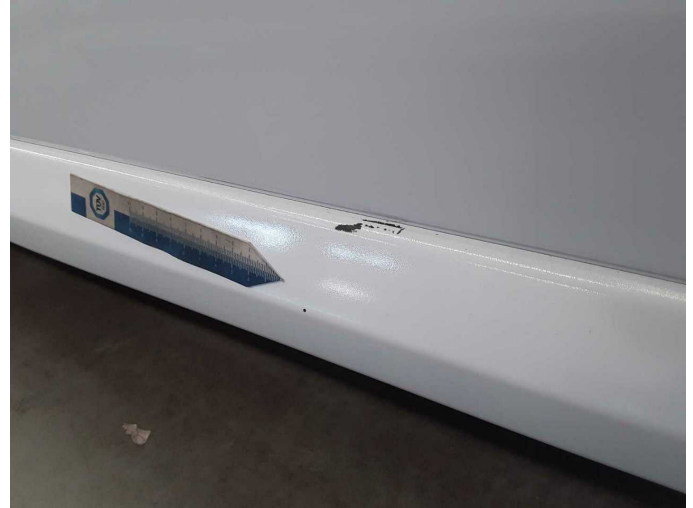
Damage 3: Door - front right side: Brightware - lower - Scratch(es) - Smart repair

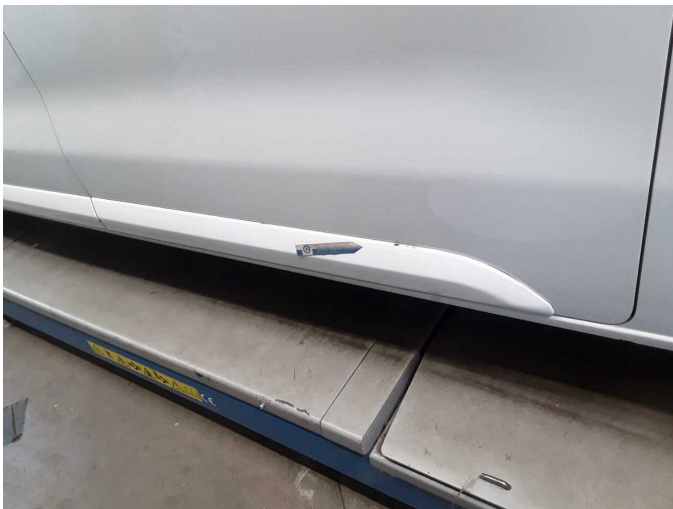
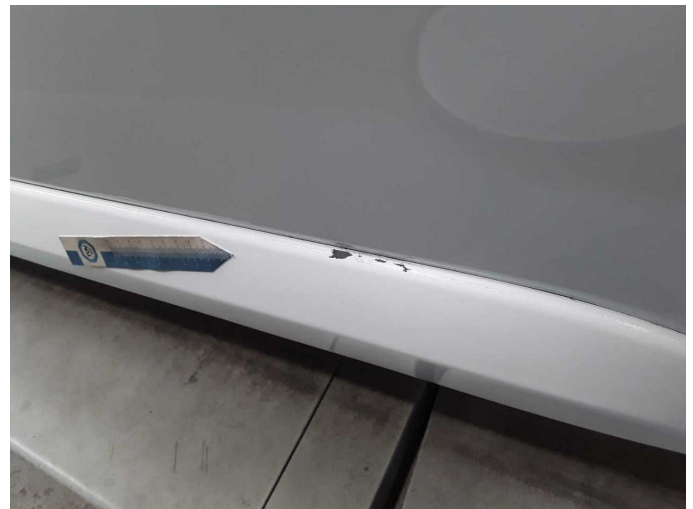
Damage 4: Door - rear left side: Brightware - lower - Scratched - Smart repair

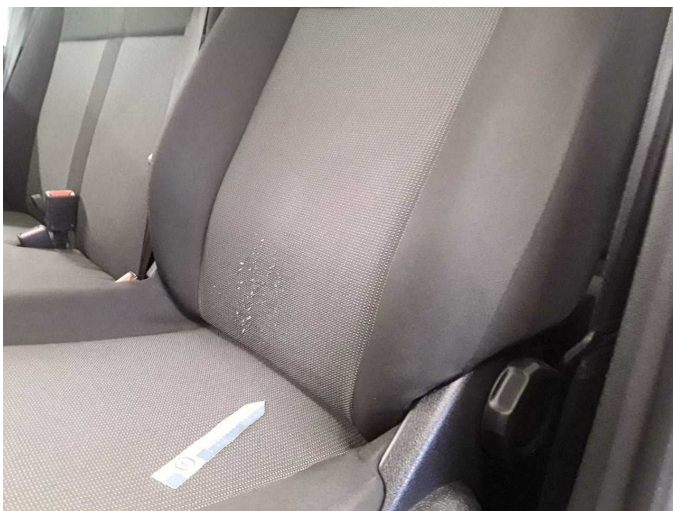
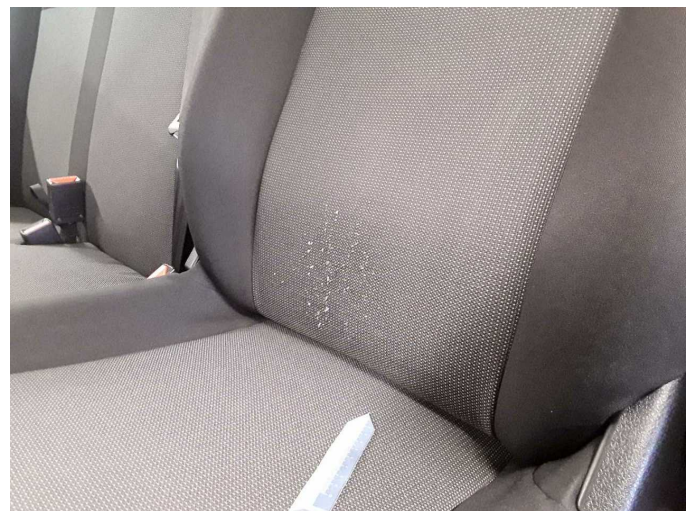
Damage 5: Seat - front: Backrest cover - left side - Worn - Smart repair

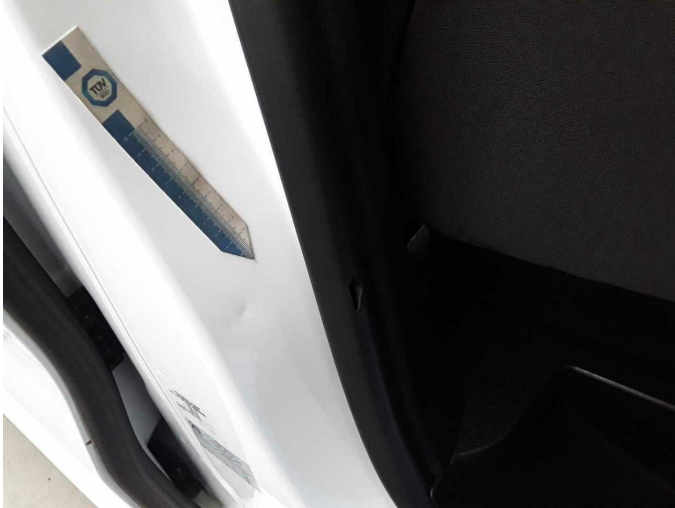
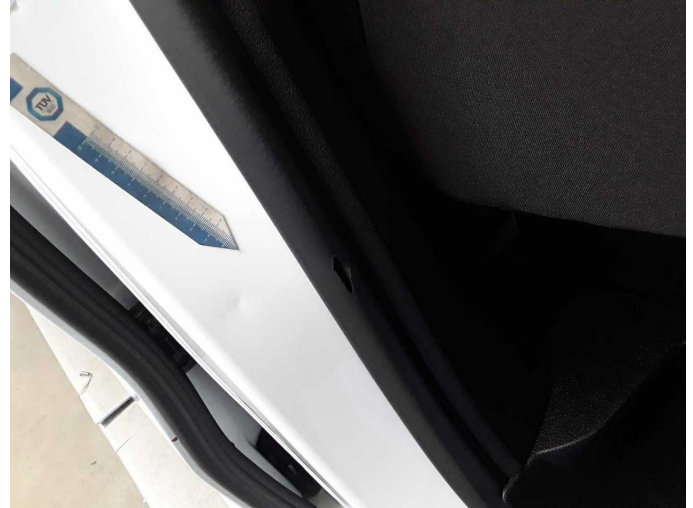
Damage 6: Cab: Door rubber seal - right side - Damaged - Replace

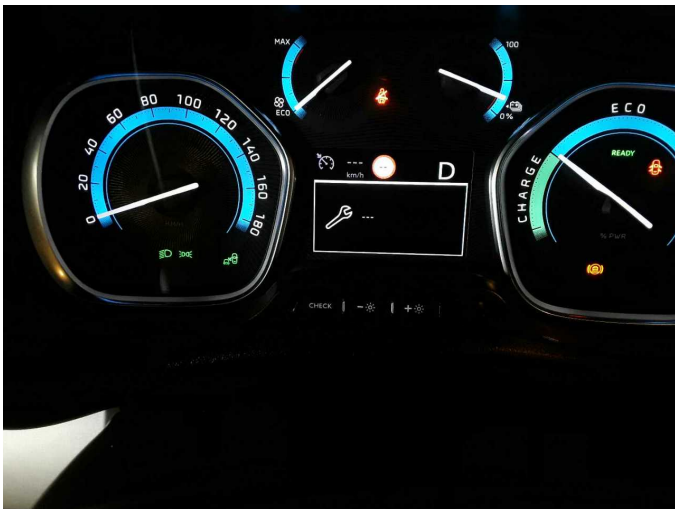
Damage 7: Misc.: Inspection / maintenance - Due - Perform

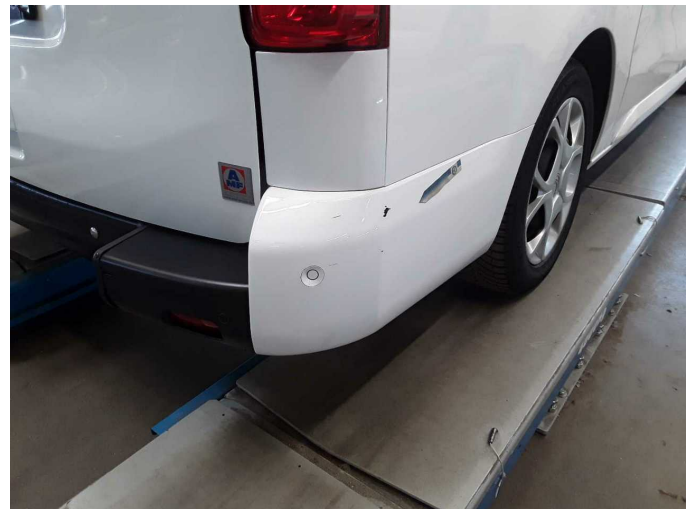
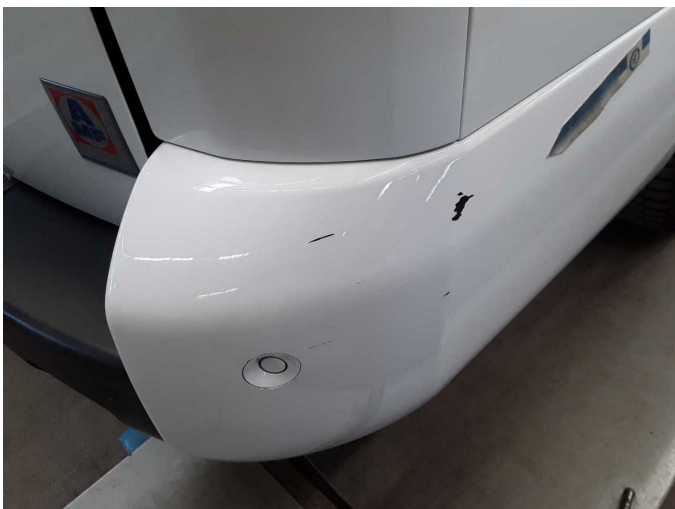
Damage 8: Rear bumper: Rear bumper - Scratch(es) - Paint

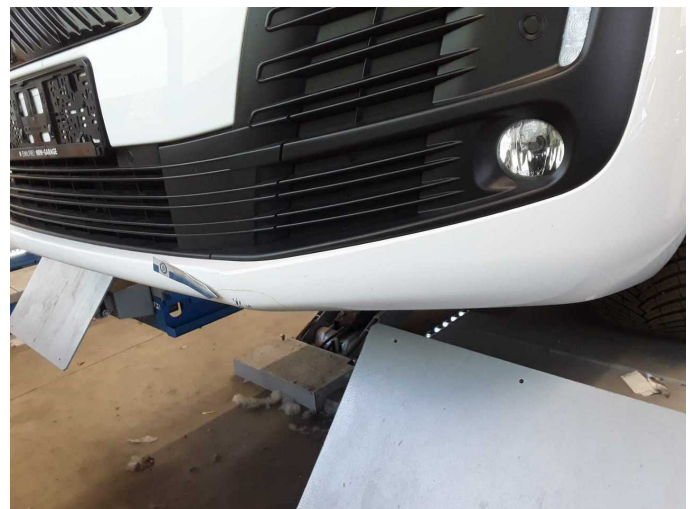
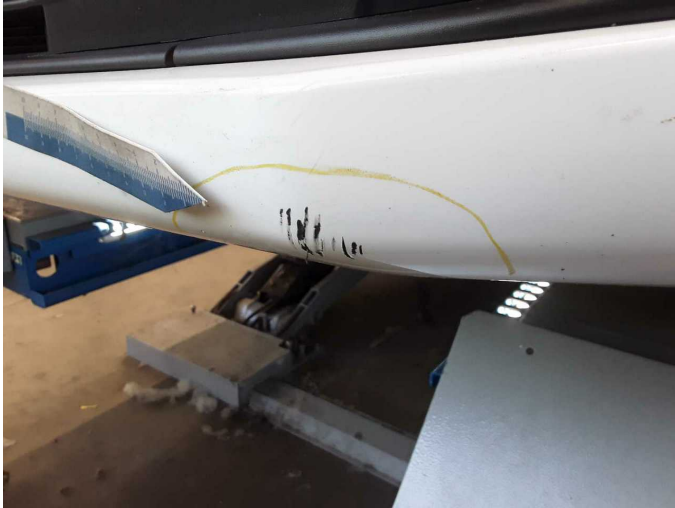
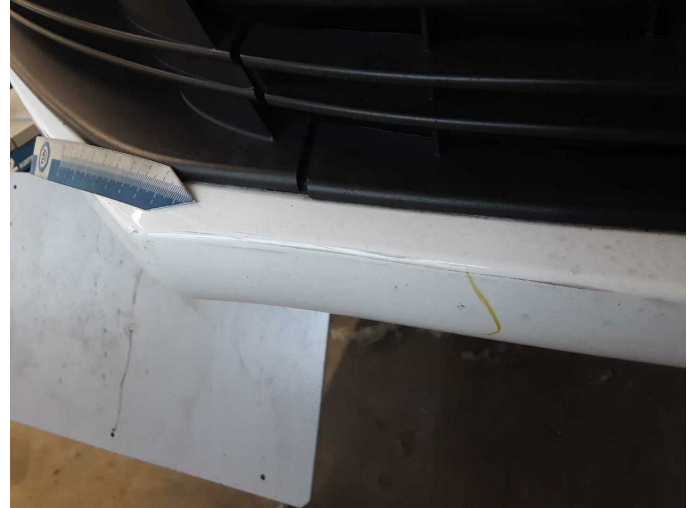
Damage 9: Front bumper: Front bumper - Scratch(es) - Paint

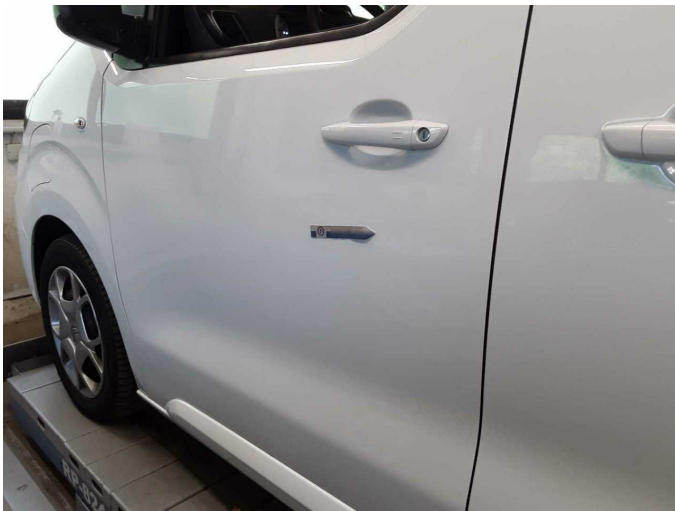
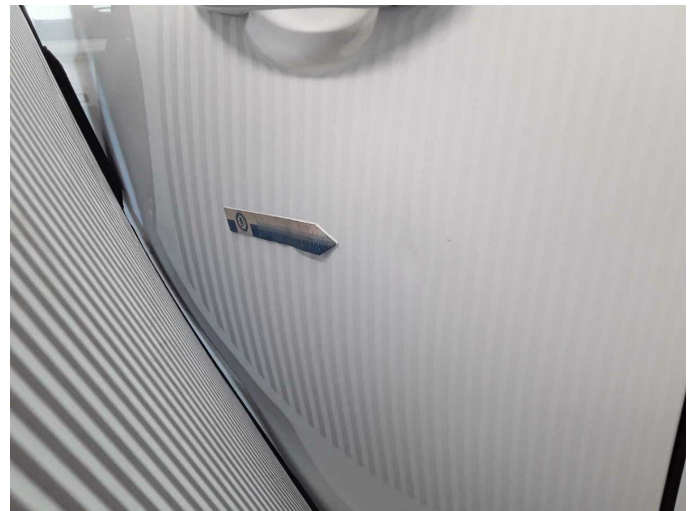
Wear and tear 3: Door - front left side: Door - dent(s) - No deduction

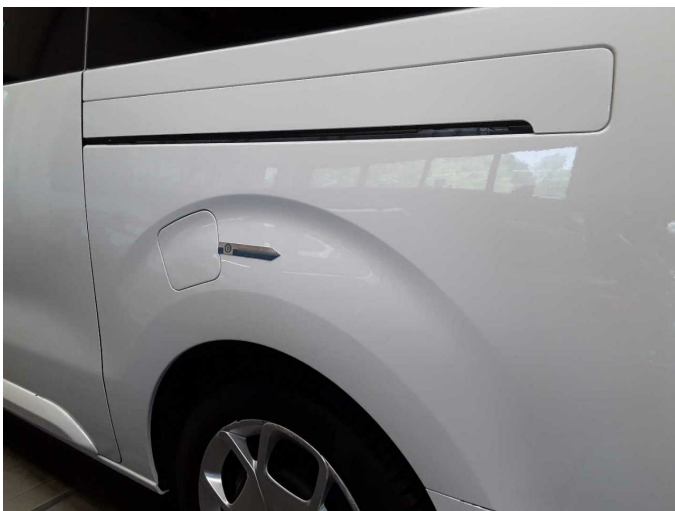
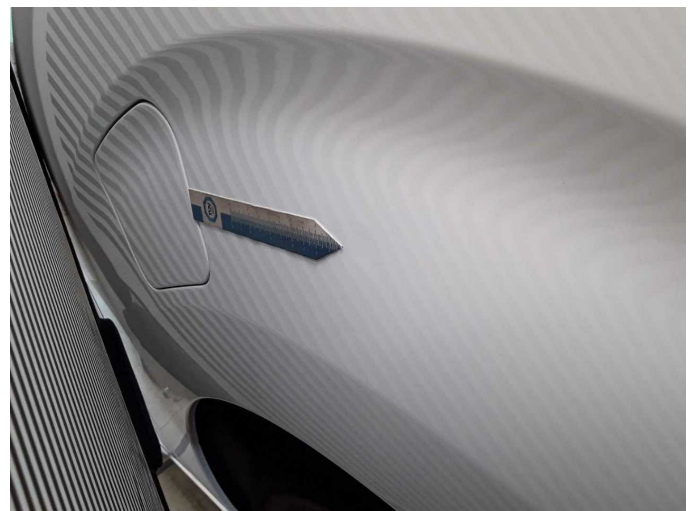
Wear and tear 4: Side panel - rear left side: Side panel - dent(s) - No deduction
