# 2-FHV-917

2-FHV-917 · ST Line 1.0i EcoBoost 125pk M6 · 6 August 2026 · Zaventem (BE)

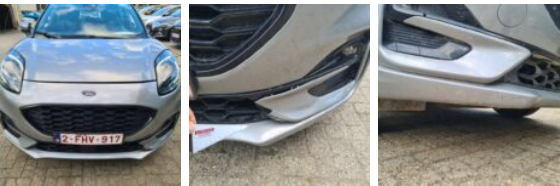
| Front | Collision Damage | Panelbeating & Spray | No |
