Expertise

Protocol number: 46739972  
Order No. / Reference: 26750479  
Inspection date: 28 Jul 2026

Manufacturer: Ford

Model: Transit 350 L3H2 Lkw VA Trend

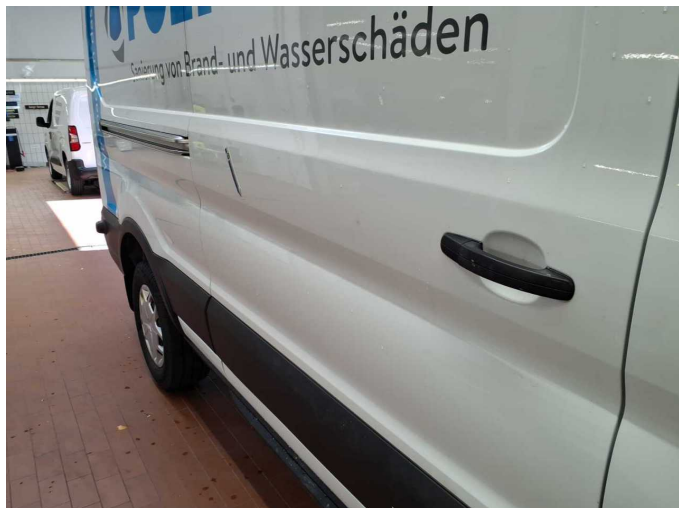
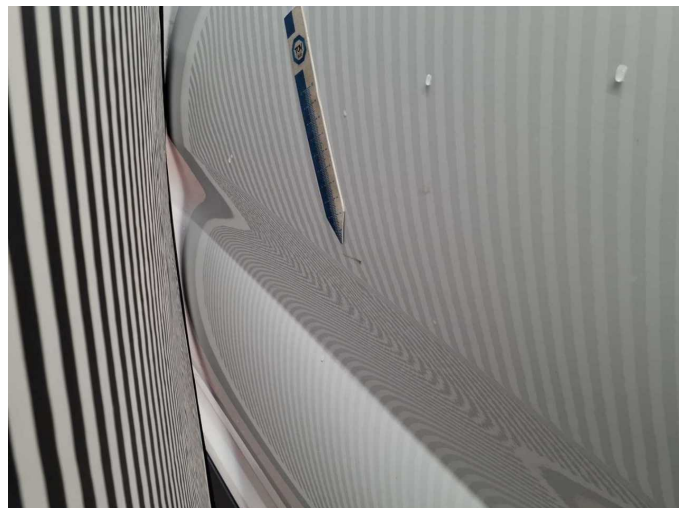
| No. | Component group | Description |
|---|---|---|
| 1 | Sliding door, right | Sliding door - dent(s) - Smooth repair work |

**Damage 1:** Sliding door, right: Sliding door - dent(s) - Smooth repair work

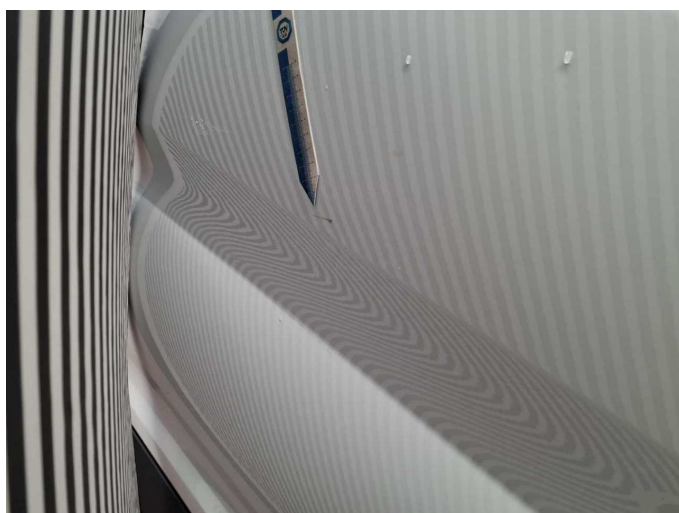
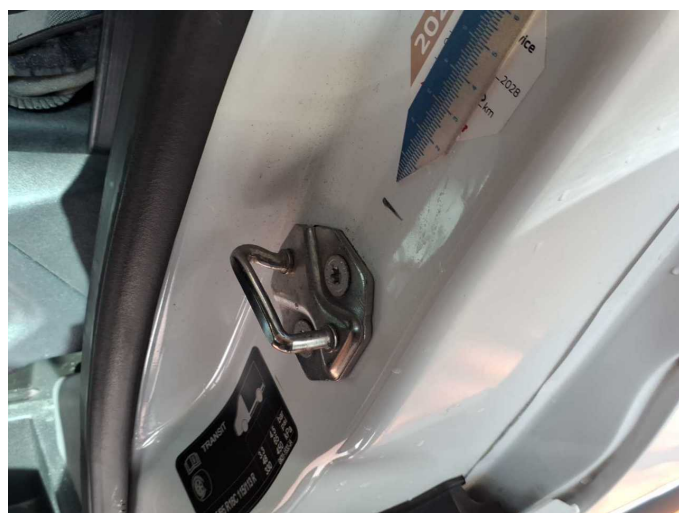
| No. | Component group | Description |
|---|---|---|
| 2 | Sill - left side | Sill - Scratch(es) - Smart repair |

**Damage 1:** Sliding door, right: Sliding door - dent(s) - Smooth repair work

**Damage 2:** Sill - left side: Sill - Scratch(es) - Smart repair

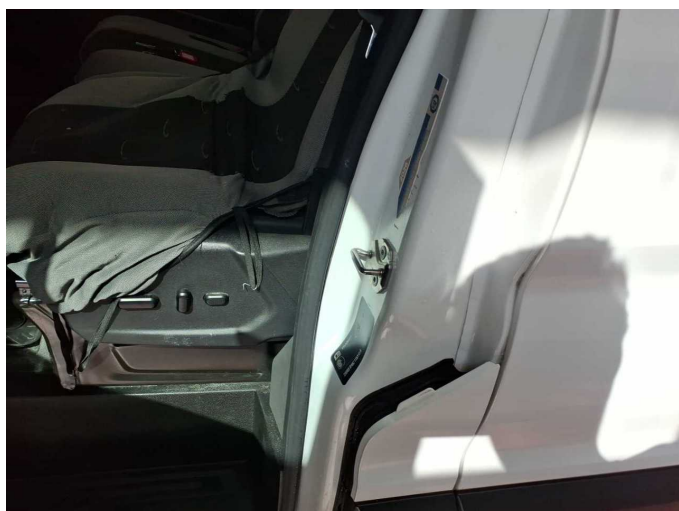
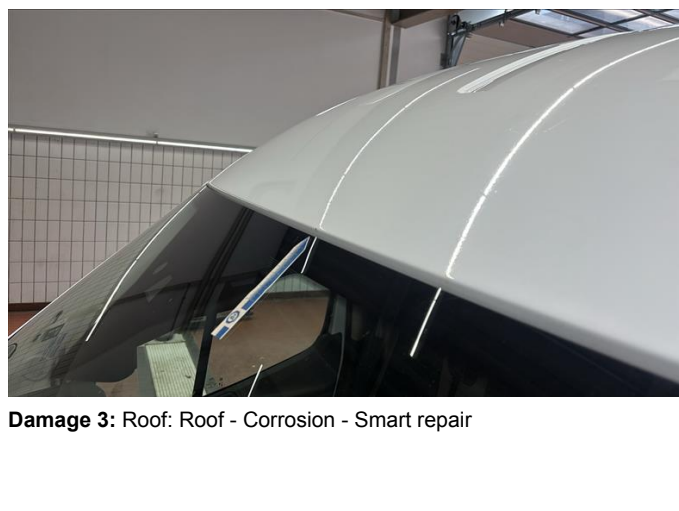
| No. | Component group | Description |
|---|---|---|
| 3 | Roof | Roof - Corrosion - Smart repair |

**Damage 2:** Sill - left side: Sill - Scratch(es) - Smart repair

**Damage 3:** Roof: Roof - Corrosion - Smart repair

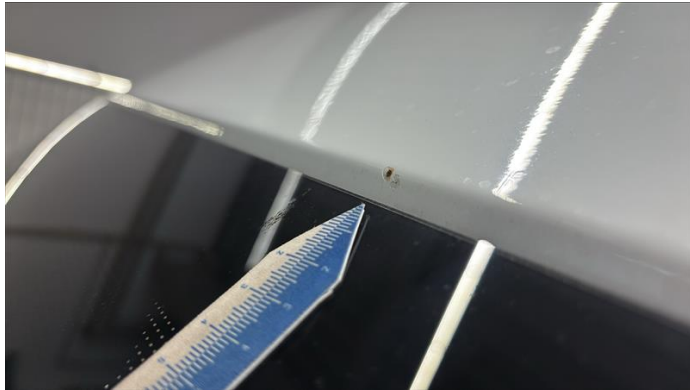
**Damage 3:** Roof: Roof - Corrosion - Smart repair

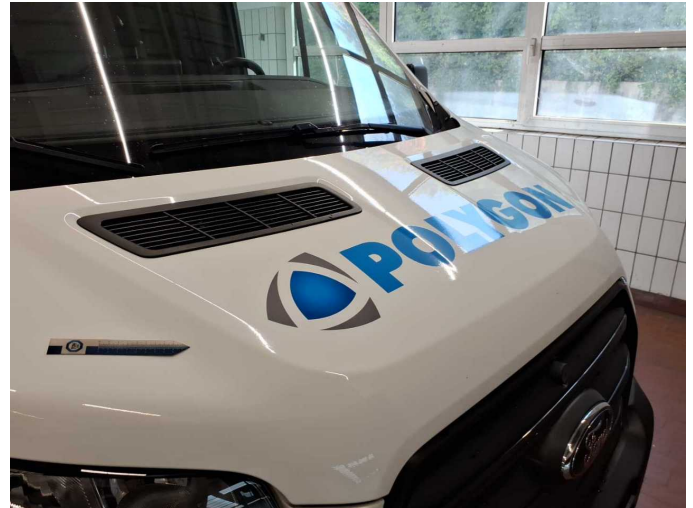
| No. | Component group | Description |
|---|---|---|
| 4 | Body | Body - Glued / labelled - De-glue / neutralise |

**Damage 4:** Body: Body - Glued / labelled - De-glue / neutralise

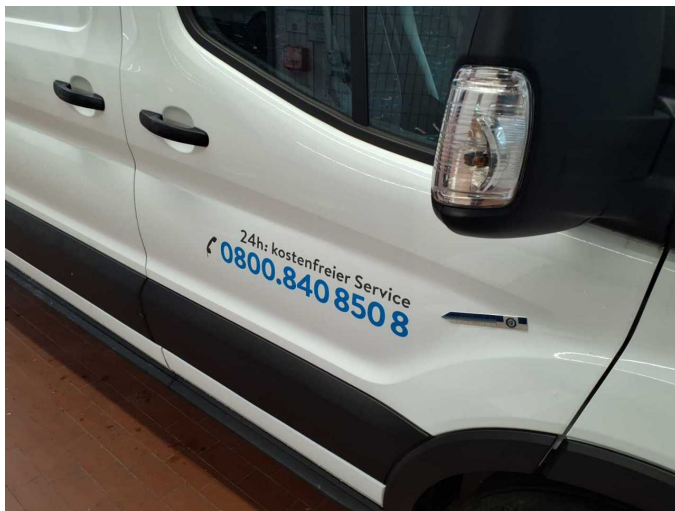
**Damage 4:** Body: Body - Glued / labelled - De-glue / neutralise

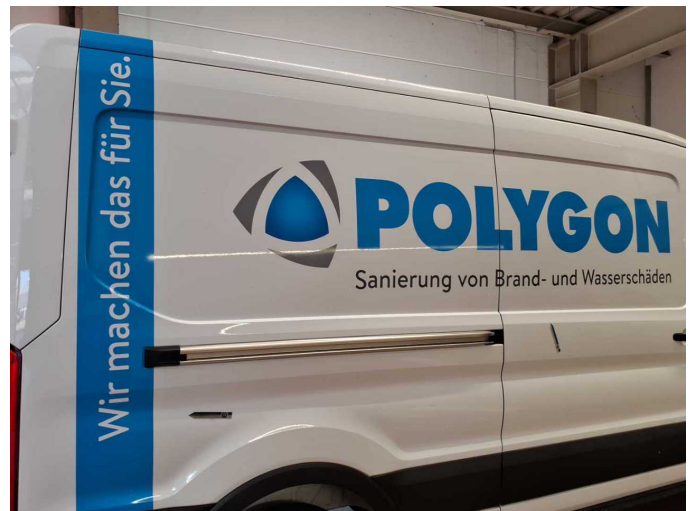
**Damage 4:** Body: Body - Glued / labelled - De-glue / neutralise

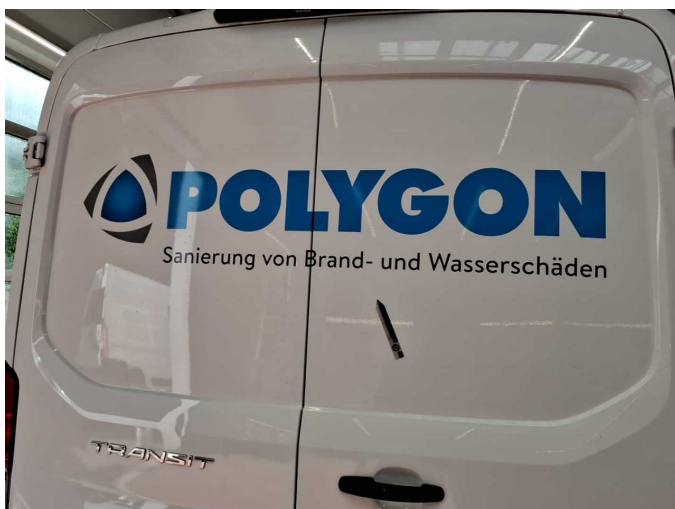
**Damage 4:** Body: Body - Glued / labelled - De-glue / neutralise

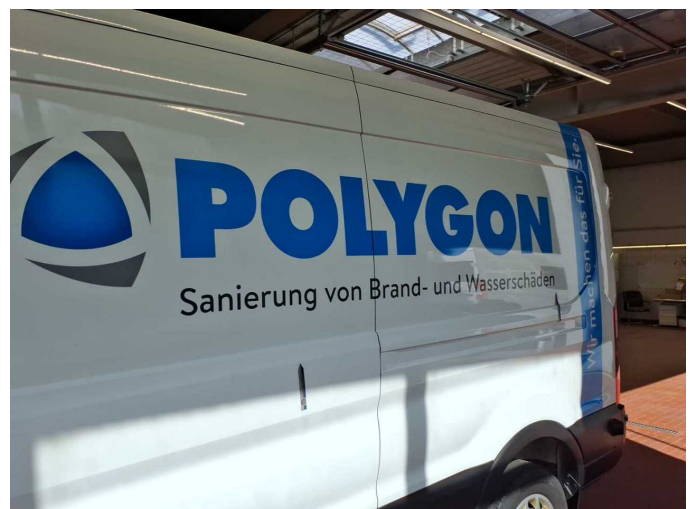
**Damage 4:** Body: Body - Glued / labelled - De-glue / neutralise

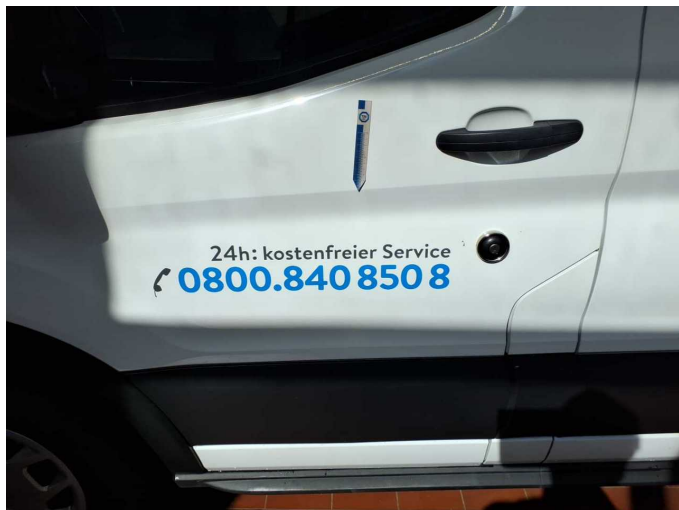
**Damage 4:** Body: Body - Glued / labelled - De-glue / neutralise

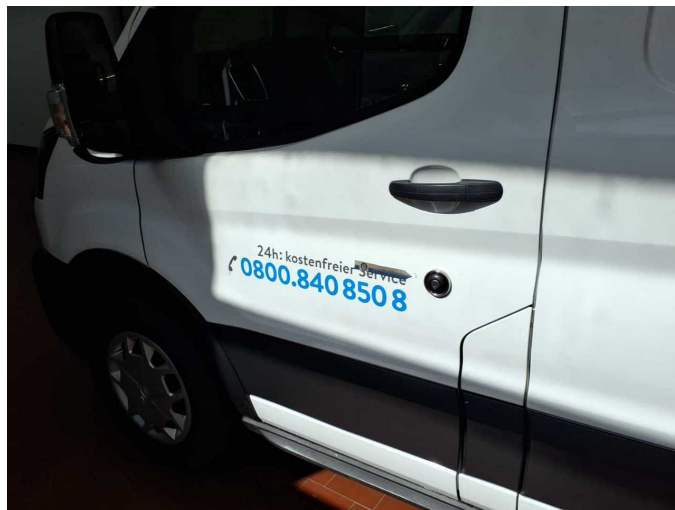
| No. | Component group | Description |
|---|---|---|
| 5 | Door - front left side | Door - Scratch(es) - Paint |

**Damage 5:** Door - front left side: Door - Scratch(es) - Paint

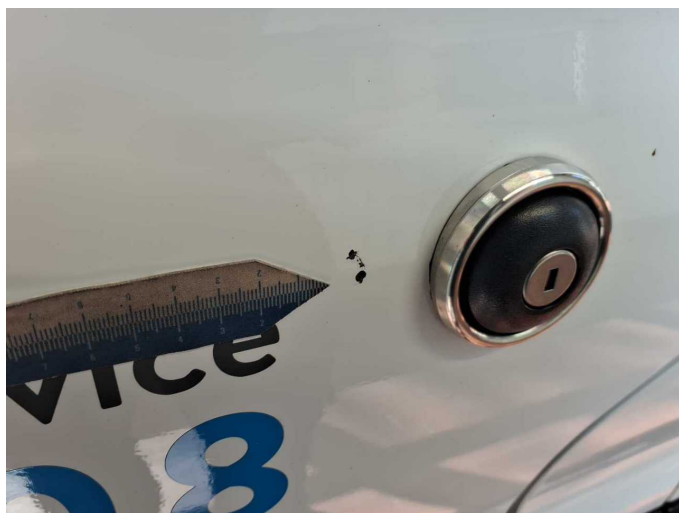
**Damage 5:** Door - front left side: Door - Scratch(es) - Paint

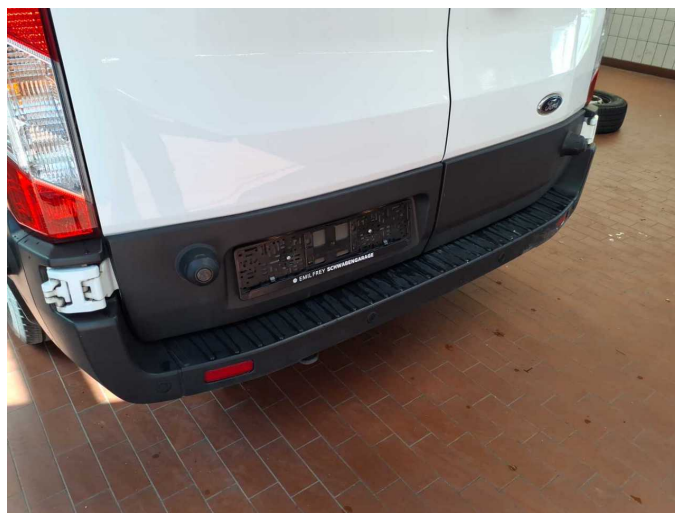
| No. | Component group | Description |
|---|---|---|
| 1 | Rear bumper | Rear bumper - Scratch(es) - No deduction |

**Wear and tear 1:** Rear bumper: Rear bumper - Scratch(es) - No deduction

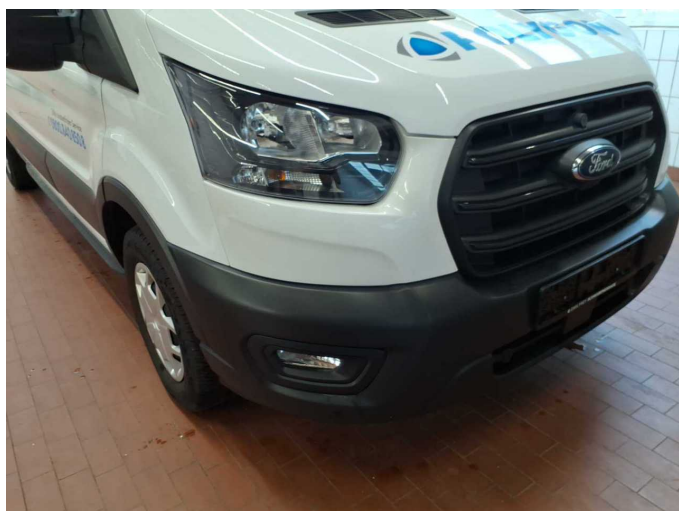
| No. | Component group | Description |
|---|---|---|
| 2 | Front bumper | Front bumper - Scratch(es) - No deduction |

**Wear and tear 2:** Front bumper: Front bumper - Scratch(es) - No deduction

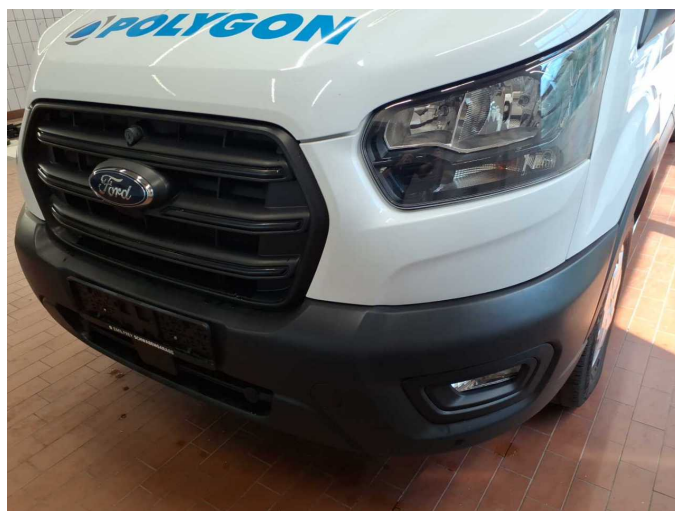
**Wear and tear 2:** Front bumper: Front bumper - Scratch(es) - No deduction

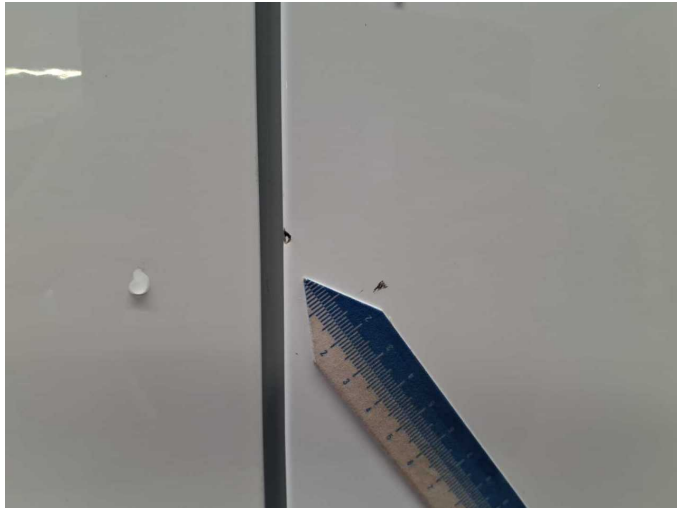
| No. | Component group | Description |
|---|---|---|
| 5 | Door - front left side | Door edge - Scratch(es) - Smart repair |

**Wear and tear 5:** Door - front left side: Door edge - Scratch(es) - Smart repair

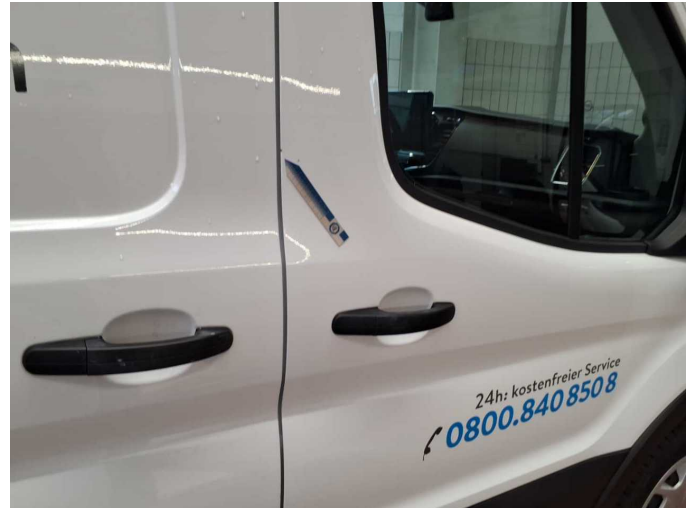
**Wear and tear 5:** Door - front left side: Door edge - Scratch(es) - Smart repair
