Expertise

Protocol number: 46191417
Order No. / Reference: 26152411
Inspection date: 21 May 2026

Model: Vito 116 CDI Lang HA Aut. PRO

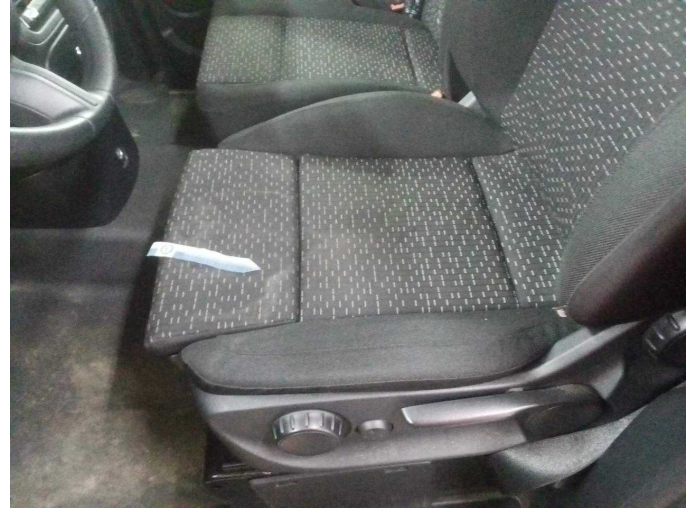
Damage 1: Seat - front: Seat cover - left side - Soiled - Clean

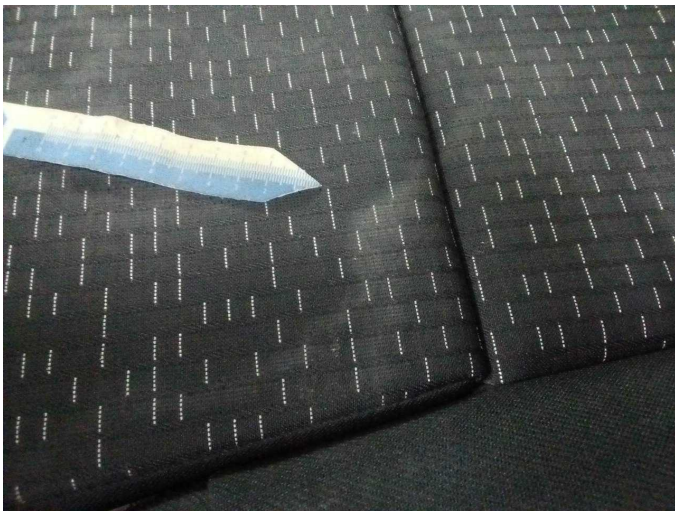
Damage 1: Seat - front: Seat cover - left side - Soiled - Clean

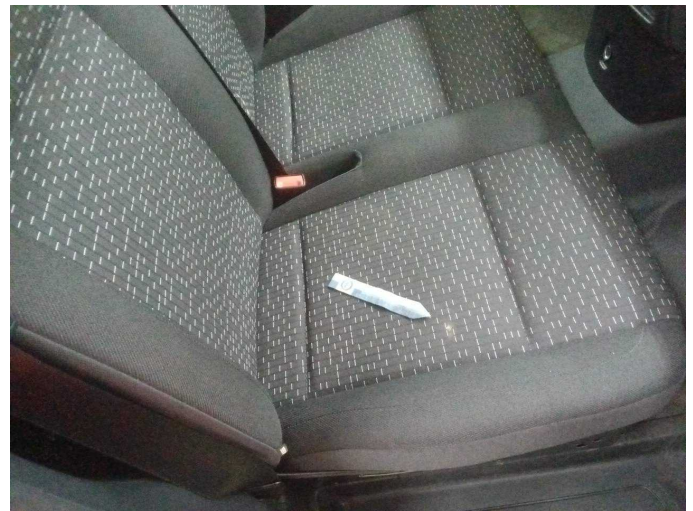
Damage 2: Seat - front: Seat cover - right side - Soiled - Clean

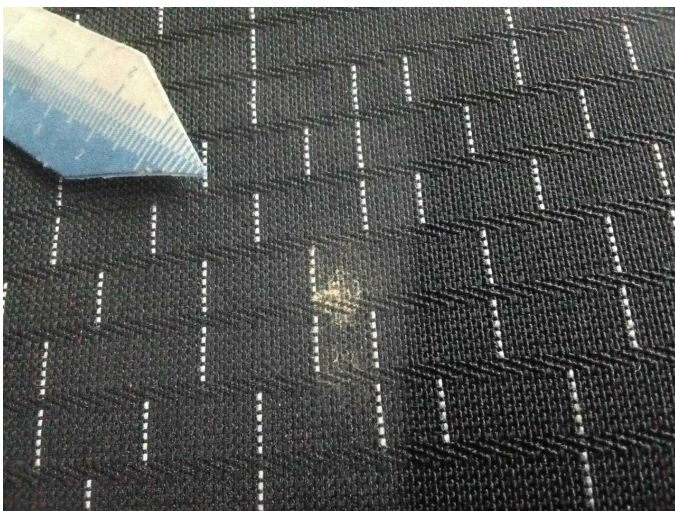
Damage 2: Seat - front: Seat cover - right side - Soiled - Clean

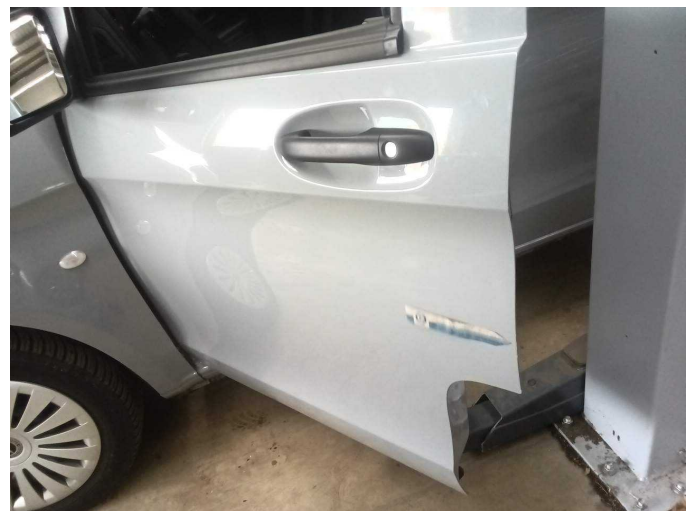
Damage 3: Door - front left side: Door edge - Scratch(es) - Smart repair

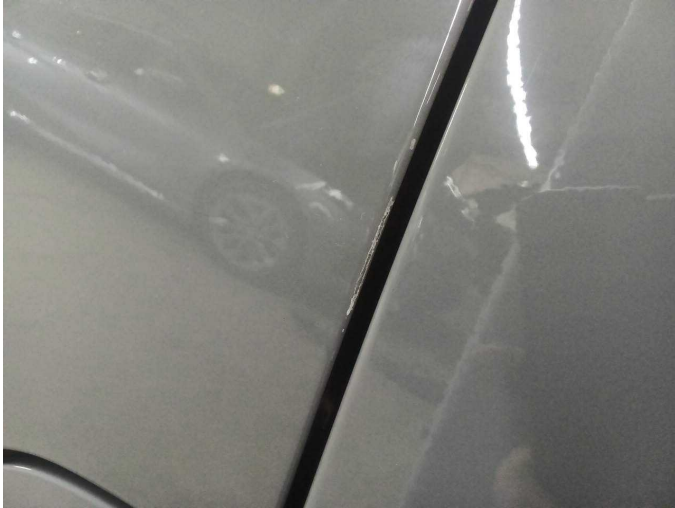
Damage 3: Door - front left side: Door edge - Scratch(es) - Smart repair

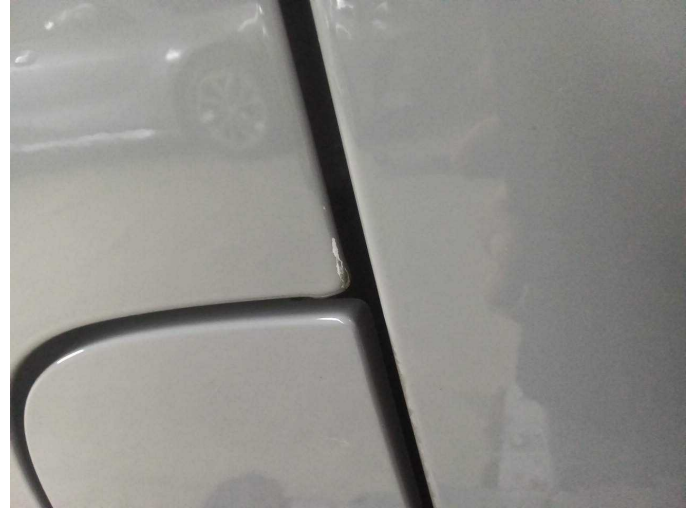
Damage 3: Door - front left side: Door edge - Scratch(es) - Smart repair

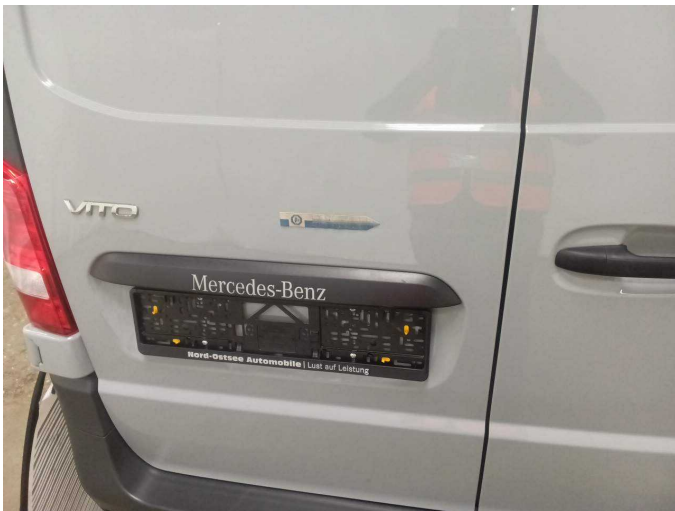
Damage 4: Boot lid / rear door: Boot lid - Scratch(es) - Smart repair

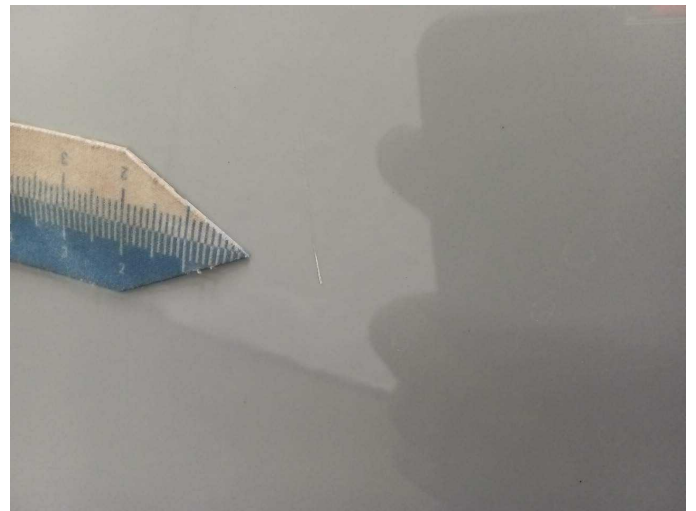
Damage 4: Boot lid / rear door: Boot lid - Scratch(es) - Smart repair

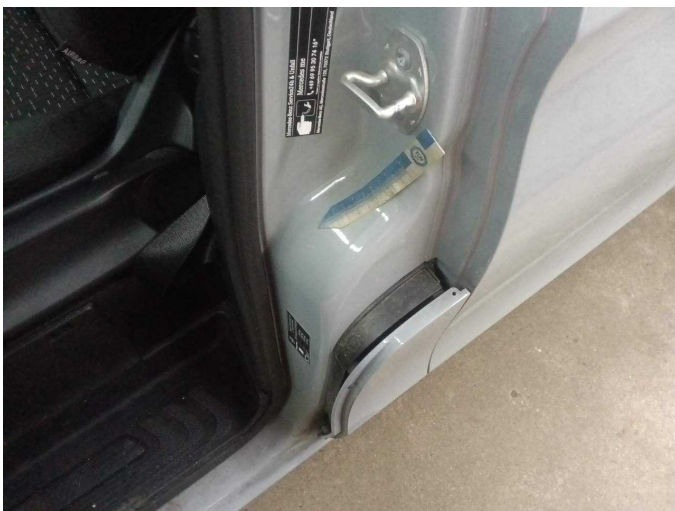
Damage 5: Body: B-pillar - left side - Scratch(es) - Smart repair

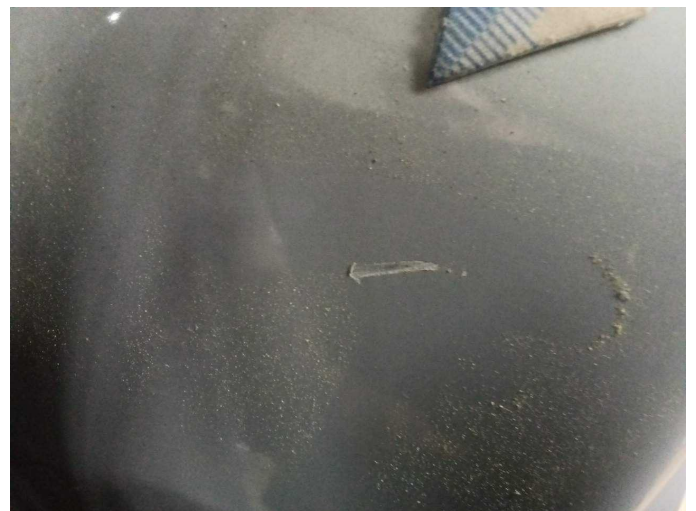
Damage 5: Body: B-pillar - left side - Scratch(es) - Smart repair

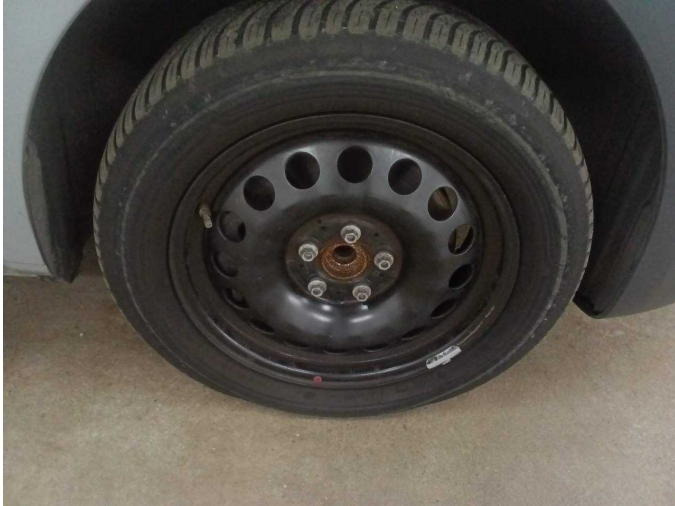
Damage 6: Wheel / tyres: Tyre - front right side - Damaged - Replace

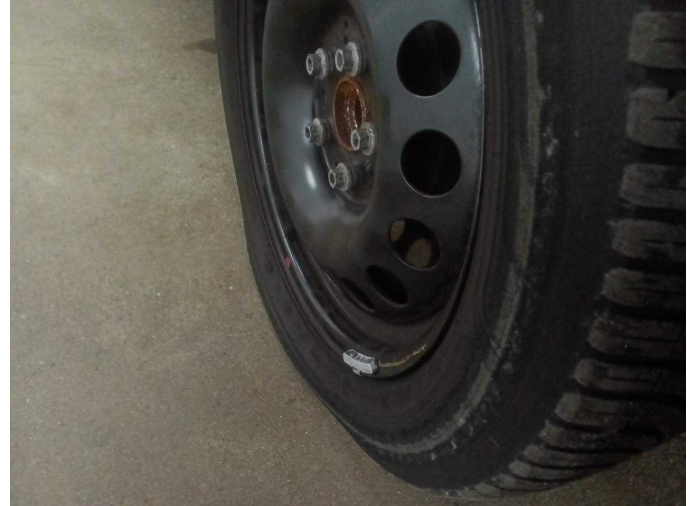
Damage 6: Wheel / tyres: Tyre - front right side - Damaged - Replace

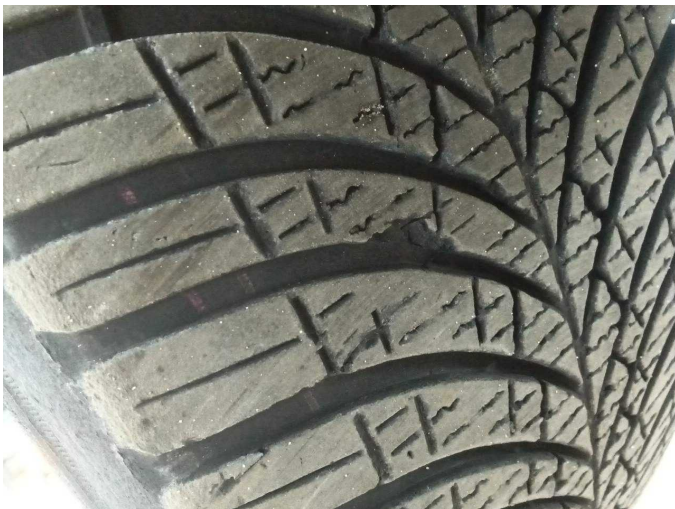
Damage 6: Wheel / tyres: Tyre - front right side - Damaged - Replace

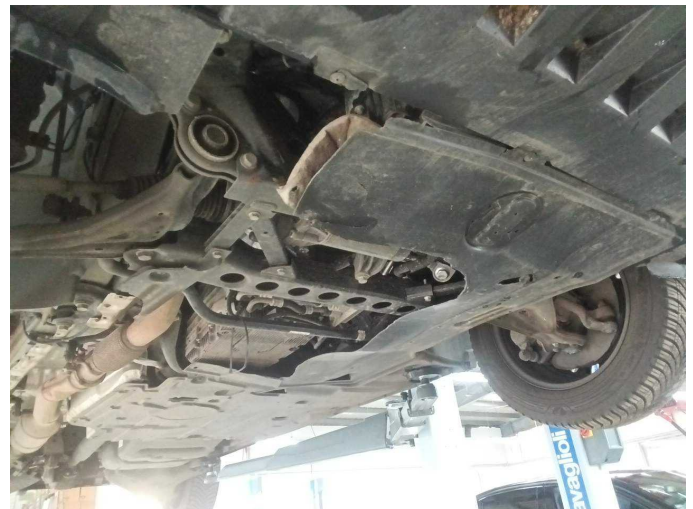
Damage 7: Body: Underbody panelling - Broken / torn - Replace

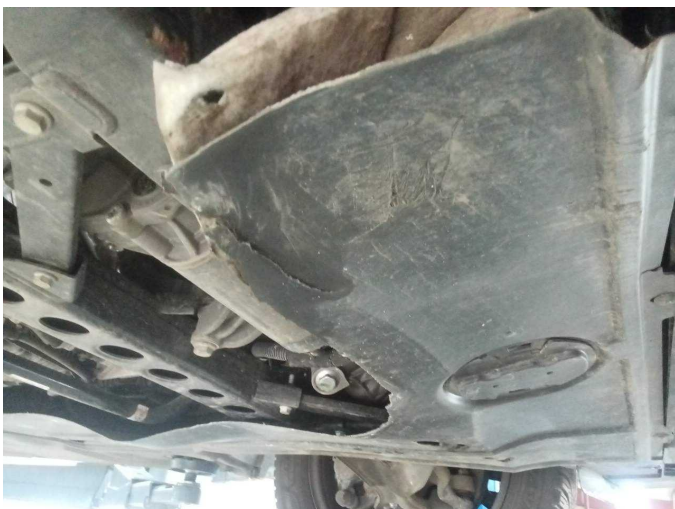
Damage 7: Body: Underbody panelling - Broken / torn - Replace

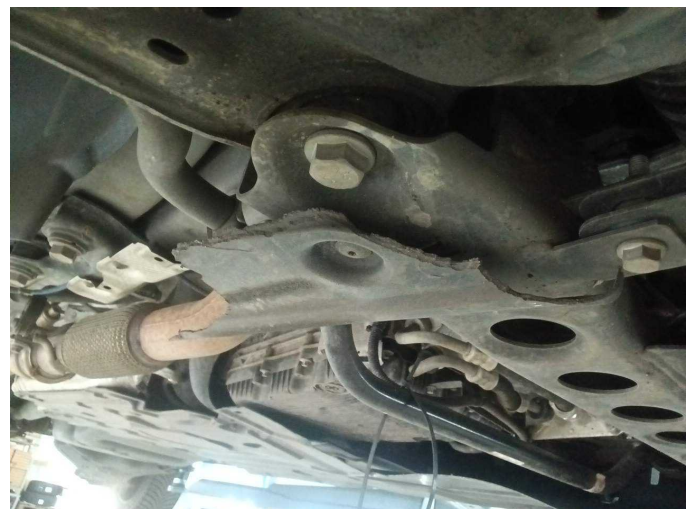
Damage 7: Body: Underbody panelling - Broken / torn - Replace

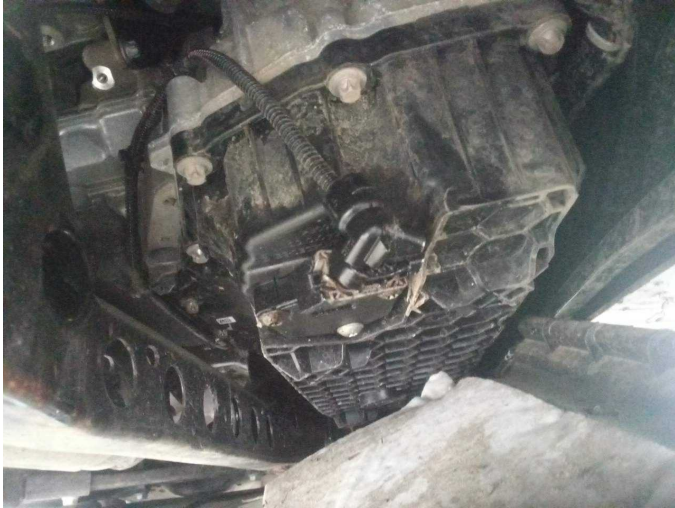
Damage 8: Engine: Engine oil sump (Ölstandsensord/Ölqualitätsensord) - Broken / torn - Replace

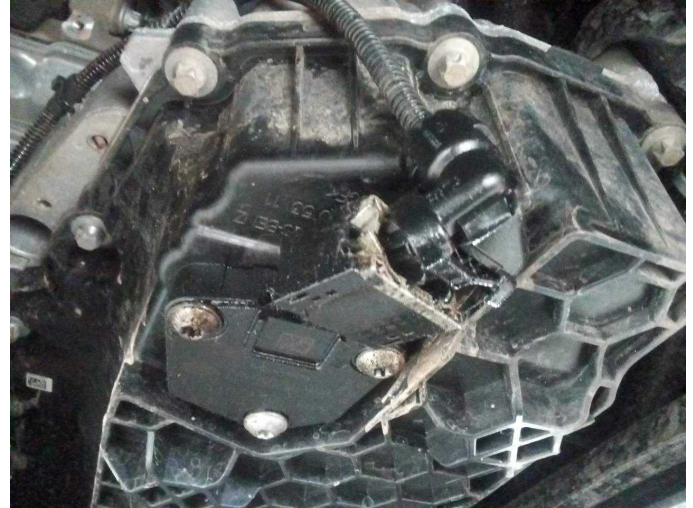
Damage 8: Engine: Engine oil sump (Ölstandsensord/Ölqualitätsensord) - Broken / torn - Replace

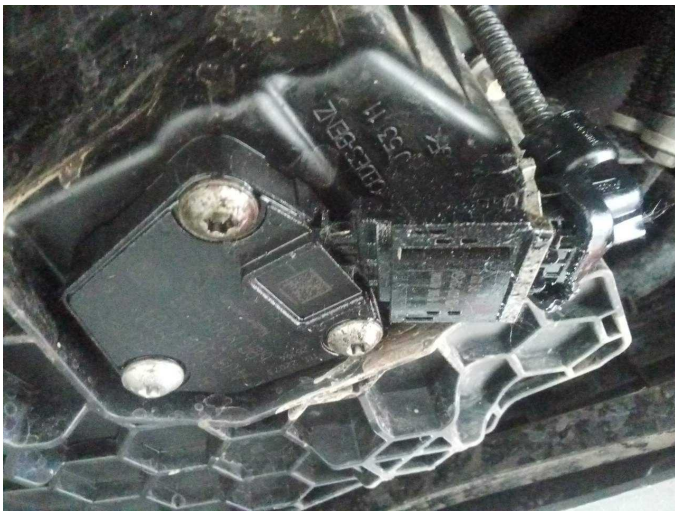
Damage 8: Engine: Engine oil sump (Ölstandsensord/Ölqualitätsensord) - Broken / torn - Replace

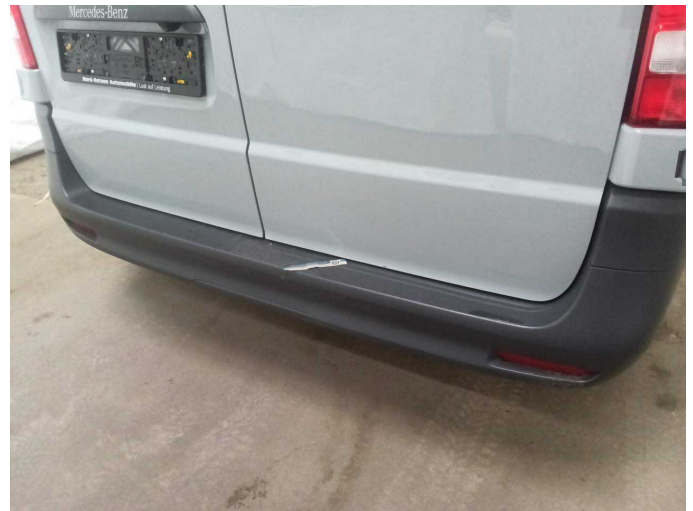
Damage 9: Rear bumper: Rear bumper - Scratched - Replace

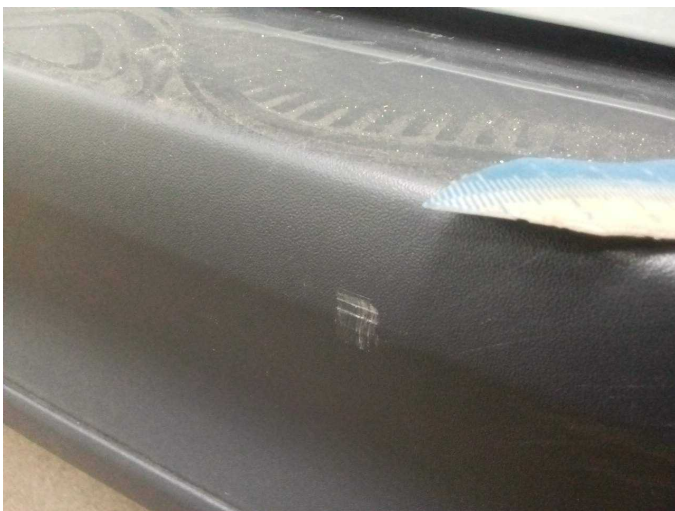
Damage 9: Rear bumper: Rear bumper - Scratched - Replace

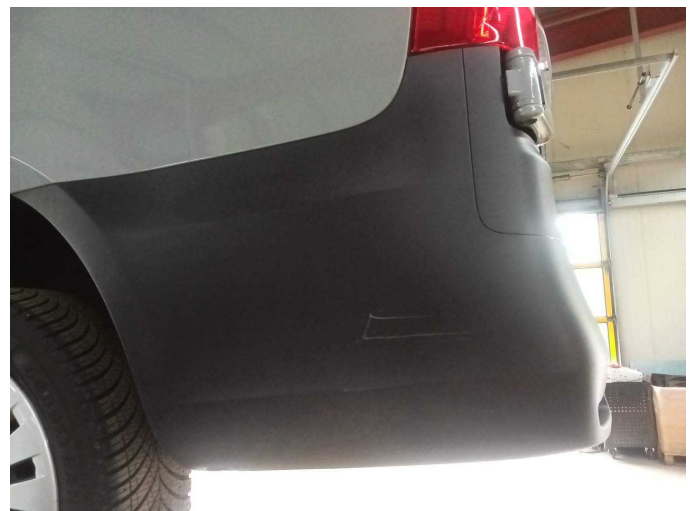
Damage 9: Rear bumper: Rear bumper - Scratched - Replace

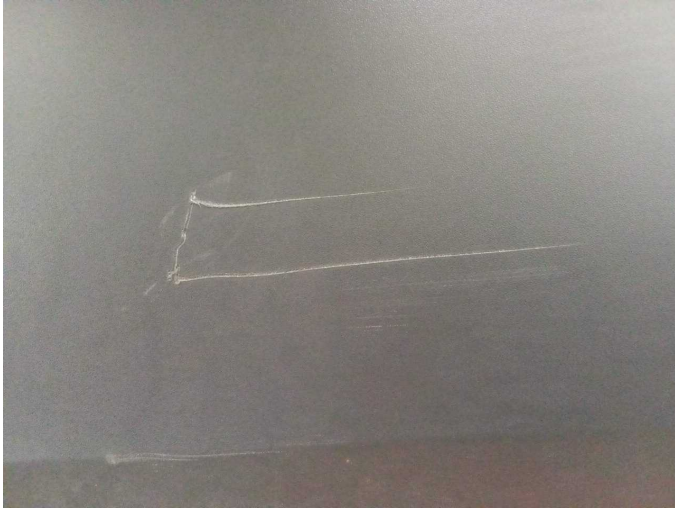
Damage 9: Rear bumper: Rear bumper - Scratched - Replace

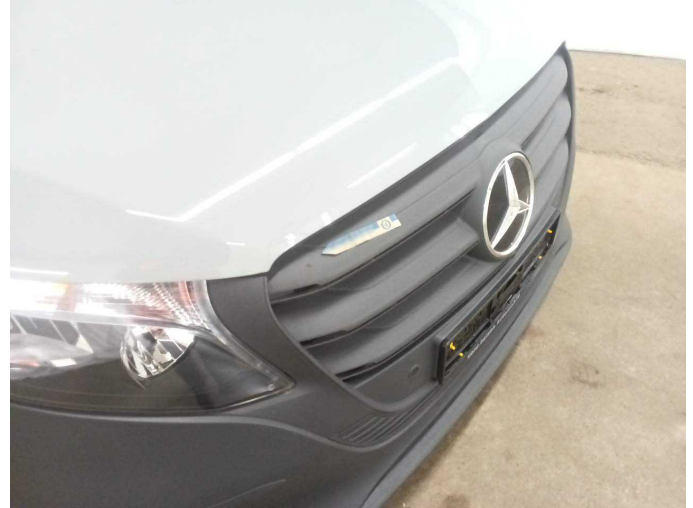
Damage 10: Front bumper: Front bumper - Scratched - Replace

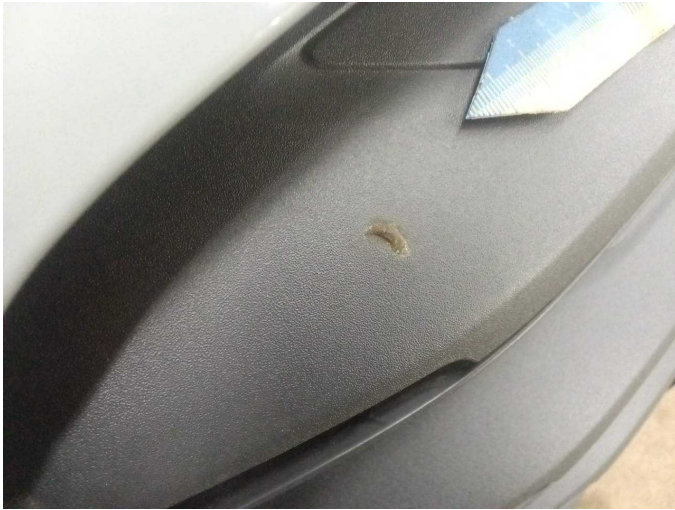
Damage 10: Front bumper: Front bumper - Scratched - Replace

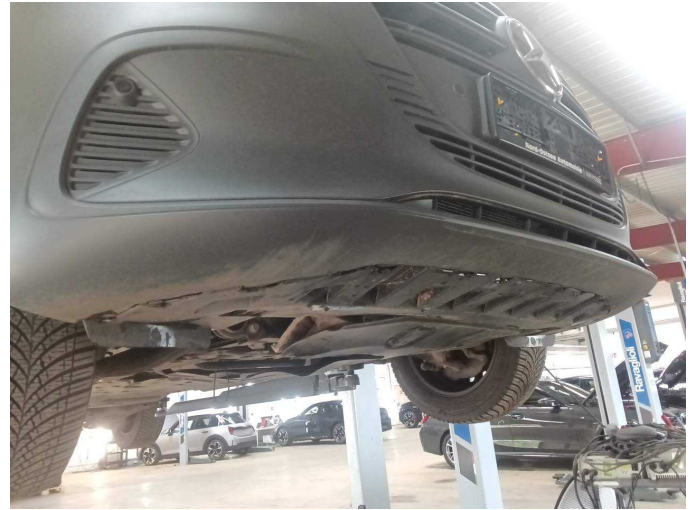
Damage 10: Front bumper: Front bumper - Scratched - Replace

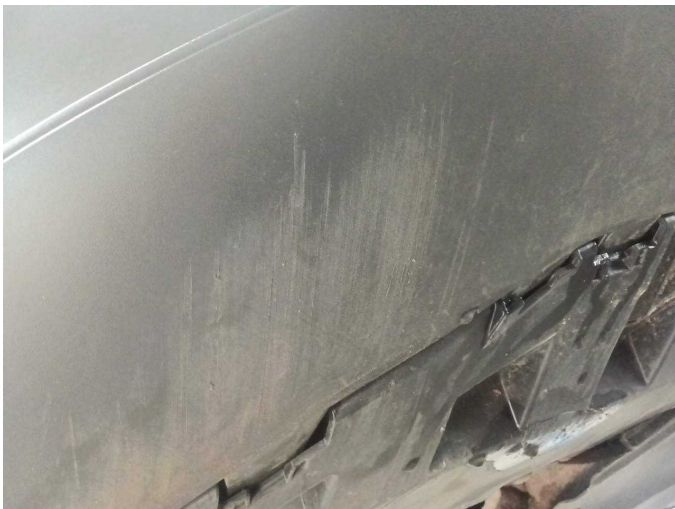
Damage 10: Front bumper: Front bumper - Scratched - Replace

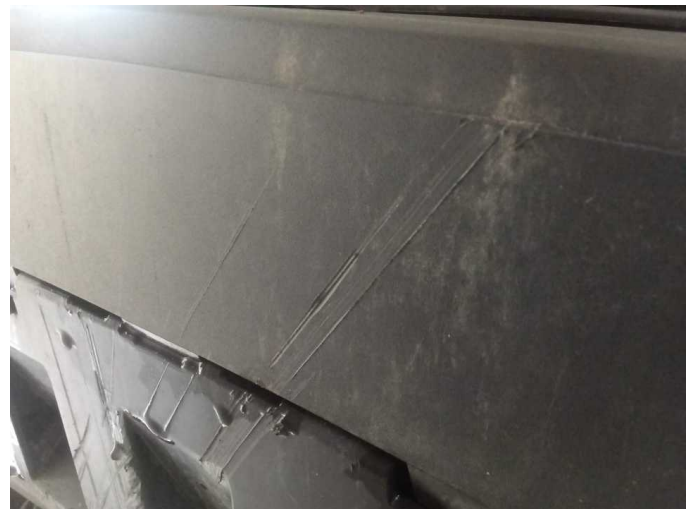
Damage 10: Front bumper: Front bumper - Scratched - Replace

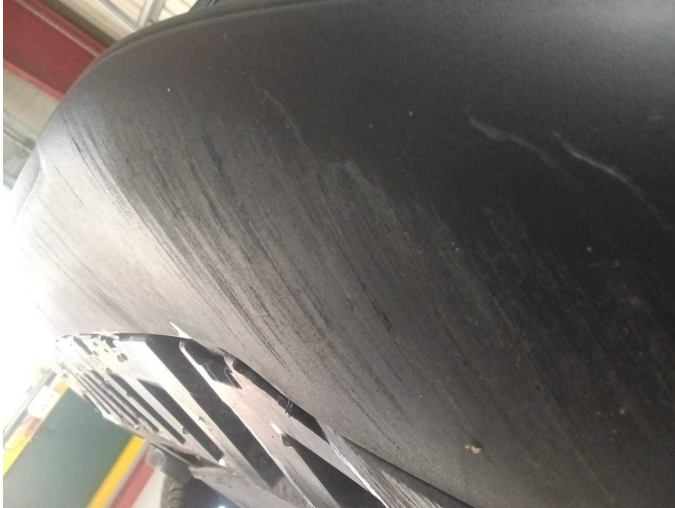
Damage 10: Front bumper: Front bumper - Scratched - Replace
