Expertise

Protocol number: 46346969
Order No. / Reference: 26670855
Inspection date: 3 Jul 2026

Manufacturer: Peugeot

Model: 508 SW Plug-In Hybrid 225 e-EAT8 GT

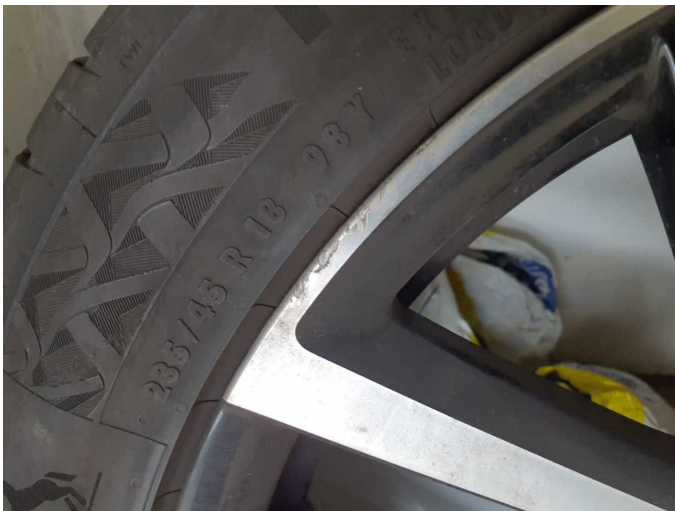
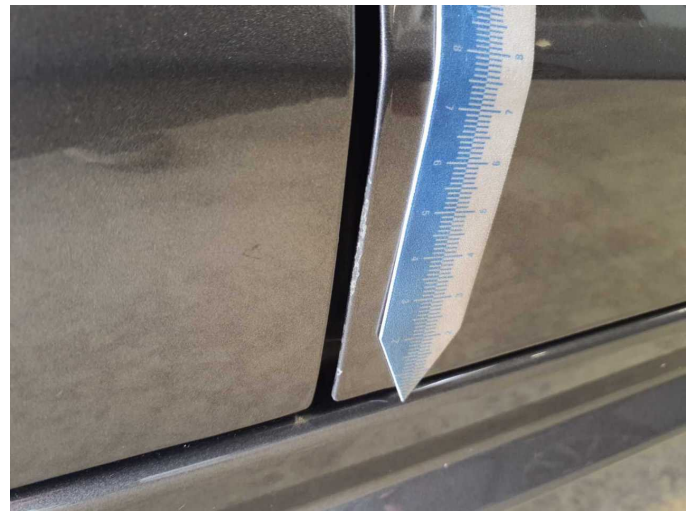
Damage 3: 2nd wheel set: 1 alloy rim - Scratch(es) - Loss in value

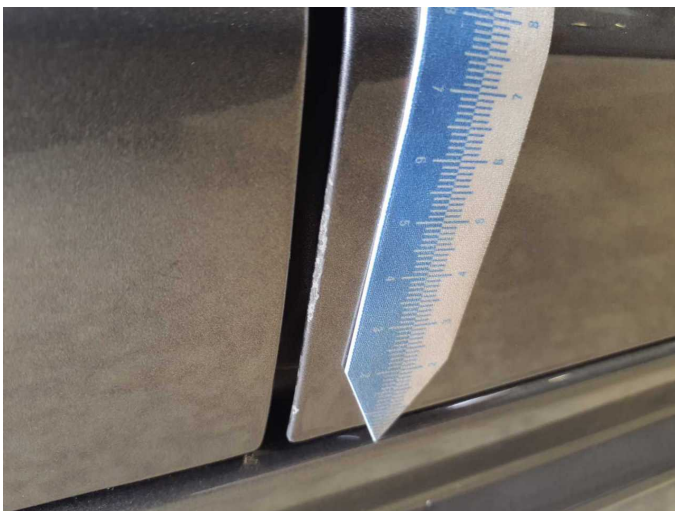
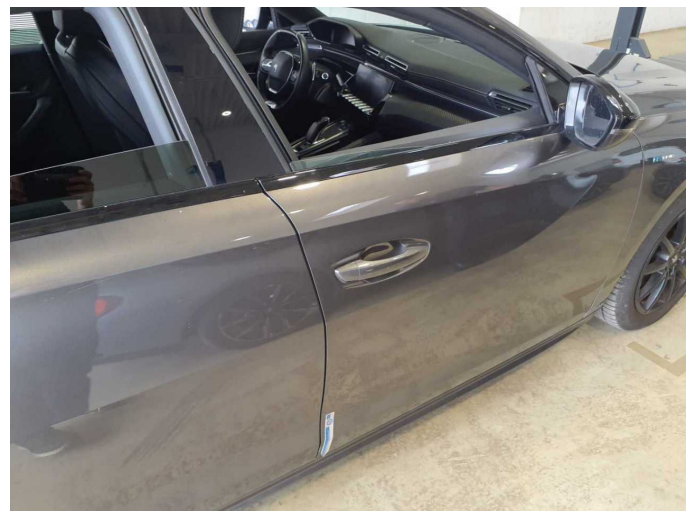
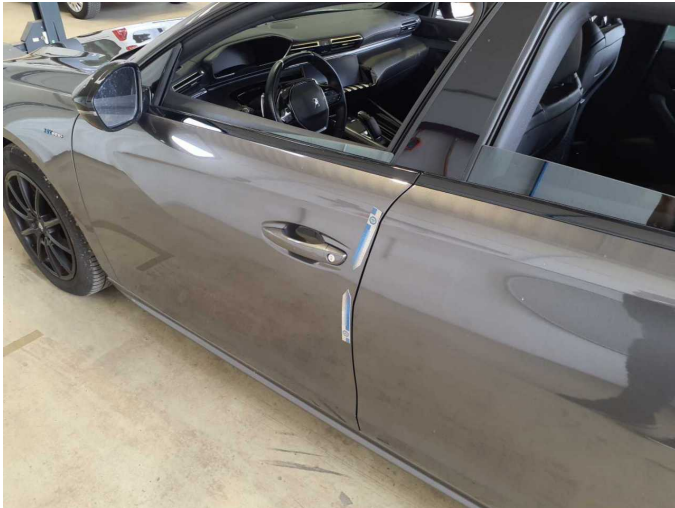
Damage 4: Door - front right side: Door edge - Scratch(es) - Smart repair

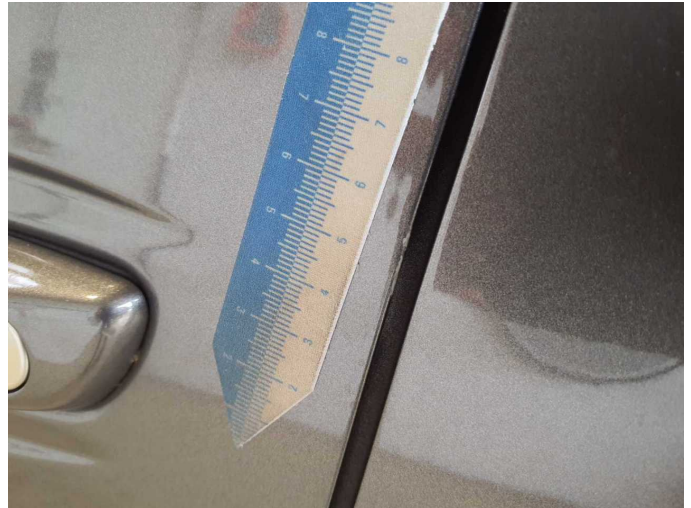
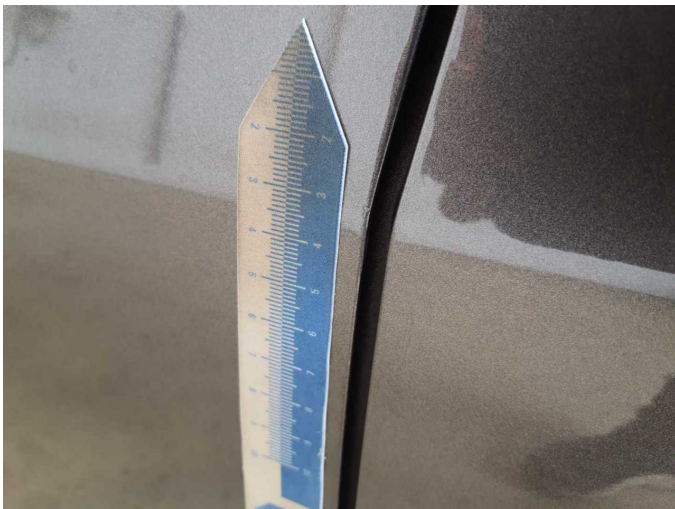
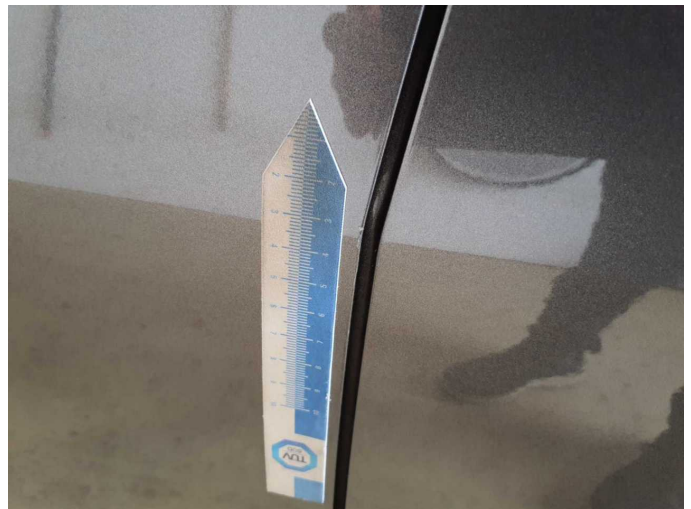
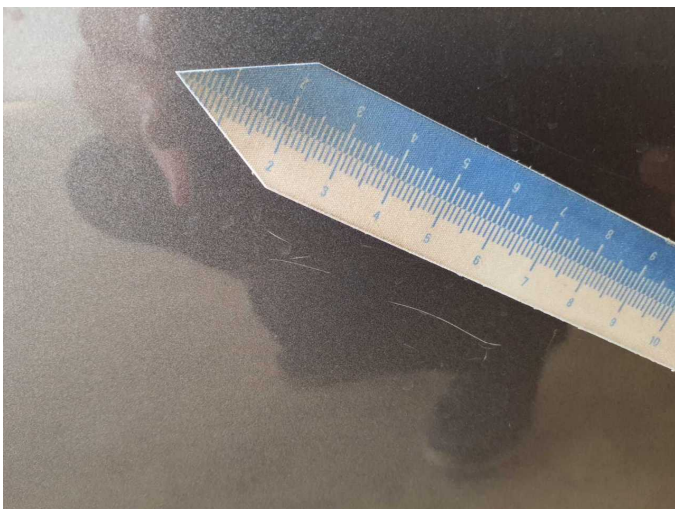
Damage 5: Door - front left side: Door edge - Scratch(es) - Smart repair

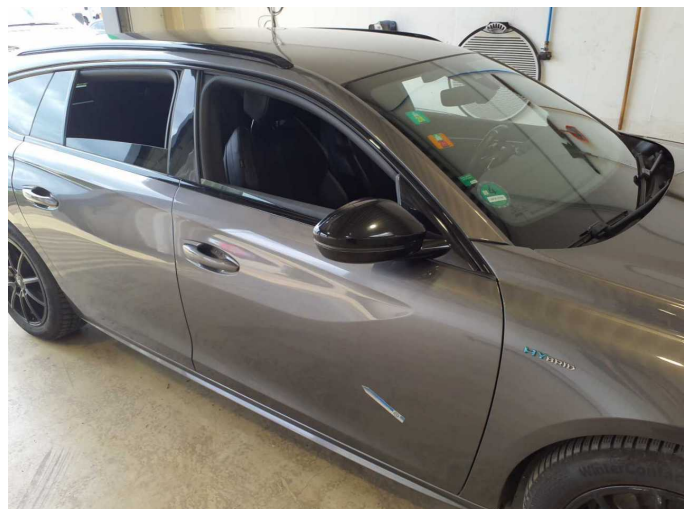
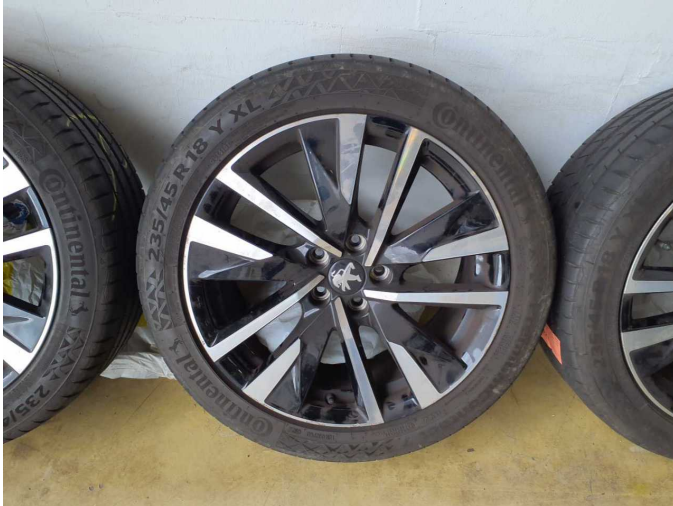
Damage 6: Door - front right side: Door - Scratch(es) - Smart repair

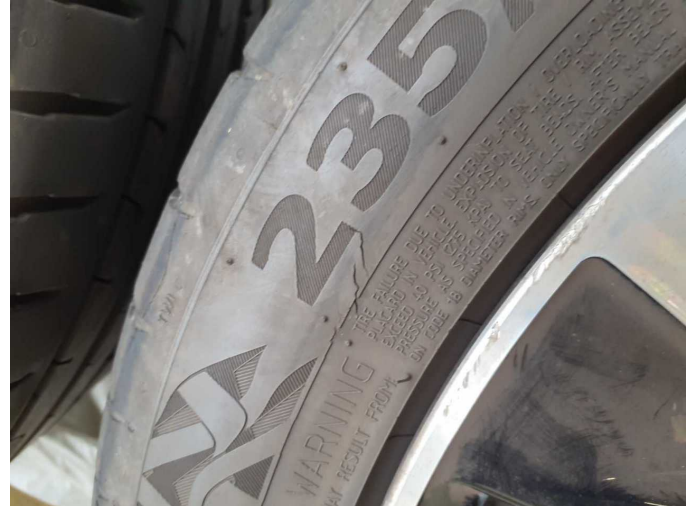
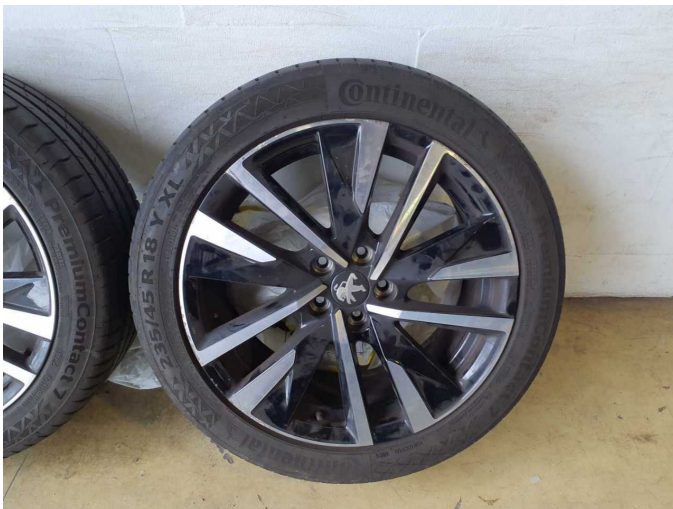
Damage 7: 2nd wheel set: 1 tyre - Porous / cracked - Replace

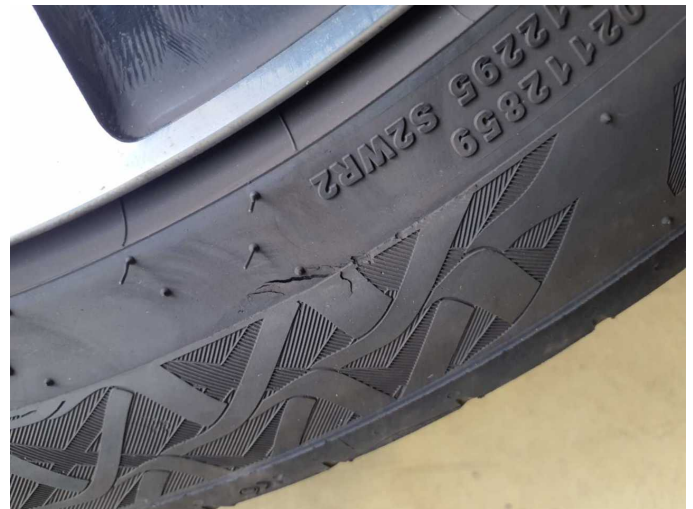
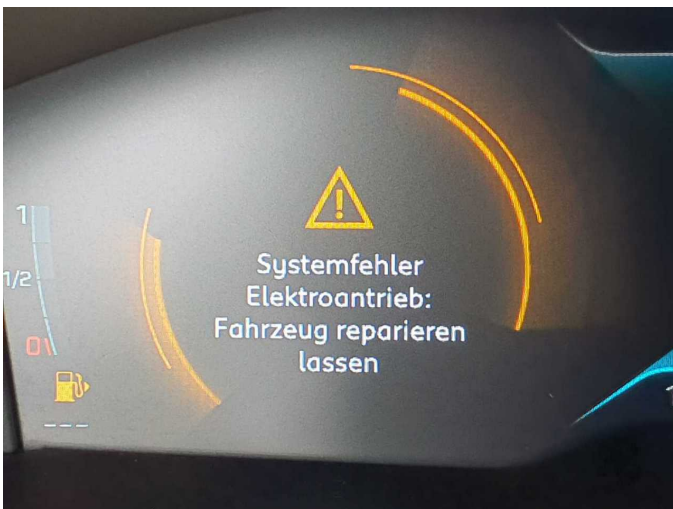
Damage 8: 2nd wheel set: 1 tyre - Porous / cracked - Replace

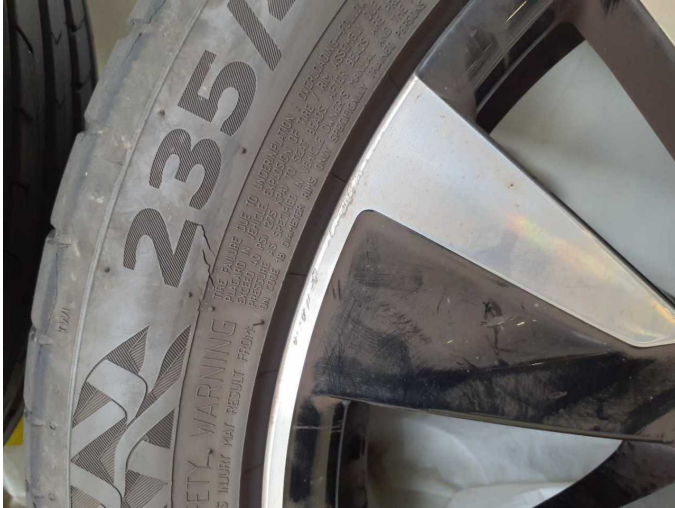
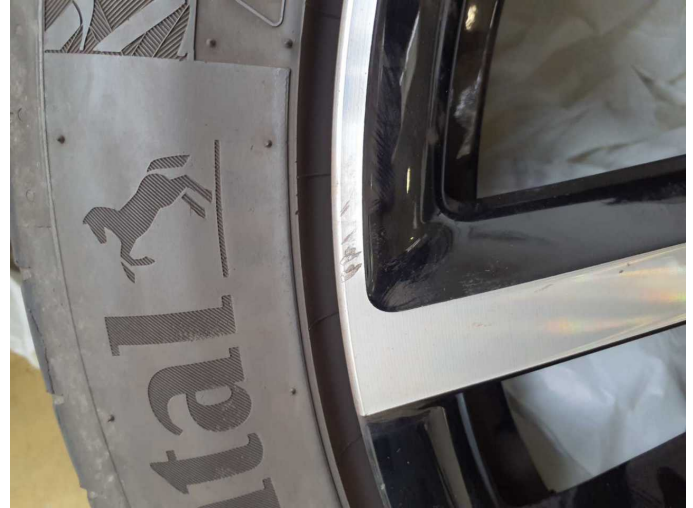
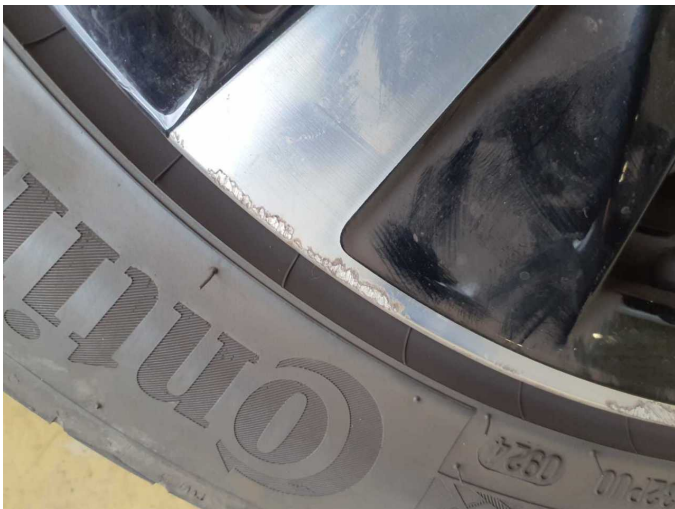
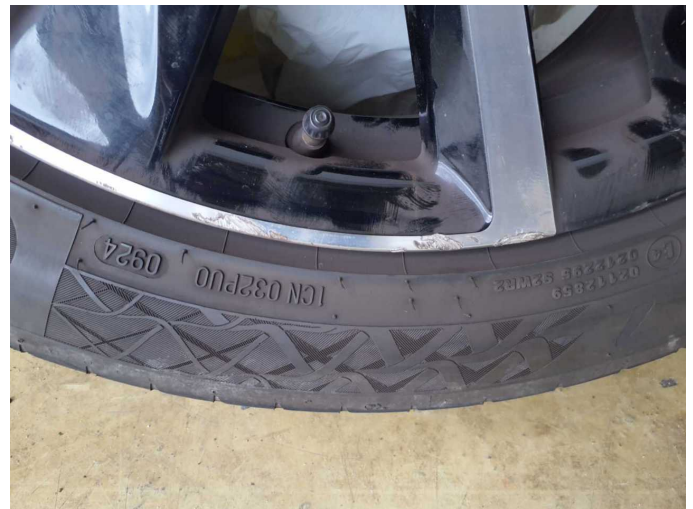
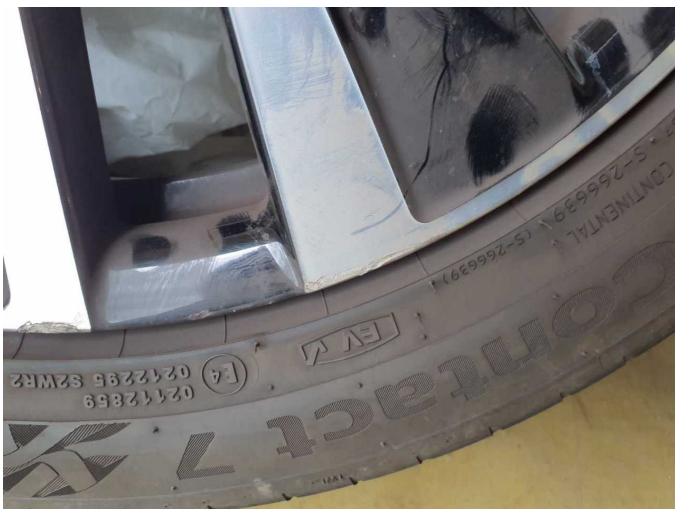
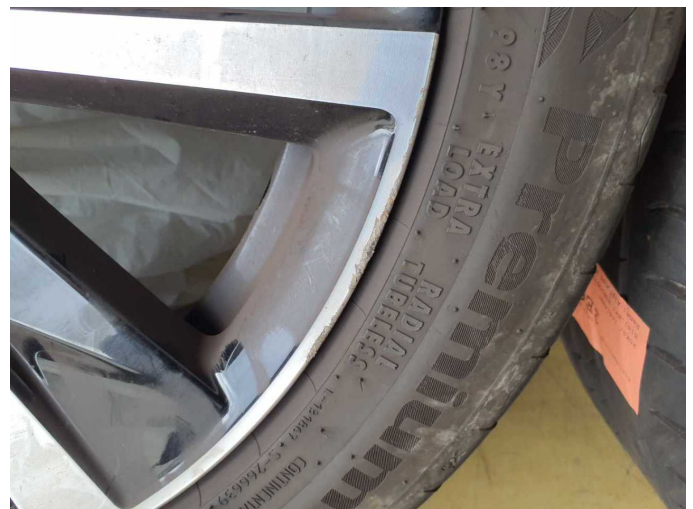
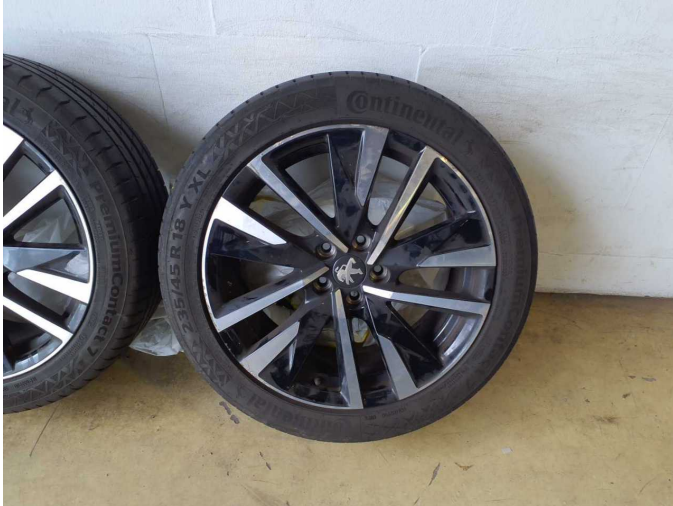
Damage 11: 2nd wheel set: 1 alloy rim - Scratch(es) - Replace

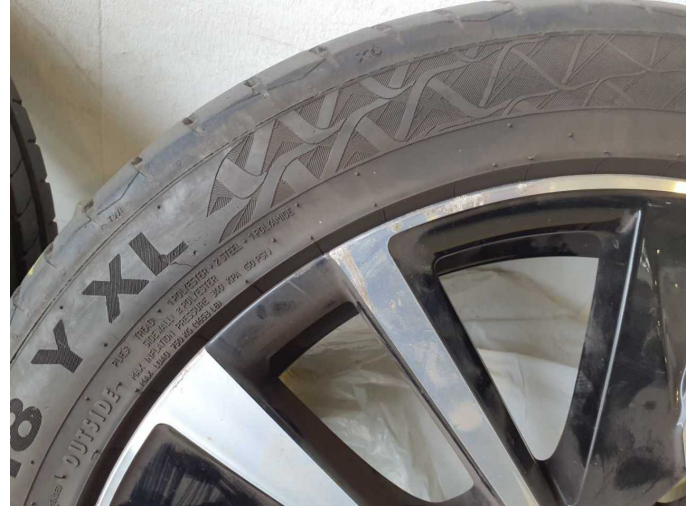
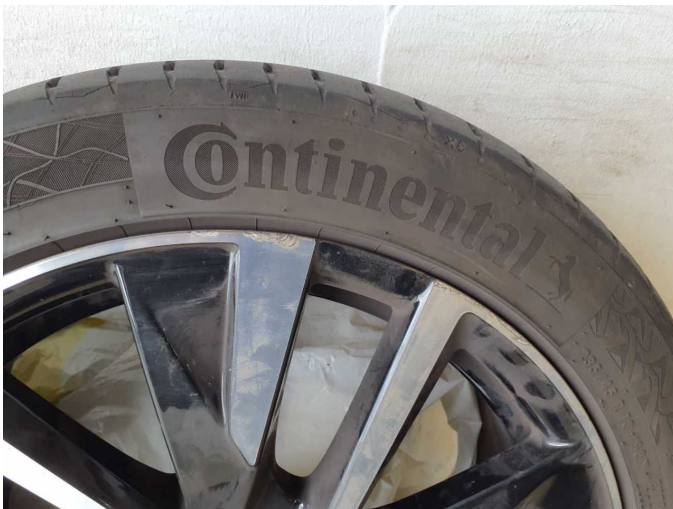
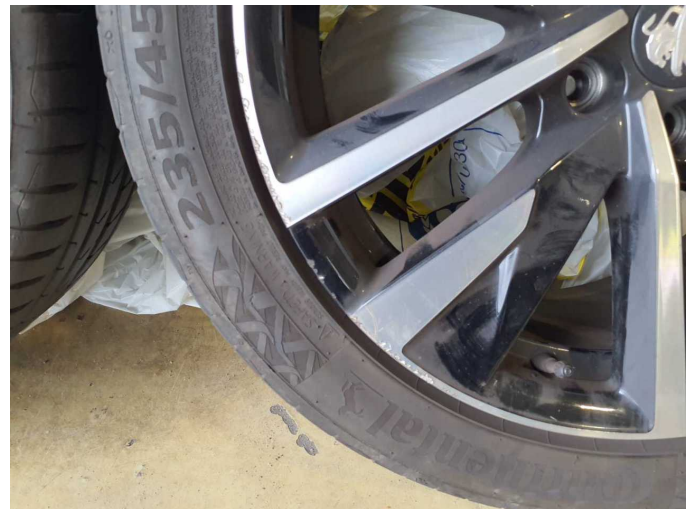
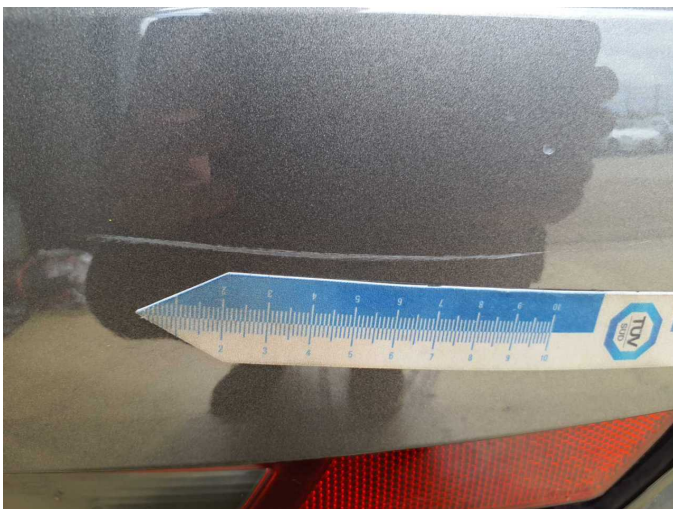
Damage 12: 2nd wheel set: 1 alloy rim - Scratch(es) - Replace

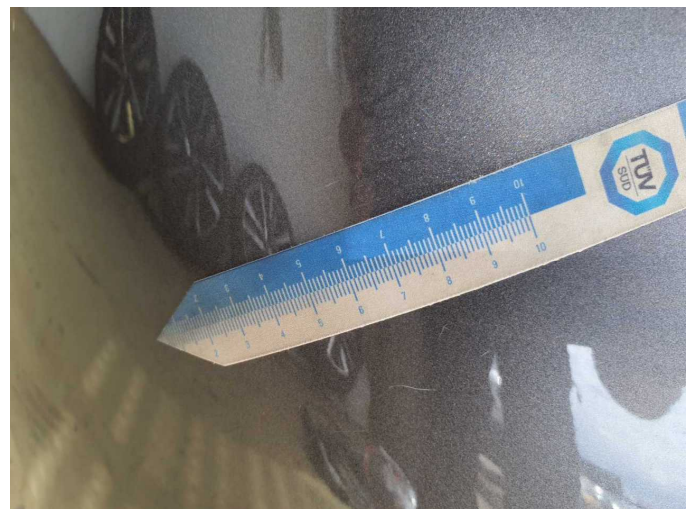
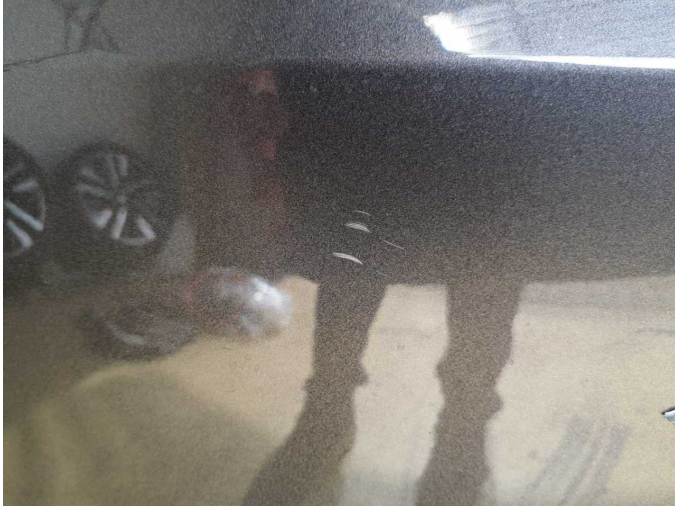
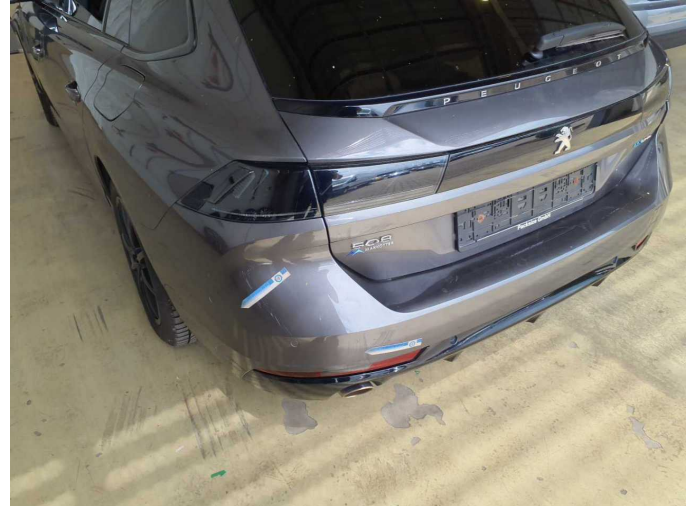
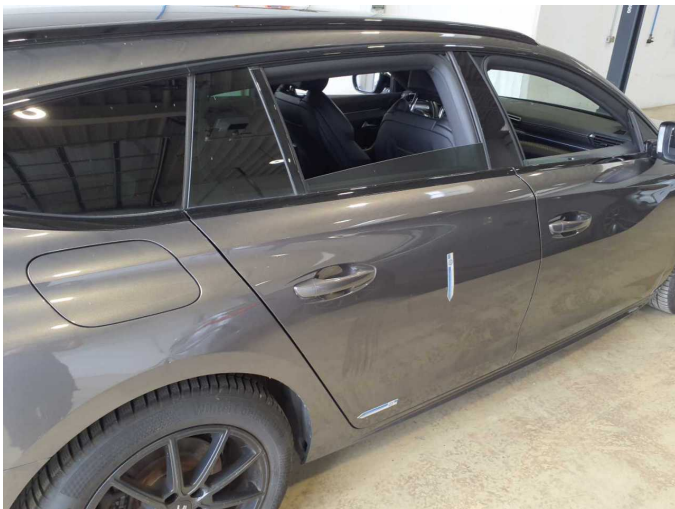
Damage 13: Rear bumper: Rear bumper - Scratch(es) - Paint

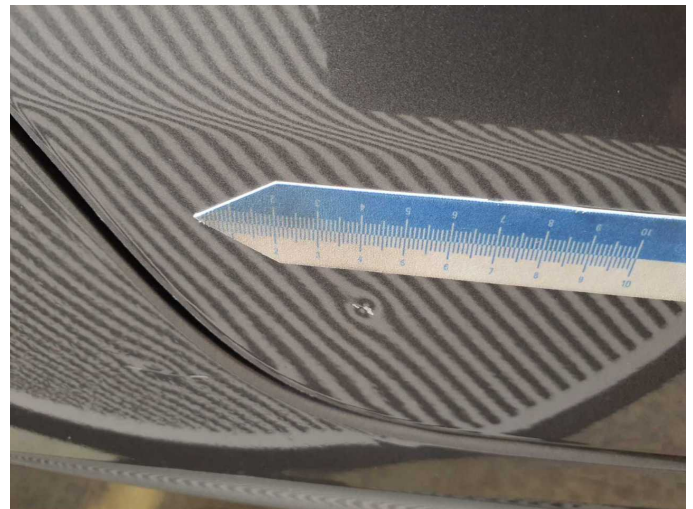
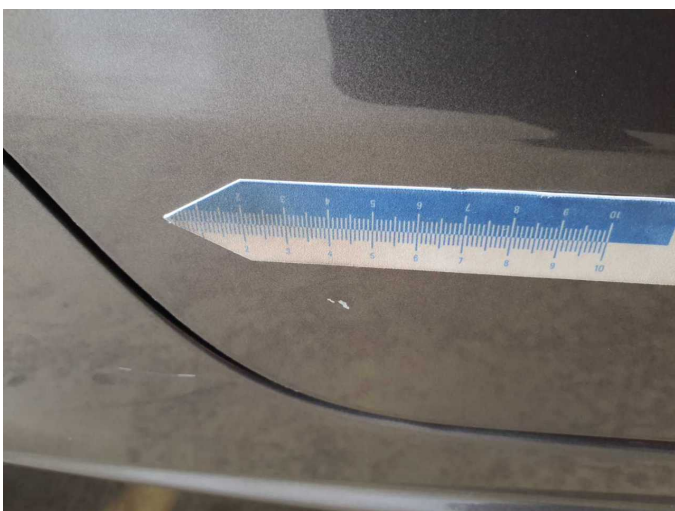
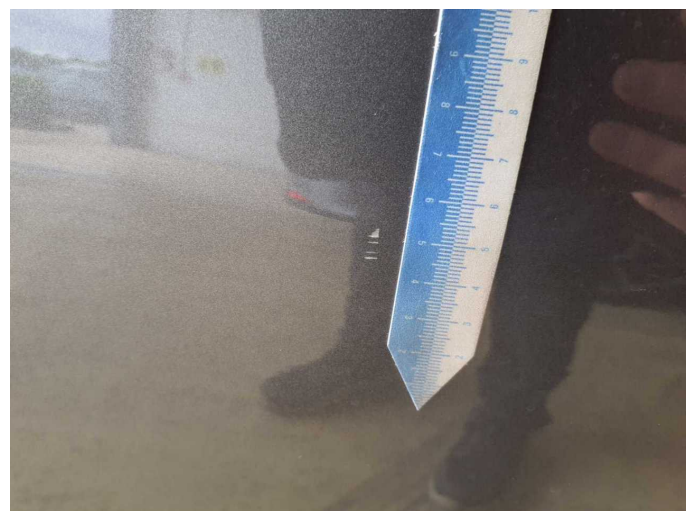
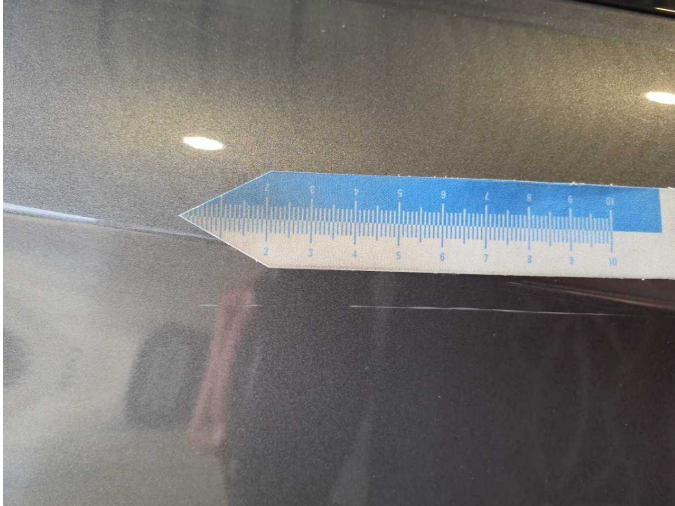
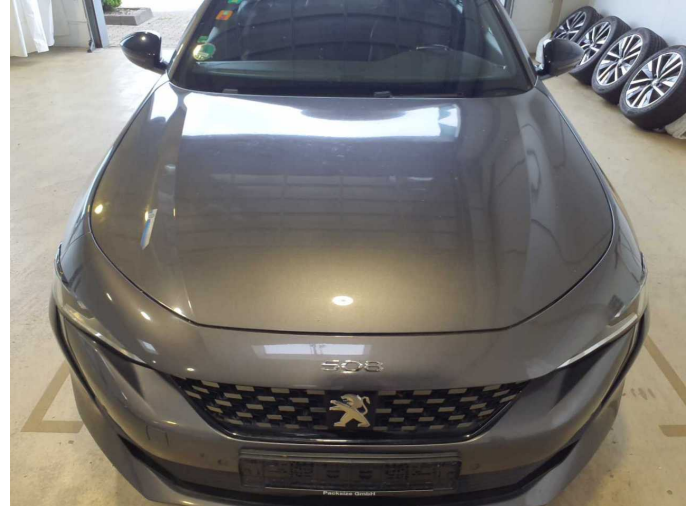
Damage 14: Door - rear right side: Door - Dent / paintcoat damage - Repair and paint

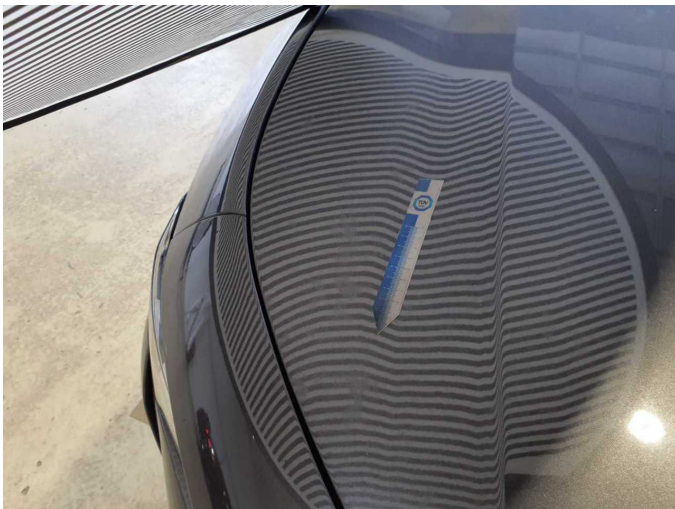
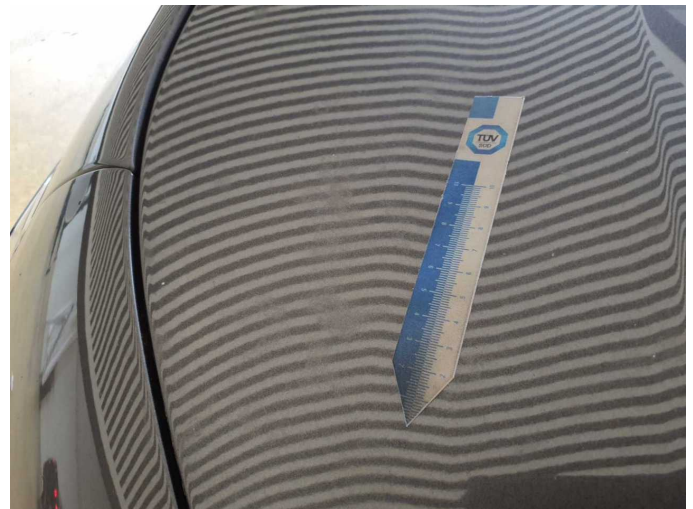
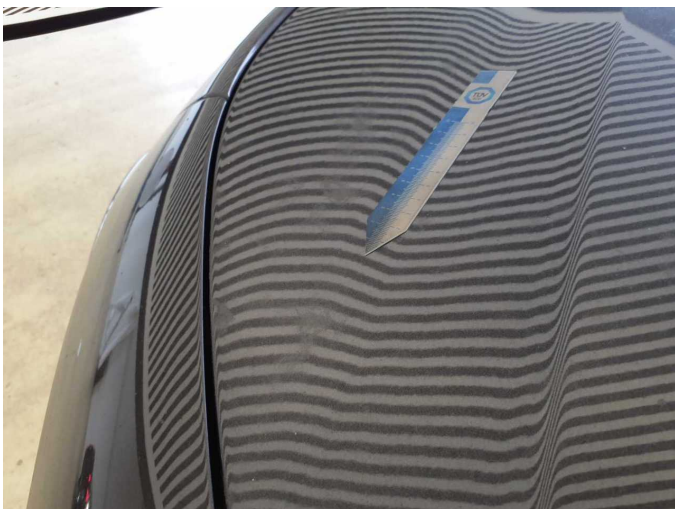
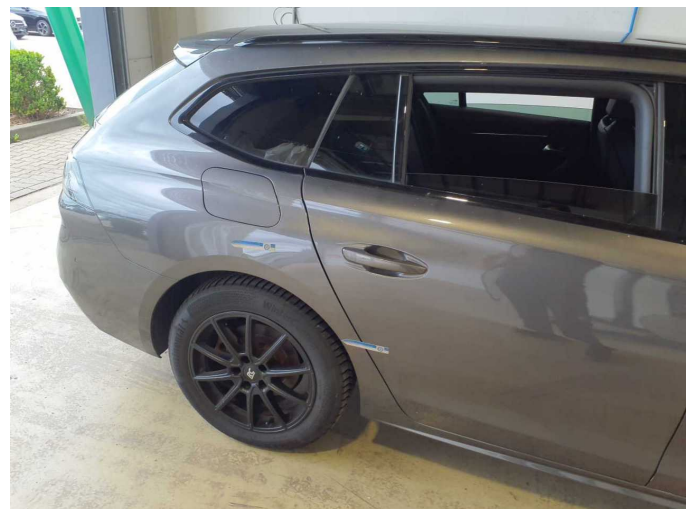
Damage 15: Bonnet: Bonnet (Anätzung) - Paint defect - Repair and paint

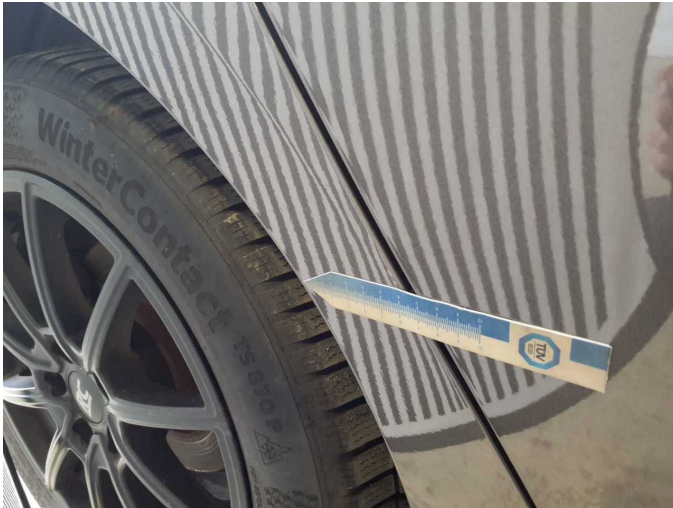
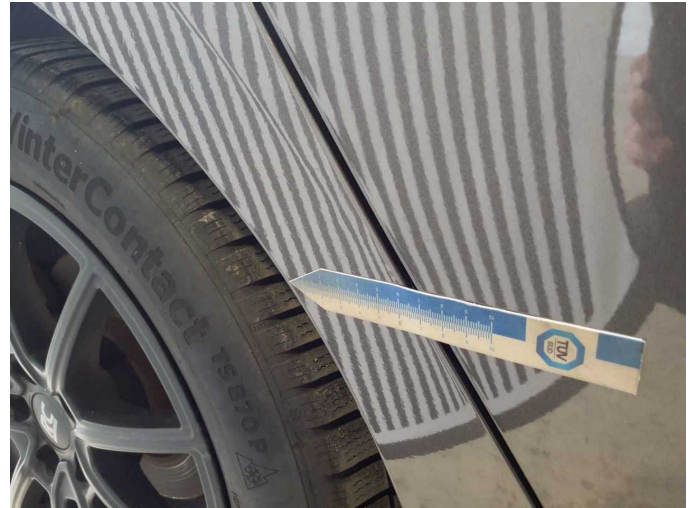
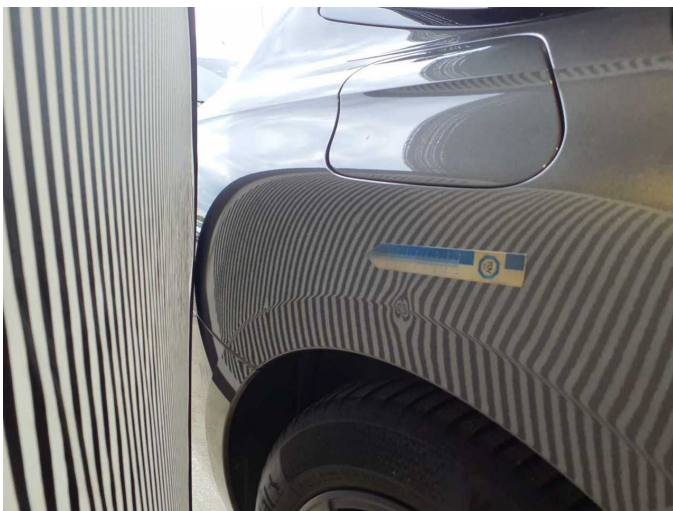
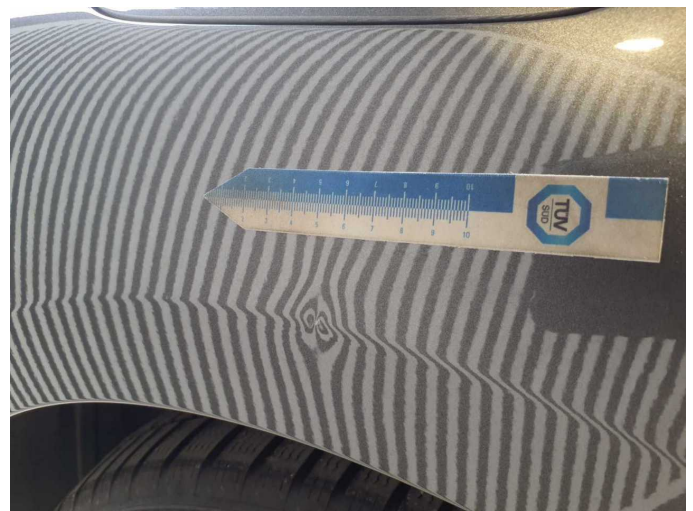
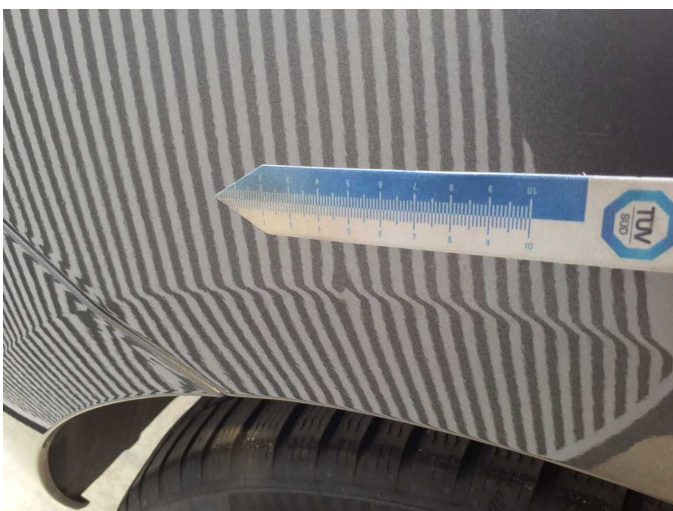
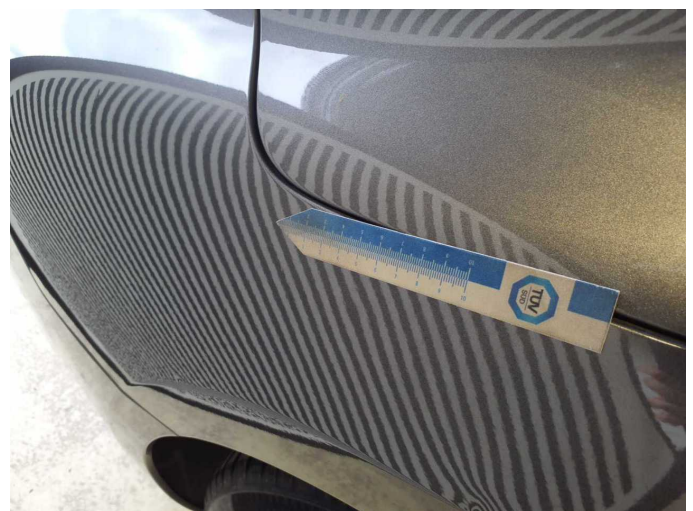
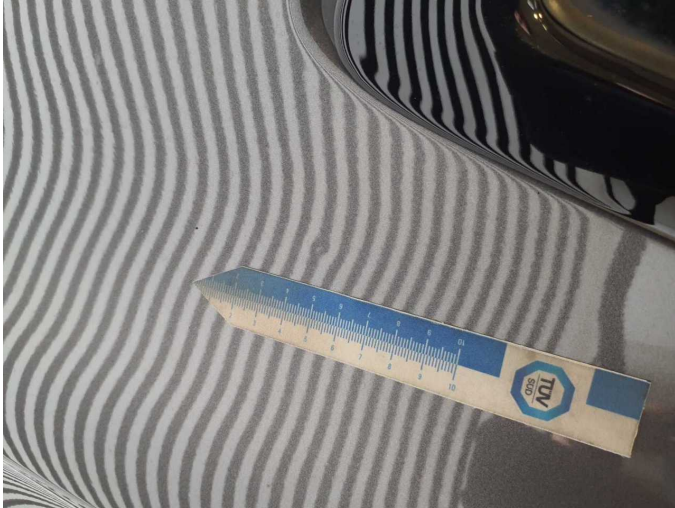
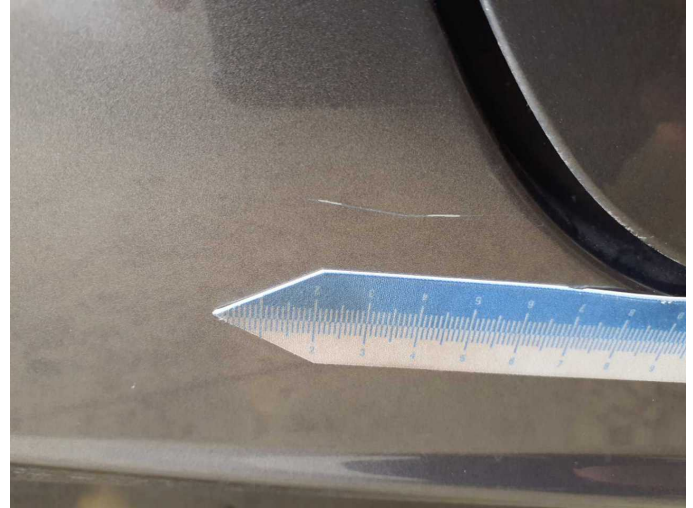
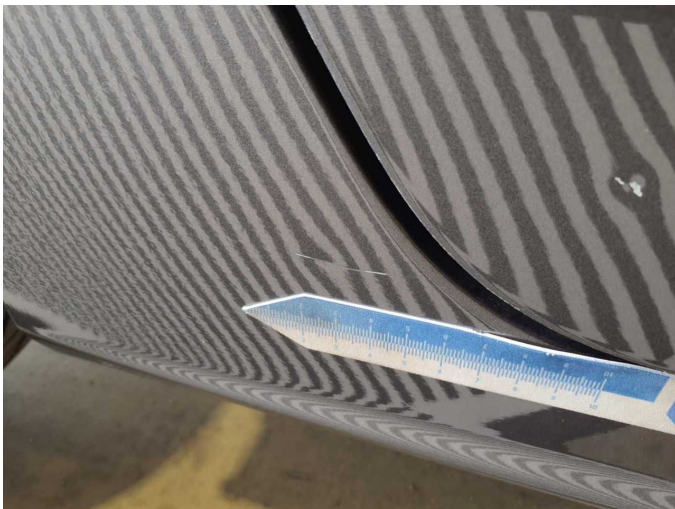
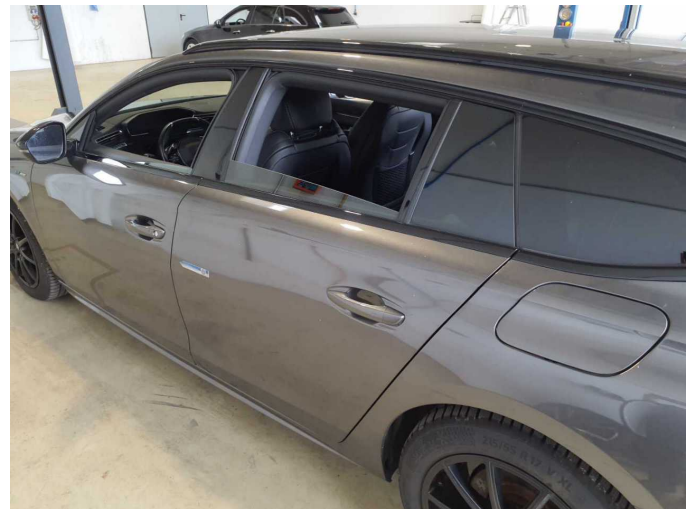
Damage 16: Side panel - rear right side: Side panel - Dent / paintcoat damage - Repair and paint

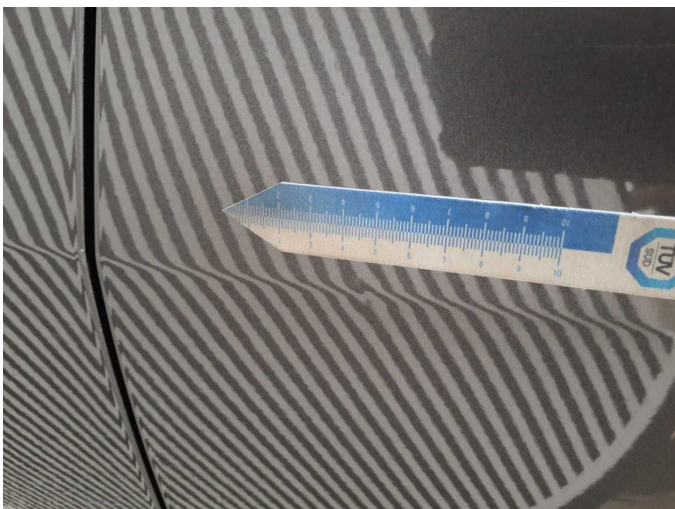
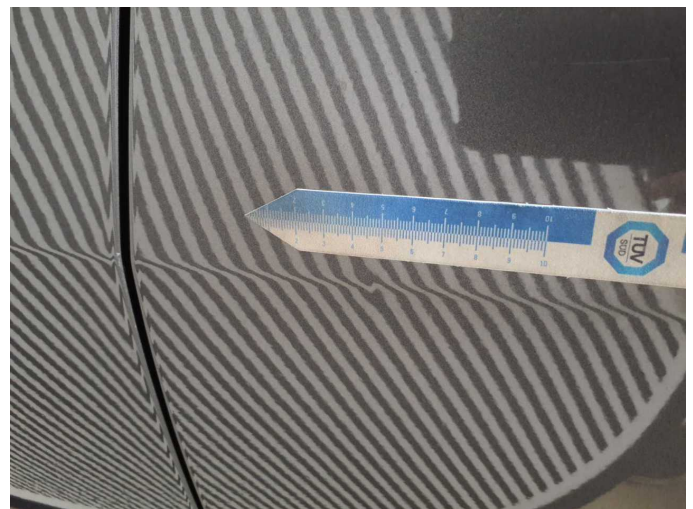
Wear and tear 8: Door - rear left side: Door - dent(s) - No deduction
