Expertise

Protocol number: 46042917
Order No. / Reference: 26154097
Inspection date: 16 Jun 2026

Manufacturer: Mercedes-Benz

Model: Vito 116 CDI Extralang HA Aut. PRO Kasten

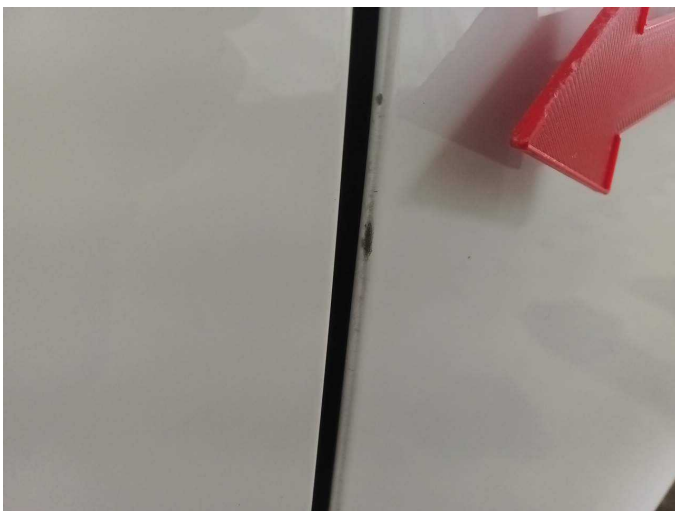
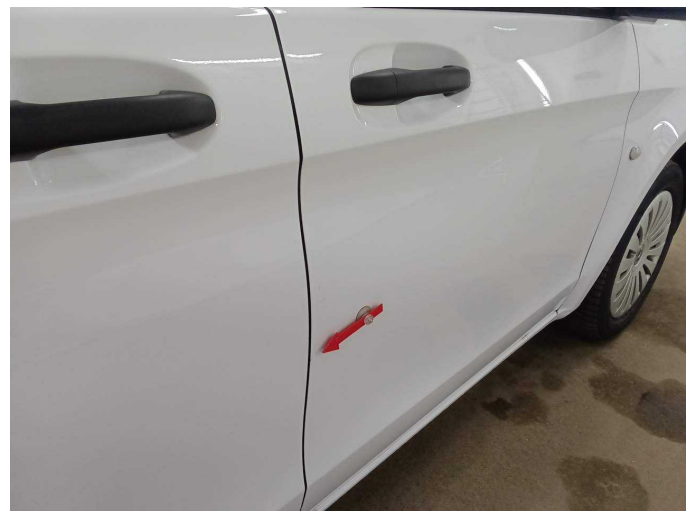
Damage 1: Door - front right side: Door edge - Scratch(es) - Smart repair

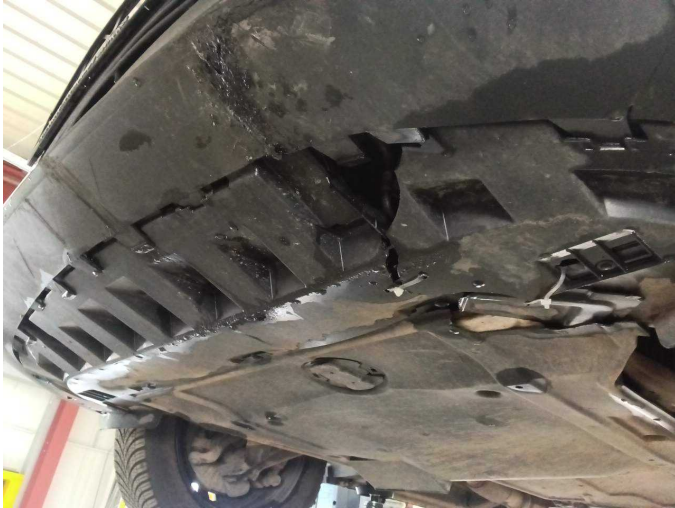
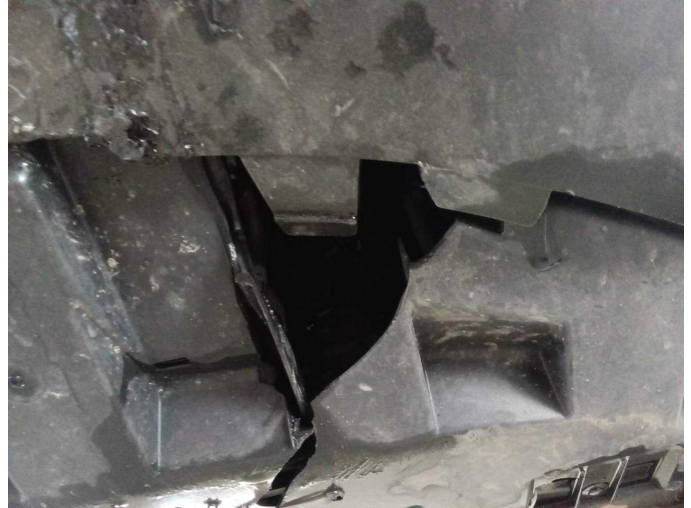
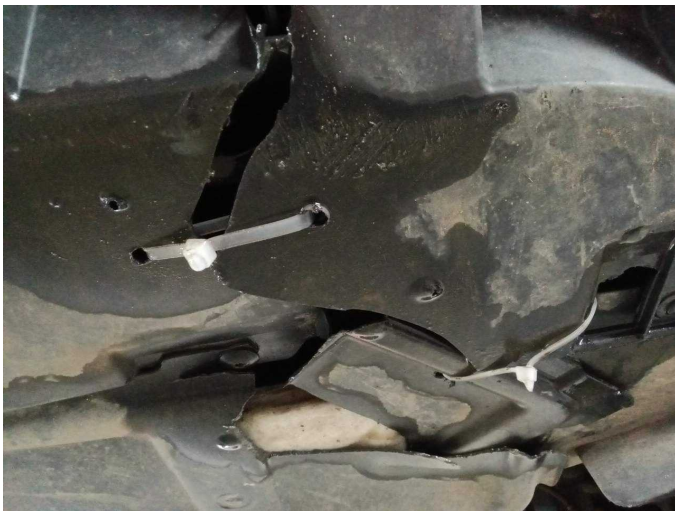
Damage 2: Body: Underbody panelling - Broken / torn - Replace

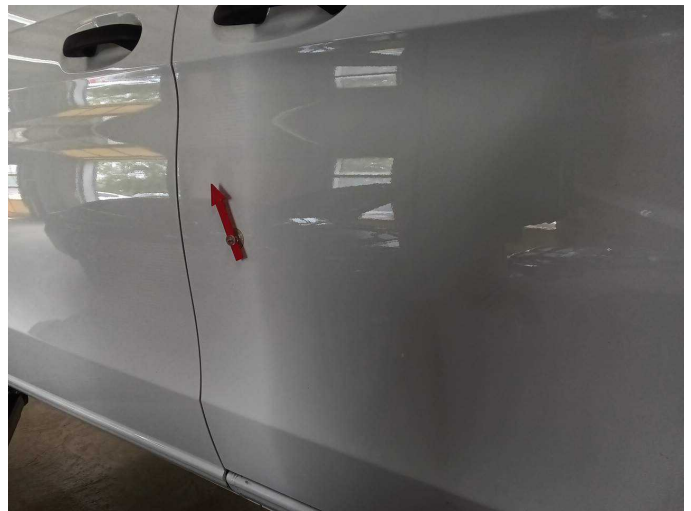
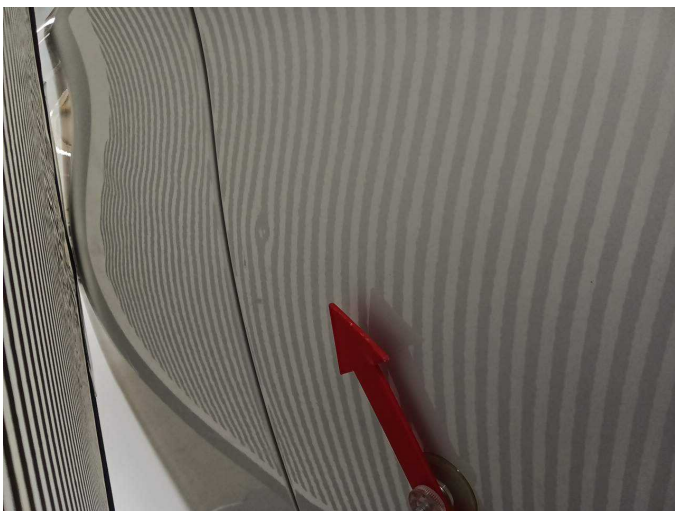
Damage 3: Door - front right side: Door - dent(s) - Smooth repair work

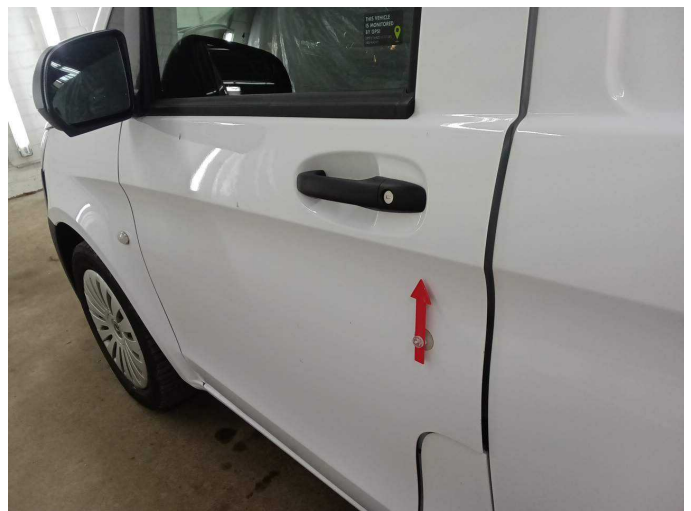
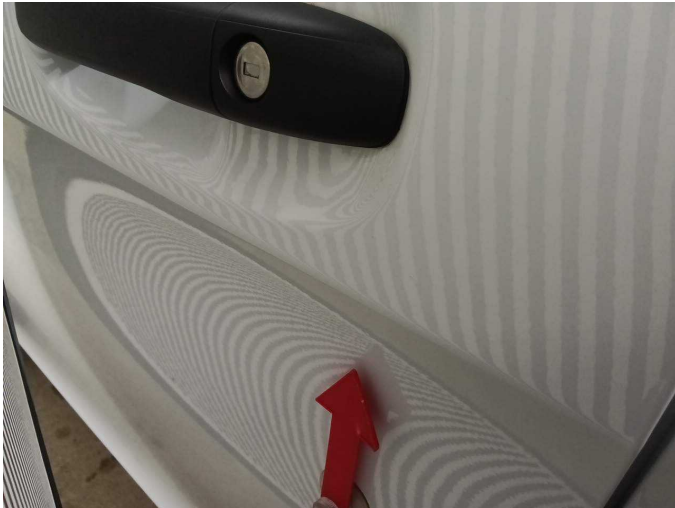
Damage 4: Door - front left side: Door - dent(s) - Smooth repair work

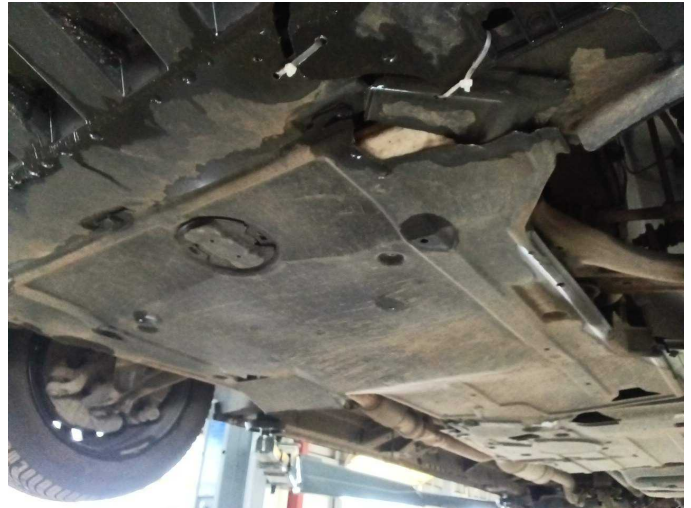
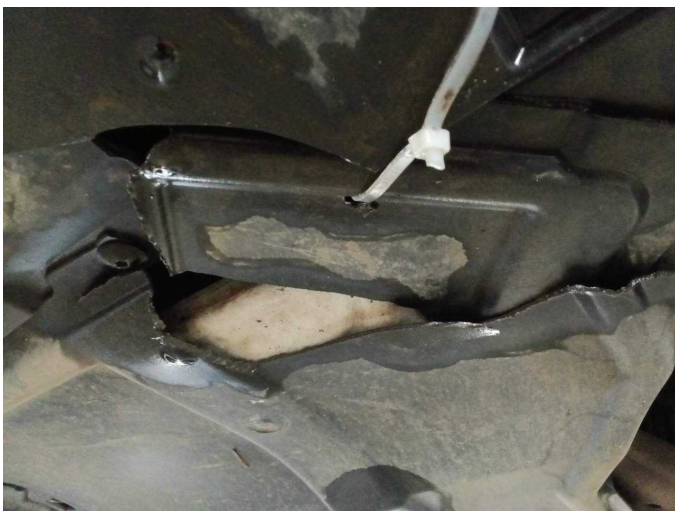
Damage 5: Engine: Engine cowling - lower - Broken / torn - Replace

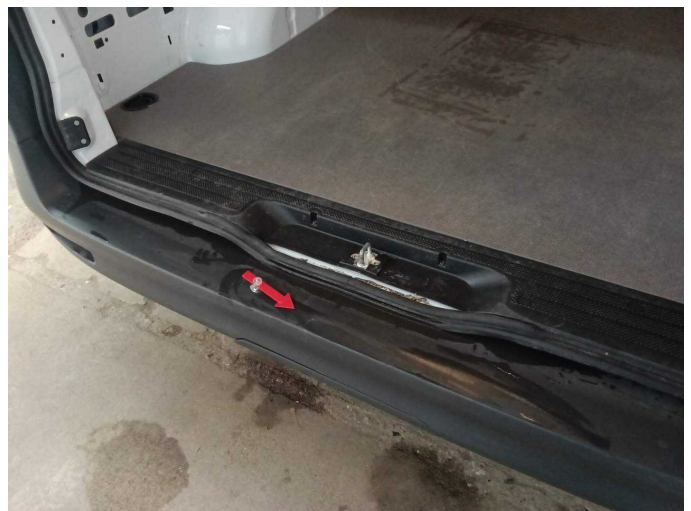
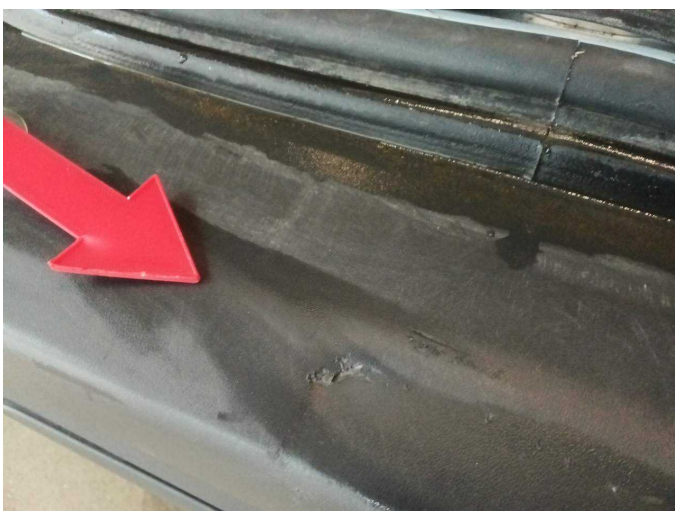
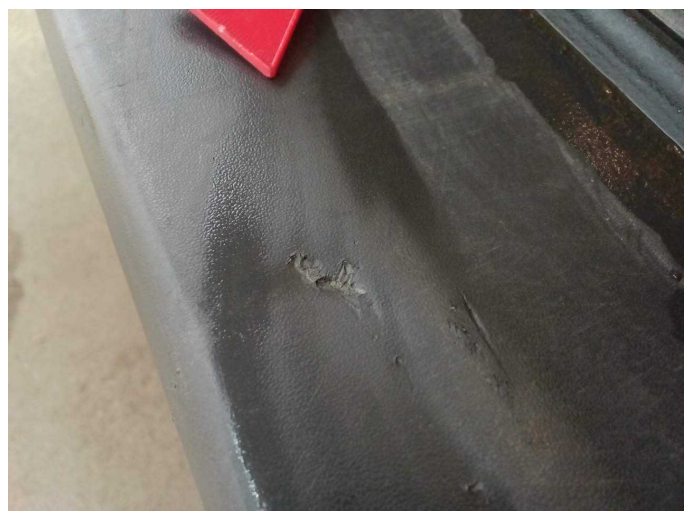
Damage 6: Rear bumper: Rear bumper - Scratched - Replace

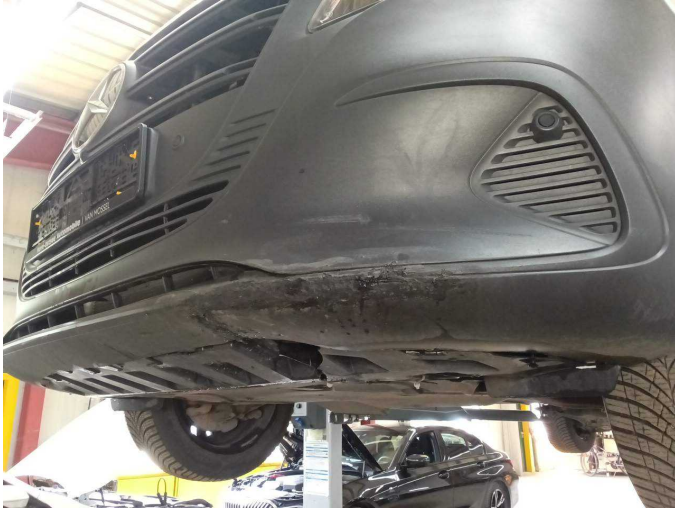
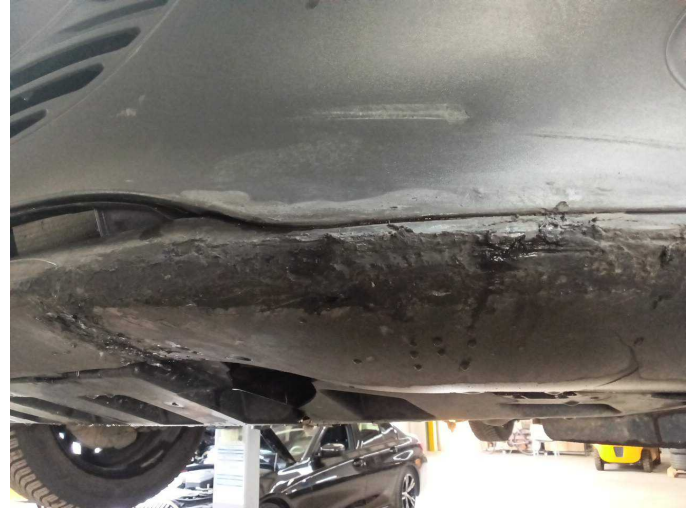
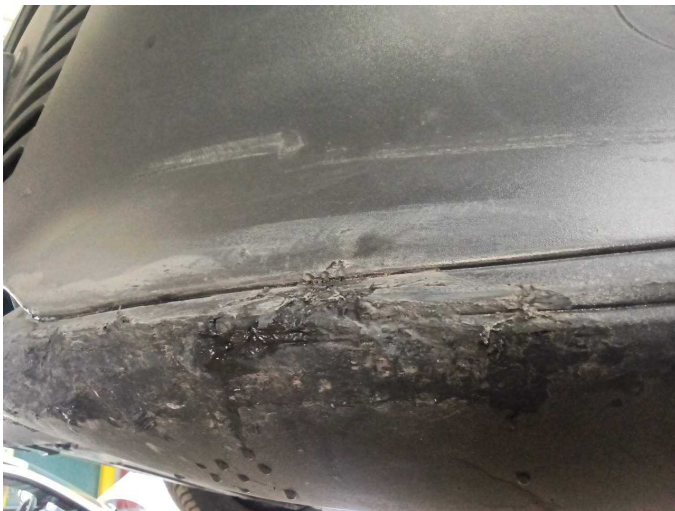
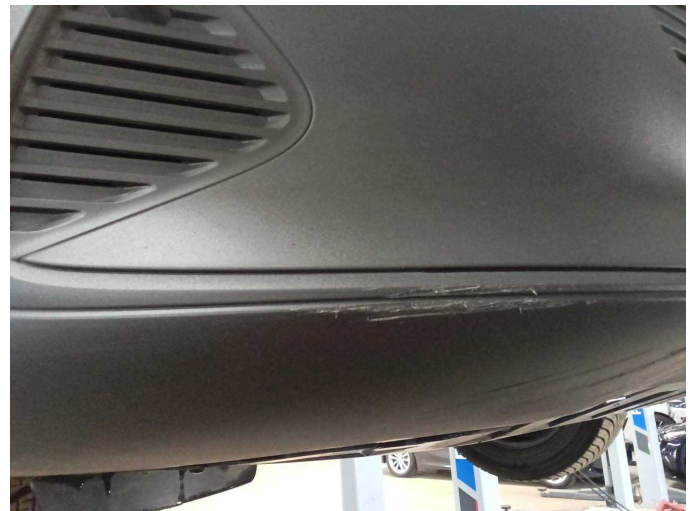
Damage 7: Front bumper: Front bumper (Nicht fachgerecht instandgesetzt) - Broken / torn - Replace
