Expertise

Protocol number: 45923190
Order No. / Reference: 26451667
Inspection date: 11 Jun 2026

Model: Vivaro 2.0 D Cargo L EHZ Autm. Elegance

VIN: VXEVFEHZ7N7042612

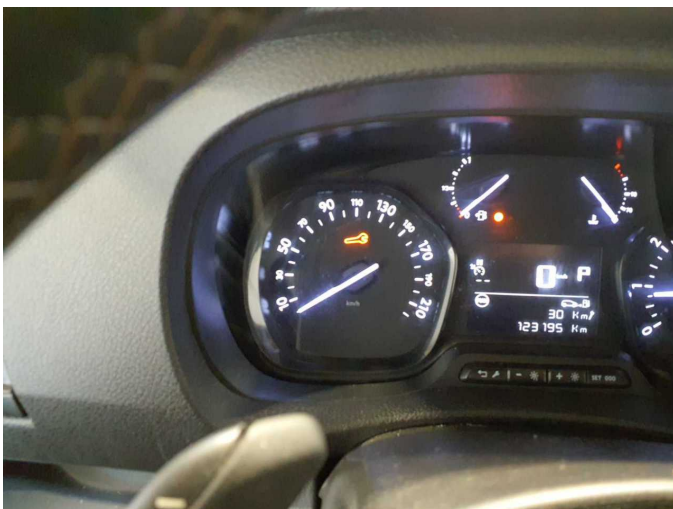
Damage 1: Misc.: Inspection / maintenance (in 30km) - No evidence - No deduction

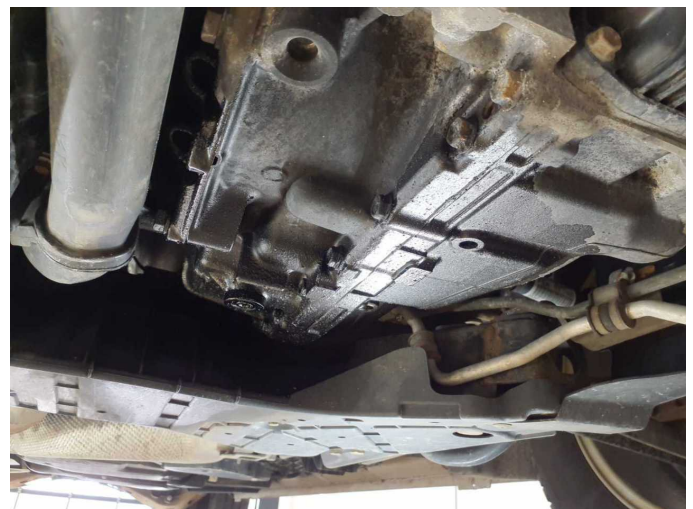
Damage 3: Gearbox: Gearbox - Leaking - Perform diagnosis

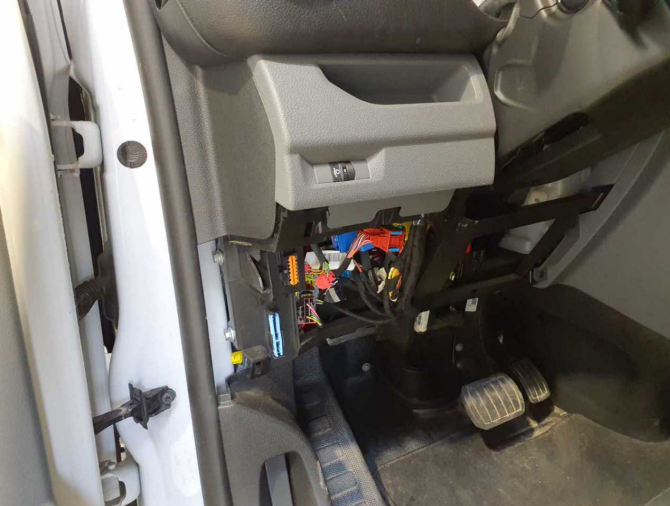
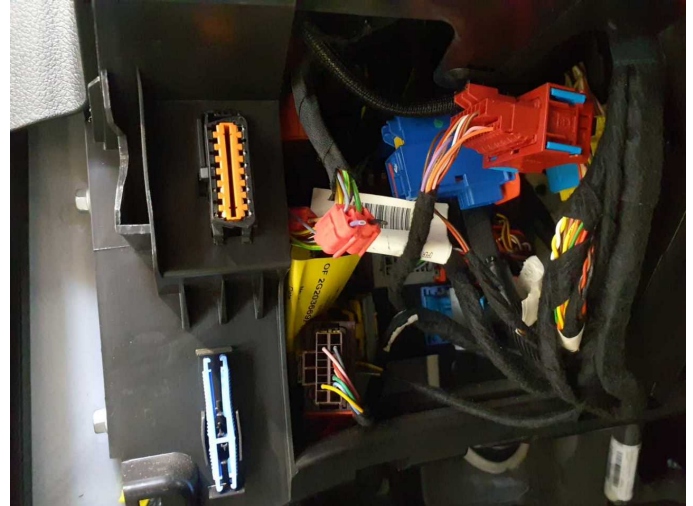
Damage 4: Electronic systems: Electronic systems - Specify findings - Perform diagnosis

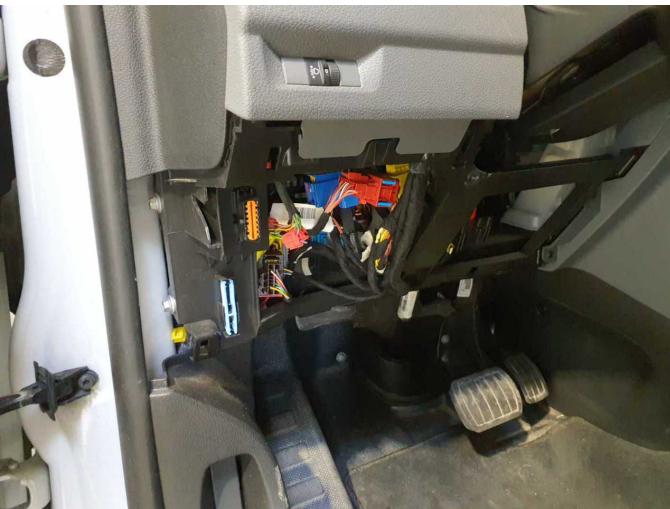
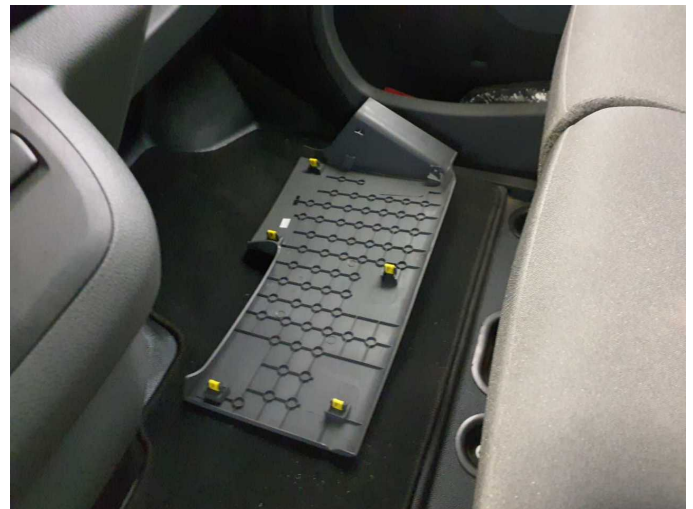
Damage 5: Trim / covers: Trim / covers - Loose - Un- / install

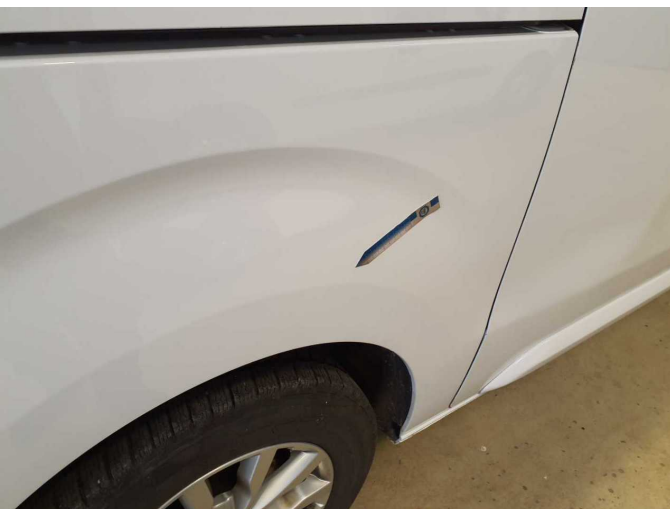
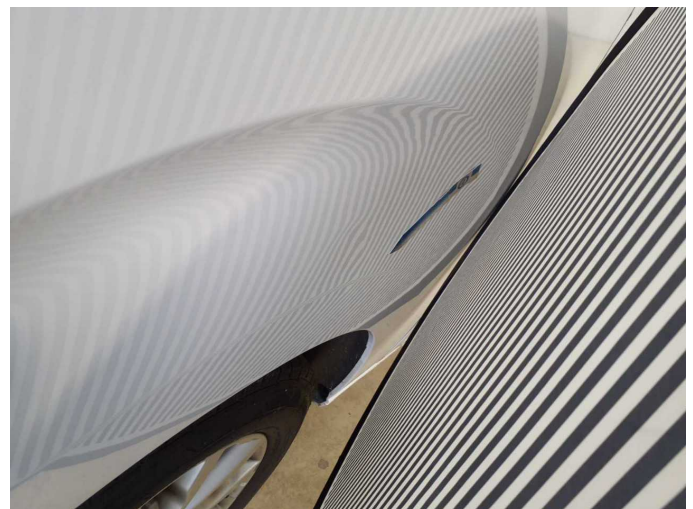
Damage 6: Side panel - rear right side: Side panel - dent(s) - Smooth repair work

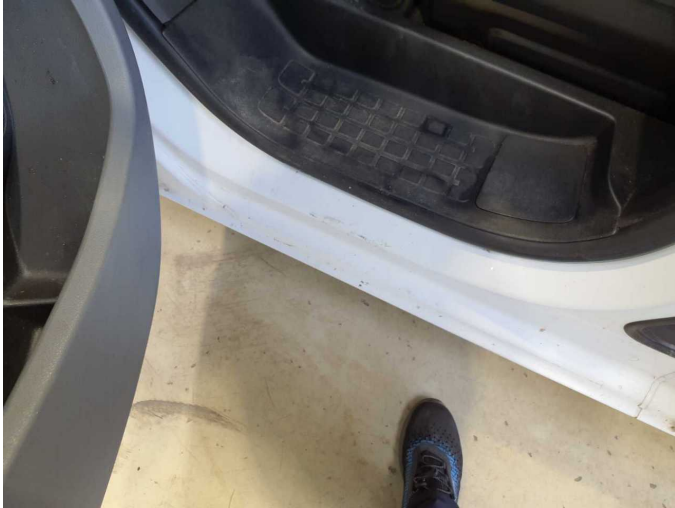
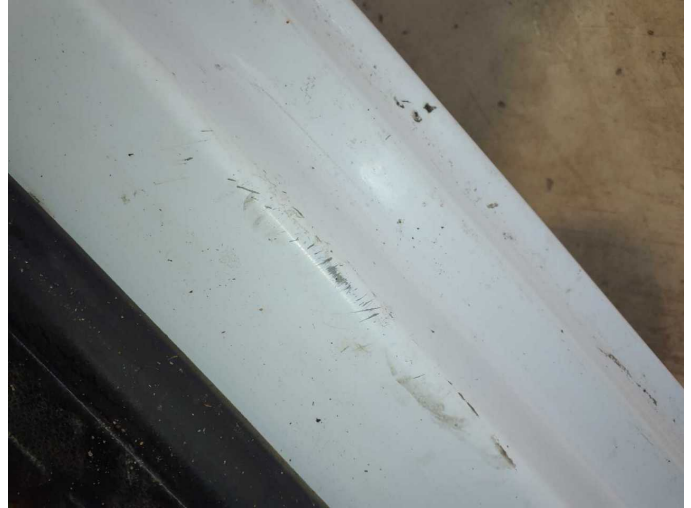
Damage 7: Sill - left side: Sill - Scratch(es) - Smart repair

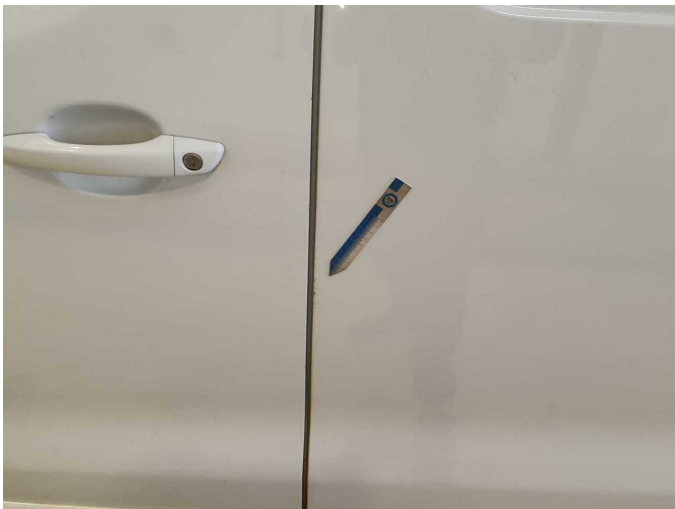
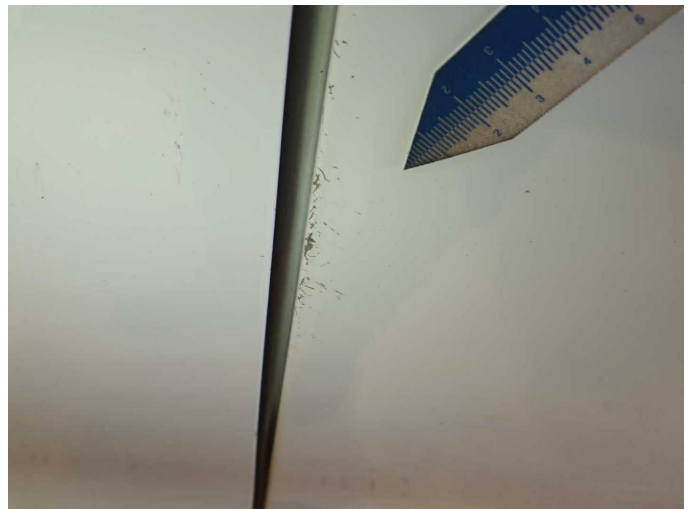
Damage 8: Side panel - rear left side: Side panel - Scratch(es) - Smart repair

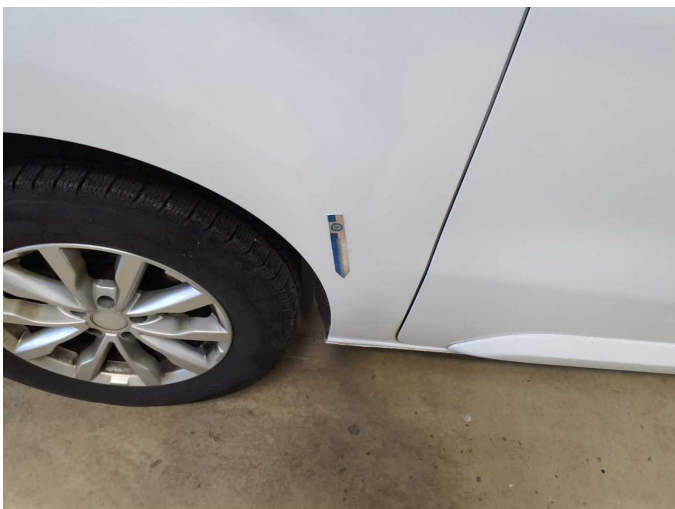
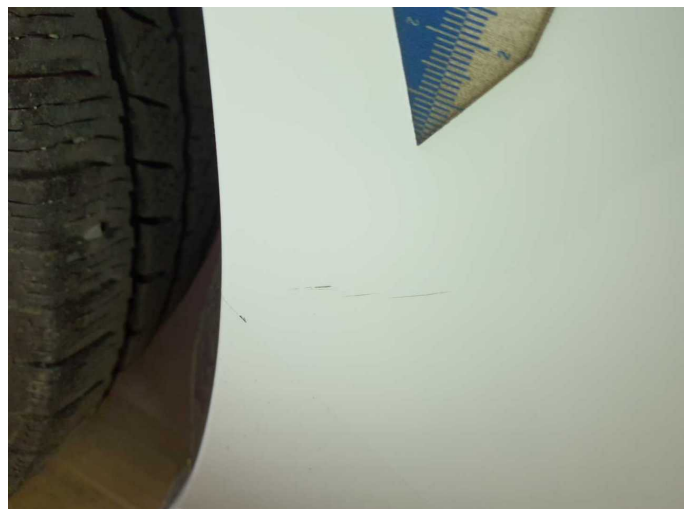
Damage 9: Side panel - rear right side: Side panel - Scratch(es) - Smart repair

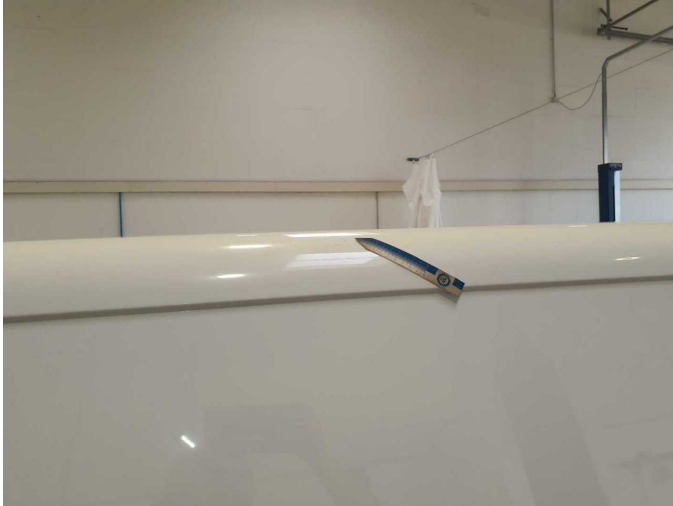
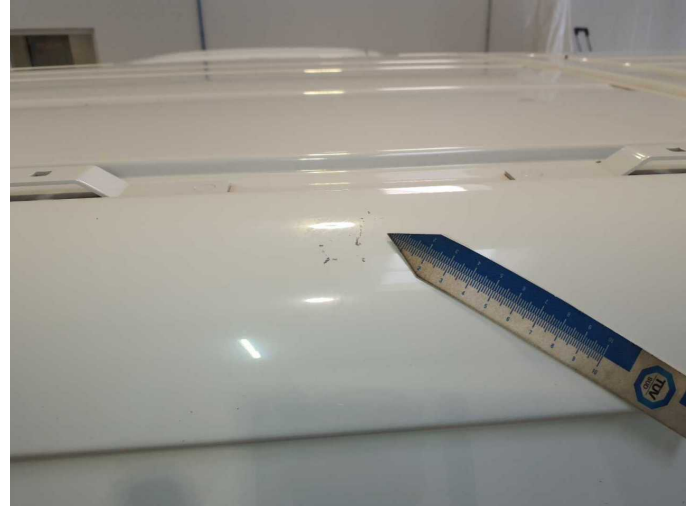
Damage 10: Roof: Roof rail - left side - Scratch(es) - Smart repair

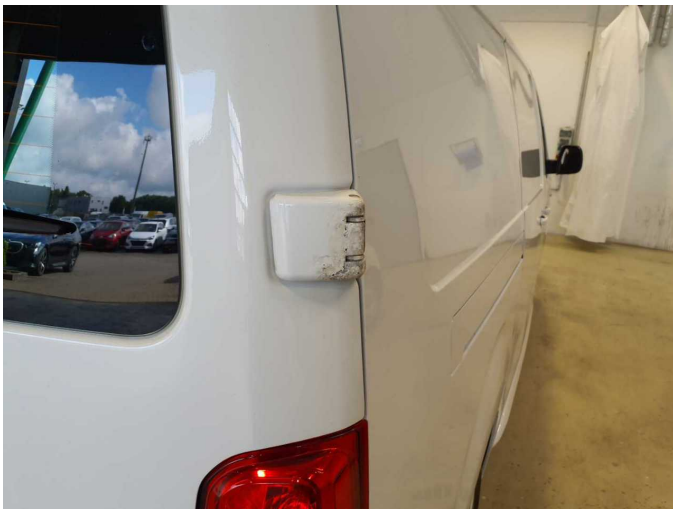
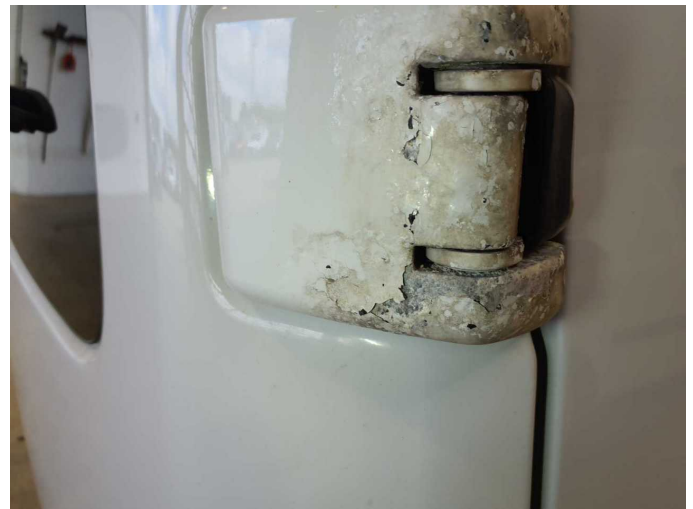
Damage 11: Boot lid / rear door: Hinge (Lack löst sich) - Paint defect - Smart repair

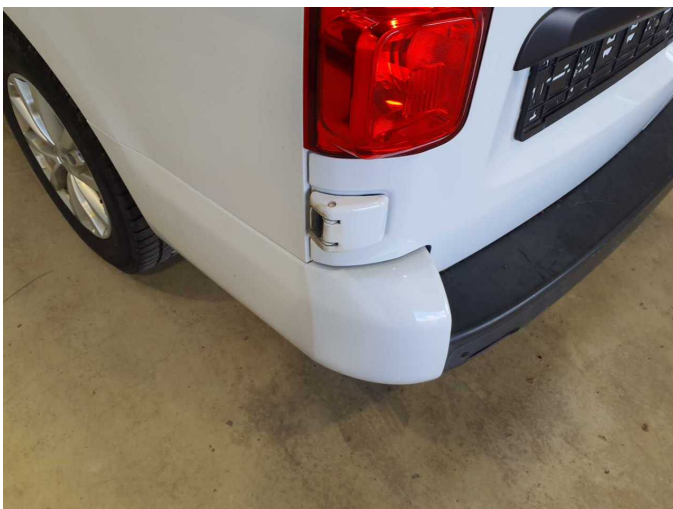
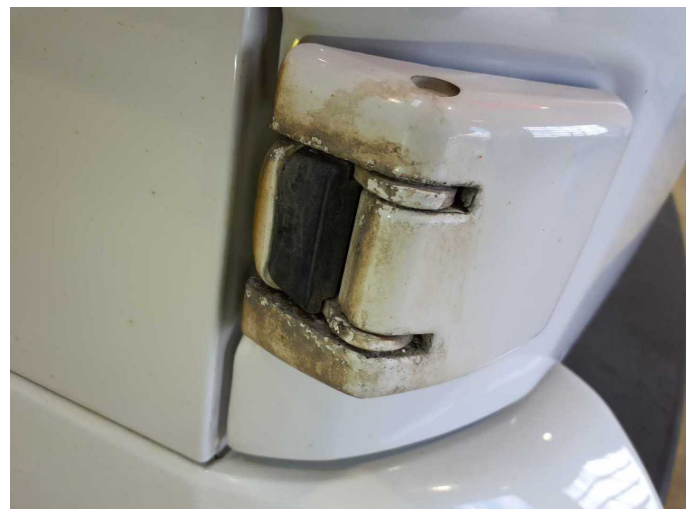
Damage 12: Boot lid / rear door: Hinge - Scratch(es) - Smart repair

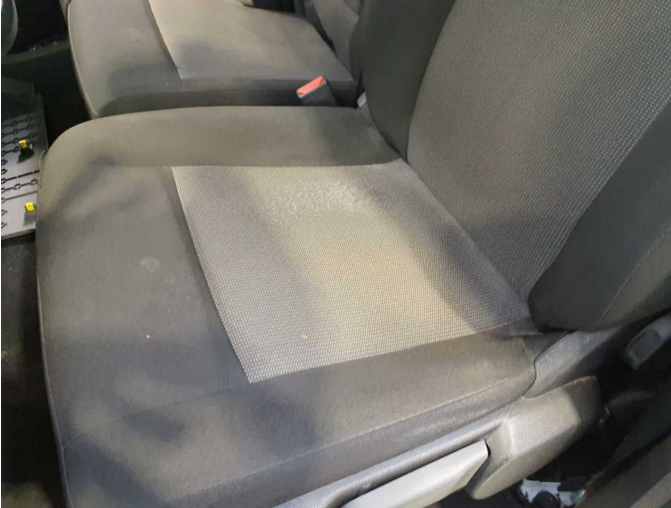
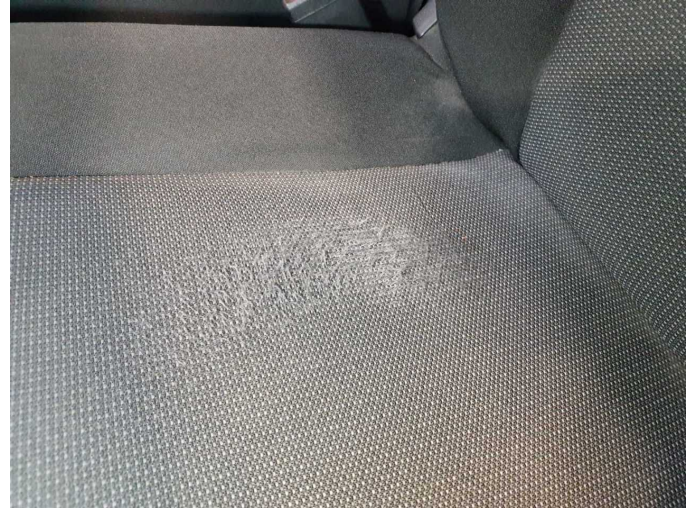
Damage 13: Seat - front: Seat cover - left side - Scratch(es) - Smart repair

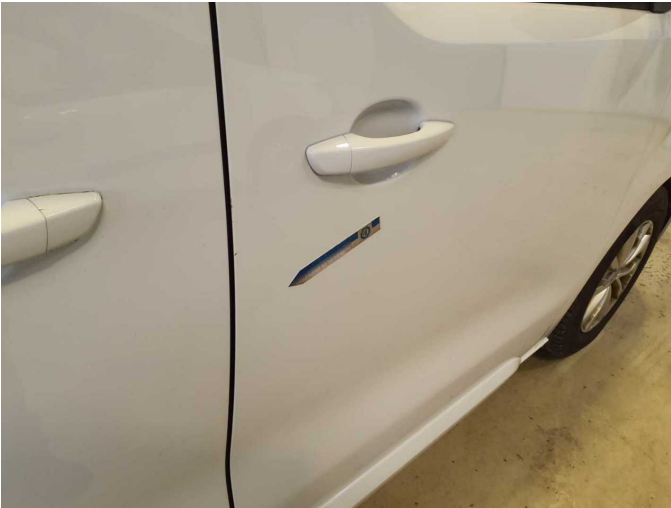
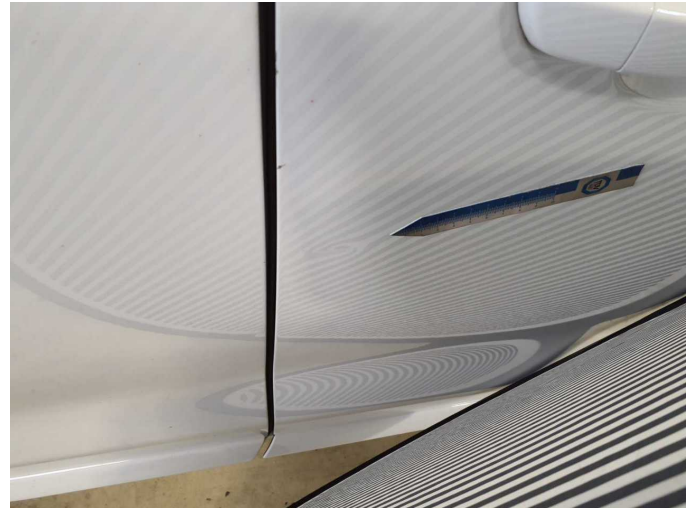
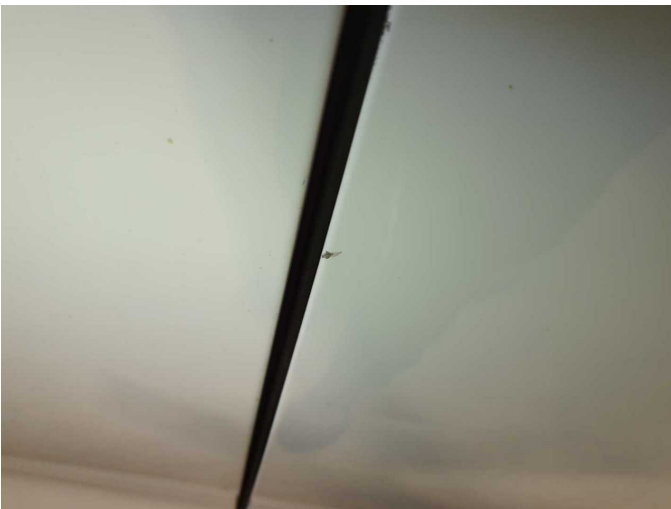
Damage 14: Door - front right side: Door - Dent / paintcoat damage - Smart repair

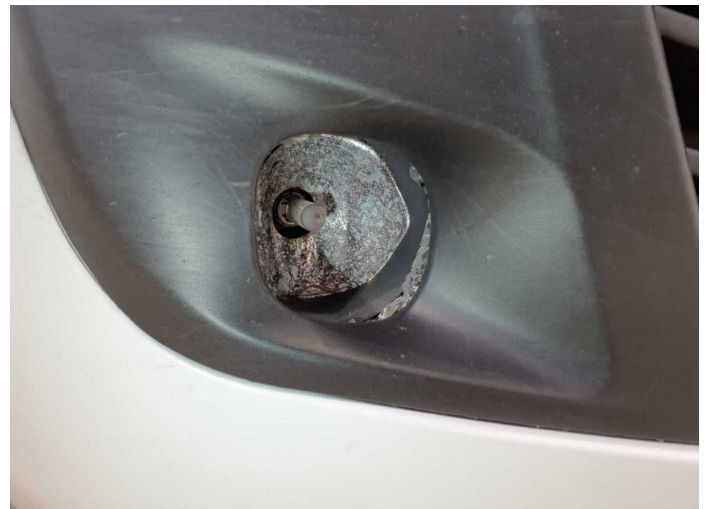
Damage 15: Fog lamp: Fog lamp - front right side - Broken / torn - Replace

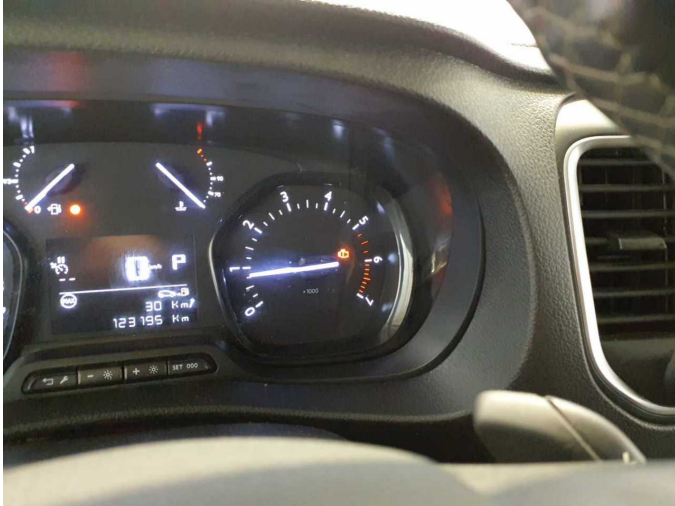
Damage 16: Engine: Engine (Motorkontrolle,nicht fahrbereit) - Specify findings - Perform diagnosis

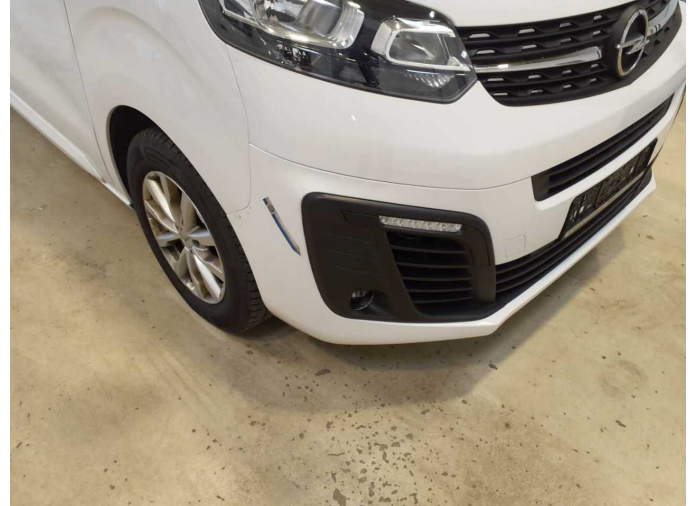
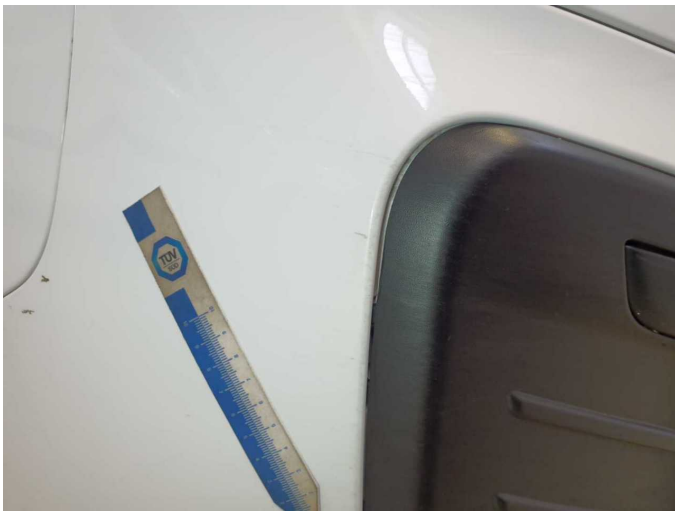
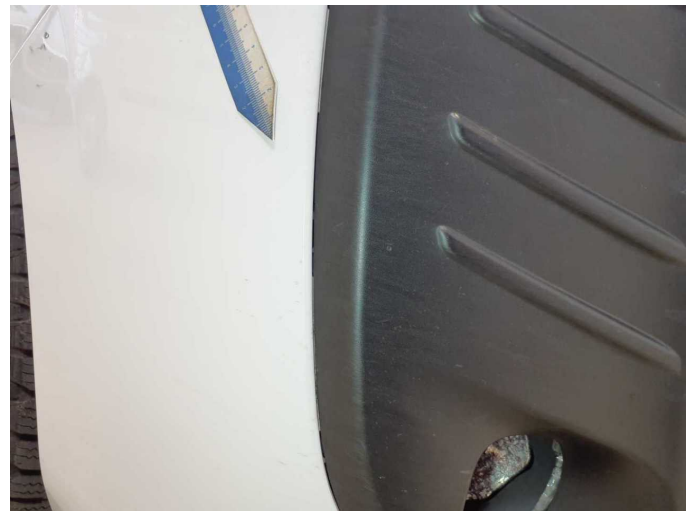
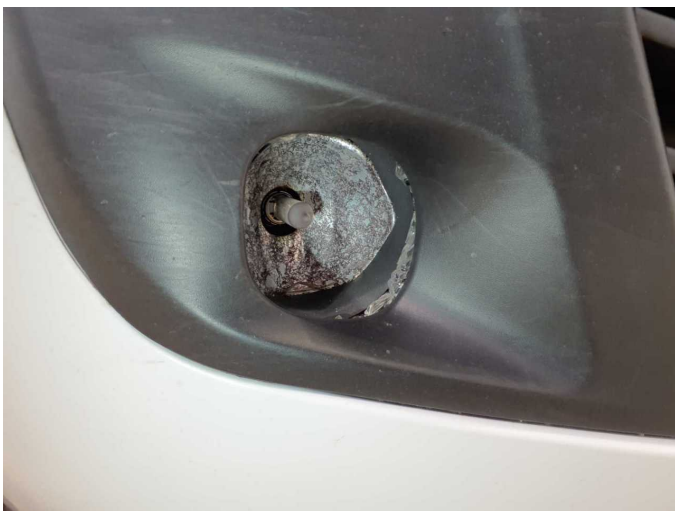
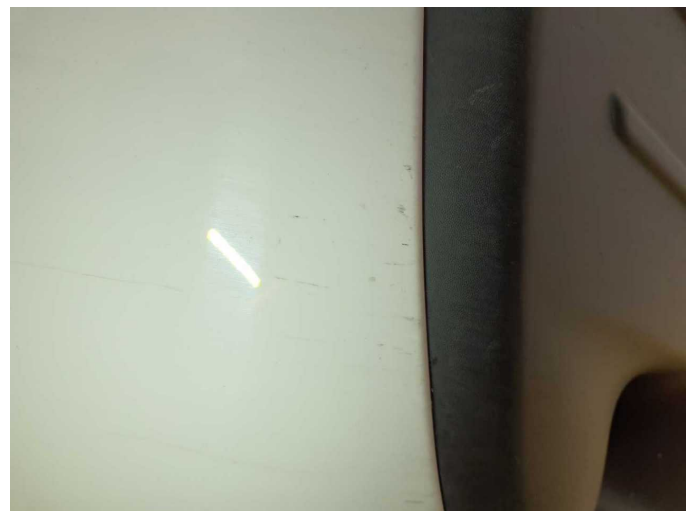
Damage 17: Front bumper: Front bumper (Inklusive Anbauteile) - Scratch(es) - Paint

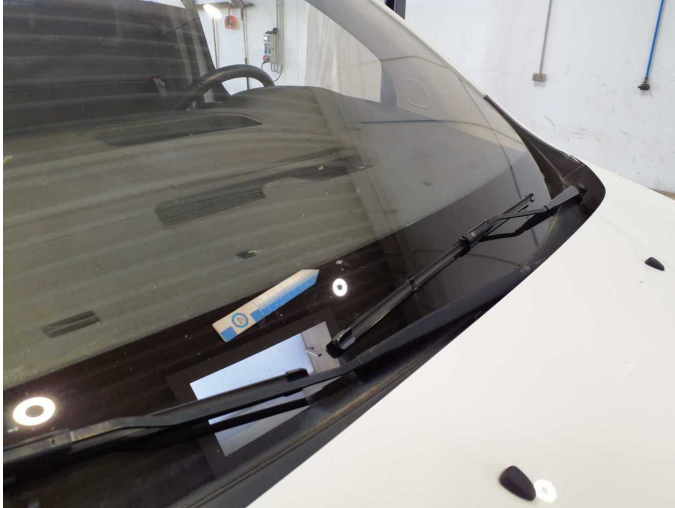
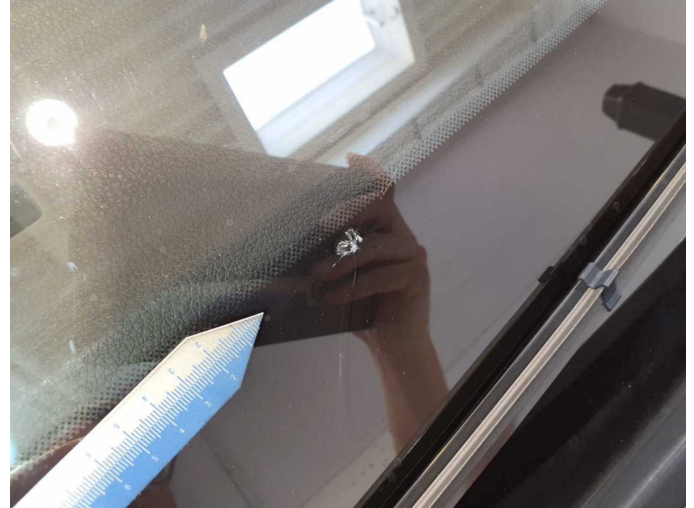
Damage 18: Vehicle glazing: Windscreen - Stone chips - Replace

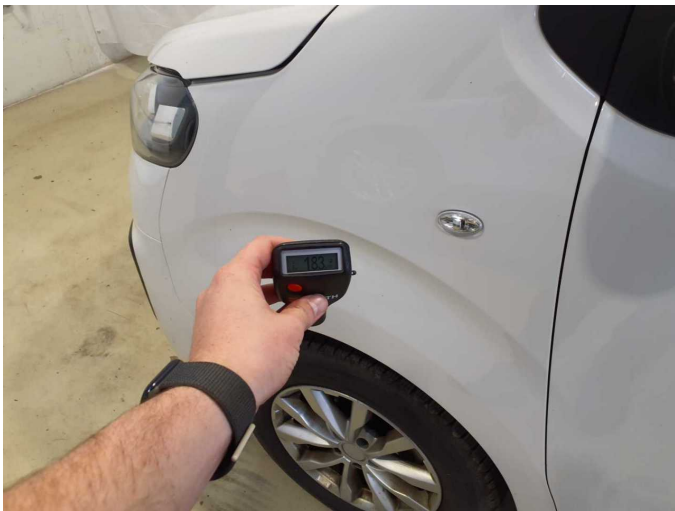
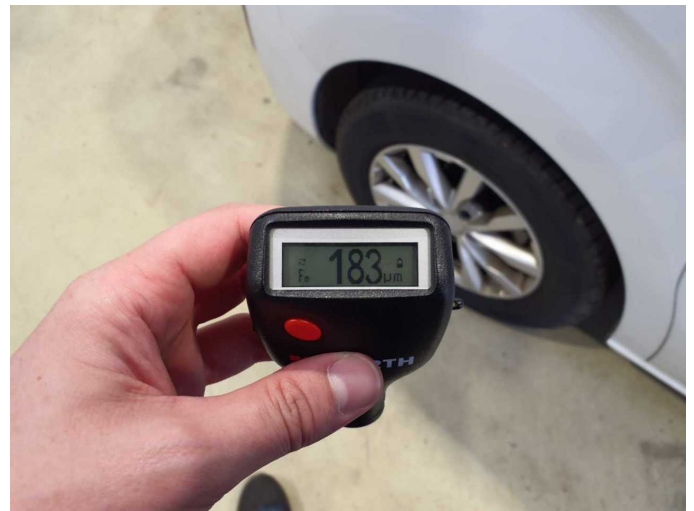
Repainting 1: Mudguard - left side

No.	Repainting
1	Mudguard - left side, Professionally carried out, Invoice of repair done Non-existent
2	Bonnet, Professionally carried out, Invoice of repair done Non-existent

Mudguard - left side	183 µm	Bonnet	209 µm
----------------------	--------	--------	--------
