Expertise

Protocol number: 46626673  
Order No. / Reference: 26019350-1  
Inspection date: 17 Jul 2026

Manufacturer: Ford

Model: Focus Turnier 1.5 EcoBlue Start-Stopp-System Aut. TITANIUM

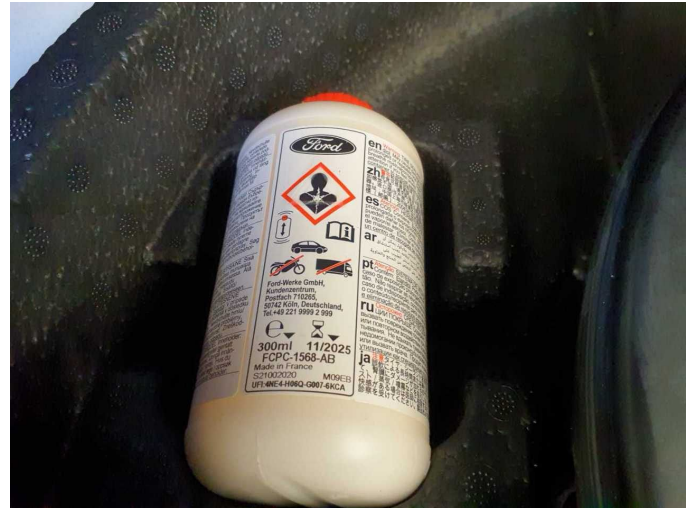
| No. | Component group | Description |
|---|---|---|
| 1 | Equipment | Tirefit filler - Expired - Replace |

**Damage 1:** Equipment: Tirefit filler - Expired - Replace

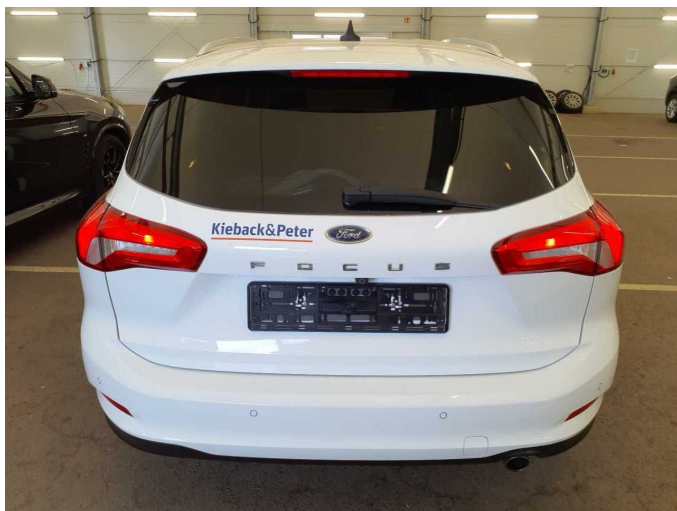
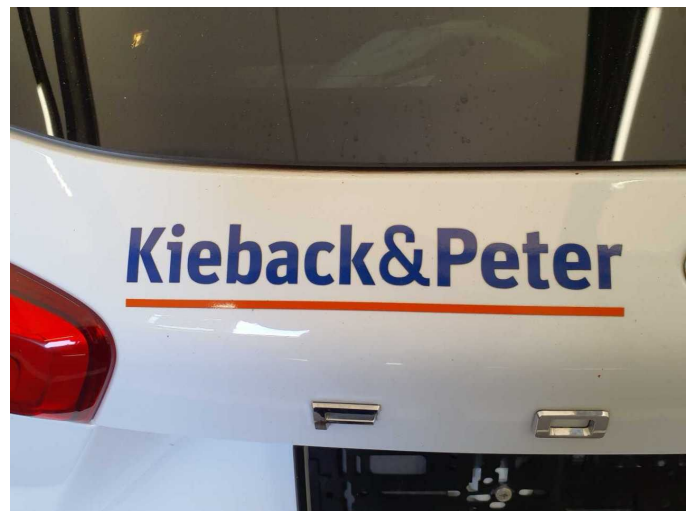
| No. | Component group | Description |
|---|---|---|
| 2 | Boot lid / rear door | Boot lid - Glued / labelled - De-glue / neutralise |

**Damage 2:** Boot lid / rear door: Boot lid - Glued / labelled - De-glue / neutralise

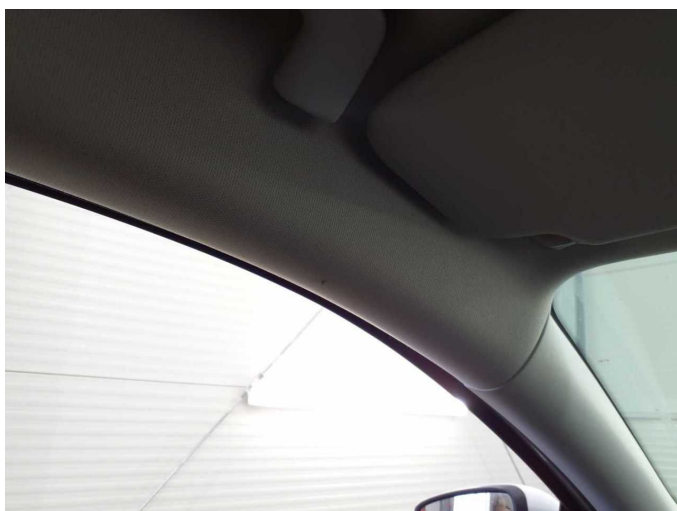
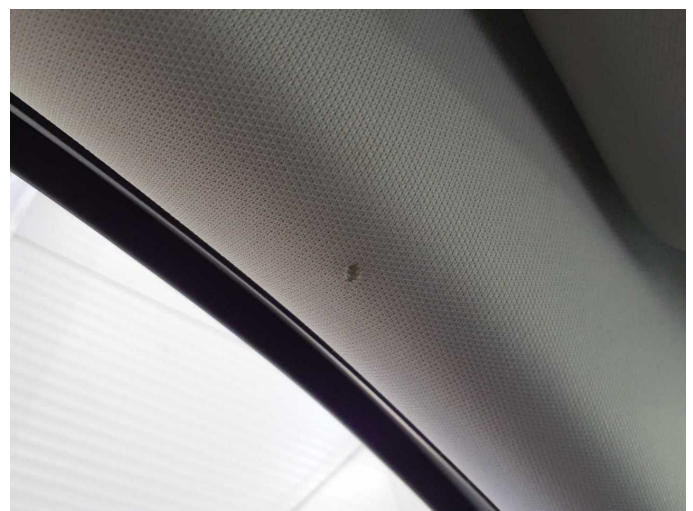
| No. | Component group | Description |
|---|---|---|
| 3 | Trim / covers | Roof lining - Holes - Smart repair |

**Damage 3:** Trim / covers: Roof lining - Holes - Smart repair

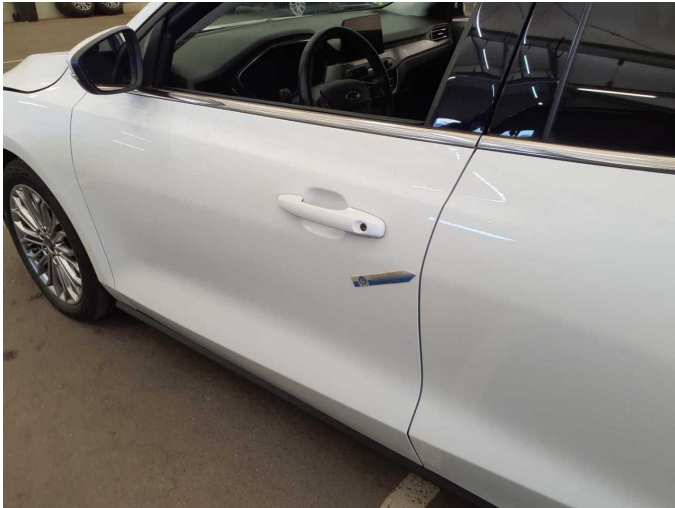
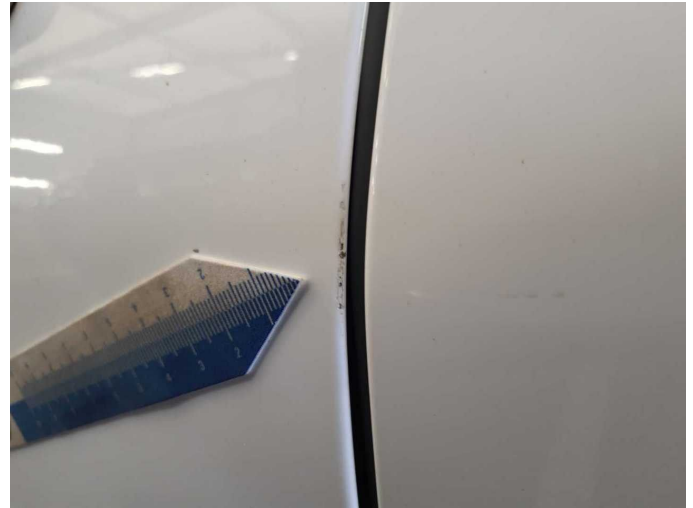
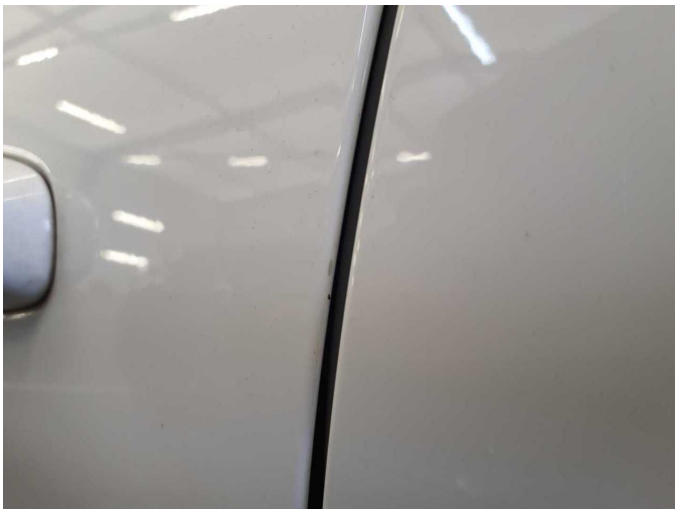
| No. | Component group | Description |
|---|---|---|
| 4 | Door - front left side | Door edge - Scratch(es) - Smart repair |

**Damage 4:** Door - front left side: Door edge - Scratch(es) - Smart repair
