Protocol number: 46231117
Order No. / Reference: 25935097
Inspection date: 15 Jun 2026

Manufacturer: Mercedes-Benz

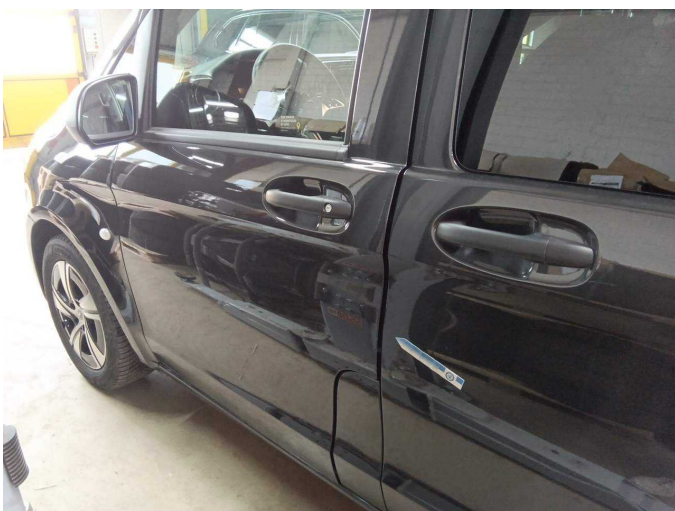
Damage 1: Door - front left side: Door edge - Scratch(es) - Smart repair

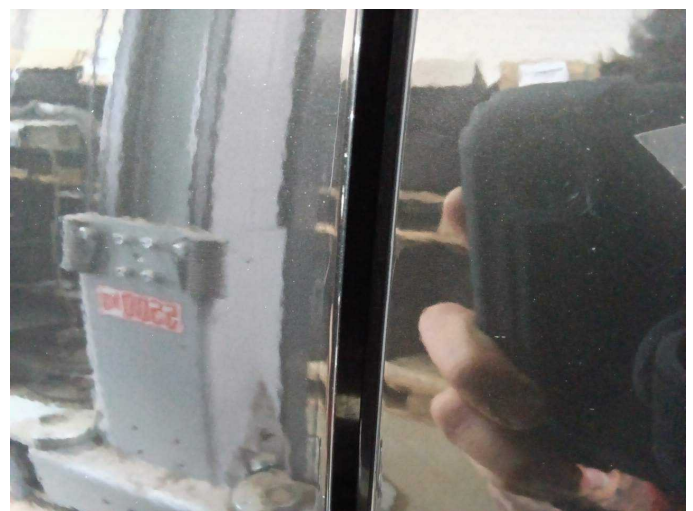
Damage 1: Door - front left side: Door edge - Scratch(es) - Smart repair

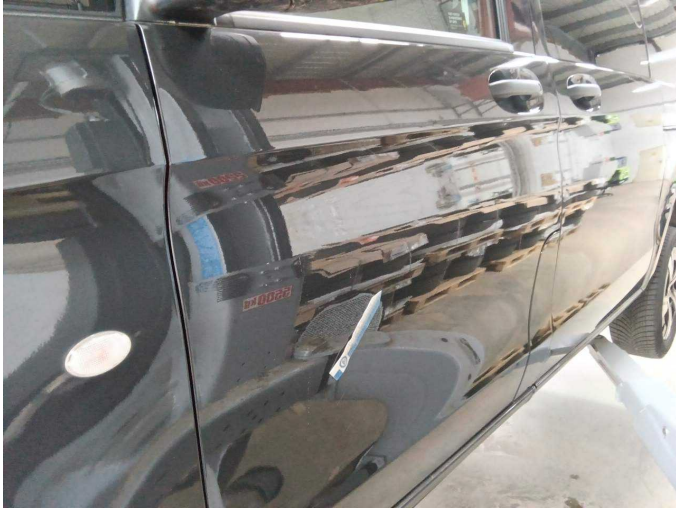
Damage 2: Door - front left side: Door (1) - dent(s) - Smooth repair work

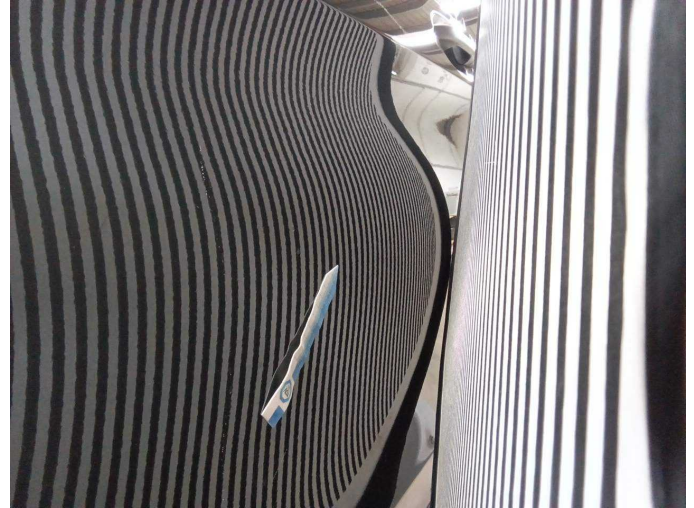
Damage 2: Door - front left side: Door (1) - dent(s) - Smooth repair work

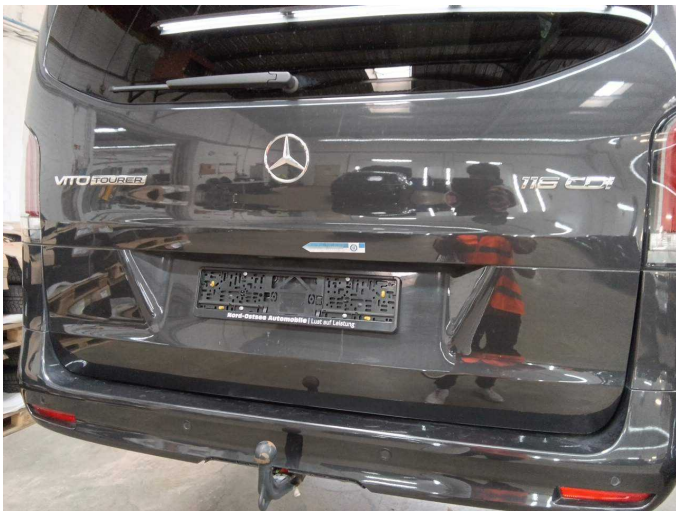
Damage 3: Boot lid / rear door: Boot lid (3) - dent(s) - Smooth repair work

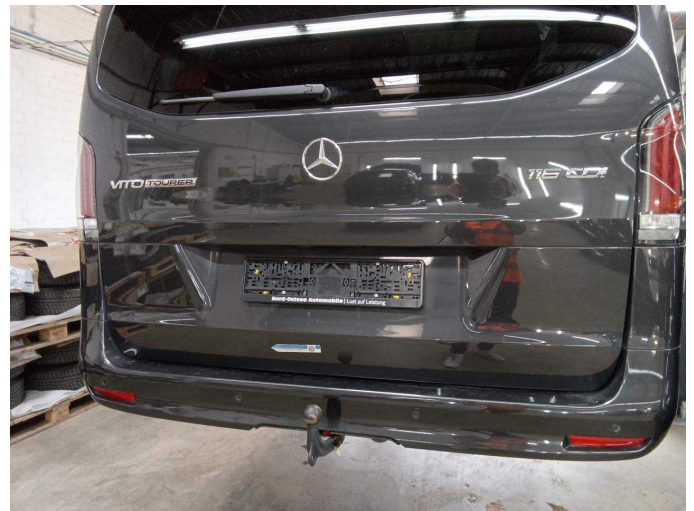
Damage 3: Boot lid / rear door: Boot lid (3) - dent(s) - Smooth repair work

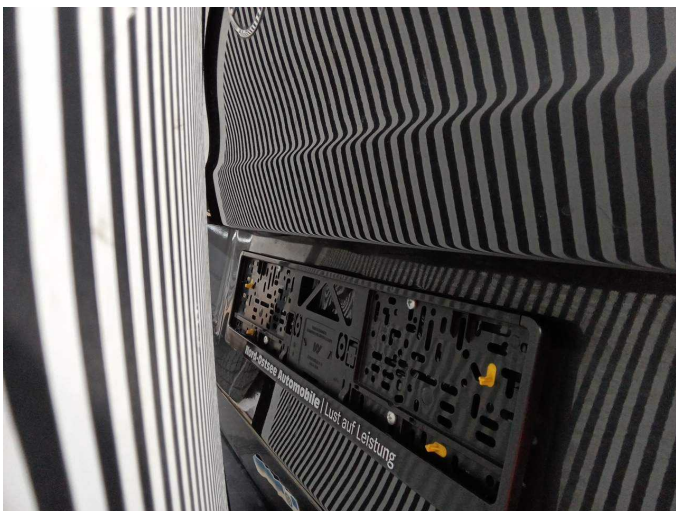
Damage 3: Boot lid / rear door: Boot lid (3) - dent(s) - Smooth repair work

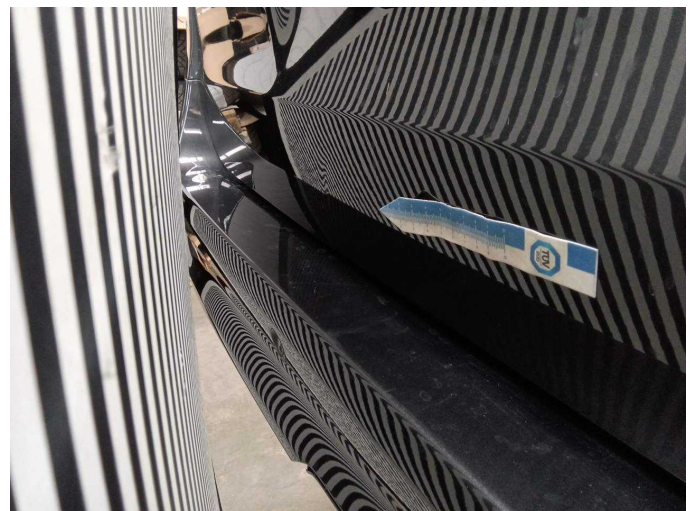
Damage 3: Boot lid / rear door: Boot lid (3) - dent(s) - Smooth repair work

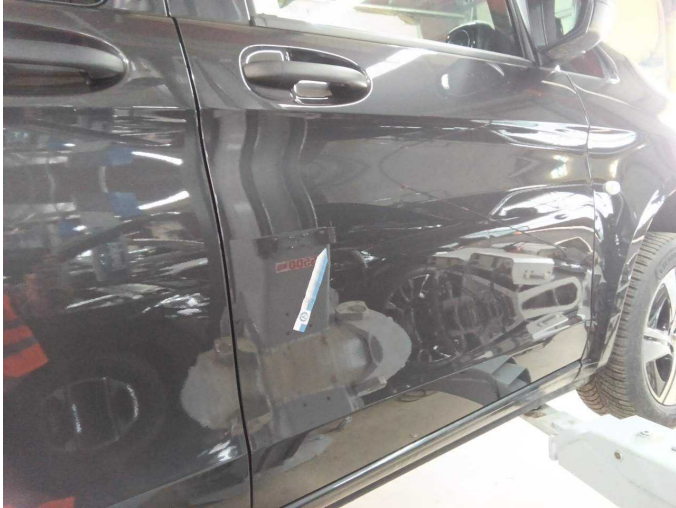
Damage 4: Door - front right side: Door - Dent / paintcoat damage - Repair and paint

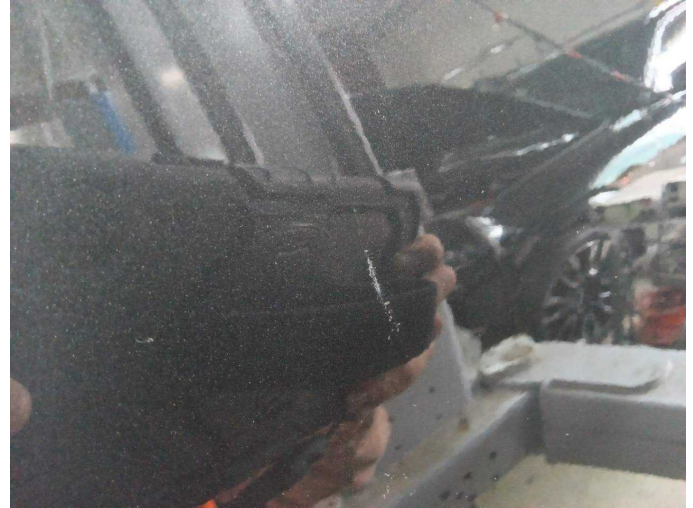
Damage 4: Door - front right side: Door - Dent / paintcoat damage - Repair and paint

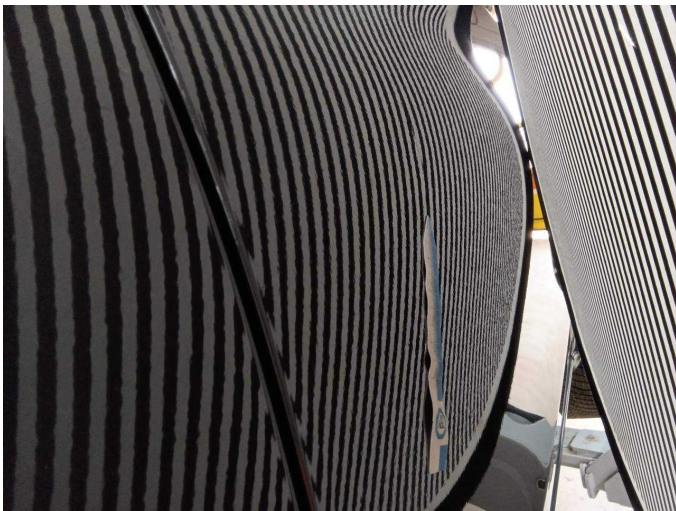
Damage 4: Door - front right side: Door - Dent / paintcoat damage - Repair and paint

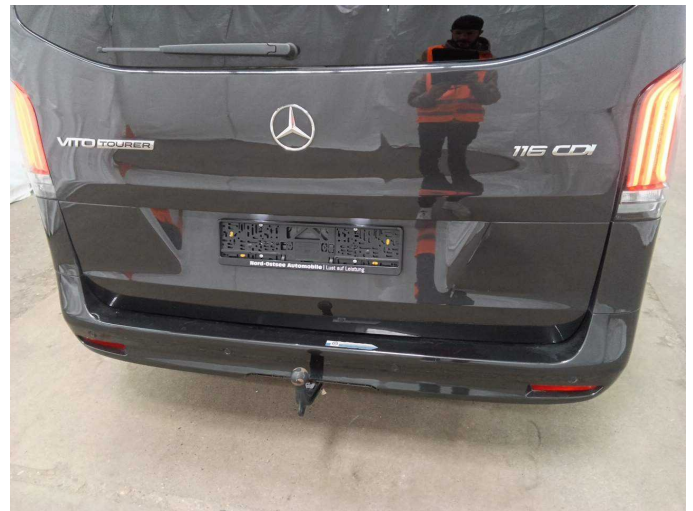
Damage 5: Rear bumper: Rear bumper - Scratch(es) - Paint

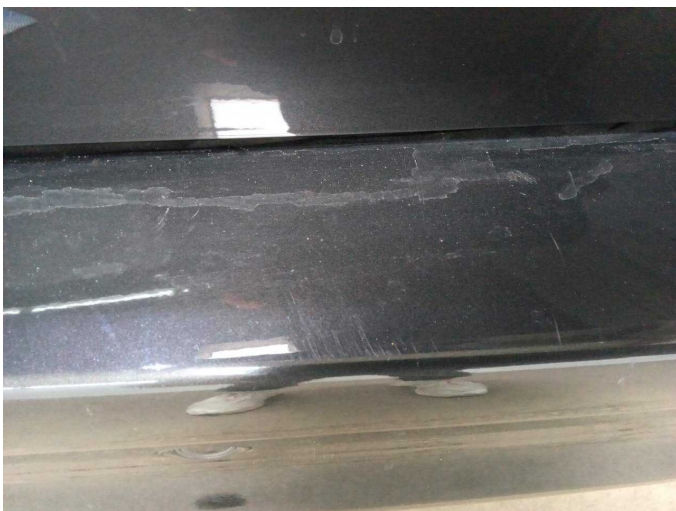
Damage 5: Rear bumper: Rear bumper - Scratch(es) - Paint

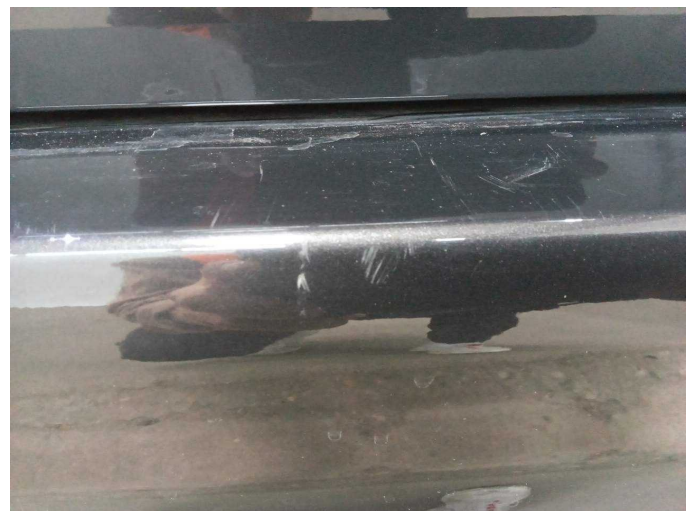
Damage 5: Rear bumper: Rear bumper - Scratch(es) - Paint

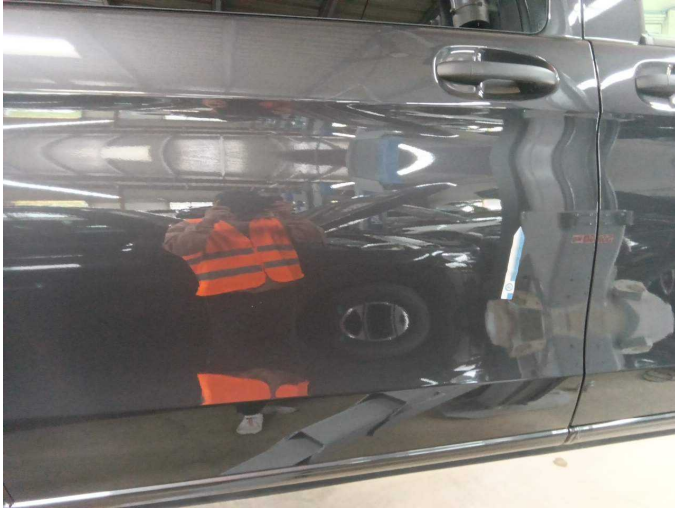
Damage 6: Sliding door, right: Sliding door - Dent / paintcoat damage - Repair and paint

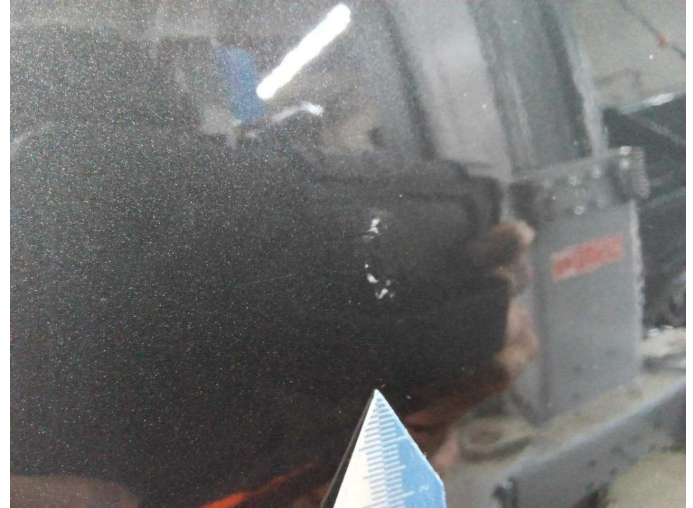
Damage 6: Sliding door, right: Sliding door - Dent / paintcoat damage - Repair and paint

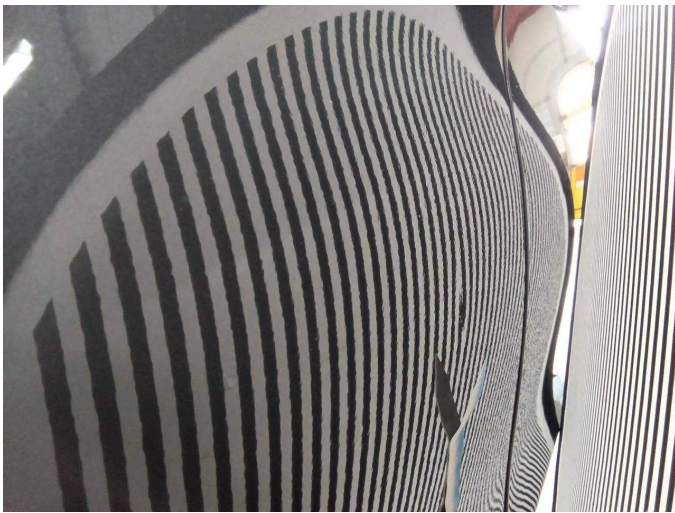
Damage 6: Sliding door, right: Sliding door - Dent / paintcoat damage - Repair and paint
