Expertise

Protocol number: 47187935  
Order No. / Reference: 26751273  
Inspection date: 18 Aug 2026

Manufacturer: Ford

Model: S-Max 2.0 EcoBlue Aut. TITANIUM

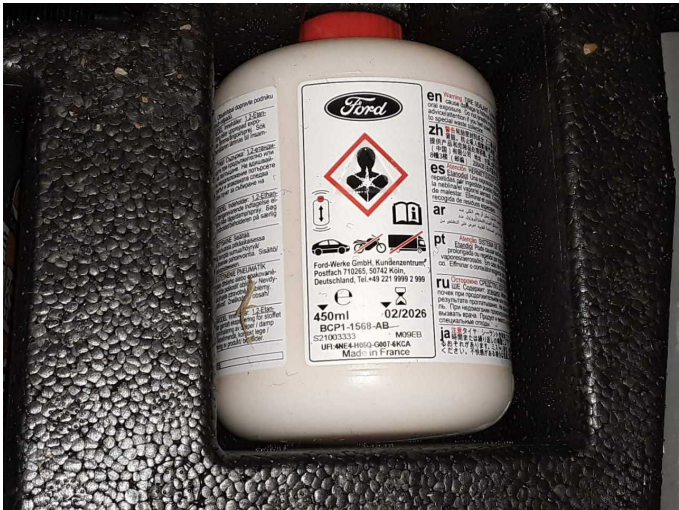
| No. | Component group | Description |
|---|---|---|
| 1 | Equipment | Tirefit filler - Expired - Replace |

Damage 1: Equipment: Tirefit filler - Expired - Replace

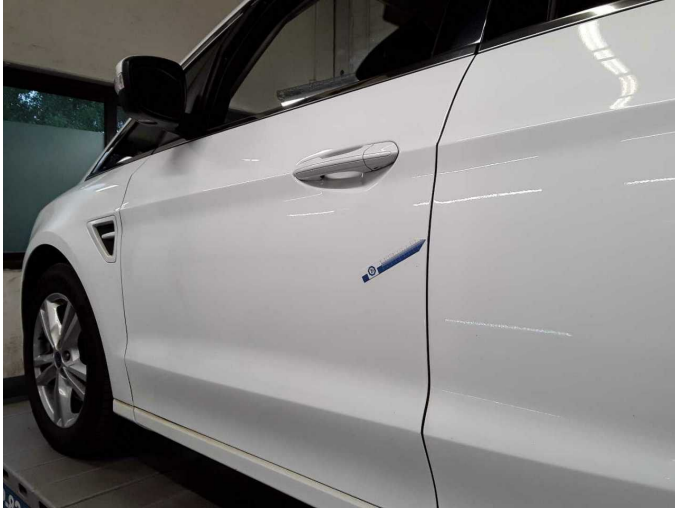
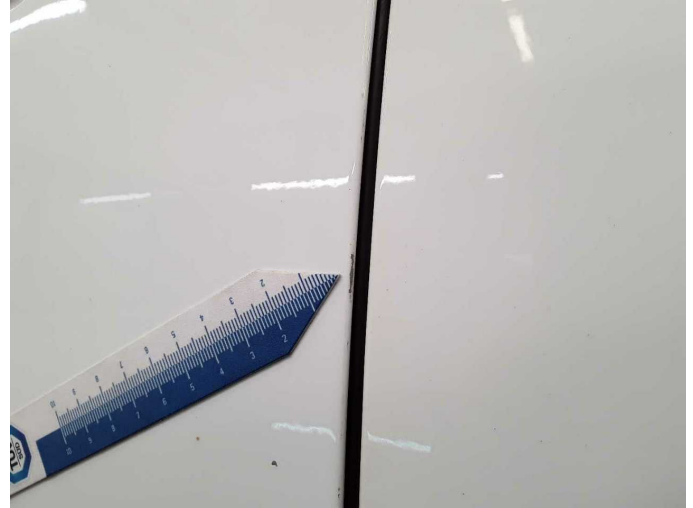
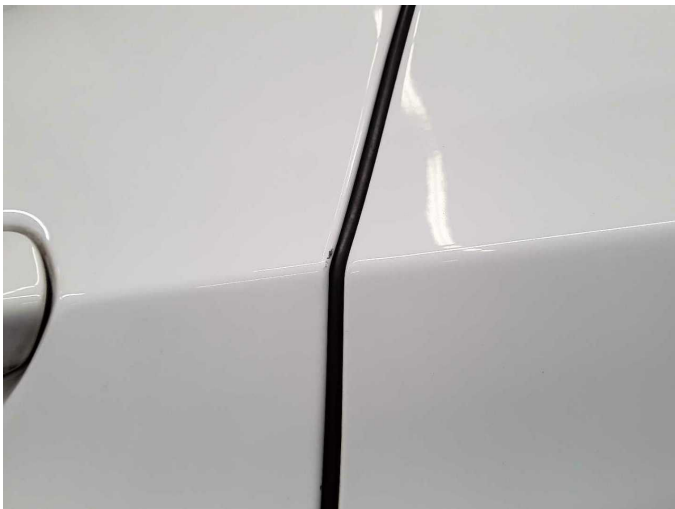
| No. | Component group | Description |
|---|---|---|
| 2 | Door - front left side | Door edge - Scratched - Smart repair |

**Damage 2:** Door - front left side: Door edge - Scratched - Smart repair

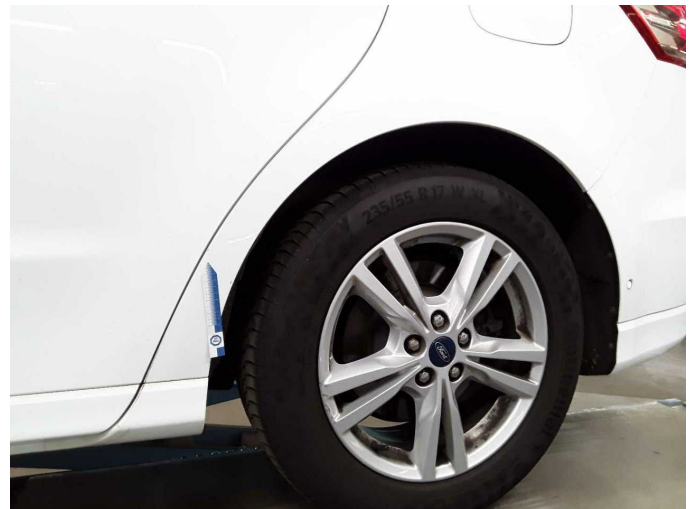
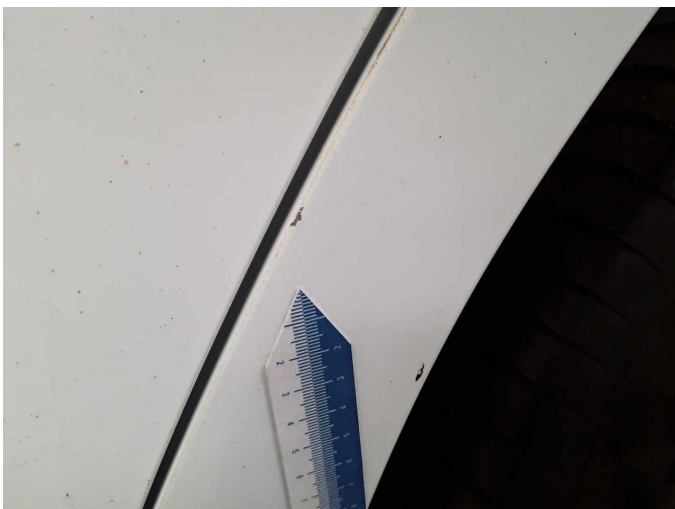
| No. | Component group | Description |
|---|---|---|
| 3 | Side panel - rear left side | Side panel - Scratch(es) - Smart repair |

**Damage 3:** Side panel - rear left side: Side panel - Scratch(es) - Smart repair

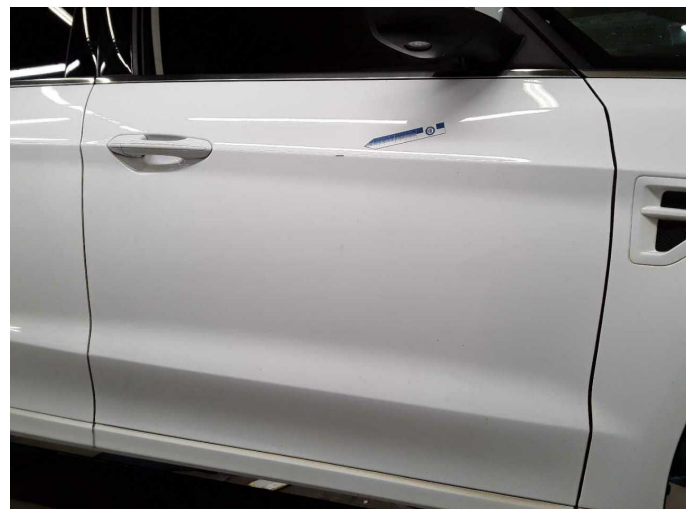
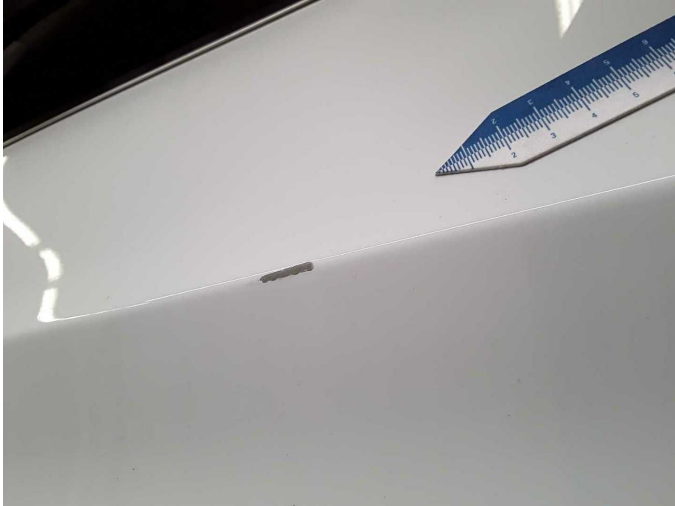
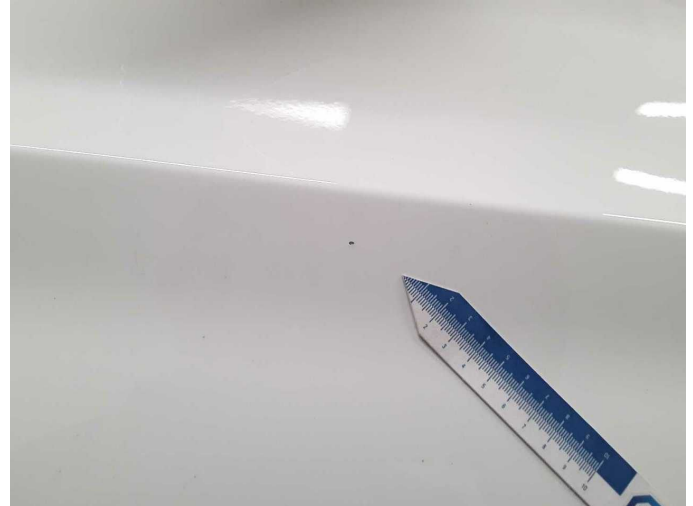
| No. | Component group | Description |
|---|---|---|
| 4 | Door - front right side | Door - Scratch(es) - Paint |

**Damage 4:** Door - front right side: Door - Scratch(es) - Paint

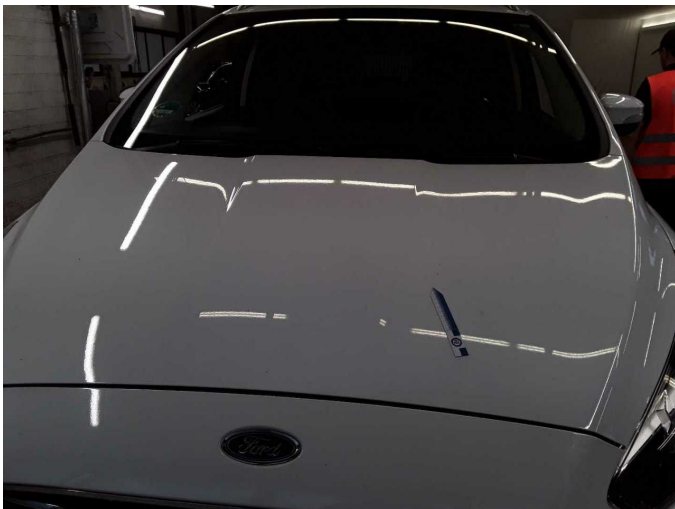
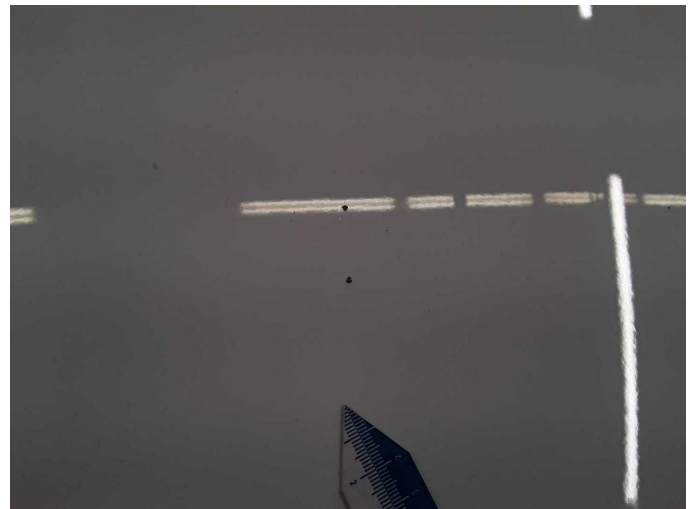
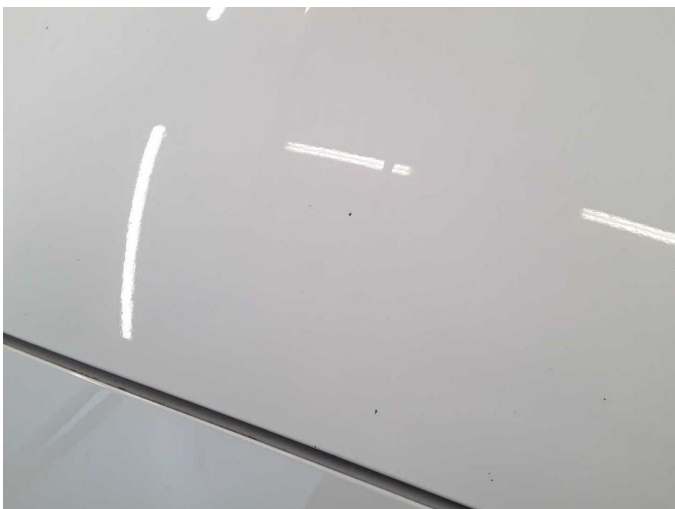
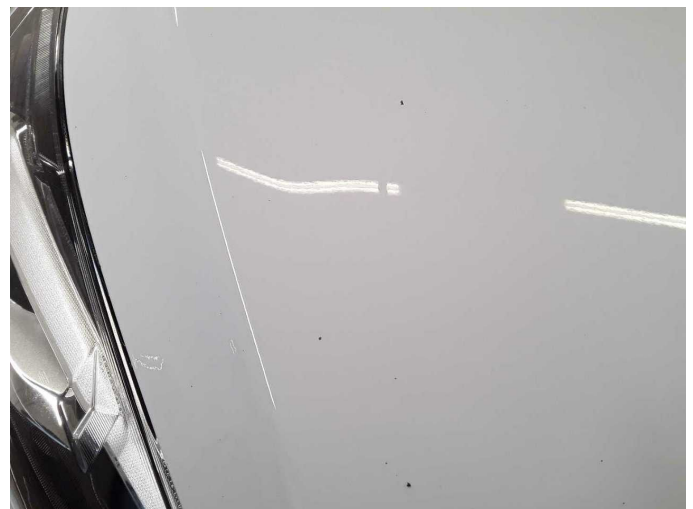
| No. | Component group | Description |
|---|---|---|
| 5 | Bonnet | Bonnet (Übermäßige Steinschläge) - Stone chips - Paint |

**Damage 5:** Bonnet: Bonnet (Übermäßige Steinschläge) - Stone chips - Paint

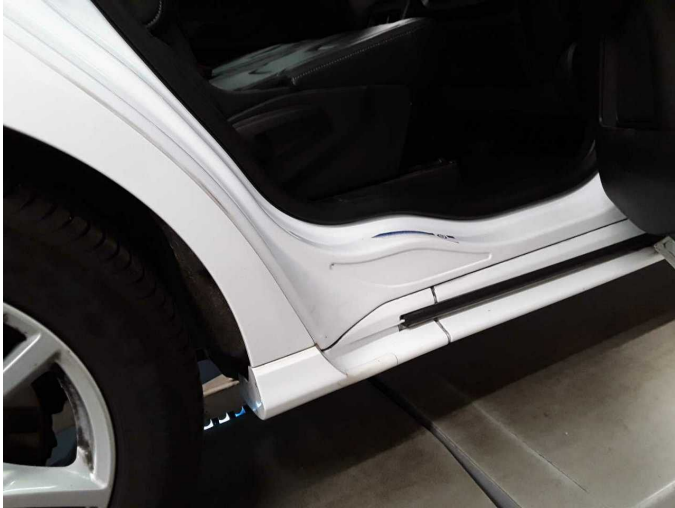
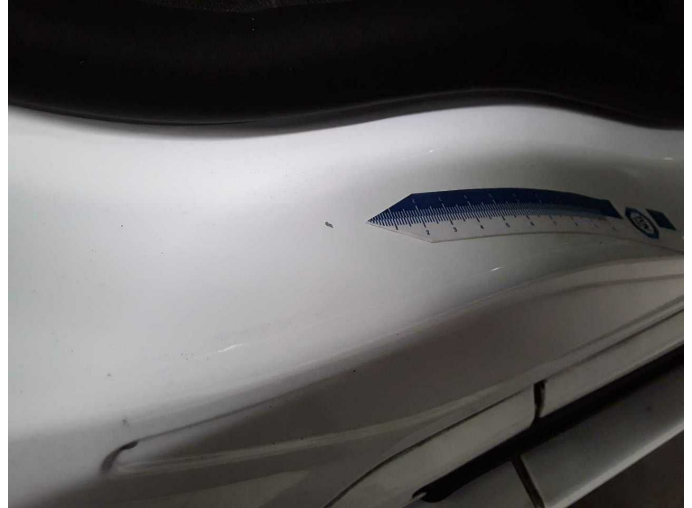
| No. | Component group | Description |
|---|---|---|
| 1 | Side panel - rear right side | Sill - Scratch(es) - No deduction |

**Wear and tear 1:** Side panel - rear right side: Sill - Scratch(es) - No deduction

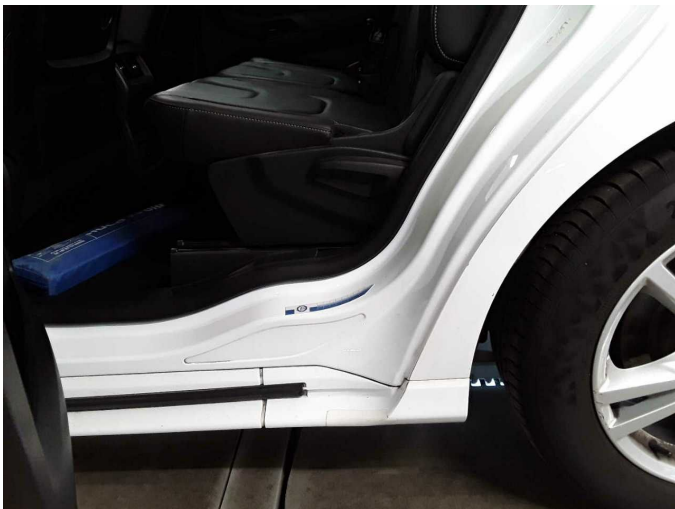
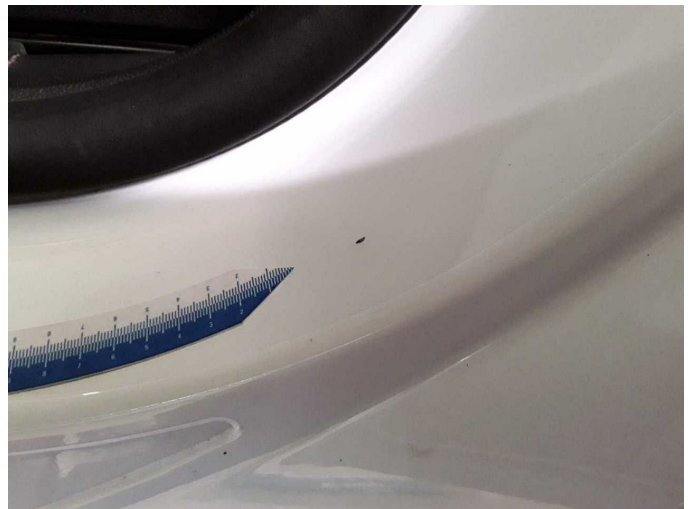
| No. | Component group | Description |
|---|---|---|
| 2 | Side panel - rear left side | Sill - Scratch(es) - No deduction |

**Wear and tear 2:** Side panel - rear left side: Sill - Scratch(es) - No deduction

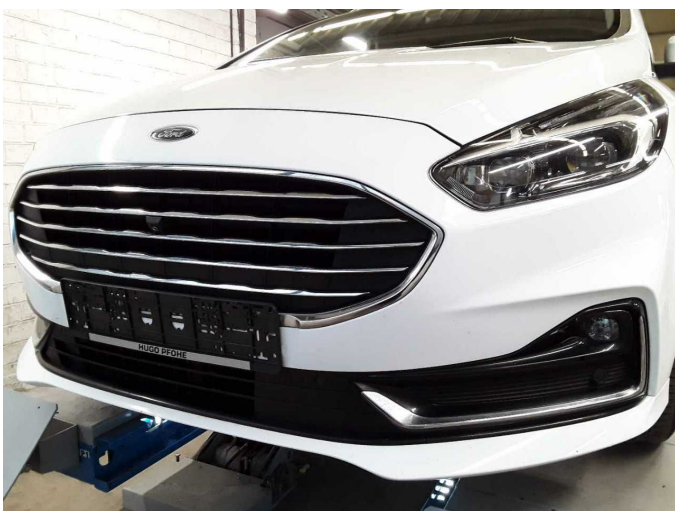
| No. | Component group | Description |
|---|---|---|
| 3 | Front bumper | Front bumper - Stone chips - No deduction |

**Wear and tear 3:** Front bumper: Front bumper - Stone chips - No deduction

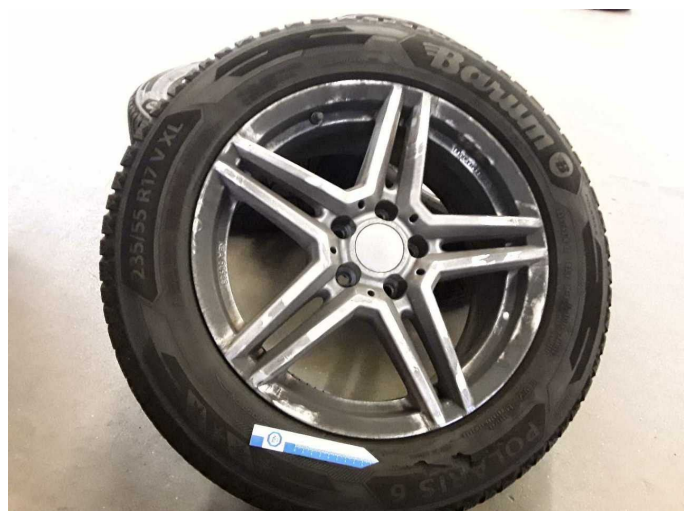
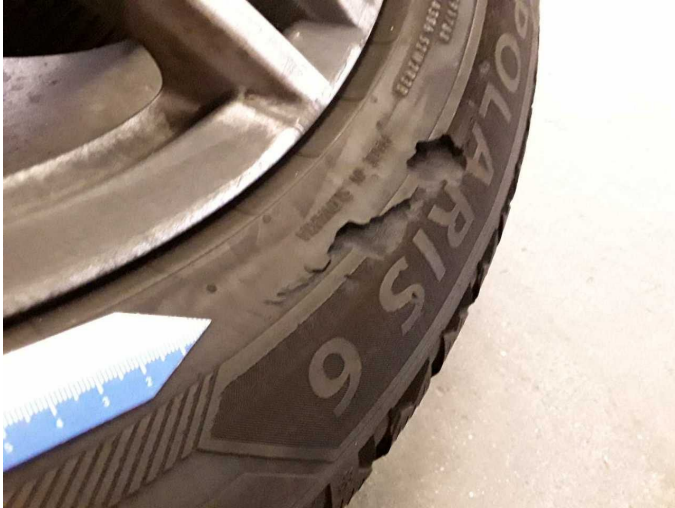
| No. | Component group | Description |
|---|---|---|
| 4 | 2nd wheel set | 1 tyre (Flankenbeschädigung, Nicht Bestandteil der Ausstattung) - Damaged - Replace |

**Wear and tear 4:** 2nd wheel set: 1 tyre (Flankenbeschädigung, Nicht Bestandteil der Ausstattung) - Damaged - Replace
