Expertise

Protocol number: 46678129  
Order No. / Reference: 26620928  
Inspection date: 20 Jul 2026

Manufacturer: Opel

Model: Astra 1.5 D Start/Stop Sports Tourer Business Edition

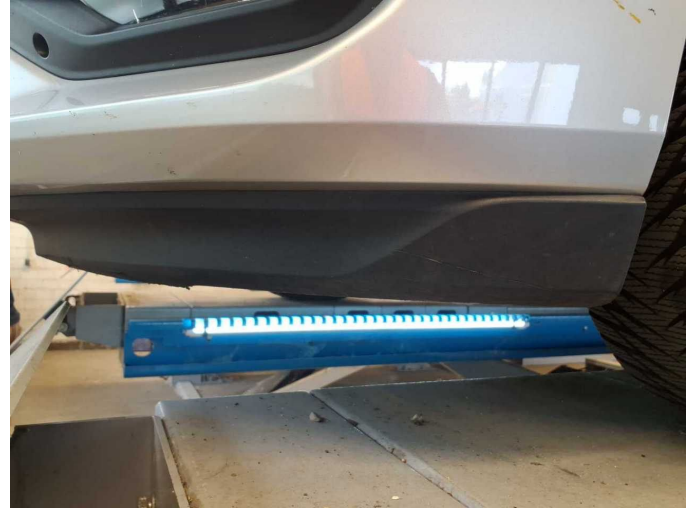
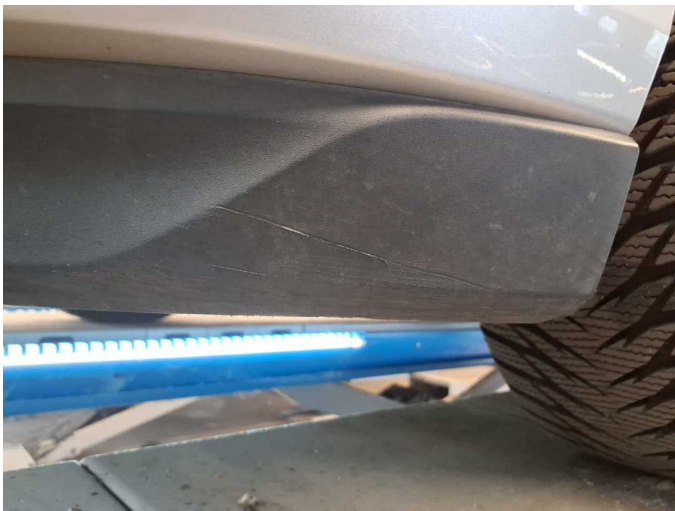
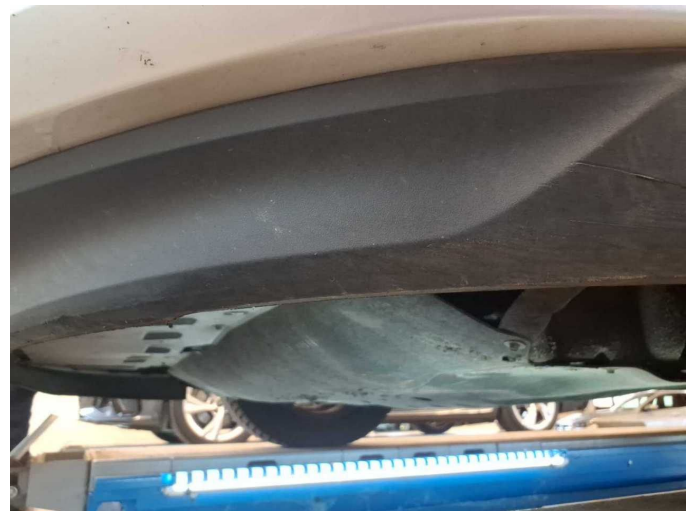
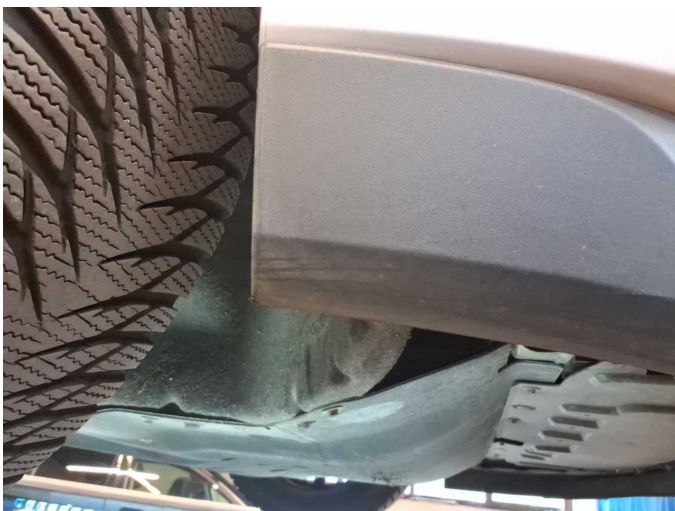
| No. | Component group | Description |
|---|---|---|
| 2 | Front bumper | Spoiler - Scratched - Loss in value |

**Damage 2:** Front bumper: Spoiler - Scratched - Loss in value

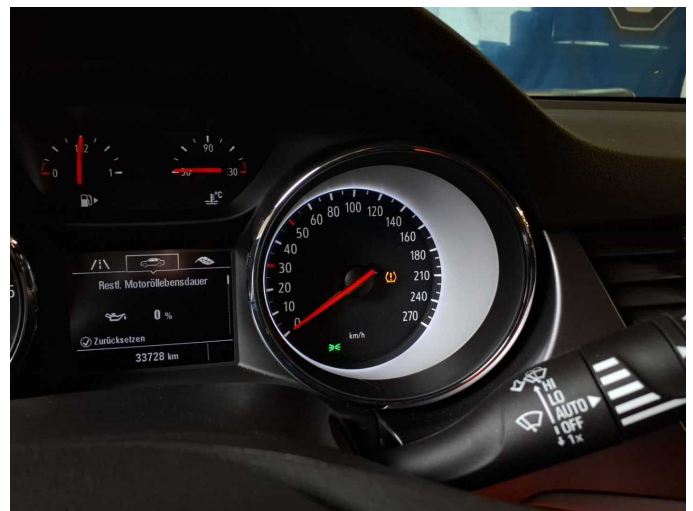
| No. | Component group | Description |
|---|---|---|
| 3 | Wheel / tyres | Pressure sensor - on - Perform diagnosis |

**Damage 3:** Wheel / tyres: Pressure sensor - on - Perform diagnosis

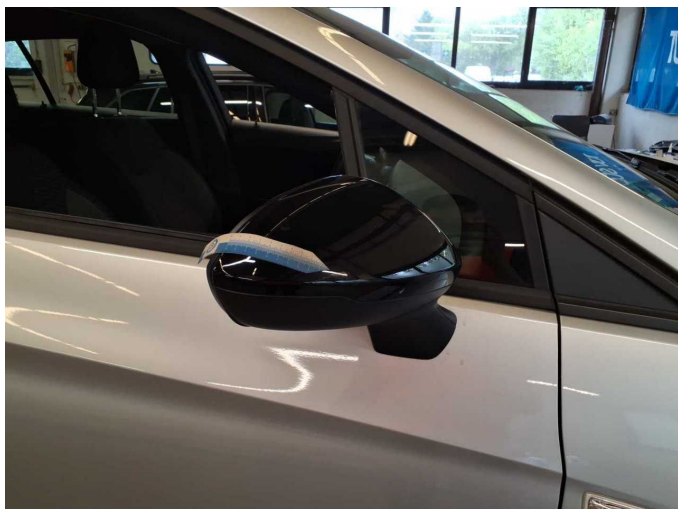
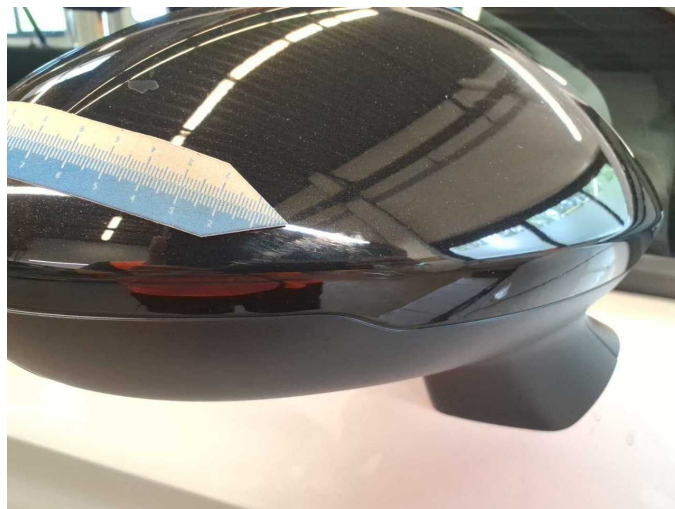
| No. | Component group | Description |
|---|---|---|
| 4 | Wing mirror - right side | Cap - Scratch(es) - Smart repair |

**Damage 4:** Wing mirror - right side: Cap - Scratch(es) - Smart repair

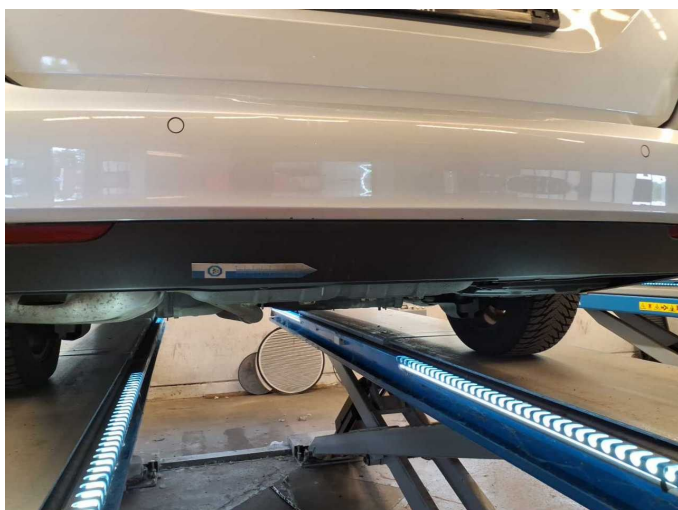
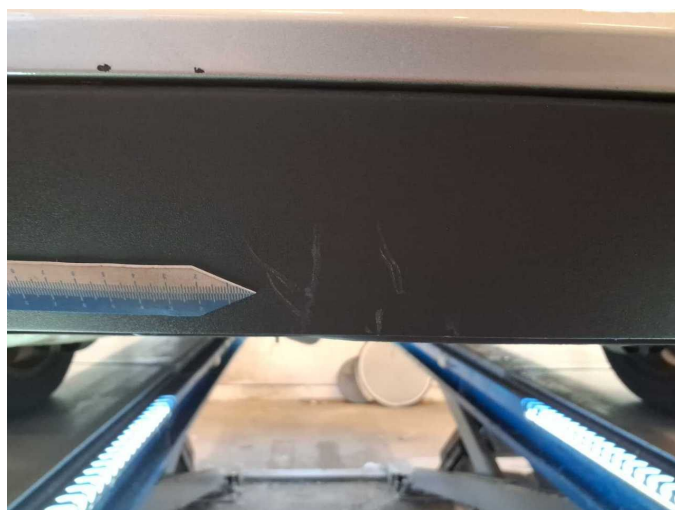
| No. | Component group | Description |
|---|---|---|
| 5 | Rear bumper | Spoiler - Scratch(es) - Smart repair |

**Damage 5:** Rear bumper: Spoiler - Scratch(es) - Smart repair

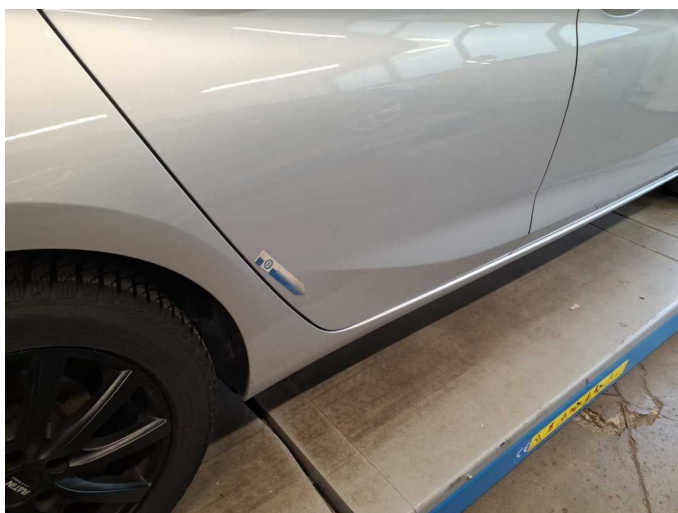
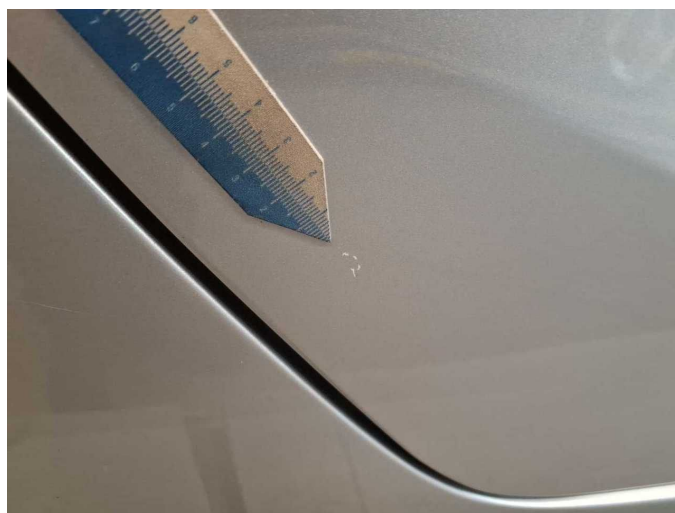
| No. | Component group | Description |
|---|---|---|
| 6 | Door - rear right side | Door - Scratch(es) - Smart repair |

**Damage 6:** Door - rear right side: Door - Scratch(es) - Smart repair

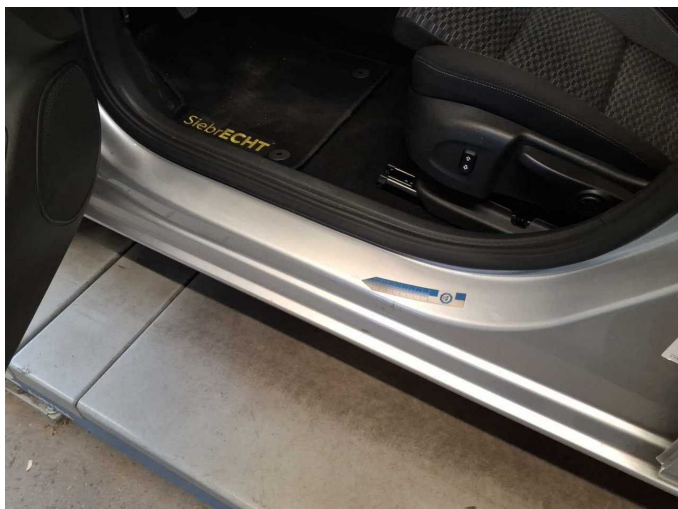
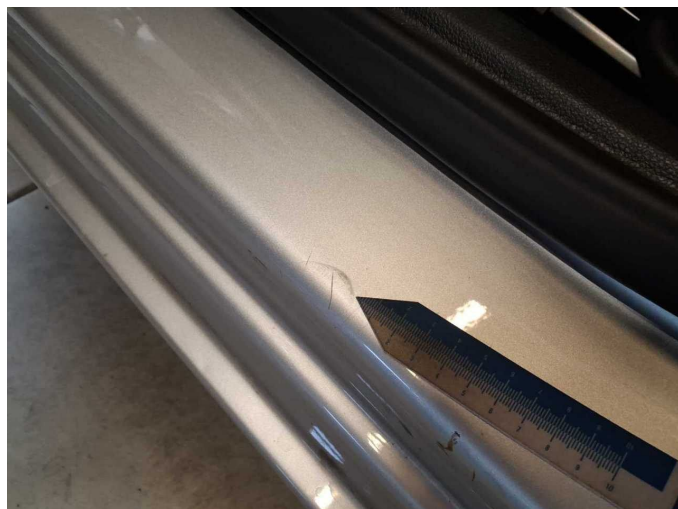
| No. | Component group | Description |
|---|---|---|
| 7 | Sill - left side | Sill - Scratch(es) - Smart repair |

**Damage 7:** Sill - left side: Sill - Scratch(es) - Smart repair

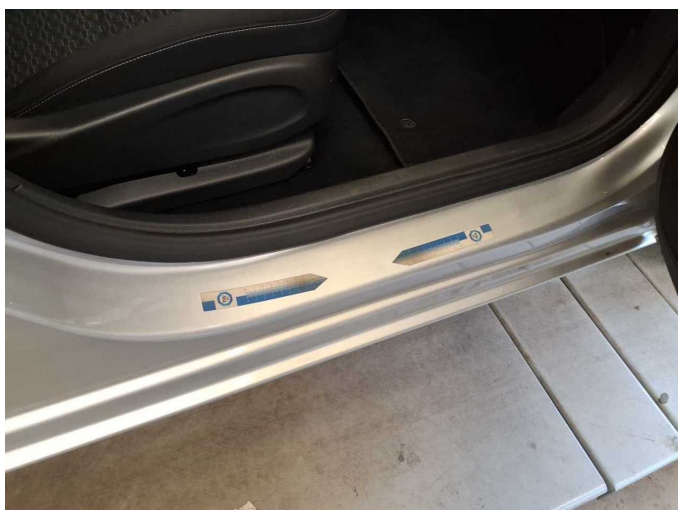
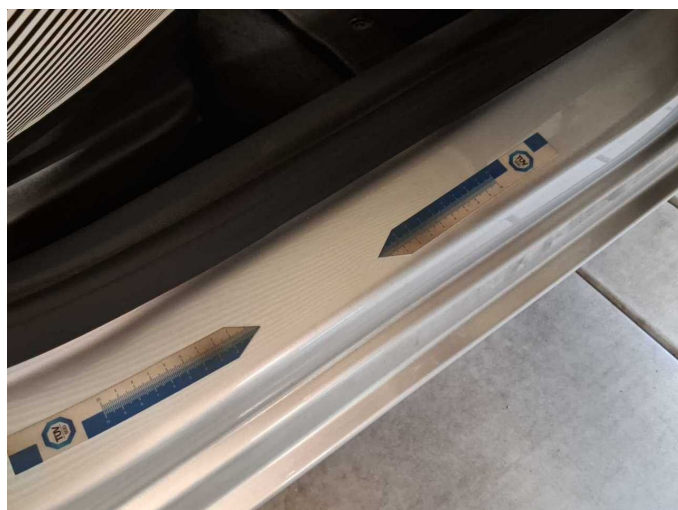
| No. | Component group | Description |
|---|---|---|
| 8 | Sill - right side | Sill - dent(s) - Smooth repair work |

**Damage 8:** Sill - right side: Sill - dent(s) - Smooth repair work

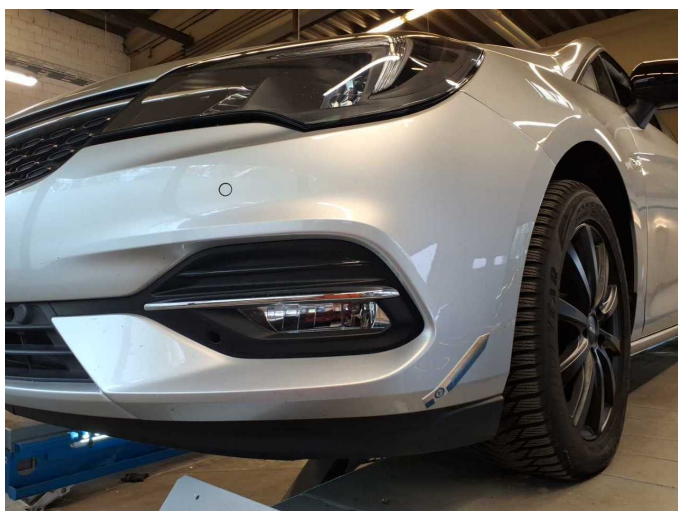
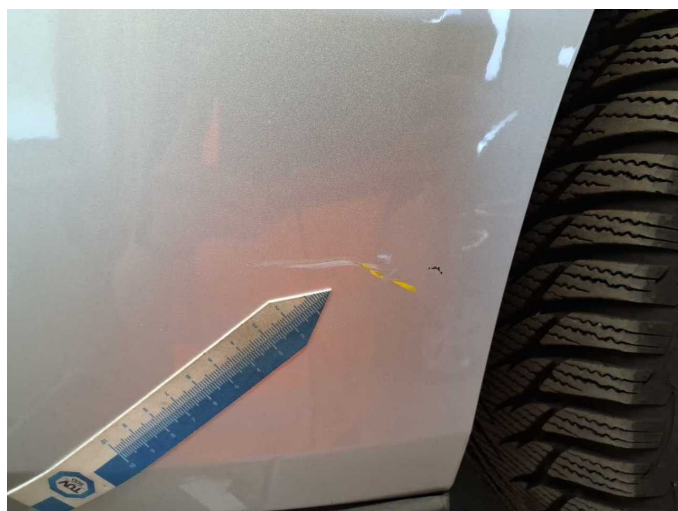
| No. | Component group | Description |
|---|---|---|
| 9 | Front bumper | Front bumper - Scratch(es) - Smart repair |

**Damage 9:** Front bumper: Front bumper - Scratch(es) - Smart repair

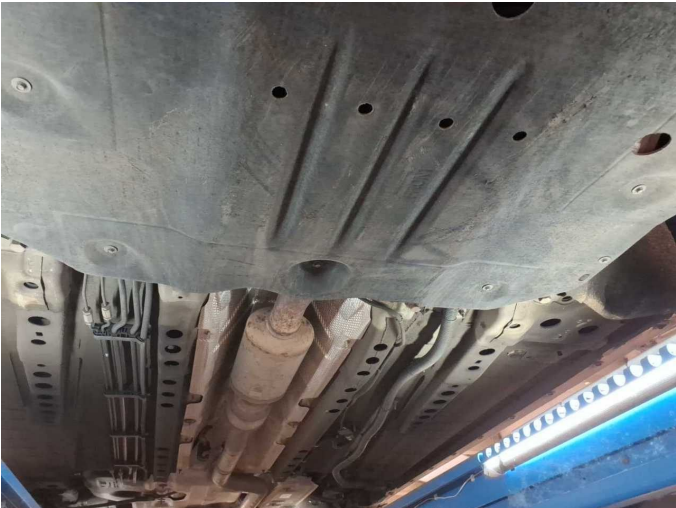
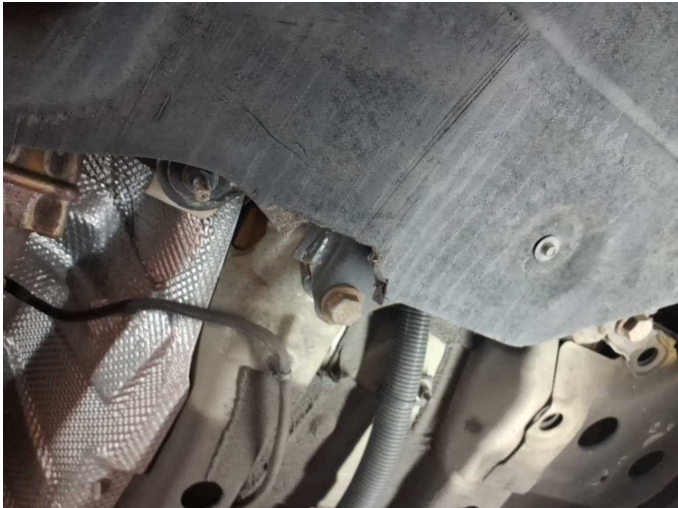
| No. | Component group | Description |
|---|---|---|
| 10 | Engine | Engine cowling - lower - Broken / torn - Replace |

Damage 10: Engine: Engine cowling - lower - Broken / torn - Replace

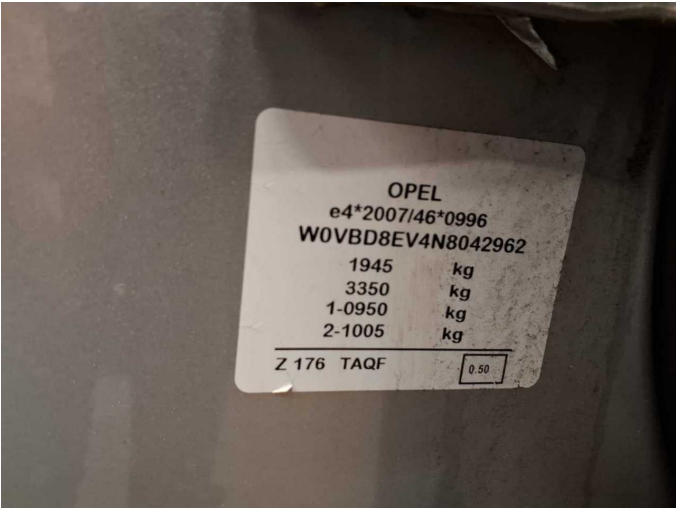
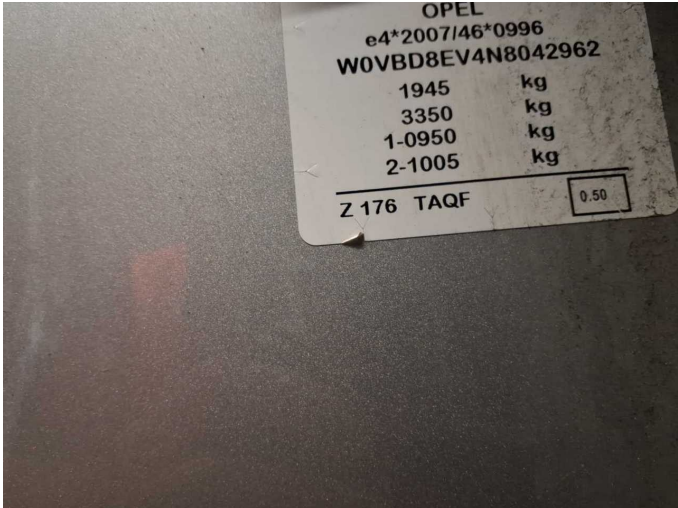
| No. | Component group | Description |
|---|---|---|
| 11 | Body | Identification plate - Damaged - Replace |

Damage 11: Body: Identification plate - Damaged - Replace

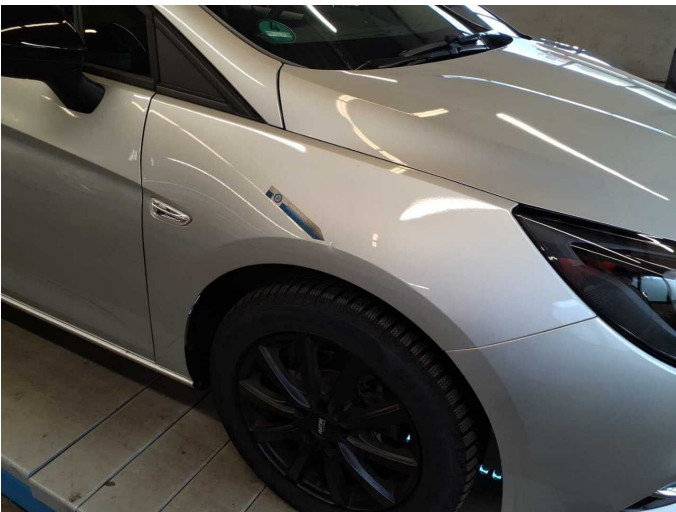
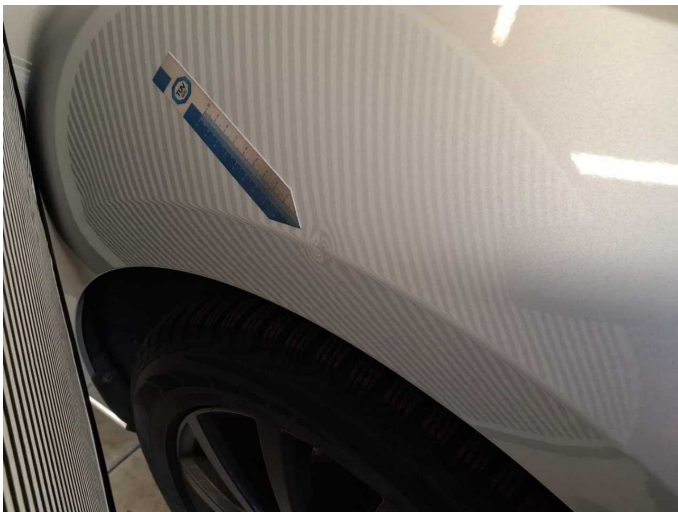
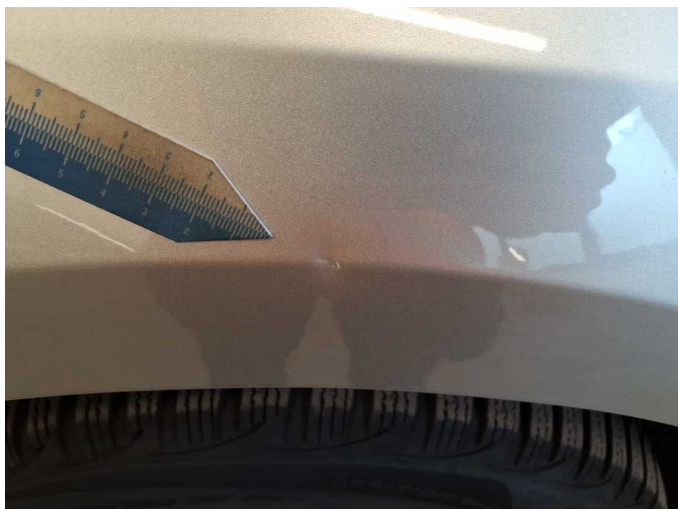
| No. | Component group | Description |
|---|---|---|
| 12 | Mudguard - right side | Mudguard - right side - Dent / paintcoat damage - Repair and paint |

Damage 12: Mudguard - right side: Mudguard - right side - Dent / paintcoat damage - Repair and paint

**Damage 12:** Mudguard - right side: Mudguard - right side - Dent / paintcoat damage - Repair and paint

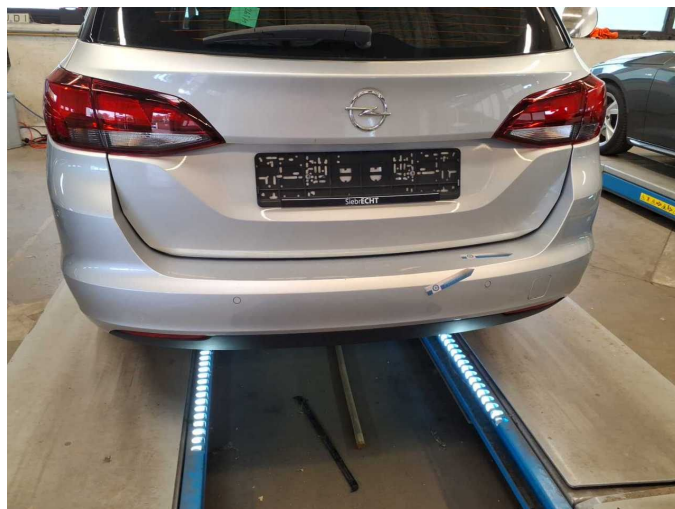
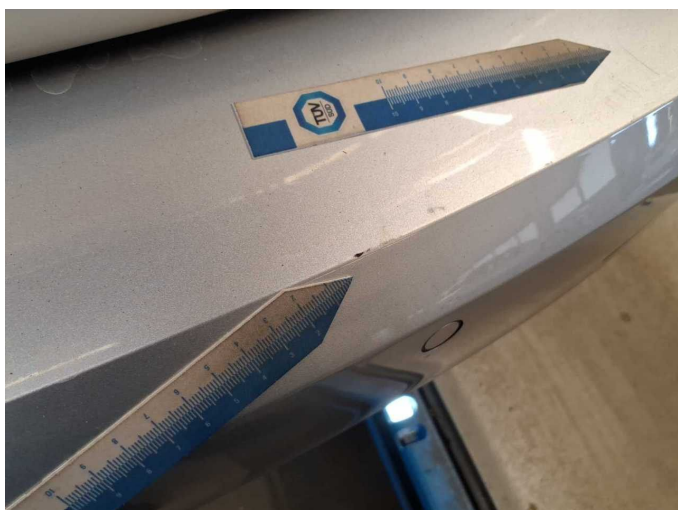
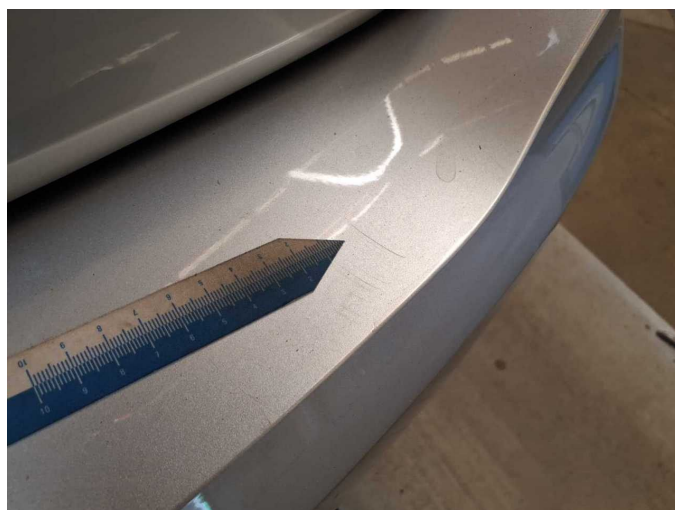
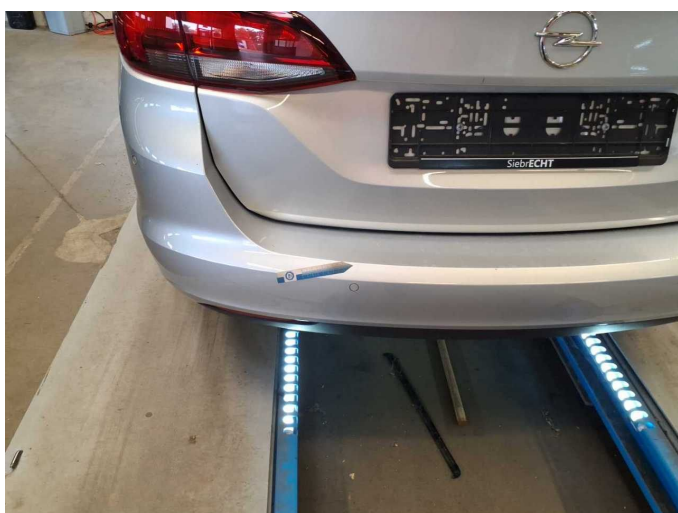
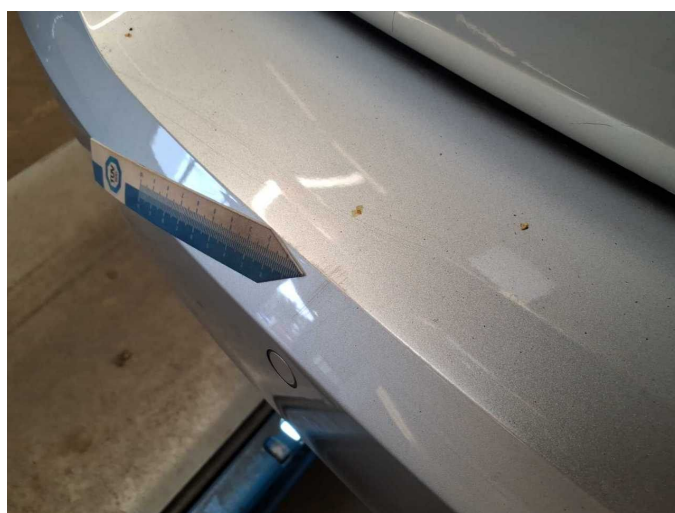
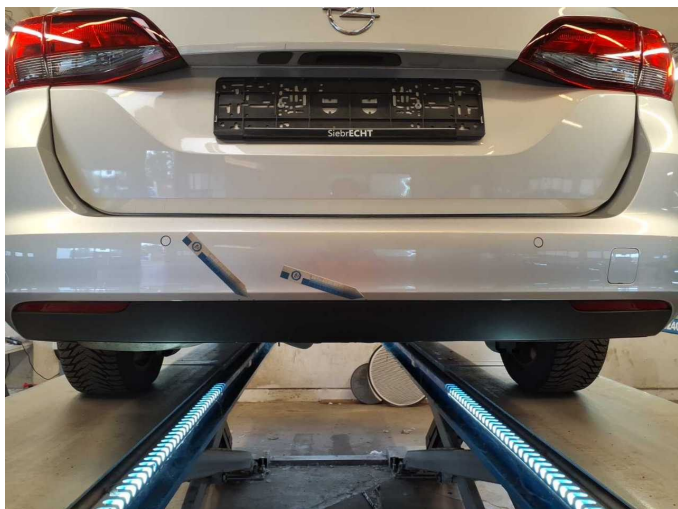
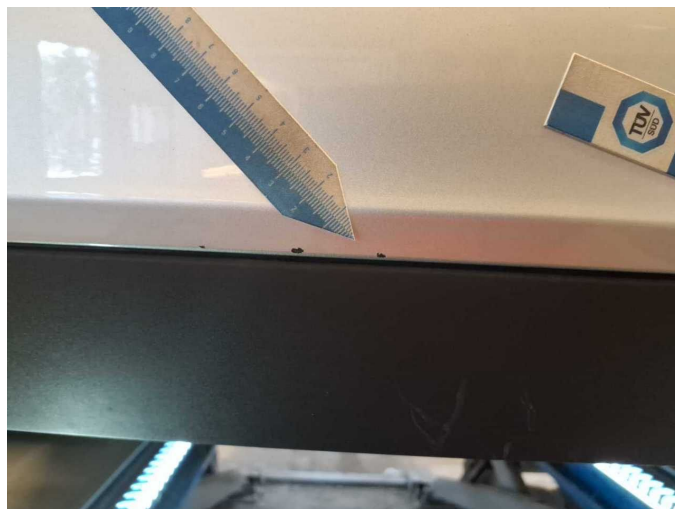
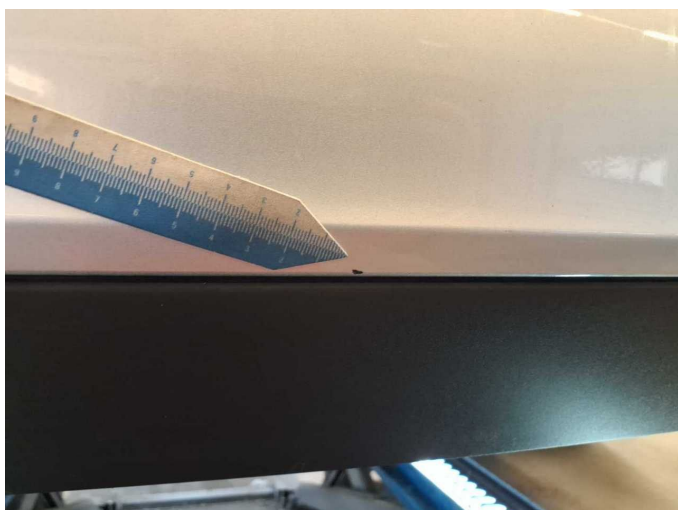
| No. | Component group | Description |
|---|---|---|
| 13 | Rear bumper | Rear bumper - Scratch(es) - Paint |

**Damage 13:** Rear bumper: Rear bumper - Scratch(es) - Paint

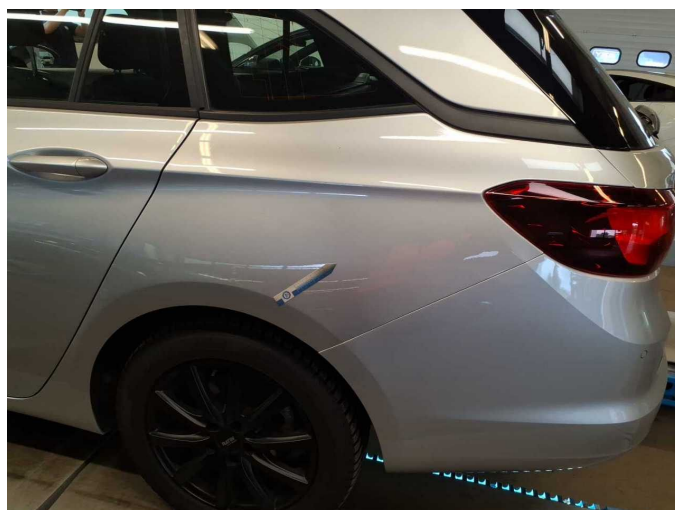
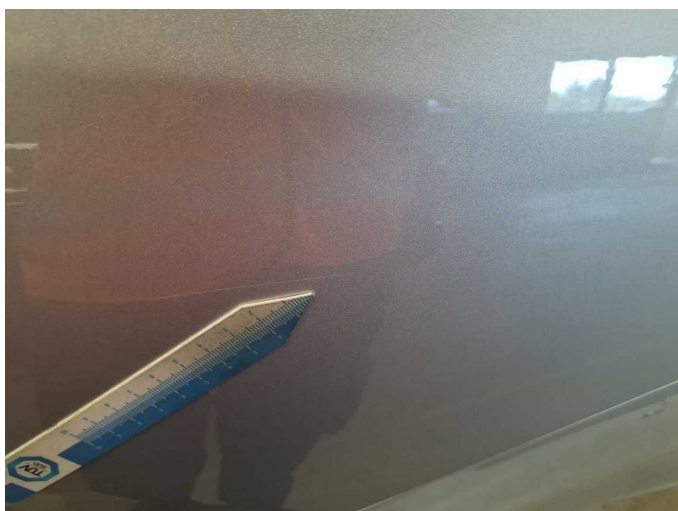
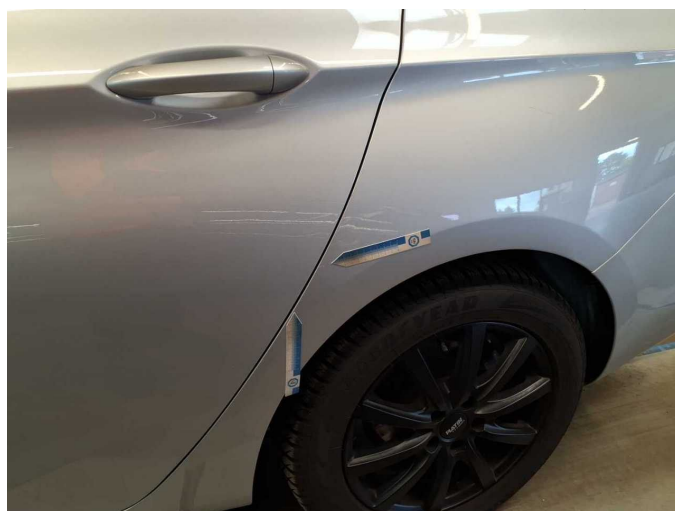
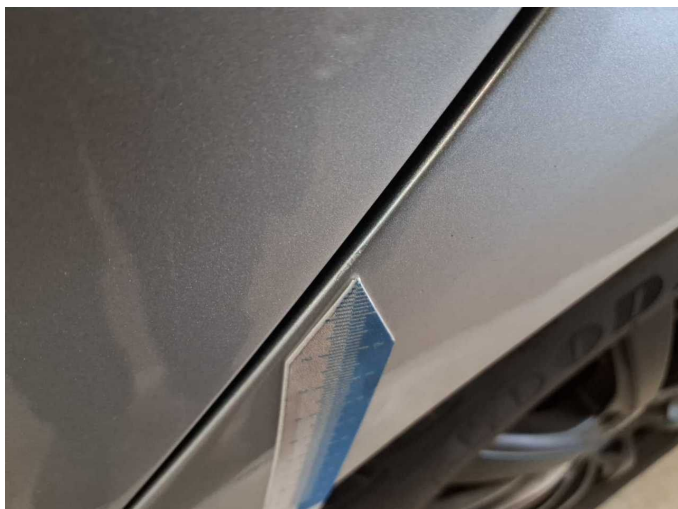
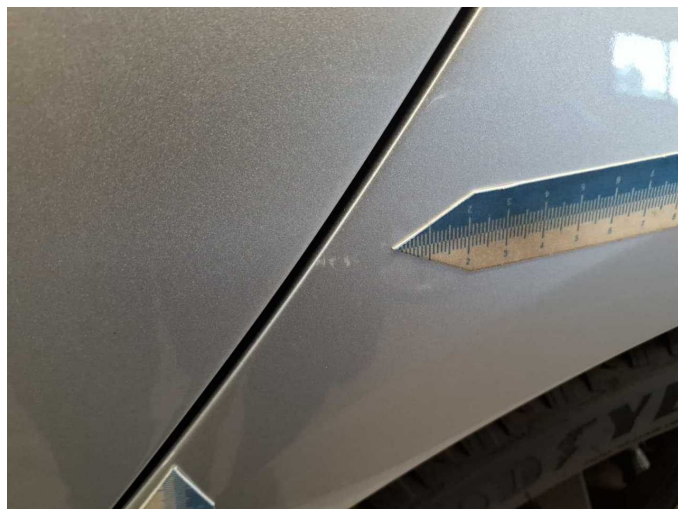
| No. | Component group | Description |
|---|---|---|
| 14 | Side panel - rear left side | Side panel - Scratch(es) - Paint |

**Damage 14:** Side panel - rear left side: Side panel - Scratch(es) - Paint

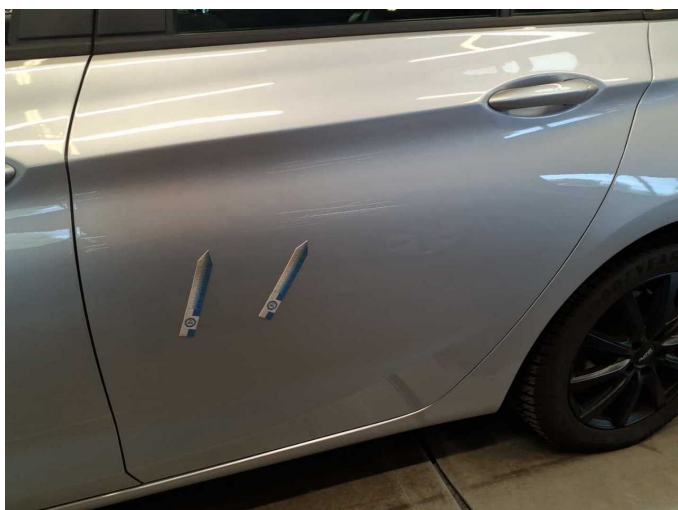
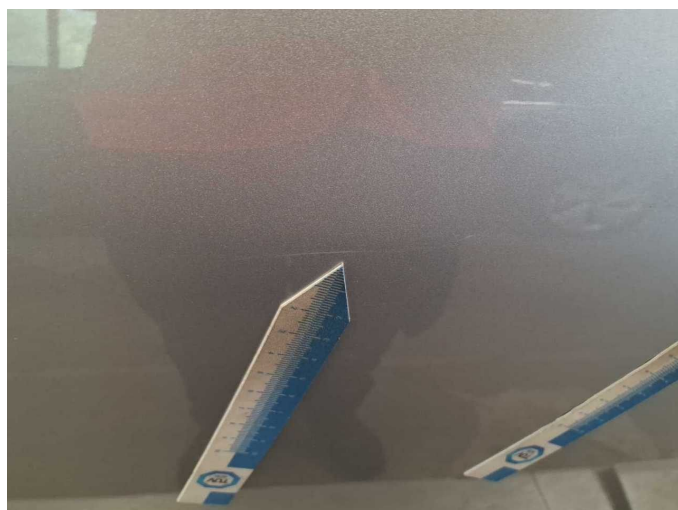
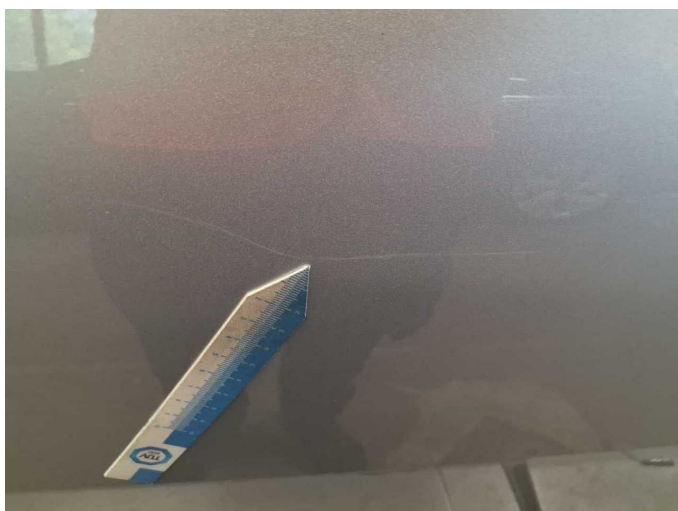
| No. | Component group | Description |
|---|---|---|
| 15 | Door - rear left side | Door - Scratch(es) - Paint |

**Damage 15:** Door - rear left side: Door - Scratch(es) - Paint

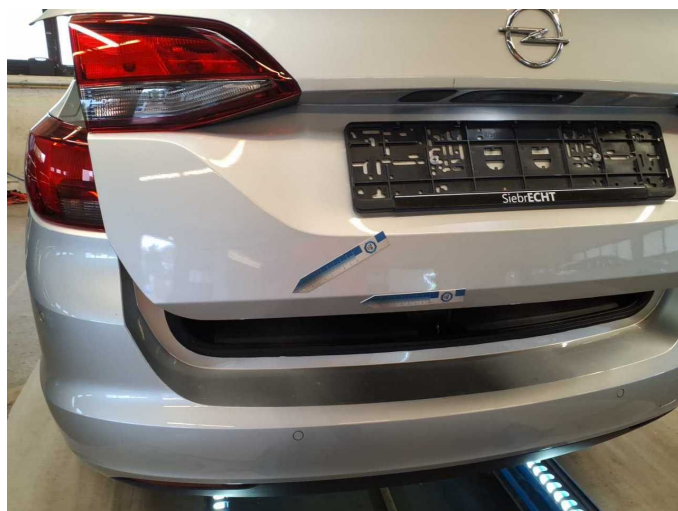
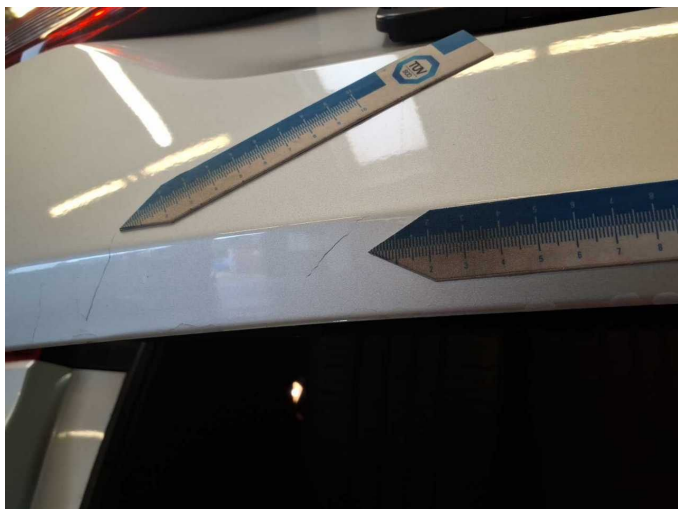
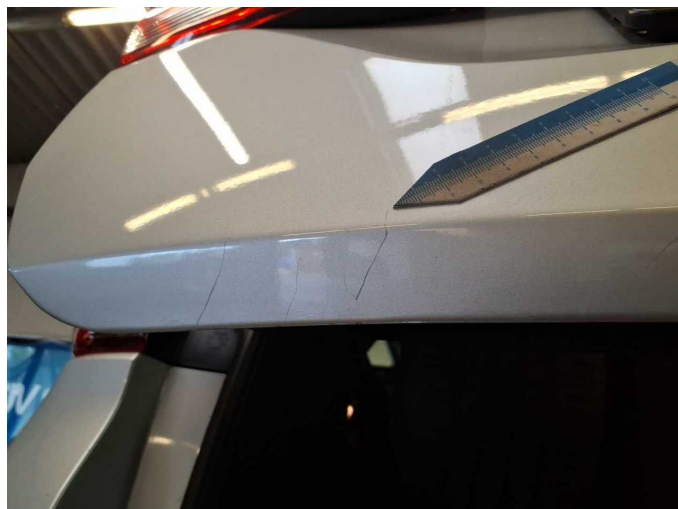
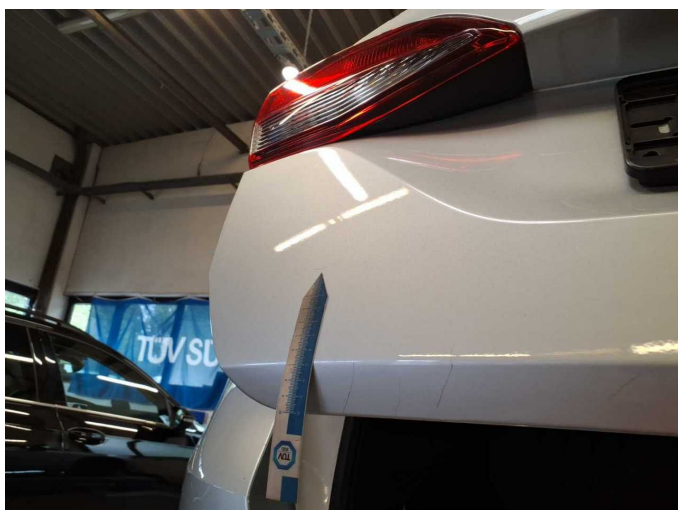
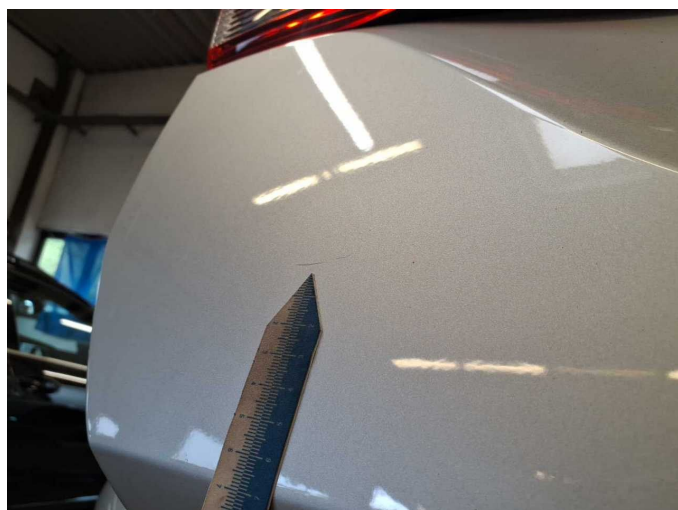
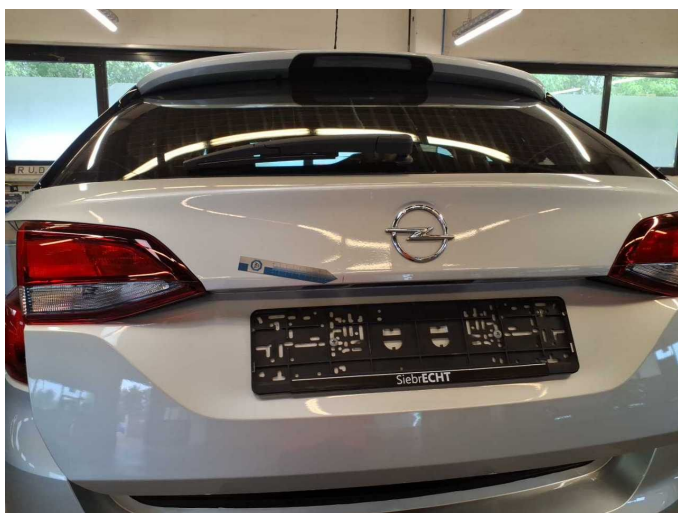
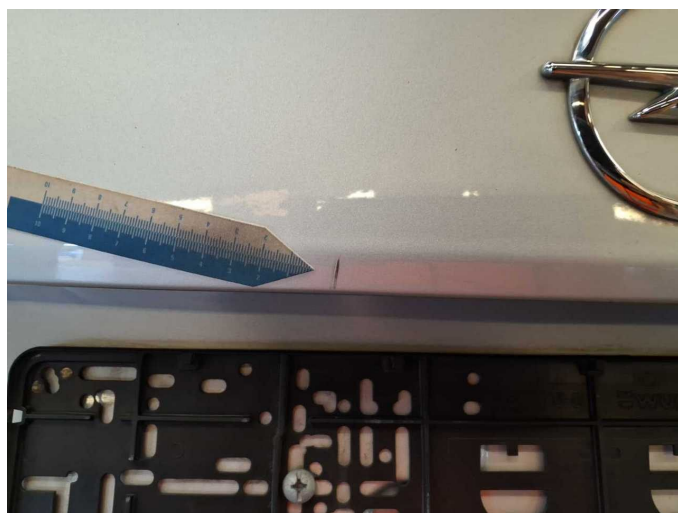
| No. | Component group | Description |
|---|---|---|
| 16 | Boot lid / rear door | Boot lid - Scratch(es) - Paint |

**Damage 16:** Boot lid / rear door: Boot lid - Scratch(es) - Paint

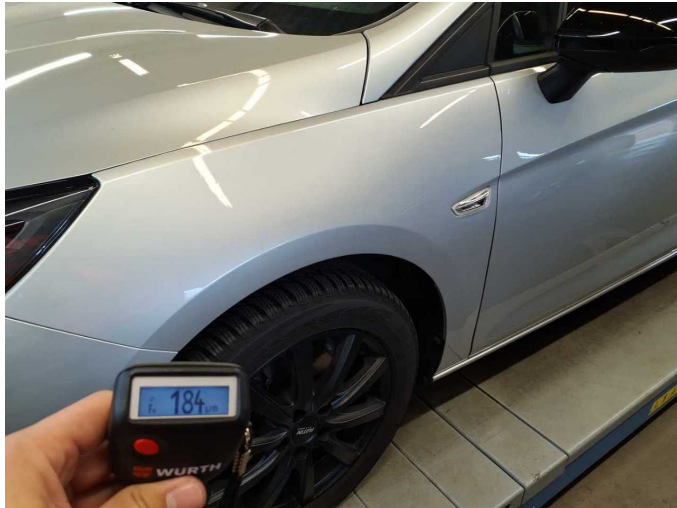
| No. | Repainting |
|---|---|
| 1 | Mudguard - left side, Professionally carried out, Invoice of repair done Non-existent |

| Mudguard - left side | 184 µm | Side panel - rear left side | 187 µm |

**Repainting 1:** Mudguard - left side

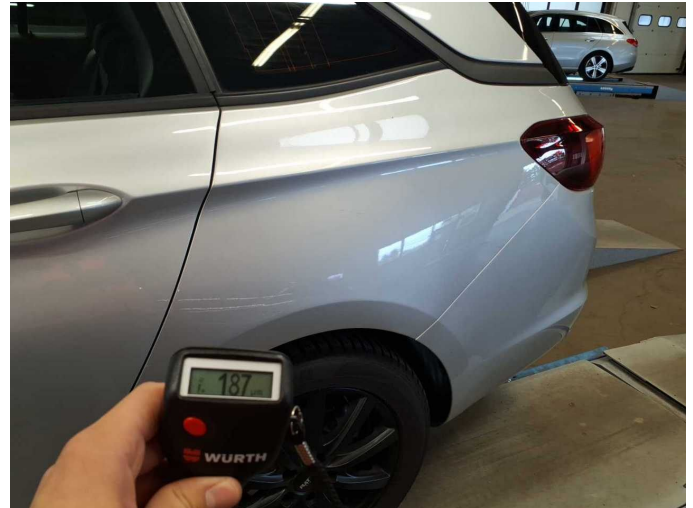
| No. | Repainting |
|---|---|
| 2 | Side panel - rear left side, Professionally carried out, Invoice of repair done Non-existent |

**Repainting 2:** Side panel - rear left side

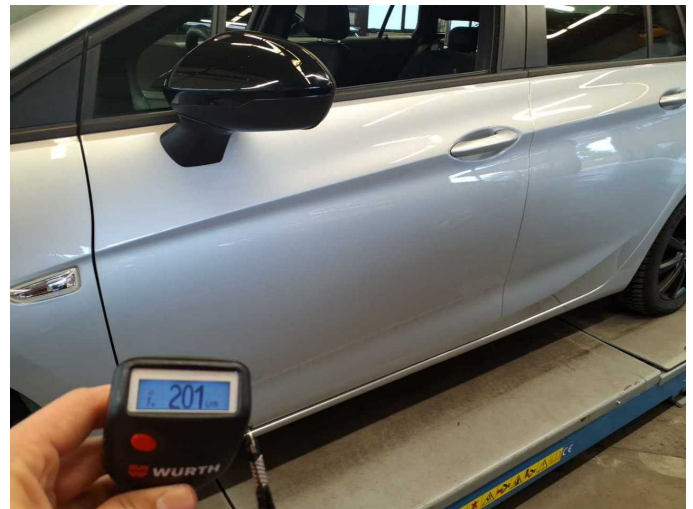
| No. | Repainting |
|---|---|
| 4 | Door - front left side, Professionally carried out, Invoice of repair done Non-existent |

| Door - rear left side | 170 µm | Door - front left side | 201 µm |

**Repainting 4:** Door - front left side
