Expertise

Protocol number: 46506300  
Order No. / Reference: 26464861  
Inspection date: 14 Jul 2026

Manufacturer: Ford

Model: Kuga 2.5 Duratec FHEV 4x4 TITANIUM X

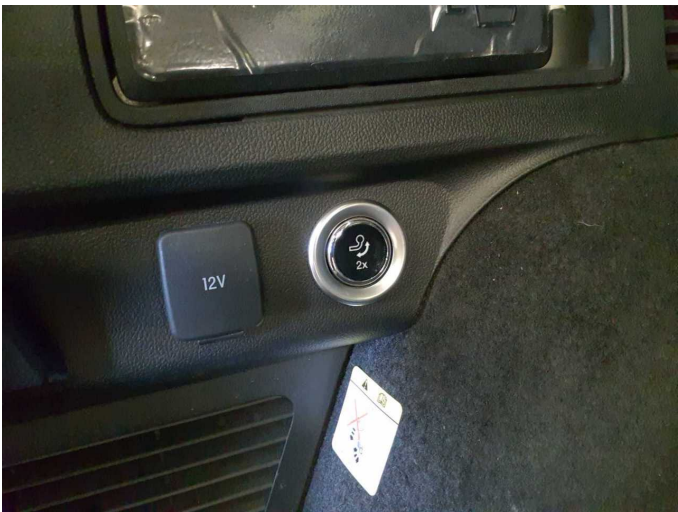
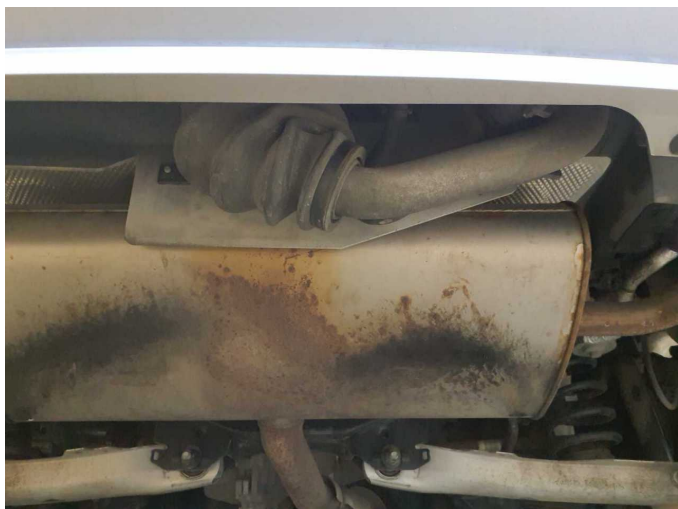
| No. | Component group | Description |
|---|---|---|
| 1 | Rear of vehicle | Trailer hitch (Schwenkbar) - Non-operational - Perform diagnosis |

Damage 1: Rear of vehicle: Trailer hitch (Schwenkbar) - Non-operational  
- Perform diagnosis

**Damage 1:** Rear of vehicle: Trailer hitch (Schwenkbar) - Non-operational  
- Perform diagnosis

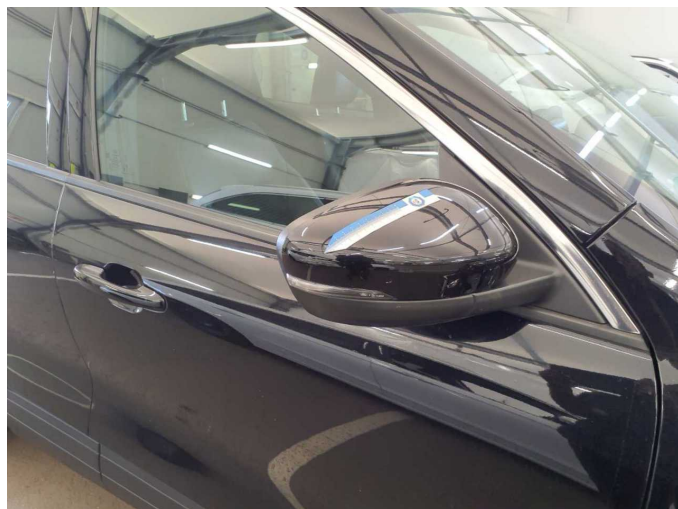
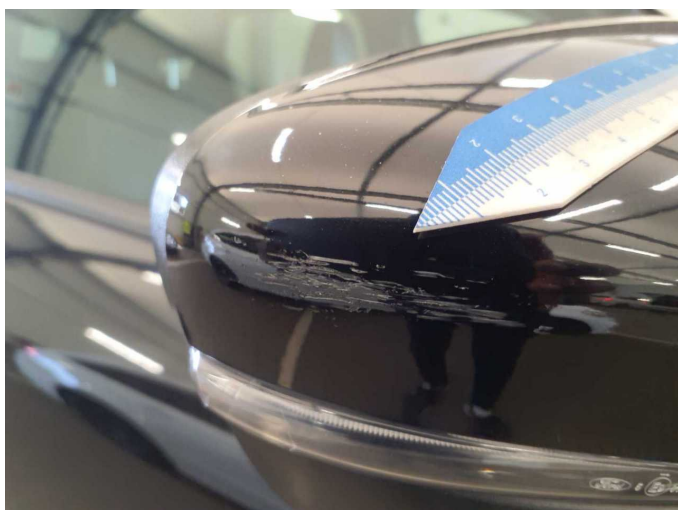
| No. | Component group | Description |
|---|---|---|
| 2 | Wing mirror - right side | Cap - Scratch(es) - Smart repair |

**Damage 2:** Wing mirror - right side: Cap - Scratch(es) - Smart repair

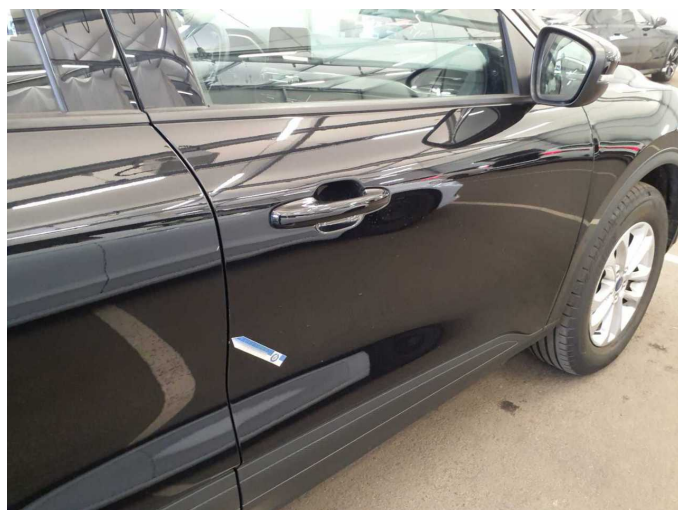
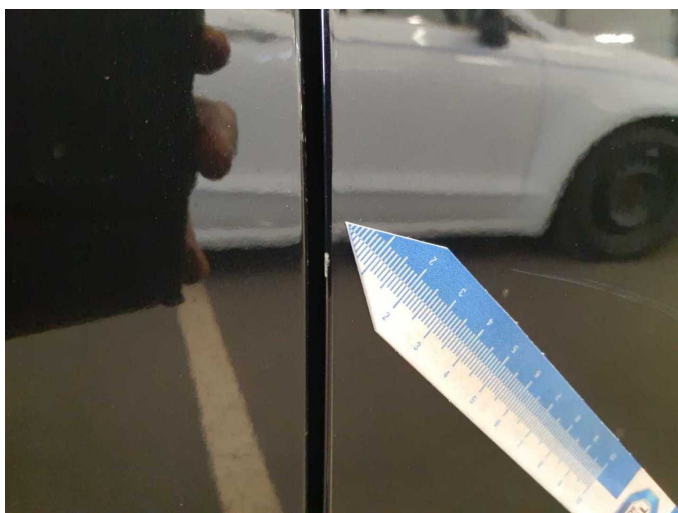
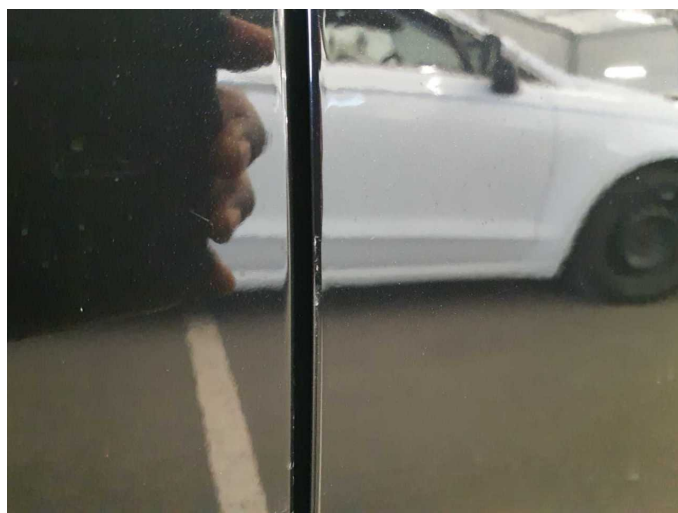
| No. | Component group | Description |
|---|---|---|
| 3 | Door - front right side | Door edge - Scratch(es) - Smart repair |

**Damage 3:** Door - front right side: Door edge - Scratch(es) - Smart repair

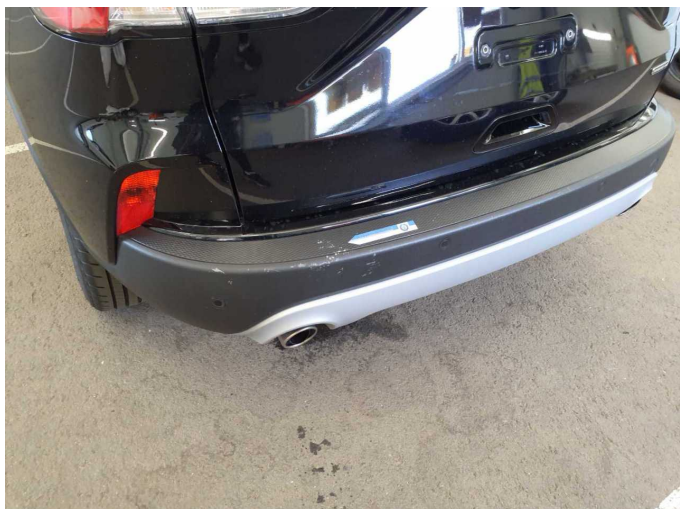
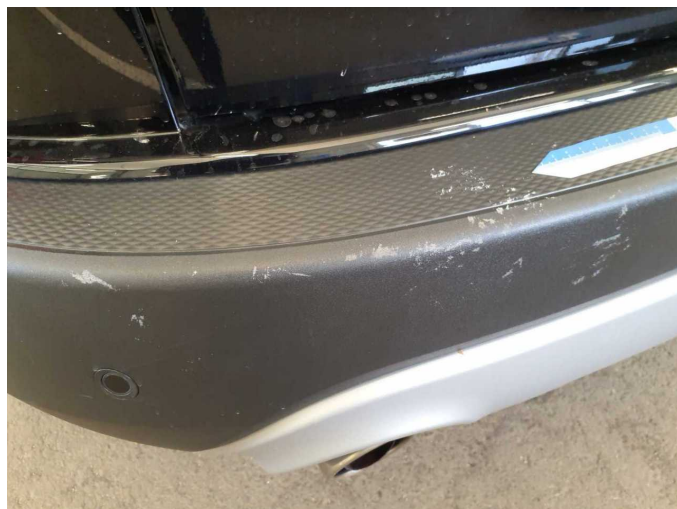
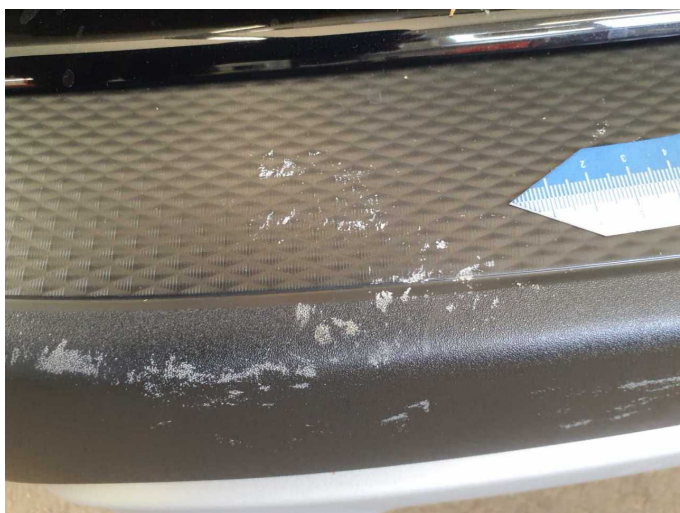
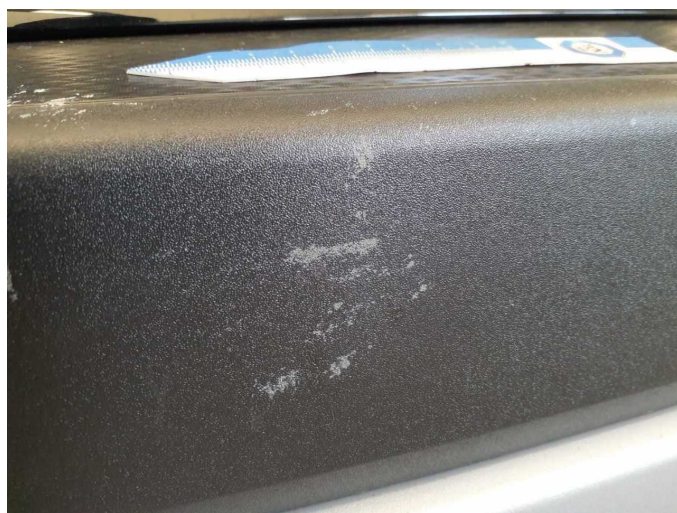
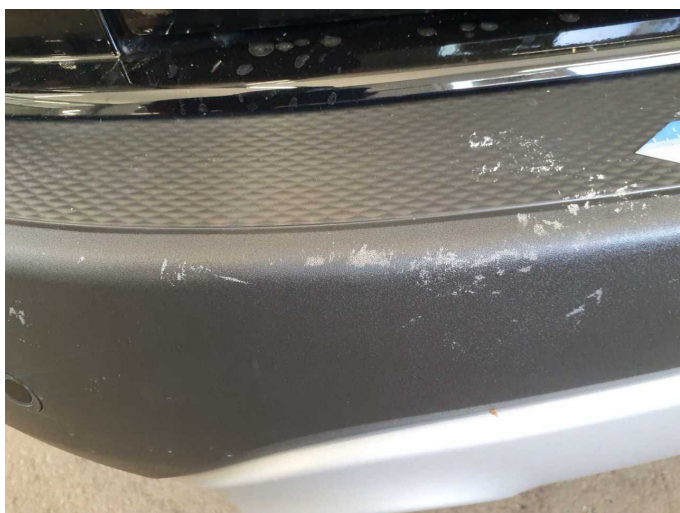
| No. | Component group | Description |
|---|---|---|
| 4 | Rear bumper | Rear bumper - Soiled - Clean |

**Damage 4:** Rear bumper: Rear bumper - Soiled - Clean

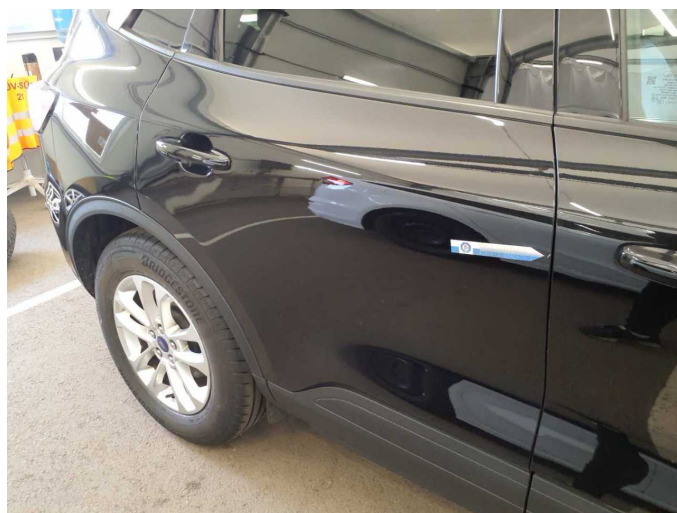
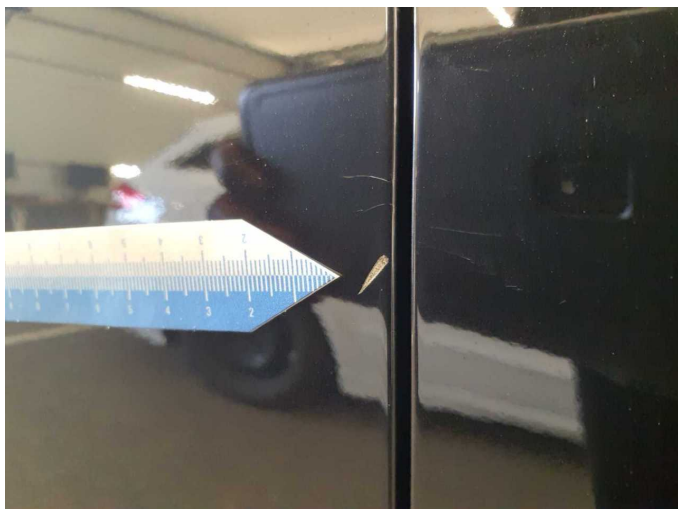
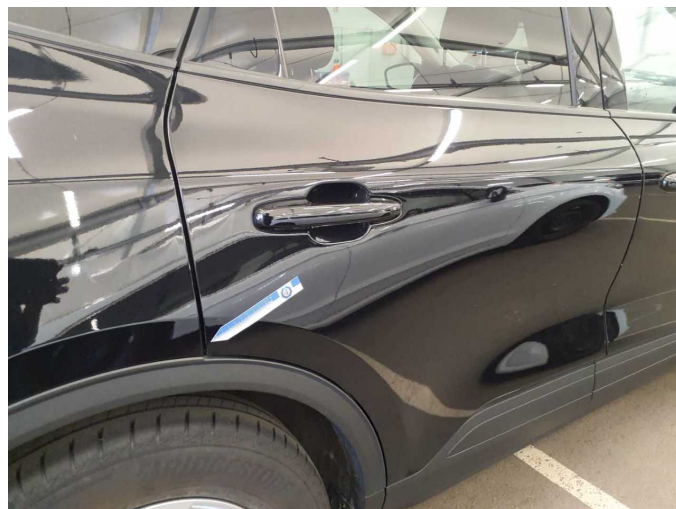
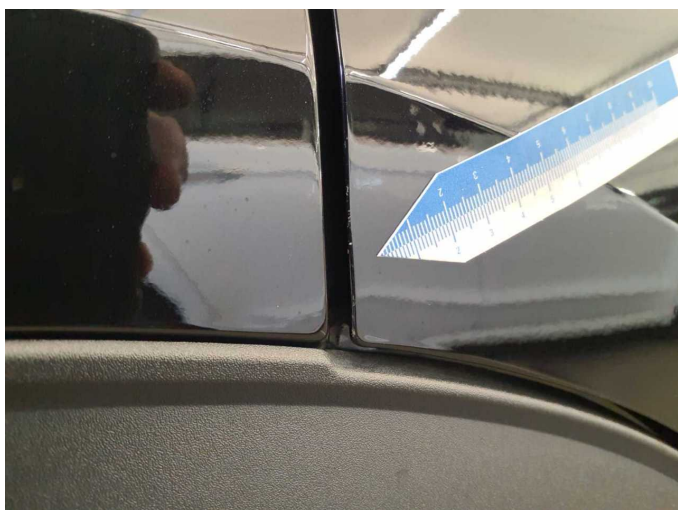
| No. | Component group | Description |
|---|---|---|
| 5 | Door - rear right side | Door - Scratch(es) - Smart repair |

**Damage 5:** Door - rear right side: Door - Scratch(es) - Smart repair

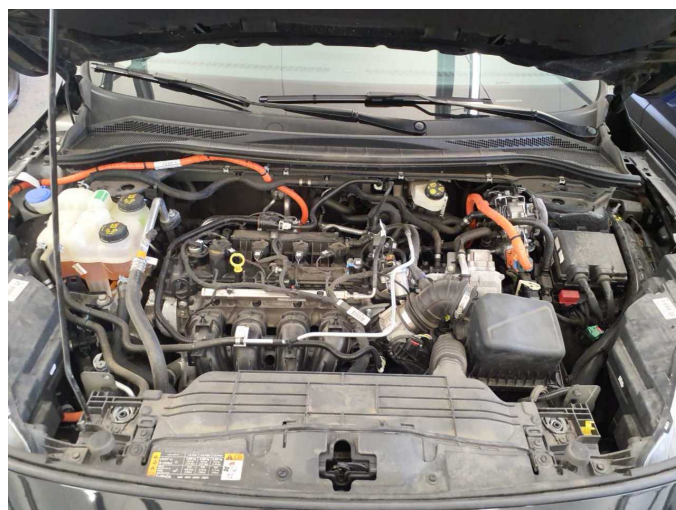
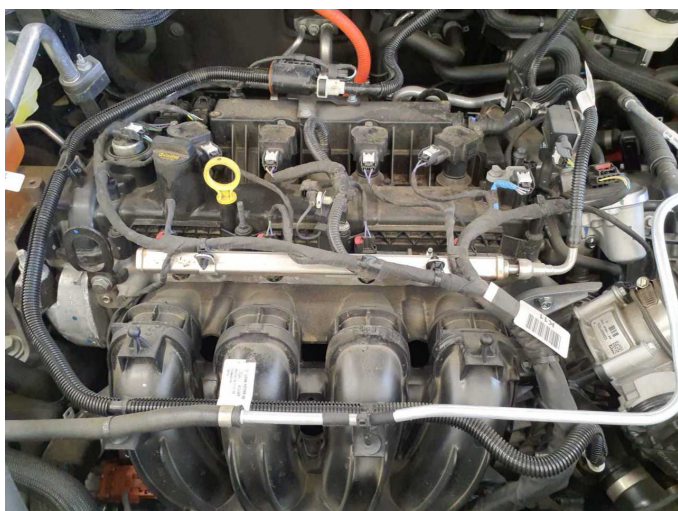
Engine - Engine cover

**Missing part 1:** Engine: Engine cover - Missing - Replace

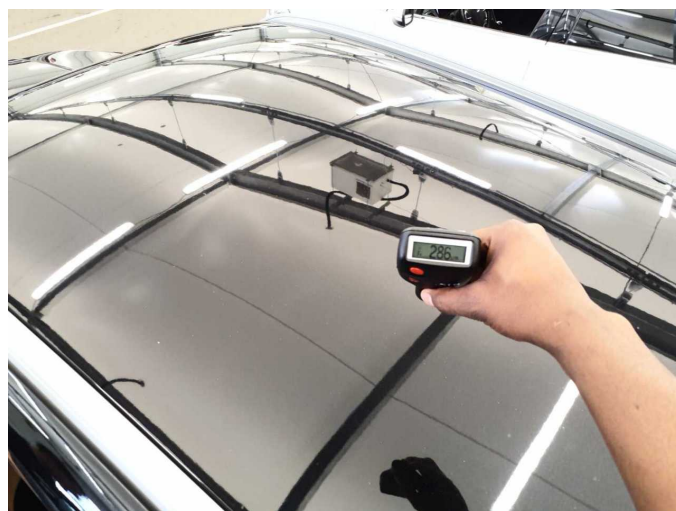
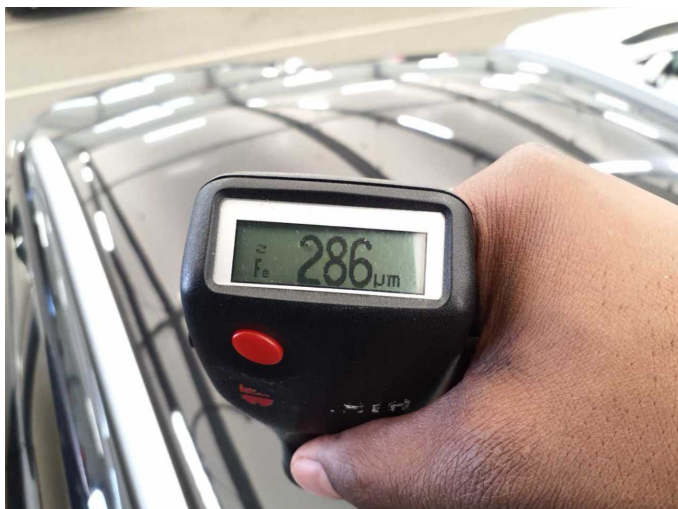
1 Roof, Professionally carried out, Invoice of repair done Non-existent

| Roof | 286 µm |

**Repainting 1:** Roof

**Repainting 1: Roof**
