Expertise

Protocol number: 46283915
Order No. / Reference: 26483924
Inspection date: 24 Jun 2026

Model: Sharan 2.0 TDI (BlueMotion Technology) Comfortline

VIN: WVVZZZ7NZLV003738

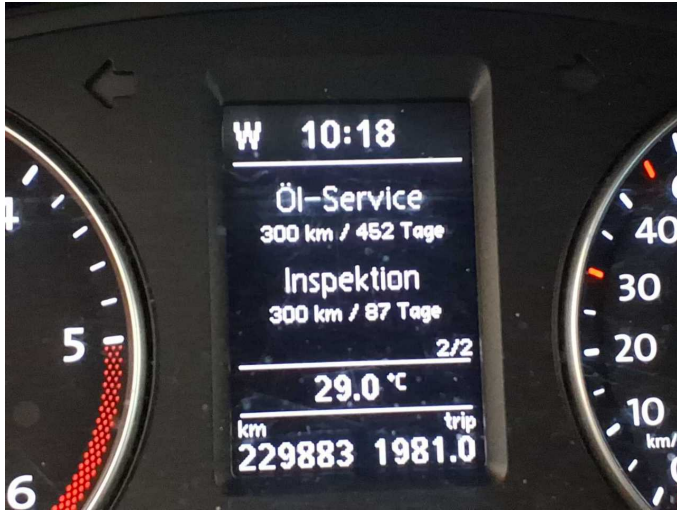
Damage 1: Misc.: Inspection / maintenance (Motorölservice/Inspektion fällig in 300km Restreichweite) - No evidence - No deduction

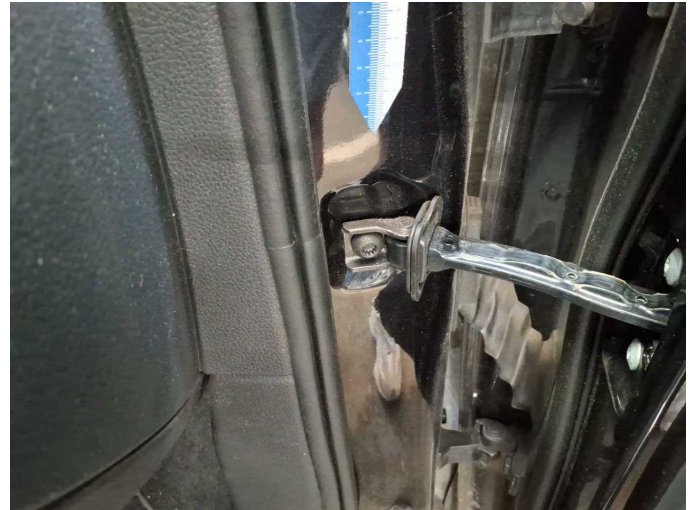
Damage 2: Door - front right side: Door check strap / arrestor - Loose - Un- / install

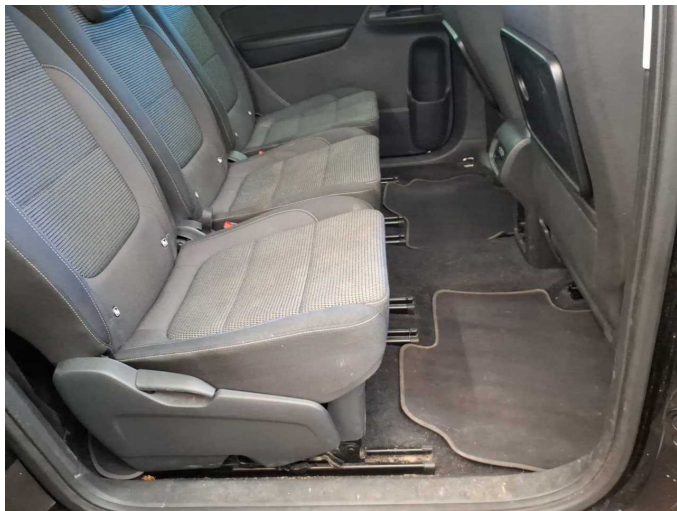
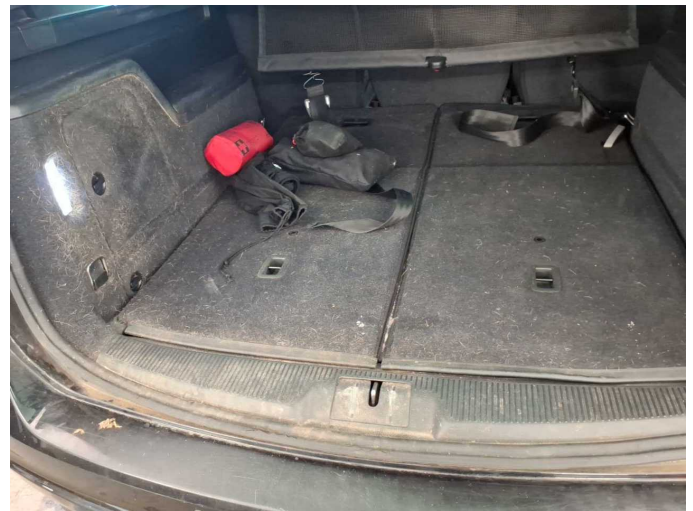
Damage 3: Interior: Interior (Tierhaare, Intensivreinigung Laderaum Notwendig) - Soiled - Clean

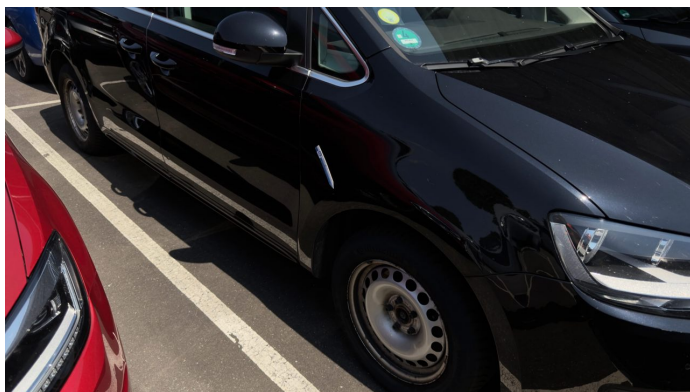
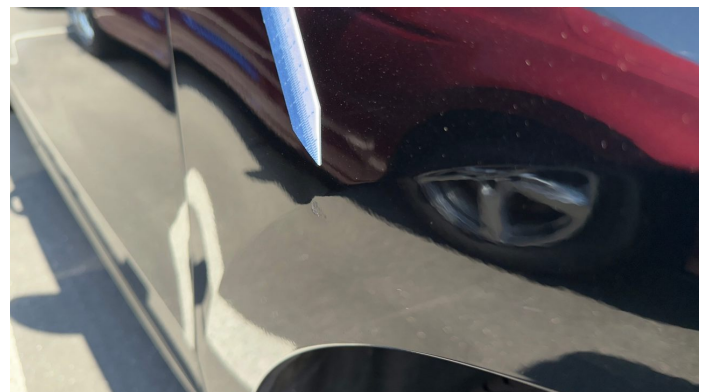
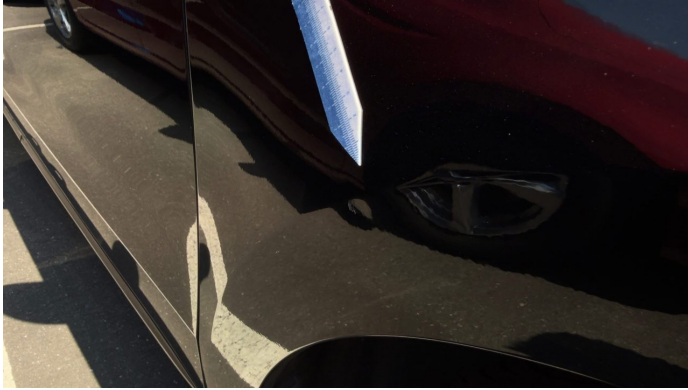
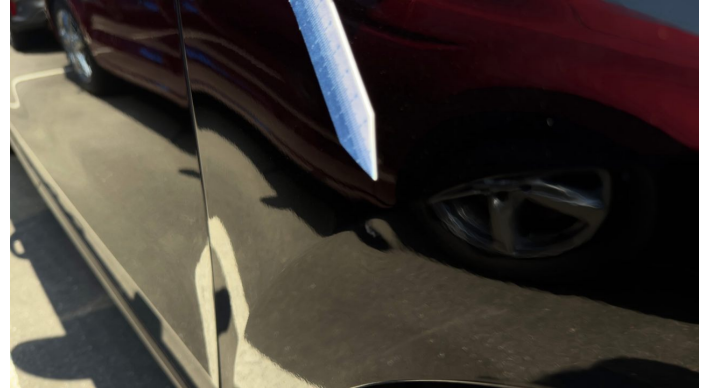
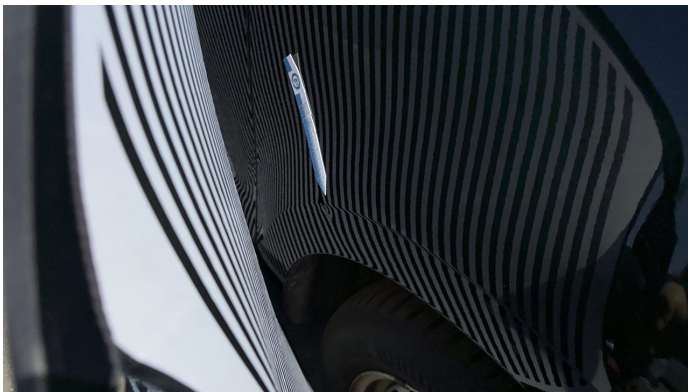
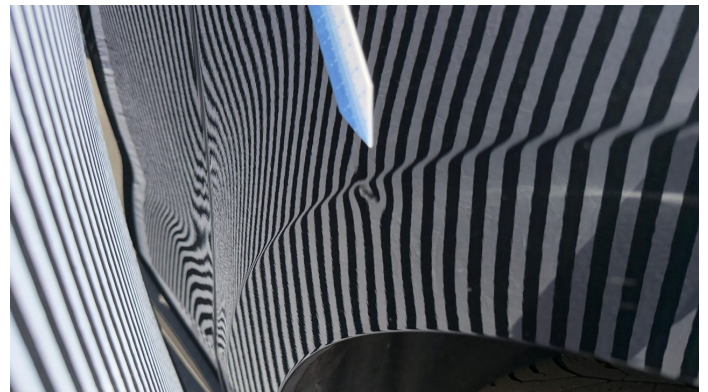
Damage 4: Mudguard - right side: Mudguard - right side - Dent / paintcoat damage - Repair and paint

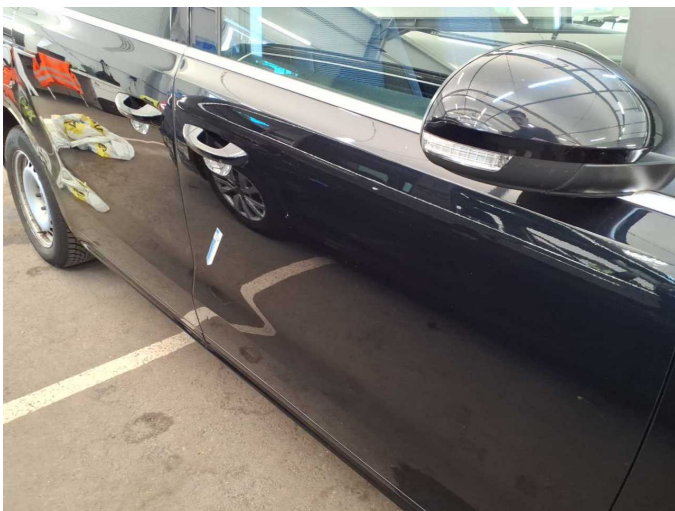
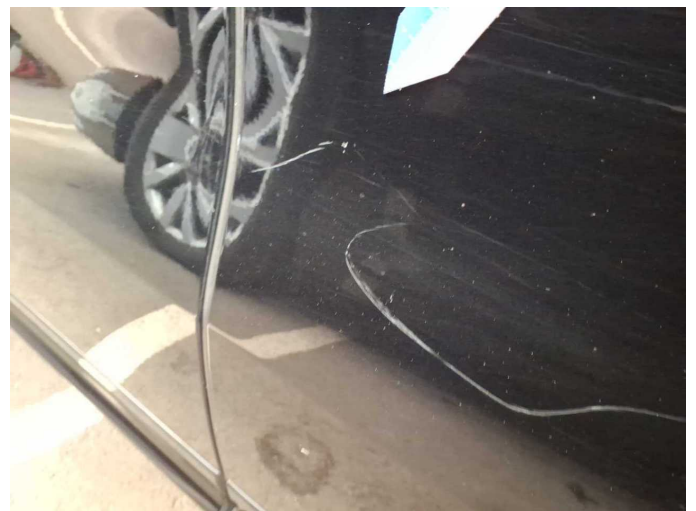
Damage 5: Door - front right side: Door - Scratch(es) - Paint

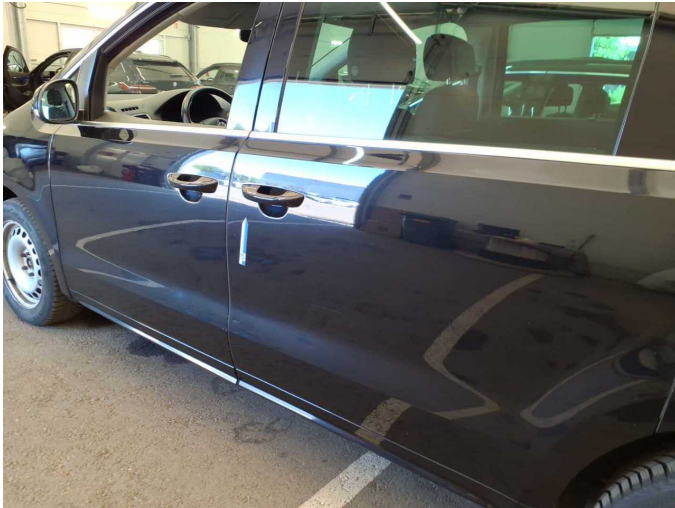
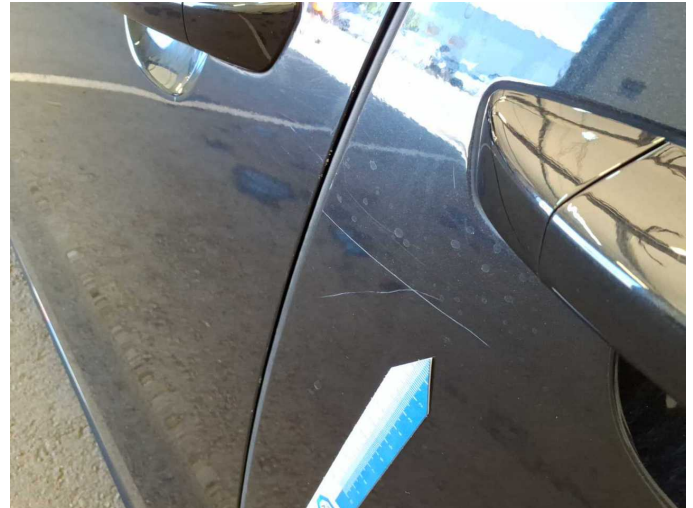
Damage 6: Door - rear left side: Door - Scratch(es) - Paint

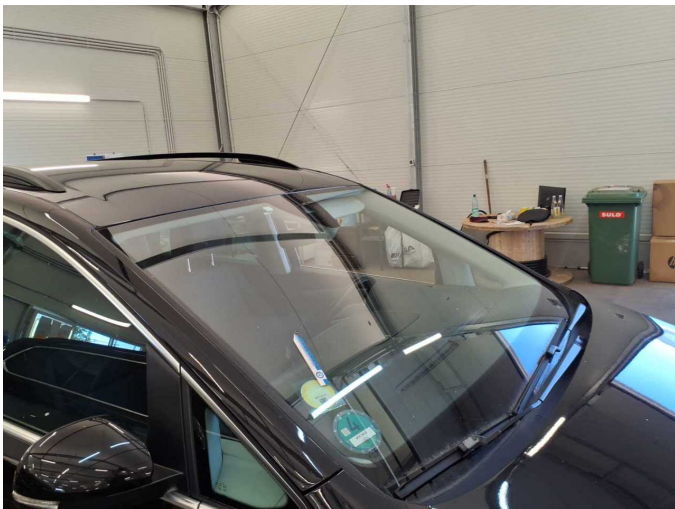
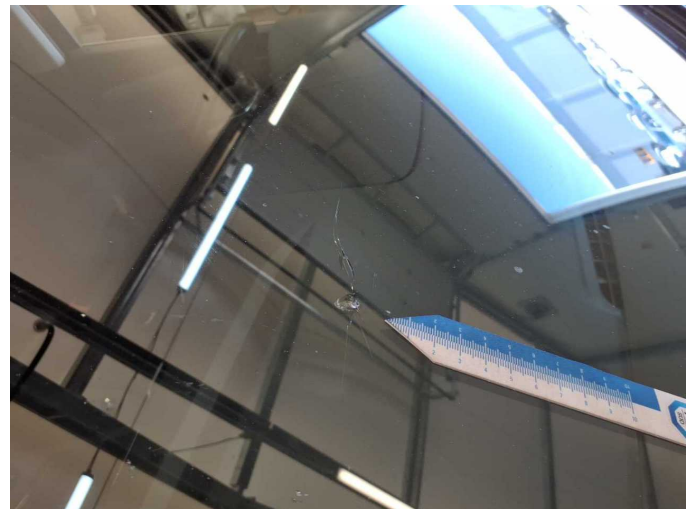
Damage 7: Vehicle glazing: Windscreen (Mit Rissbildung) - Stone chips - Replace

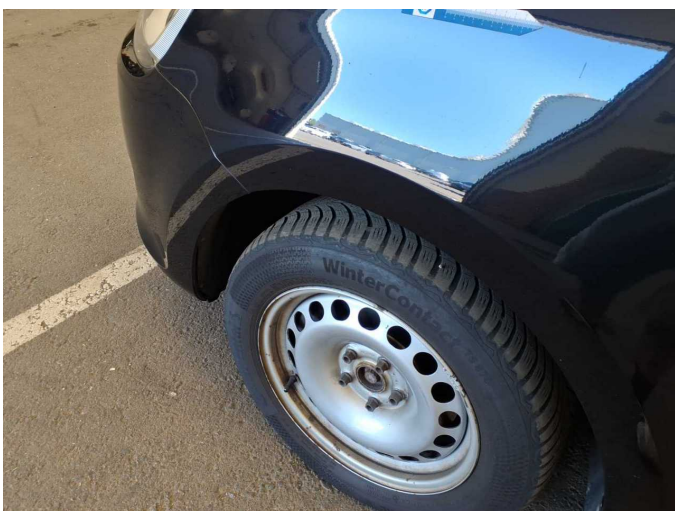
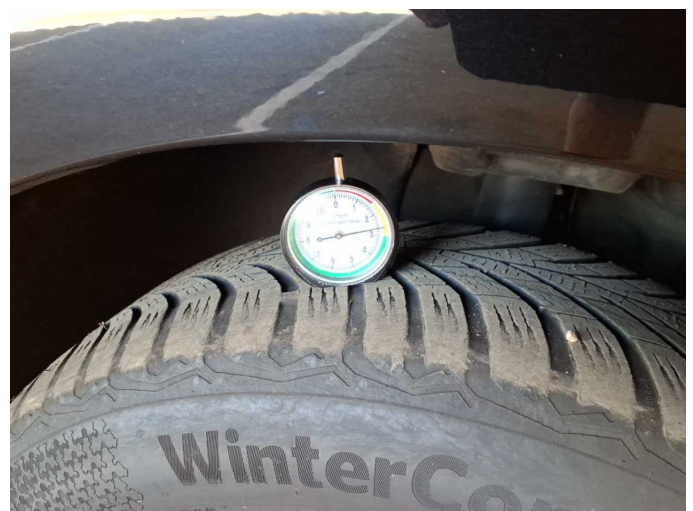
Wear and tear 3: Wheel / tyres: Tyre - front left side (Nicht Bestandteil der Ausstattung) - Does not meet the leasing specifications - No deduction

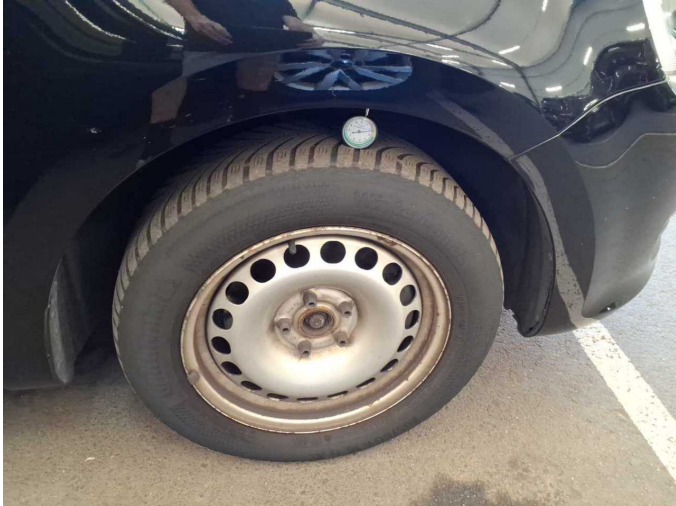
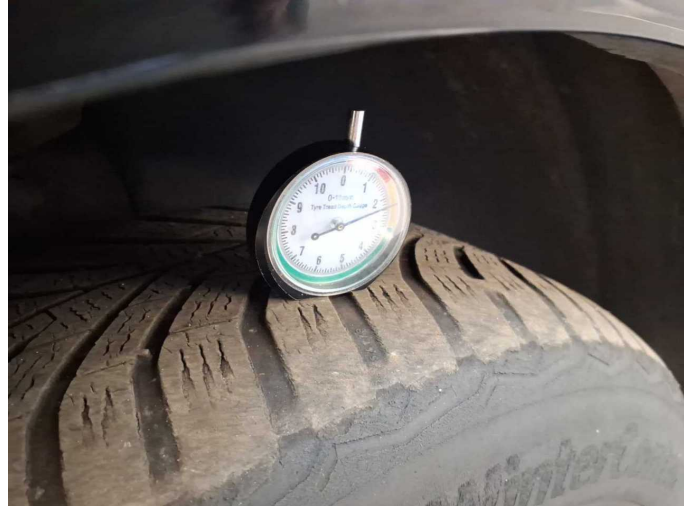
Wear and tear 4: Wheel / tyres: Tyre - front right side (Nicht Bestandteil der Ausstattung) - Does not meet the leasing specifications - No deduction

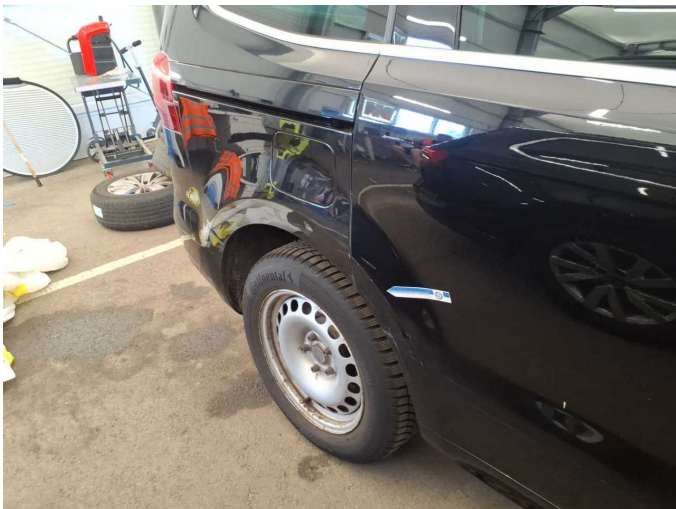
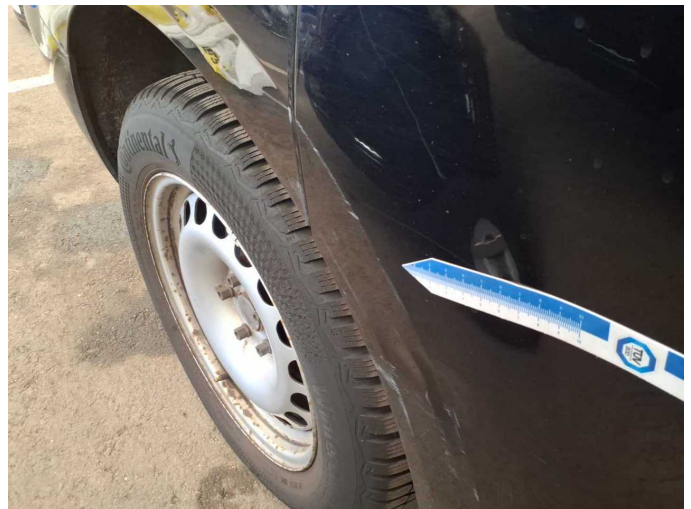
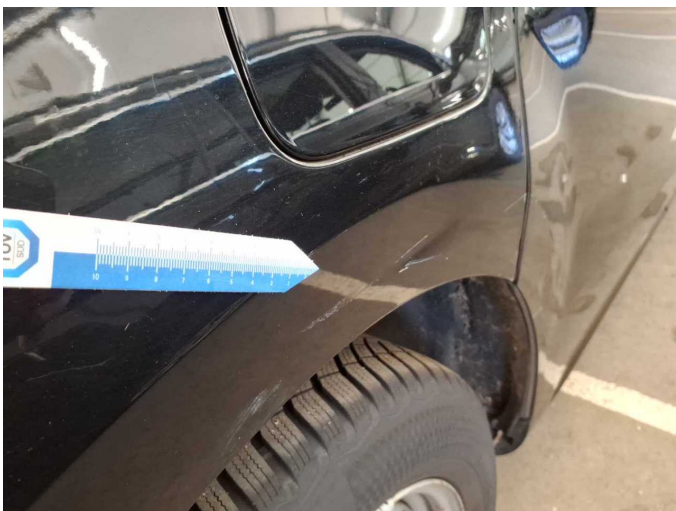
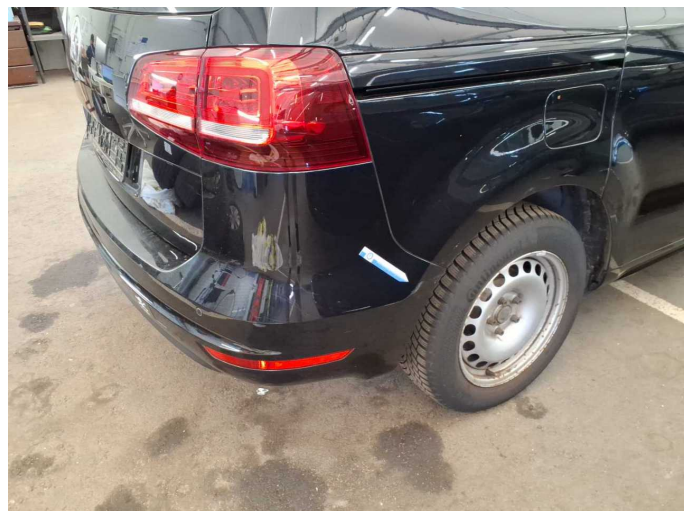
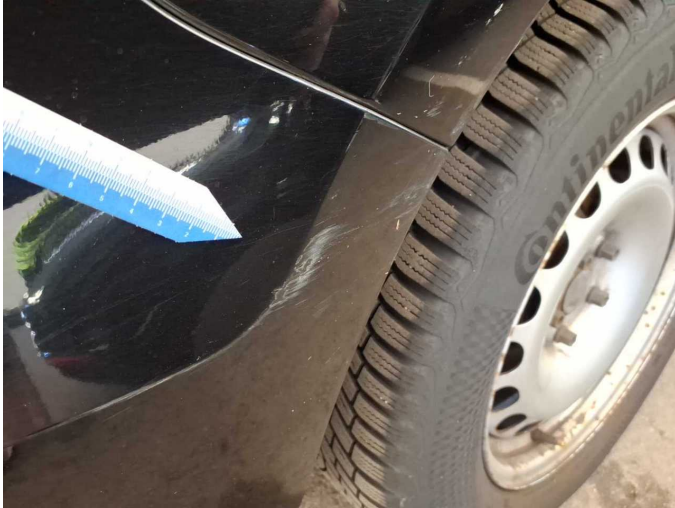
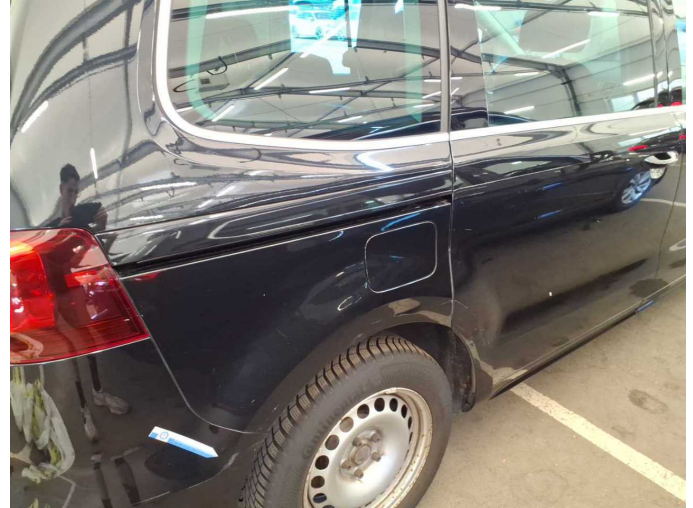
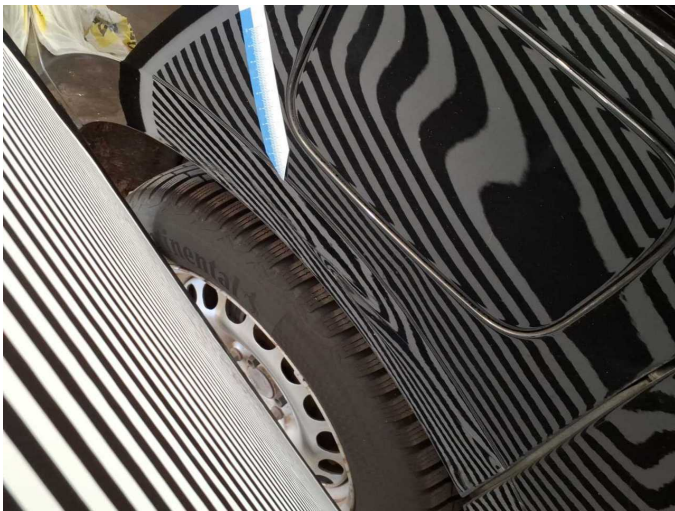
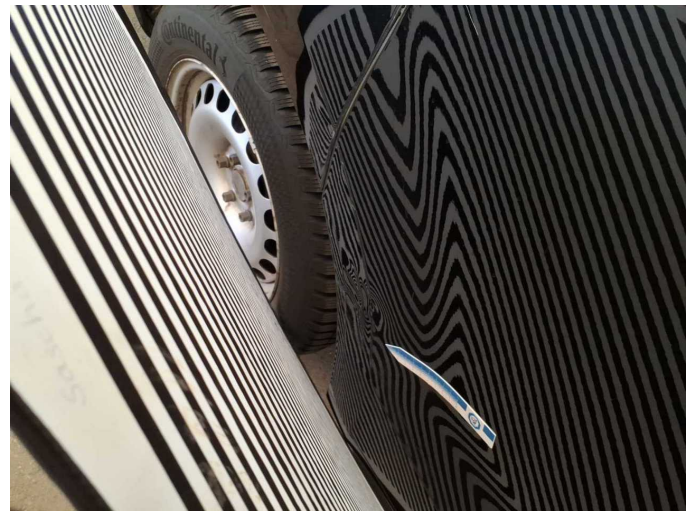
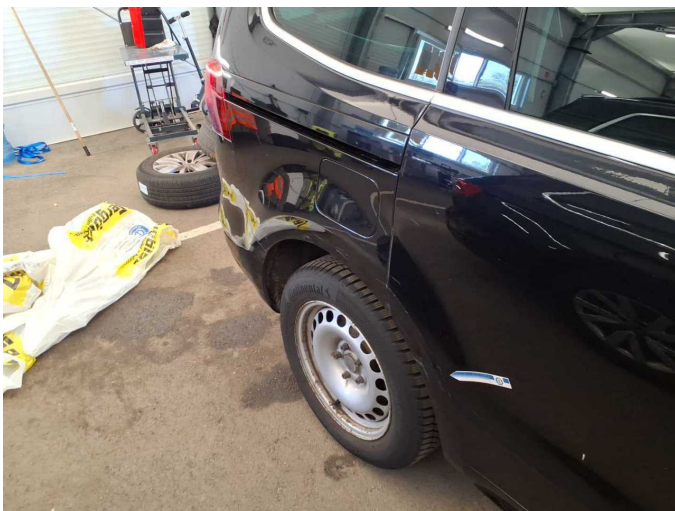
No.	Previous damage	Extent of damage (Net)
1	Front, Underbody, Provided by user / customer, from 21 Jul 2023	1.773,75 €
2	Rear, Side right, Provided by user / customer, from 7 May 2021	6.102,13 €

No.	Accident
1	Rear, Side right

Accident 1: Rear, Side right

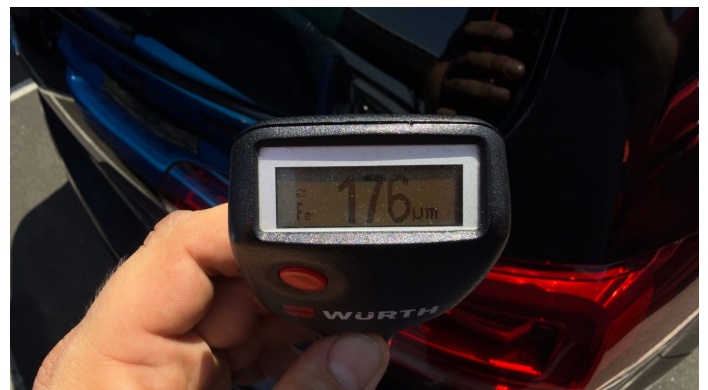
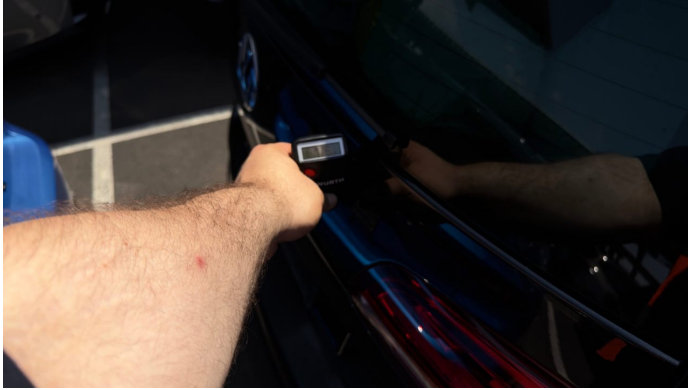
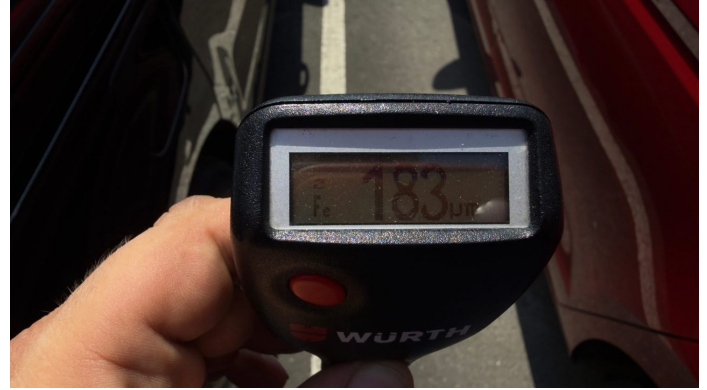
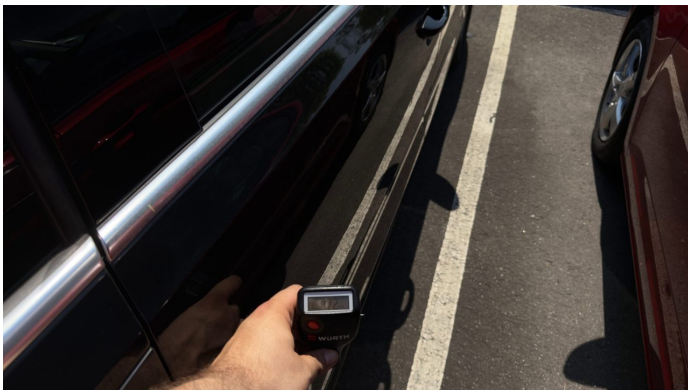
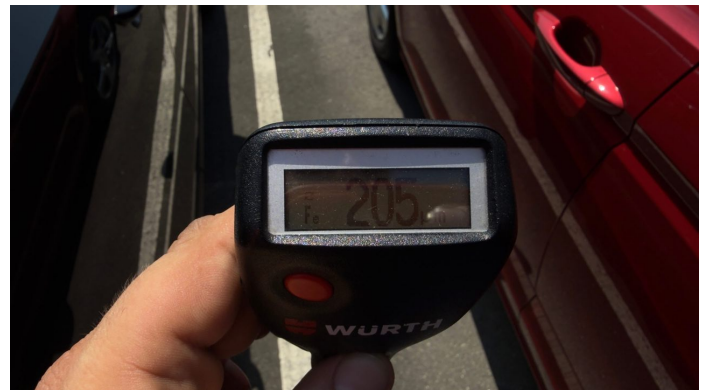
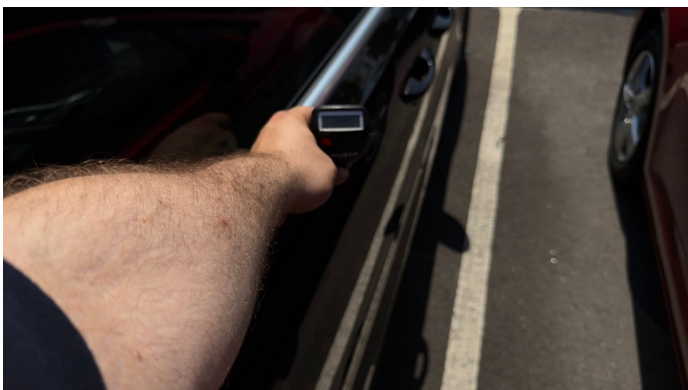
No.	Repainting
1	Boot lid / rear door, Side panel - rear right side, Door - rear right side, Professionally carried out, Invoice of repair done Non-existent

Boot lid / rear door	176 µm	Side panel - rear right side	183 µm
Door - rear right side	205 µm

Repainting 1: Boot lid / rear door, Side panel - rear right side, Door - rear right side
