Expertise

Protocol number: 46293316
Order No. / Reference: 26535424
Inspection date: 24 Jun 2026

Model: 208 BlueHDi 100 GT

VIN: VR3UBYHTKP5146838

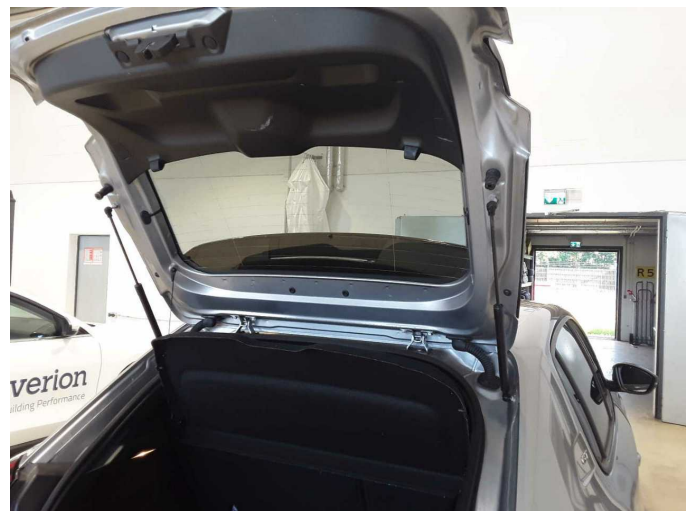
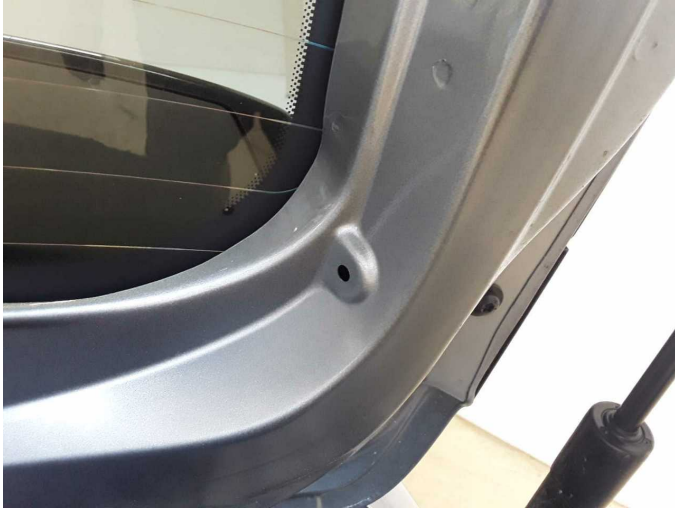
Damage 2: Trim / covers: Boot lid - interior trim (Aufhänger fehlt) - Differs from the original configuration - Replace

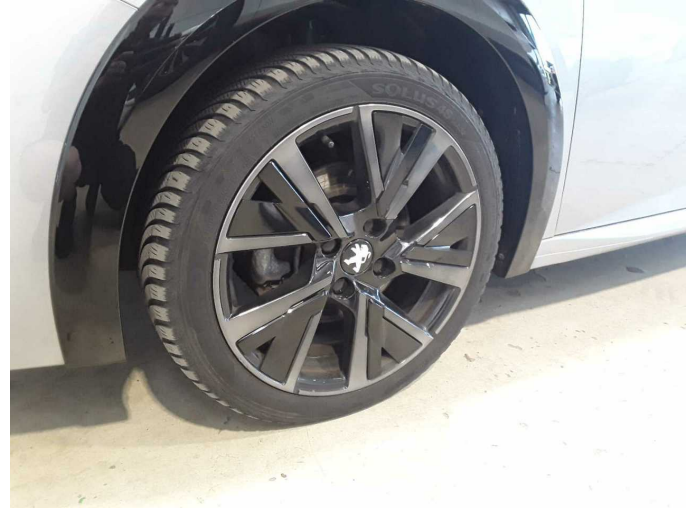
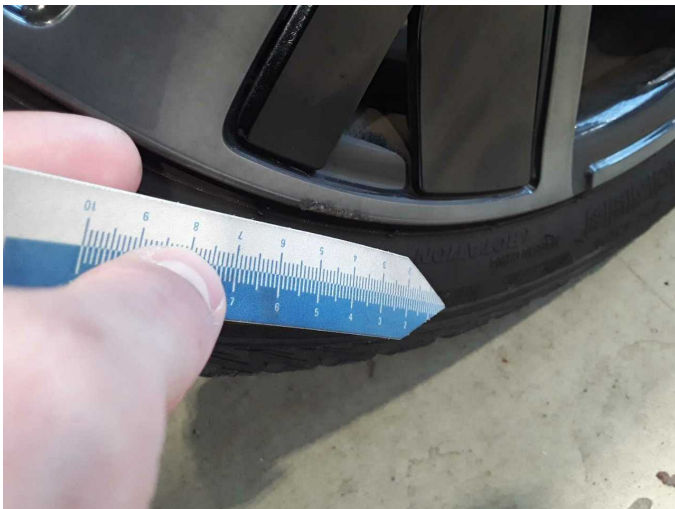
Damage 3: Wheel / tyres: Alloy rim - front left side - Scratch(es) - Loss in value

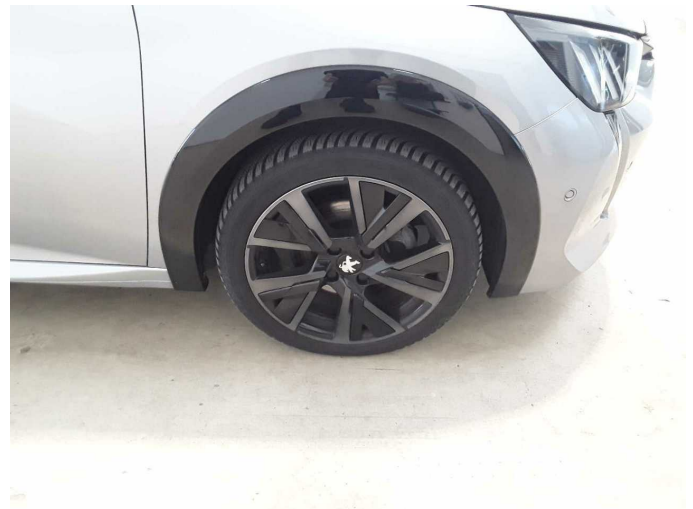
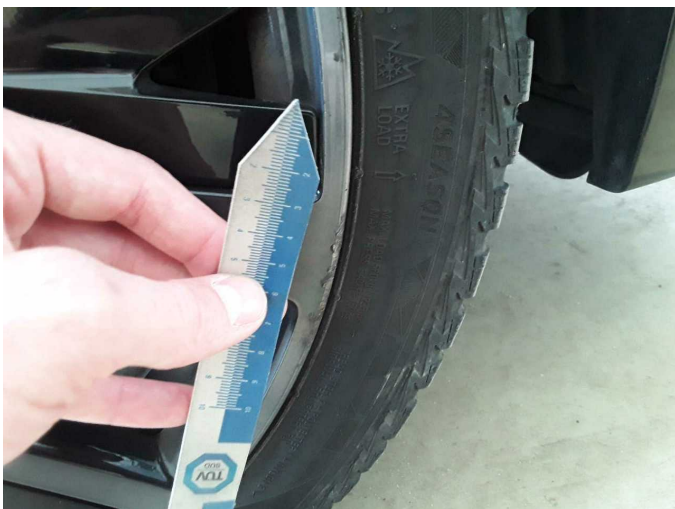
Damage 4: Wheel / tyres: Alloy rim - front right side - Scratch(es) - Loss in value

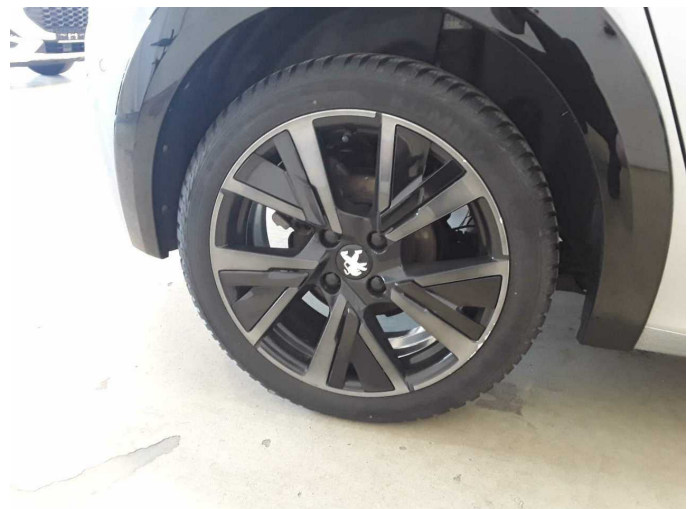
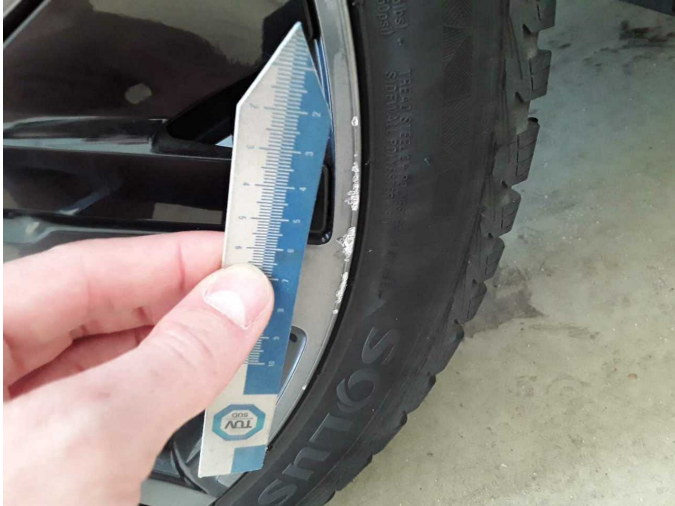
Damage 5: Wheel / tyres: Alloy rim - rear right side - Scratch(es) - Replace

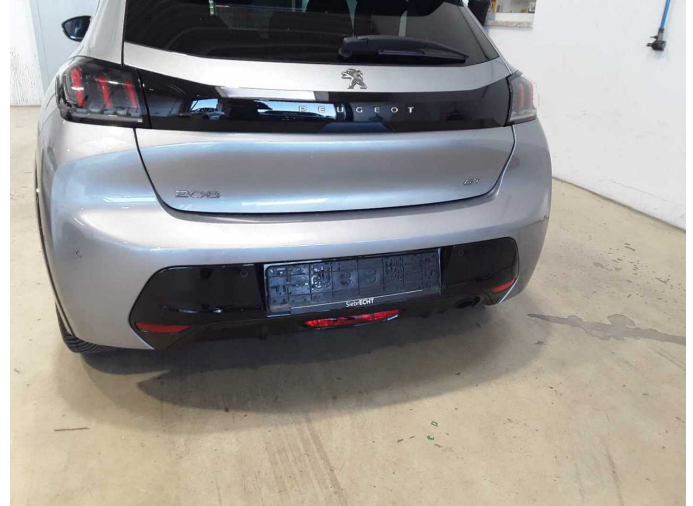
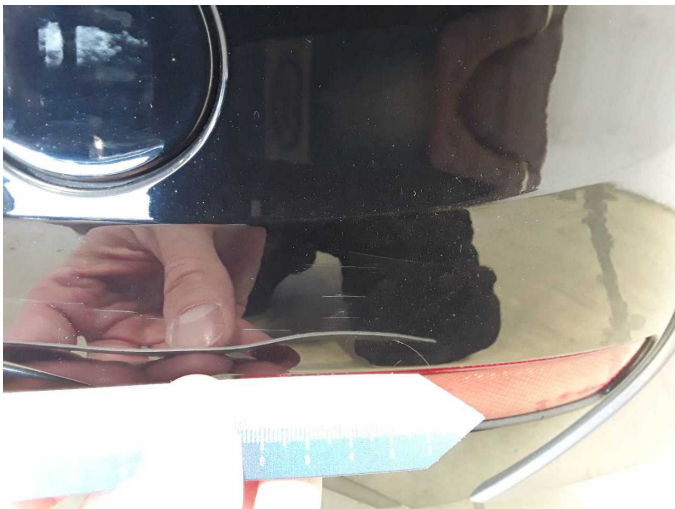
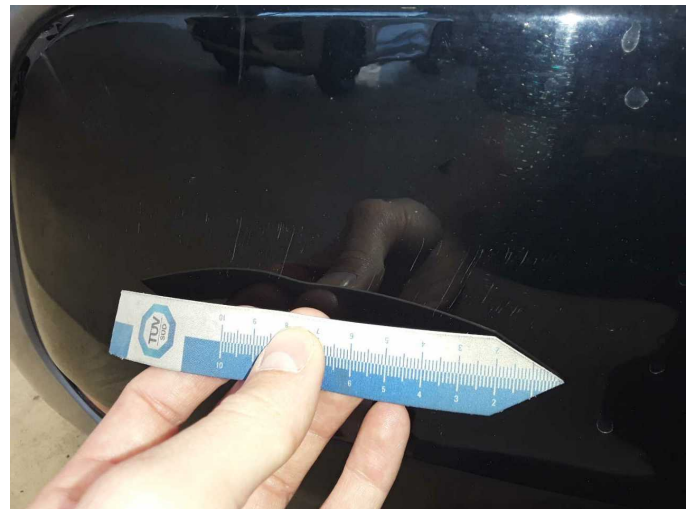
Damage 6: Rear bumper: Spoiler - Scratch(es) - Paint

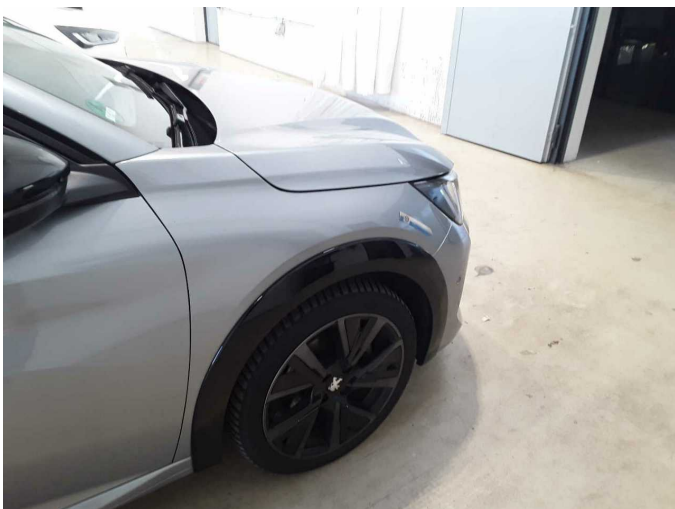
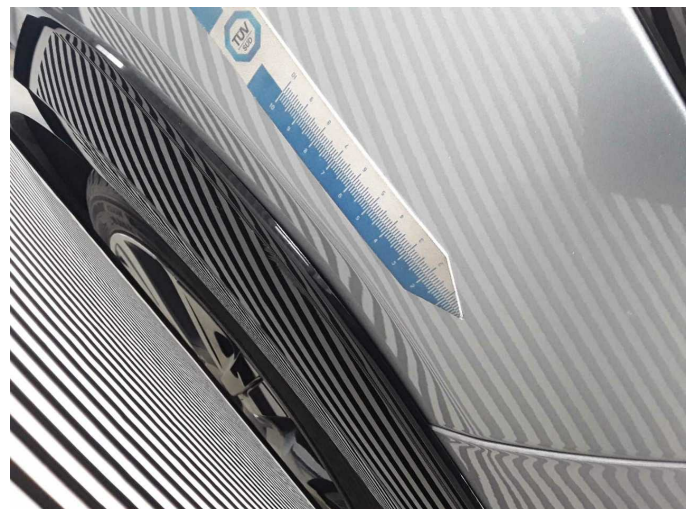
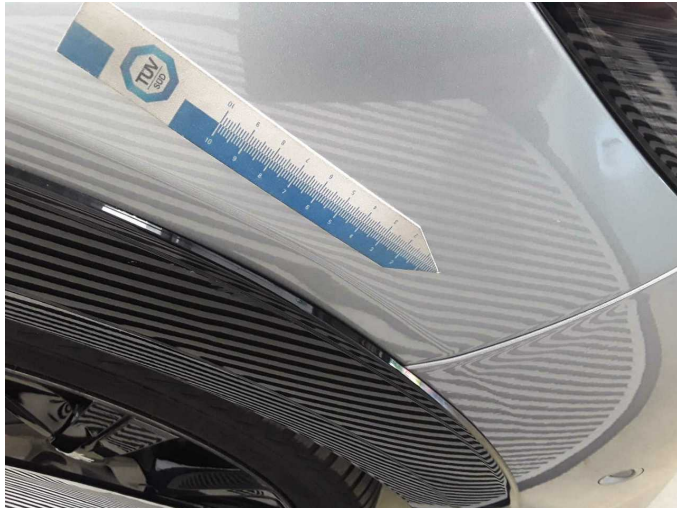
Damage 7: Mudguard - right side: Mudguard - right side - Deformed - Paint

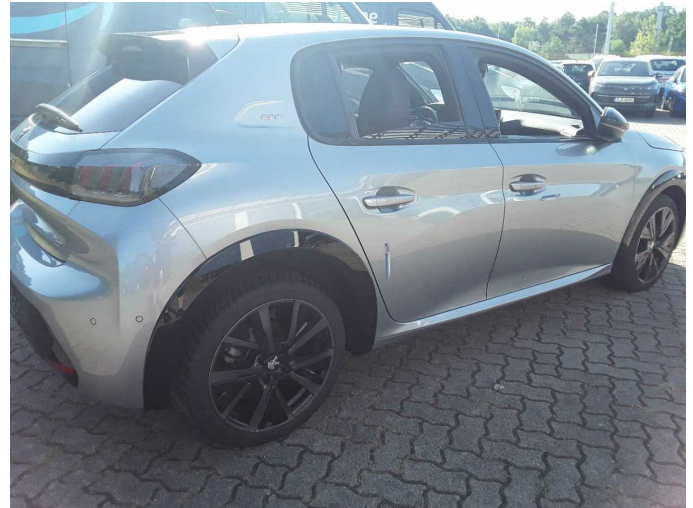
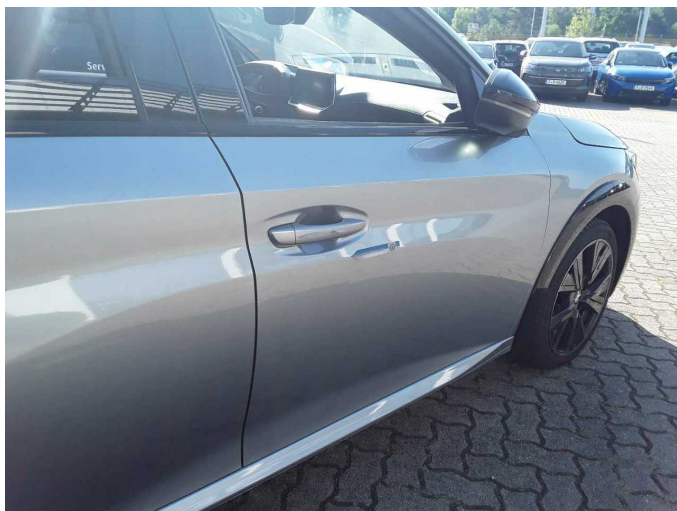
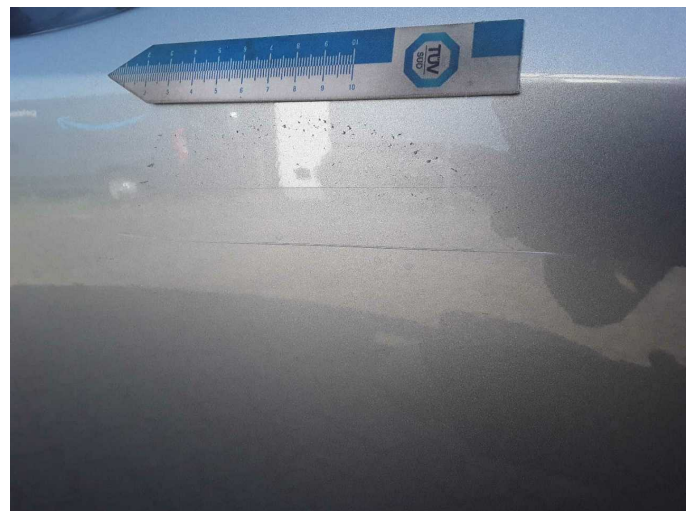
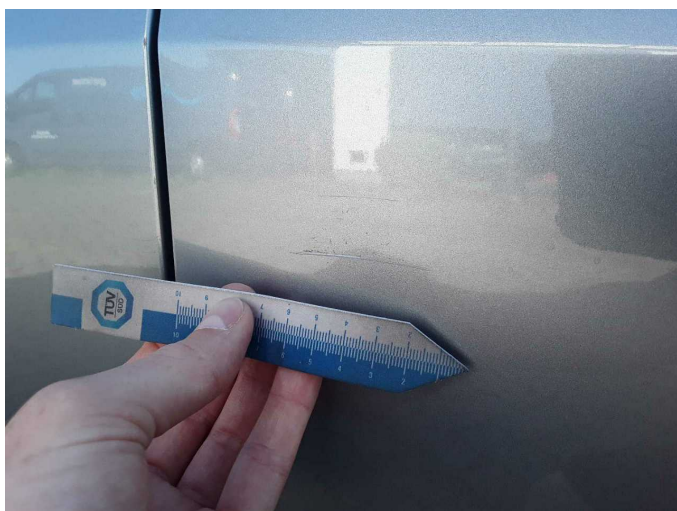
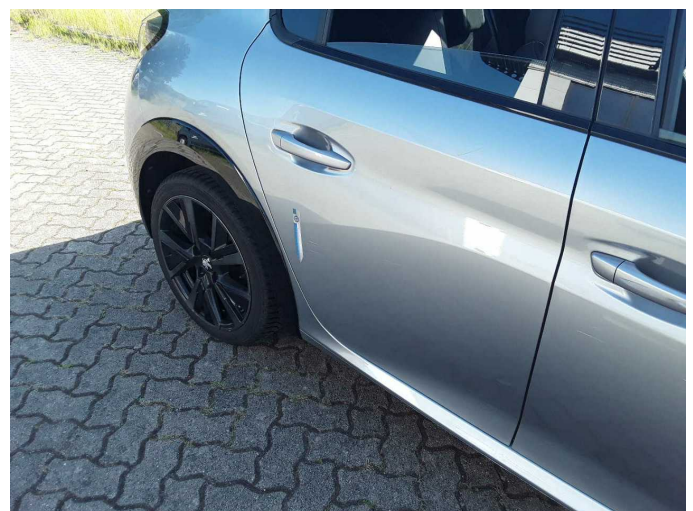
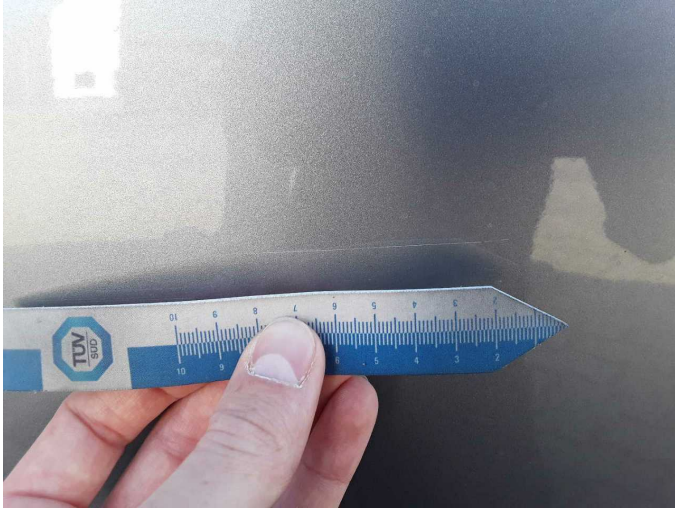
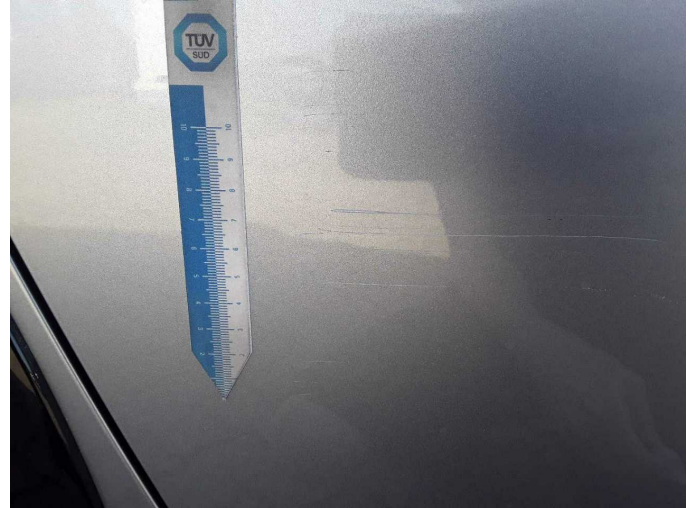
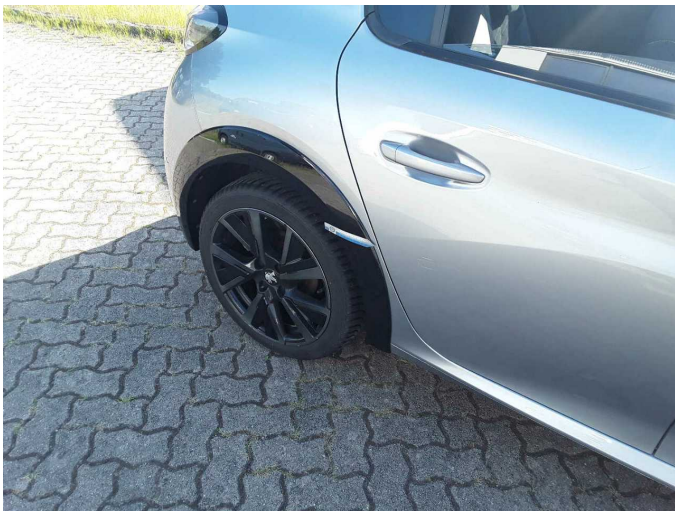
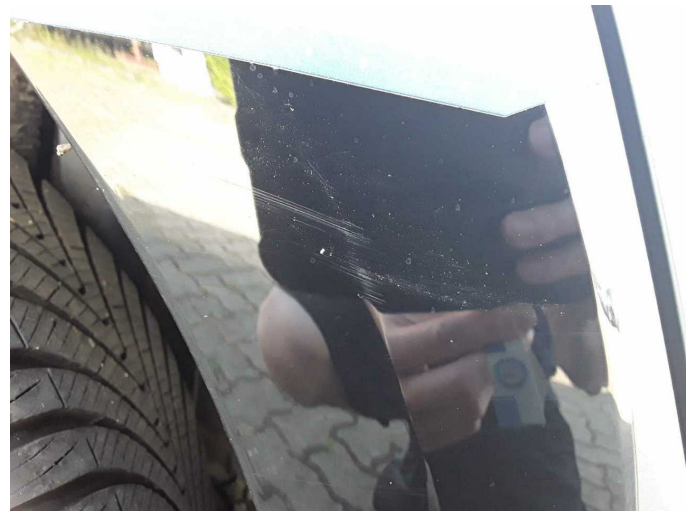
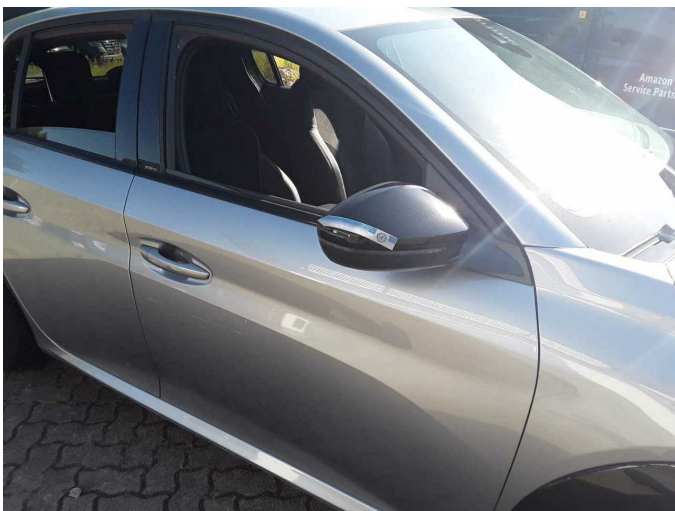
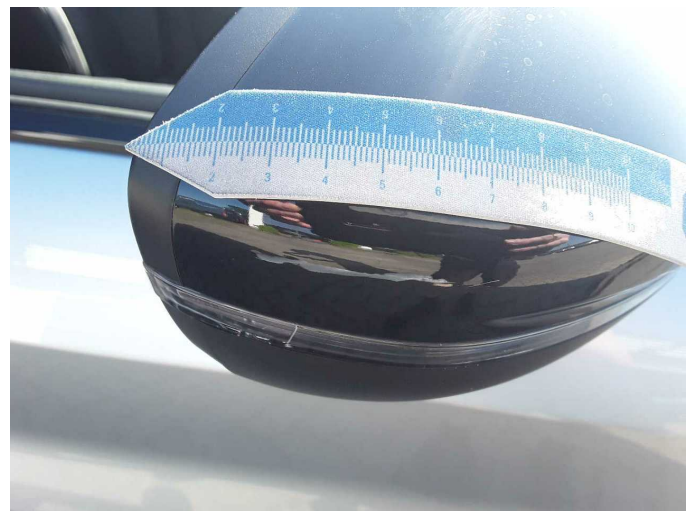
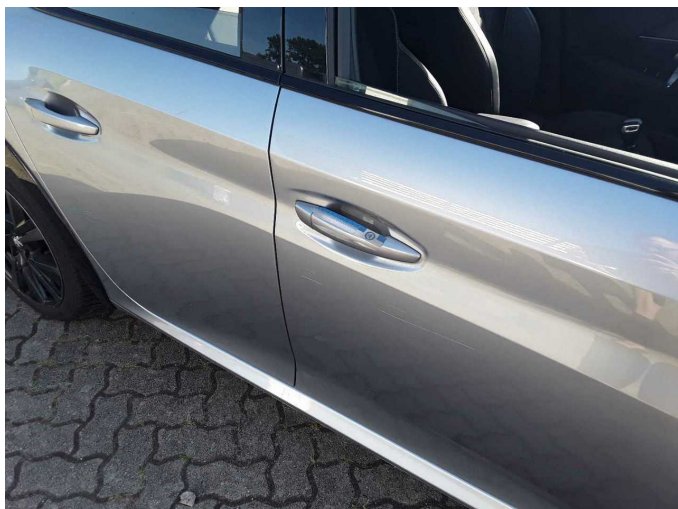
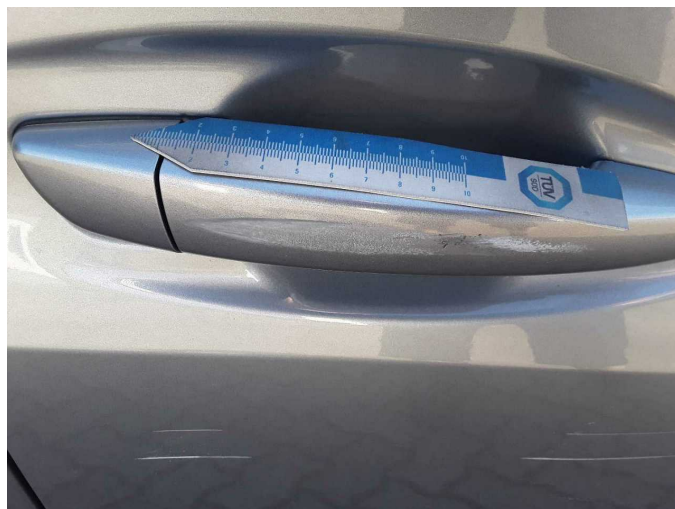
1 Side right

Accident 1: Side right
