## Expertise

Protocol number: 46072888  
Order No. / Reference: 26520980  
Inspection date: 18 Jun 2026

Manufacturer: Renault

Model: Trafic ENERGY dCi 120 L1H1 3.0t Komfort

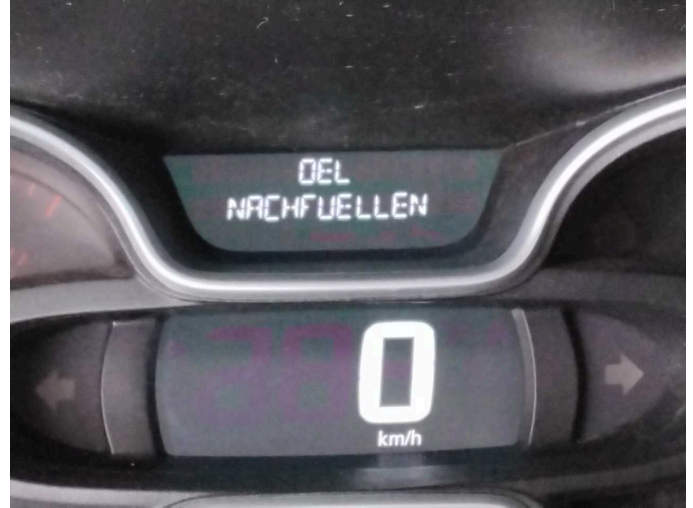
Damage 2: Instrument panel: Indicator light (Öl nachfüllen) - on - Perform diagnosis

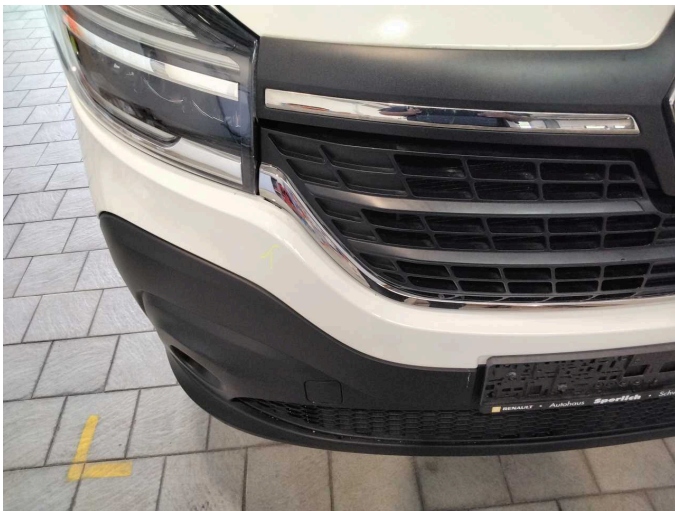
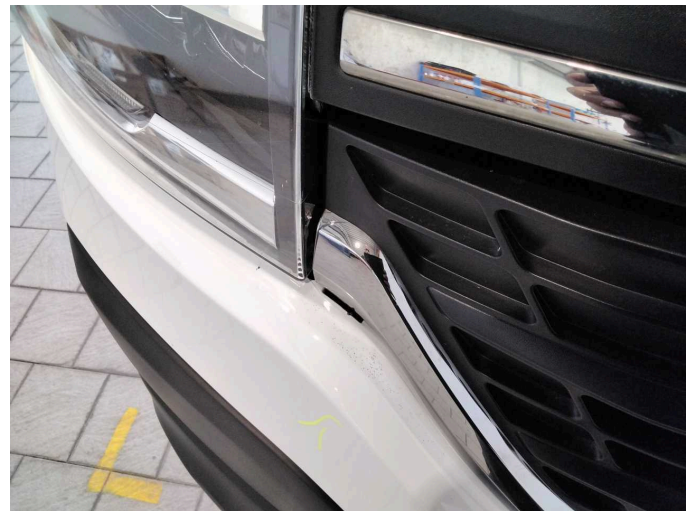
Damage 3: Front bumper: Grille - Malposition - Perform diagnosis

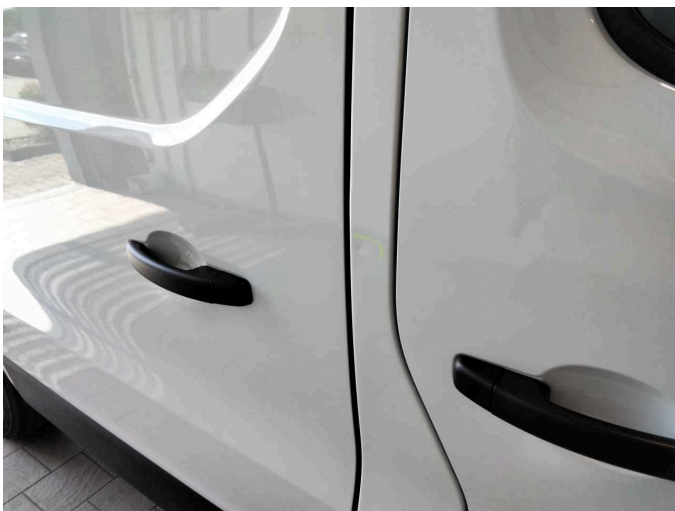
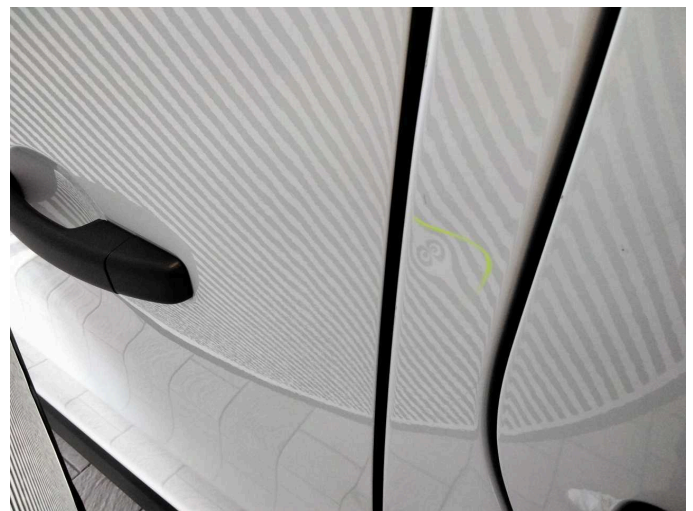
Damage 4: Body: B-pillar - right side - dent(s) - Smooth repair work

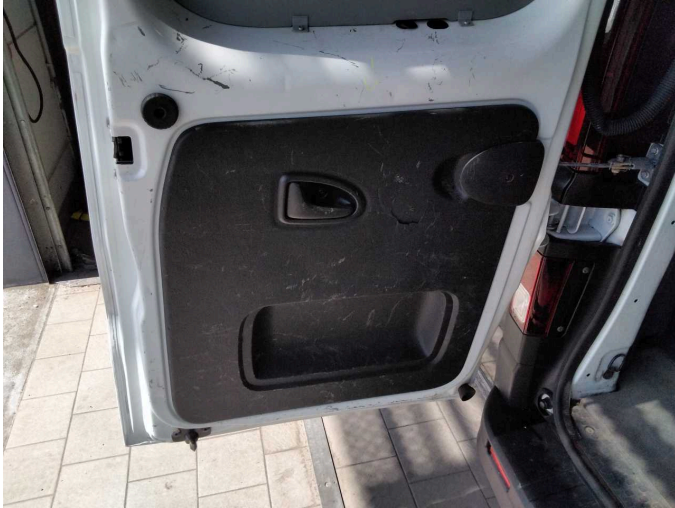
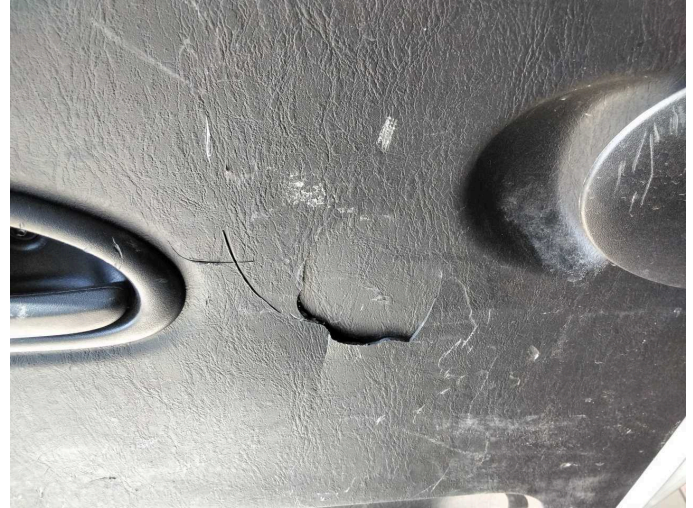
**Damage 5:** Trim / covers: Door trim - rear left side - Broken / torn - Replace

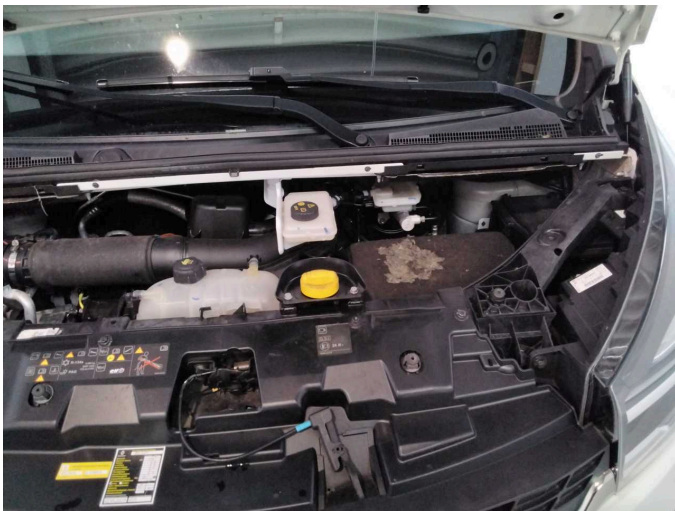
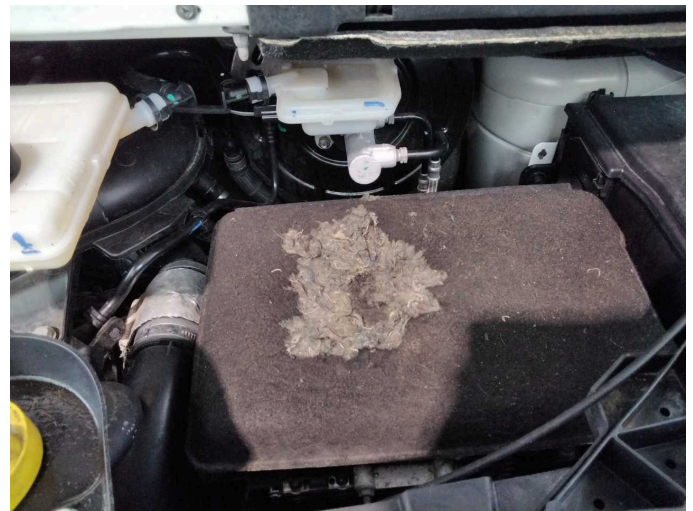
**Damage 6:** Bonnet: Insulation lining - Damage caused by marten / rodent - Replace

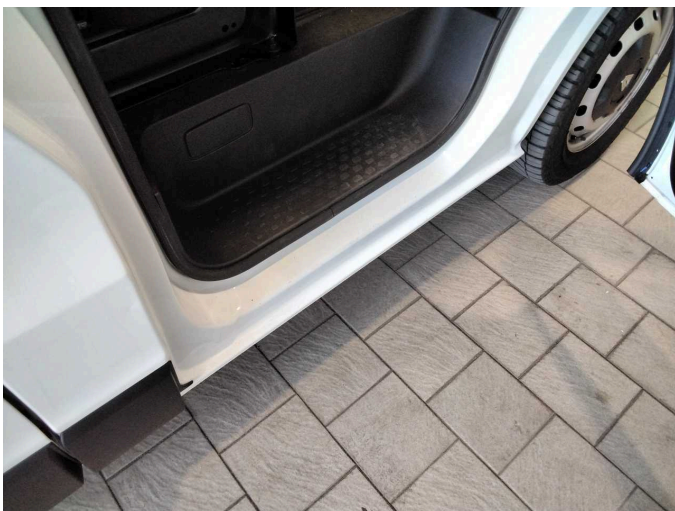
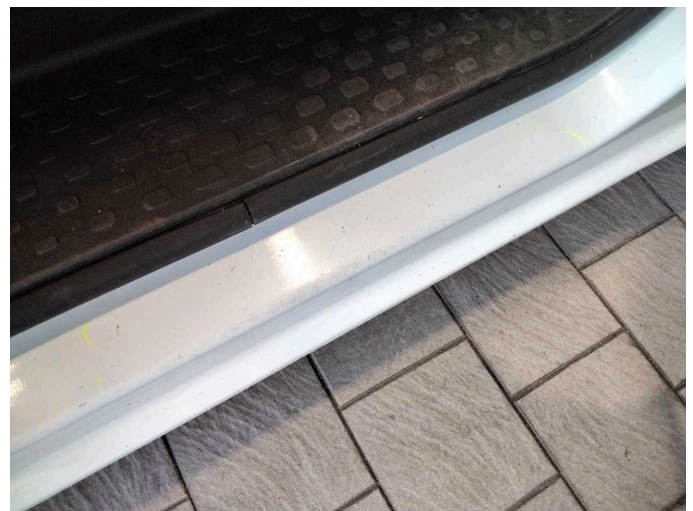
**Damage 7:** Sill - right side: Sill - Scratch(es) - Smart repair

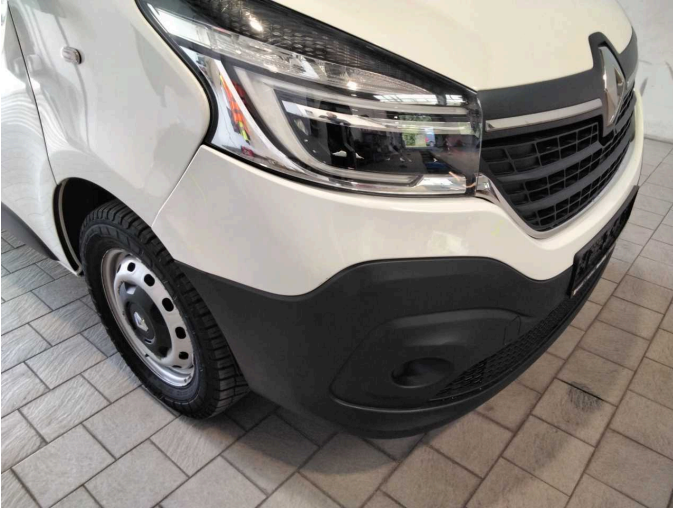
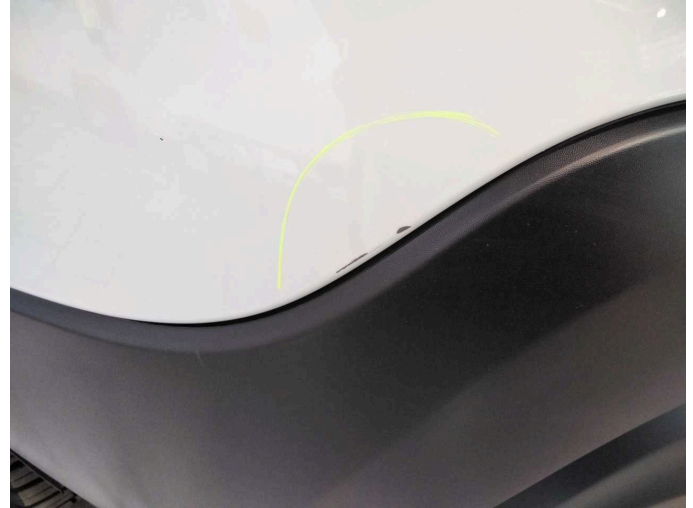
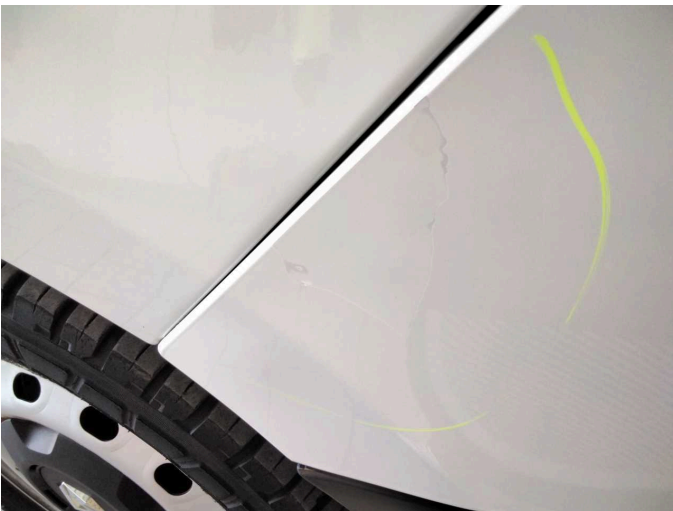
**Damage 8:** Front bumper: Front bumper (Rechte Seite) - Paint defect - Smart repair

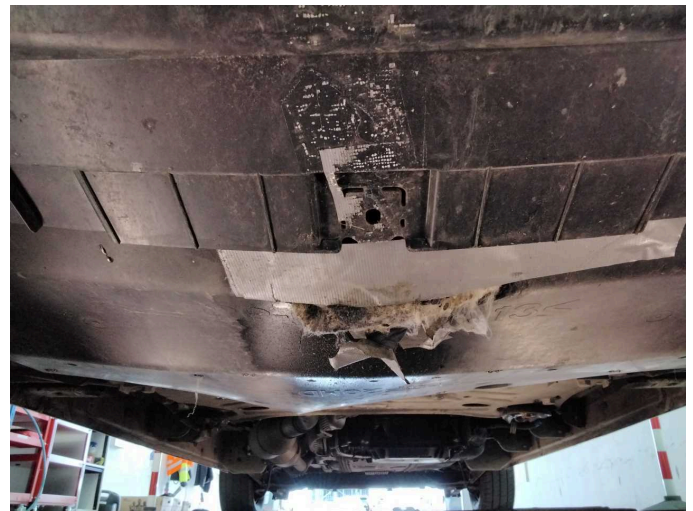
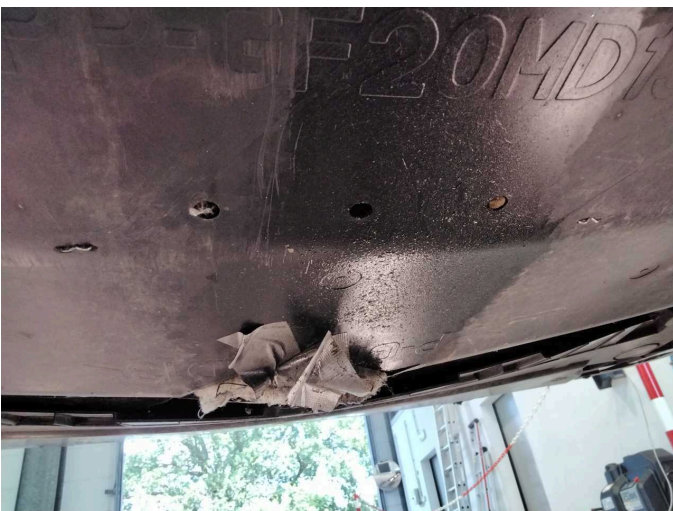
**Damage 9:** Body: Underbody paneling (Ölfeucht) - Perform diagnosis

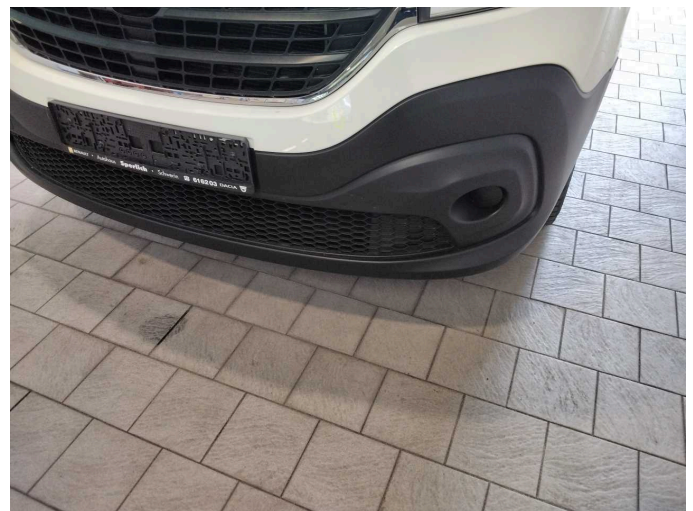
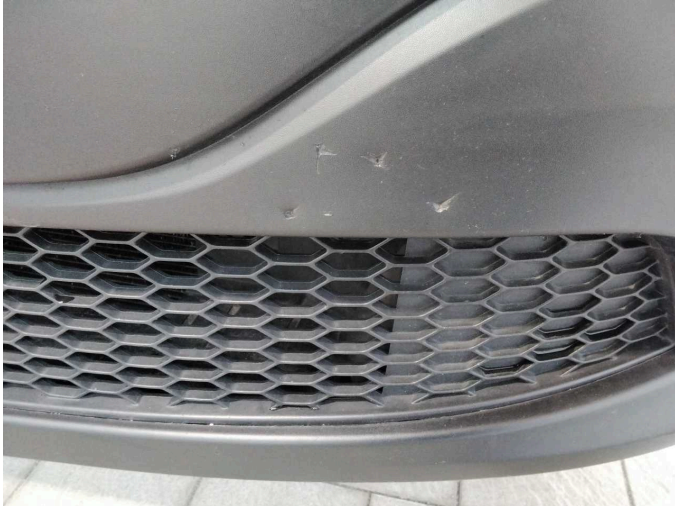
**Damage 10:** Front bumper: Front bumper - Damaged - Loss in value

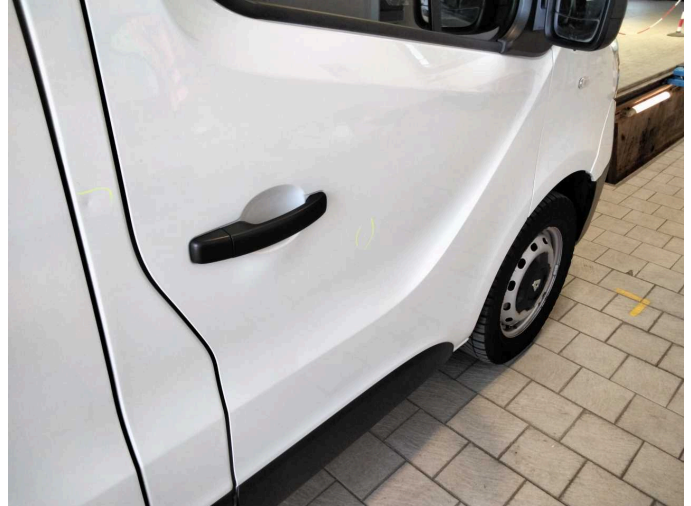
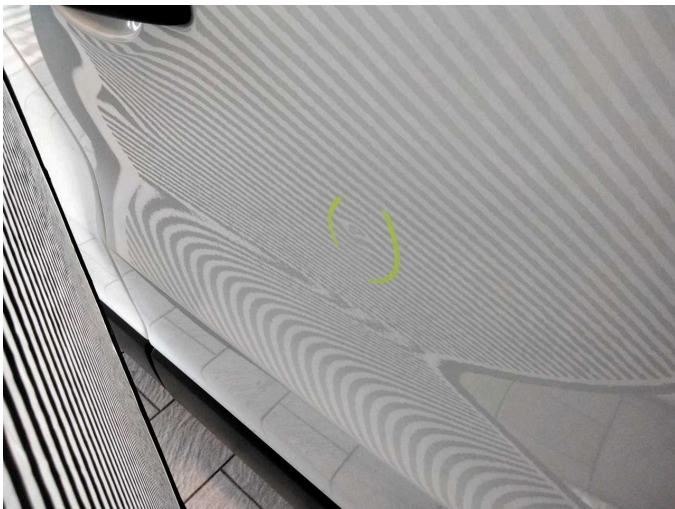
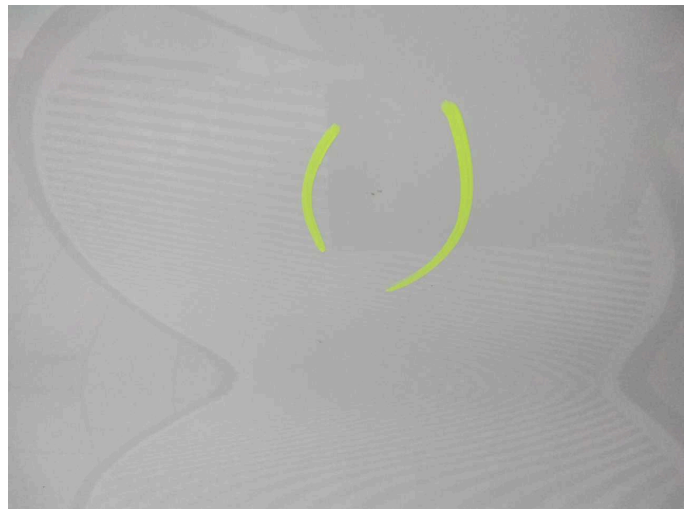
**Damage 11:** Door - front right side: Door - Dent / paintcoat damage - Smart repair

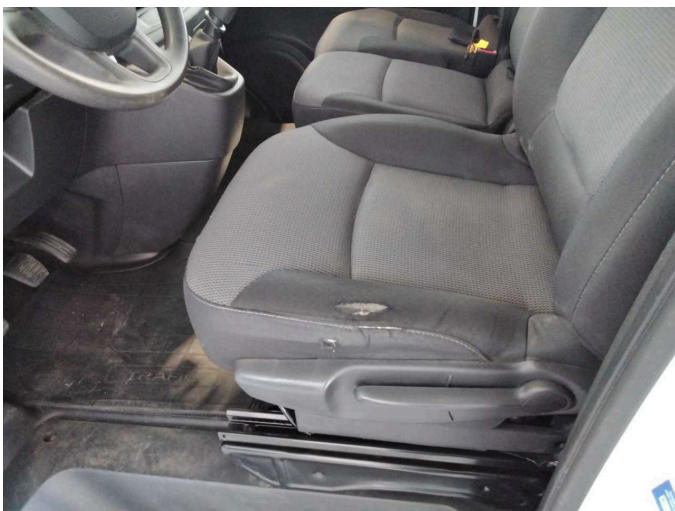
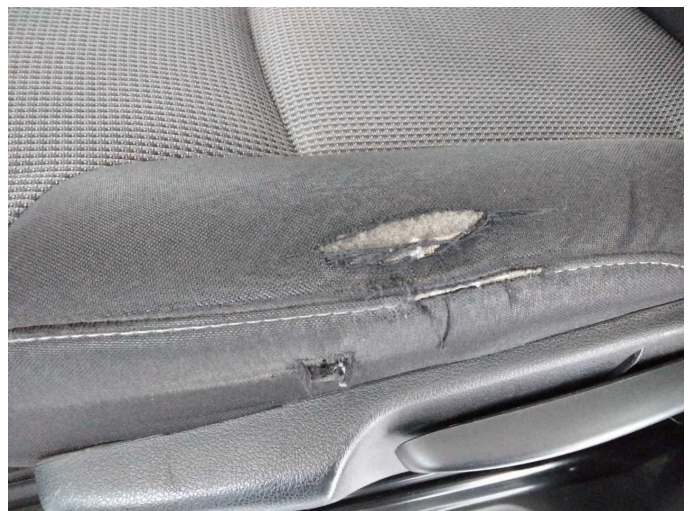
**Damage 12:** Seat - front: Seat cover - left side - Broken / torn - Replace

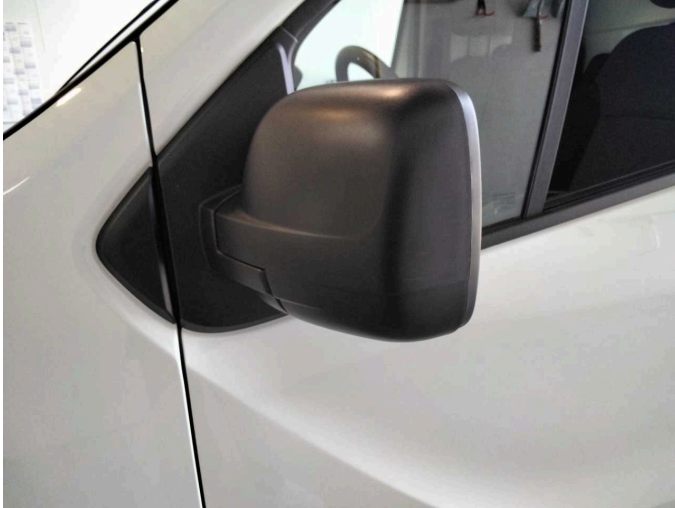
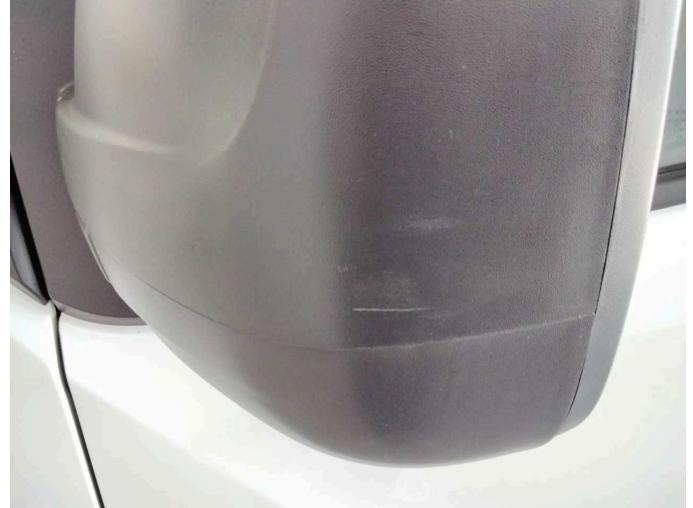
**Wear and tear 1:** Wing mirror - left side: Cap - Scratch(es) - No deduction

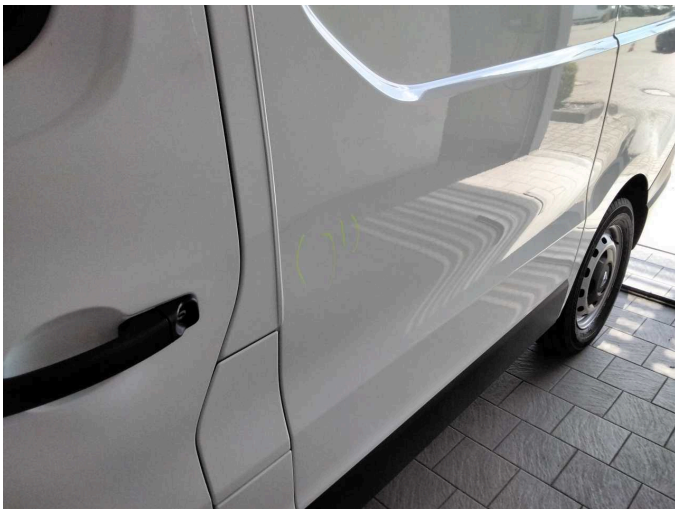
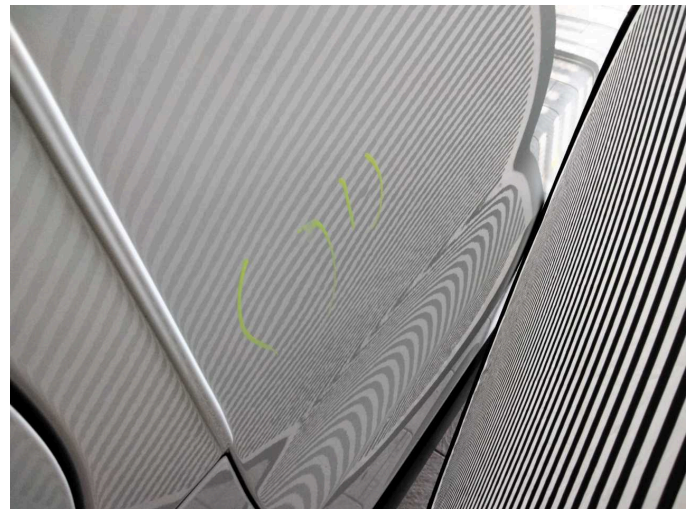
**Wear and tear 2:** Side panel - rear left side: Side panel - dent(s) - No deduction

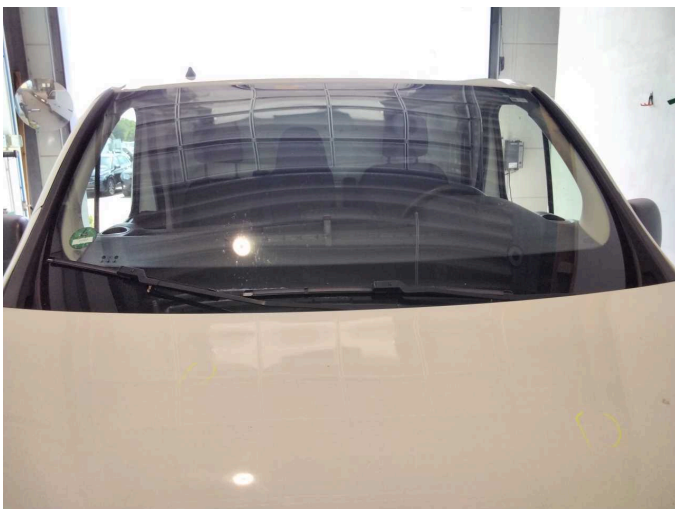
**Wear and tear 3:** Vehicle glazing: Windscreen - Stone chips - No deduction

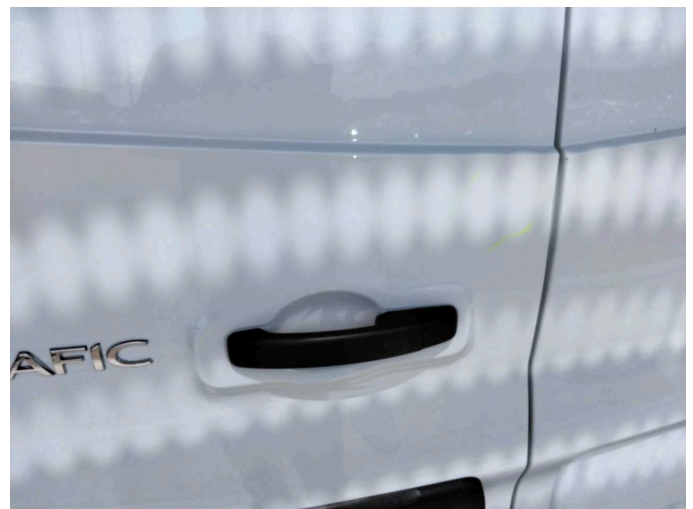
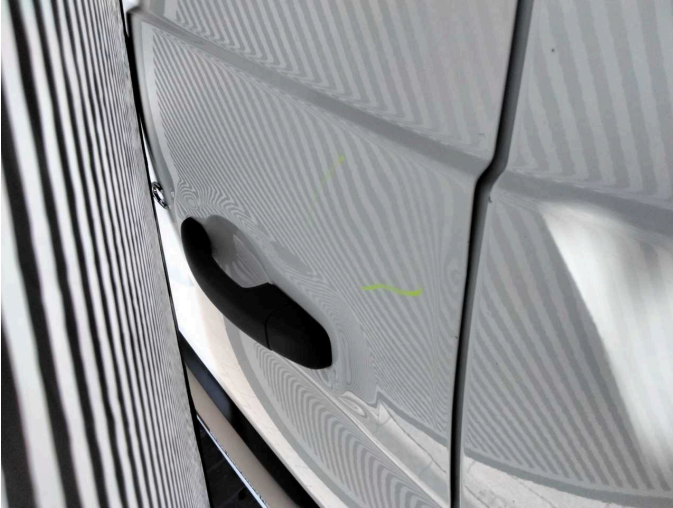
**Wear and tear 4:** Boot lid / rear door: Rear door - left side - dent(s) - No deduction

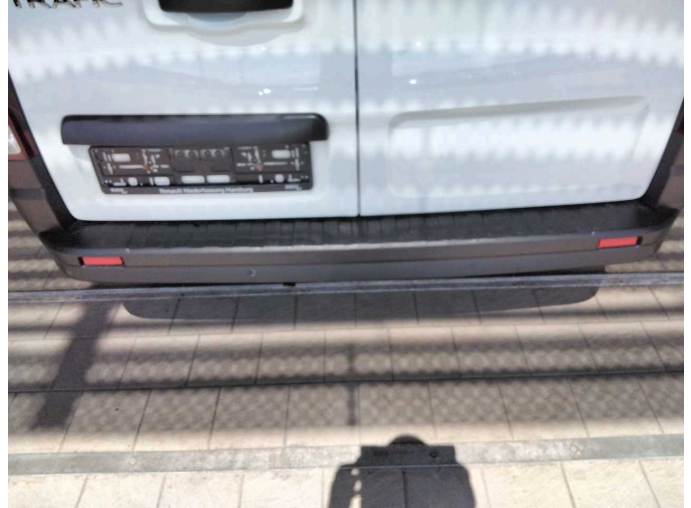
**Wear and tear 5:** Rear bumper: Rear bumper - Scratch(es) - No deduction

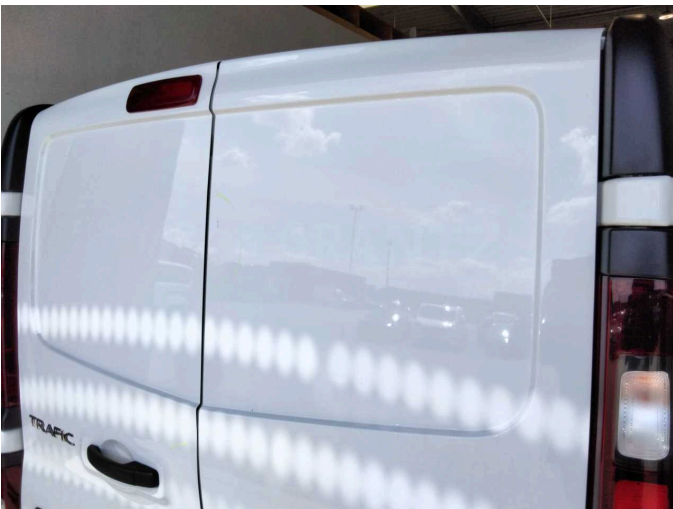
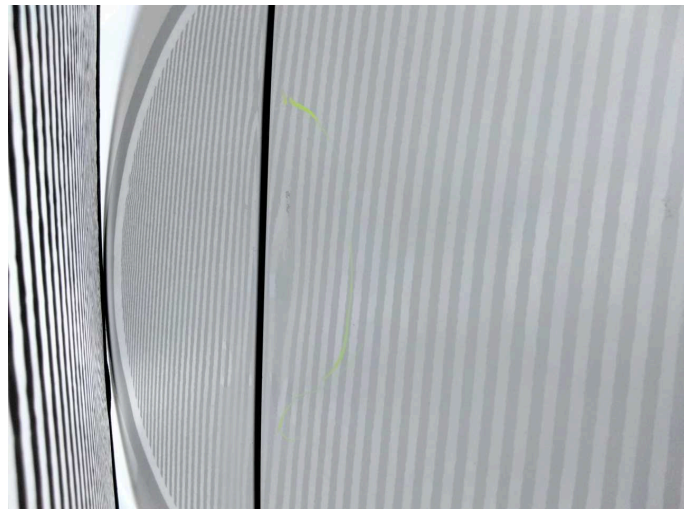
**Wear and tear 6:** Boot lid / rear door: Rear door - right side - dent(s) - Smooth repair work

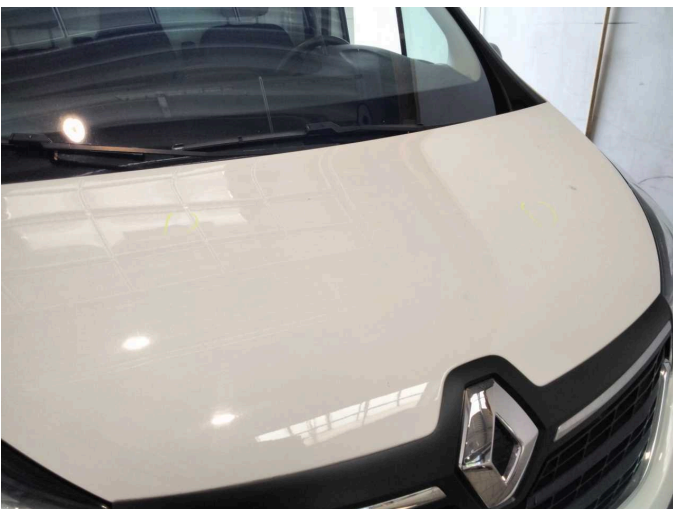
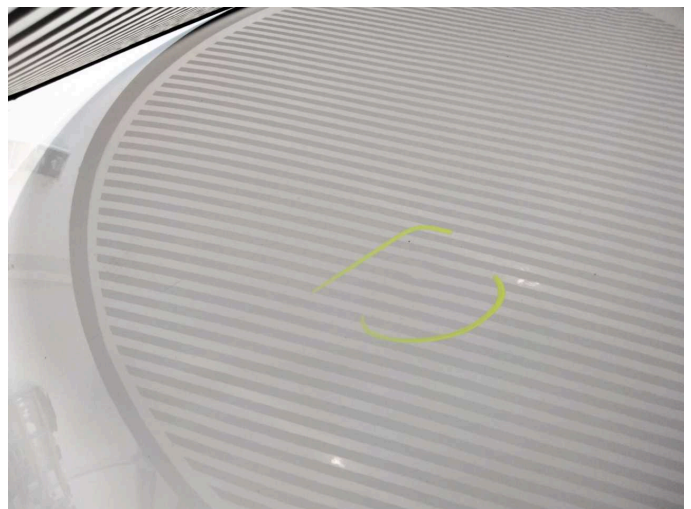
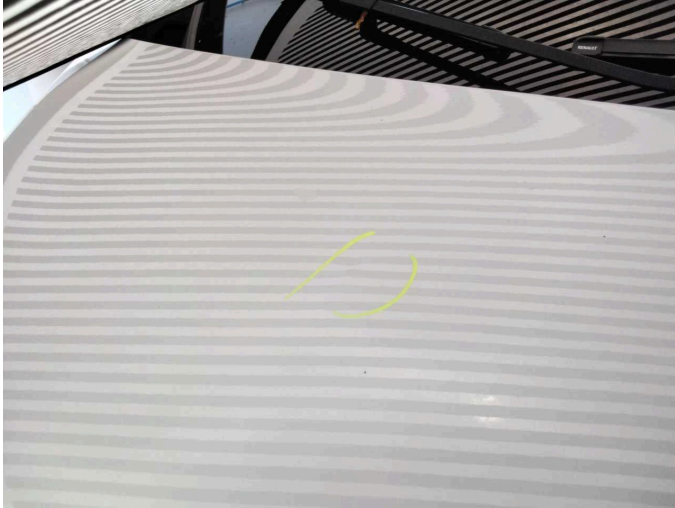
**Wear and tear 7:** Bonnet: Bonnet - dent(s) - Smooth repair work
