Expertise

Protocol number: 46193298
Order No. / Reference: 26519093
Inspection date: 19 Jun 2026

Manufacturer: Citroën

Model: e-C4 136 FEEL PACK

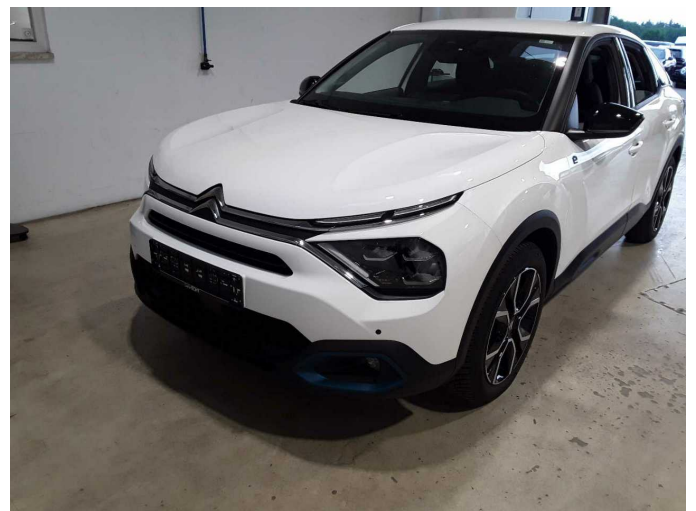
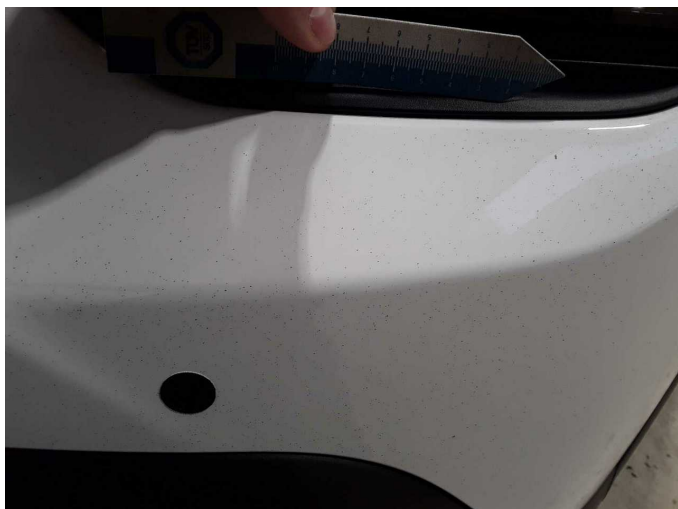
No.	Component group	Description
1	Front bumper	Front bumper - Soiled - Conditioning
2	Misc.	Main inspection - No evidence - Perform
3	Rear bumper	Rear bumper - Scratch(es) - Smart repair

Damage 1: Front bumper: Front bumper - Soiled - Conditioning

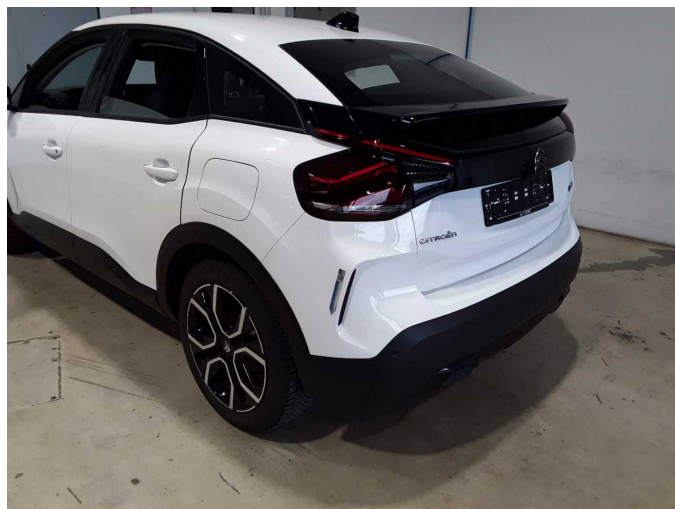
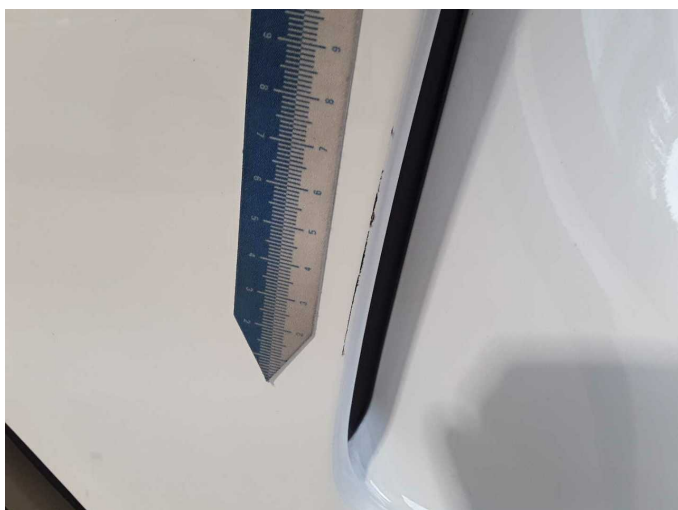
Damage 3: Rear bumper: Rear bumper - Scratch(es) - Smart repair
