Expertise

Protocol number: 45646649
Order No. / Reference: 26152846
Inspection date: 27 May 2026

Model: Vito 116 CDI Lang HA PRO

VIN: W1VVLBEZ0T4564978

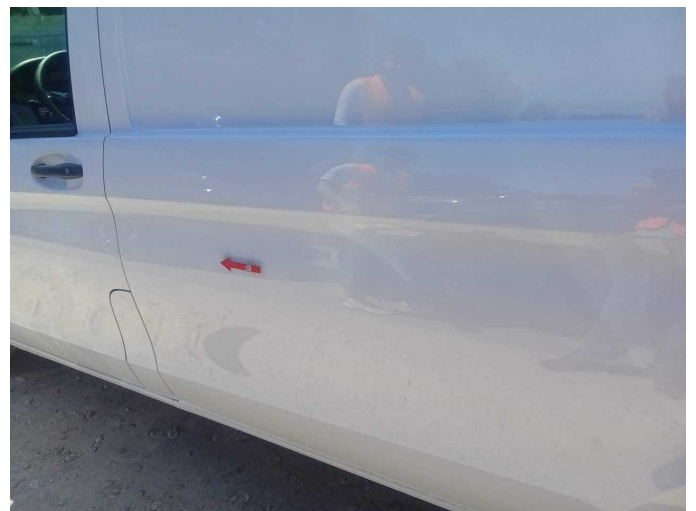
Damage 1: Side panel - rear left side: Side panel - dent(s) - Smooth repair work

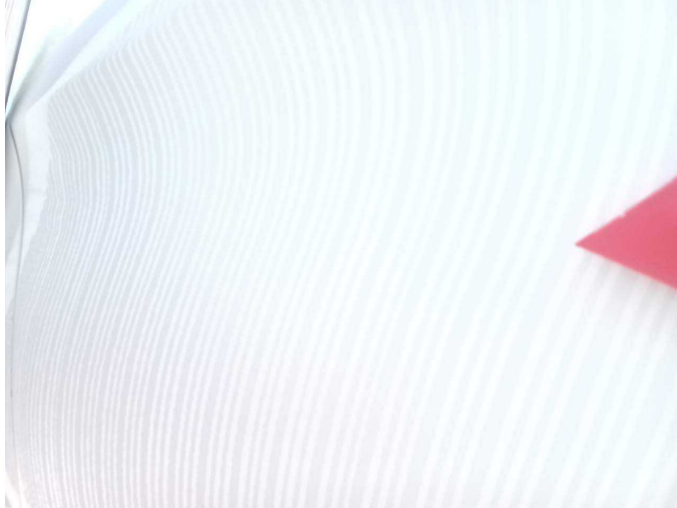
Damage 1: Side panel - rear left side: Side panel - dent(s) - Smooth repair work

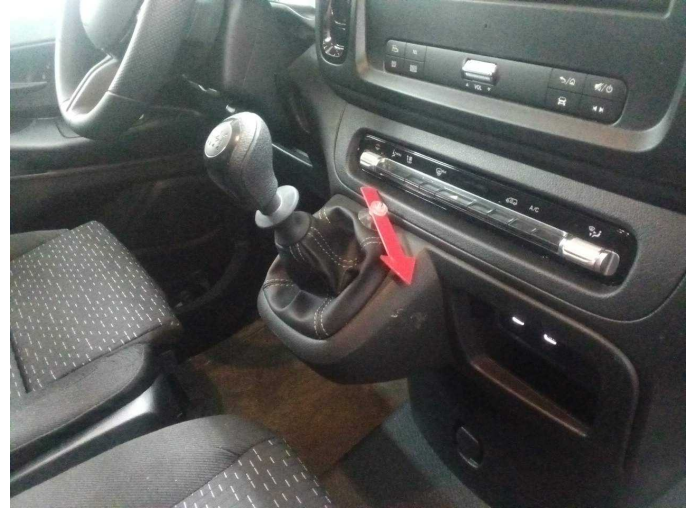
Damage 2: Interior: Interior (Mittelkonsole) - Scratch(es) - Replace

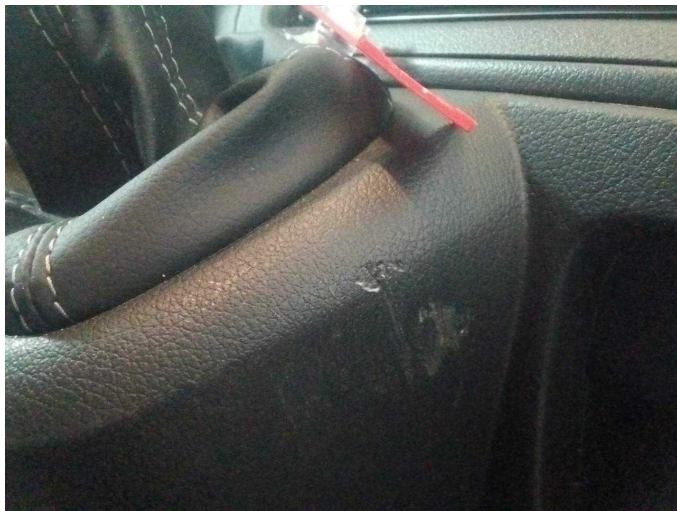
Damage 2: Interior: Interior (Mittelkonsole) - Scratch(es) - Replace

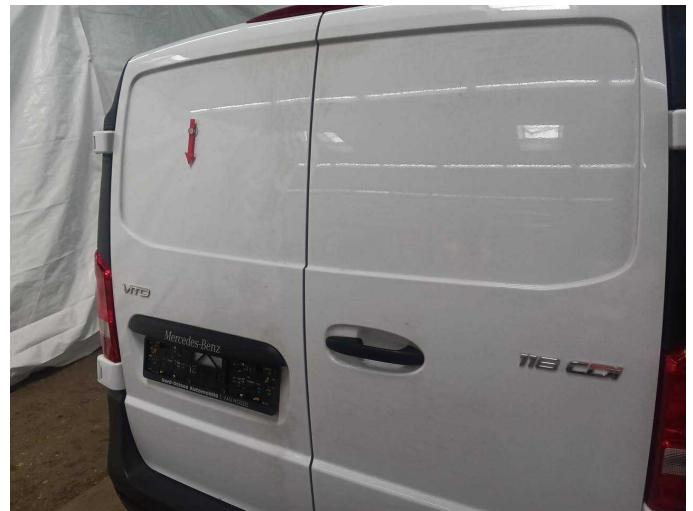
Damage 3: Boot lid / rear door: Boot lid (2 Dellen) - dent(s) - Smooth repair work

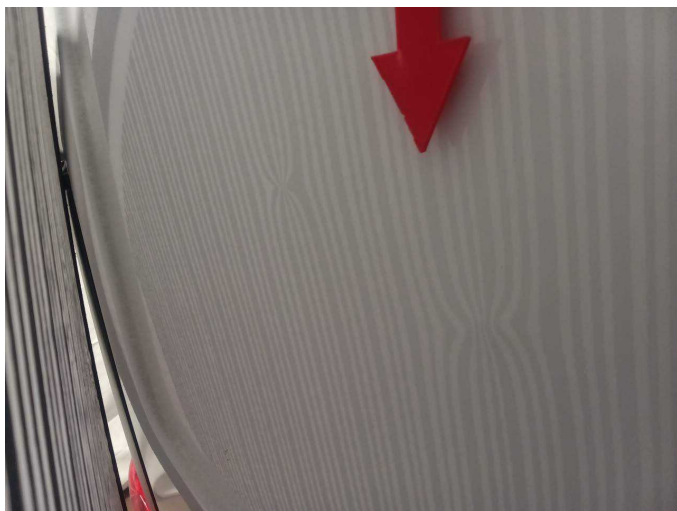
Damage 3: Boot lid / rear door: Boot lid (2 Dellen) - dent(s) - Smooth repair work

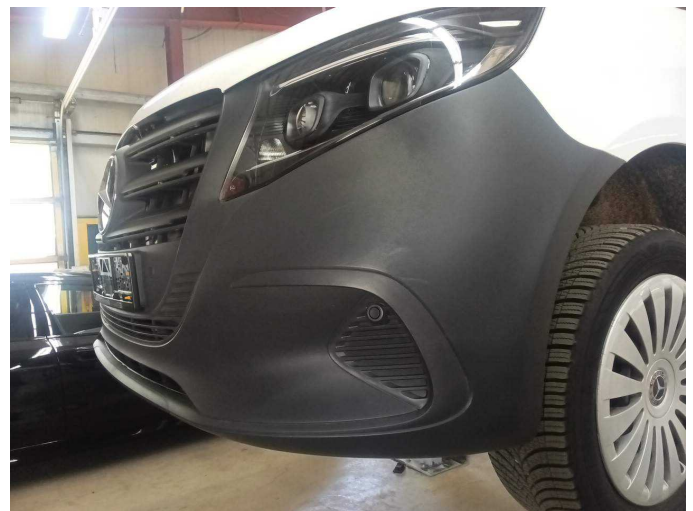
Damage 4: Front bumper: Front bumper - Scratched - Loss in value

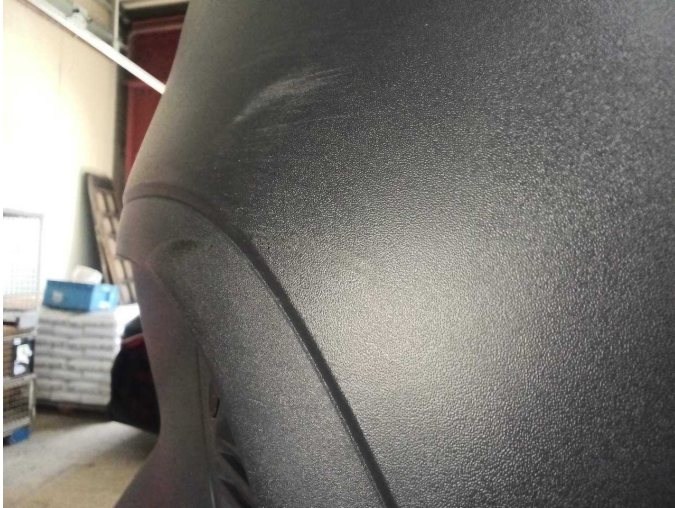
Damage 4: Front bumper: Front bumper - Scratched - Loss in value

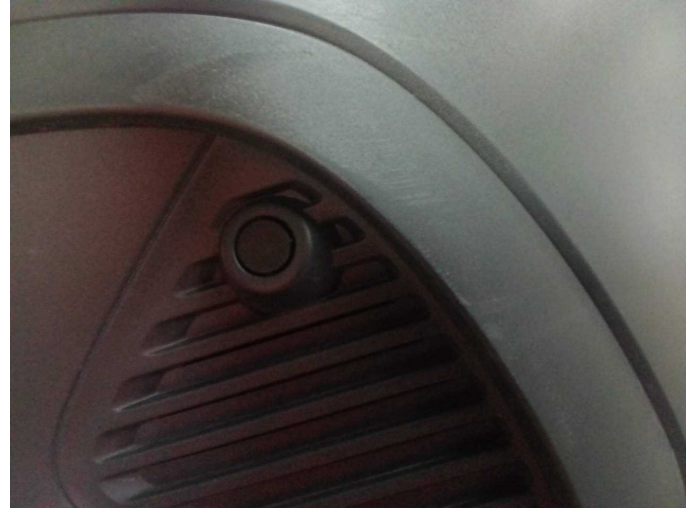
Damage 4: Front bumper: Front bumper - Scratched - Loss in value

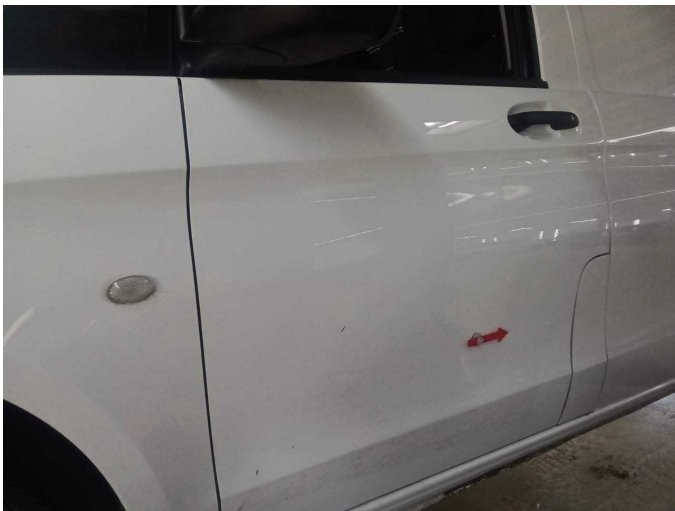
Damage 5: Door - front left side: Door - Dent / paintcoat damage - Repair and paint

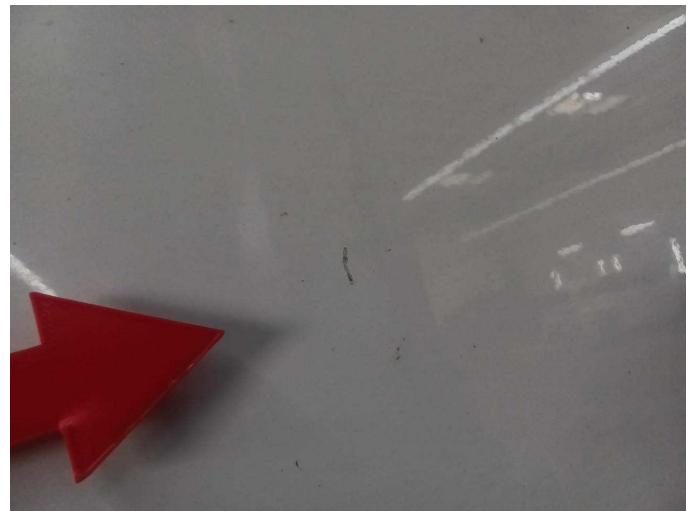
Damage 5: Door - front left side: Door - Dent / paintcoat damage - Repair and paint

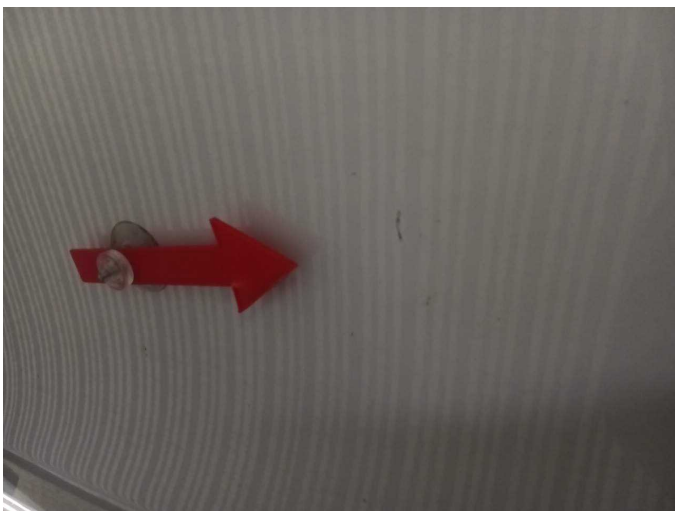
Damage 5: Door - front left side: Door - Dent / paintcoat damage - Repair and paint

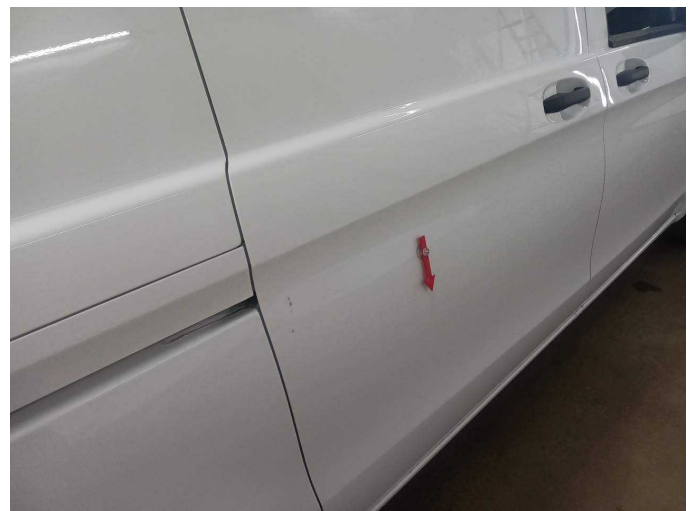
Wear and tear 3: Sliding door, right: Sliding door - Scratch(es) - No deduction

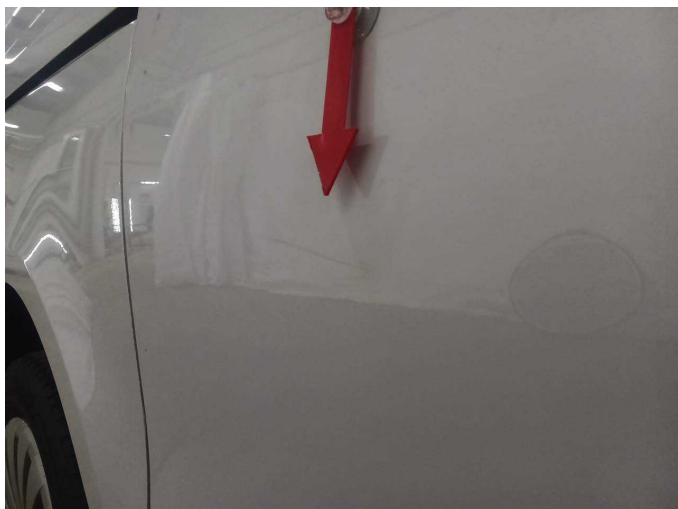
Wear and tear 3: Sliding door, right: Sliding door - Scratch(es) - No deduction

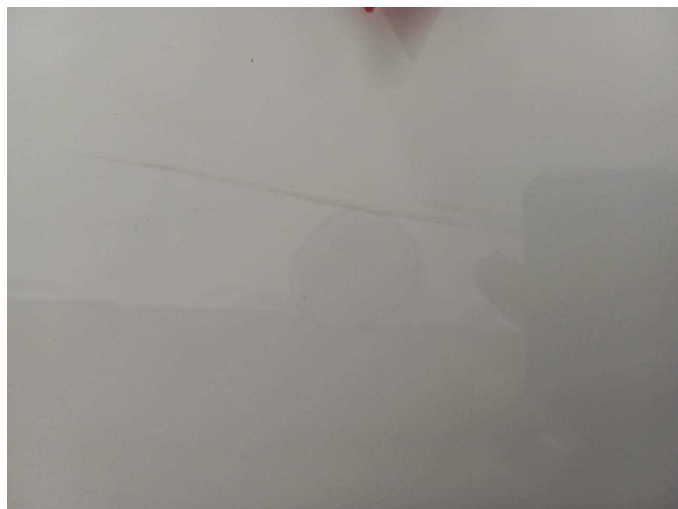
Wear and tear 3: Sliding door, right: Sliding door - Scratch(es) - No deduction
