Expertise

Protocol number: 45046957
Order No. / Reference: 26274843
Inspection date: 20 Apr 2026

Manufacturer: Opel

Model: Astra Sports Tourer 1.5 D Automatik Elegance

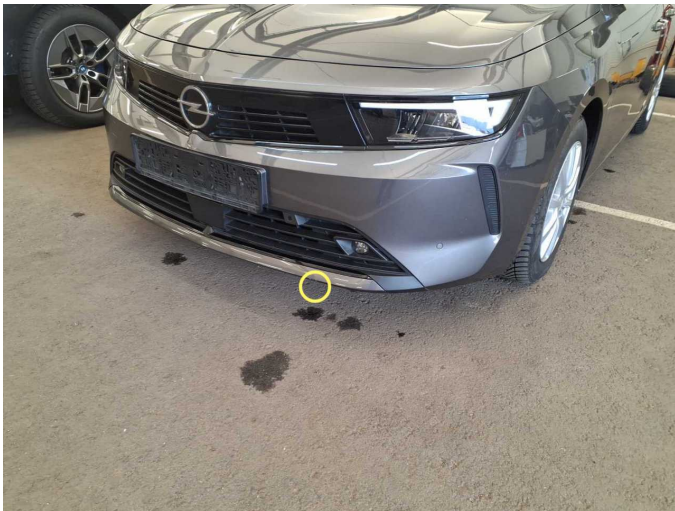
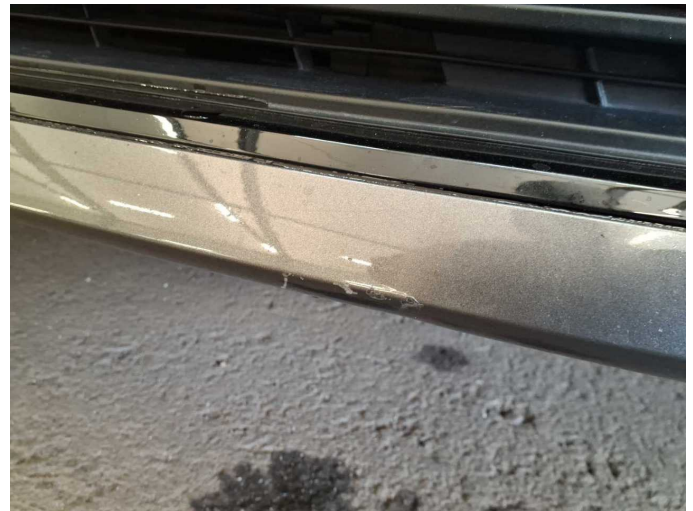
Damage 1: Front bumper: Front bumper - Scratch(es) - Smart repair

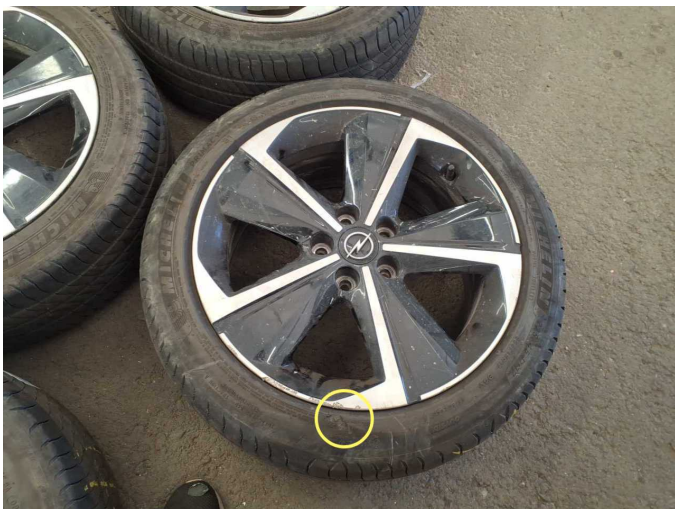
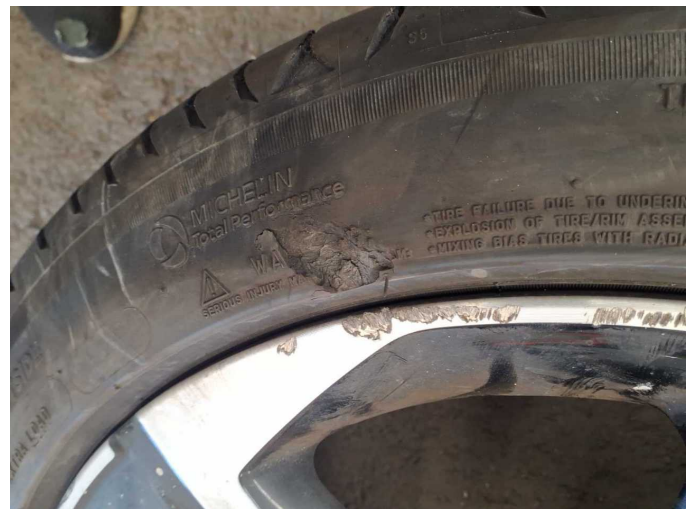
Damage 2: 2nd wheel set: 1 tyre - Damaged - Replace

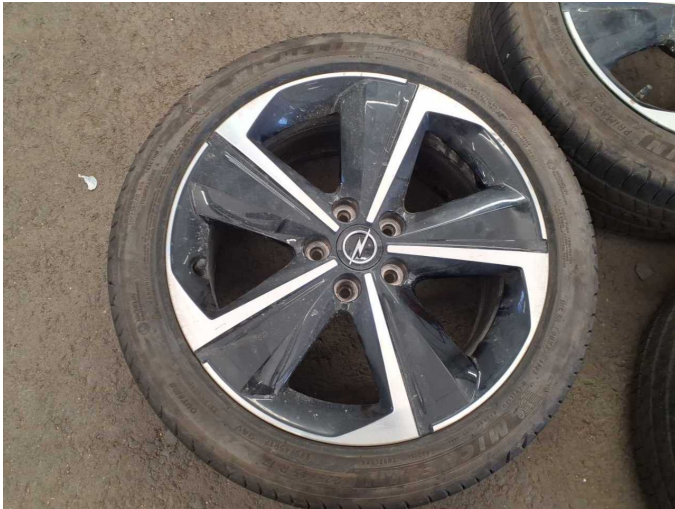
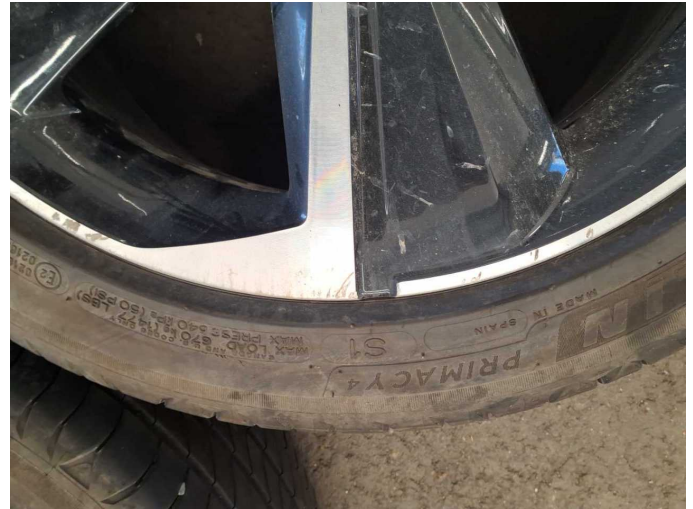
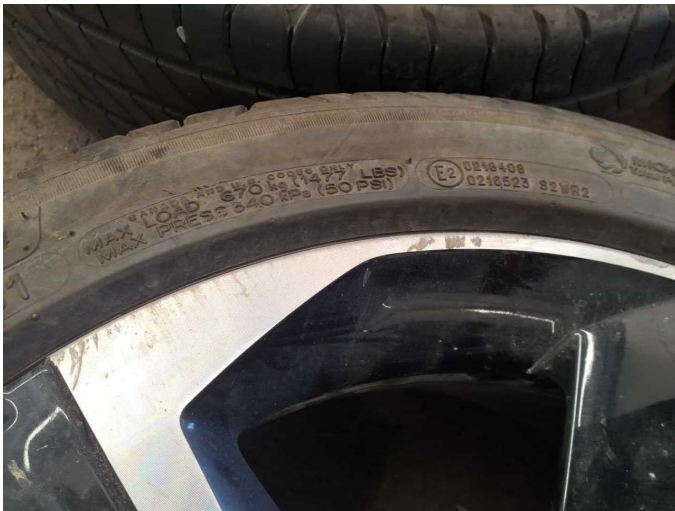
Damage 4: 2nd wheel set: 1 alloy rim - Scratched - Replace

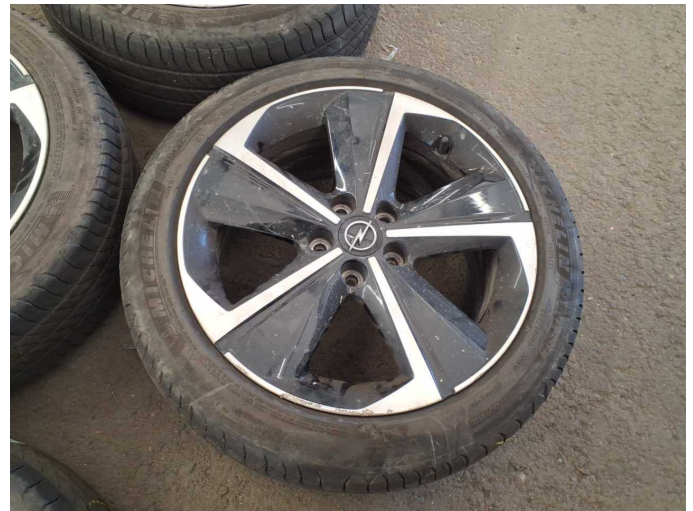
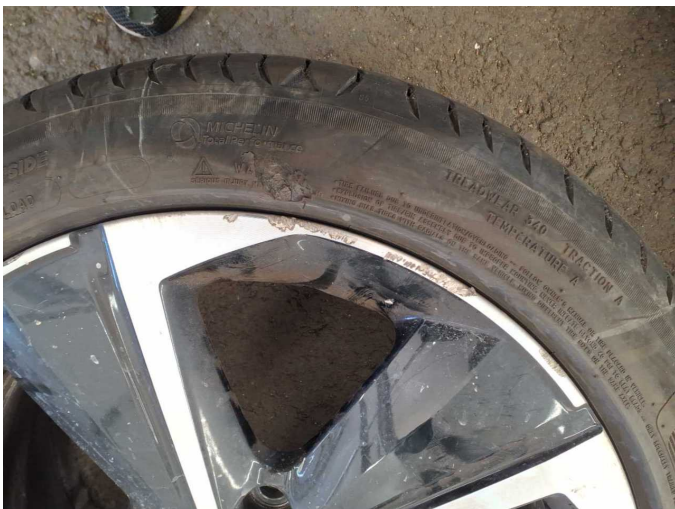
Damage 5: 2nd wheel set: 1 alloy rim - Scratched - Replace

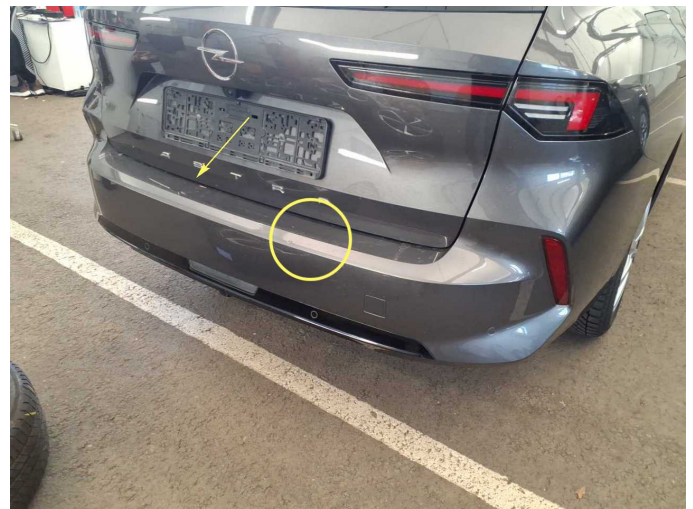
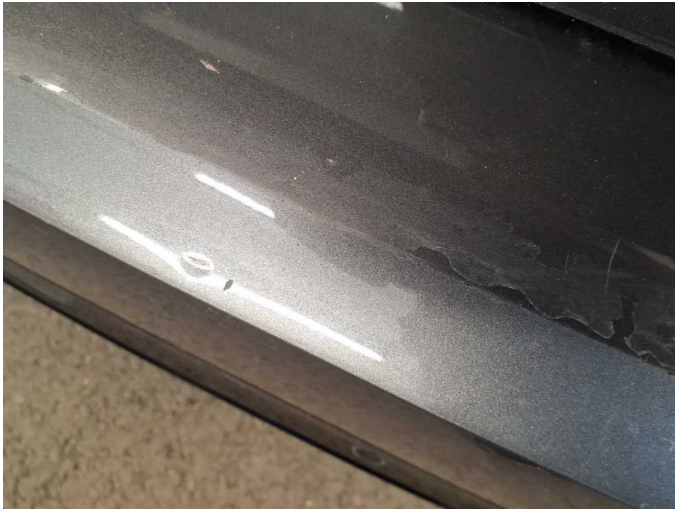
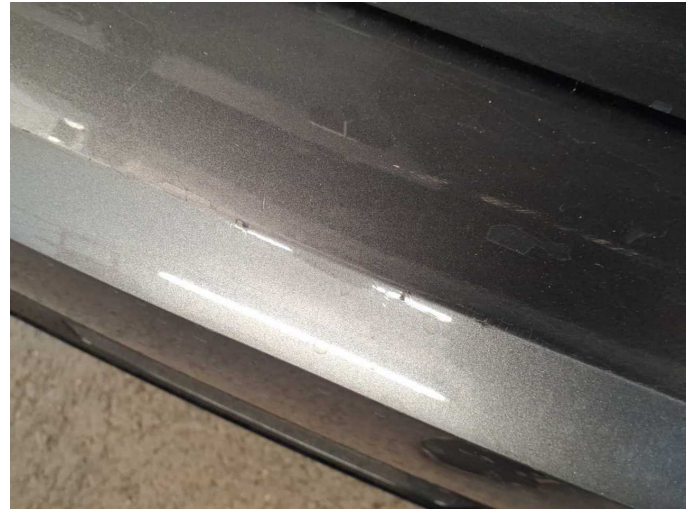
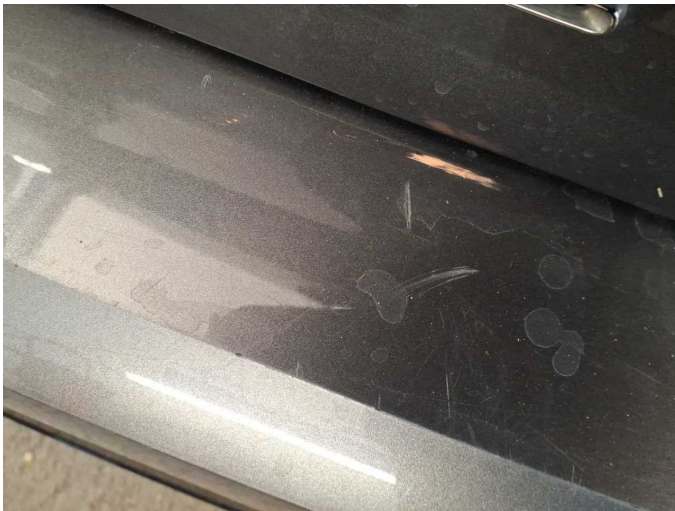
Damage 6: Rear bumper: Rear bumper - Dent / paintcoat damage - Repair and paint

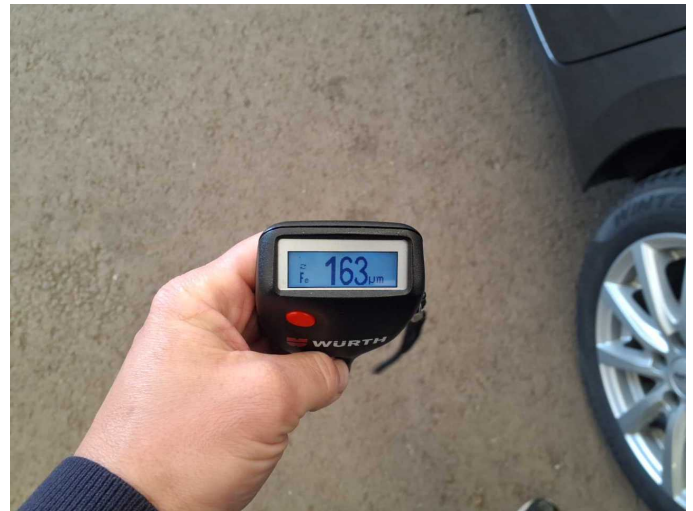
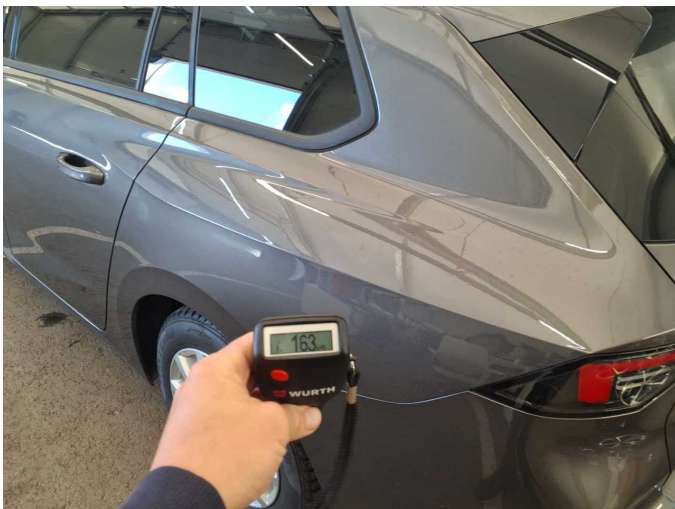
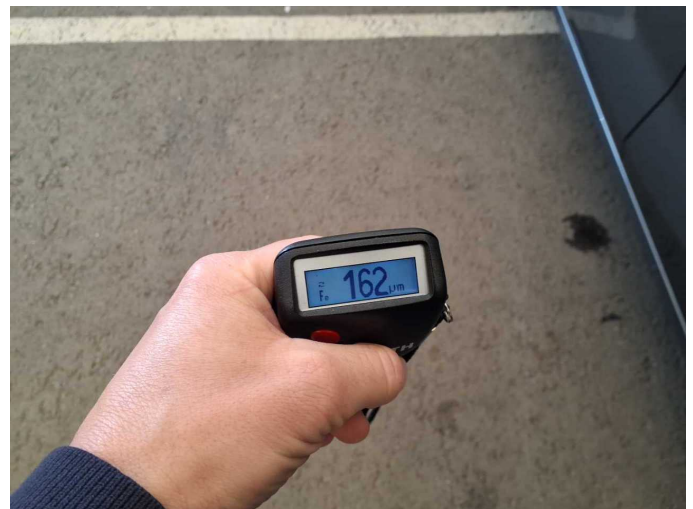
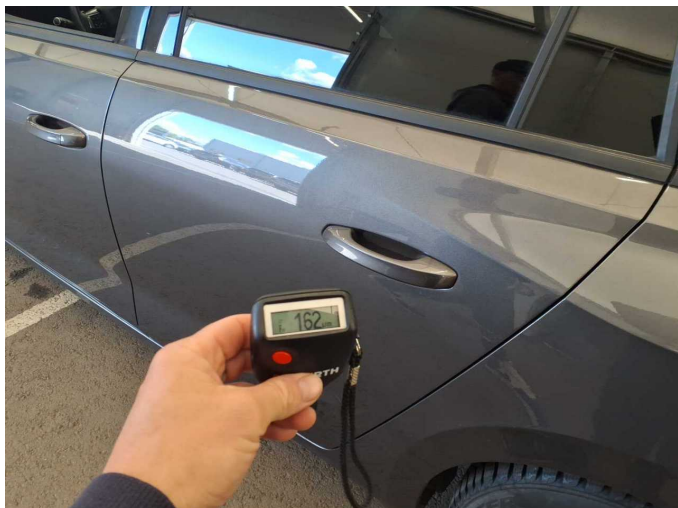
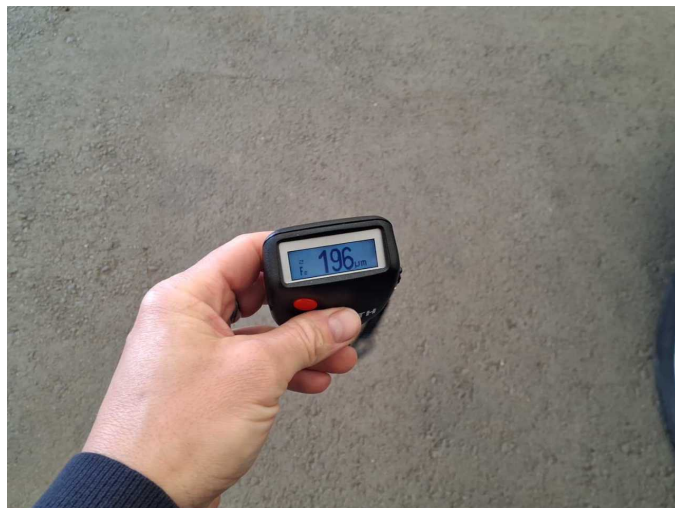
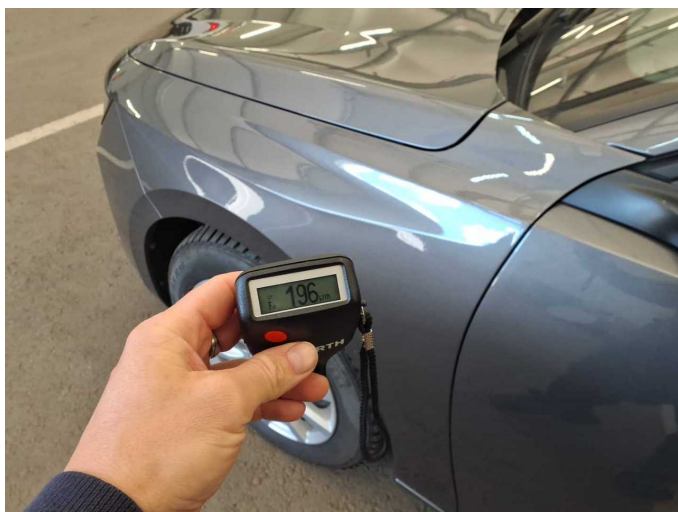
- 1 Mudguard - left side, Side panel - rear left side, Door - rear left side, Professionally carried out, Invoice of repair done Non-existent

Mudguard - left side	196 µm	Side panel - rear left side	163 µm
Door - rear left side	162 µm

Repainting 1: Mudguard - left side, Side panel - rear left side, Door - rear left side
