Expertise

Protocol number: 45948028
Order No. / Reference: 26335420
Inspection date: 15 Jun 2026

Model: V60 T6 AWD Recharge Core

VIN: YV1ZWH1V2P1531245

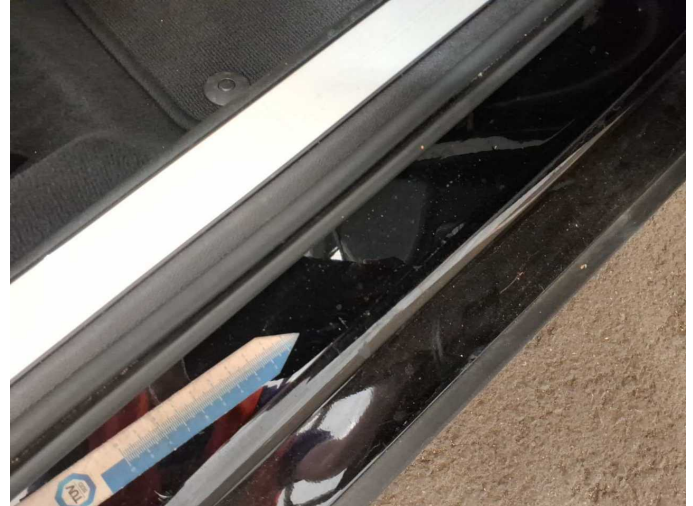
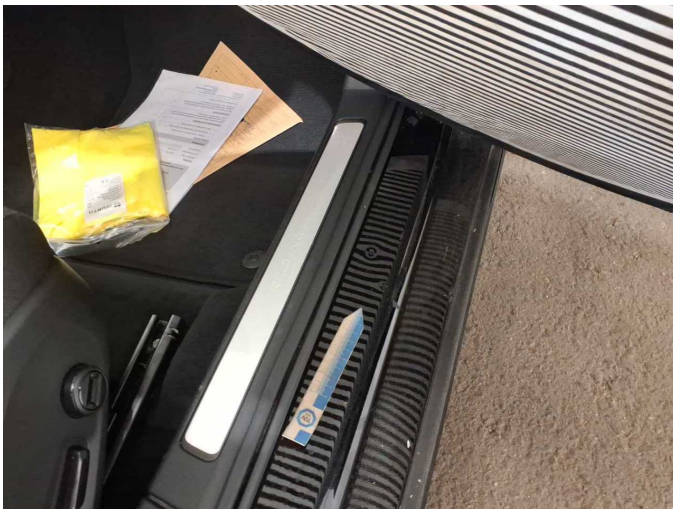
Damage 1: Sill - right side: Sill - Dent / paintcoat damage - Smart repair

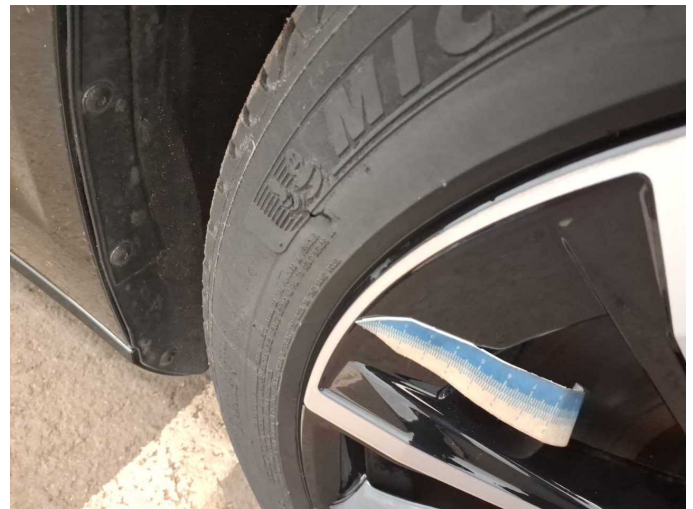
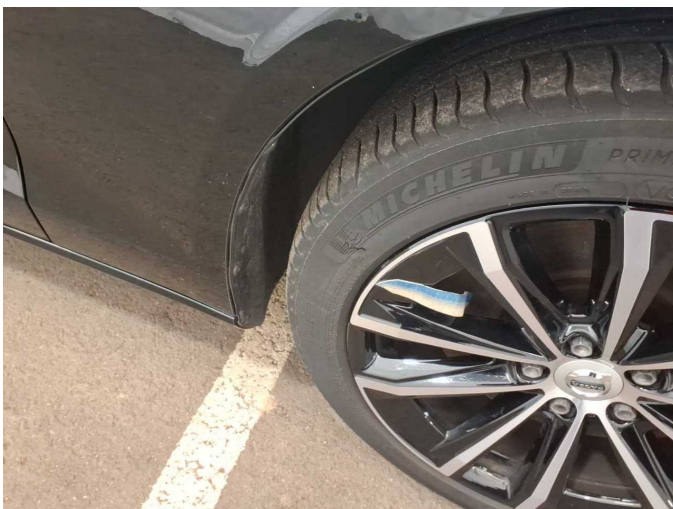
Damage 2: Wheel / tyres: Tyre - front right side (nicht fahrbereit) - Broken / torn - Replace

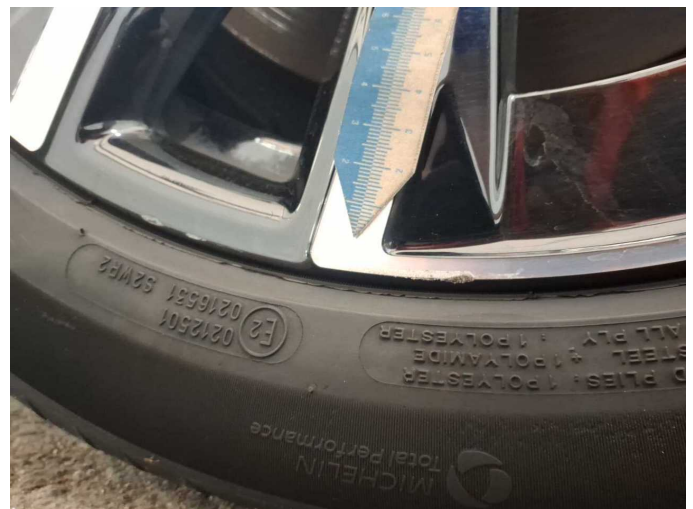
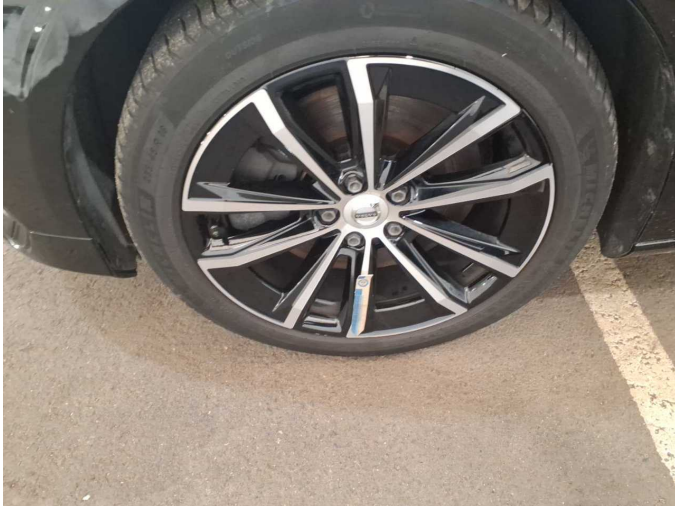
Damage 3: Wheel / tyres: Alloy rim - front left side - Scratch(es) - Loss in value

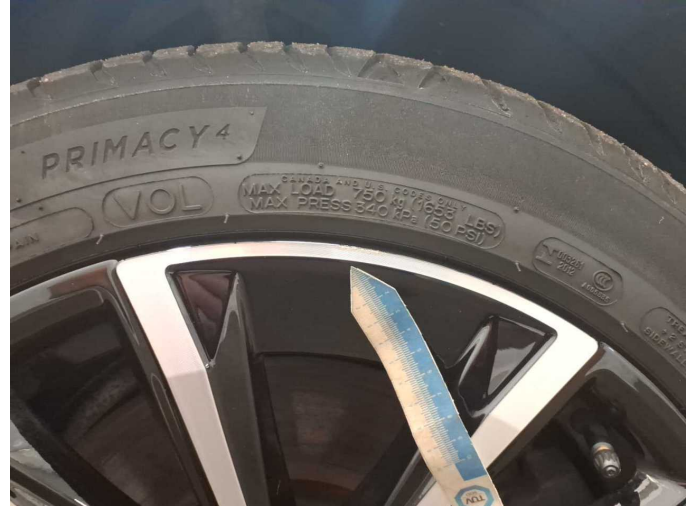
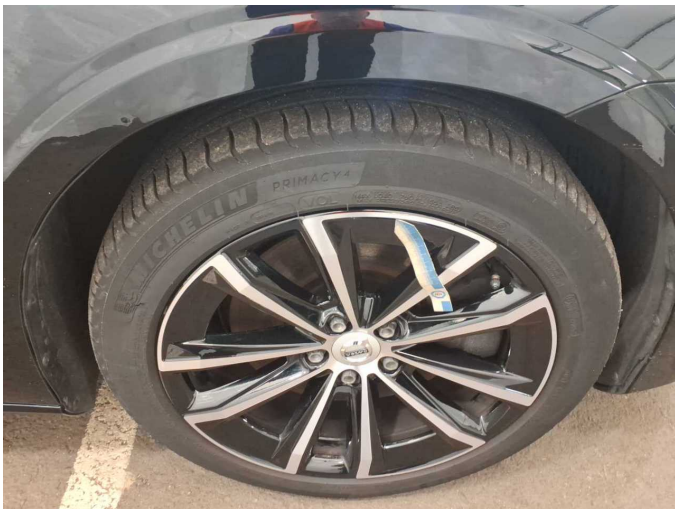
Damage 4: Wheel / tyres: Alloy rim - front right side - Scratch(es) - Loss in value

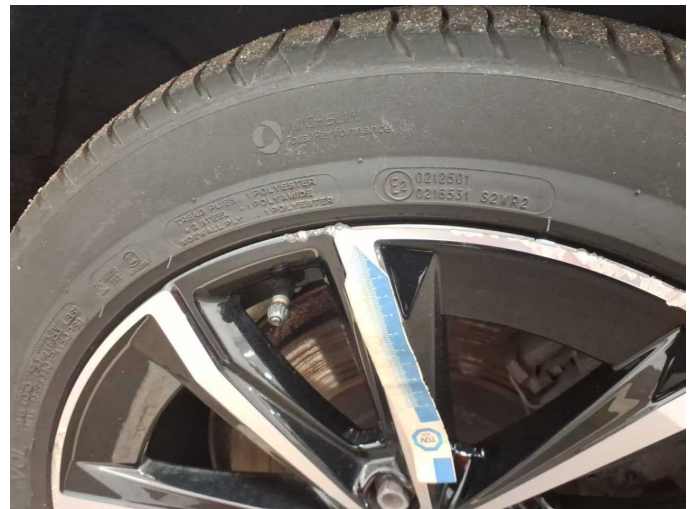
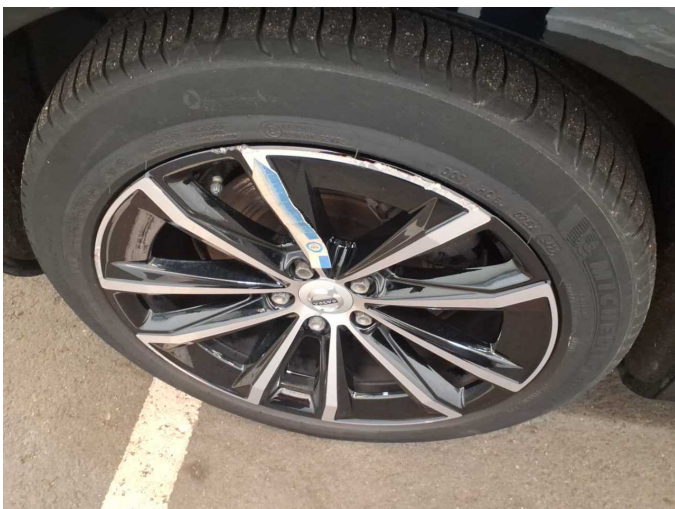
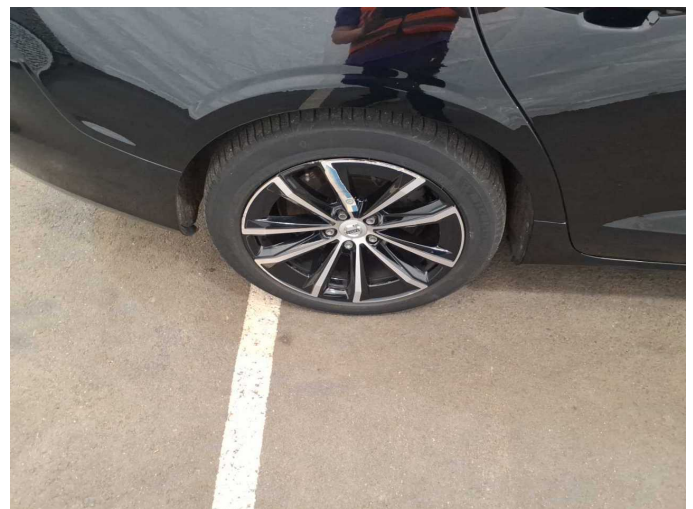
Damage 5: Wheel / tyres: Alloy rim - rear right side - Scratched - Loss in value

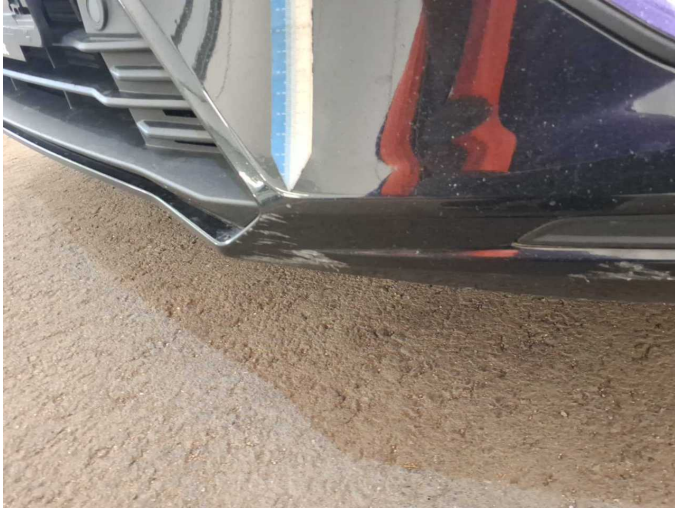
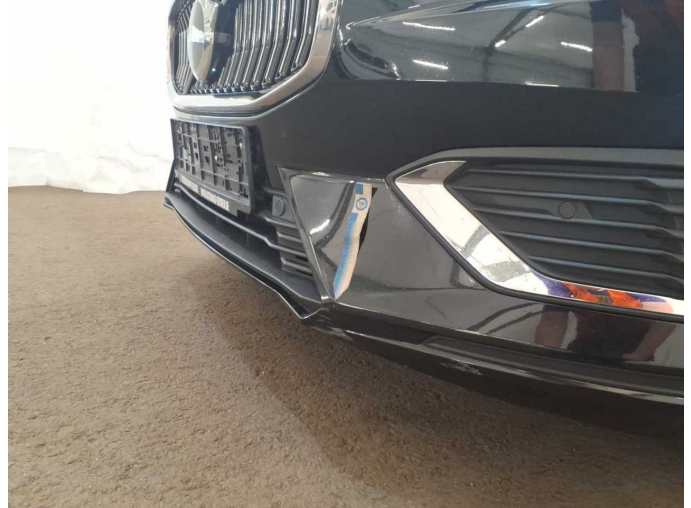
Damage 6: Front bumper: Front bumper - Scratched - Paint

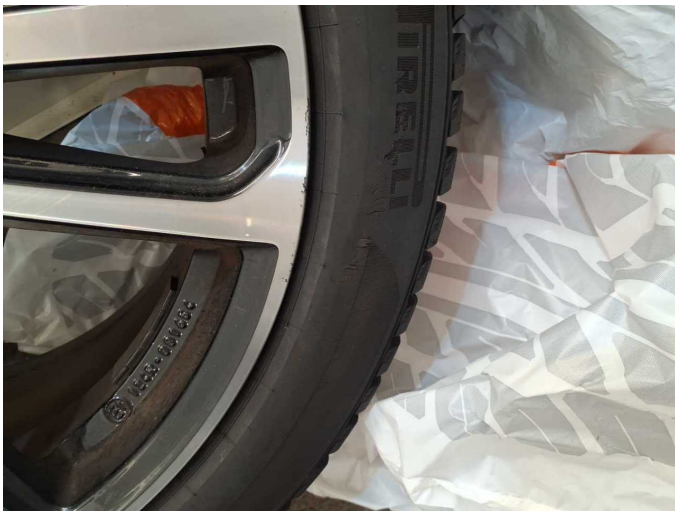
Wear and tear 4: 2nd wheel set: 1 tyre (Nicht Bestandteil der Ausstattung) - Broken / torn - No deduction

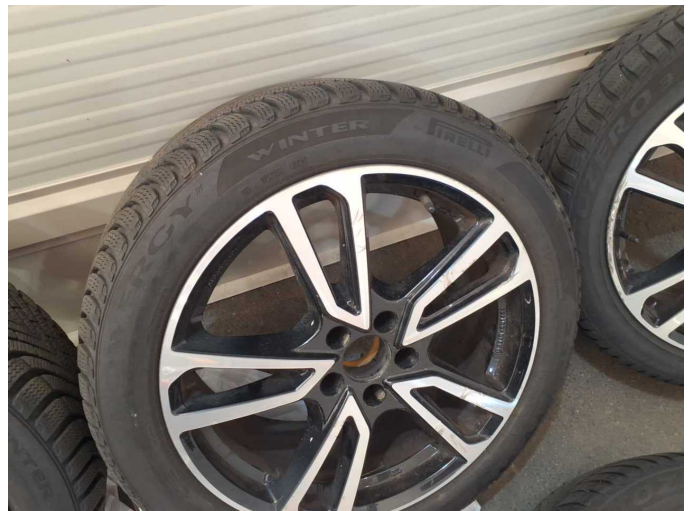
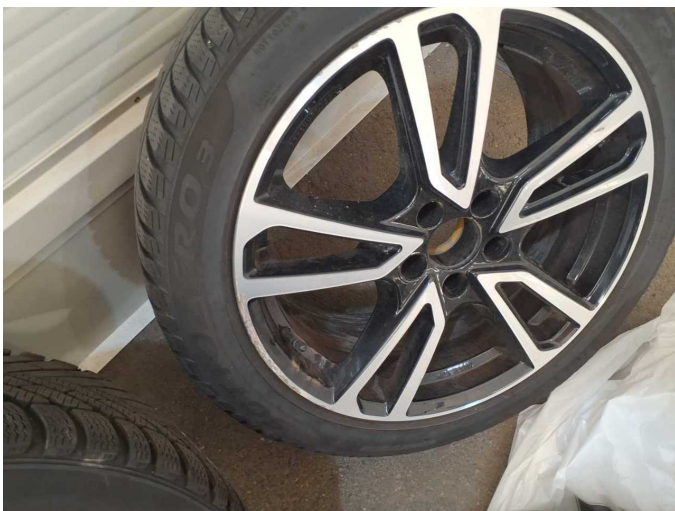
Wear and tear 5: 2nd wheel set: 2 alloy rims - Scratch(es) - No deduction
