## Expertise

Protocol number: 45860722  
Order No. / Reference: 26443776  
Inspection date: 9 Jun 2026

Manufacturer: Opel

Model: Corsa-e Elegance

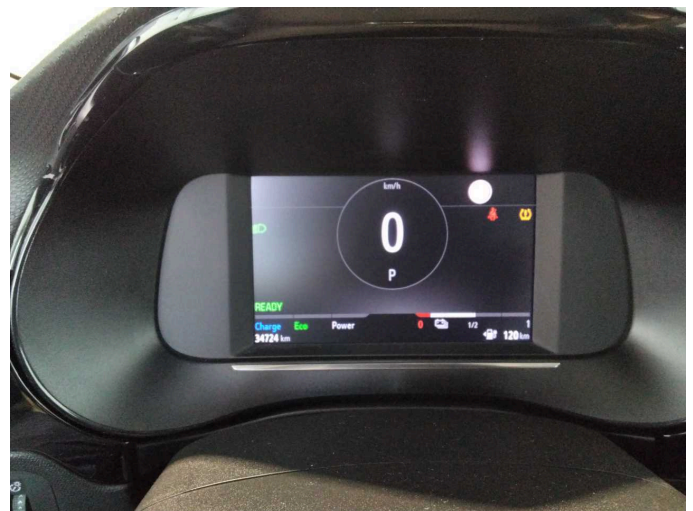
Damage 1: Wheel / tyres: Pressure sensor (Reifendruck) - on - Perform diagnosis

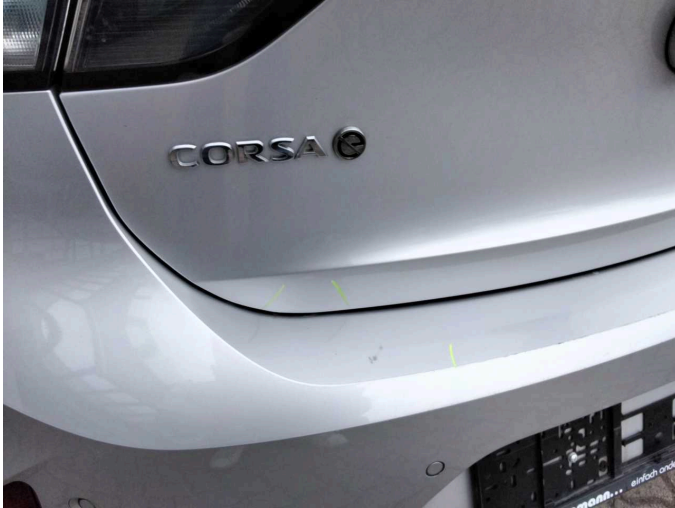
**Damage 2:** Boot lid / rear door: Boot lid - Scratch(es) - Smart repair

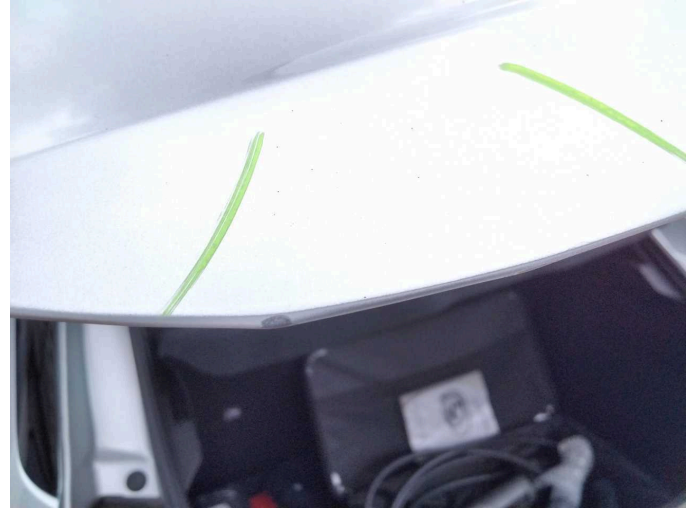
**Damage 2:** Boot lid / rear door: Boot lid - Scratch(es) - Smart repair

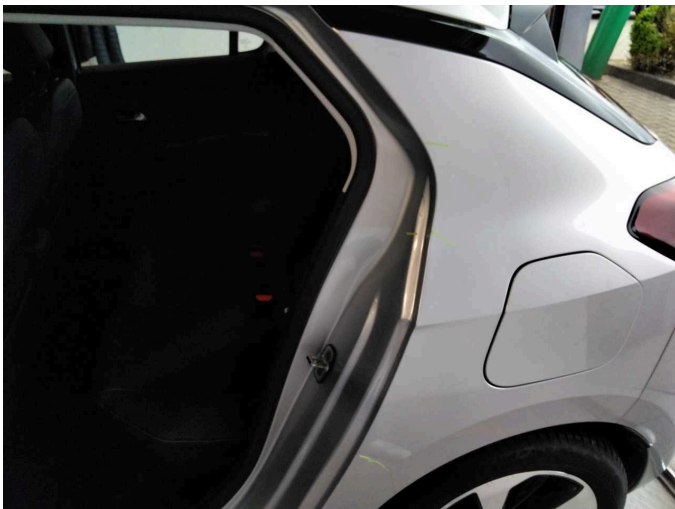
**Damage 3:** Body: C-pillar - left side - Scratch(es) - Smart repair

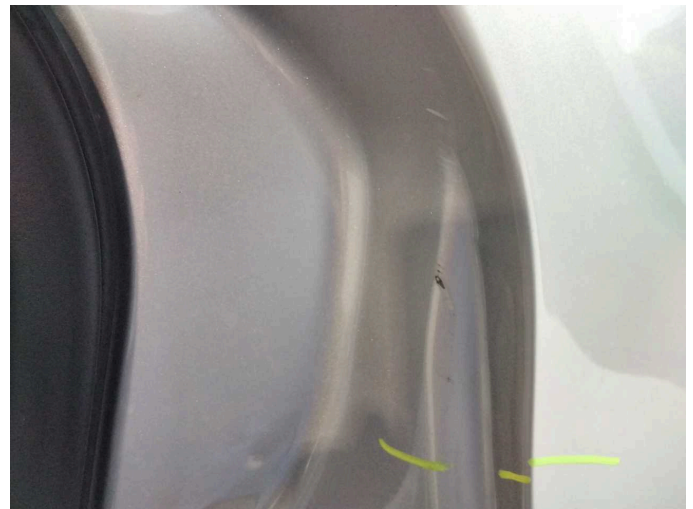
**Damage 3:** Body: C-pillar - left side - Scratch(es) - Smart repair

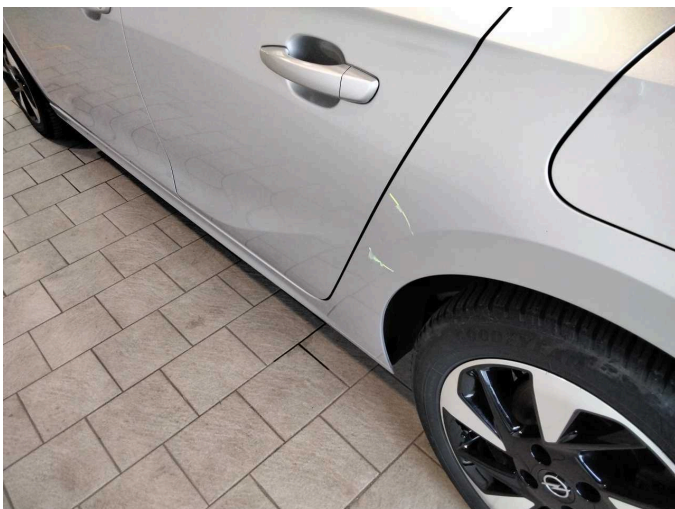
**Damage 4:** Side panel - rear left side: Side panel - dent(s) - Smart repair

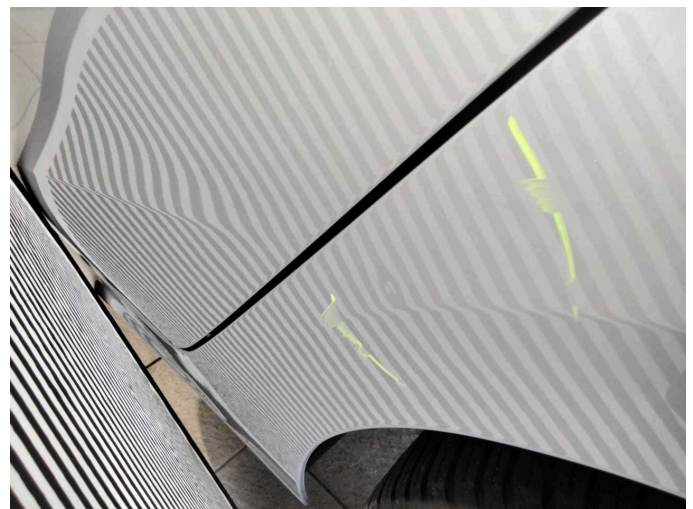
**Damage 4:** Side panel - rear left side: Side panel - dent(s) - Smart repair

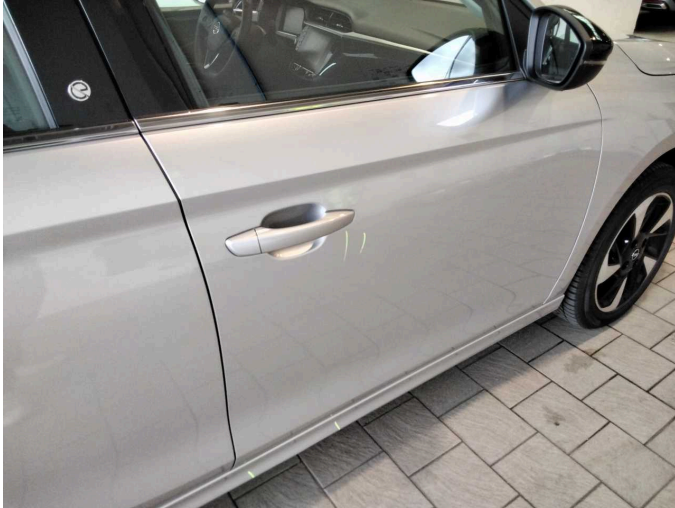
**Damage 5:** Door - front right side: Door - Scratch(es) - Smart repair

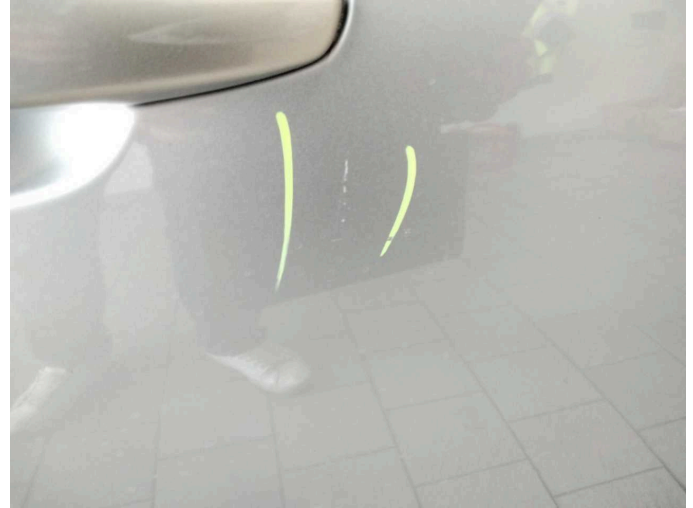
**Damage 5:** Door - front right side: Door - Scratch(es) - Smart repair

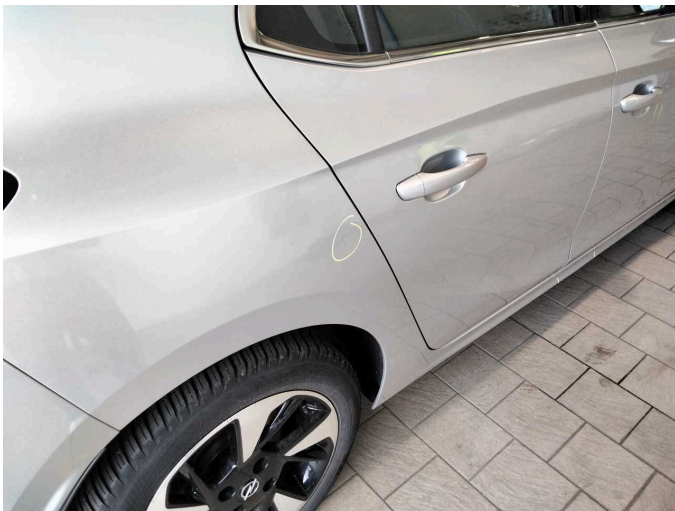
**Damage 6:** Side panel - rear right side: Side panel - dent(s) - Smart repair

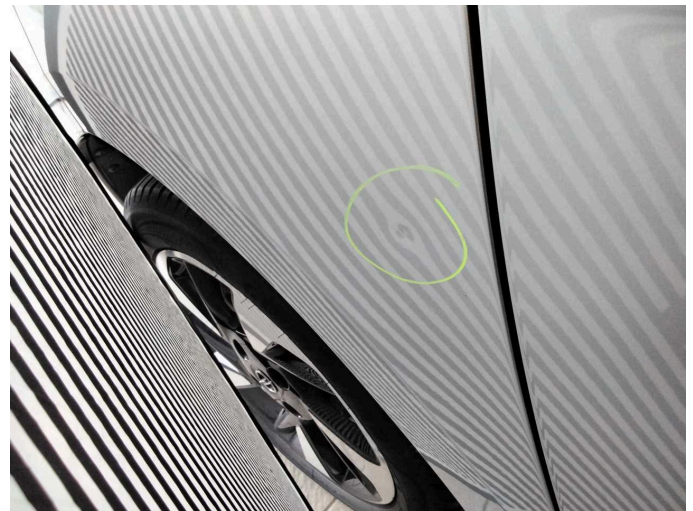
**Damage 6:** Side panel - rear right side: Side panel - dent(s) - Smart repair

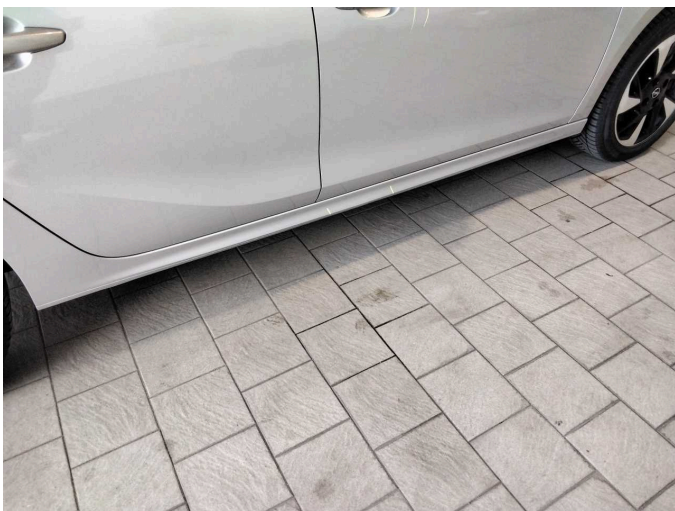
**Damage 7:** Sill - right side: Sill - Scratch(es) - Smart repair

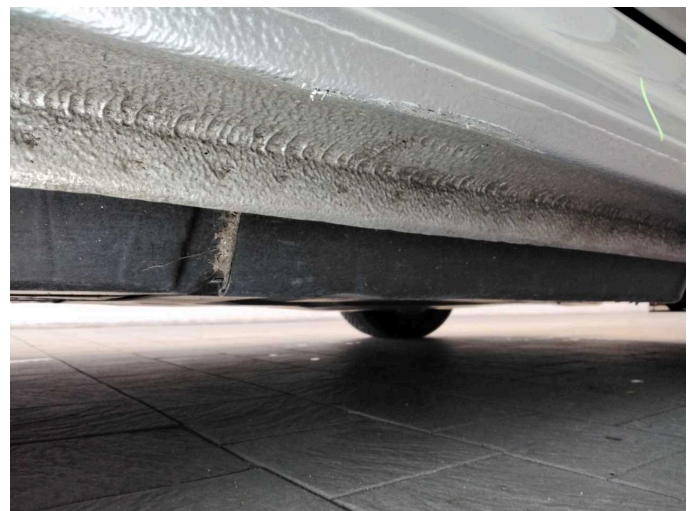
**Damage 7:** Sill - right side: Sill - Scratch(es) - Smart repair

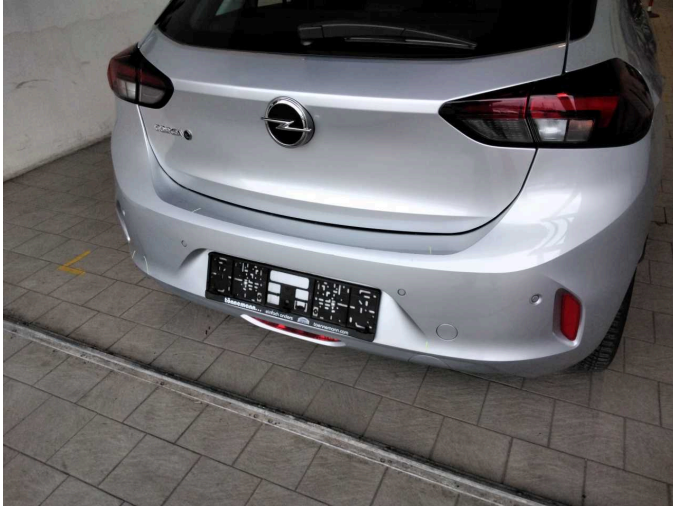
**Damage 8:** Rear bumper: Rear bumper - Scratch(es) - Smart repair

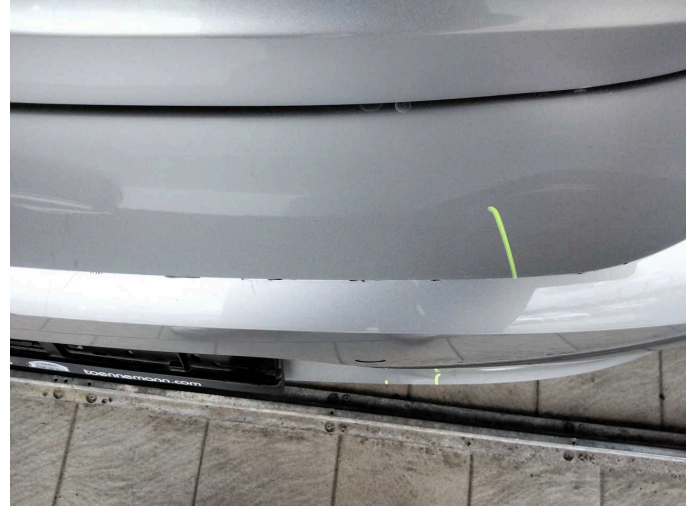
**Damage 8:** Rear bumper: Rear bumper - Scratch(es) - Smart repair

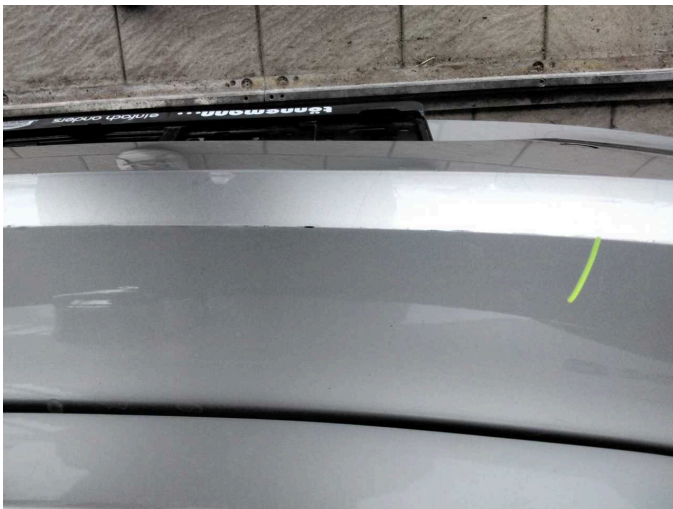
**Damage 8:** Rear bumper: Rear bumper - Scratch(es) - Smart repair

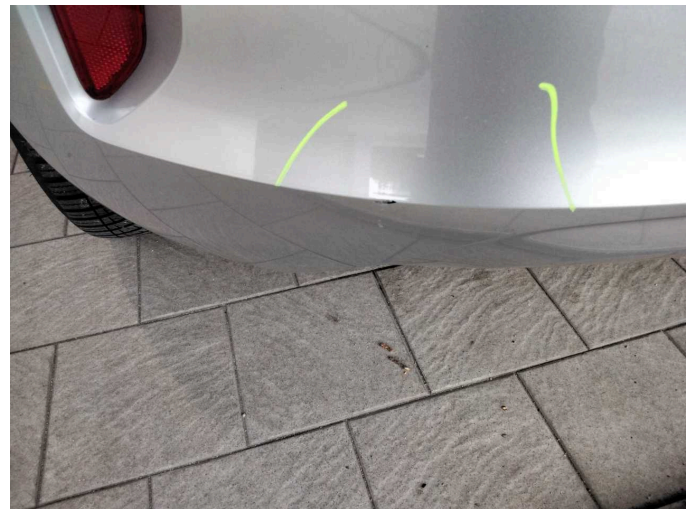
**Damage 8:** Rear bumper: Rear bumper - Scratch(es) - Smart repair

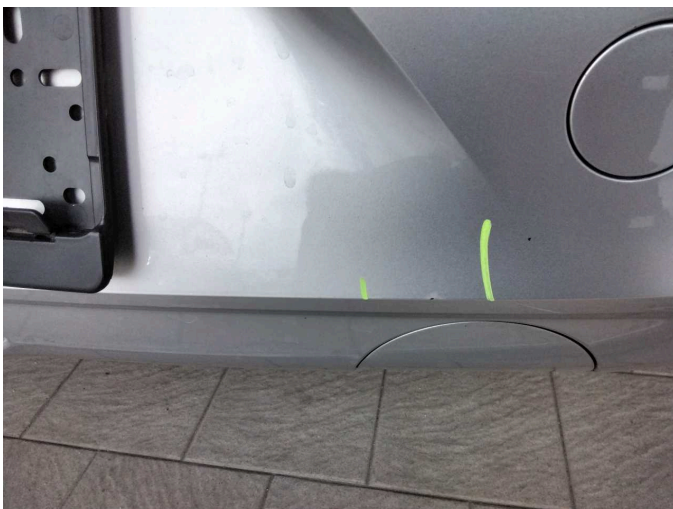
**Damage 8:** Rear bumper: Rear bumper - Scratch(es) - Smart repair

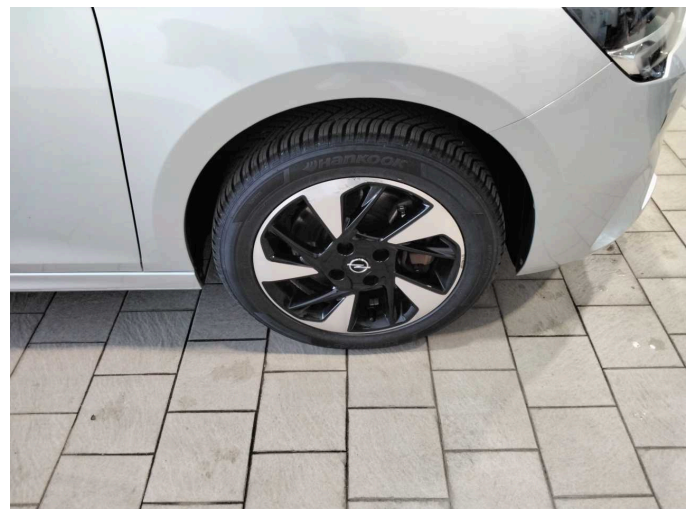
**Damage 9:** Wheel / tyres: Alloy rim - front right side - Damaged - Replace

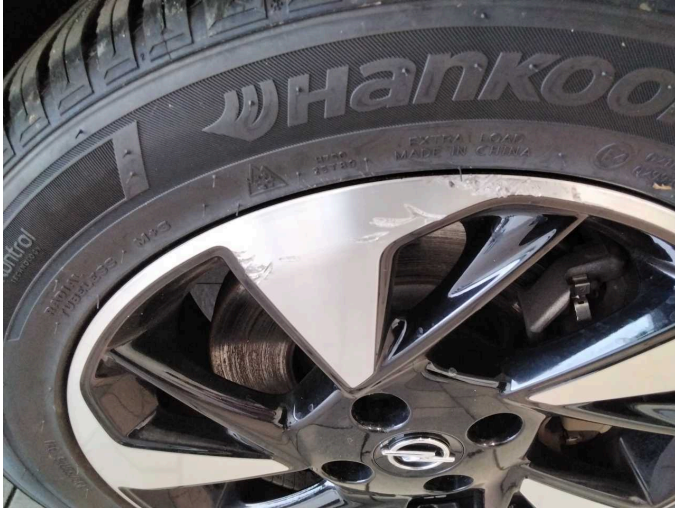
**Damage 9:** Wheel / tyres: Alloy rim - front right side - Damaged - Replace

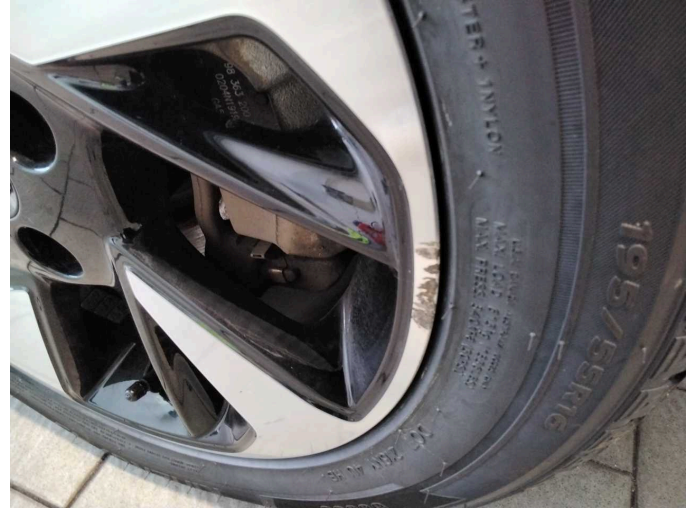
**Damage 9:** Wheel / tyres: Alloy rim - front right side - Damaged - Replace

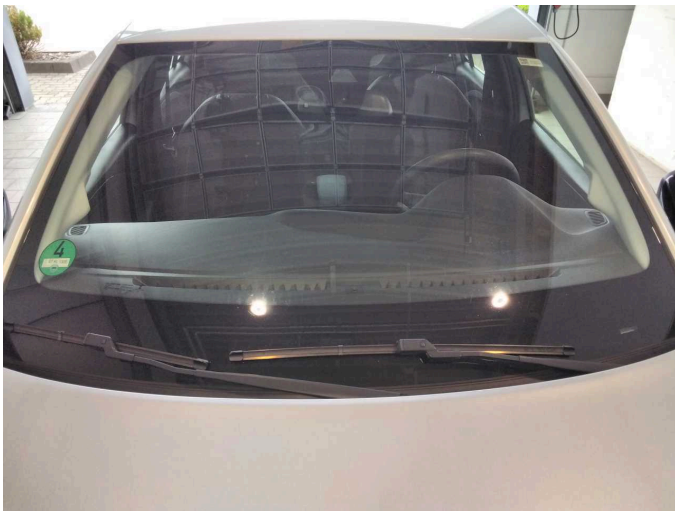
**Wear and tear 1:** Vehicle glazing: Windscreen - Stone chips - No deduction

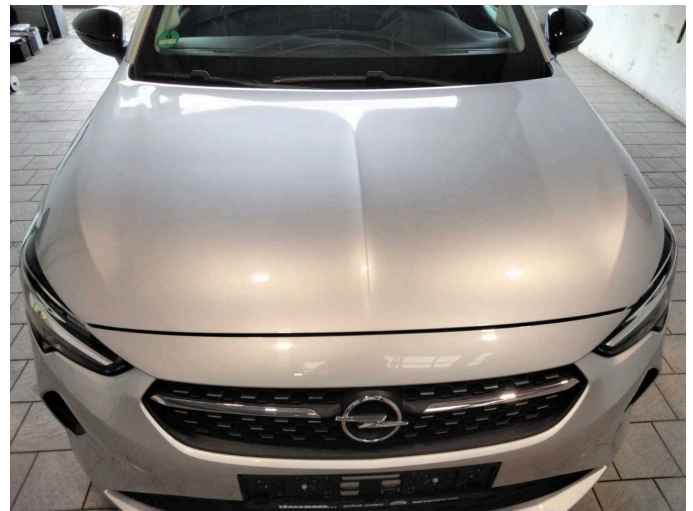
**Wear and tear 2:** Bonnet: Bonnet - Stone chips - No deduction

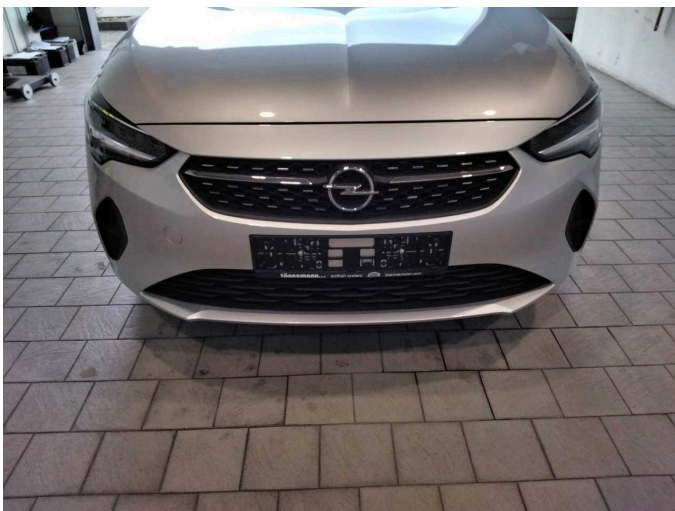
**Wear and tear 3:** Front bumper: Front bumper - Stone chips - No deduction

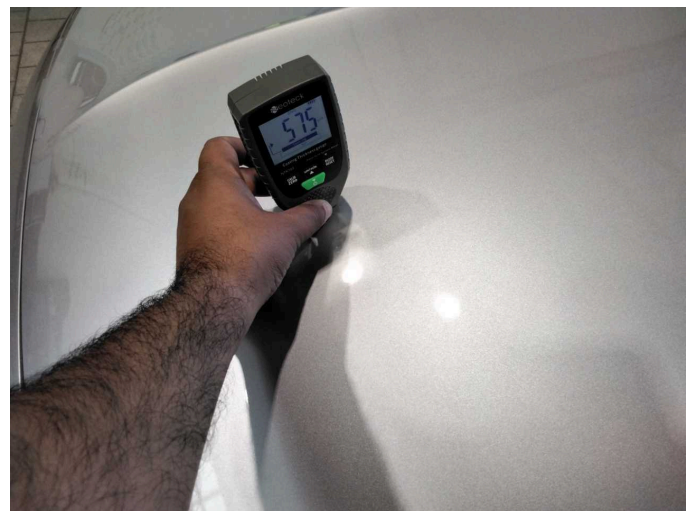
**Bonnet:** 575 µm

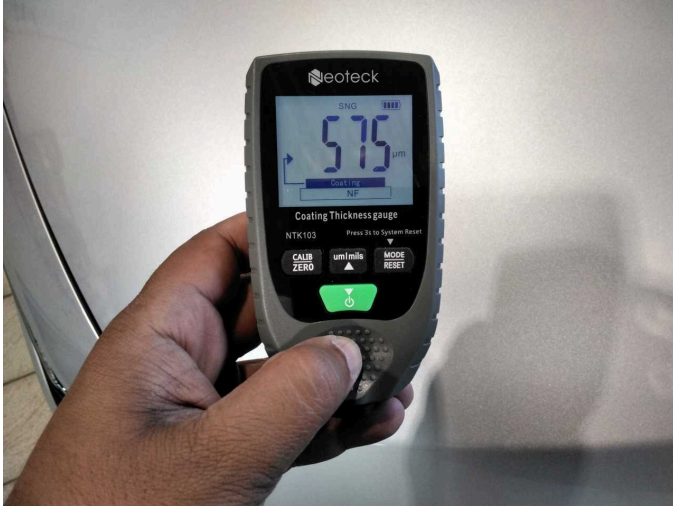
Bonnet: 575 µm

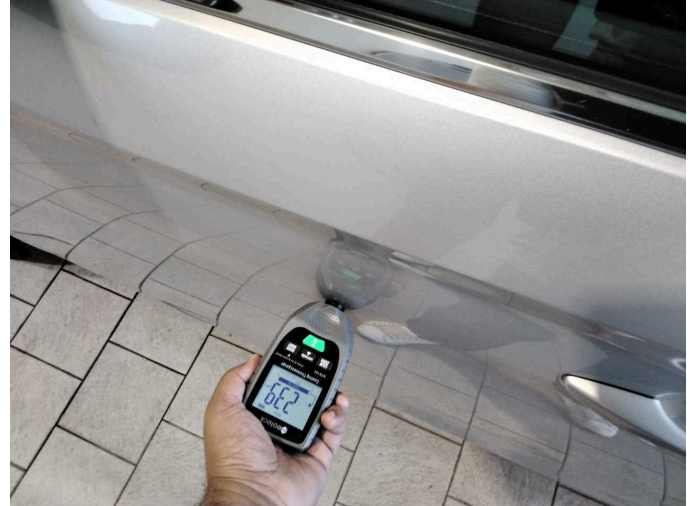
Door - front left side: 239 µm

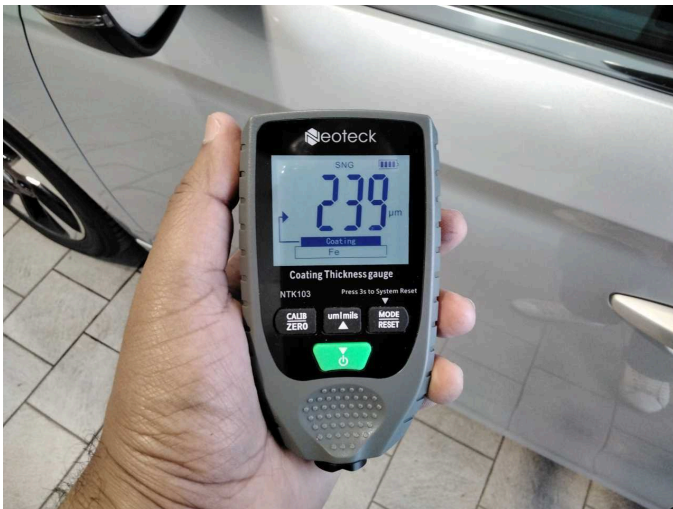
Door - front left side: 239 µm
