Expertise

Protocol number: 46257214
Order No. / Reference: 26152532
Inspection date: 29 Jun 2026

Model: Vito 116 CDI Tourer Lang Aut. SELECT

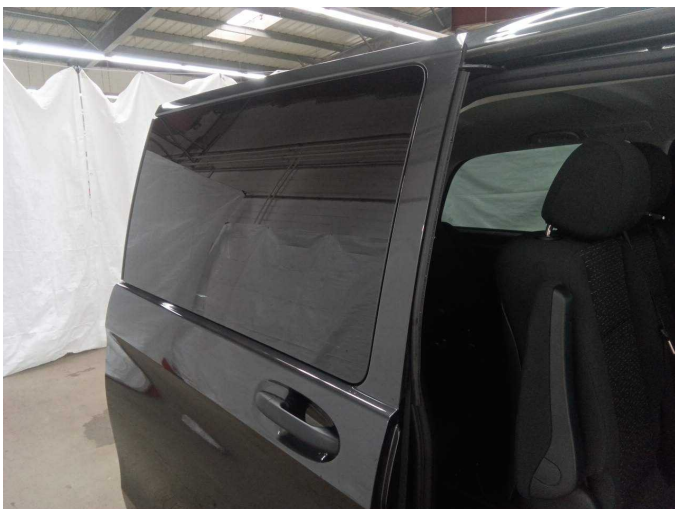
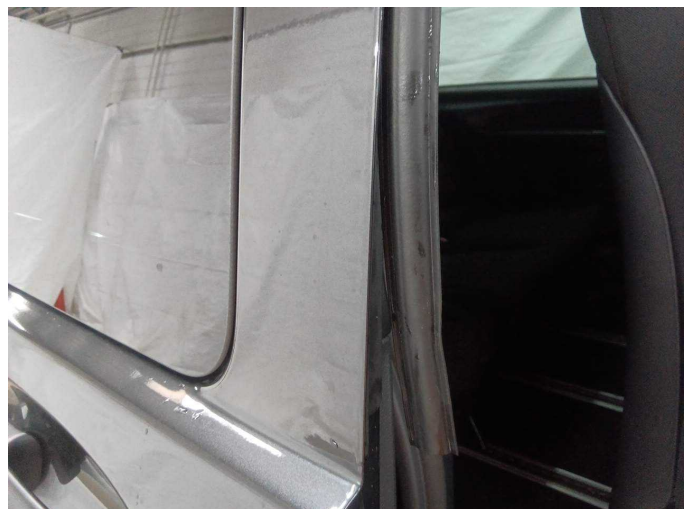
Damage 1: Sliding door, right: Door seal - Sub-function - Replace

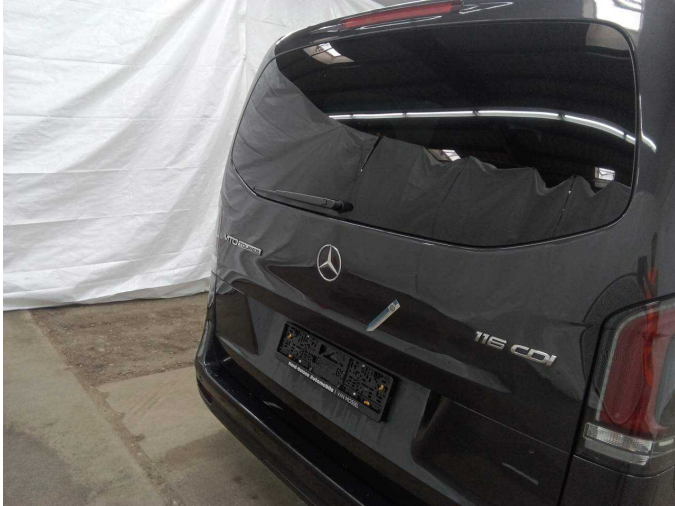
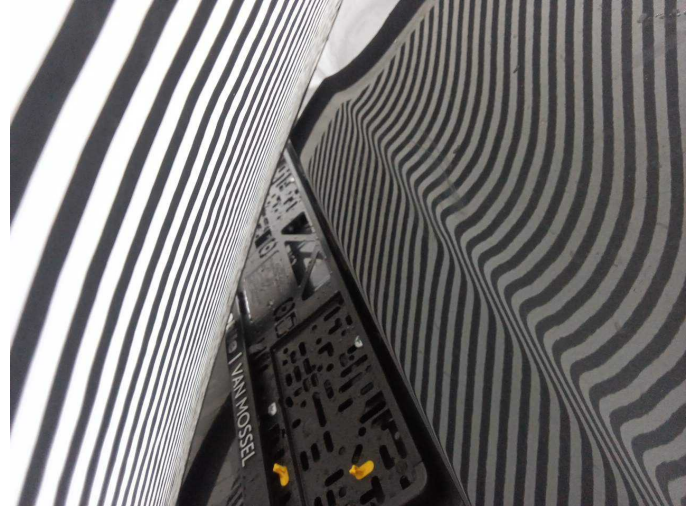
Damage 2: Boot lid / rear door: Boot lid (2) - dent(s) - Smooth repair work

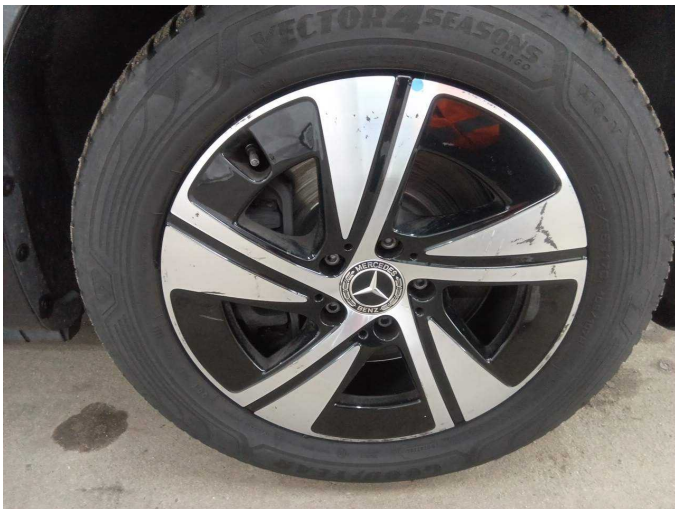
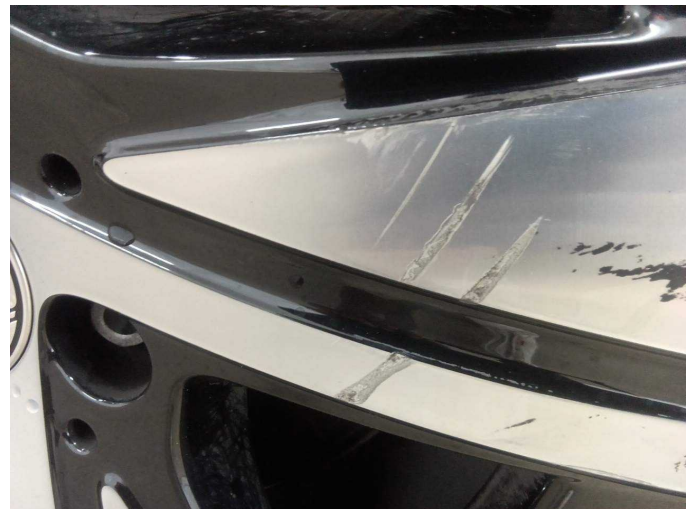
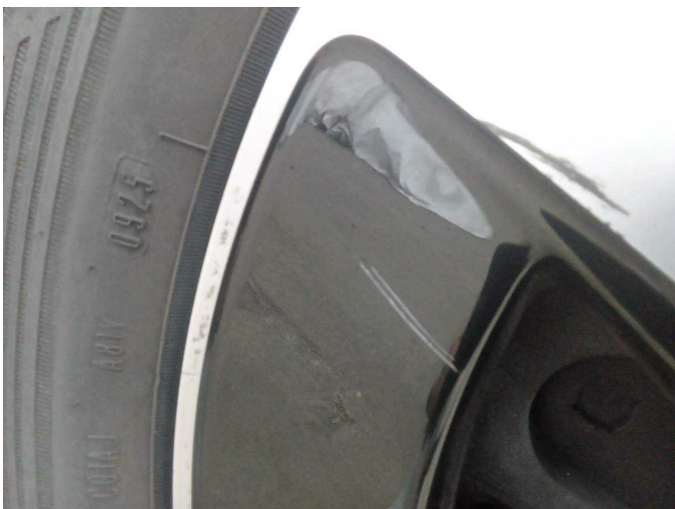
Damage 3: Wheel / tyres: Alloy rim - front right side - Scratch(es) - Replace

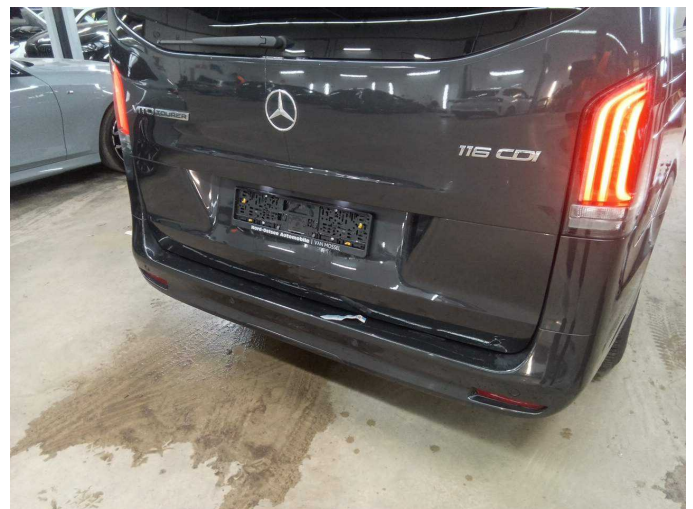
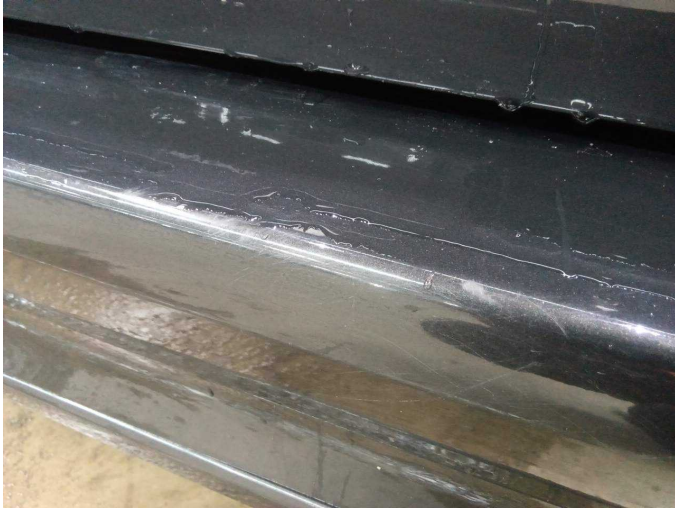
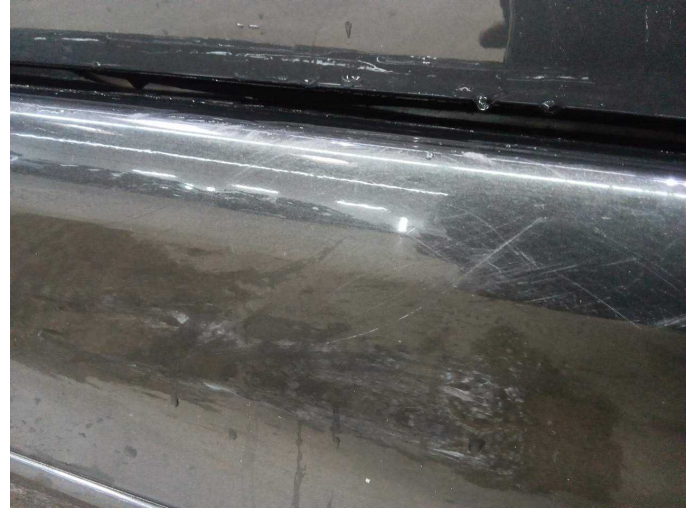
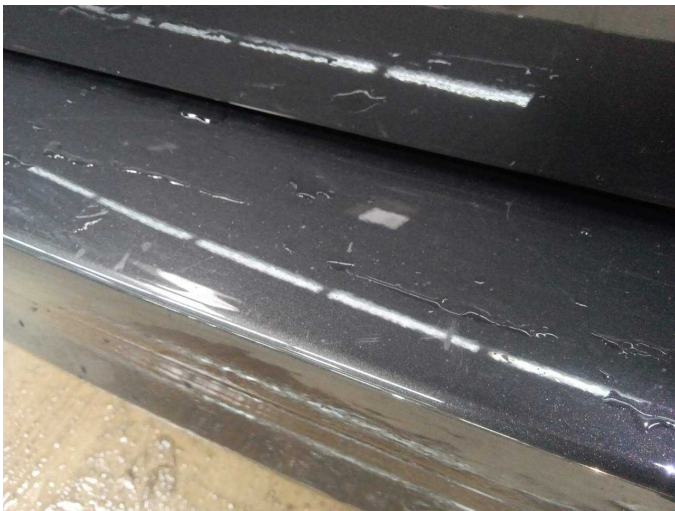
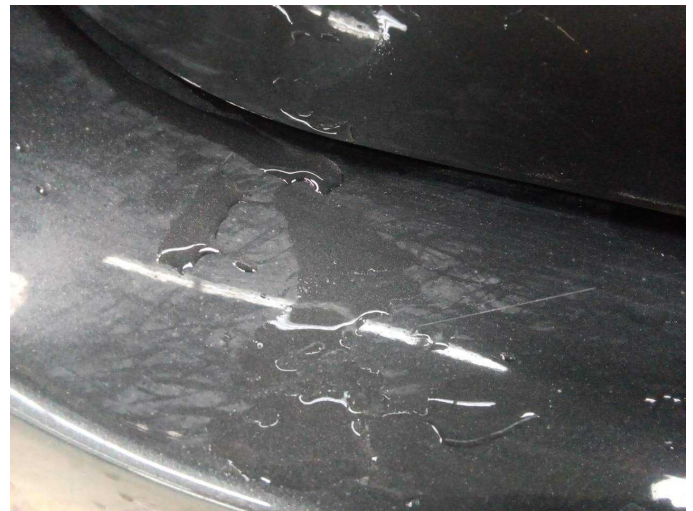
Damage 4: Rear bumper: Rear bumper - Scratch(es) - Paint

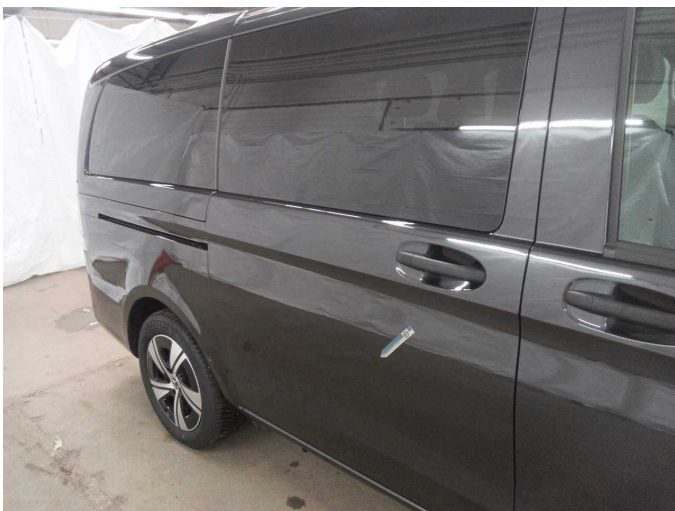
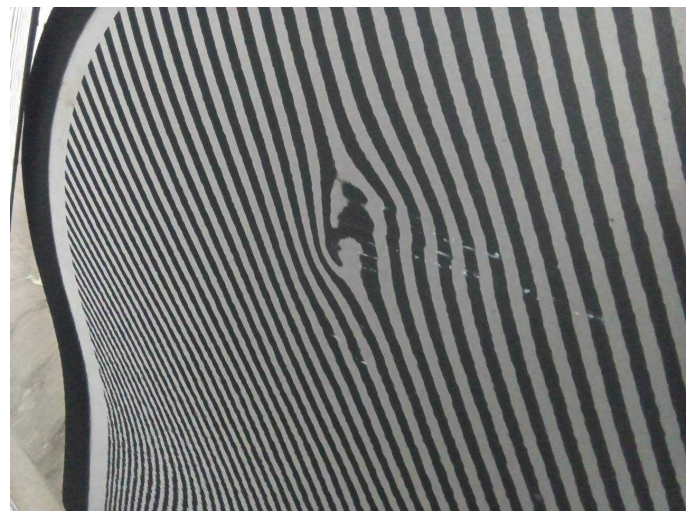
Damage 5: Sliding door, right: Sliding door - Dent / paintcoat damage - Repair and paint

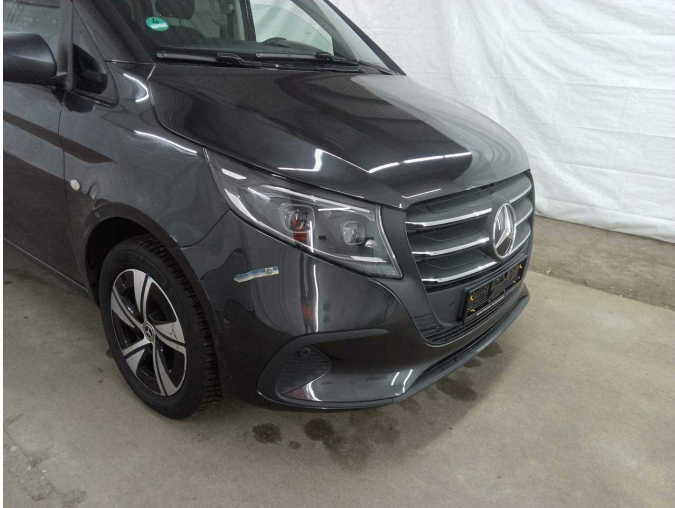
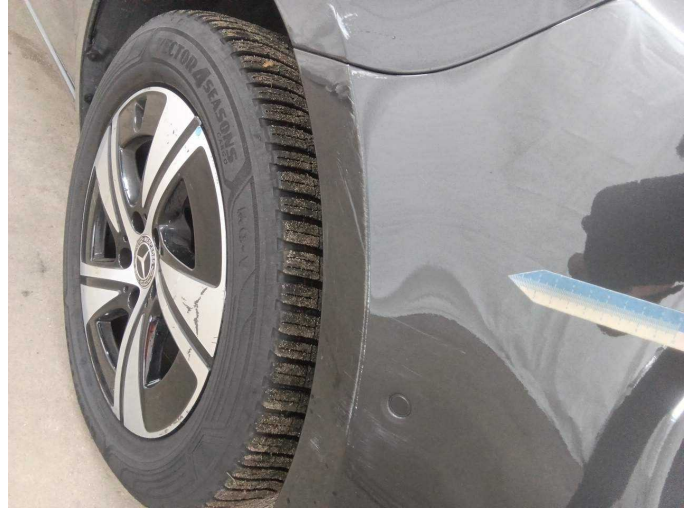
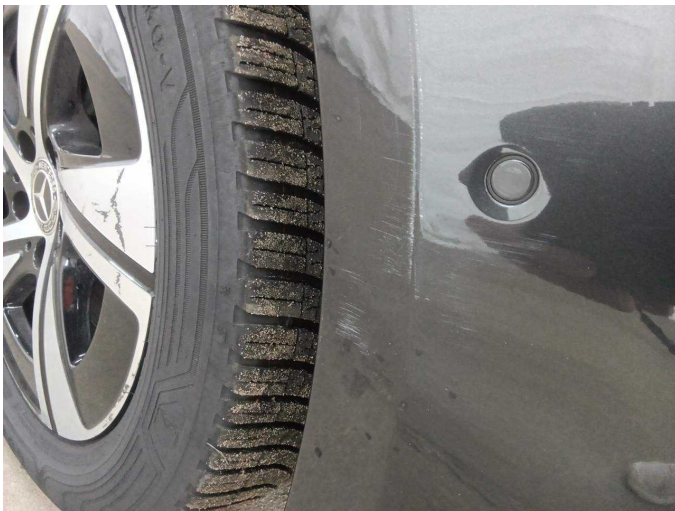
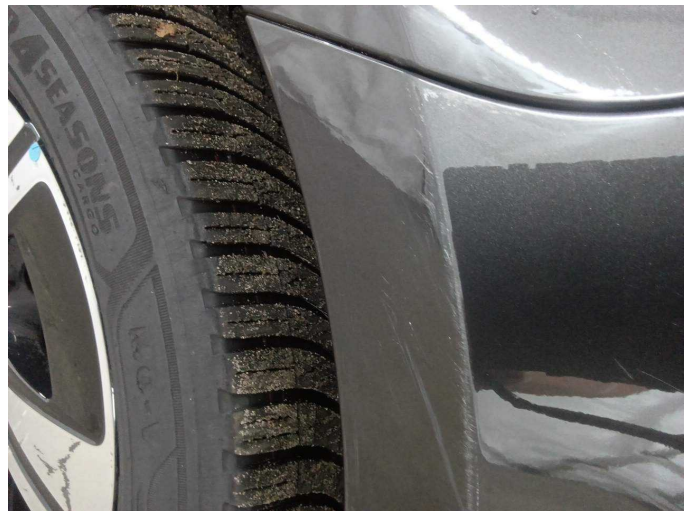
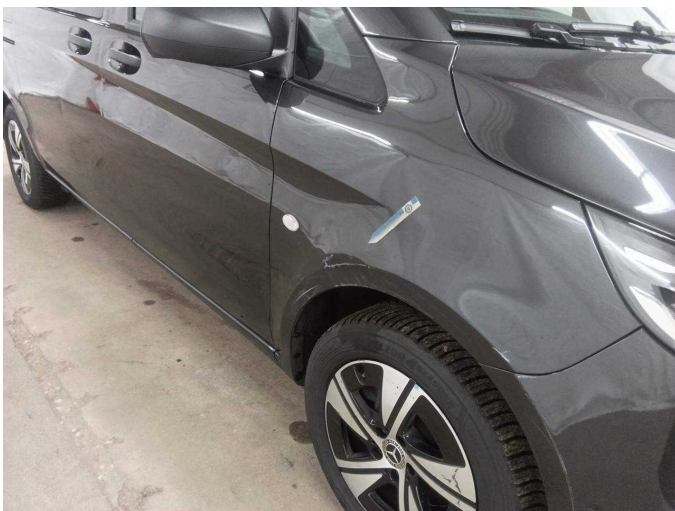
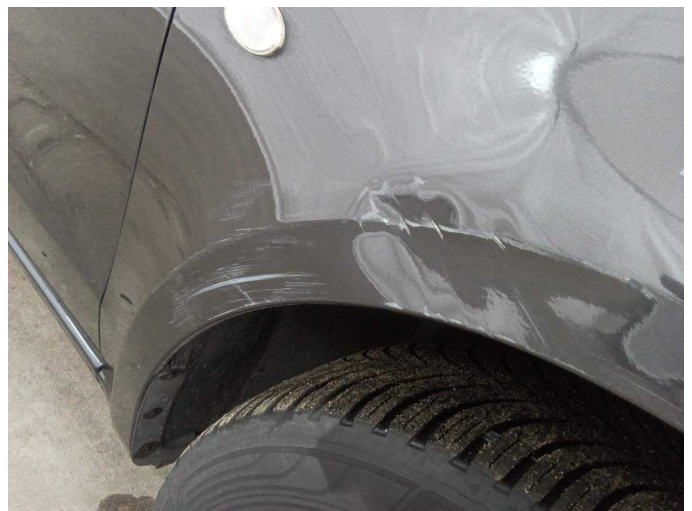
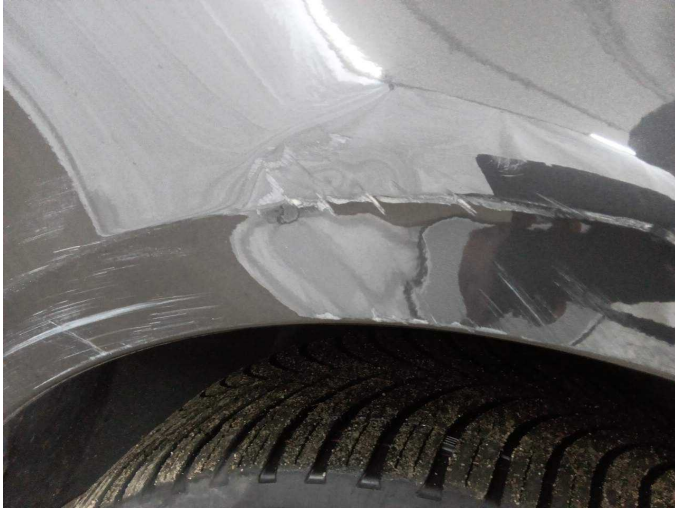
No.	Accident
1	Side right

Accident 1: Side right
