Expertise

Protocol number: 46708804  
Order No. / Reference: 26597112  
Inspection date: 24 Jul 2026

| Manufacturer: Opel | Model: Astra 1.5 D Start/Stop Sports Tourer Business Edition |
| VIN: W0VBD8EU2N8043891 | |

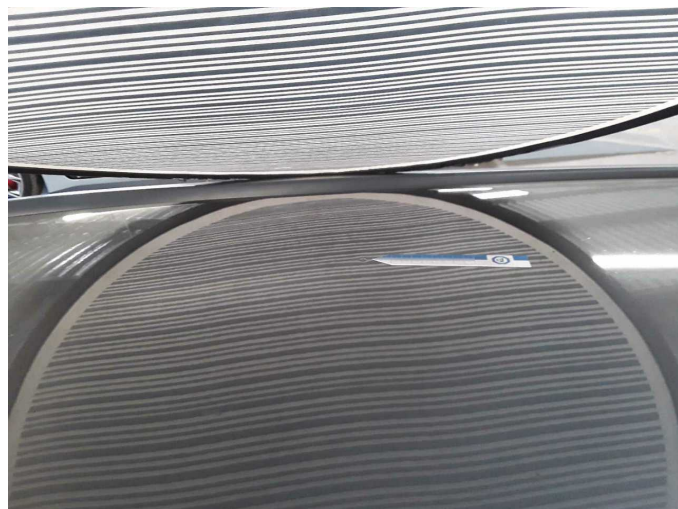
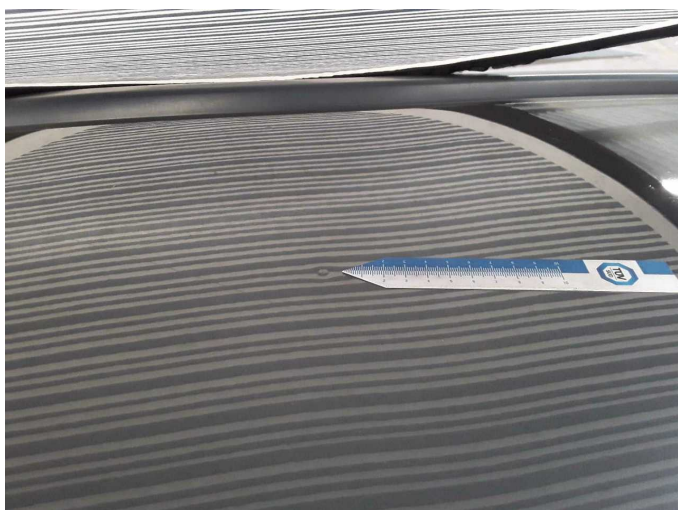
| No. | Component group | Description |
|---|---|---|
| 1 | Roof | Roof - dent(s) - Smooth repair work |

**Damage 1:** Roof: Roof - dent(s) - Smooth repair work

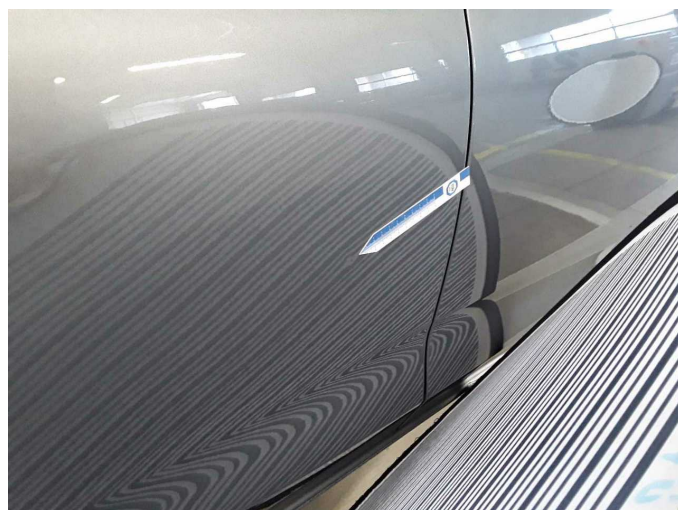
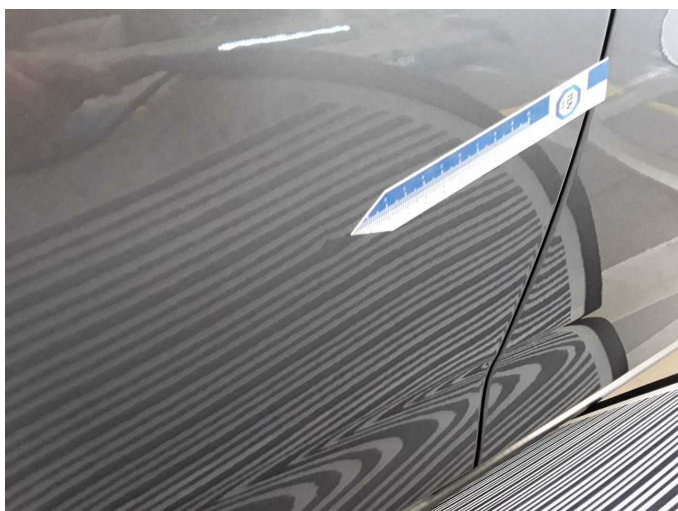
| No. | Component group | Description |
|---|---|---|
| 2 | Door - rear right side | Door - dent(s) - Smooth repair work |

**Damage 2:** Door - rear right side: Door - dent(s) - Smooth repair work

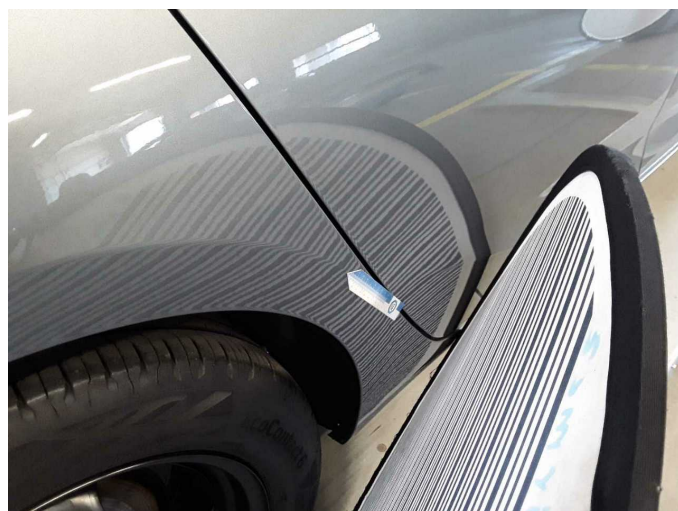
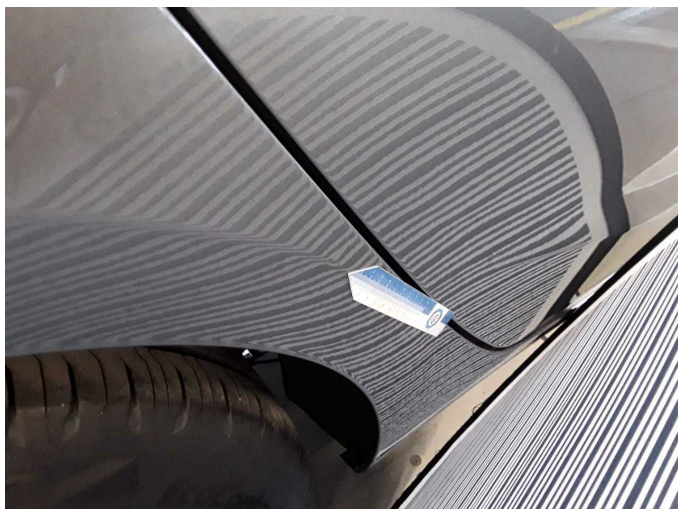
| No. | Component group | Description |
|---|---|---|
| 3 | Side panel - rear right side | Side panel - dent(s) - Smooth repair work |

**Damage 3:** Side panel - rear right side: Side panel - dent(s) - Smooth repair work

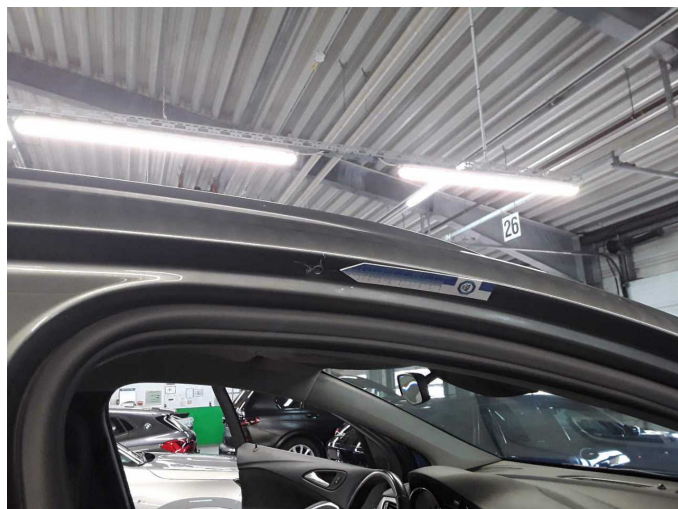
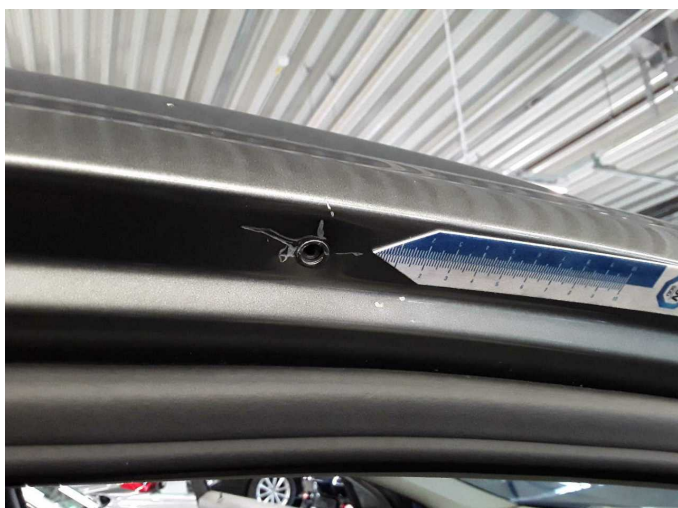
| No. | Component group | Description |
|---|---|---|
| 4 | Roof | Roof rail - right side - Dent / paintcoat damage - Smart repair |

**Damage 4:** Roof: Roof rail - right side - Dent / paintcoat damage - Smart repair

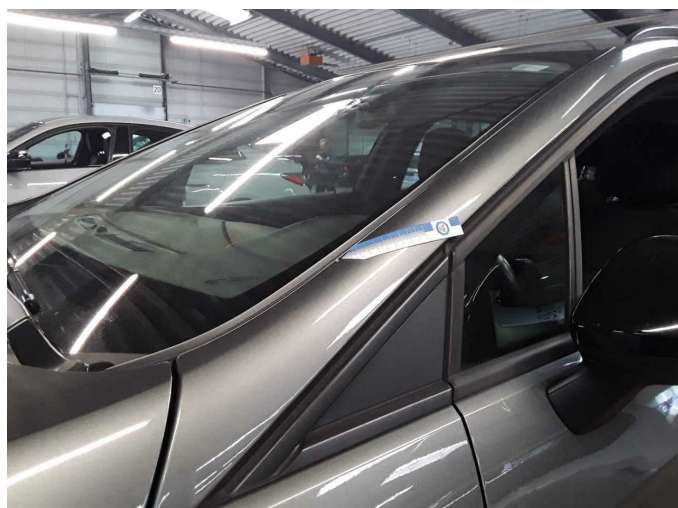
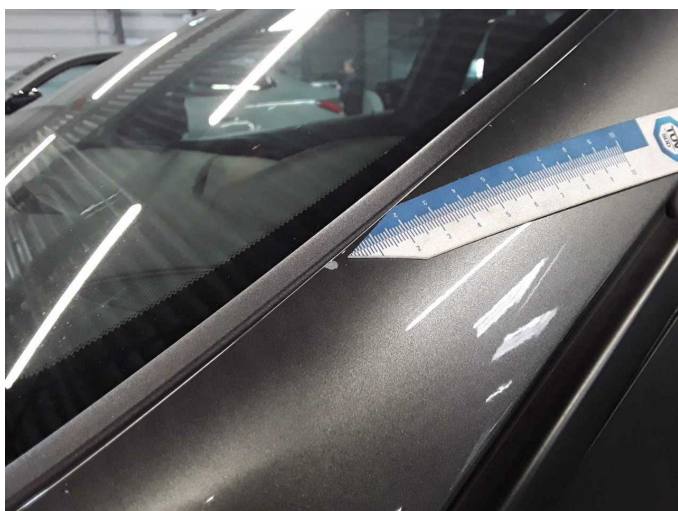
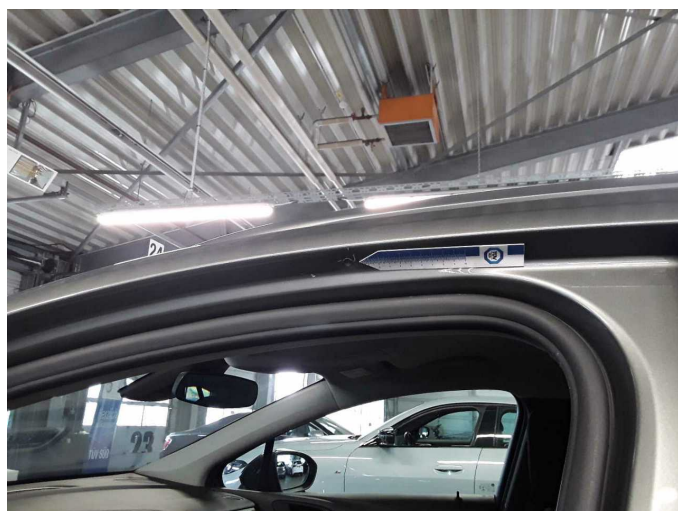
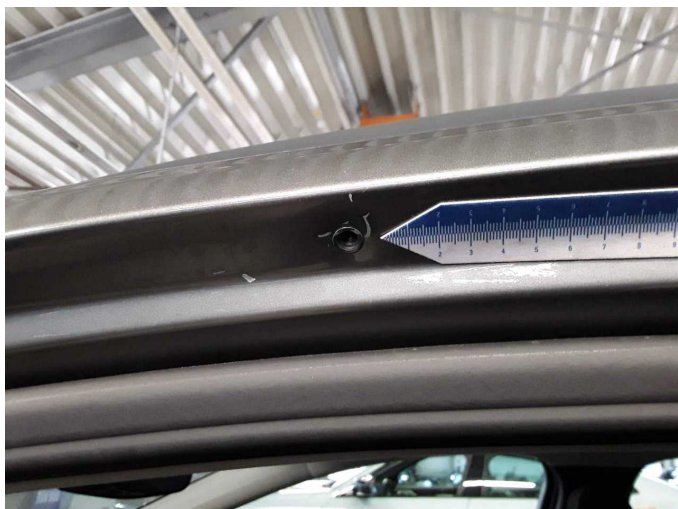
| No. | Component group | Description |
|---|---|---|
| 5 | Roof | Roof rail - left side - Dent / paintcoat damage - Smart repair |

**Damage 5:** Roof: Roof rail - left side - Dent / paintcoat damage - Smart repair

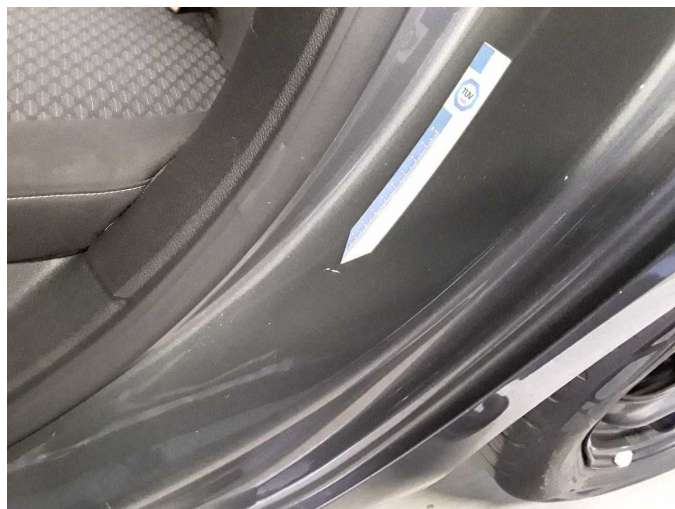
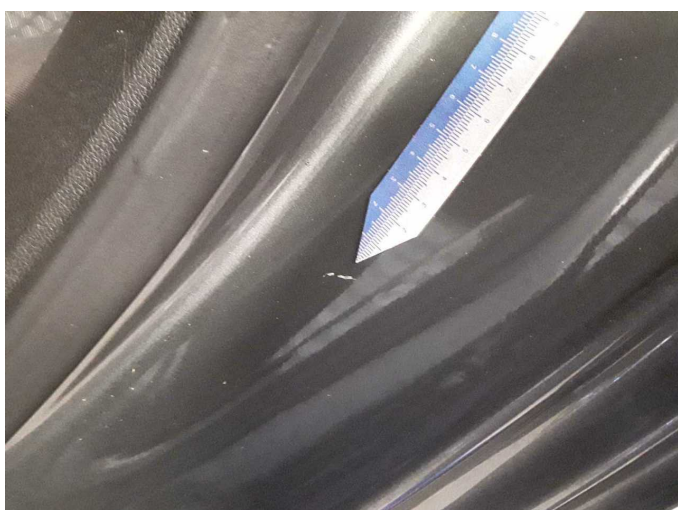
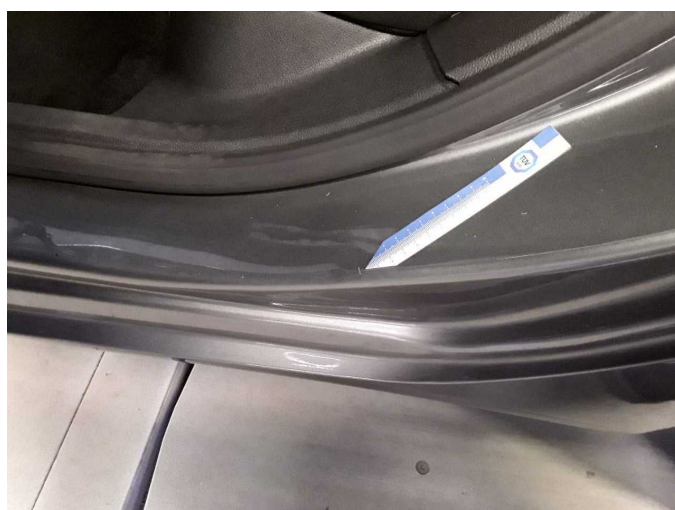
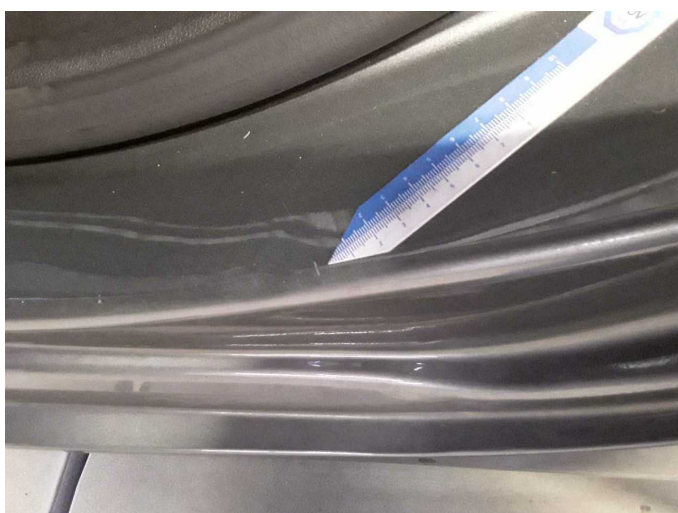
| No. | Component group | Description |
|---|---|---|
| 6 | Side panel - rear left side | Elbow - Scratched - Smart repair |

**Damage 6:** Side panel - rear left side: Elbow - Scratched - Smart repair

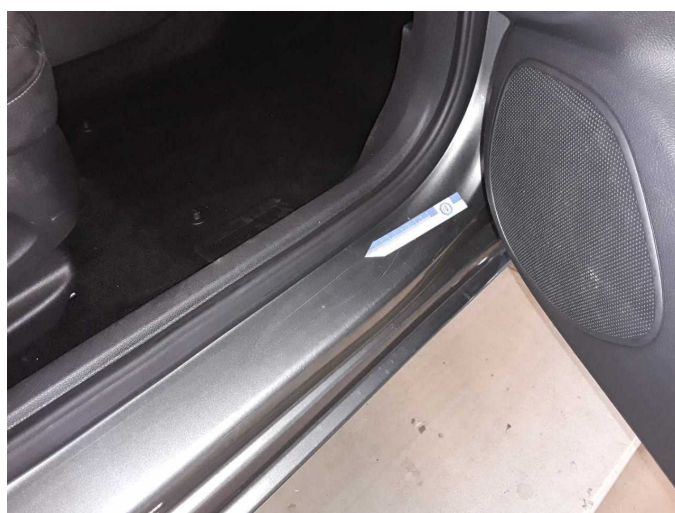
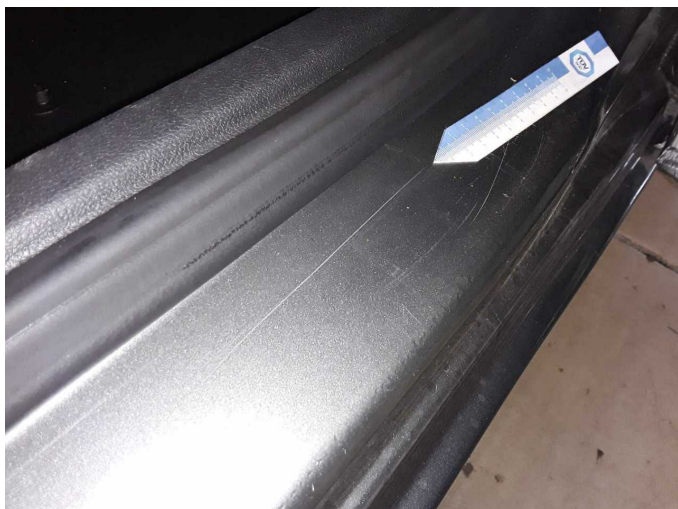
| No. | Component group | Description |
|---|---|---|
| 7 | Sill - right side | Sill - Scratch(es) - Smart repair |

**Damage 7:** Sill - right side: Sill - Scratch(es) - Smart repair

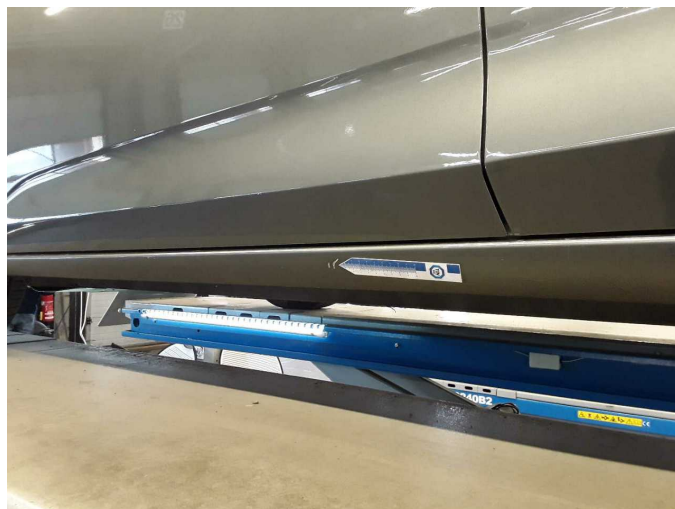
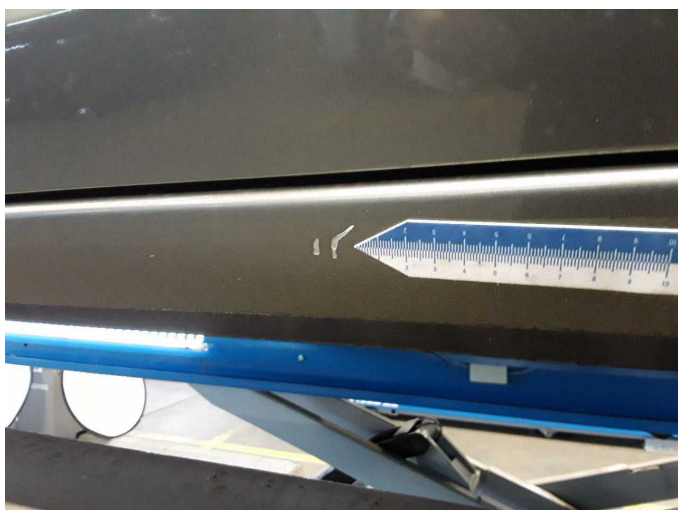
| No. | Component group | Description |
|---|---|---|
| 8 | Sill - left side | Sill - Scratch(es) - Smart repair |

**Damage 8:** Sill - left side: Sill - Scratch(es) - Smart repair

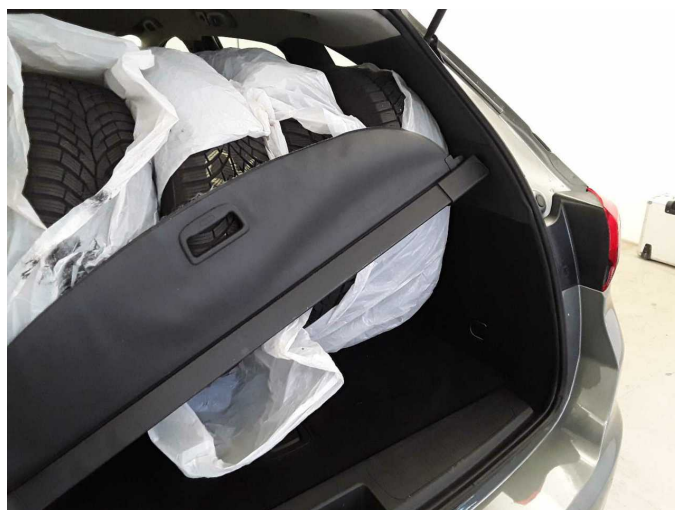
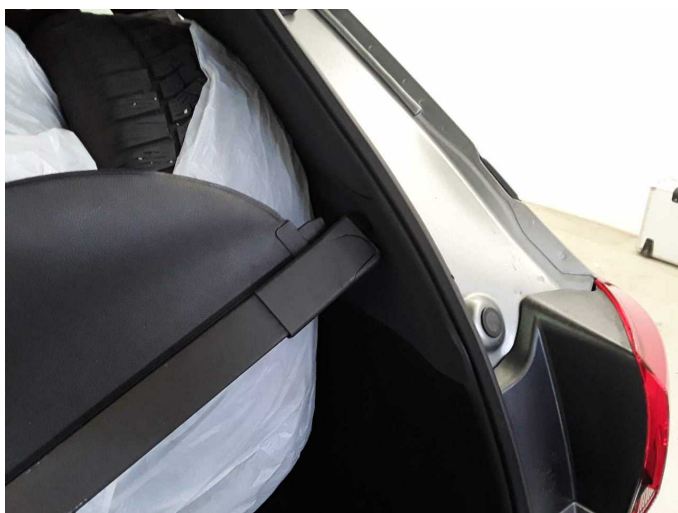
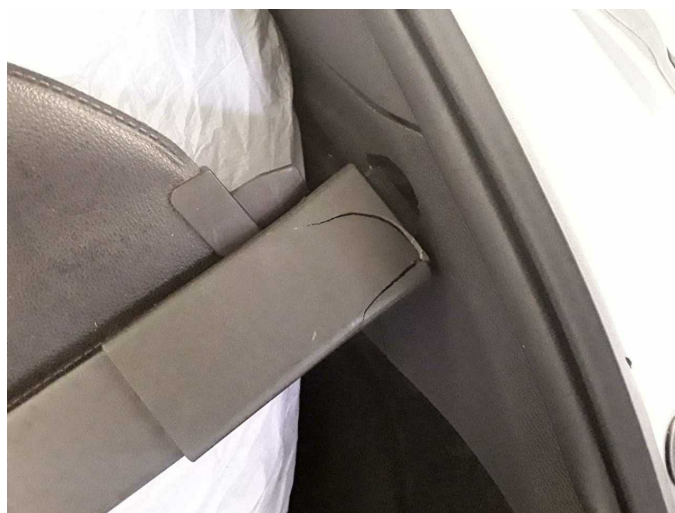
| No. | Component group | Description |
|---|---|---|
| 9 | Interior | Boot cover / roller cover - Broken / torn - Replace |

**Damage 9:** Interior: Boot cover / roller cover - Broken / torn - Replace

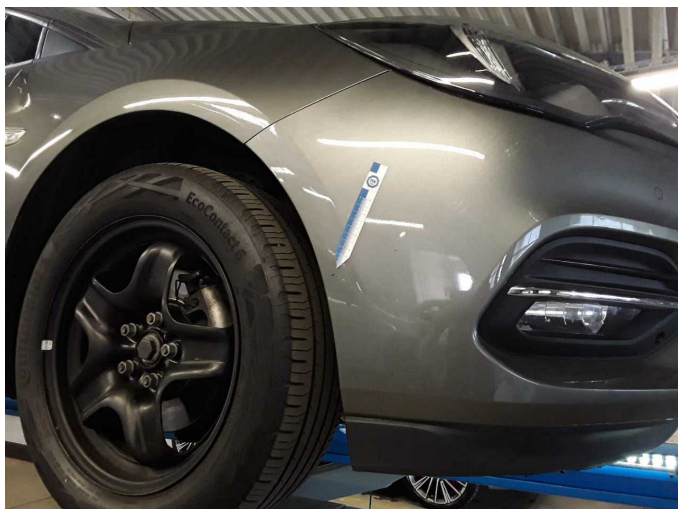
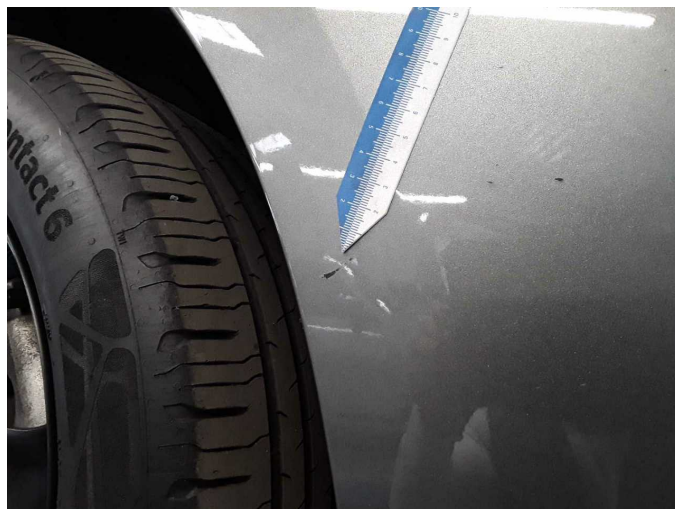
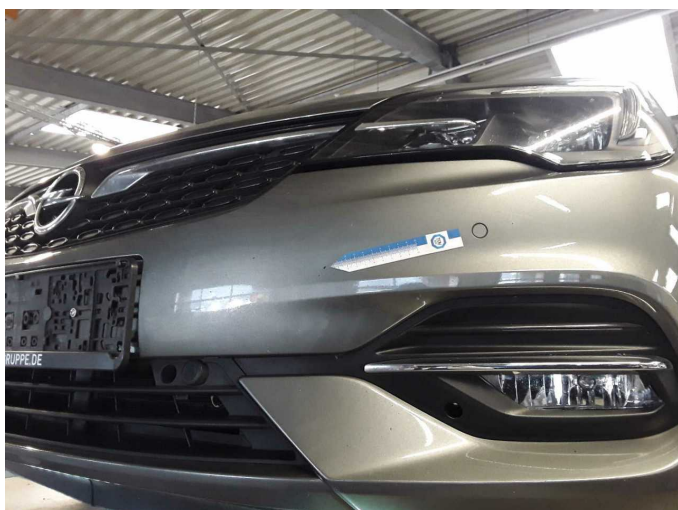
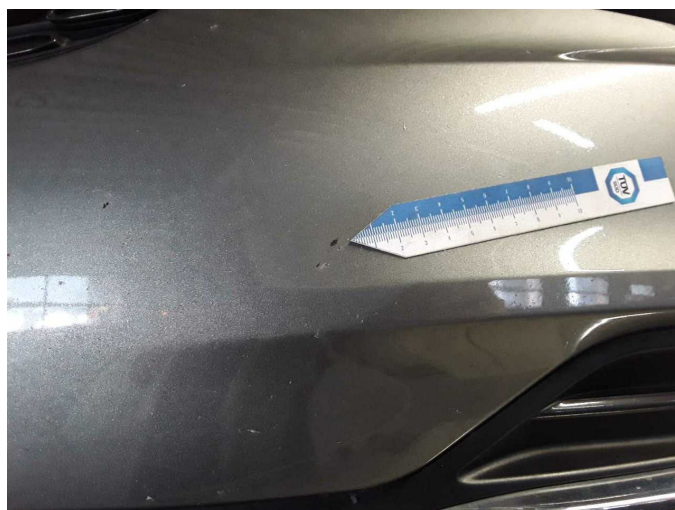
| No. | Component group | Description |
|---|---|---|
| 10 | Front bumper | Front bumper - Stone chips - Paint |

**Damage 10:** Front bumper: Front bumper - Stone chips - Paint

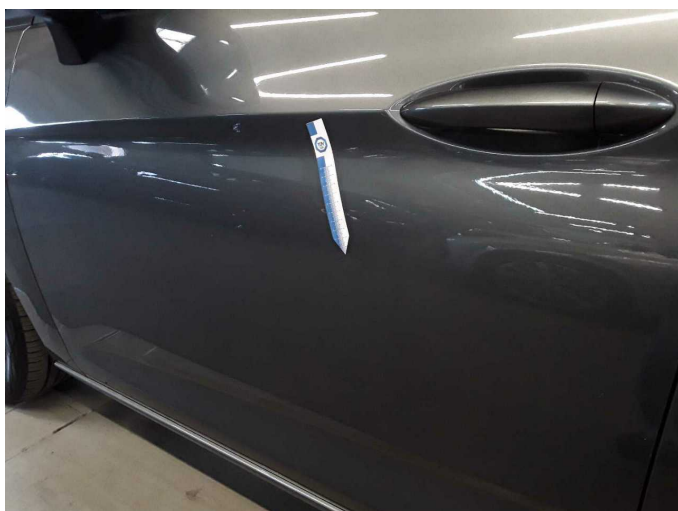
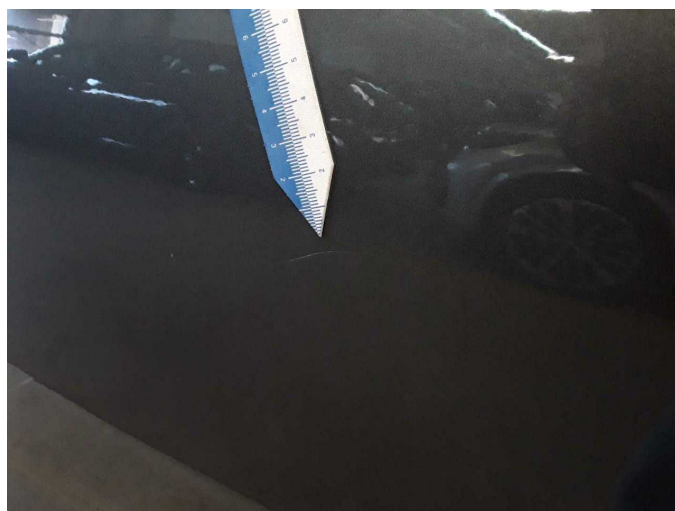
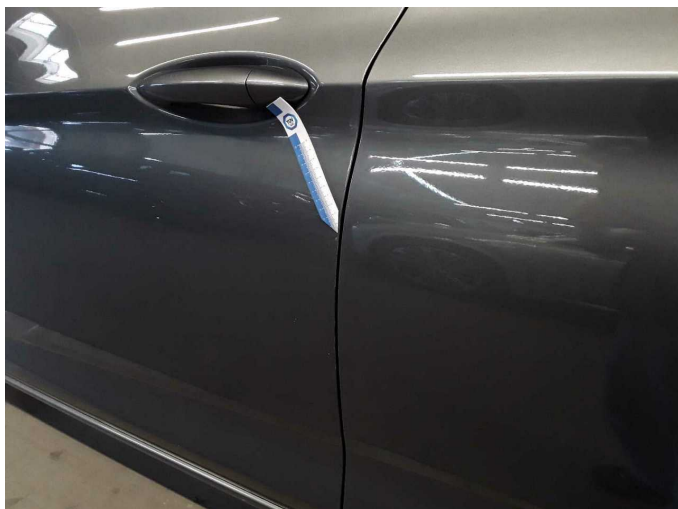
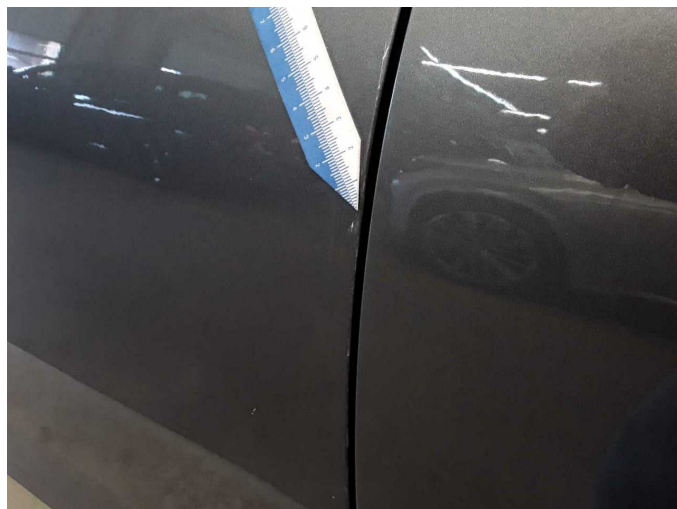
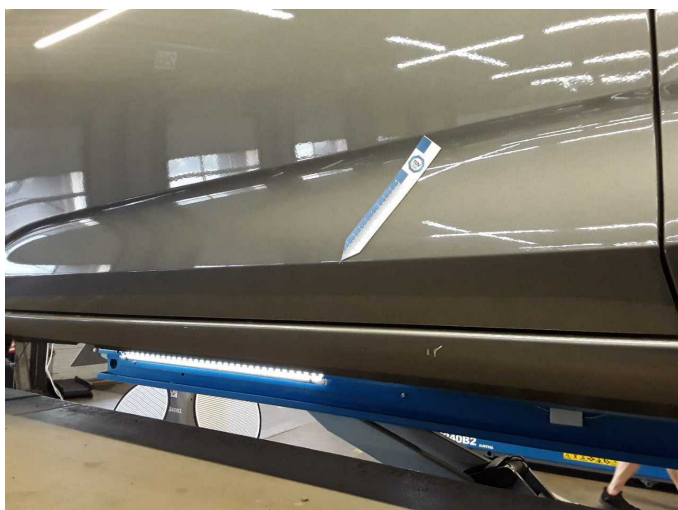
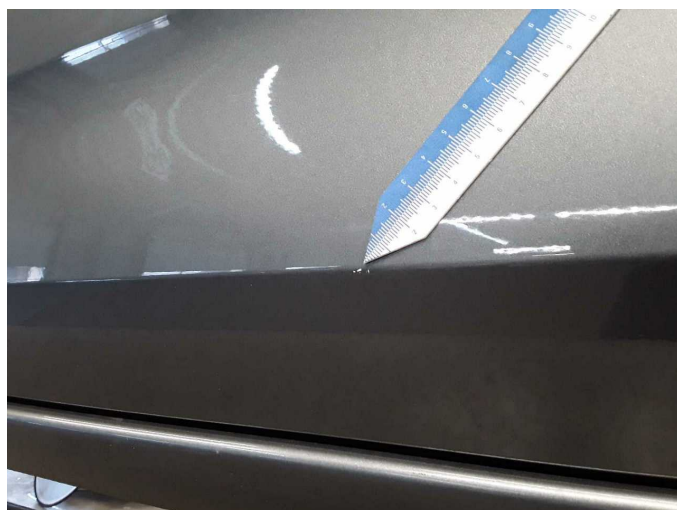
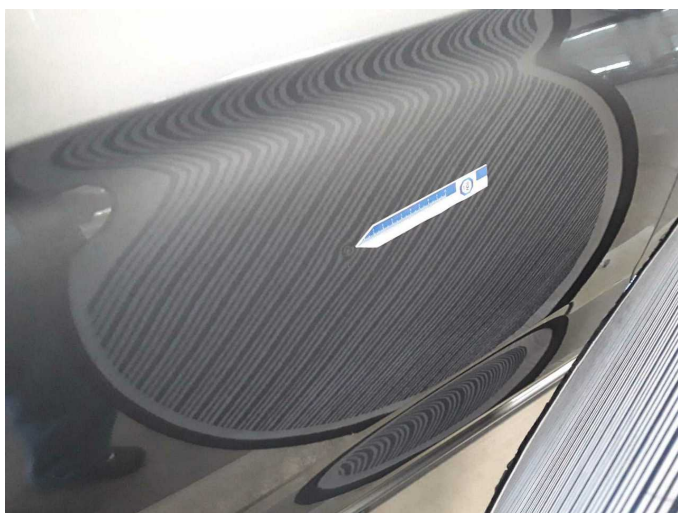
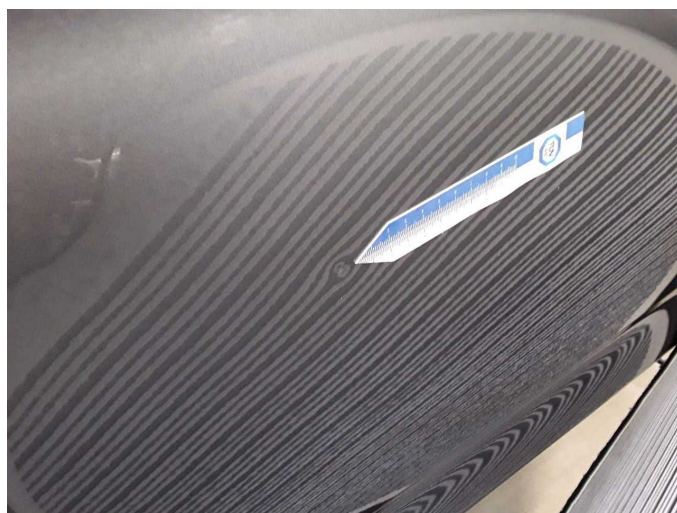
| No. | Component group | Description |
|---|---|---|
| 11 | Door - front left side | Door - Dent / paintcoat damage - Repair and paint |

**Damage 11:** Door - front left side: Door - Dent / paintcoat damage - Repair and paint

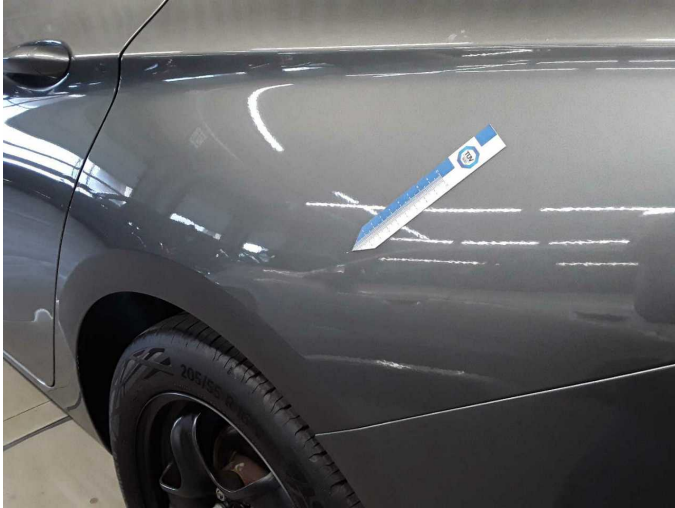
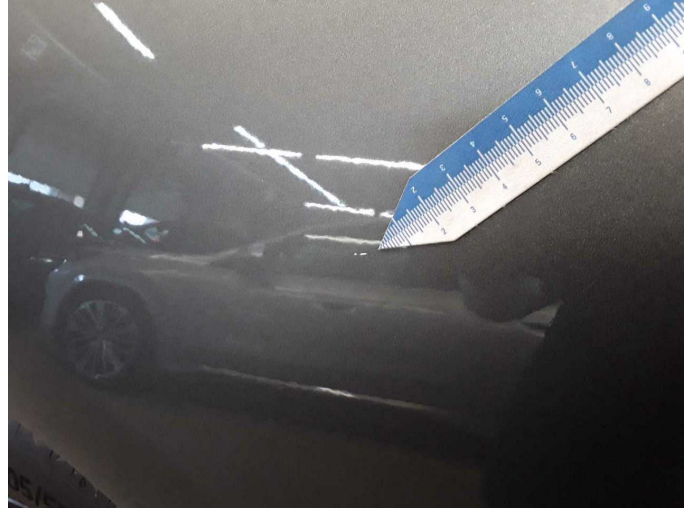
| No. | Component group | Description |
|---|---|---|
| 1 | Side panel - rear left side | Side panel - Scratch(es) - No deduction |

**Wear and tear 1:** Side panel - rear left side: Side panel - Scratch(es) - No deduction

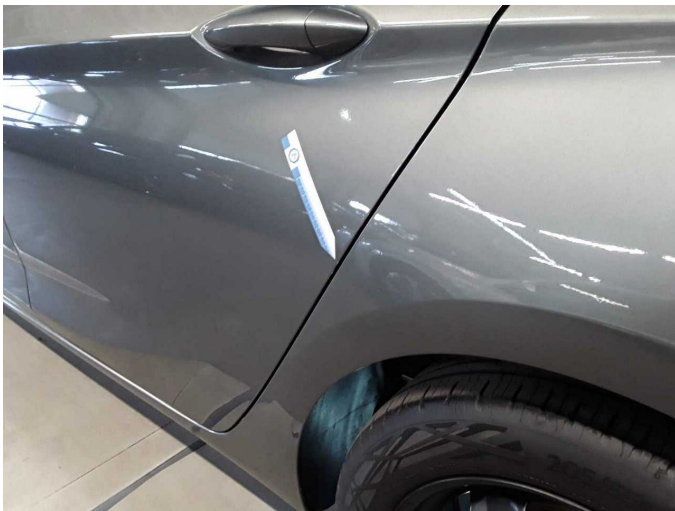
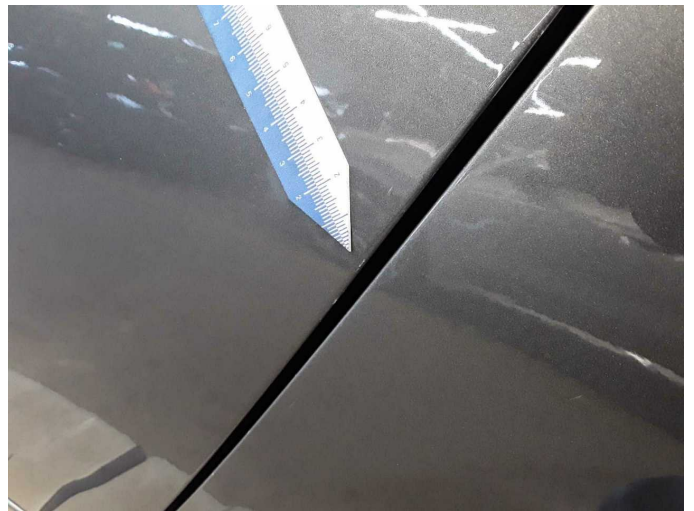
| No. | Component group | Description |
|---|---|---|
| 2 | Door - rear left side | Door - Scratch(es) - No deduction |

**Wear and tear 2:** Door - rear left side: Door - Scratch(es) - No deduction

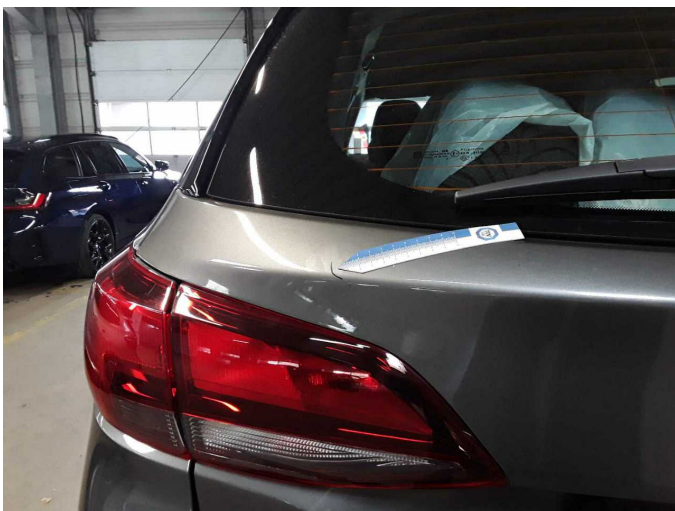
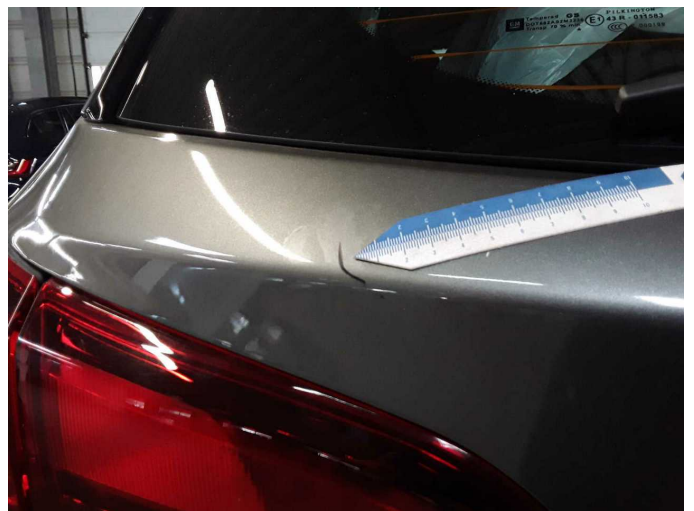
| No. | Component group | Description |
|---|---|---|
| 3 | Boot lid / rear door | Boot lid - Abrasion - No deduction |

**Wear and tear 3:** Boot lid / rear door: Boot lid - Abrasion - No deduction

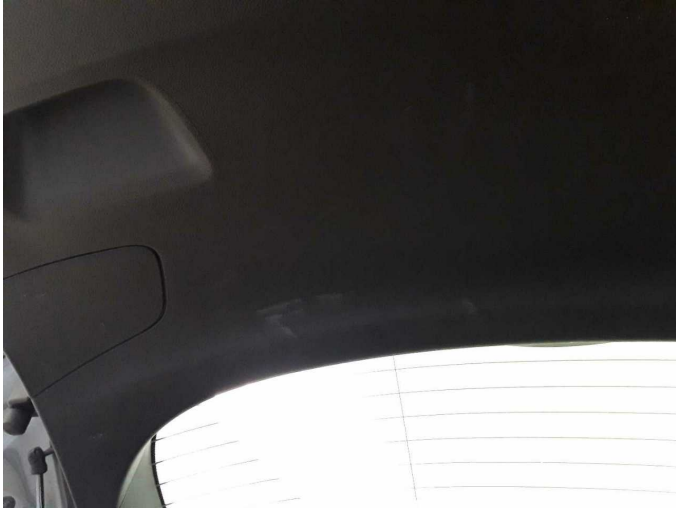
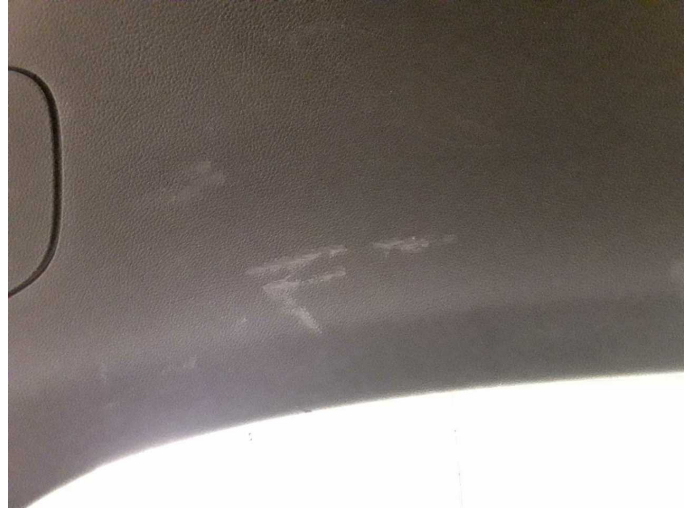
| No. | Component group | Description |
|---|---|---|
| 4 | Boot lid / rear door | Trim - standard - lower - Scratched - No deduction |

**Wear and tear 4:** Boot lid / rear door: Trim - standard - lower - Scratched  
- No deduction

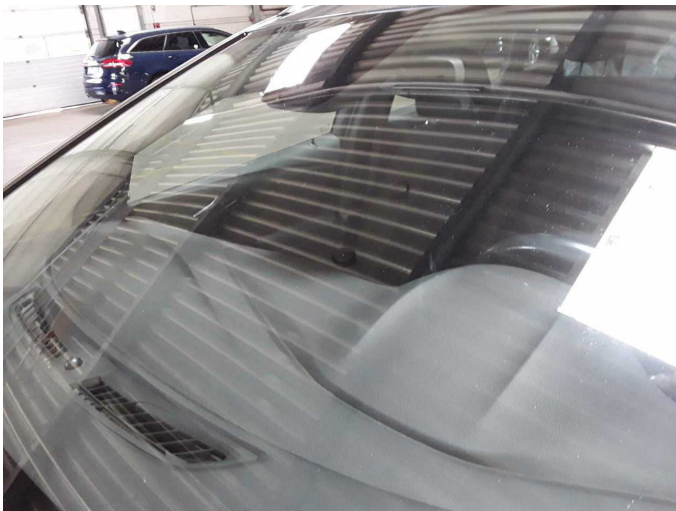
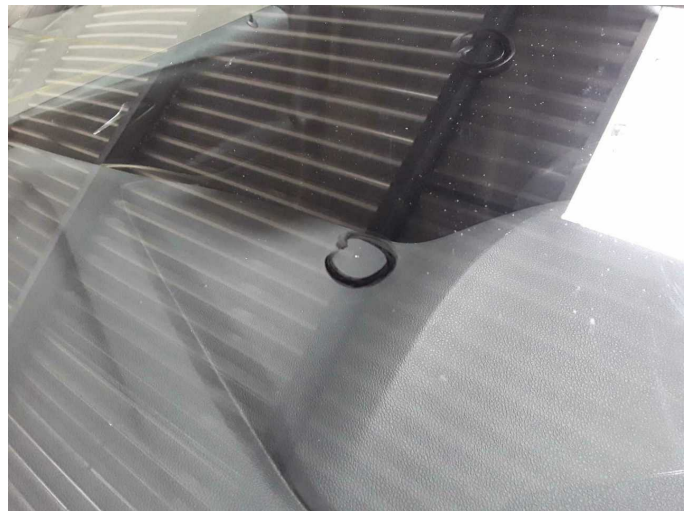
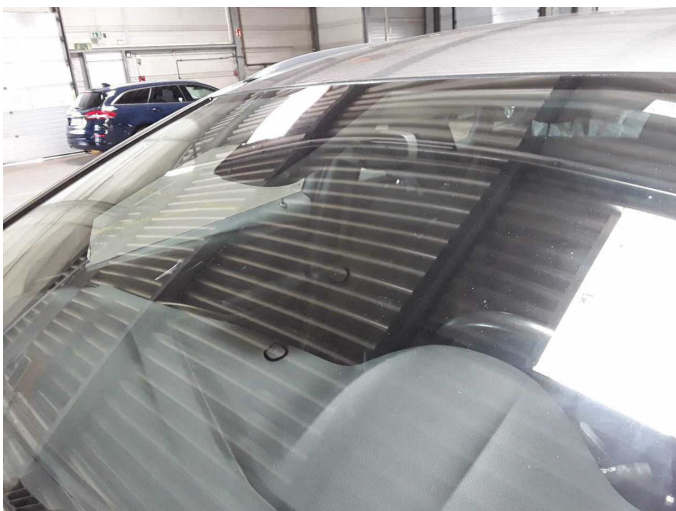
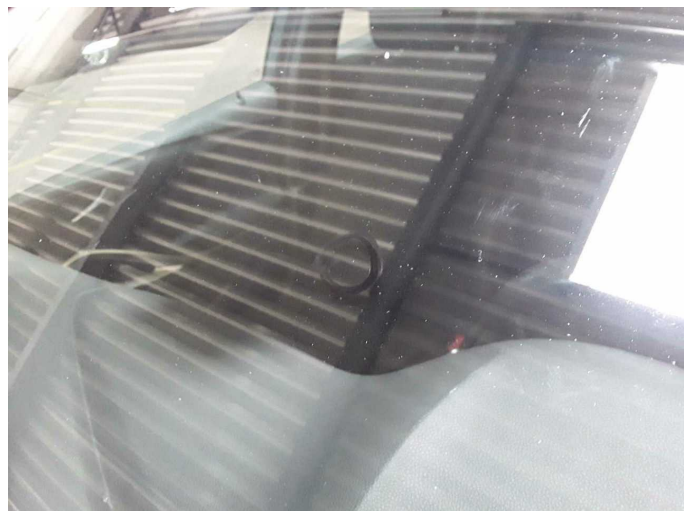
| No. | Component group | Description |
|---|---|---|
| 5 | Vehicle glazing | Windscreen - Stone chips - No deduction |

**Wear and tear 5:** Vehicle glazing: Windscreen - Stone chips - No deduction

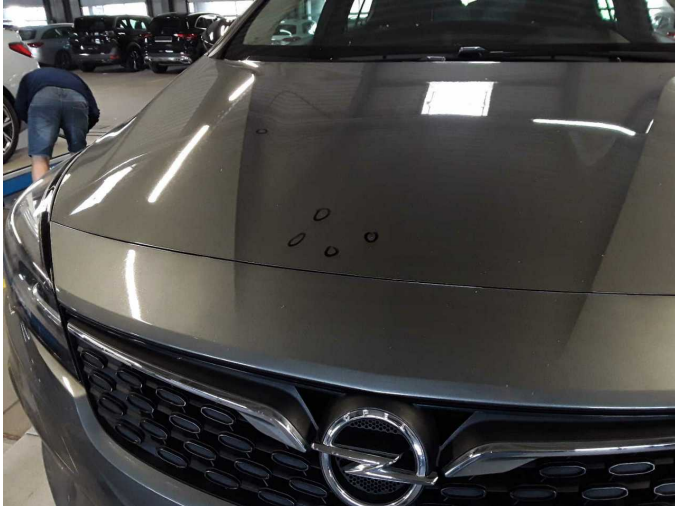
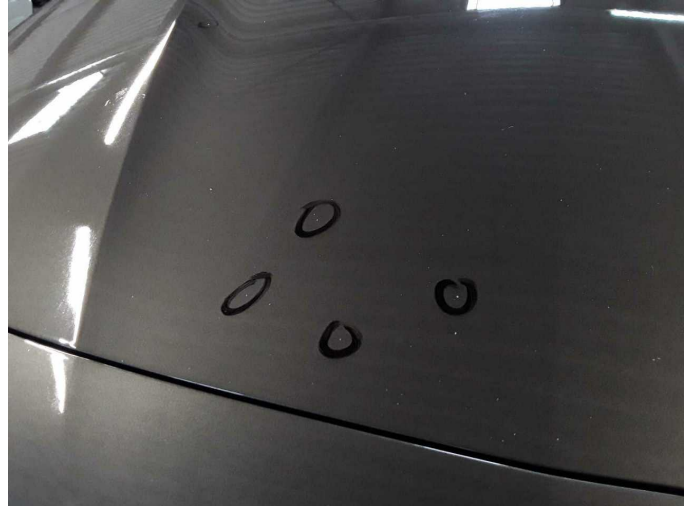
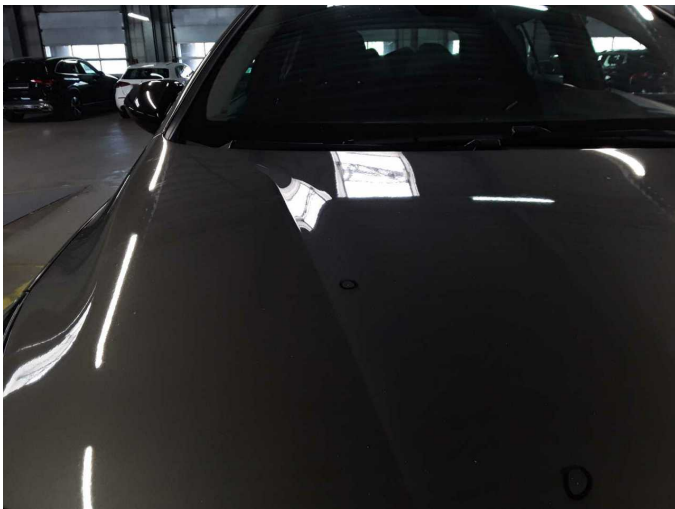
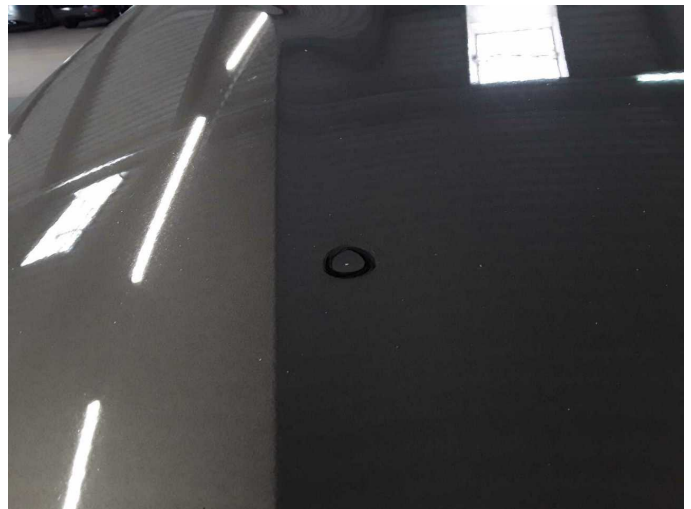
| No. | Component group | Description |
|---|---|---|
| 6 | Bonnet | Bonnet - Stone chips - No deduction |

**Wear and tear 6:** Bonnet: Bonnet - Stone chips - No deduction

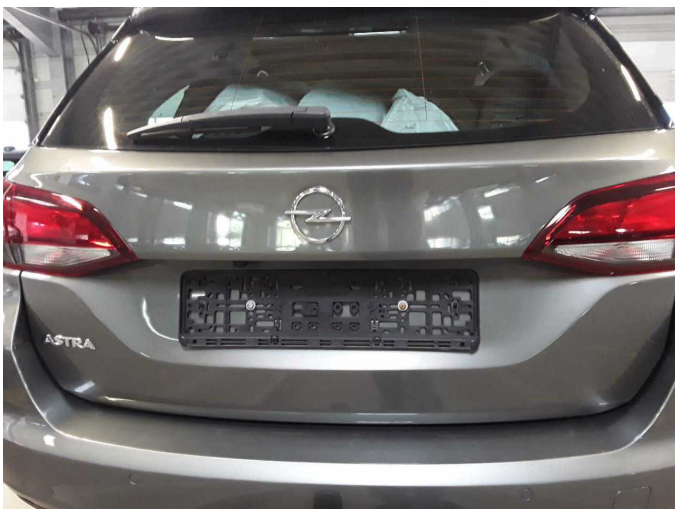
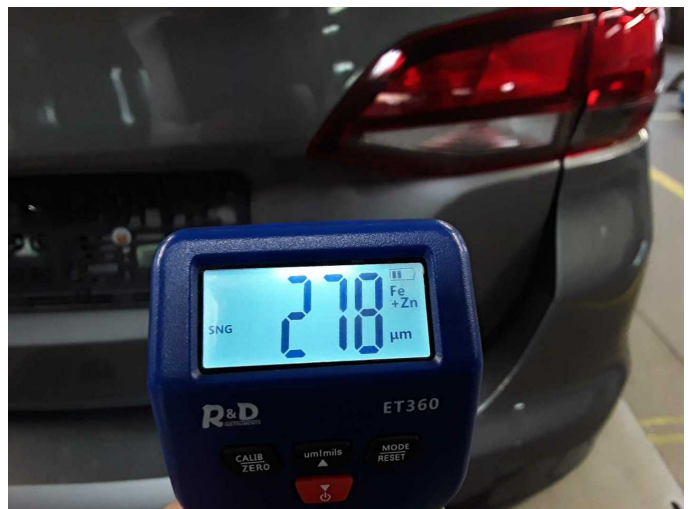
1 Boot lid / rear door, Professionally carried out

**Boot lid / rear door:** 278 µm
