Expertise

Protocol number: 45786733
Order No. / Reference: 25933805
Inspection date: 1 Jun 2026

Model: Vito 116 CDI Tourer Lang Aut. PRO

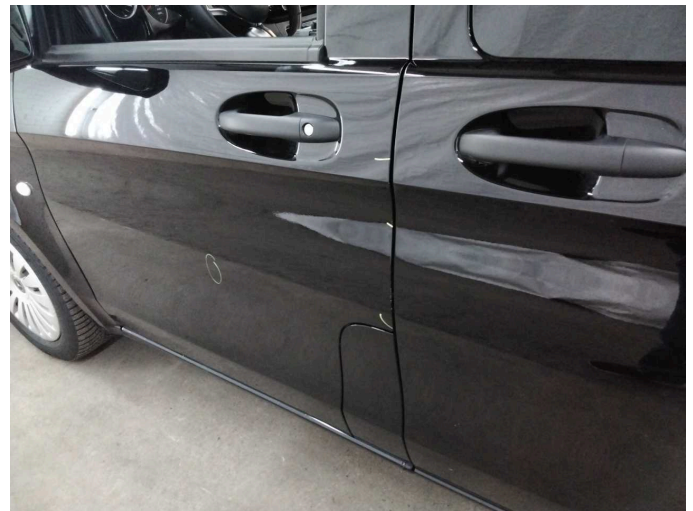
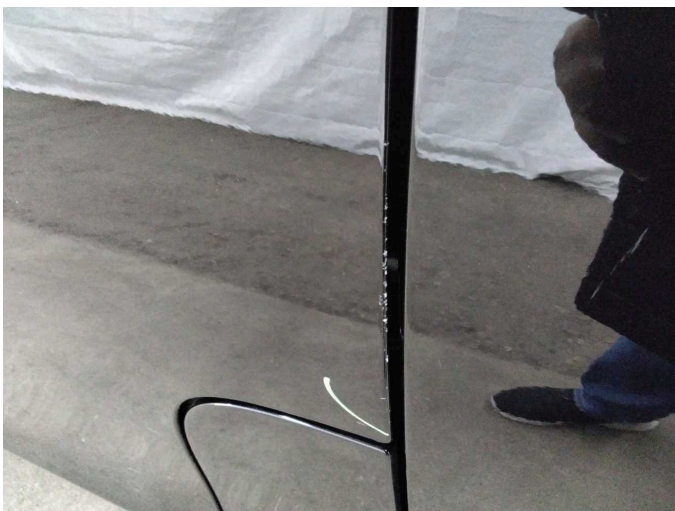
Damage 1: Door - front left side: Door edge - Scratch(es) - Smart repair

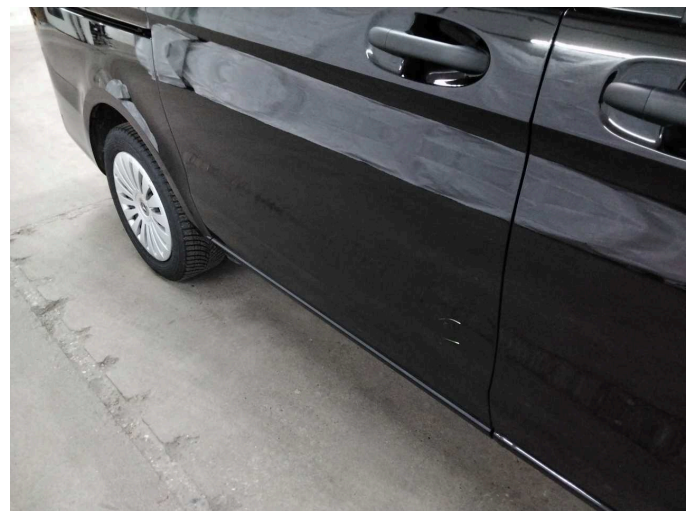
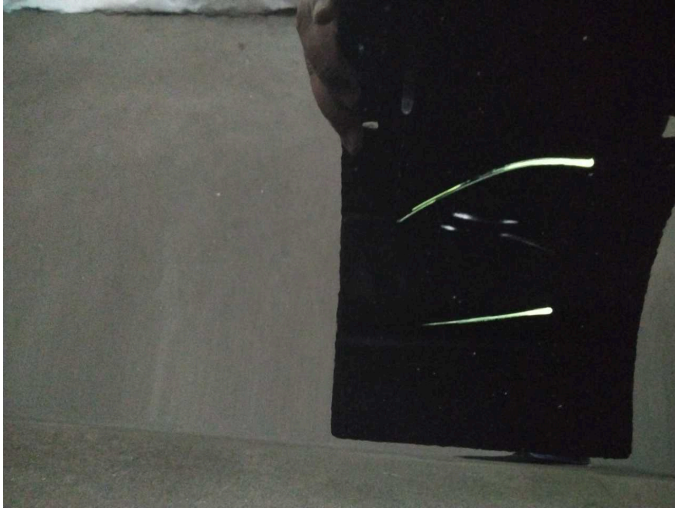
Damage 2: Door - rear right side: Door - Scratch(es) - Smart repair

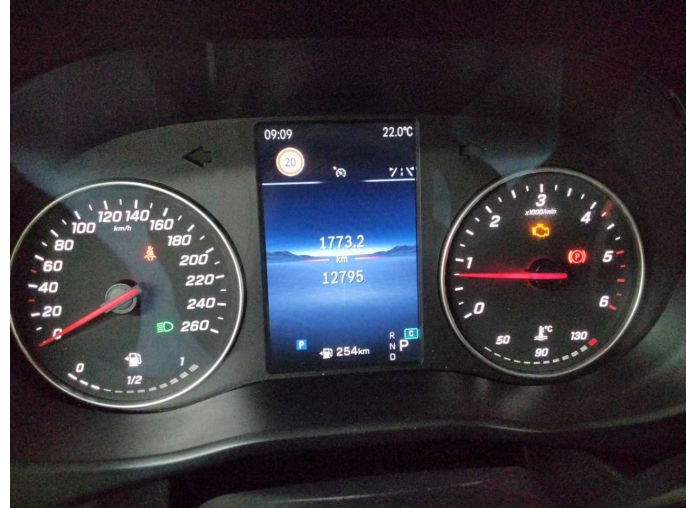
Documents submitted	At the time of the inspection, the vehicle registration certificate Part 2 (title) was available, but the vehicle registration certificate Part 1 (document) was not. (Copy)
VIN comparison	The vehicle identification number (VIN) was read from the vehicle and its conformity with the submitted documents was confirmed by the undersigned during the inspection.
Inspection	The inspection conditions were sufficient for the assessment of the vehicle. No lifting equipment or pit was available for inspecting the vehicle. Therefore, inspection of the vehicle's underside was only possible to a limited extent.
Test drive	No test drive/shunting maneuver was carried out during the inspection of the vehicle.
Engine function test	An engine test run was performed, problem has been detected This is due to the following reason.: Motorkontrolle aktiv

Damage 3: Instrument panel: Indicator light (Motorkontrolle) - on - Perform diagnosis

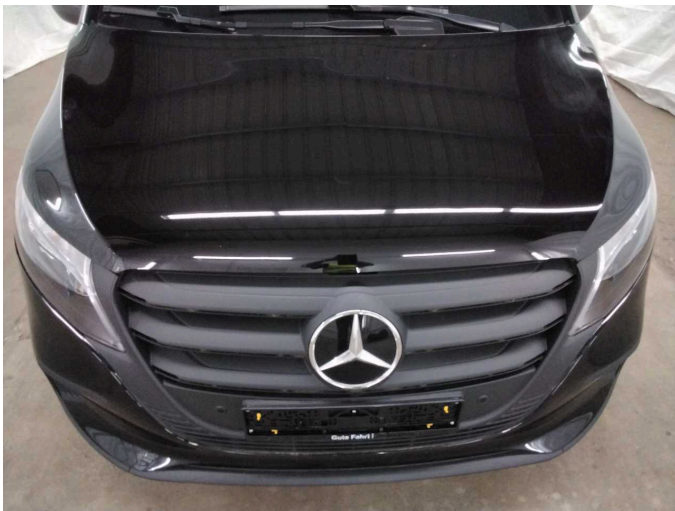
Wear and tear 3: Bonnet: Bonnet - Stone chips - No deduction

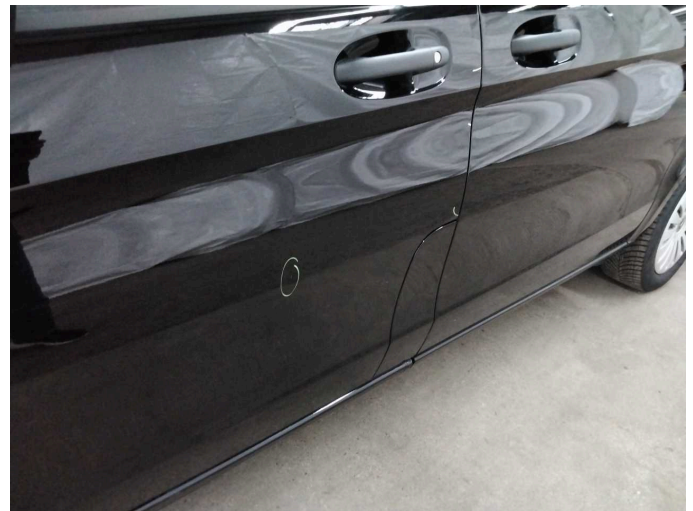
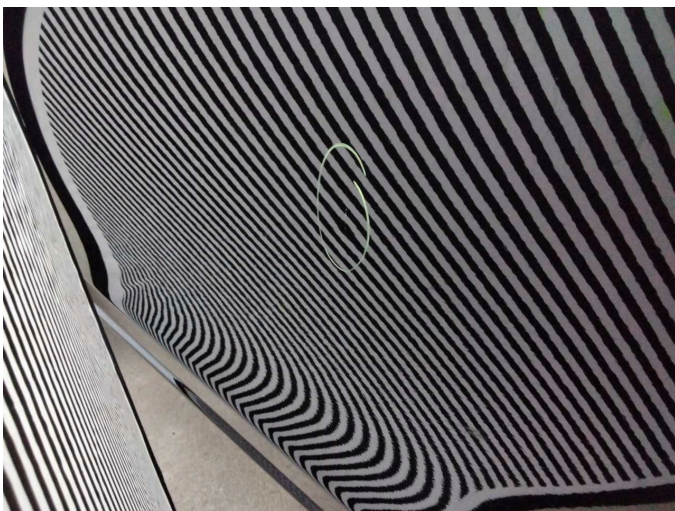
Wear and tear 6: Door - front left side: Door - Dent / paintcoat damage - No deduction
