Expertise

Protocol number: 45769797
Order No. / Reference: 26389835
Inspection date: 2 Jun 2026

Model: Leon Sportstourer 2.0 TDI DSG FR

VIN: VSSZZZKLZNR034034

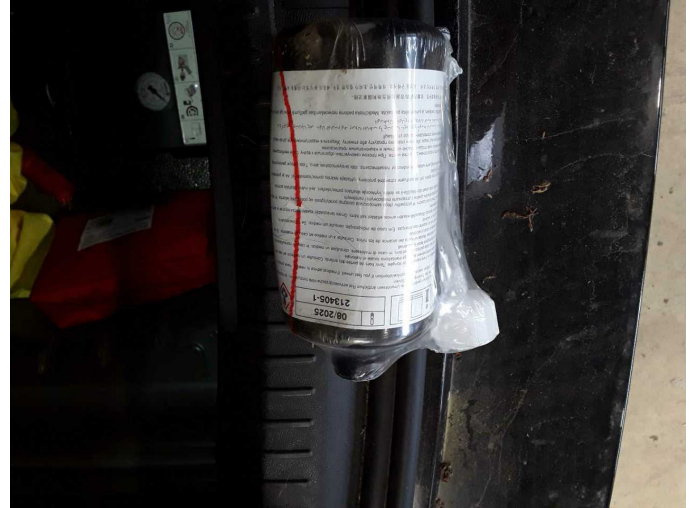
Damage 1: Equipment: Tirefit filler - Expired - Replace

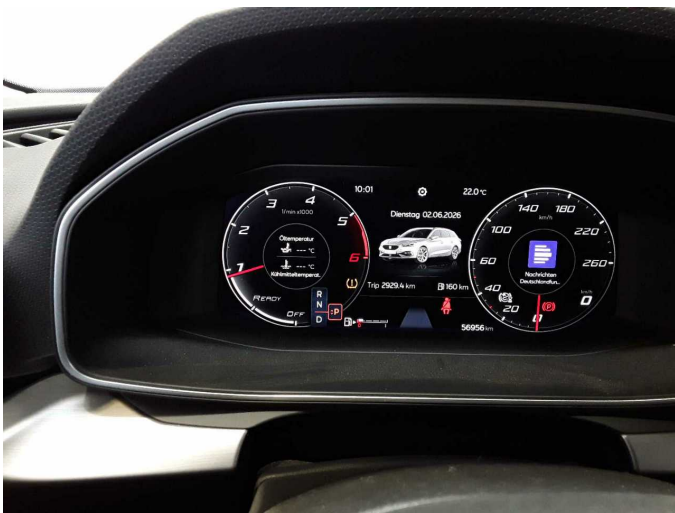
Damage 2: Instrument panel: Indicator light (Reifendruck) - on - Perform diagnosis

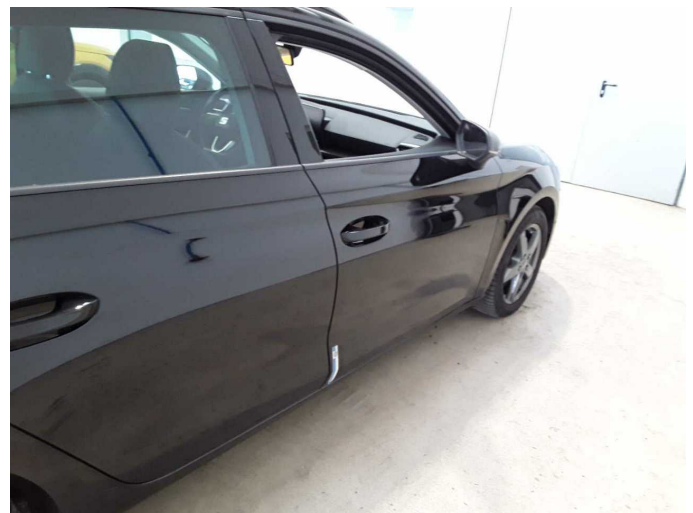
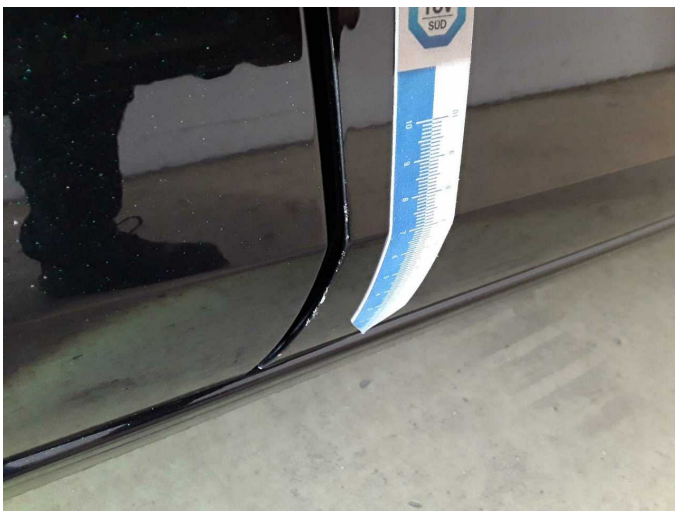
Damage 3: Door - front right side: Door edge - Scratch(es) - Smart repair
