Expertise

Protocol number: 46042273
Order No. / Reference: 26153777
Inspection date: 16 Jun 2026

Model: 317 CDI Sprinter Standard HA PRO

VIN: W1V3KBFZ7TP863830

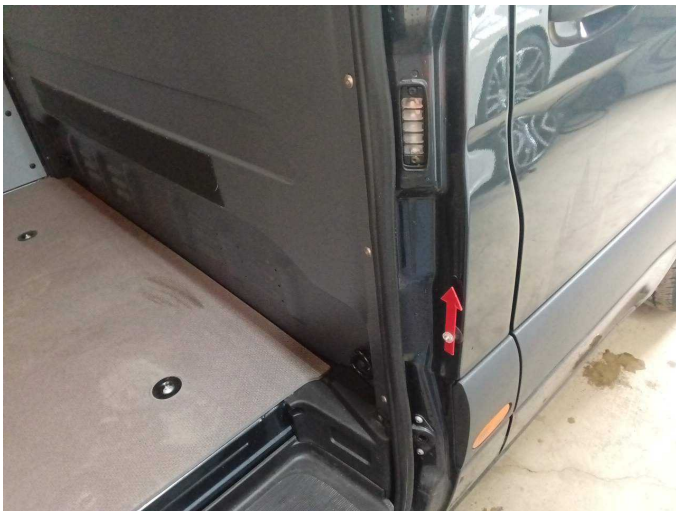
Damage 1: Body: B-pillar - right side - dent(s) - Smooth repair work

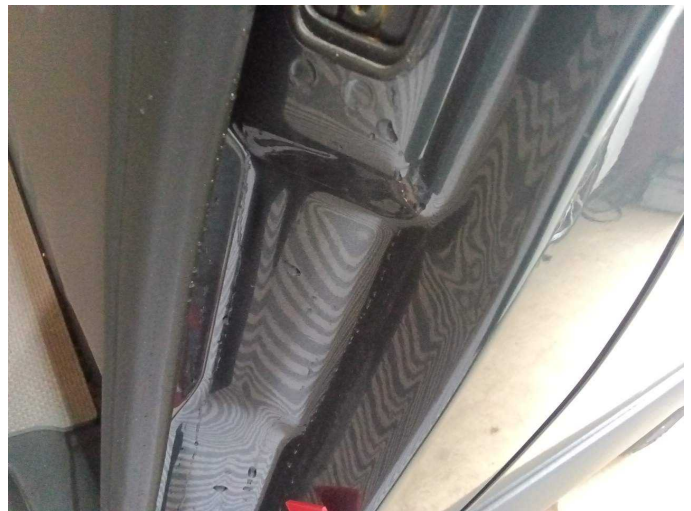
Damage 1: Body: B-pillar - right side - dent(s) - Smooth repair work

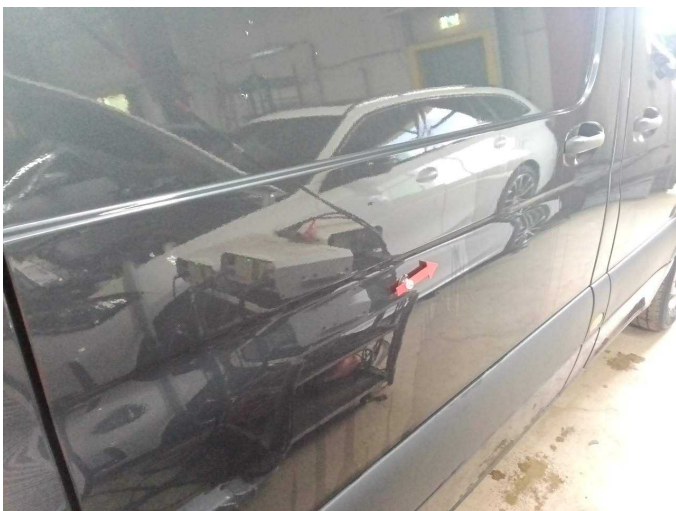
Damage 2: Sliding door, right: Sliding door - dent(s) - Smooth repair work

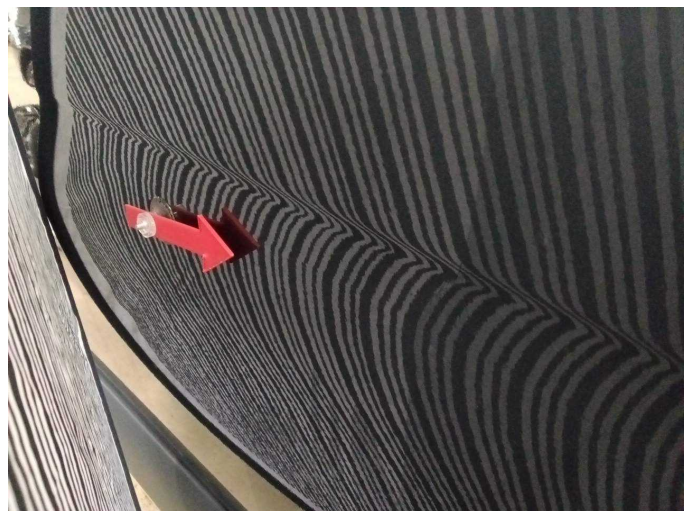
Damage 2: Sliding door, right: Sliding door - dent(s) - Smooth repair work

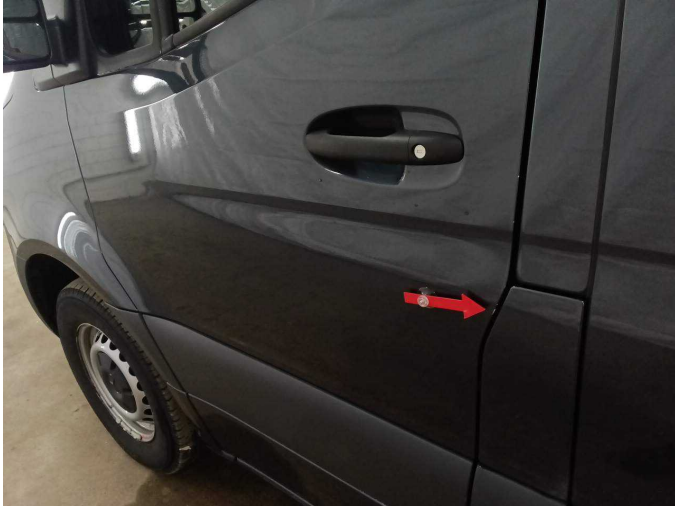
Damage 3: Door - front left side: Door edge - Scratch(es) - Smart repair

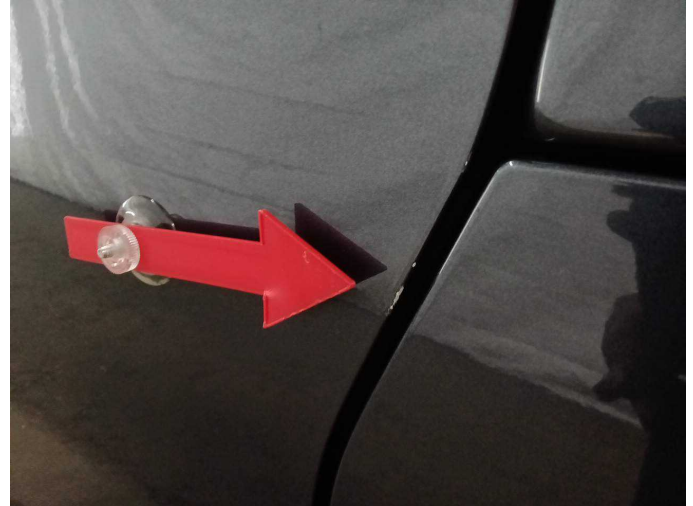
Damage 3: Door - front left side: Door edge - Scratch(es) - Smart repair

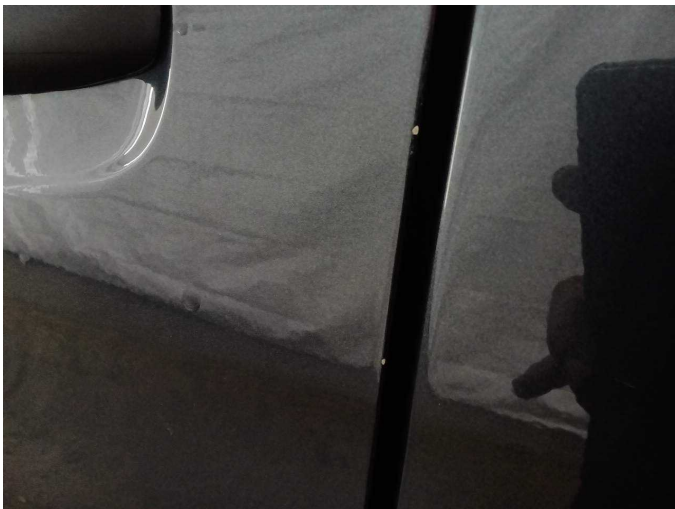
Damage 3: Door - front left side: Door edge - Scratch(es) - Smart repair

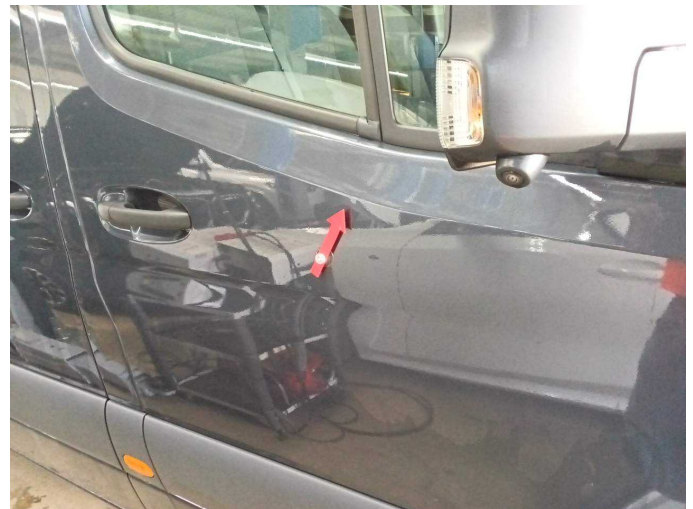
Damage 4: Door - front right side: Door - Dent / paintcoat damage - Smart repair

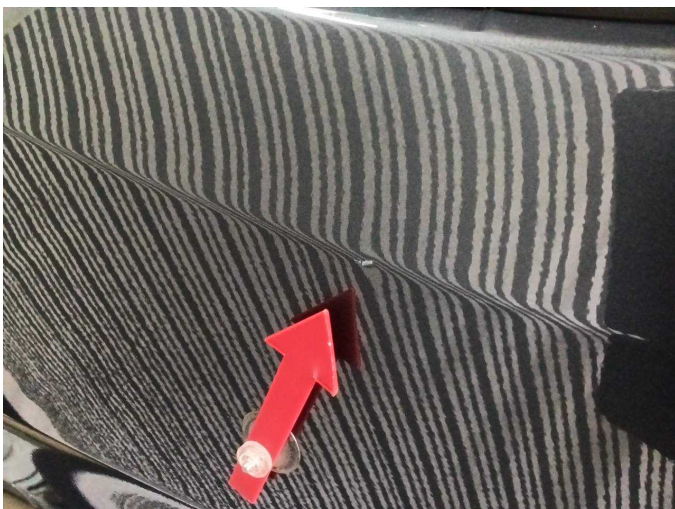
Damage 4: Door - front right side: Door - Dent / paintcoat damage - Smart repair

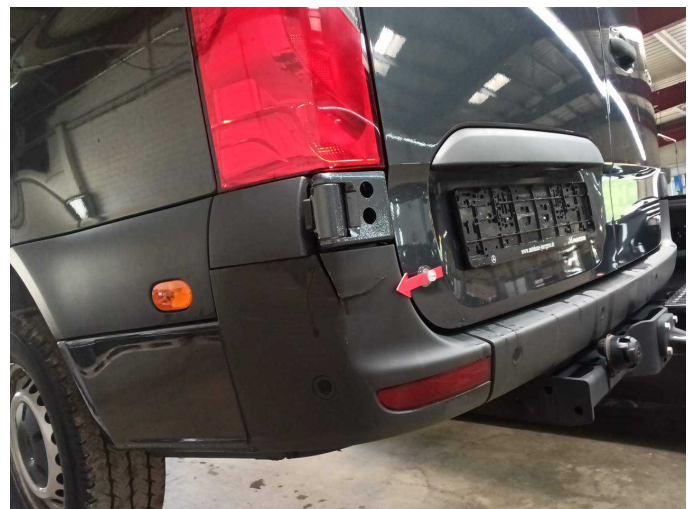
Damage 5: Rear bumper: Bumper - rear left side (Eckteil) - Broken / torn - Replace

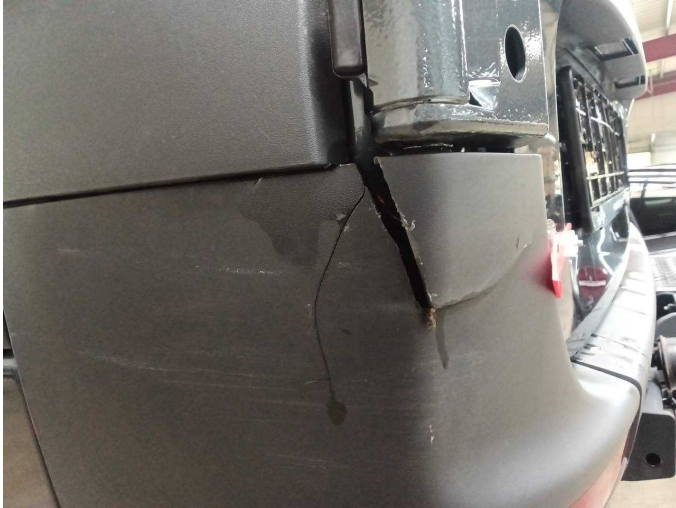
Damage 5: Rear bumper: Bumper - rear left side (Eckteil) - Broken / torn - Replace

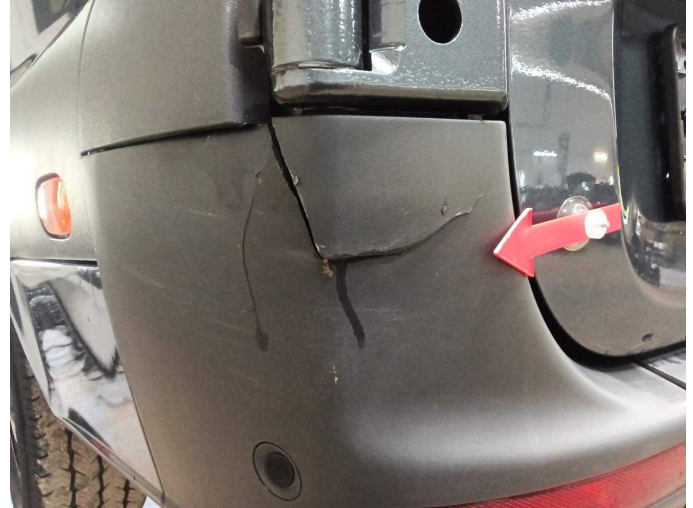
Damage 5: Rear bumper: Bumper - rear left side (Eckteil) - Broken / torn - Replace

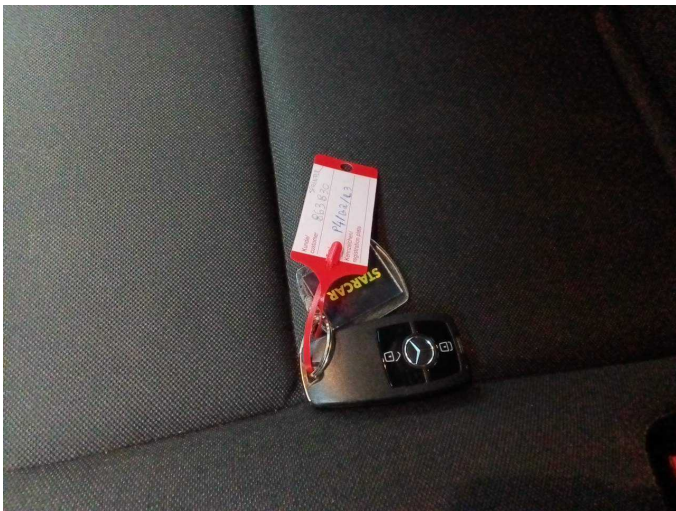
Missing part 1: Equipment: Vehicle key (1 Schlüssel vorhanden) - Missing - Perform
