Expertise

Protocol number: 46745855  
Order No. / Reference: 26783130  
Inspection date: 17 Jul 2026

| Manufacturer: Opel | Model: Astra 1.5 D Start/Stop Sports Tourer Automatik Edition |

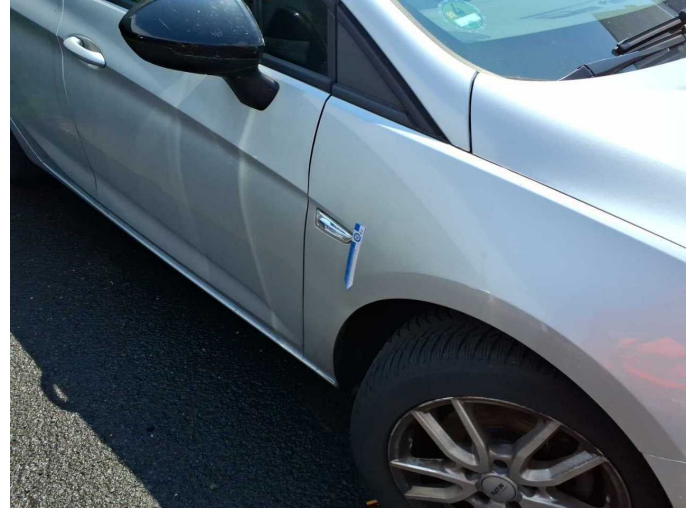
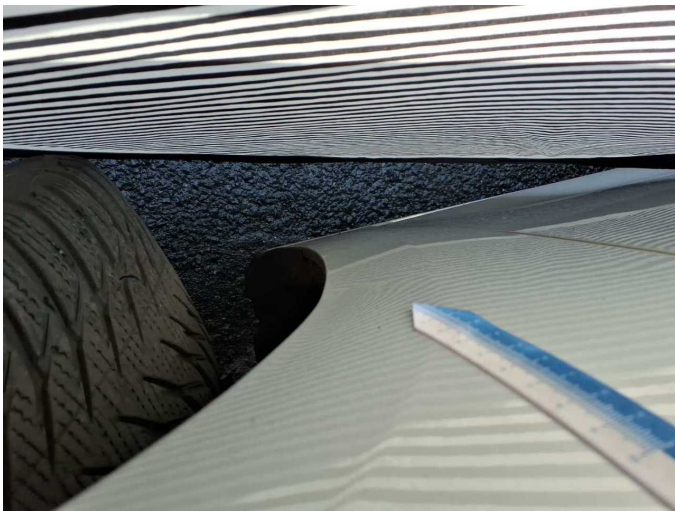
| No. | Component group | Description |
|---|---|---|
| 1 | Mudguard - right side | Mudguard - right side - dent(s) - Smooth repair work |

**Damage 1:** Mudguard - right side: Mudguard - right side - dent(s) - Smooth repair work

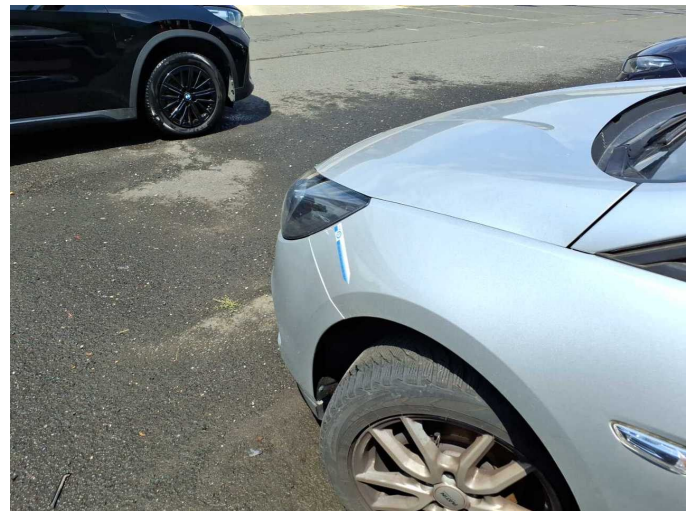
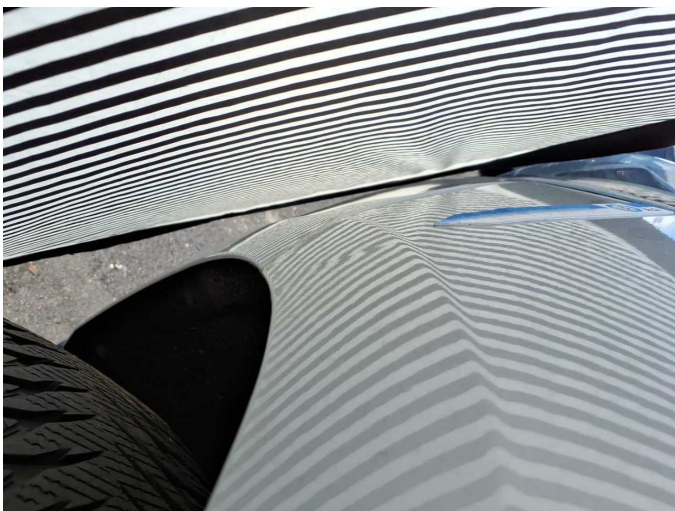
| No. | Component group | Description |
|---|---|---|
| 2 | Mudguard - left side | Mudguard - left side - dent(s) - Smooth repair work |

**Damage 2:** Mudguard - left side: Mudguard - left side - dent(s) - Smooth repair work

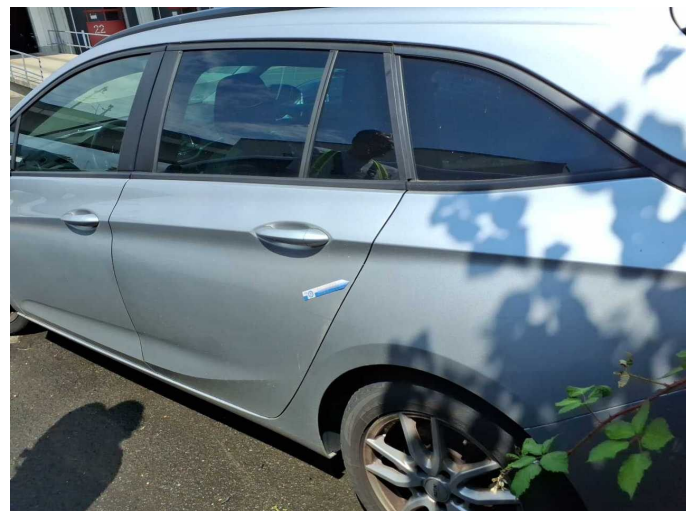
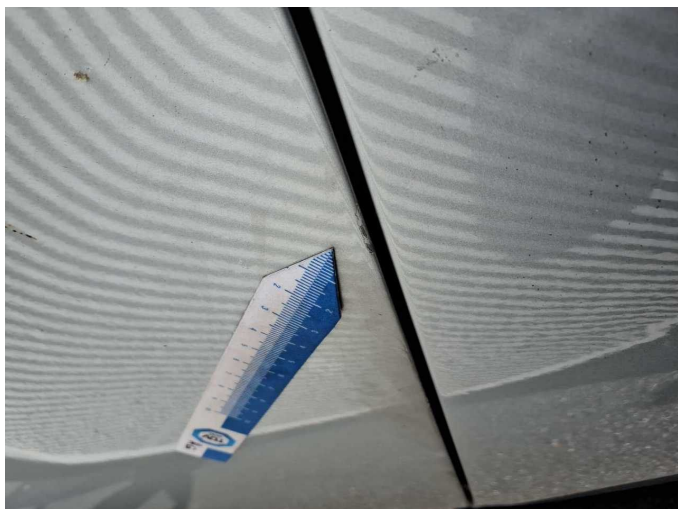
| No. | Component group | Description |
|---|---|---|
| 3 | Door - rear left side | Door edge - Scratch(es) - Smart repair |

**Damage 3:** Door - rear left side: Door edge - Scratch(es) - Smart repair

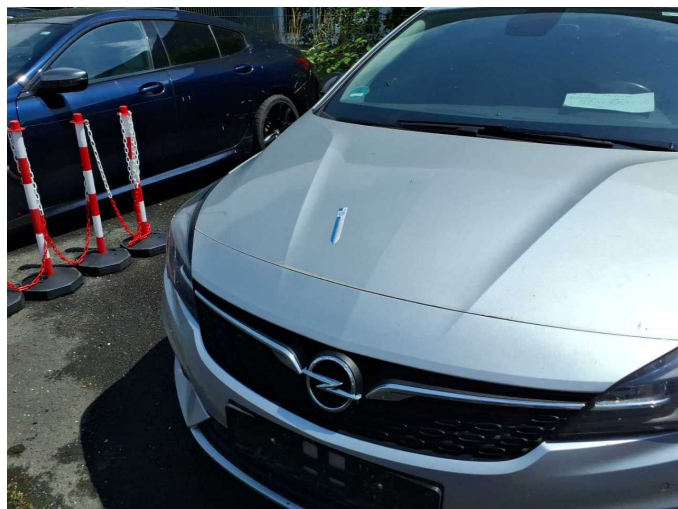
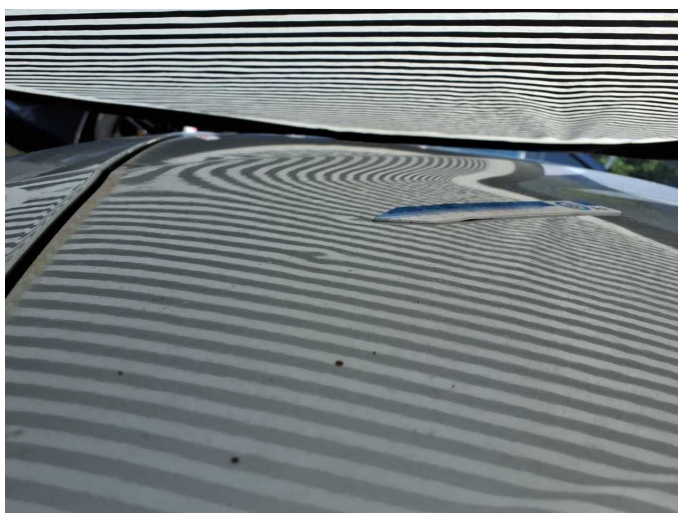
| No. | Component group | Description |
|---|---|---|
| 4 | Bonnet | Bonnet - dent(s) - Smooth repair work |

**Damage 4:** Bonnet: Bonnet - dent(s) - Smooth repair work

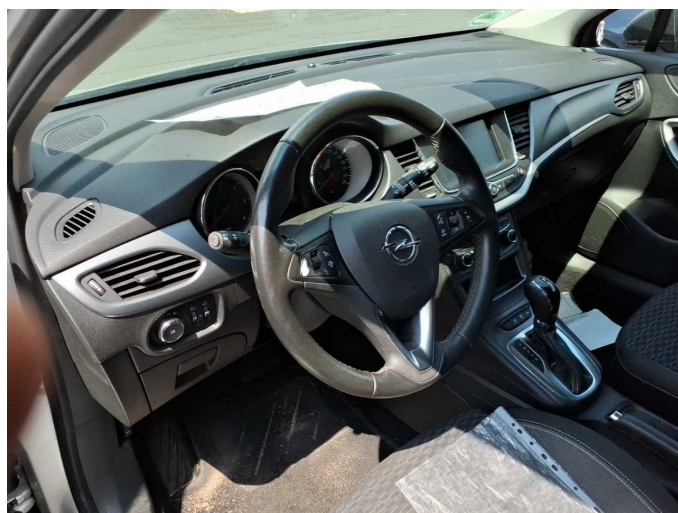
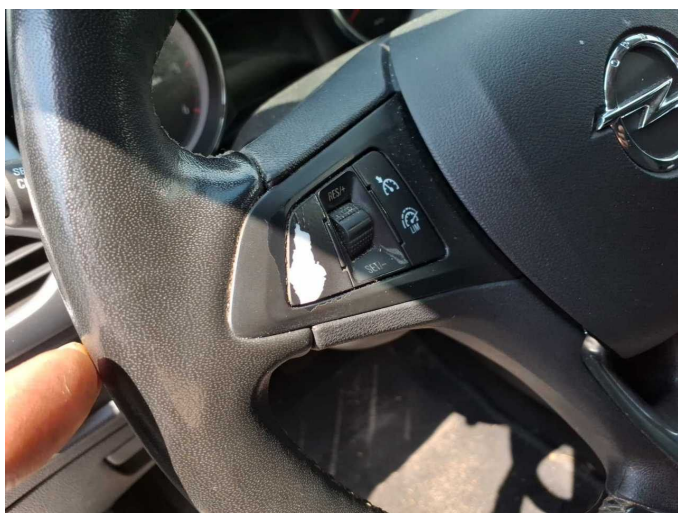
| No. | Component group | Description |
|---|---|---|
| 5 | Steering system | Steering wheel button - Abrasion - Replace |

**Damage 5:** Steering system: Steering wheel button - Abrasion - Replace

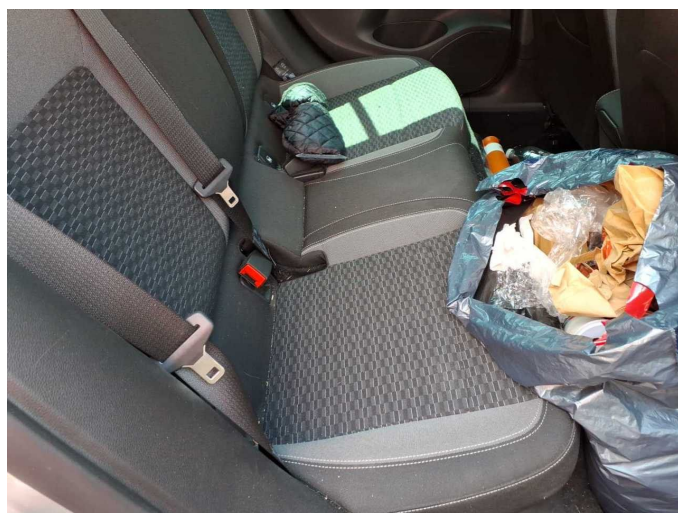
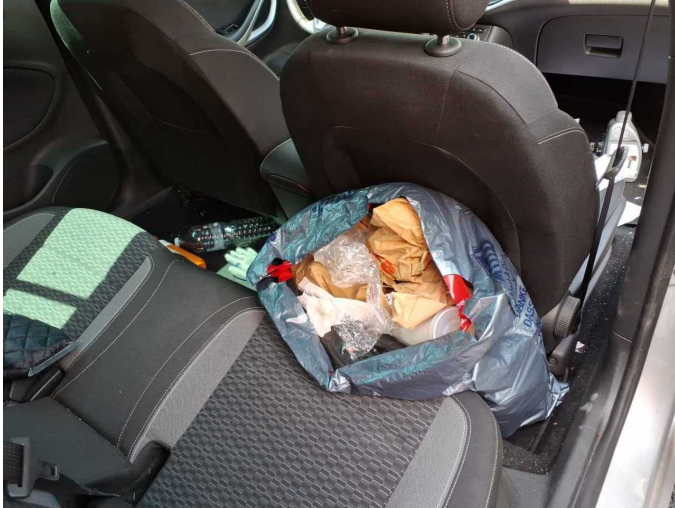
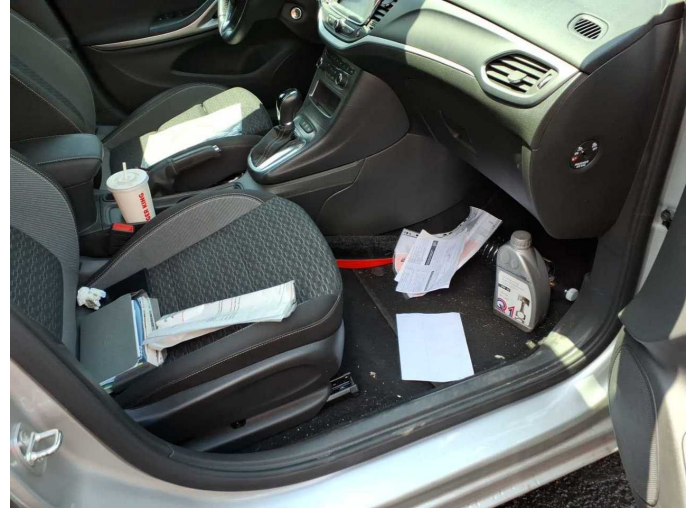
| No. | Component group | Description |
|---|---|---|
| 6 | Interior | Interior - Soiled - Clean |

**Damage 6:** Interior: Interior - Soiled - Clean

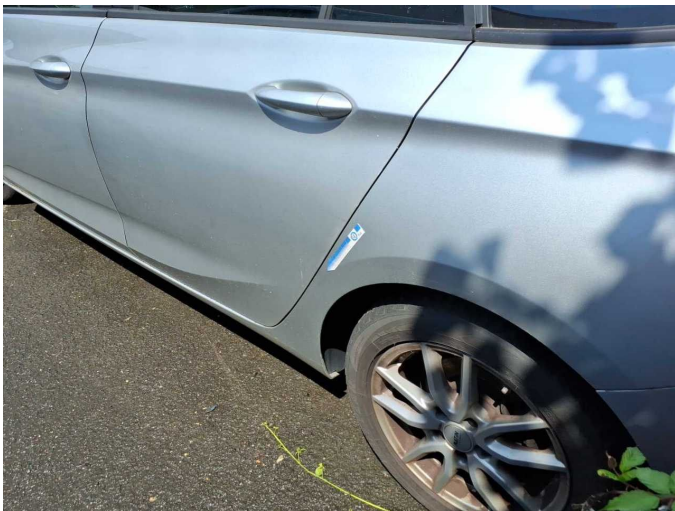
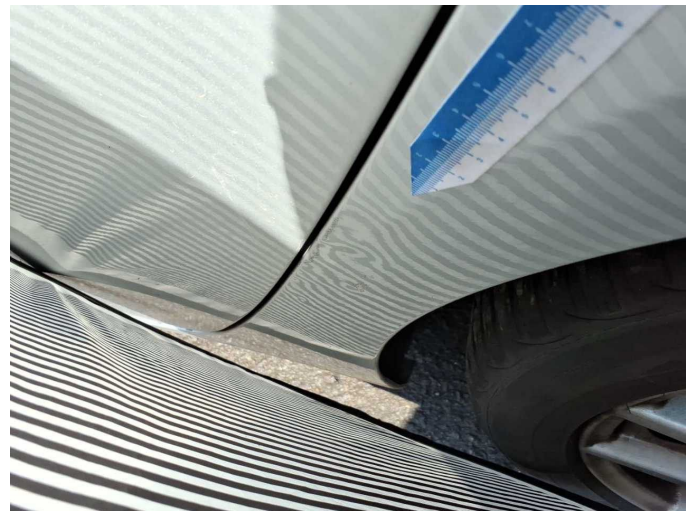
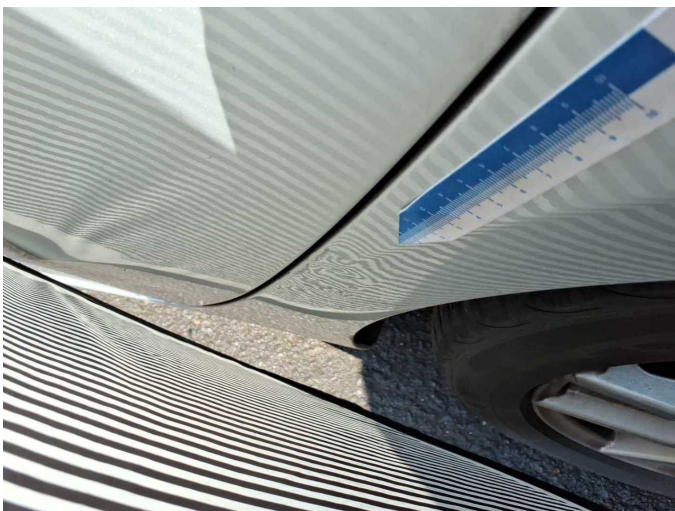
| No. | Component group | Description |
|---|---|---|
| 7 | Side panel - rear left side | Side panel - Deformed - Repair and paint |

**Damage 7:** Side panel - rear left side: Side panel - Deformed - Repair and paint

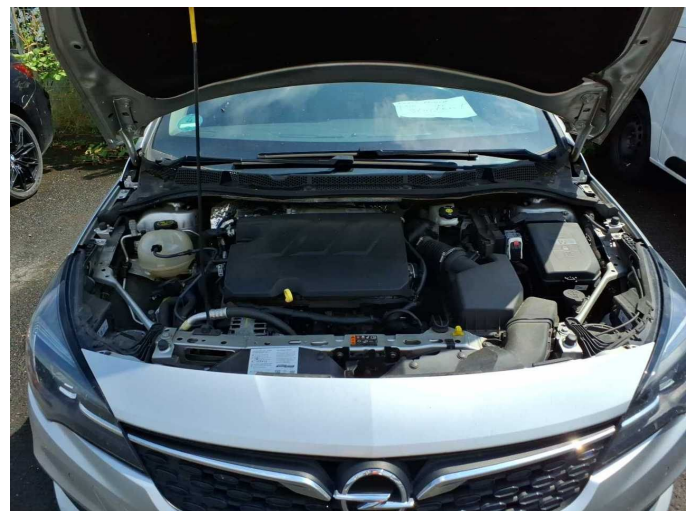
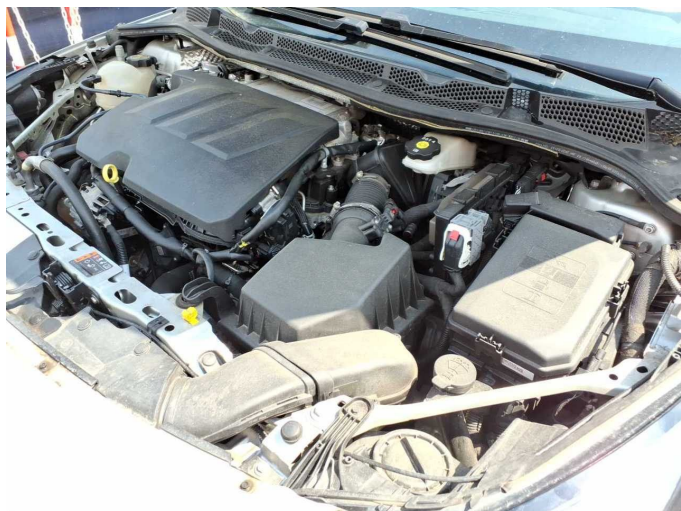
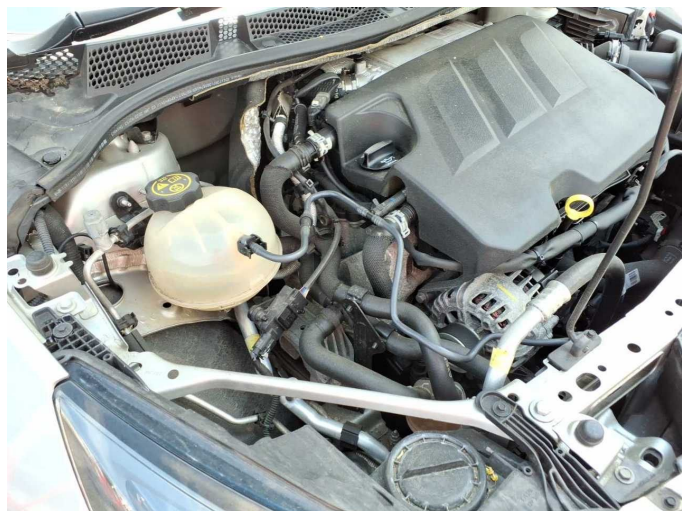
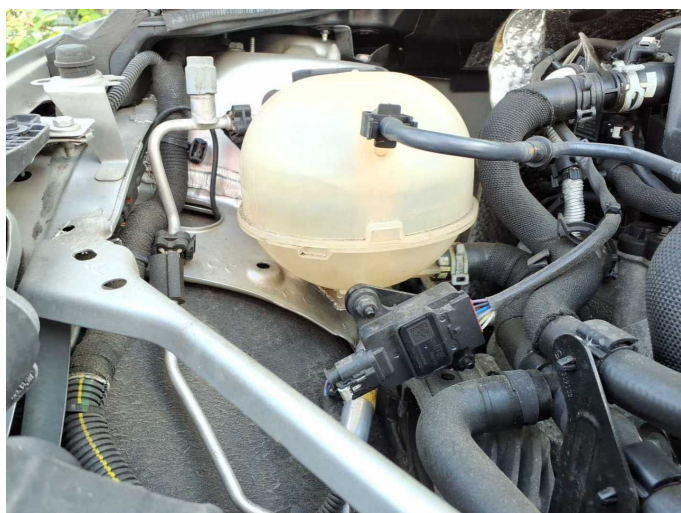
| Engine function test | <p>An engine test run could not be performed.</p> <p>This is due to the following reason.:</p> <p>Motorschaden</p> |

| No. | Component group | Description |
|---|---|---|
| 8 | Engine | Engine (Austausch Motor) - Non-operational - repair according to calculation |

**Damage 8:** Engine: Engine (Austausch Motor) - Non-operational - repair according to calculation
