Expertise

Protocol number: 46276935
Order No. / Reference: 26582102
Inspection date: 30 Jun 2026

Model: Tiguan Allspace 2.0 TDI SCR DSG Life

VIN: WVGZZZ5N6PM021696

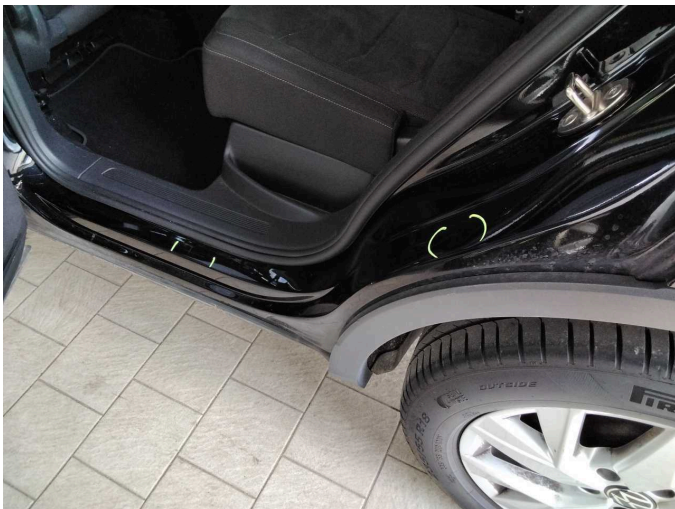
Damage 2: Body: C-pillar - left side - Dent / paintcoat damage - Smart repair

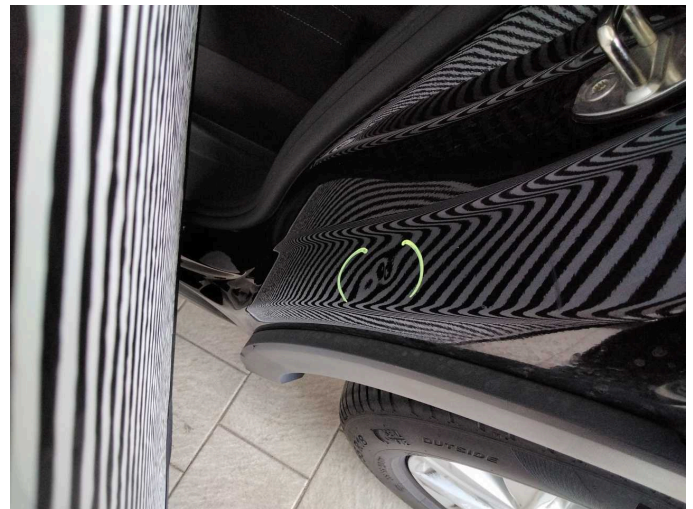
Damage 2: Body: C-pillar - left side - Dent / paintcoat damage - Smart repair

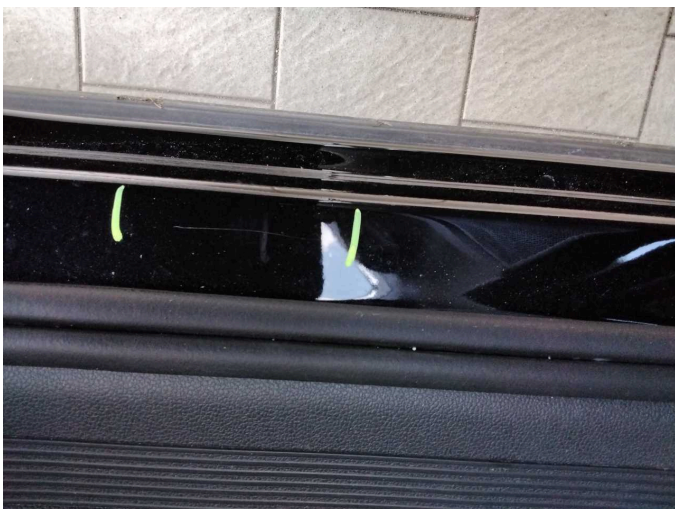
Damage 2: Body: C-pillar - left side - Dent / paintcoat damage - Smart repair

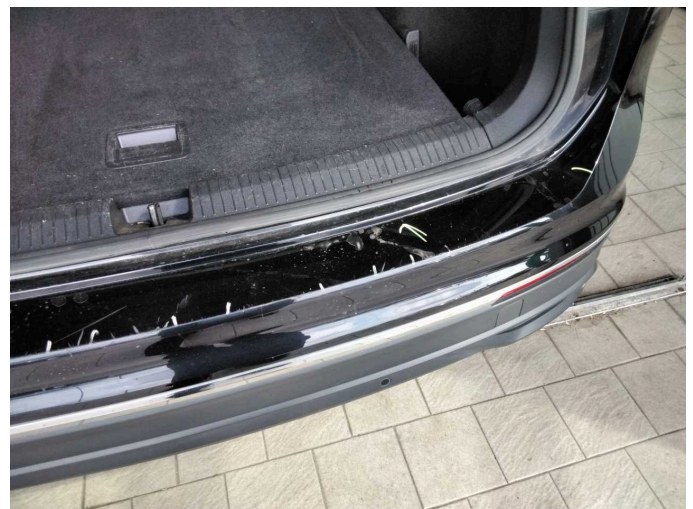
Damage 3: Boot lid / rear door: Seal - Broken / torn - Replace

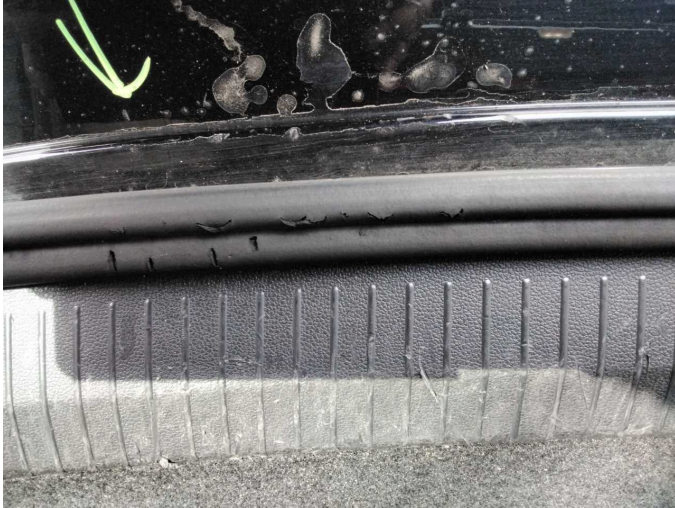
Damage 3: Boot lid / rear door: Seal - Broken / torn - Replace

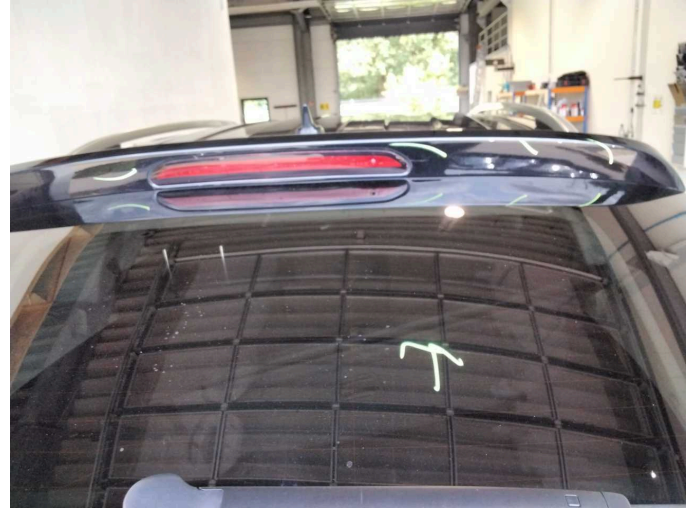
Damage 4: Boot lid / rear door: Boot lid - Scratch(es) - Smart repair

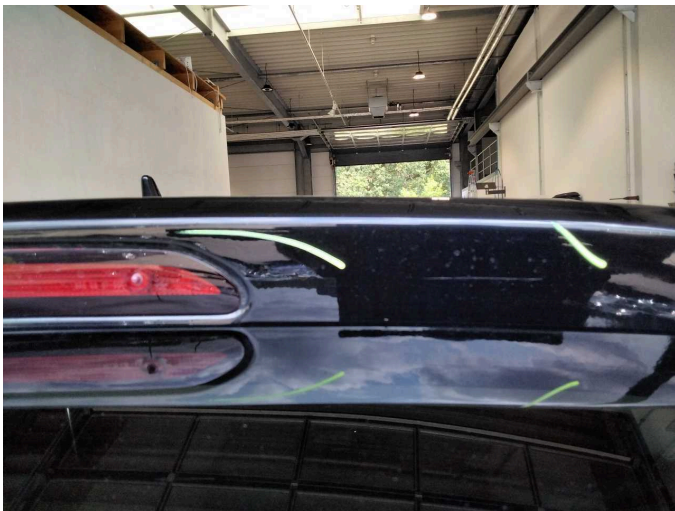
Damage 4: Boot lid / rear door: Boot lid - Scratch(es) - Smart repair

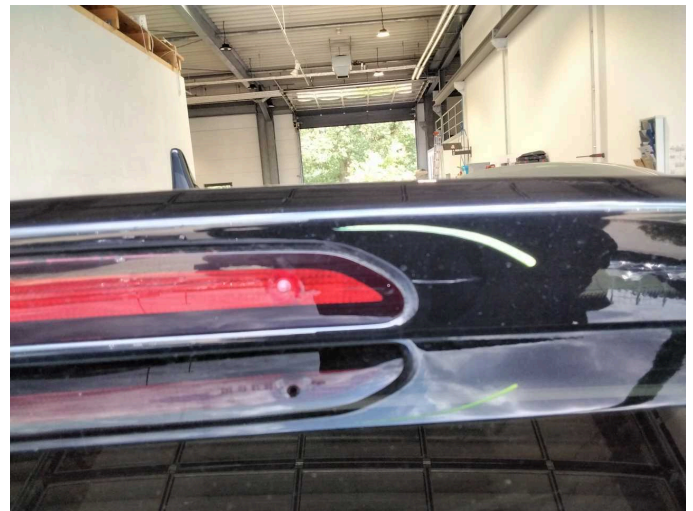
Damage 4: Boot lid / rear door: Boot lid - Scratch(es) - Smart repair

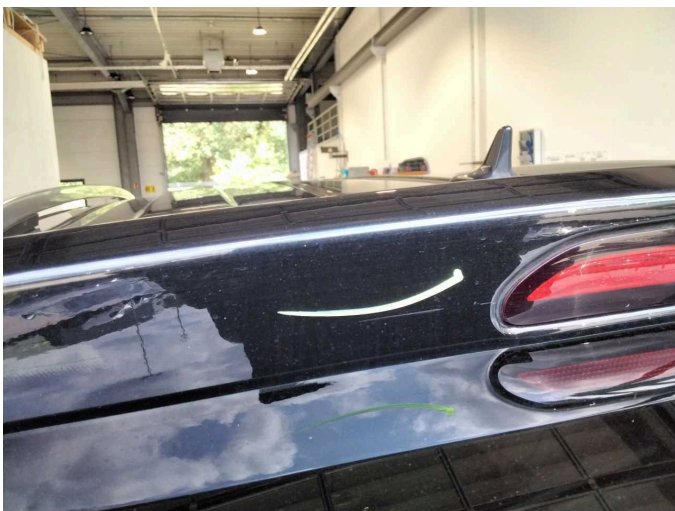
Damage 4: Boot lid / rear door: Boot lid - Scratch(es) - Smart repair

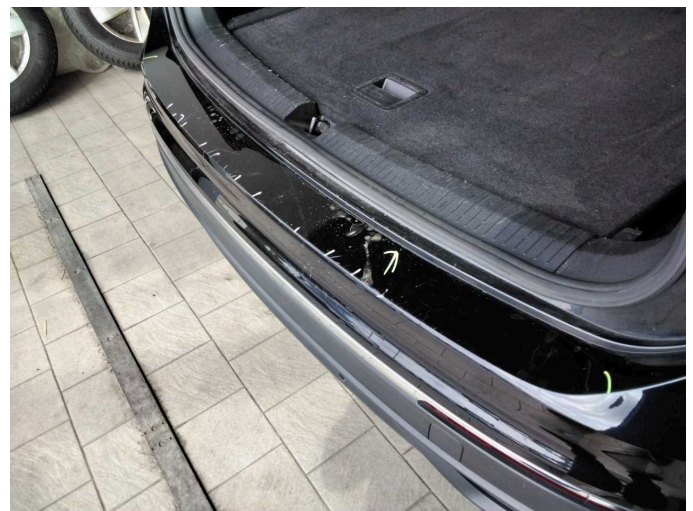
Damage 5: Rear bumper: Rear bumper - Scratch(es) - Smart repair

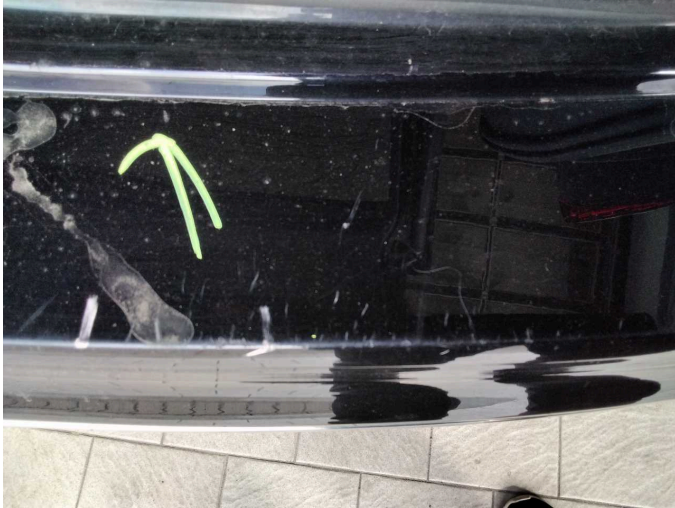
Damage 5: Rear bumper: Rear bumper - Scratch(es) - Smart repair

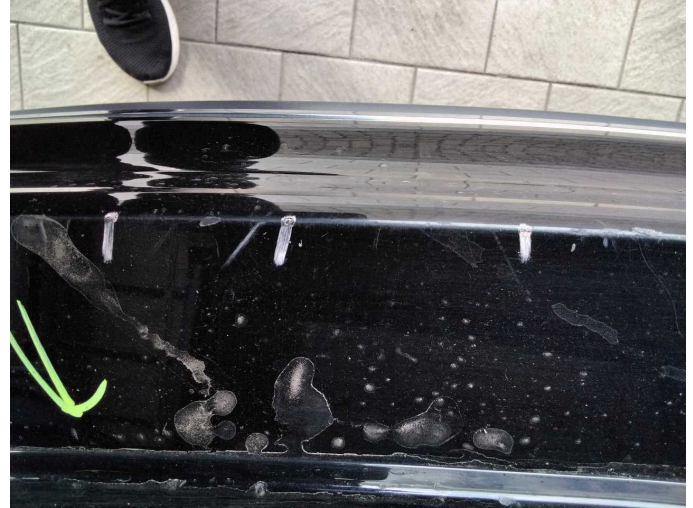
Damage 5: Rear bumper: Rear bumper - Scratch(es) - Smart repair

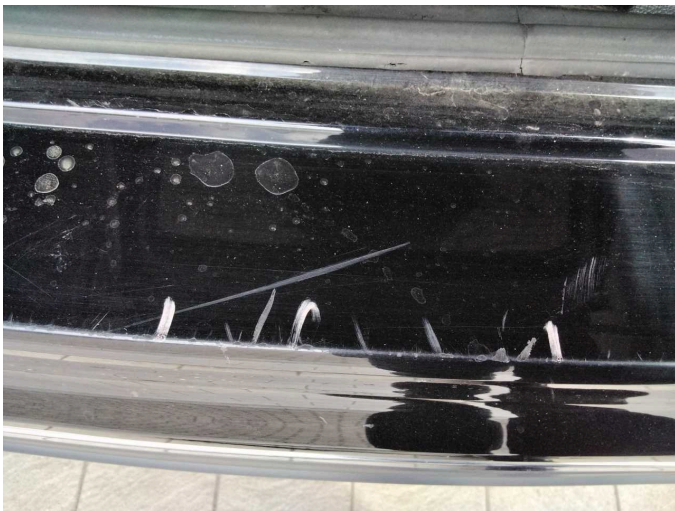
Damage 5: Rear bumper: Rear bumper - Scratch(es) - Smart repair

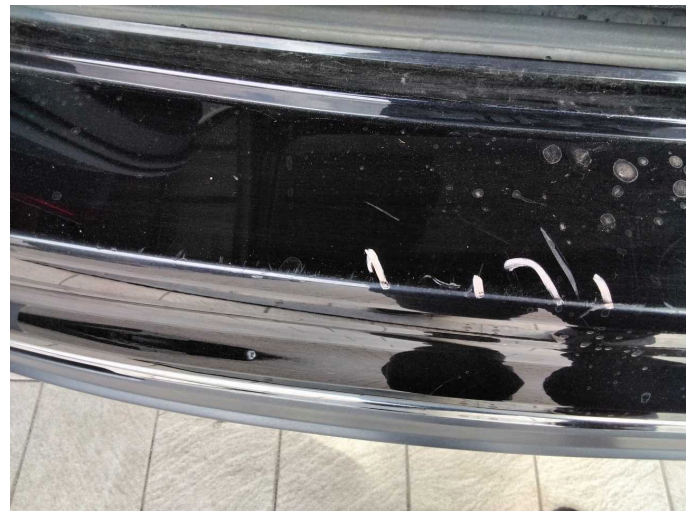
Damage 5: Rear bumper: Rear bumper - Scratch(es) - Smart repair

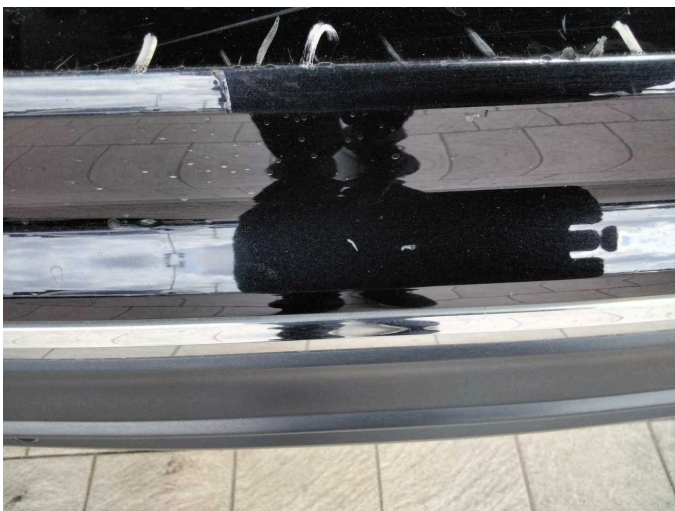
Damage 5: Rear bumper: Rear bumper - Scratch(es) - Smart repair

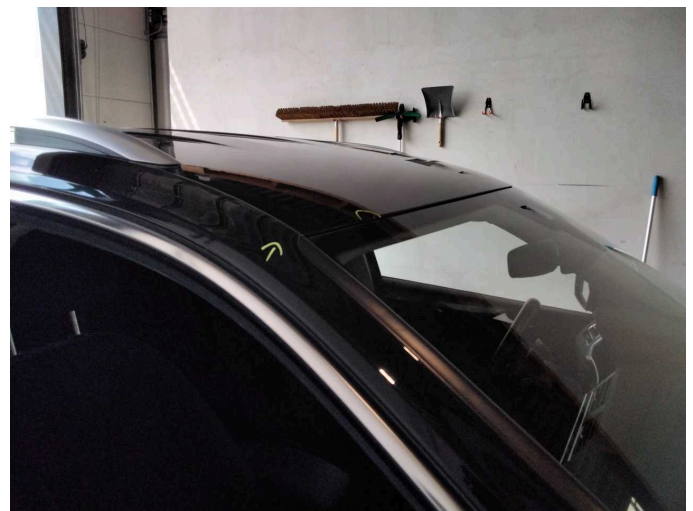
Damage 6: Roof: Roof - Scratch(es) - Smart repair

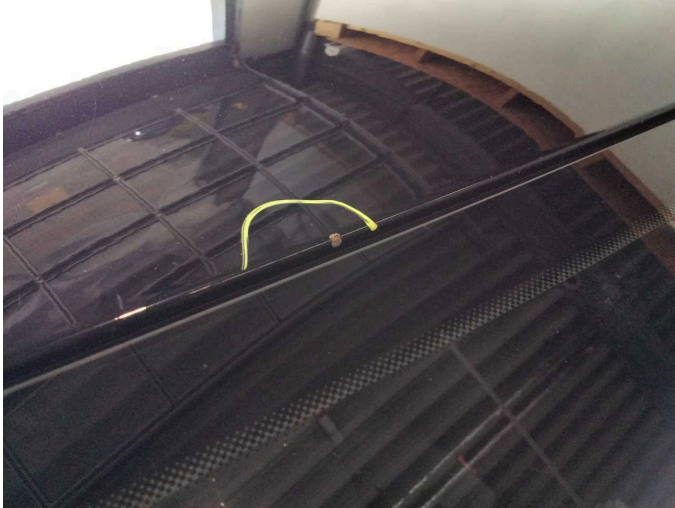
Damage 6: Roof: Roof - Scratch(es) - Smart repair

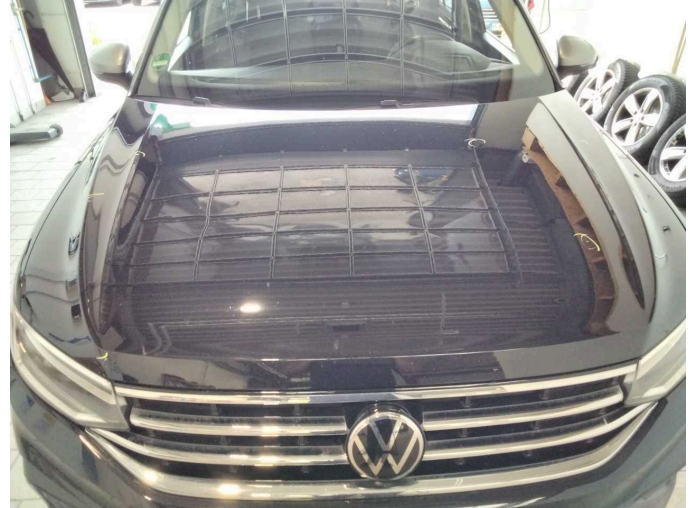
Damage 7: Bonnet: Bonnet - Stone chips - Paint

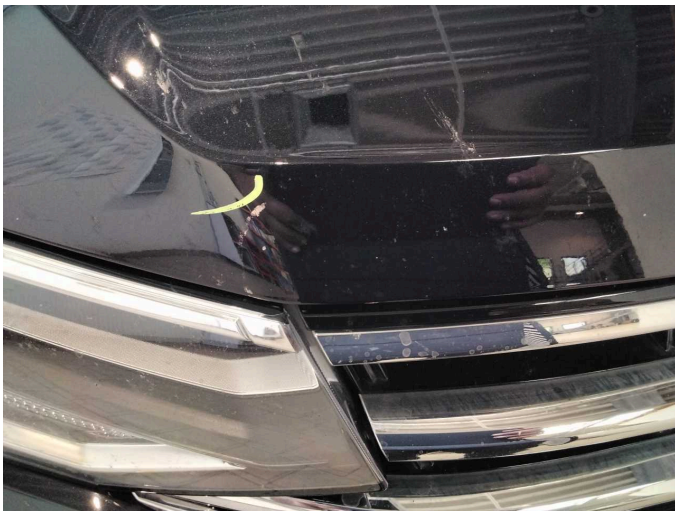
Damage 7: Bonnet: Bonnet - Stone chips - Paint

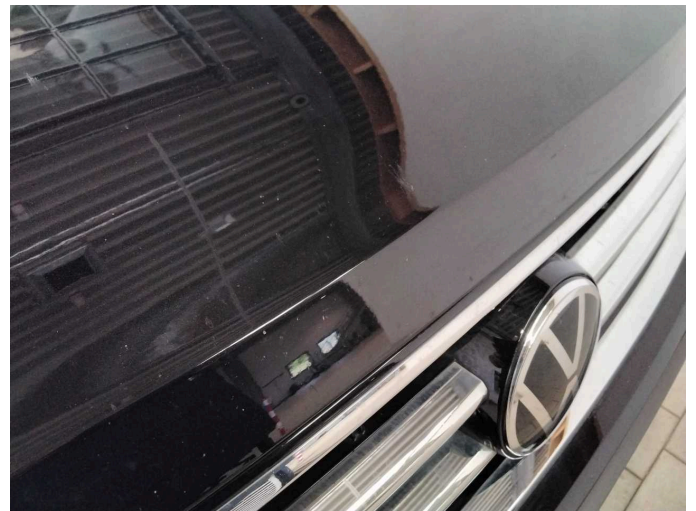
Damage 7: Bonnet: Bonnet - Stone chips - Paint

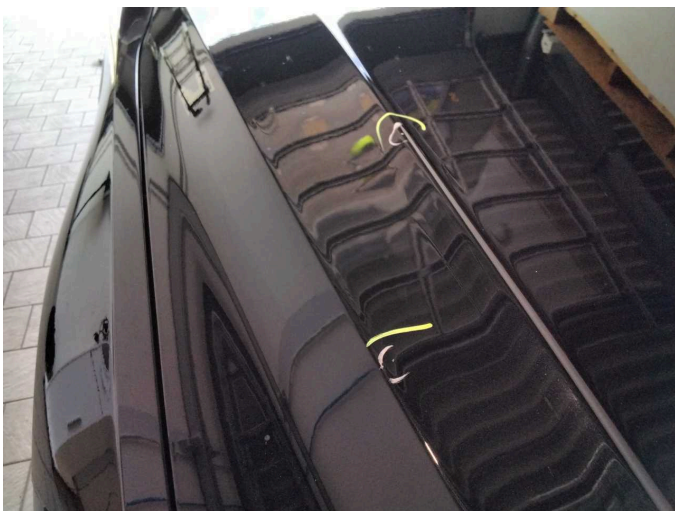
Damage 7: Bonnet: Bonnet - Stone chips - Paint

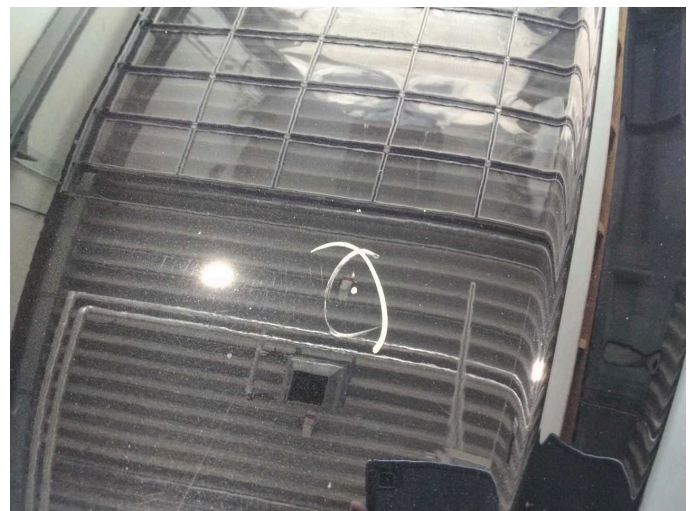
Damage 7: Bonnet: Bonnet - Stone chips - Paint

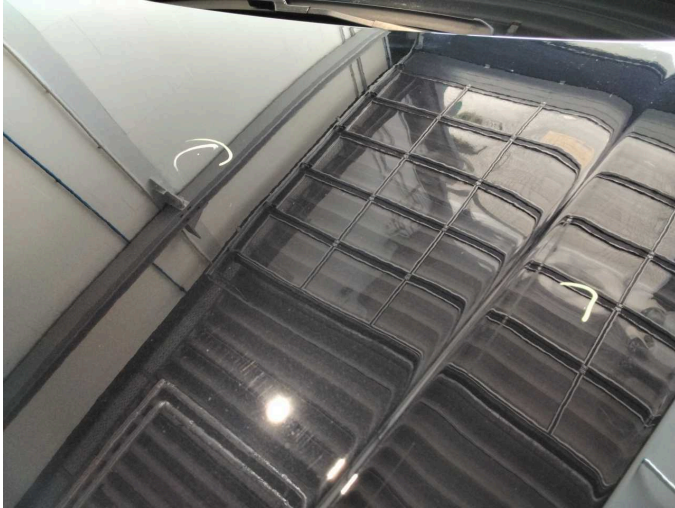
Damage 7: Bonnet: Bonnet - Stone chips - Paint

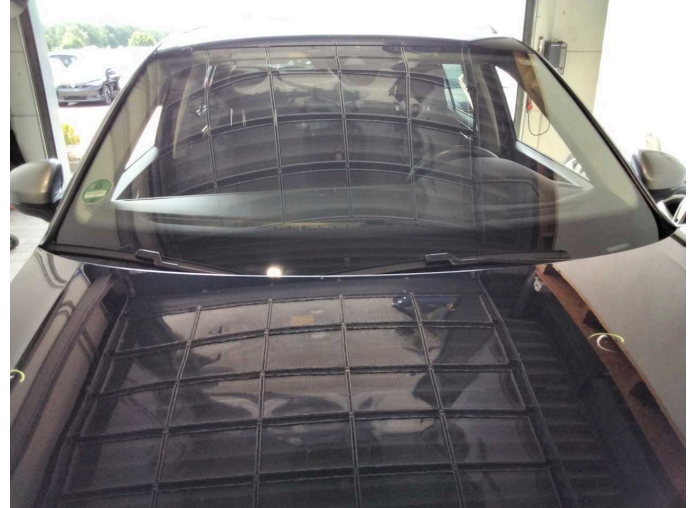
Wear and tear 1: Vehicle glazing: Windscreen - Stone chips - No deduction

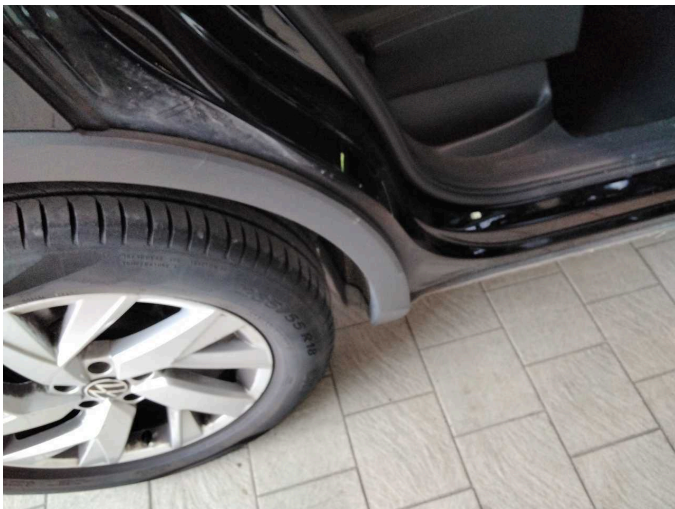
Wear and tear 3: Body: B-pillar - right side - Scratch(es) - No deduction

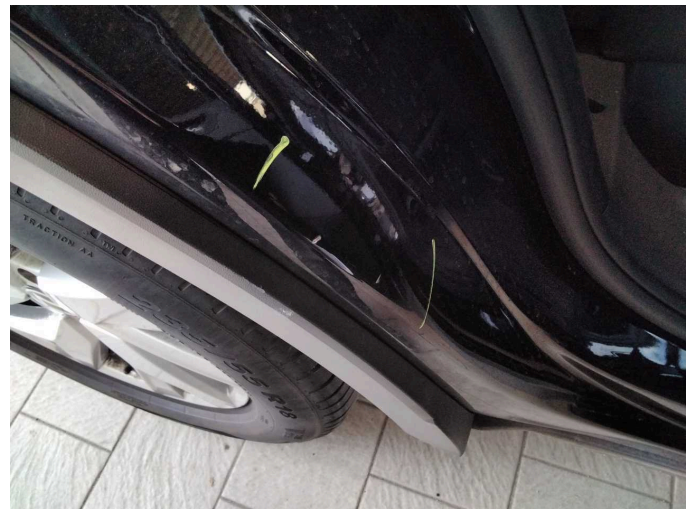
Wear and tear 3: Body: B-pillar - right side - Scratch(es) - No deduction

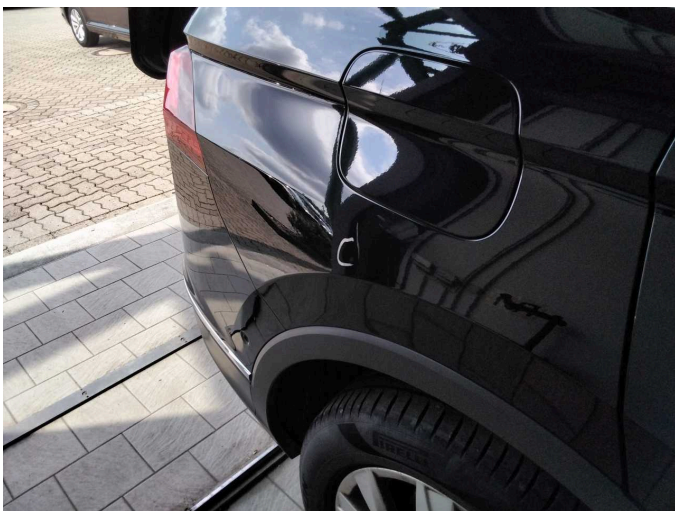
Wear and tear 4: Side panel - rear right side: Side panel - dent(s) - Smooth repair work

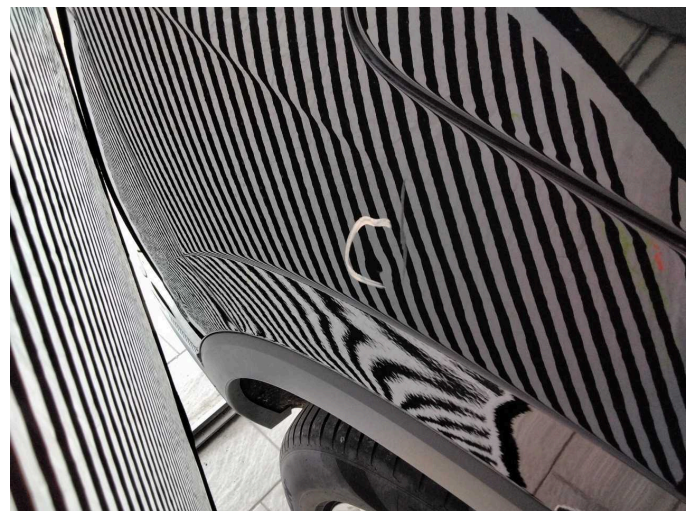
Wear and tear 4: Side panel - rear right side: Side panel - dent(s) - Smooth repair work

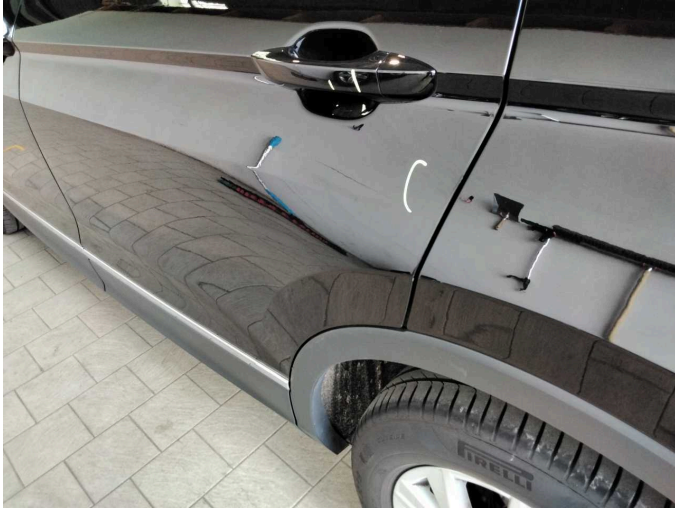
Wear and tear 5: Door - rear left side: Door - dent(s) - No deduction

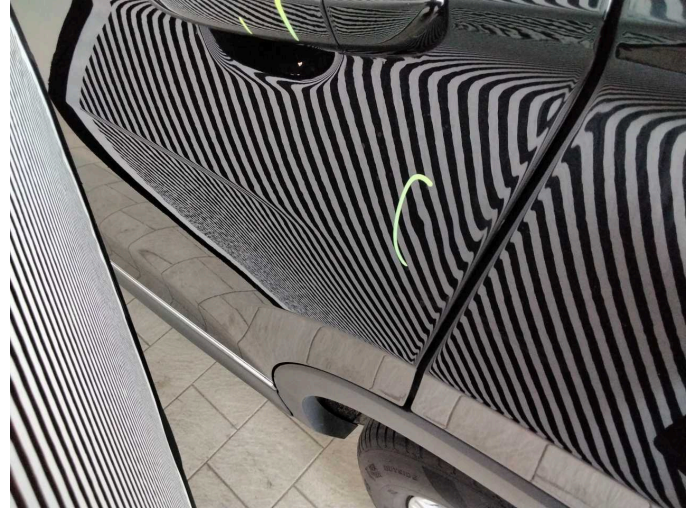
Wear and tear 5: Door - rear left side: Door - dent(s) - No deduction

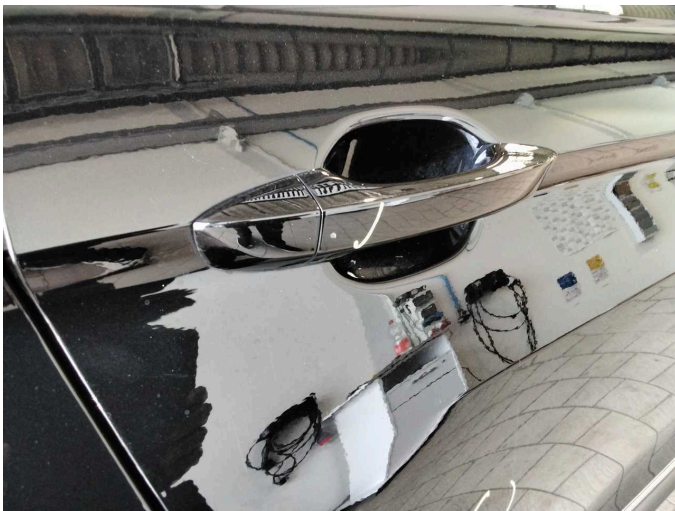
Wear and tear 6: Door - rear right side: Door handle - outside - Scratch(es) - No deduction

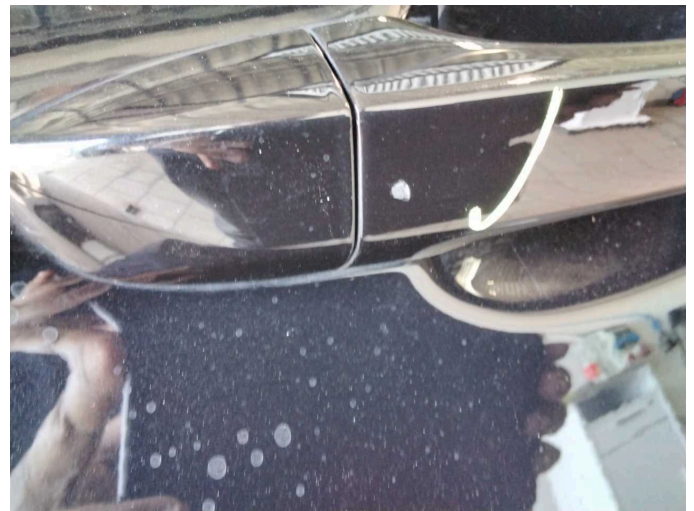
Wear and tear 6: Door - rear right side: Door handle - outside - Scratch(es) - No deduction

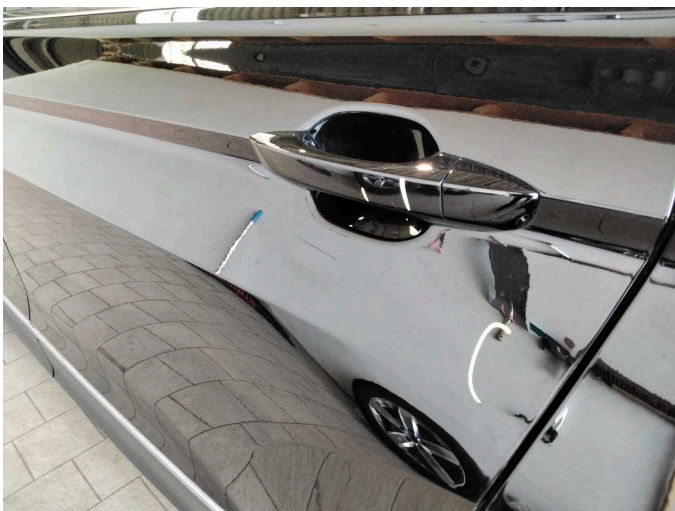
Wear and tear 7: Door - rear left side: Door handle - outside - Scratch(es) - No deduction

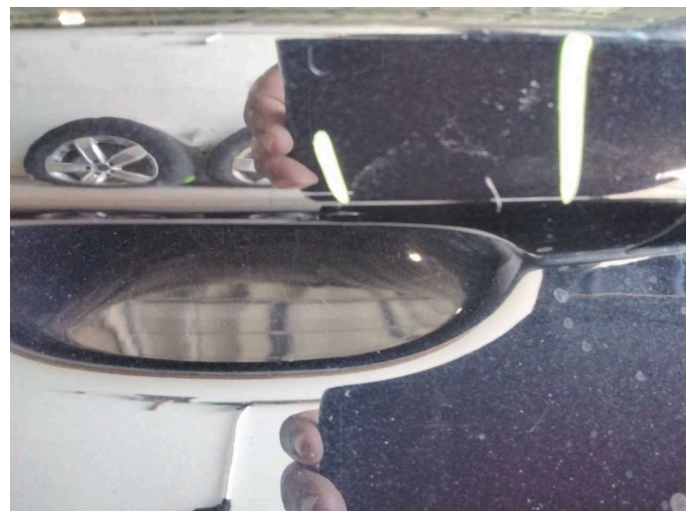
Wear and tear 7: Door - rear left side: Door handle - outside - Scratch(es) - No deduction

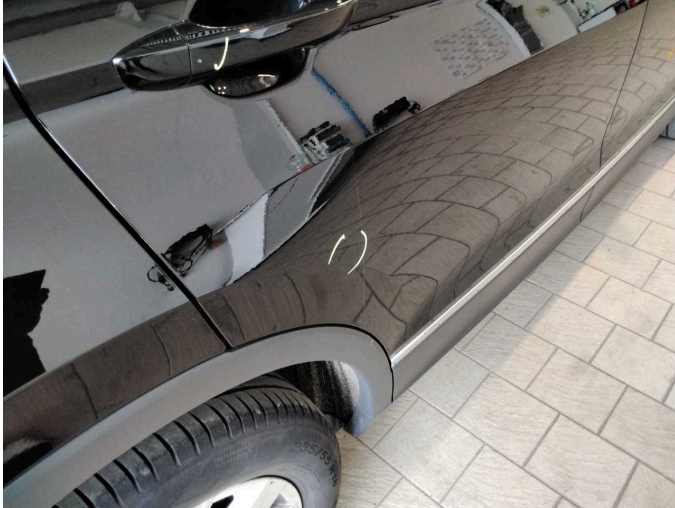
Wear and tear 8: Door - rear right side: Door - dent(s) - No deduction

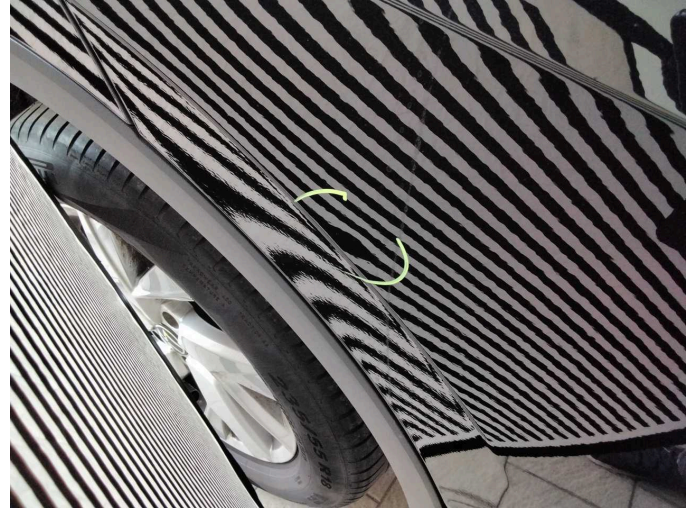
Wear and tear 8: Door - rear right side: Door - dent(s) - No deduction

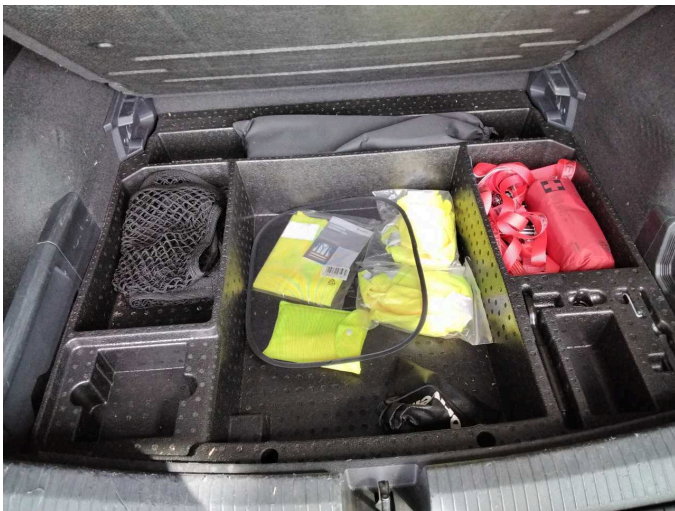
Missing part 1: Equipment: Tirefit complete - Missing - Replace

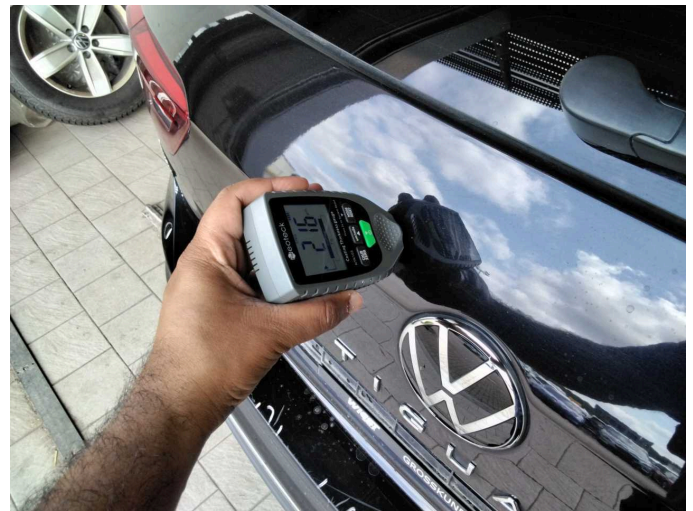
Boot lid / rear door: 216 µm

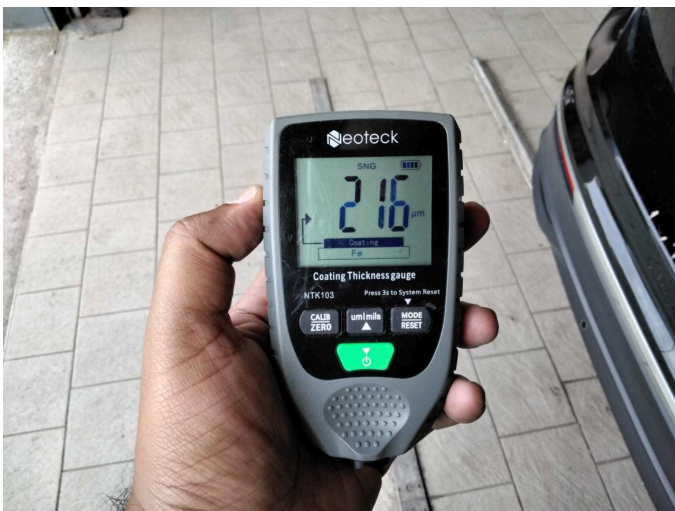
Boot lid / rear door: 216 µm

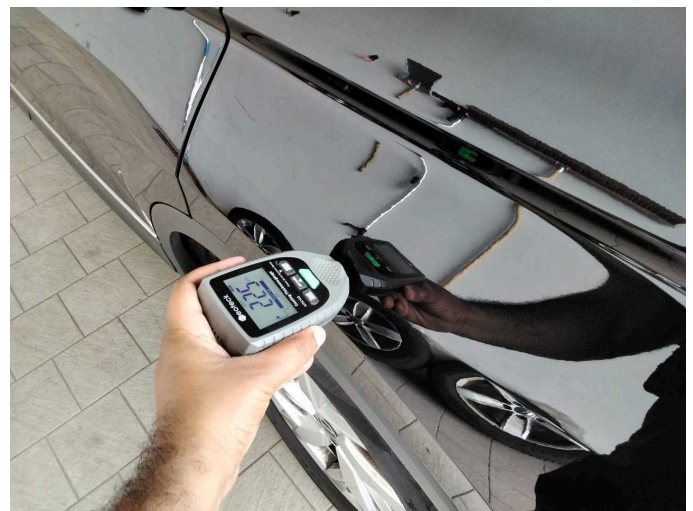
Side panel - rear left side: 225 µm

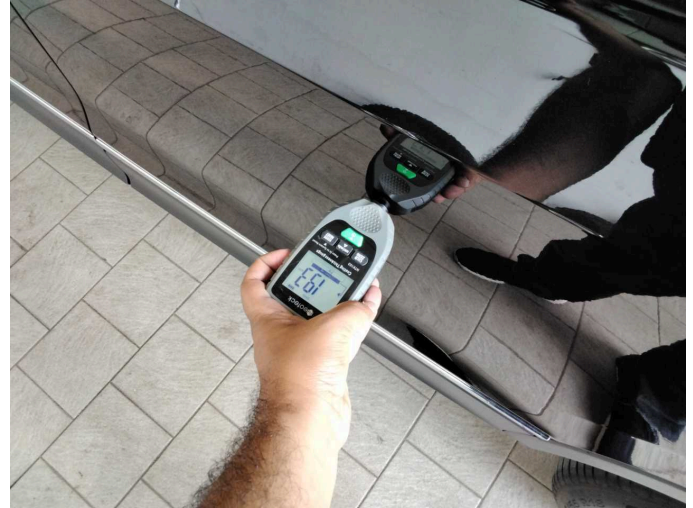
Door - rear left side: 193 µm

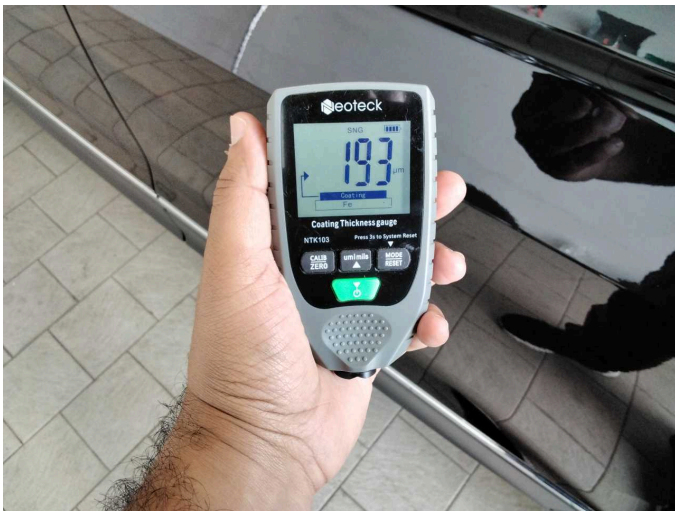
Door - rear left side: 193 µm
