Expertise

Protocol number: 46203008
Order No. / Reference: 26544888
Inspection date: 18 Jun 2026

Manufacturer: Ford

Model: Transit Connect 250 L2 Trend

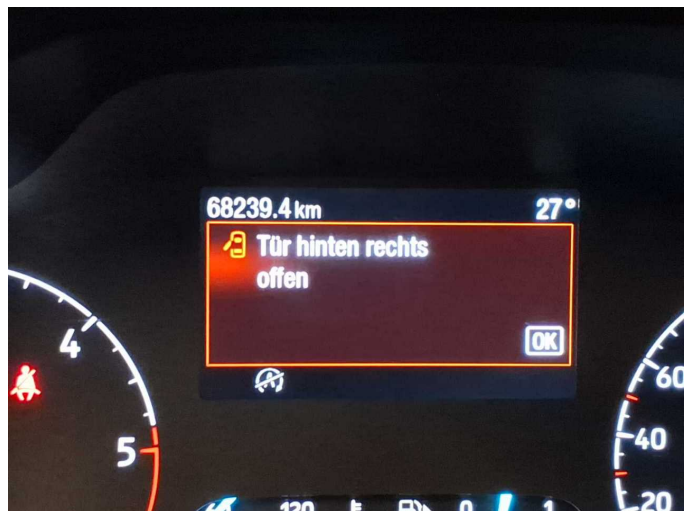
Damage 1: Instrument panel: Indicator light (Meldung Tür offen obwohl Tür zu) - Electrical fault - Perform diagnosis

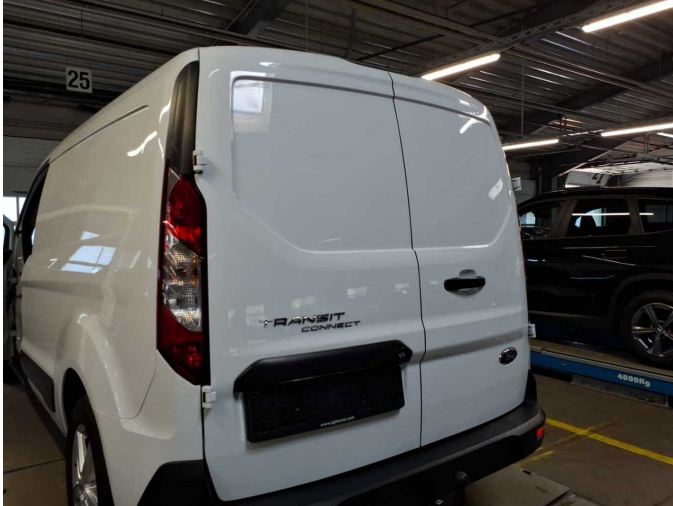
Damage 1: Instrument panel: Indicator light (Meldung Tür offen obwohl Tür zu) - Electrical fault - Perform diagnosis

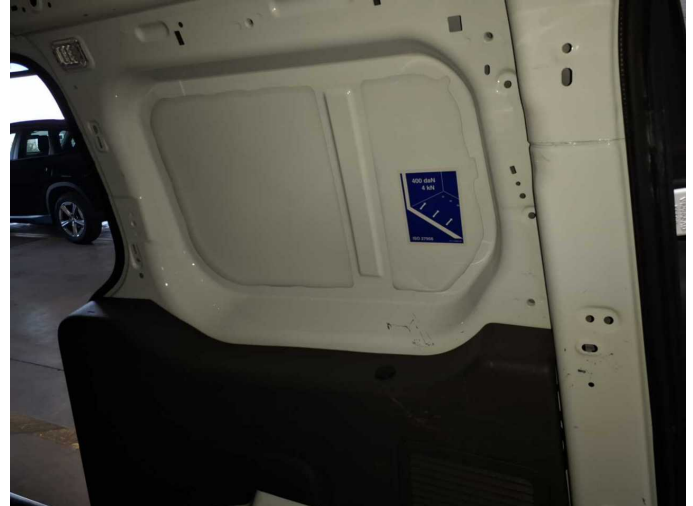
Damage 2: Interior: Cargo area floor (Laderaum) - Scratch(es) - Smart repair

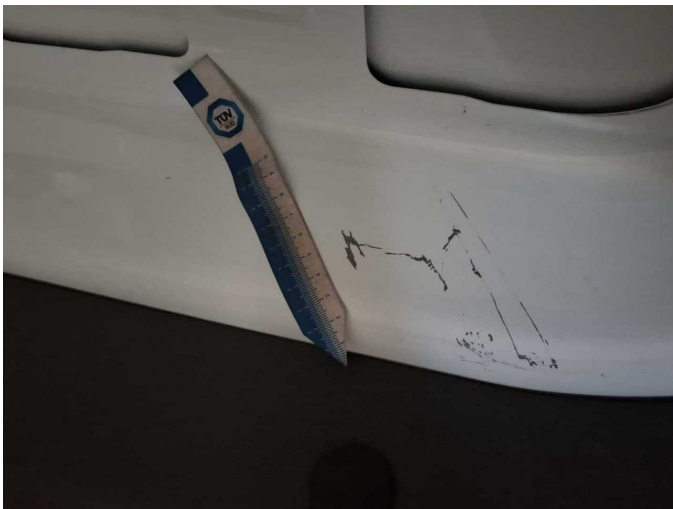
Damage 2: Interior: Cargo area floor (Laderaum) - Scratch(es) - Smart repair

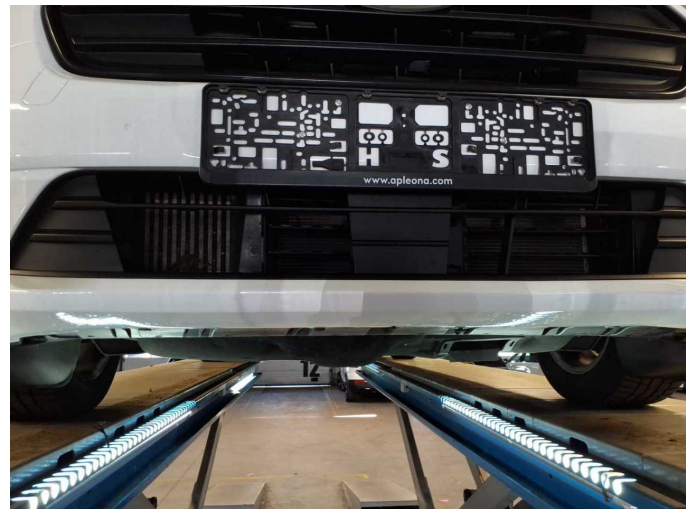
Damage 3: Front bumper: Air-inlet grille - Broken / torn - Replace

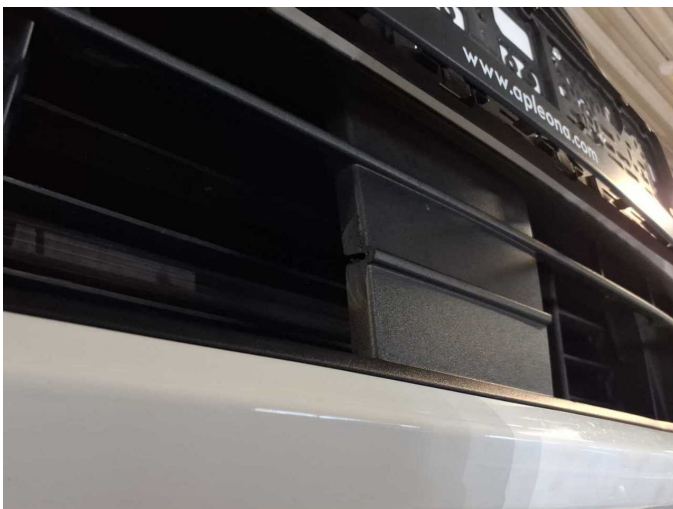
Damage 3: Front bumper: Air-inlet grille - Broken / torn - Replace

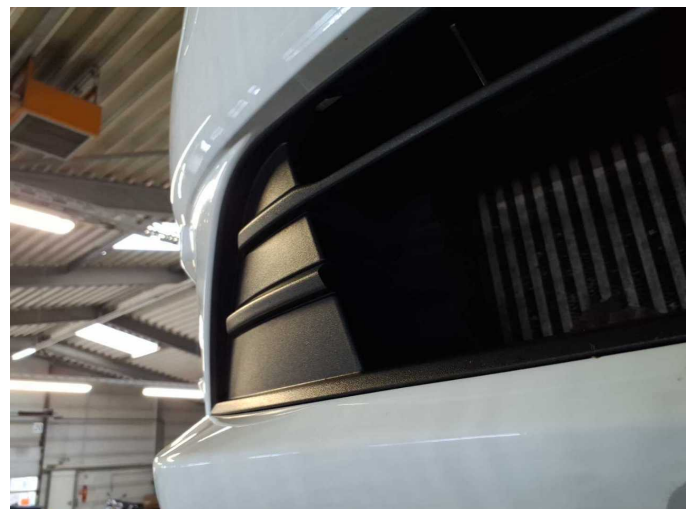
Damage 3: Front bumper: Air-inlet grille - Broken / torn - Replace

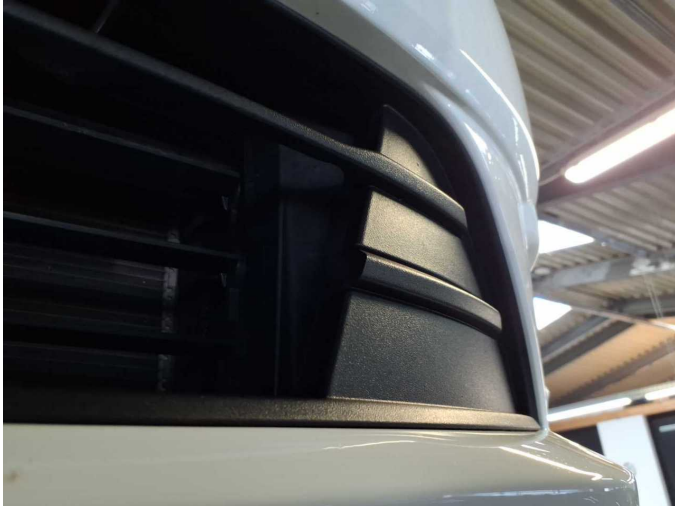
Damage 3: Front bumper: Air-inlet grille - Broken / torn - Replace

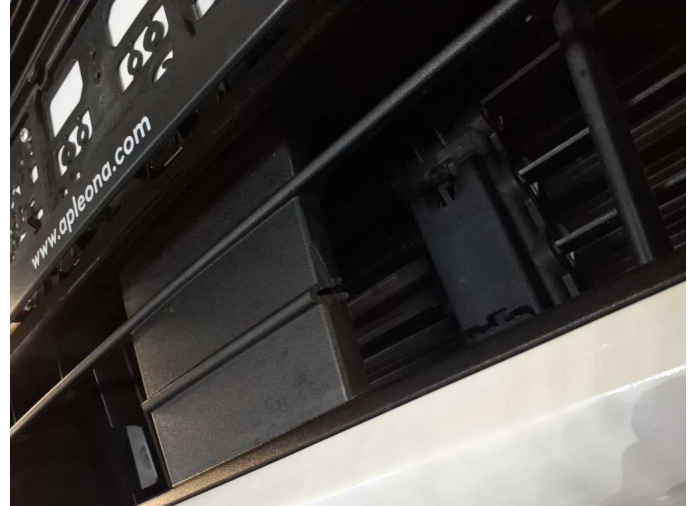
Damage 3: Front bumper: Air-inlet grille - Broken / torn - Replace

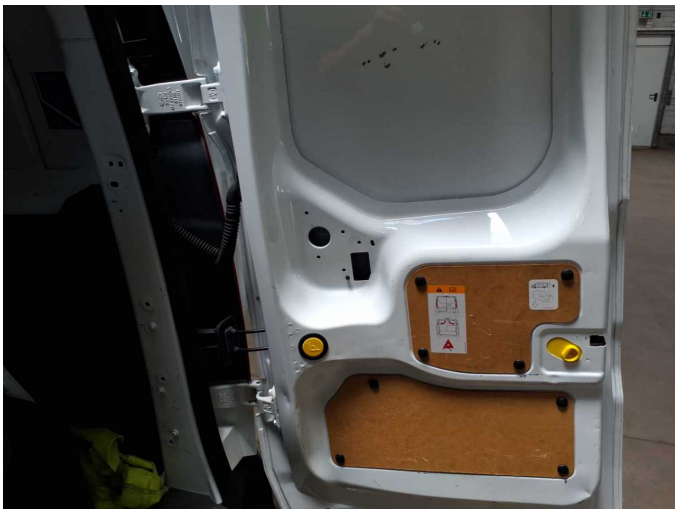
Damage 4: Boot lid / rear door: Rear door - right side (l) - Dent / paintcoat damage - Repair and paint

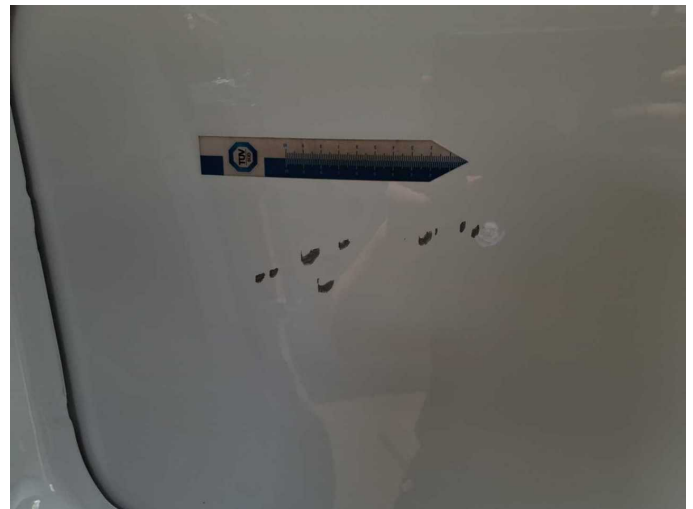
Damage 4: Boot lid / rear door: Rear door - right side (l) - Dent / paintcoat damage - Repair and paint

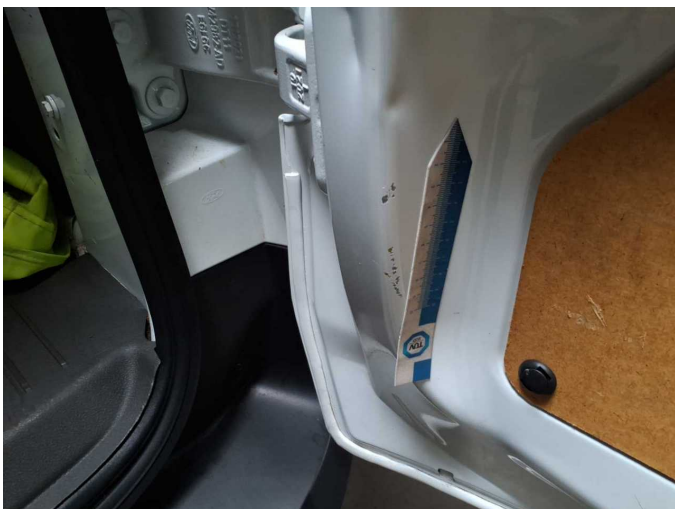
Damage 4: Boot lid / rear door: Rear door - right side (l) - Dent / paintcoat damage - Repair and paint

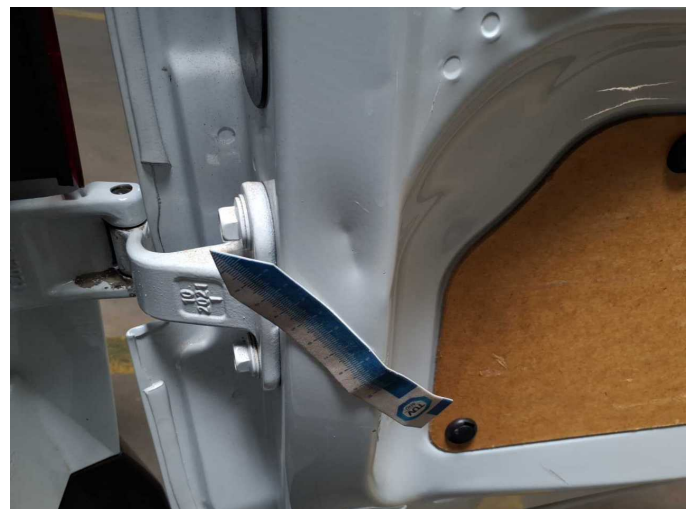
Damage 4: Boot lid / rear door: Rear door - right side (l) - Dent / paintcoat damage - Repair and paint

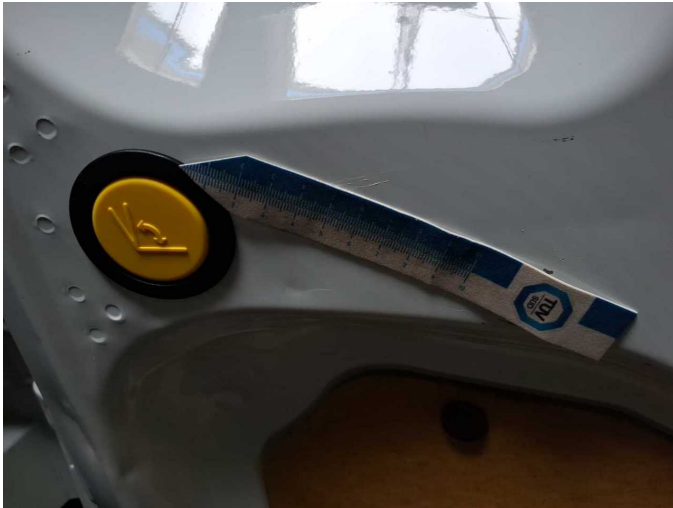
Damage 4: Boot lid / rear door: Rear door - right side (l) - Dent / paintcoat damage - Repair and paint

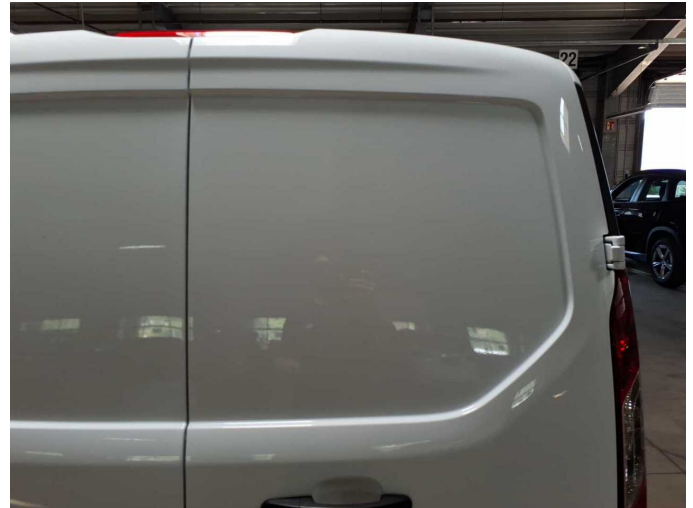
Damage 4: Boot lid / rear door: Rear door - right side (l) - Dent / paintcoat damage - Repair and paint

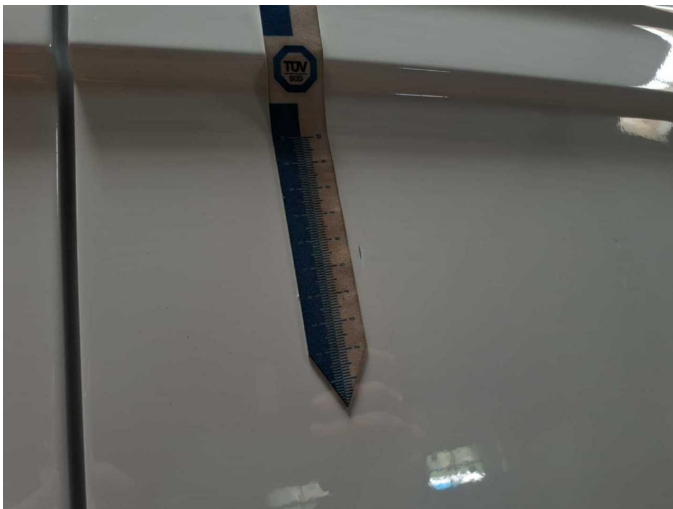
Damage 4: Boot lid / rear door: Rear door - right side (l) - Dent / paintcoat damage - Repair and paint

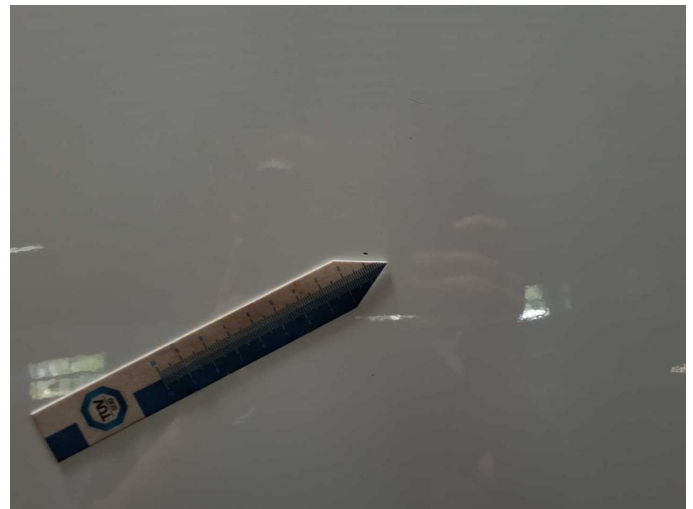
Damage 4: Boot lid / rear door: Rear door - right side (l) - Dent / paintcoat damage - Repair and paint

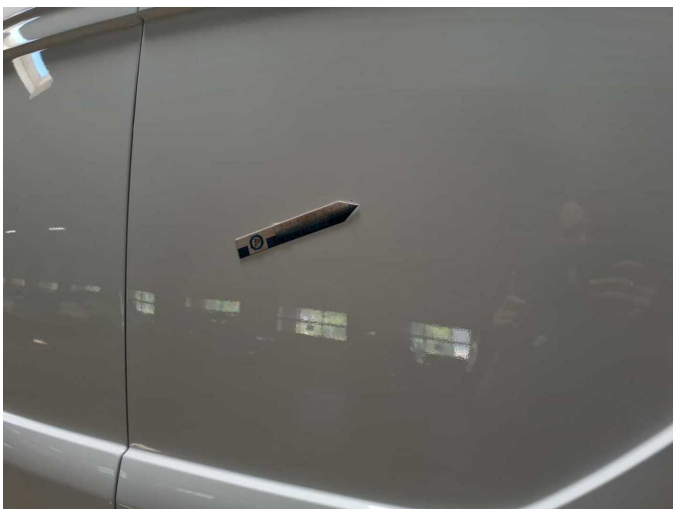
Damage 4: Boot lid / rear door: Rear door - right side (l) - Dent / paintcoat damage - Repair and paint

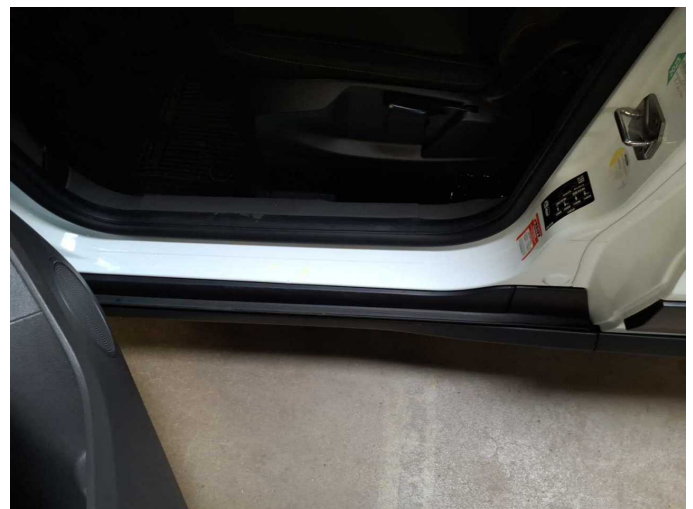
Damage 5: Sill - left side: Sill - Dent / paintcoat damage - Repair and paint

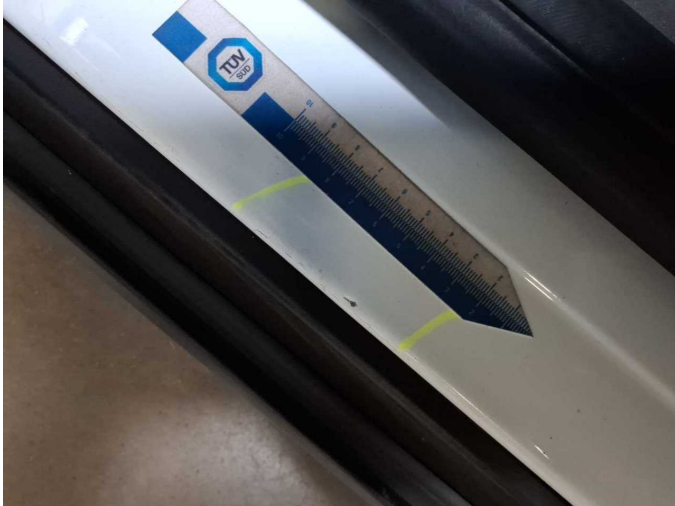
Damage 5: Sill - left side: Sill - Dent / paintcoat damage - Repair and paint

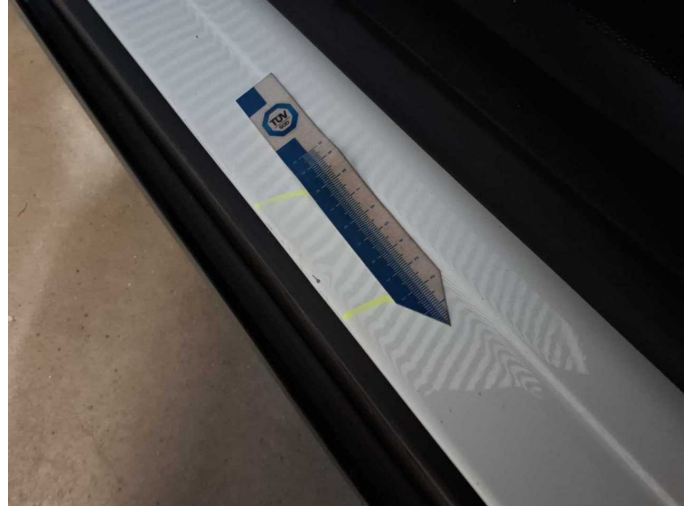
Damage 5: Sill - left side: Sill - Dent / paintcoat damage - Repair and paint

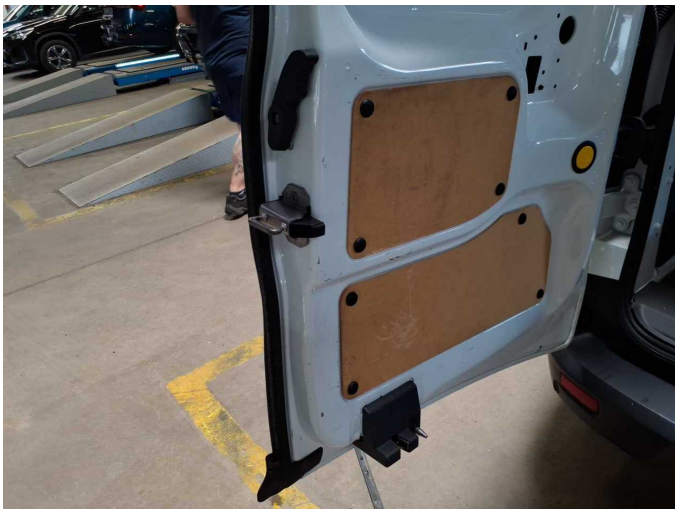
Damage 6: Boot lid / rear door: Rear door - left side - Dent / paintcoat damage - Repair and paint

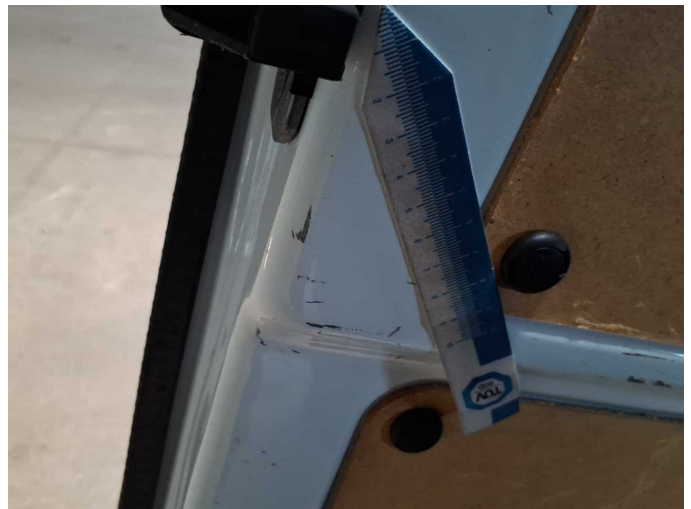
Damage 6: Boot lid / rear door: Rear door - left side - Dent / paintcoat damage - Repair and paint

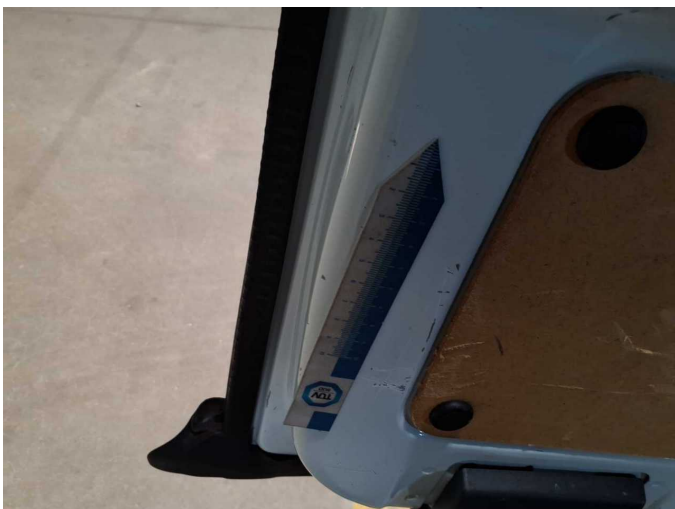
Damage 6: Boot lid / rear door: Rear door - left side - Dent / paintcoat damage - Repair and paint

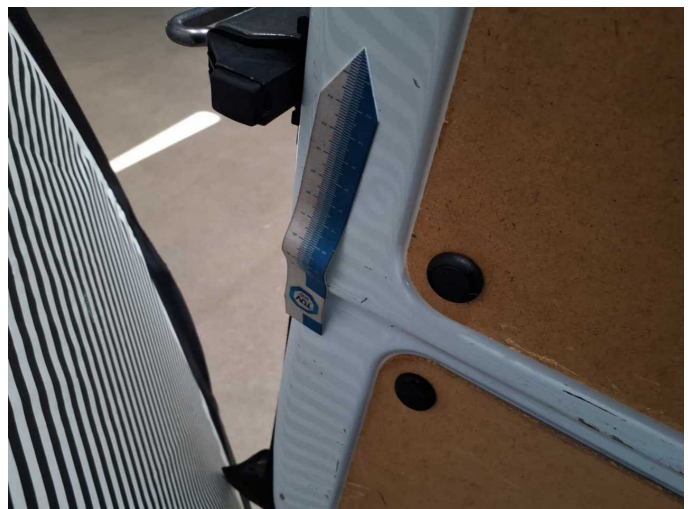
Damage 6: Boot lid / rear door: Rear door - left side - Dent / paintcoat damage - Repair and paint

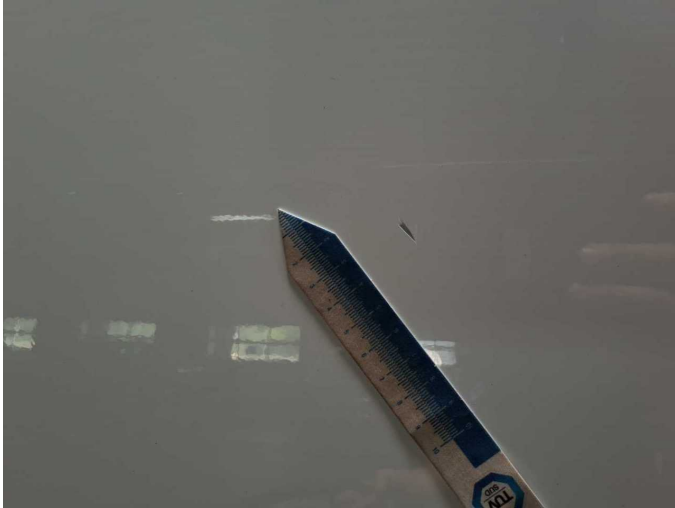
Damage 6: Boot lid / rear door: Rear door - left side - Dent / paintcoat damage - Repair and paint

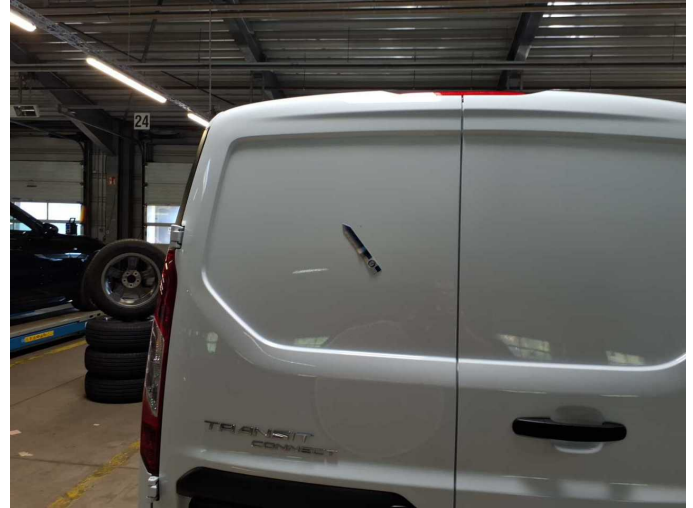
Damage 6: Boot lid / rear door: Rear door - left side - Dent / paintcoat damage - Repair and paint

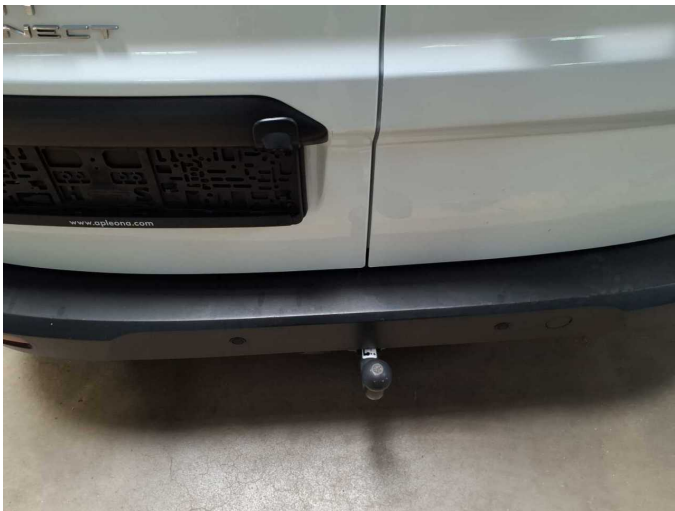
Wear and tear 1: Rear bumper: Rear bumper (unpainted) - Scratch(es)

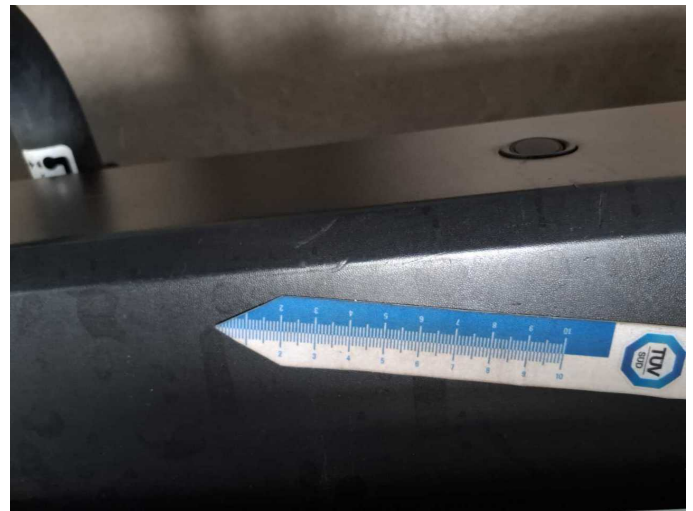
Wear and tear 1: Rear bumper: Rear bumper (unpainted) - Scratch(es)

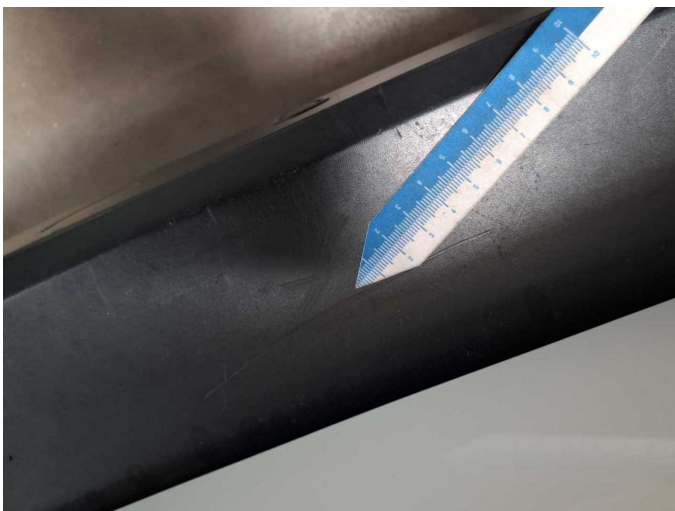
Wear and tear 1: Rear bumper: Rear bumper (unpainted) - Scratch(es)

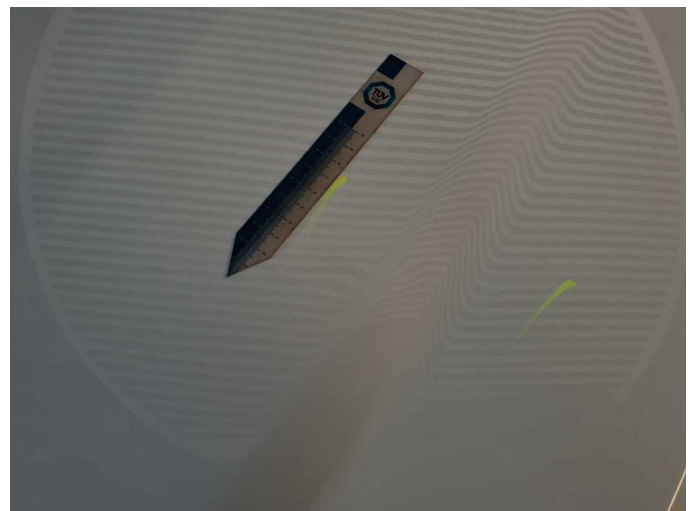
Wear and tear 2: Bonnet: Bonnet - dent(s) - No deduction

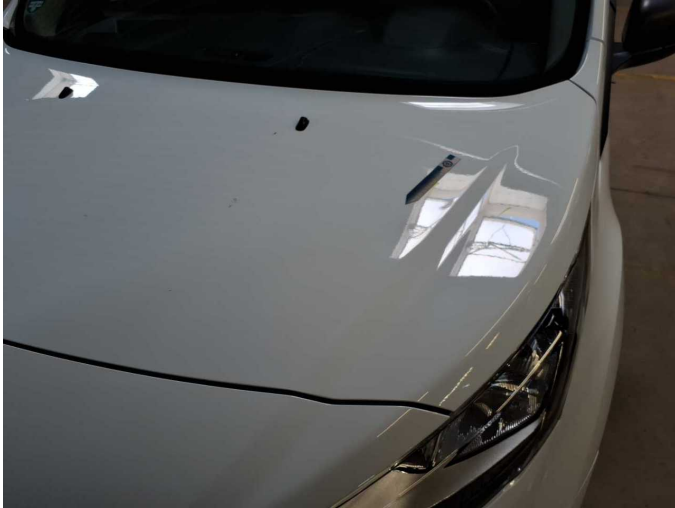
Wear and tear 2: Bonnet: Bonnet - dent(s) - No deduction
