Expertise

Protocol number: 46487319  
Order No. / Reference: 26663508  
Inspection date: 9 Jul 2026

Manufacturer: Volkswagen

Model: Passat Variant 1.4 TSI Plug-In-Hybrid DSG GTE

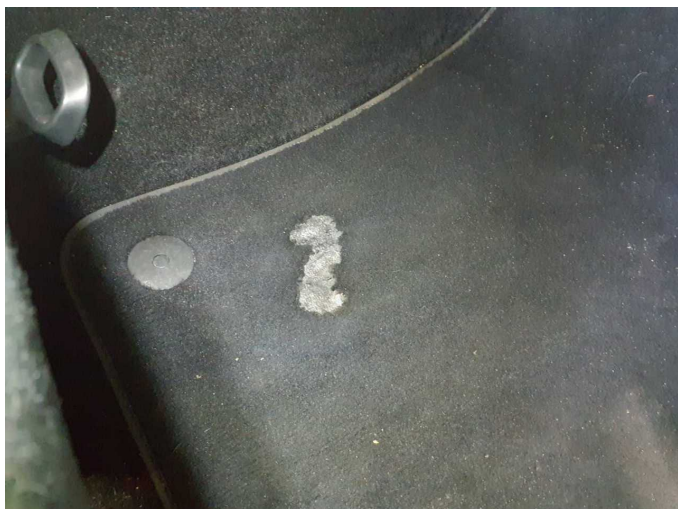
| No. | Component group | Description |
|---|---|---|
| 1 | Trim / covers | Floor mats - Broken / torn - Replace |

**Damage 1:** Trim / covers: Floor mats - Broken / torn - Replace

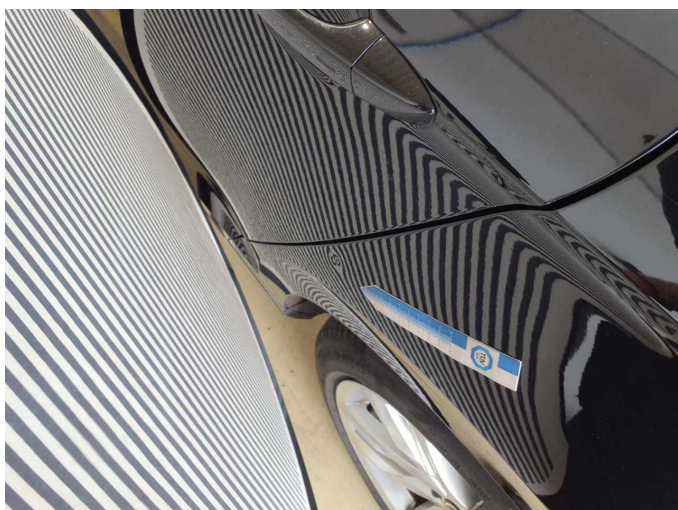
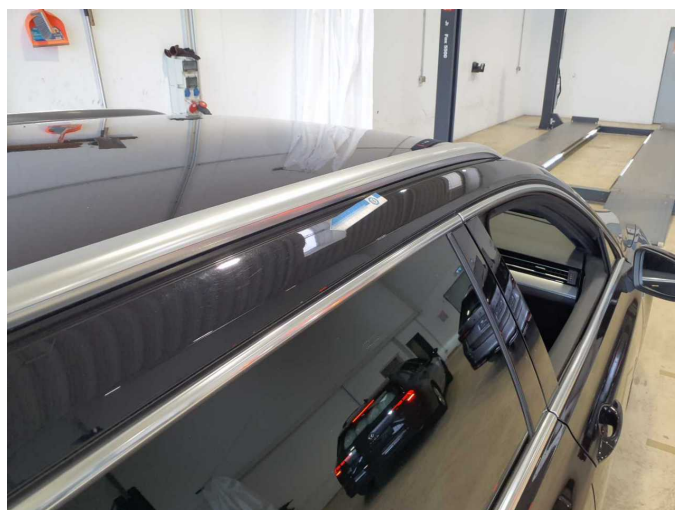
| No. | Component group | Description |
|---|---|---|
| 2 | Side panel - rear left side | Side panel - dent(s) - Smooth repair work |

**Damage 2:** Side panel - rear left side: Side panel - dent(s) - Smooth repair work

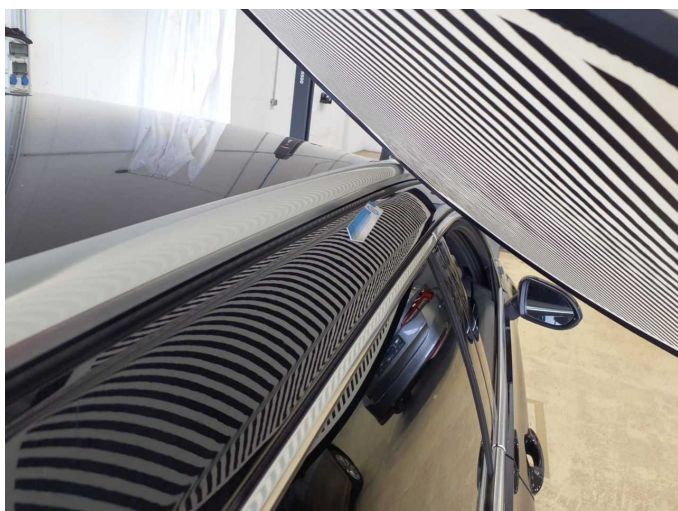
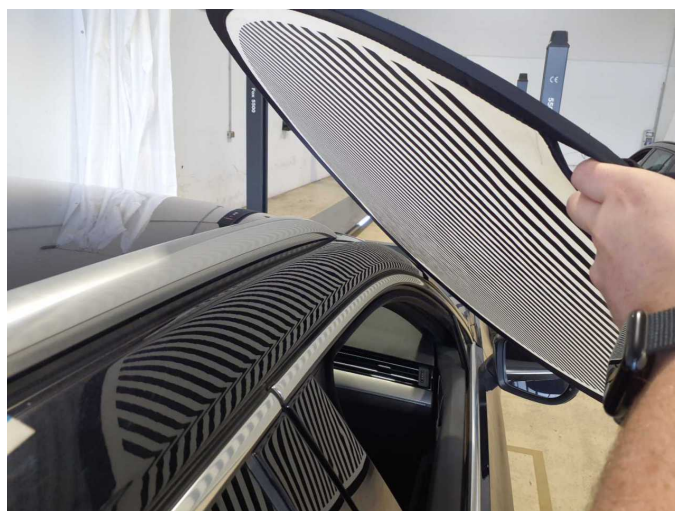
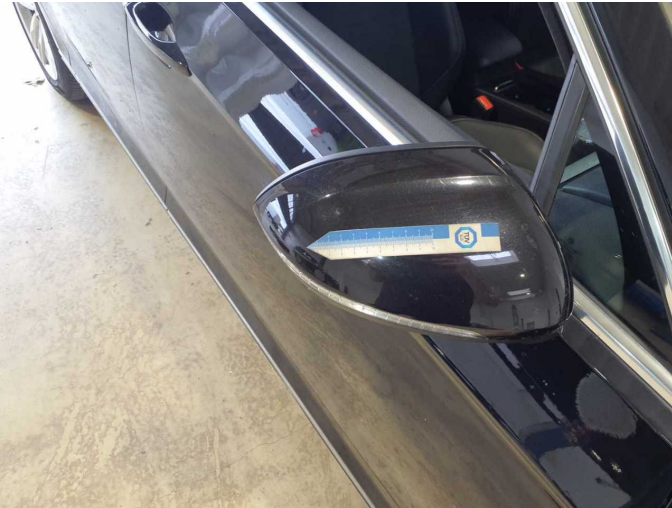
| No. | Component group | Description |
|---|---|---|
| 3 | Roof | Roof rail - right side - dent(s) - Smooth repair work |

**Damage 3:** Roof: Roof rail - right side - dent(s) - Smooth repair work

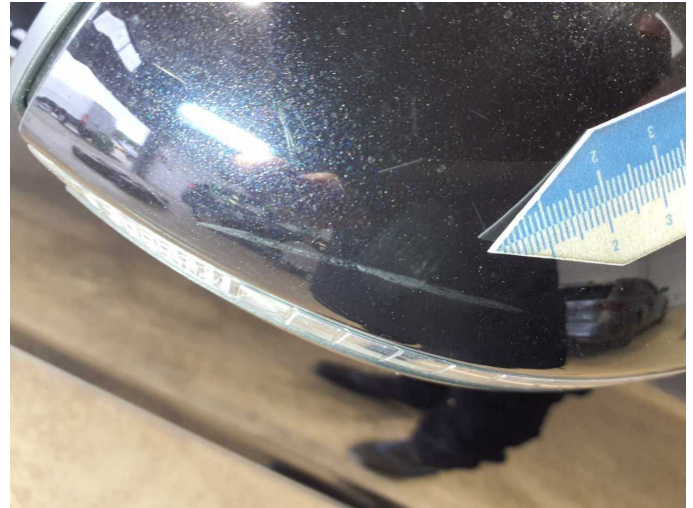
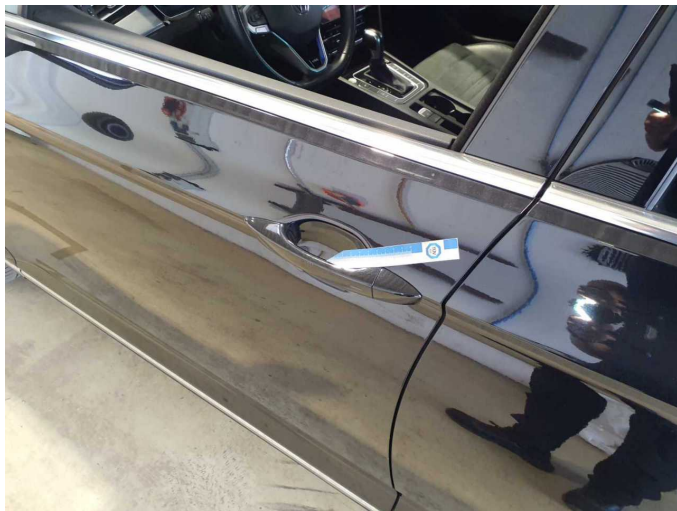
| No. | Component group | Description |
|---|---|---|
| 4 | Wing mirror - right side | Cap - Scratch(es) - Smart repair |

**Damage 4:** Wing mirror - right side: Cap - Scratch(es) - Smart repair

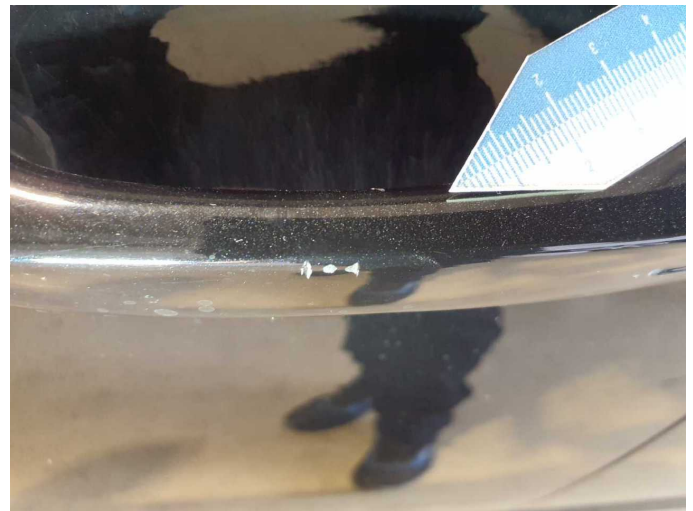
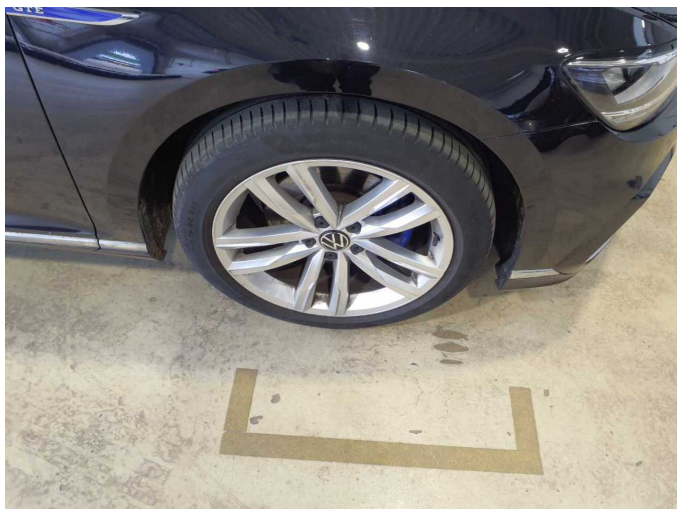
| No. | Component group | Description |
|---|---|---|
| 5 | Door - front left side | Door handle - outside - Scratch(es) - Paint |

**Damage 5:** Door - front left side: Door handle - outside - Scratch(es) - Paint

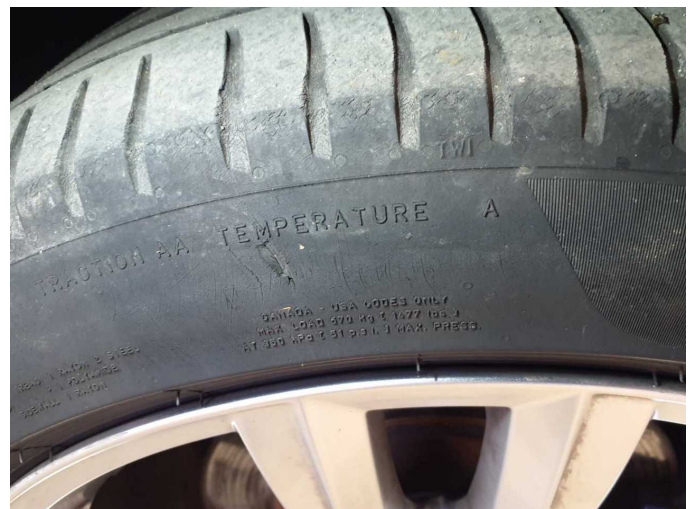
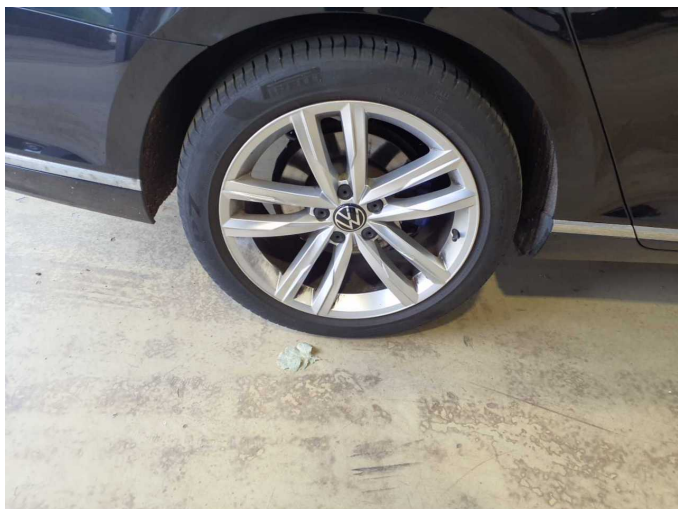
| No. | Component group | Description |
|---|---|---|
| 6 | Wheel / tyres | Tyre - front right side - Broken / torn - Replace |

**Damage 6:** Wheel / tyres: Tyre - front right side - Broken / torn - Replace

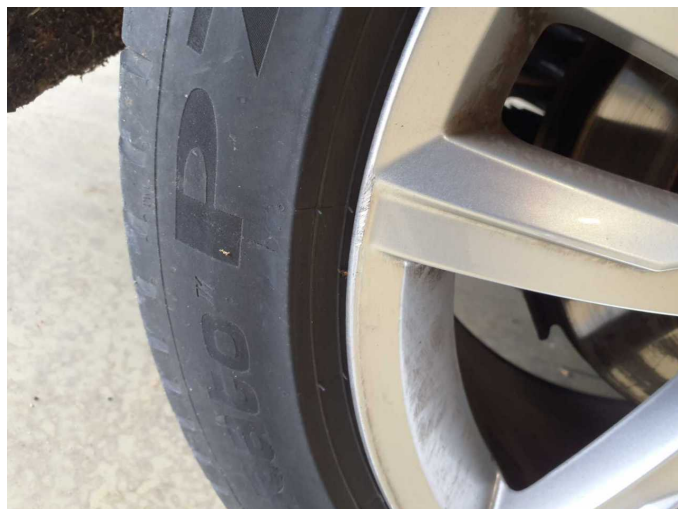
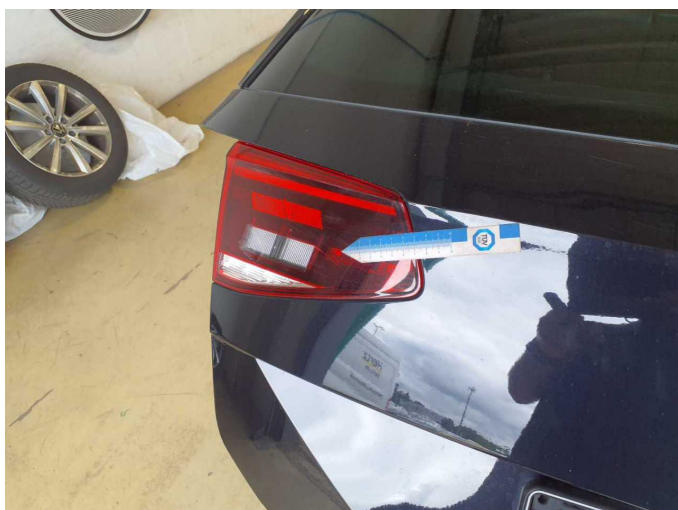
| No. | Component group | Description |
|---|---|---|
| 7 | Wheel / tyres | Alloy rim - rear right side - Scratch(es) - Loss in value |

**Damage 7:** Wheel / tyres: Alloy rim - rear right side - Scratch(es) - Loss in value

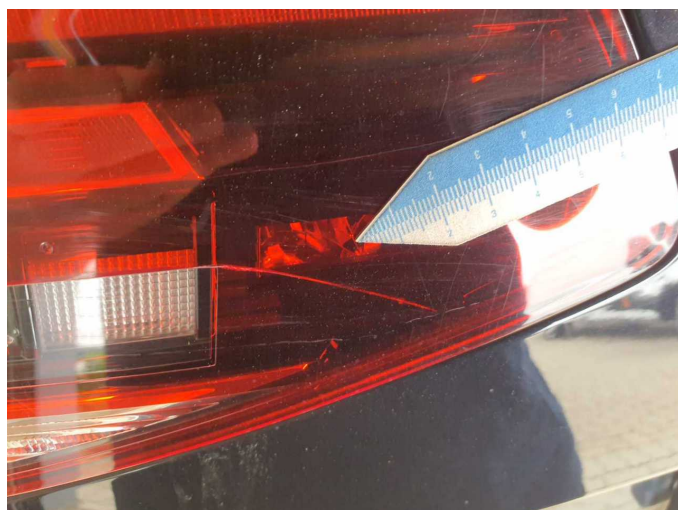
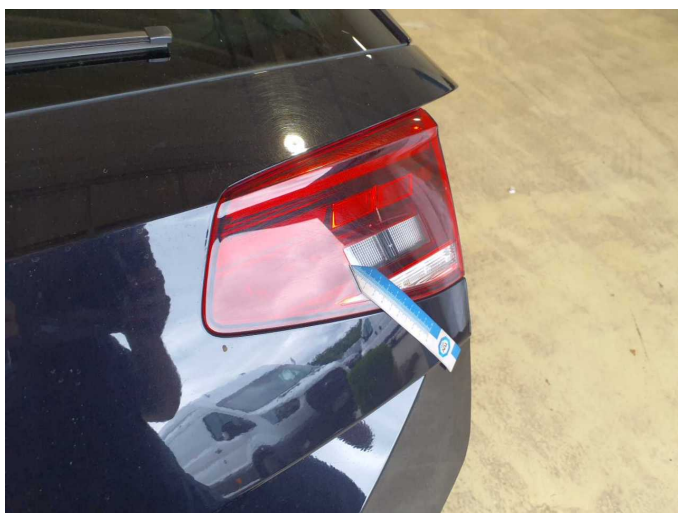
| No. | Component group | Description |
|---|---|---|
| 8 | Tail light | Tail lamp - left side - Broken / torn - Replace |

**Damage 8:** Tail light: Tail lamp - left side - Broken / torn - Replace

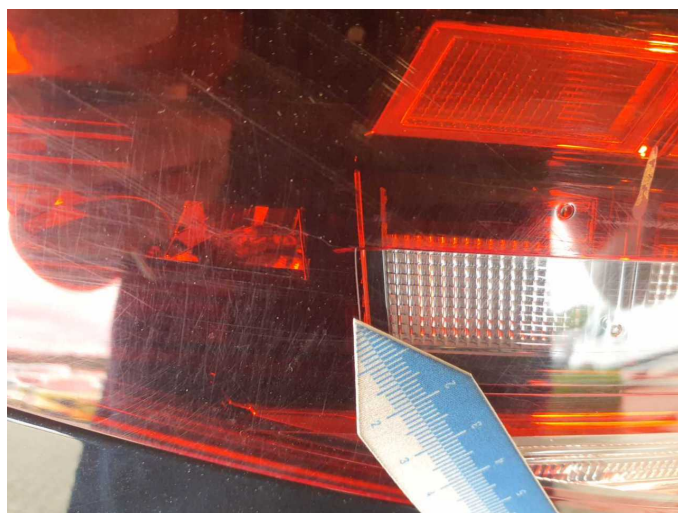
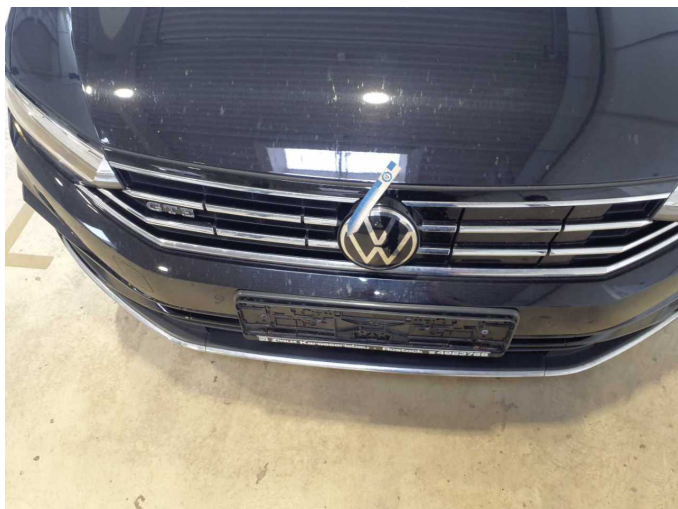
| No. | Component group | Description |
|---|---|---|
| 9 | Tail light | Tail lamp - right side - Broken / torn - Replace |

**Damage 9:** Tail light: Tail lamp - right side - Broken / torn - Replace

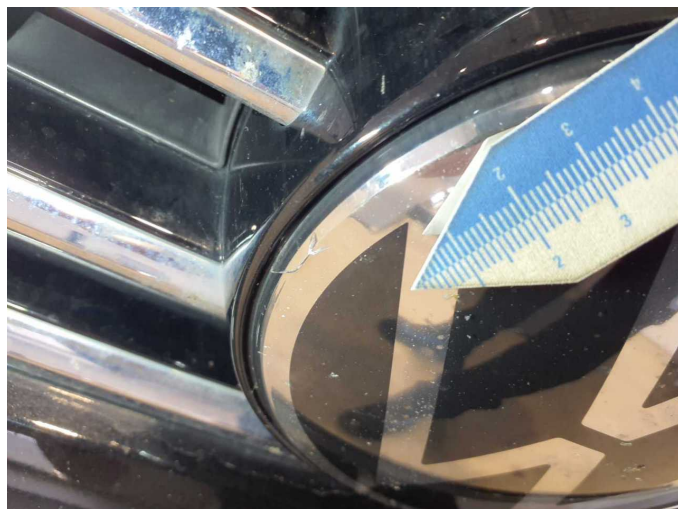
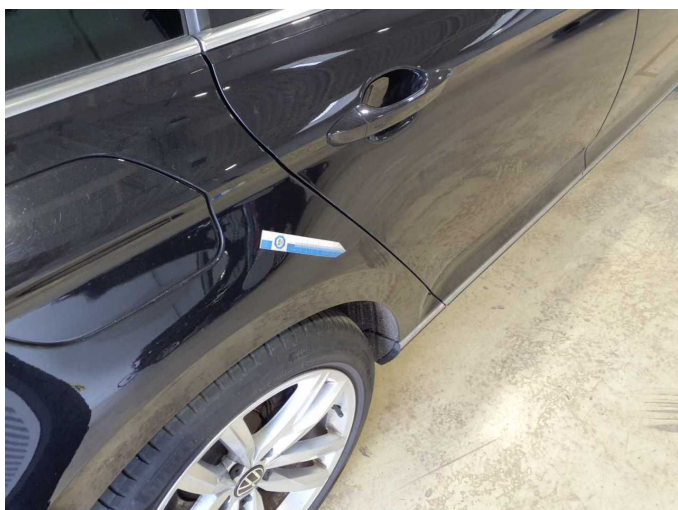
| No. | Component group | Description |
|---|---|---|
| 10 | Front structure | Emblem - Broken / torn - Replace |

**Damage 10:** Front structure: Emblem - Broken / torn - Replace

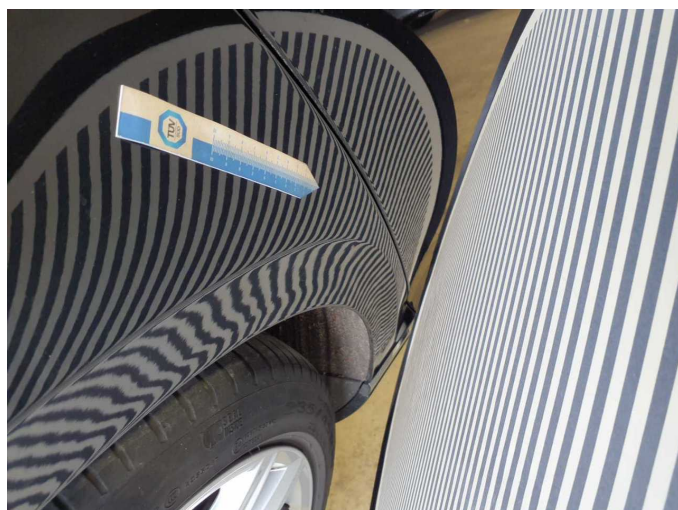
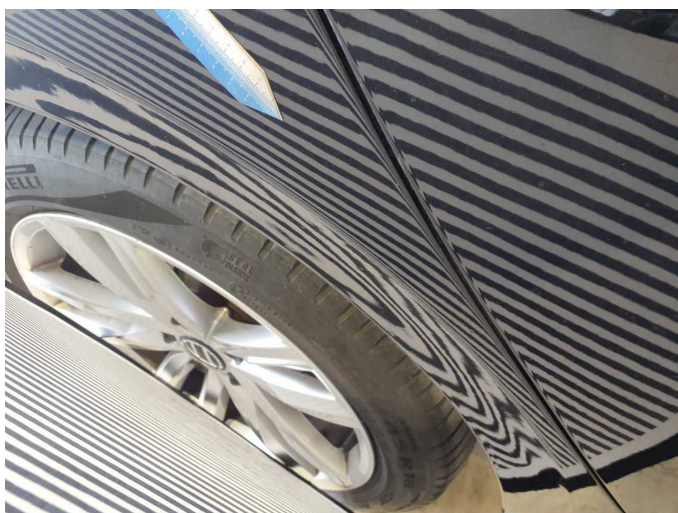
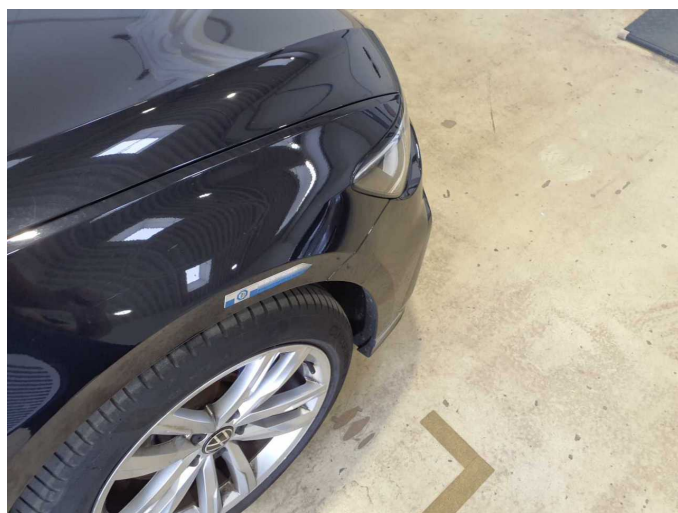
| No. | Component group | Description |
|---|---|---|
| 11 | Side panel - rear right side | Side panel (Wellig) - Unprofessionally repaired - Paint |

| Side panel - rear right side | 375 µm | Door - rear right side | 172 µm |

**Damage 11:** Side panel - rear right side: Side panel (Wellig) - Unprofessionally repaired - Paint

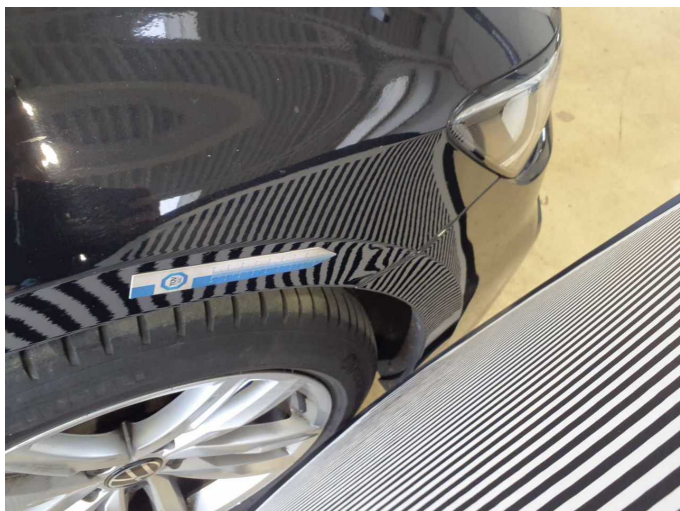
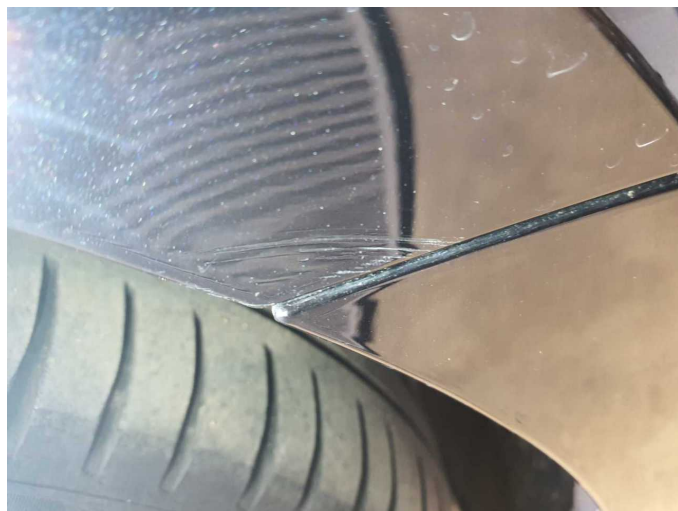
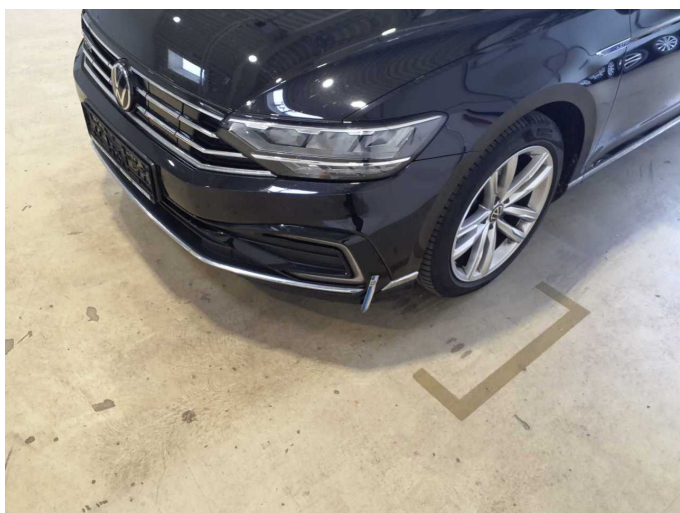
| No. | Component group | Description |
|---|---|---|
| 12 | Mudguard - right side | Mudguard - right side - Dent / paintcoat damage - Repair and paint |

**Damage 12:** Mudguard - right side: Mudguard - right side - Dent / paintcoat damage - Repair and paint

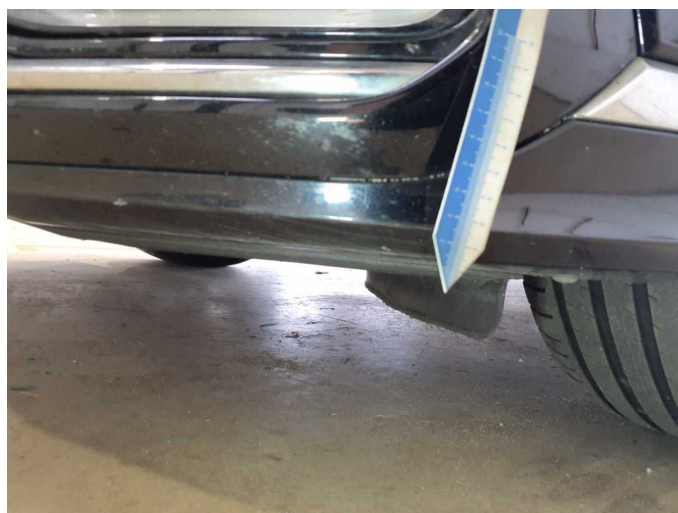
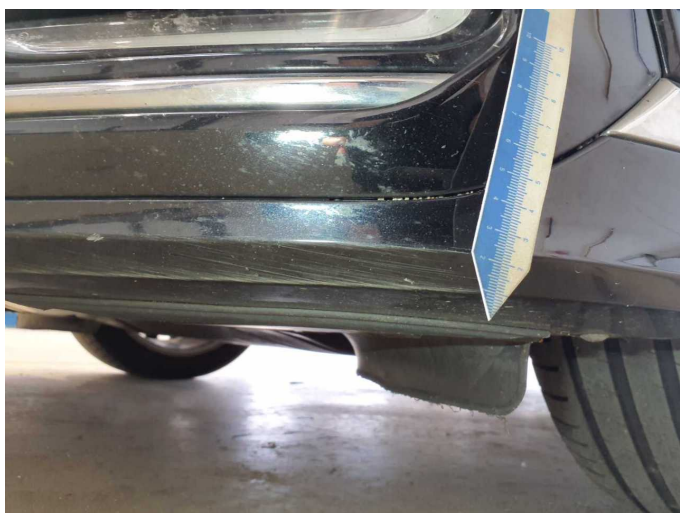
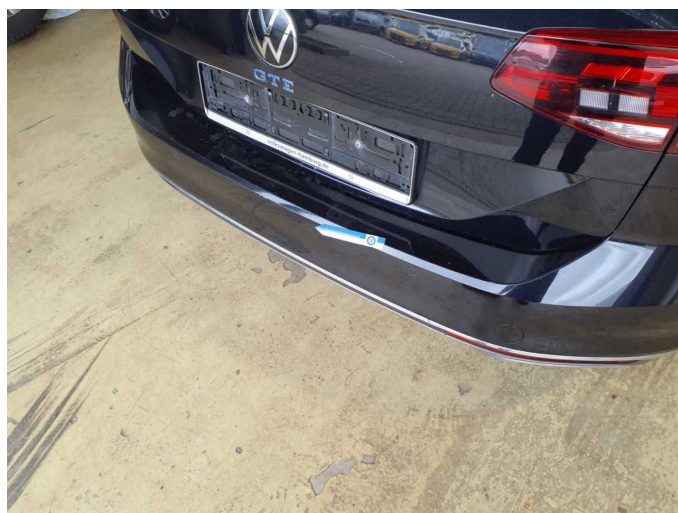
| No. | Component group | Description |
|---|---|---|
| 13 | Front bumper | Front bumper - Scratch(es) - Paint |

**Damage 13:** Front bumper: Front bumper - Scratch(es) - Paint

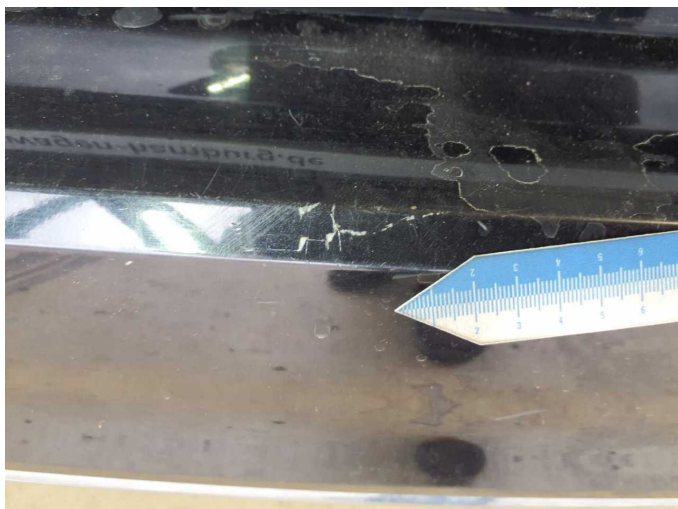
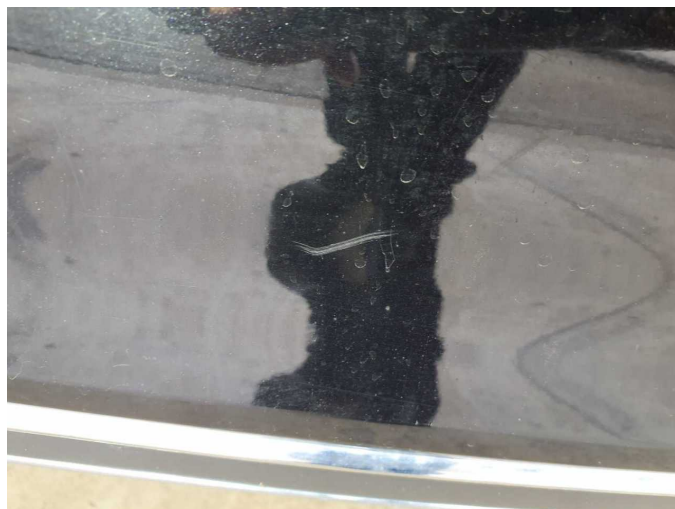
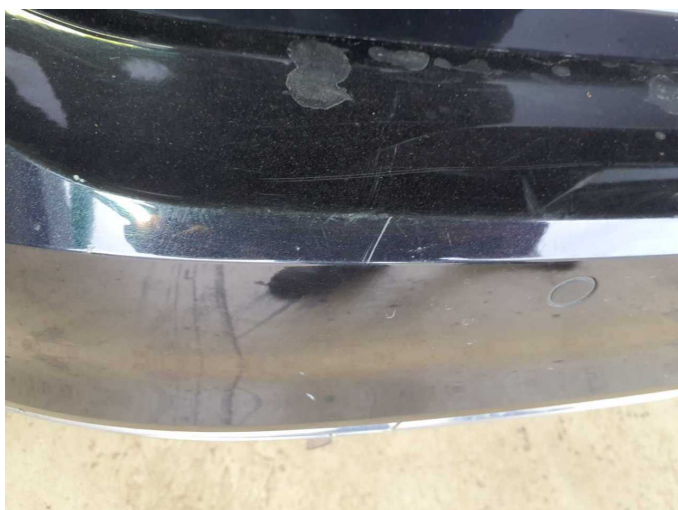
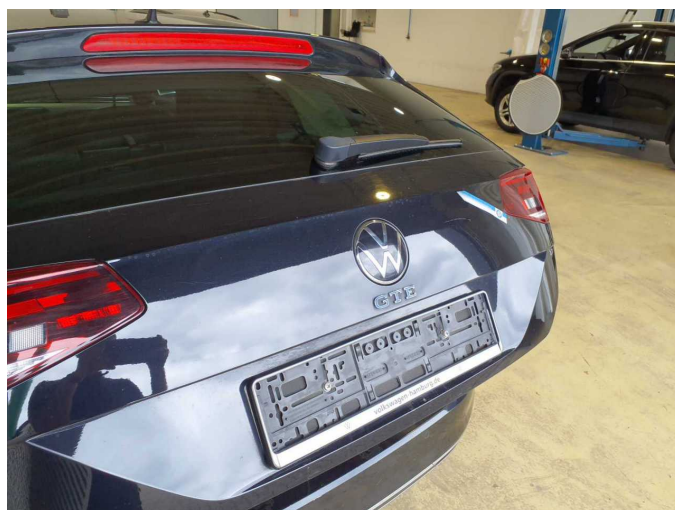
| No. | Component group | Description |
|---|---|---|
| 14 | Rear bumper | Rear bumper - Scratch(es) - Paint |

**Damage 14:** Rear bumper: Rear bumper - Scratch(es) - Paint

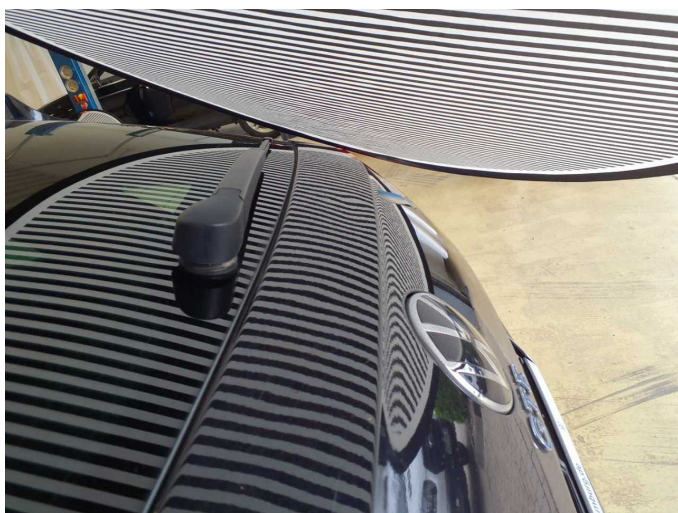
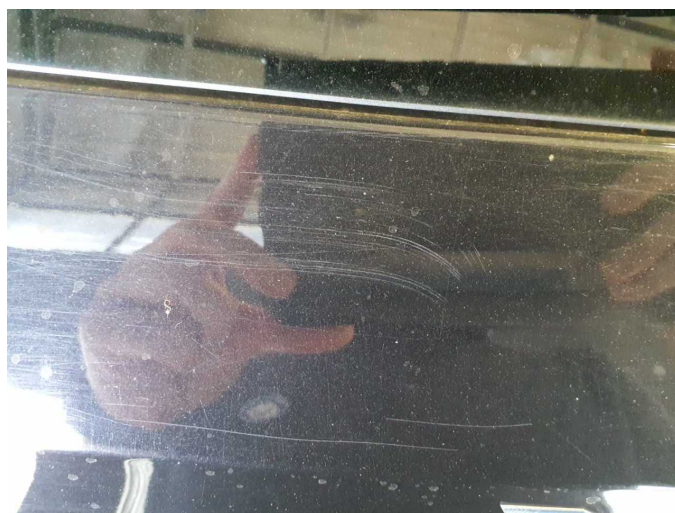
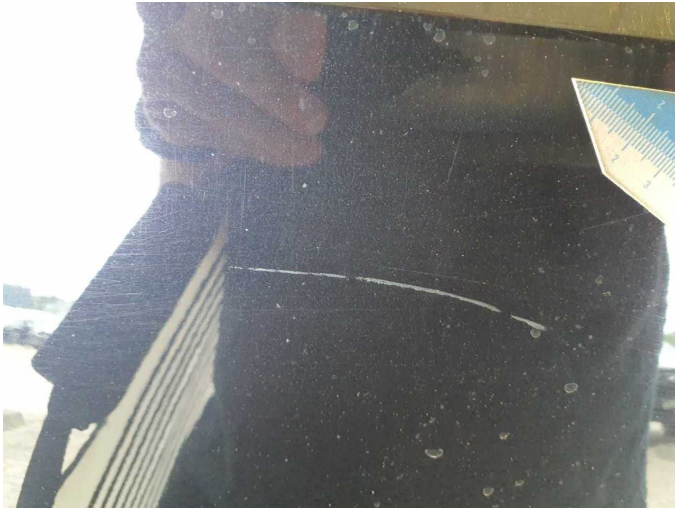
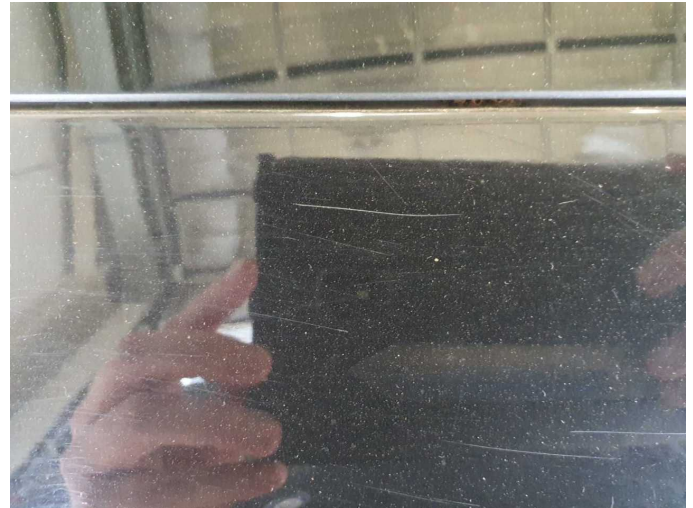
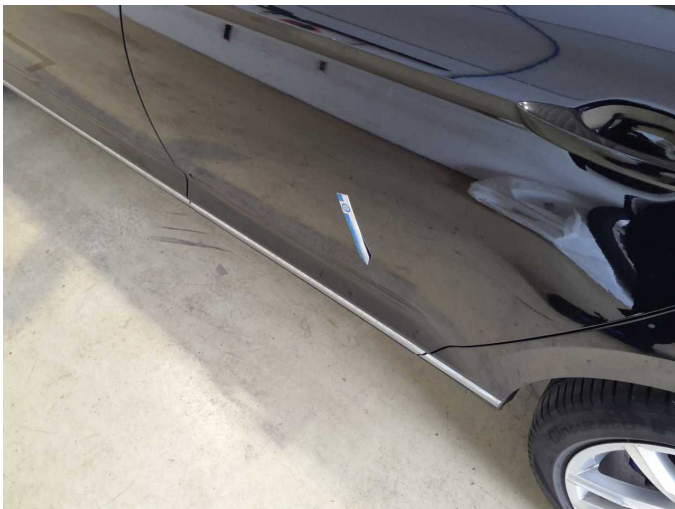
| No. | Component group | Description |
|---|---|---|
| 15 | Boot lid / rear door | Boot lid - Dent / paintcoat damage - Repair and paint |

**Damage 15:** Boot lid / rear door: Boot lid - Dent / paintcoat damage - Repair and paint

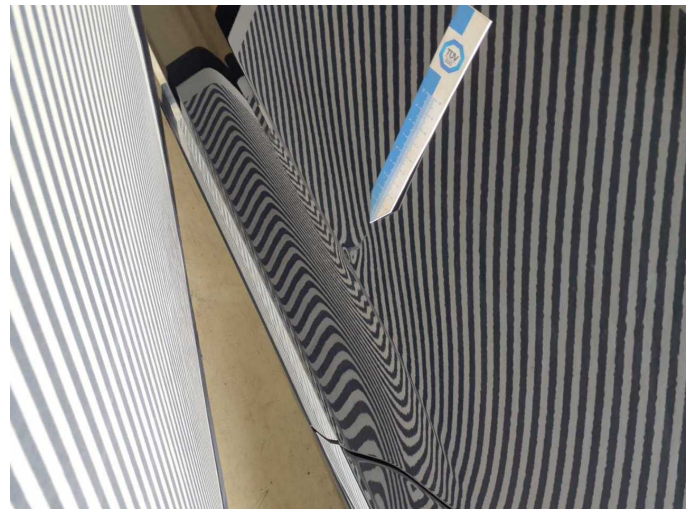
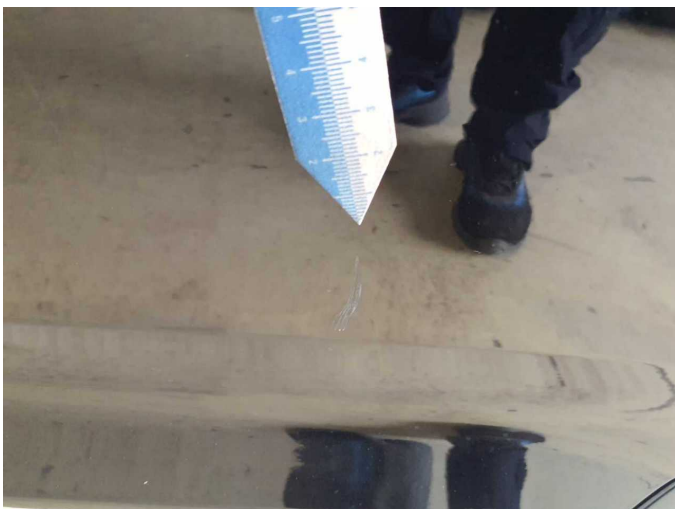
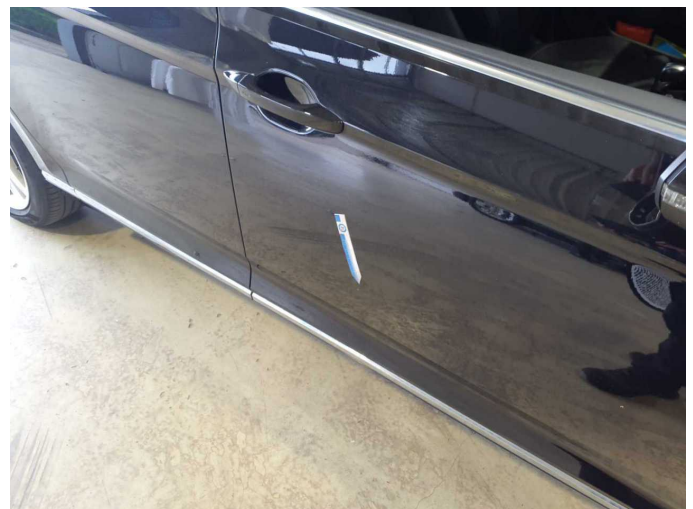
| No. | Component group | Description |
|---|---|---|
| 16 | Door - rear left side | Door - Dent / paintcoat damage - Repair and paint |

**Damage 16:** Door - rear left side: Door - Dent / paintcoat damage - Repair and paint

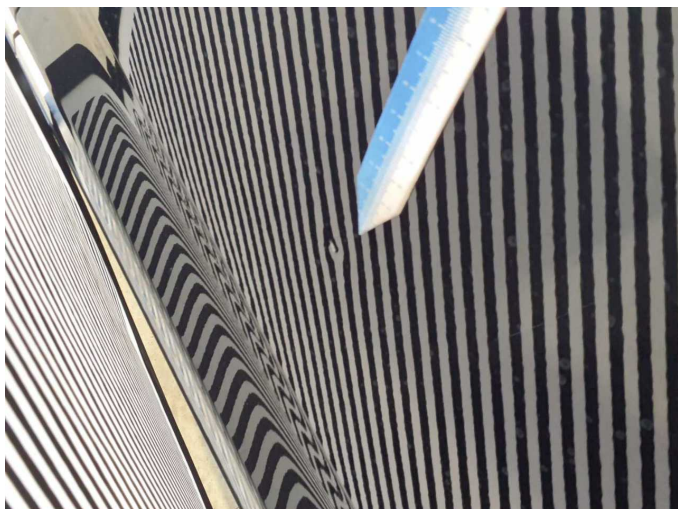
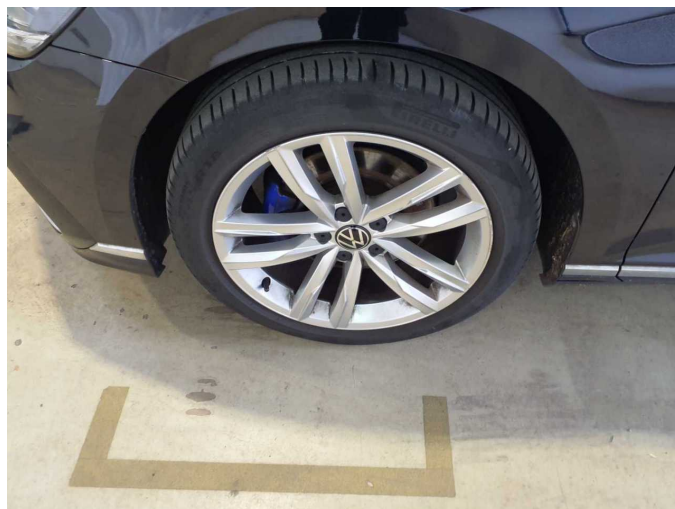
| No. | Component group | Description |
|---|---|---|
| 17 | Door - front right side | Door - Dent / paintcoat damage - Repair and paint |

**Damage 17:** Door - front right side: Door - Dent / paintcoat damage - Repair and paint

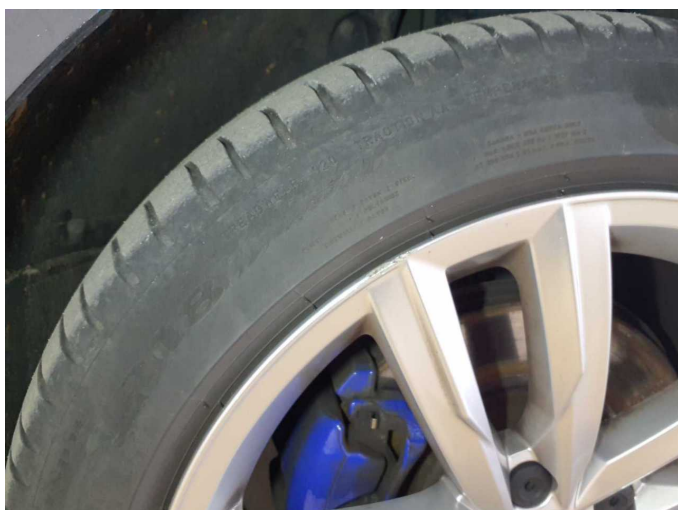
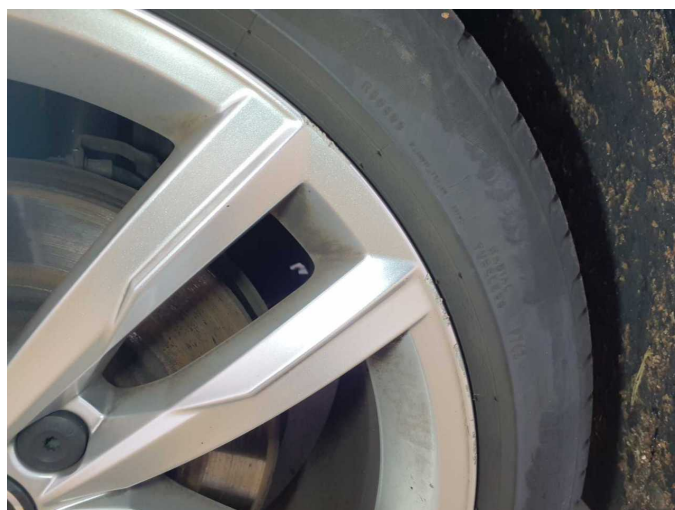
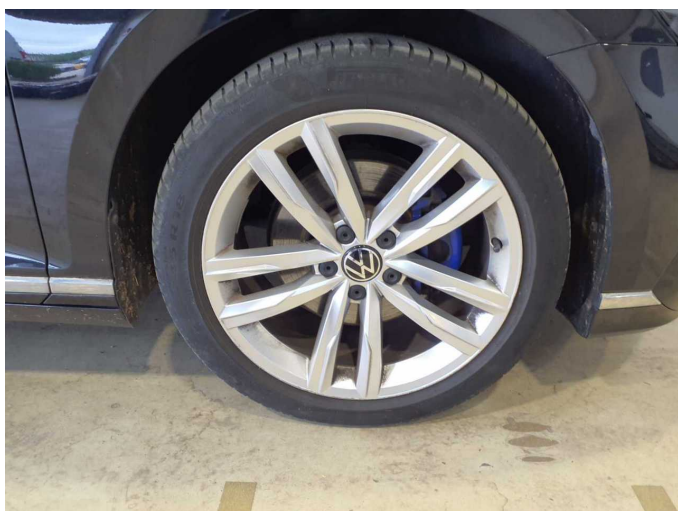
| No. | Component group | Description |
|---|---|---|
| 18 | Wheel / tyres | Alloy rim - front left side - Scratch(es) - Replace |

**Damage 18:** Wheel / tyres: Alloy rim - front left side - Scratch(es) - Replace

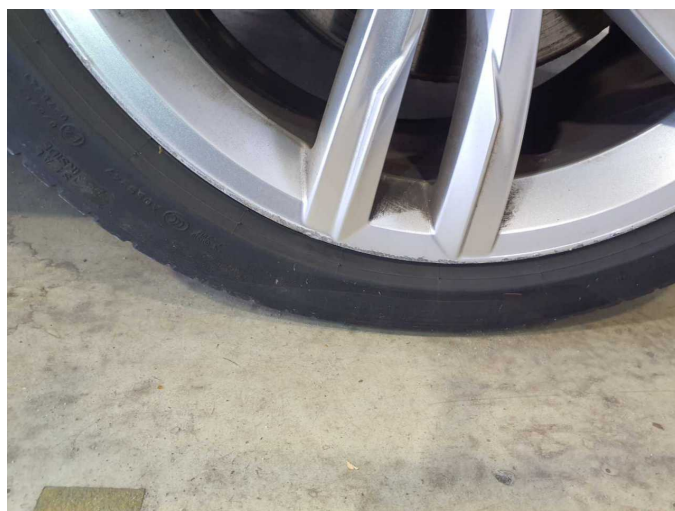
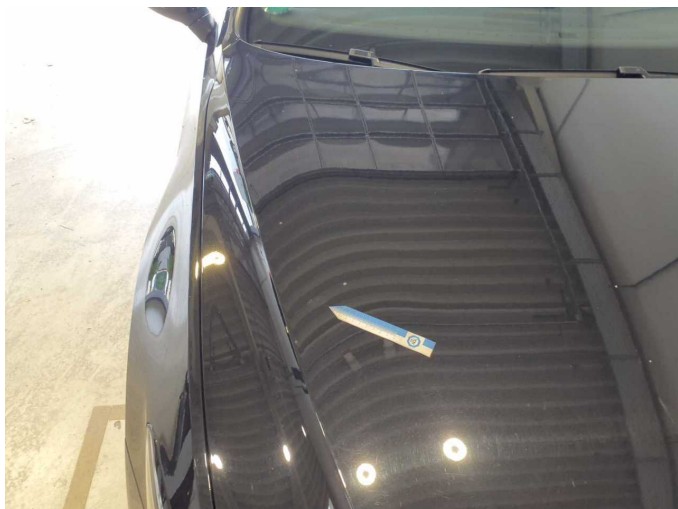
| No. | Component group | Description |
|---|---|---|
| 19 | Wheel / tyres | Alloy rim - front right side - Scratch(es) - Replace |

**Damage 19:** Wheel / tyres: Alloy rim - front right side - Scratch(es) - Replace

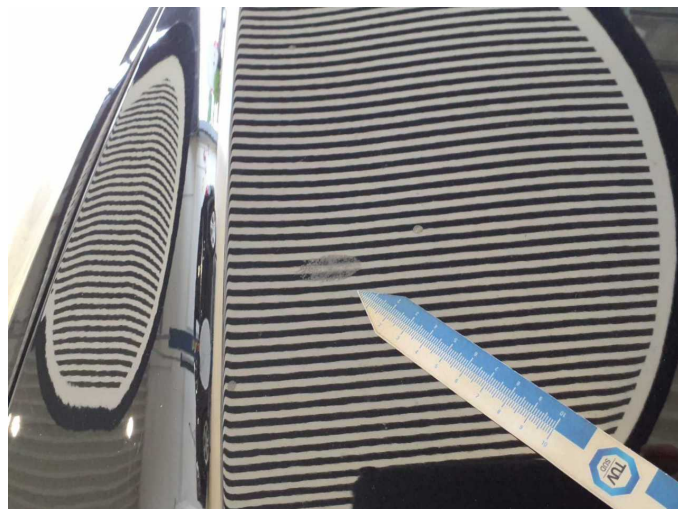
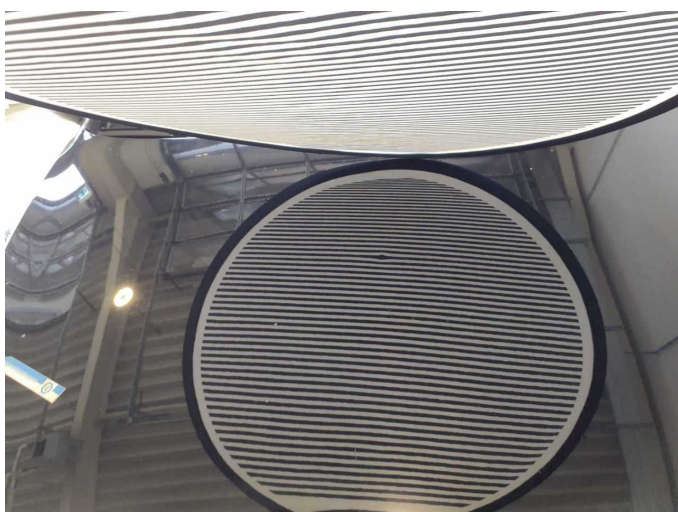
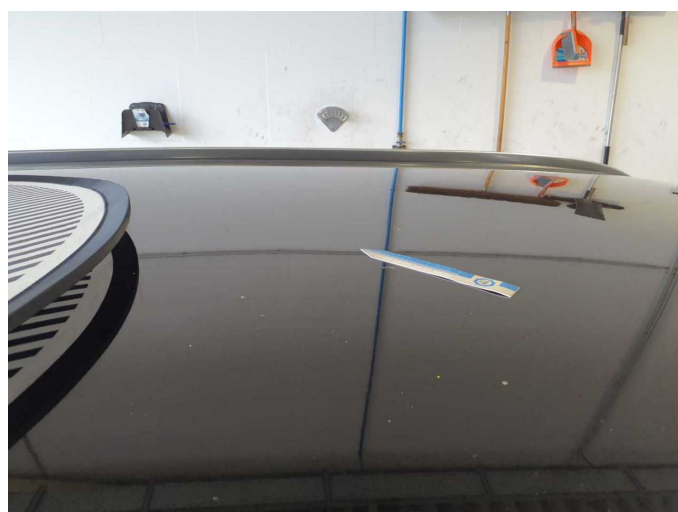
| No. | Component group | Description |
|---|---|---|
| 20 | Bonnet | Bonnet (Anätzung) - Paint defect - Repair and paint |

**Damage 20:** Bonnet: Bonnet (Anätzung) - Paint defect - Repair and paint

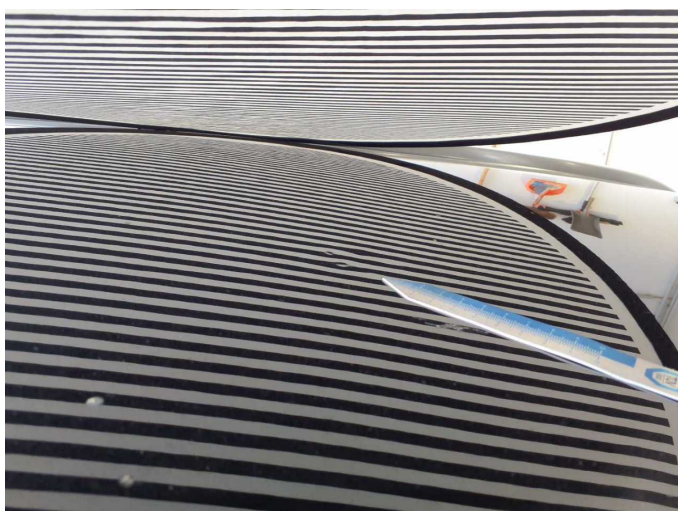
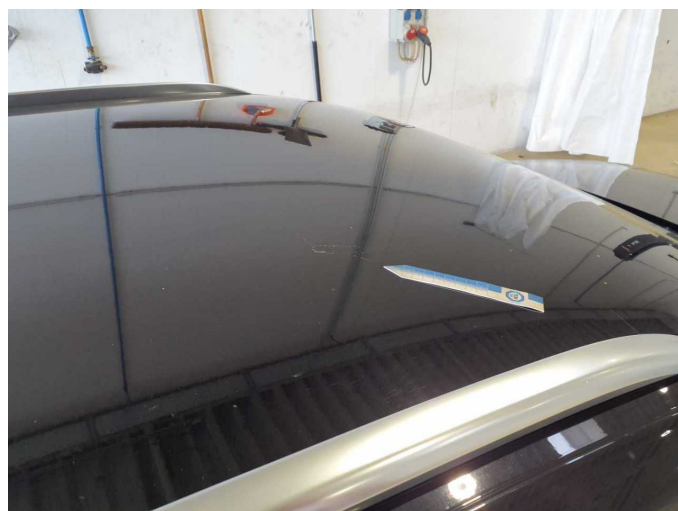
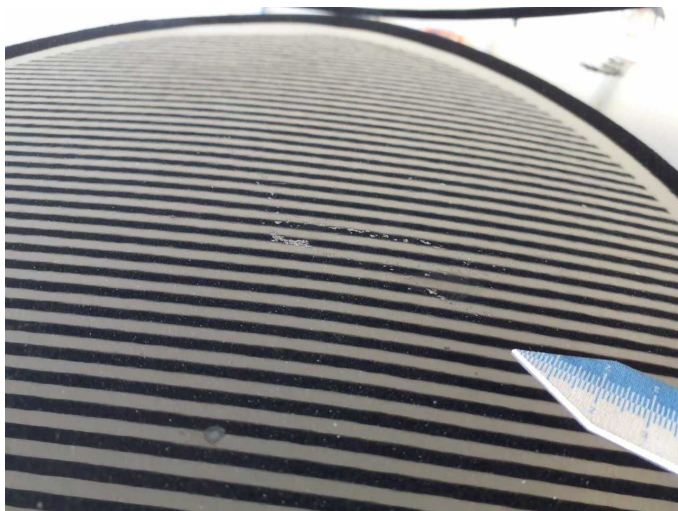
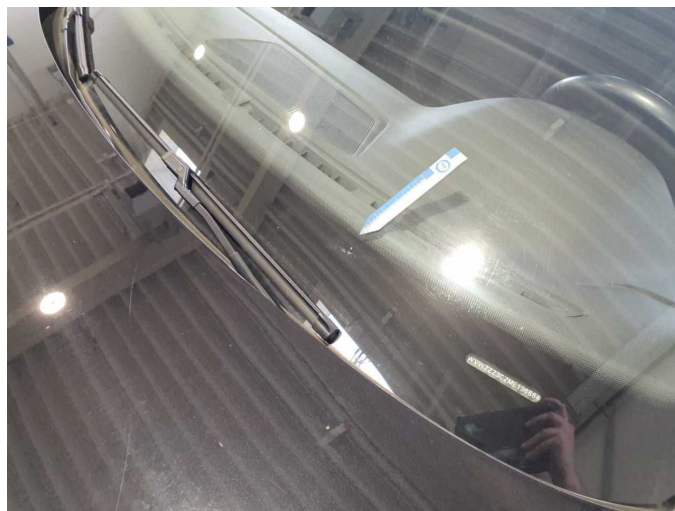
| No. | Component group | Description |
|---|---|---|
| 21 | Roof | Roof (Anätzung) - Paint defect - Repair and paint |

**Damage 21:** Roof: Roof (Anätzung) - Paint defect - Repair and paint

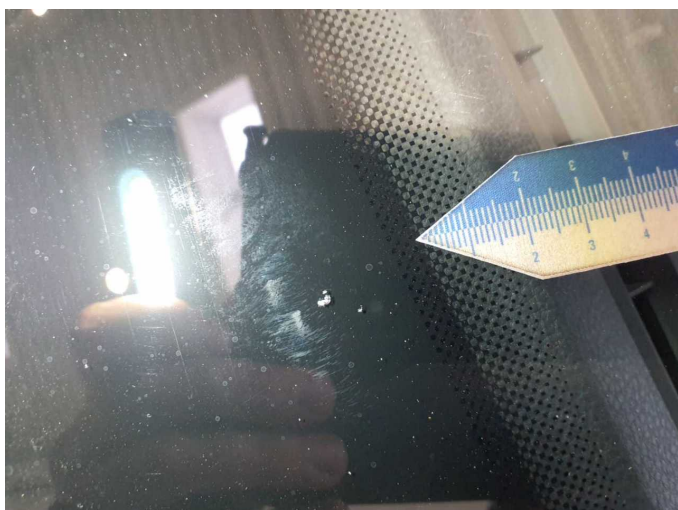
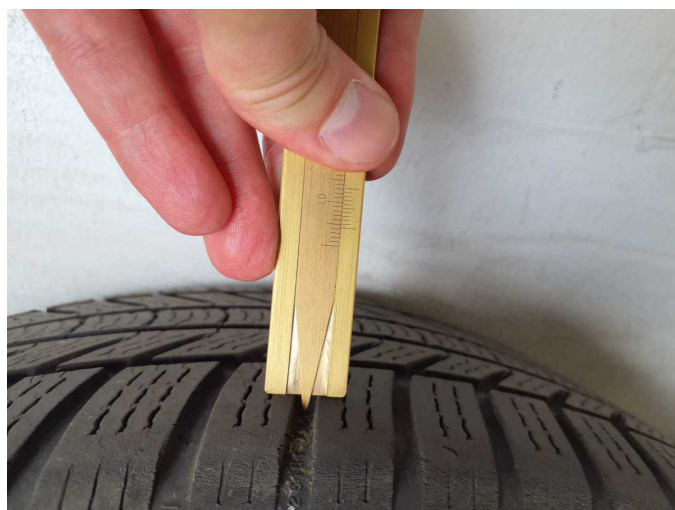
| No. | Component group | Description |
|---|---|---|
| 22 | Vehicle glazing | Windscreen - Stone chips - Replace |

**Damage 22:** Vehicle glazing: Windscreen - Stone chips - Replace

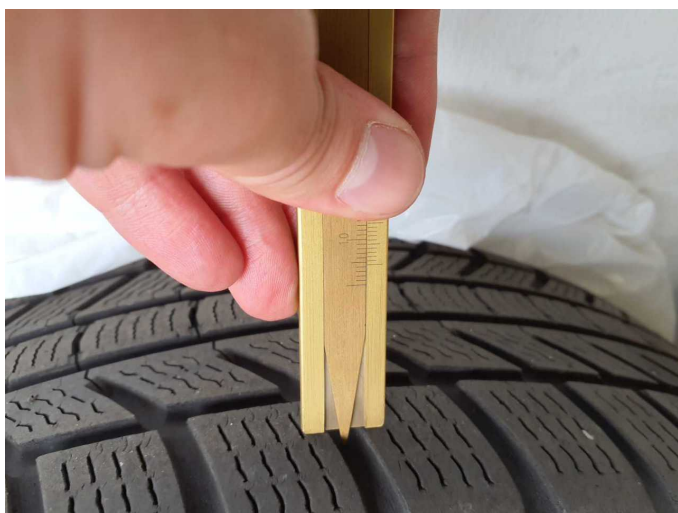
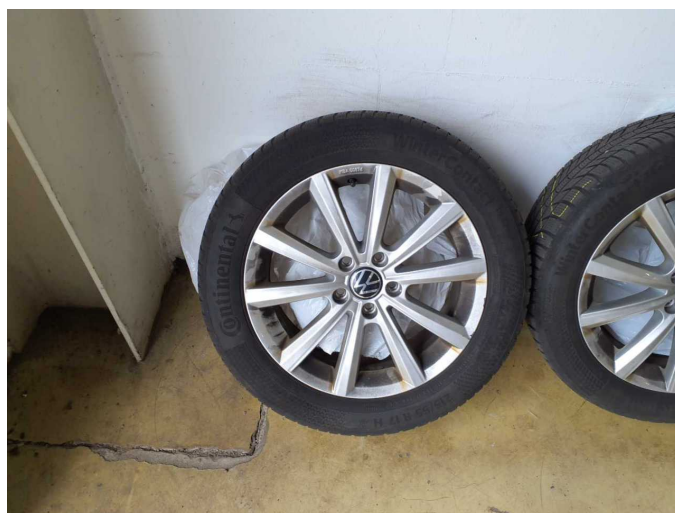
| No. | Component group | Description |
|---|---|---|
| 3 | 2nd wheel set | 2 tyres - does not meet manufacturer specifications - No deduction |

**Wear and tear 3:** 2nd wheel set: 2 tyres - does not meet manufacturer specifications - No deduction

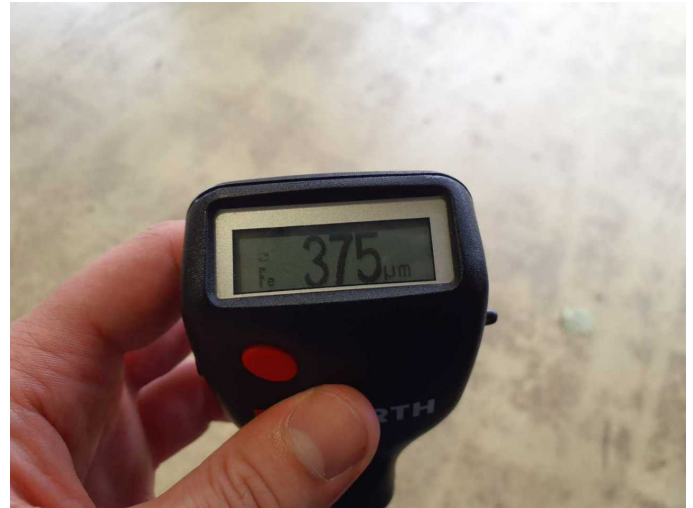
| No. | Repainting |
|---|---|
| 1 | Side panel - rear right side, Professionally carried out, Invoice of repair done Non-existent |

**Repainting 1:** Side panel - rear right side

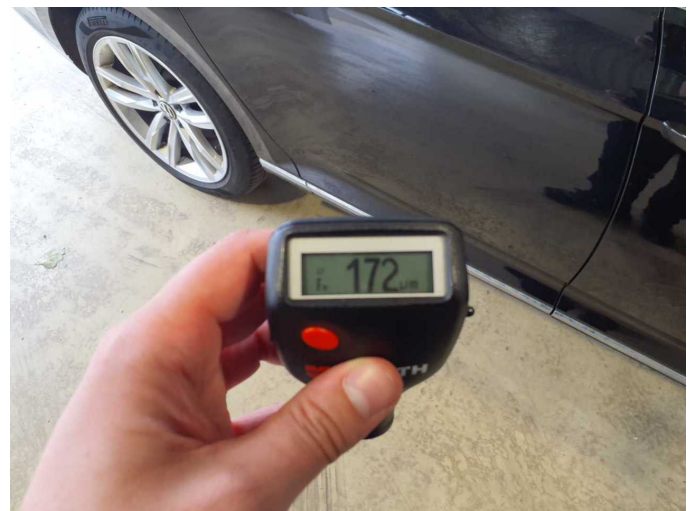
| No. | Repainting |
|---|---|
| 2 | Door - rear right side, Professionally carried out, Invoice of repair done Non-existent |

**Repainting 2:** Door - rear right side
