Expertise

Protocol number: 46229973
Order No. / Reference: 26622043
Inspection date: 29 Jun 2026

Manufacturer: Renault

Model: R 5 E-Tech Iconic Five 150 Comfort Range

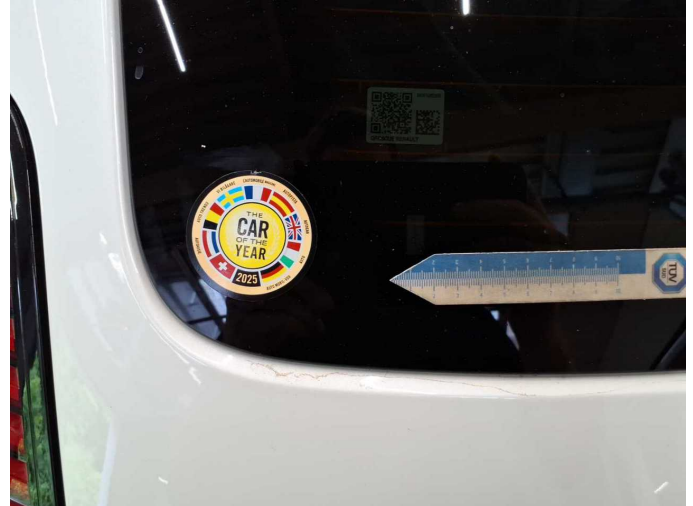
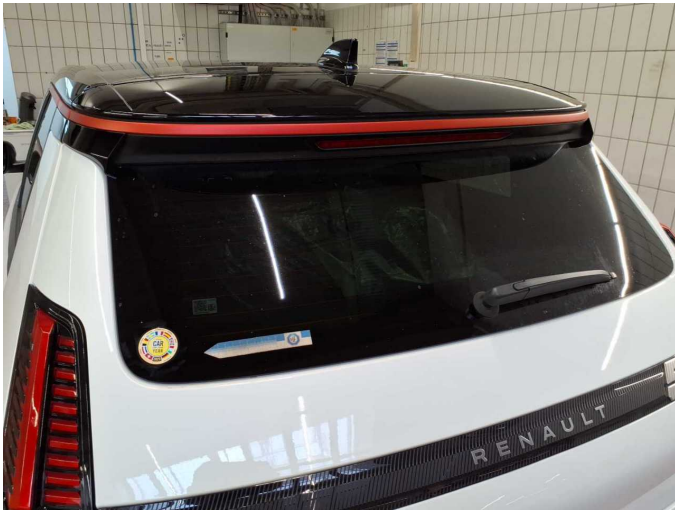
| No. | Component group | Description |
|---|---|---|
| 1 | Vehicle glazing | Rear window - Glued / labelled - De-glue / neutralise |

Damage 1: Vehicle glazing: Rear window - Glued / labelled - De-glug / neutralise
