Expertise

Protocol number: 45302679
Order No. / Reference: 25948404
Inspection date: 30 Apr 2026

Manufacturer: Opel

Model: Astra 1.5 D Start/Stop Sports Tourer Automatik Business Edition

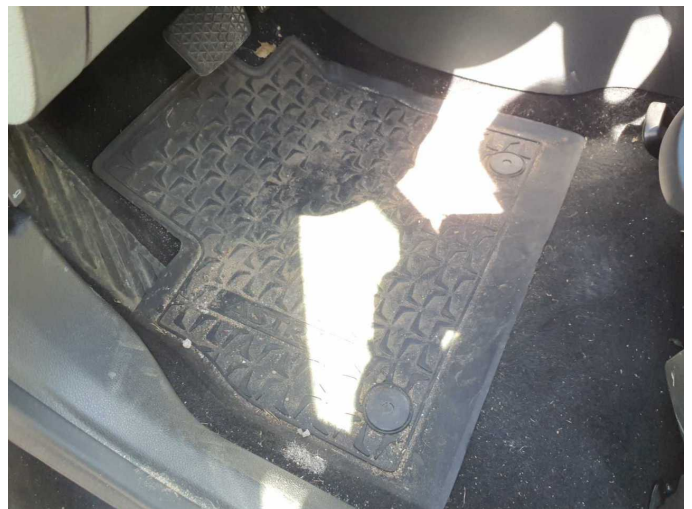
Damage 1: Interior: Interior - Soiled - Clean

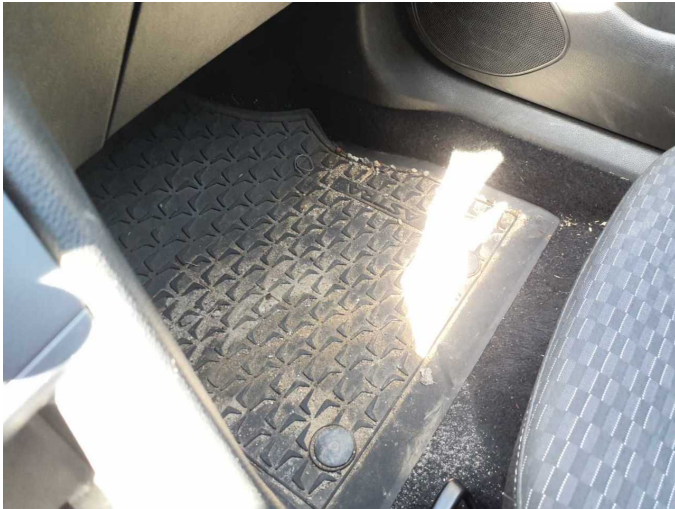
Damage 1: Interior: Interior - Soiled - Clean

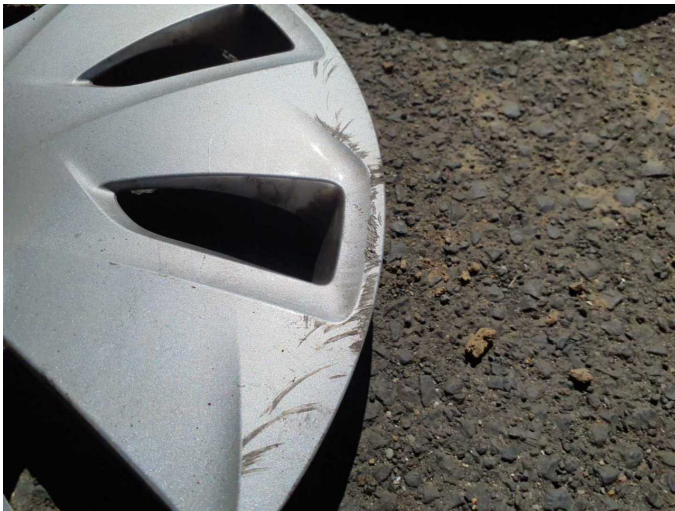
Damage 2: 2nd wheel set: 3 wheel covers - Scratched - Replace

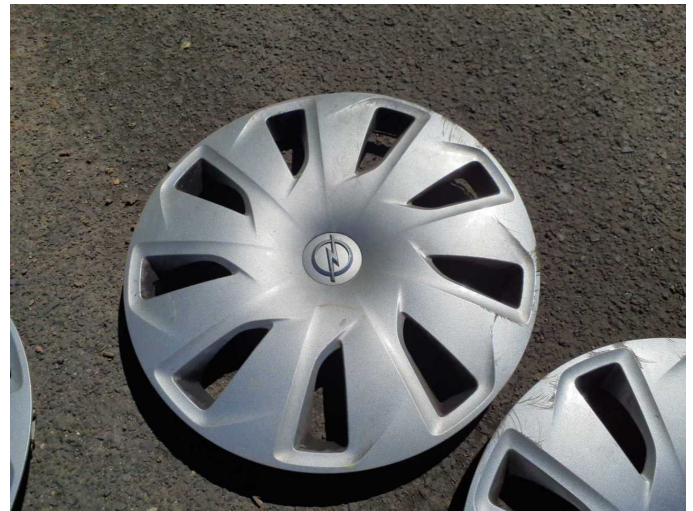
Damage 2: 2nd wheel set: 3 wheel covers - Scratched - Replace

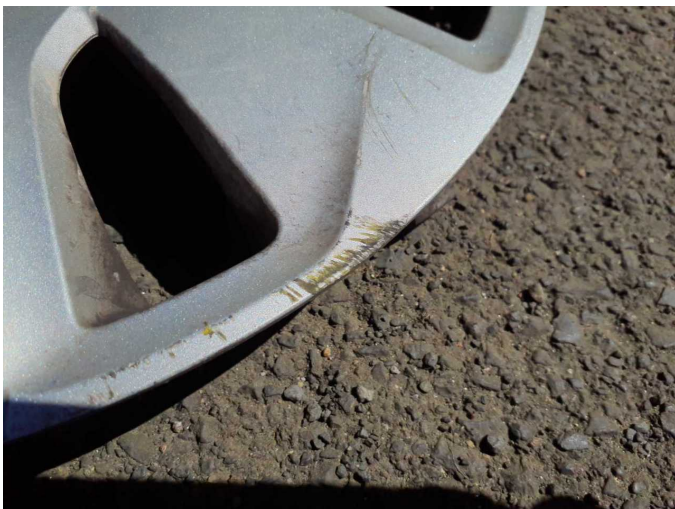
Damage 2: 2nd wheel set: 3 wheel covers - Scratched - Replace

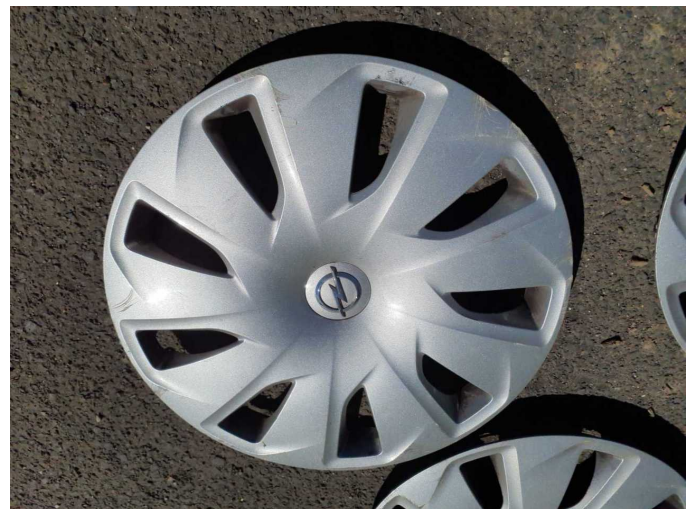
Damage 2: 2nd wheel set: 3 wheel covers - Scratched - Replace

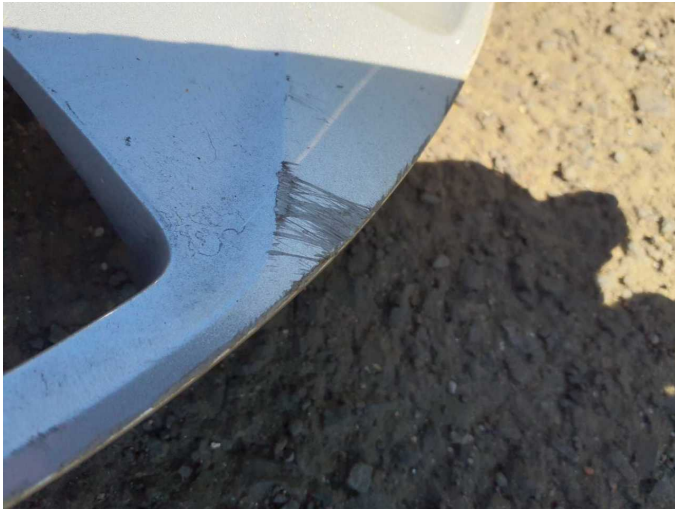
Damage 2: 2nd wheel set: 3 wheel covers - Scratched - Replace

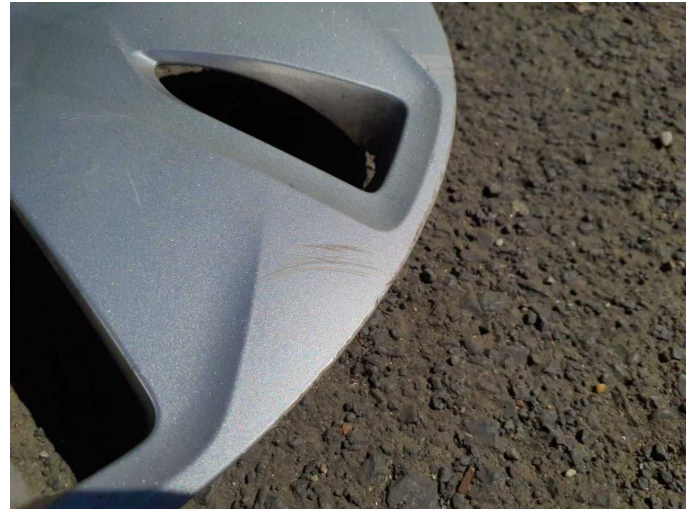
Damage 2: 2nd wheel set: 3 wheel covers - Scratched - Replace

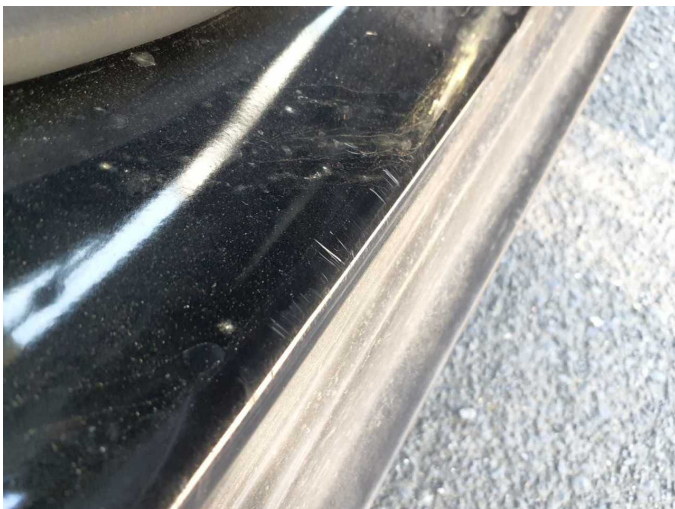
Damage 4: Sill - right side: Sill - Scratch(es) - Paint

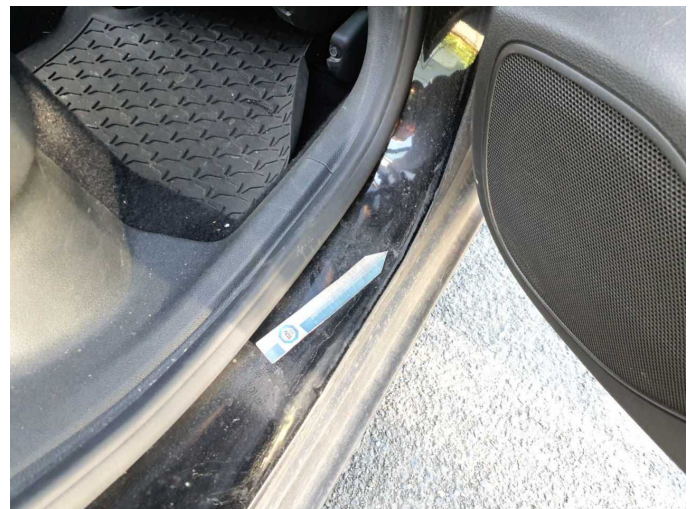
Damage 4: Sill - right side: Sill - Scratch(es) - Paint

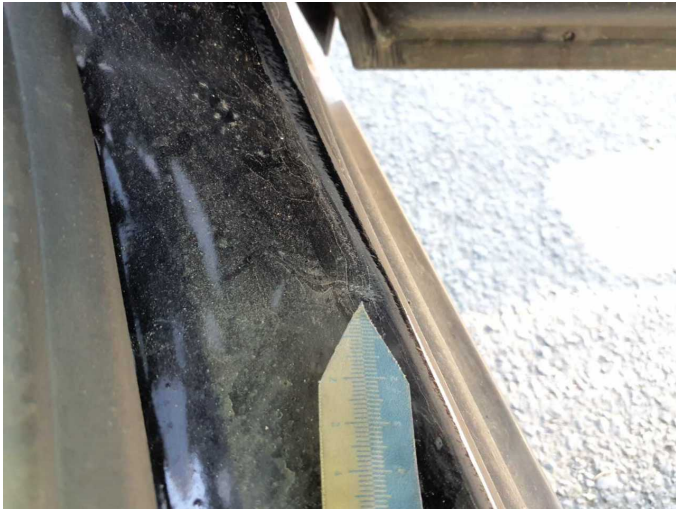
Damage 4: Sill - right side: Sill - Scratch(es) - Paint

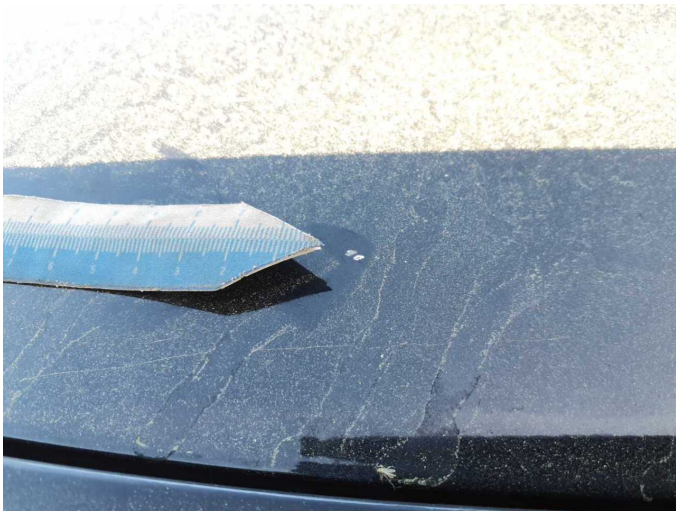
Damage 5: Bonnet: Bonnet - Stone chips - Paint

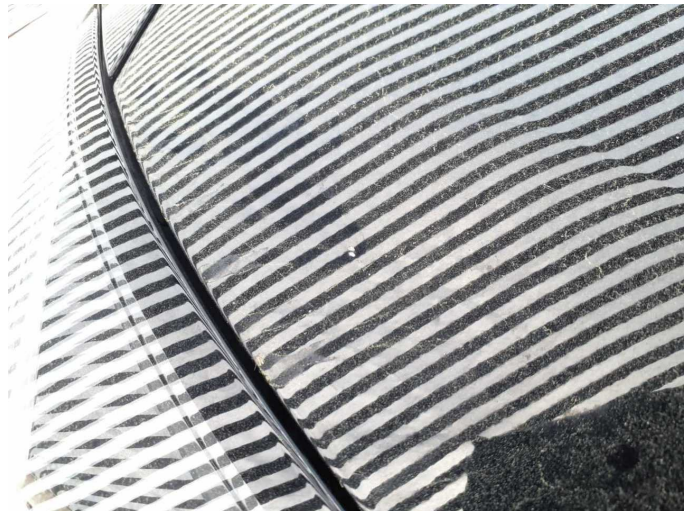
Damage 5: Bonnet: Bonnet - Stone chips - Paint

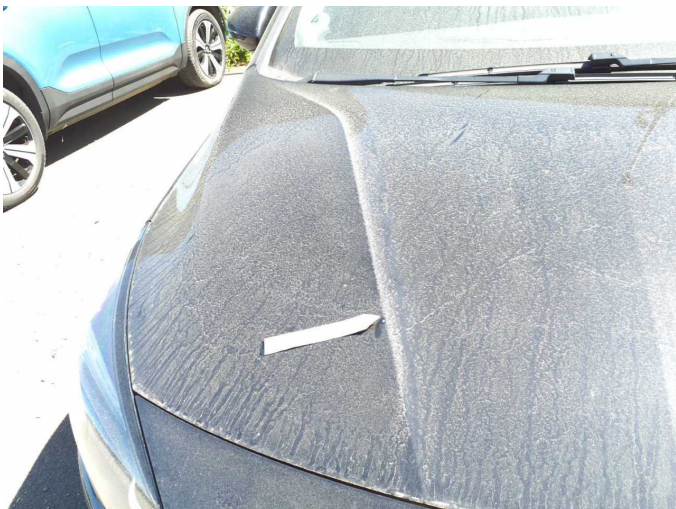
Damage 5: Bonnet: Bonnet - Stone chips - Paint

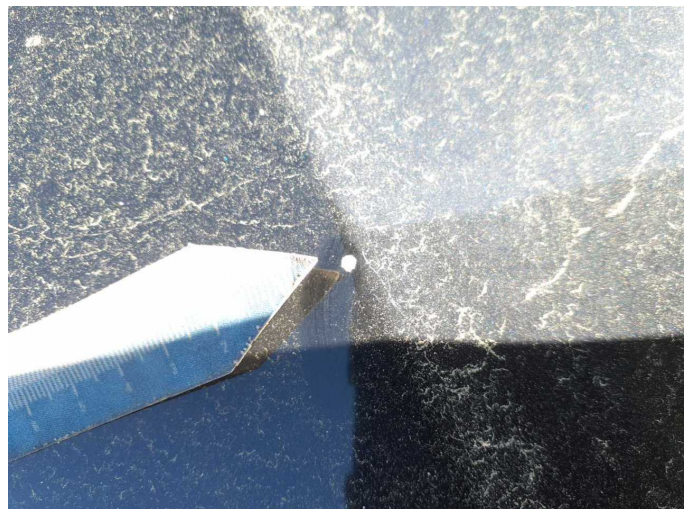
Damage 5: Bonnet: Bonnet - Stone chips - Paint

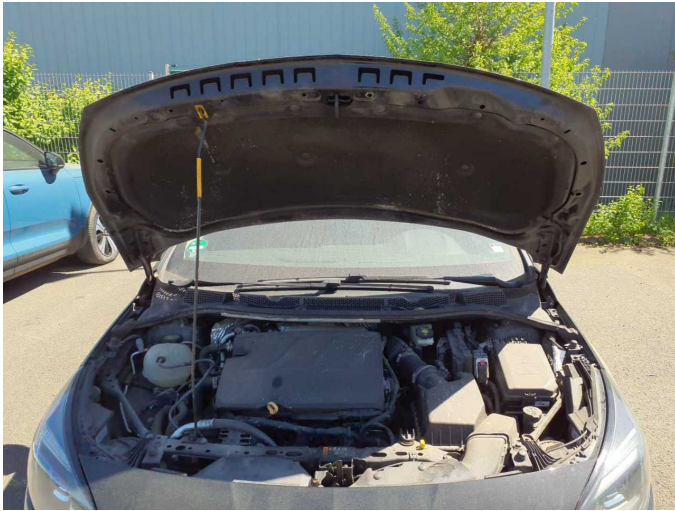
Damage 5: Bonnet: Bonnet - Stone chips - Paint

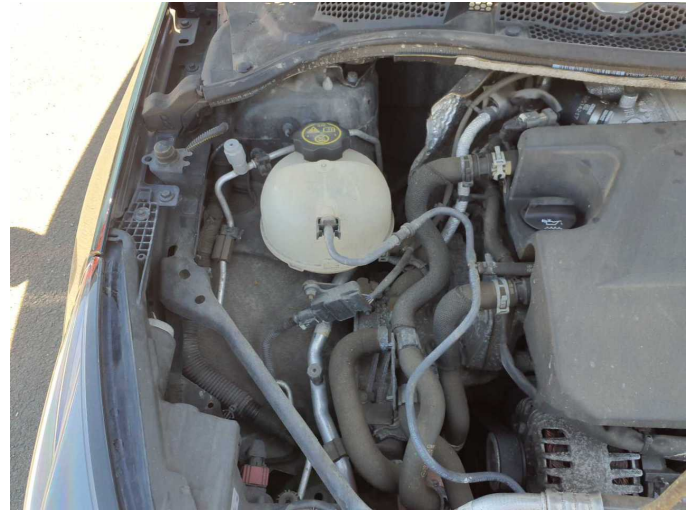
Documents submitted	At the time of the inspection, the vehicle registration certificate Part 2 (title) was available, but the vehicle registration certificate Part 1 (document) was not. (Copy)
VIN comparison	The vehicle identification number (VIN) was read from the vehicle and its conformity with the submitted documents was confirmed by the undersigned during the inspection.
Inspection	A proper visual inspection of the paintwork and bodywork was only possible to a limited extent due to insufficient lighting conditions/dampness or dirt. No lifting equipment or pit was available for inspecting the vehicle. Therefore, inspection of the vehicle's underside was only possible to a limited extent.
Test drive	The conduction of a test drive with the described vehicle was impossible to do under the given conditions.
Engine function test	An engine test run could not be performed. This is due to the following reason.: Motorschaden

readiness to drive	The vehicle was not roadworthy at the time of inspection, but only capable of being towed.

Damage 6: Engine: Engine - Damaged - Replace

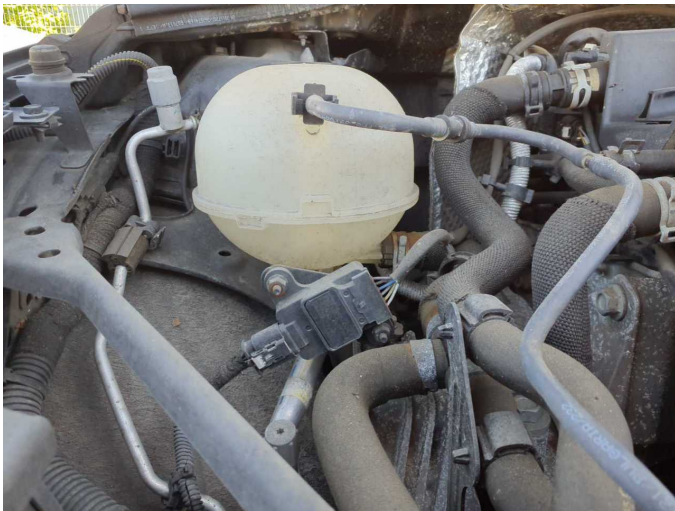
Damage 6: Engine: Engine - Damaged - Replace

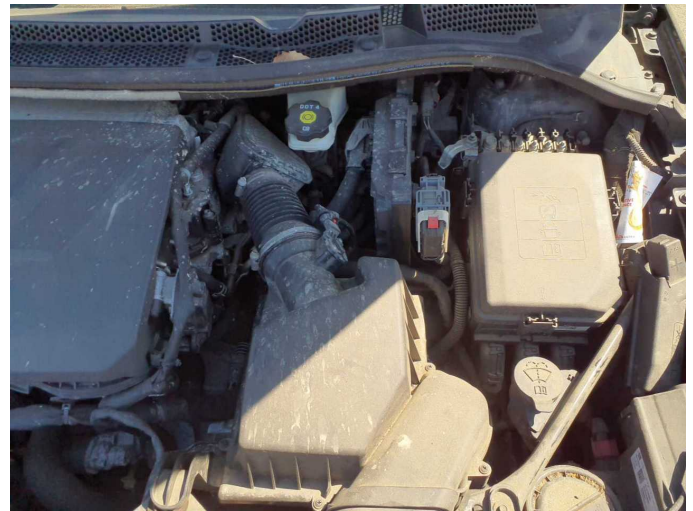
Damage 6: Engine: Engine - Damaged - Replace

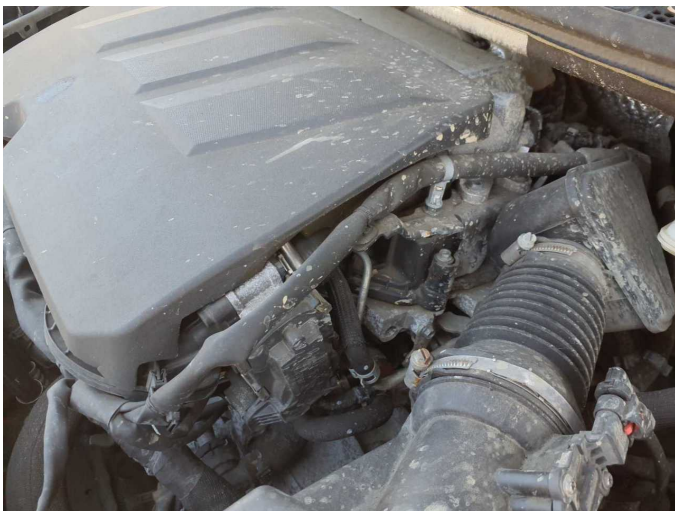
Damage 6: Engine: Engine - Damaged - Replace

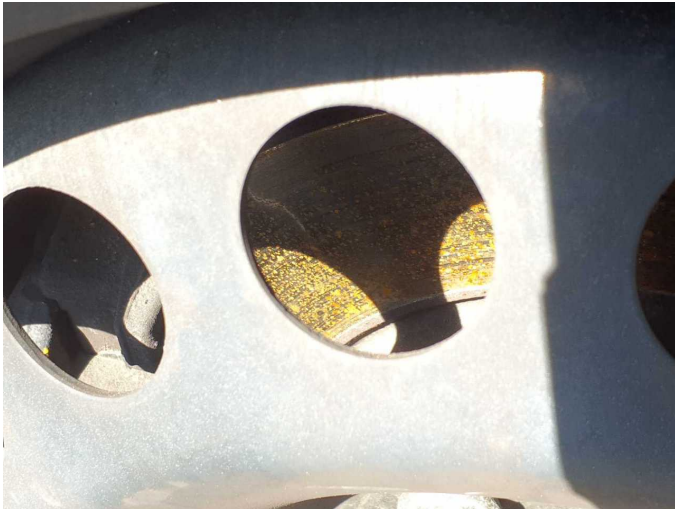
Wear and tear 2: Braking system: Brake discs and brake pads - front - Corrosion - No deduction

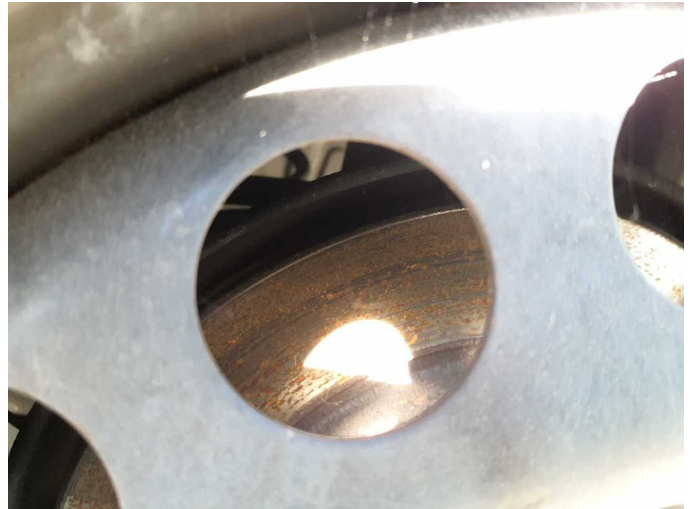
Wear and tear 2: Braking system: Brake discs and brake pads - front - Corrosion - No deduction

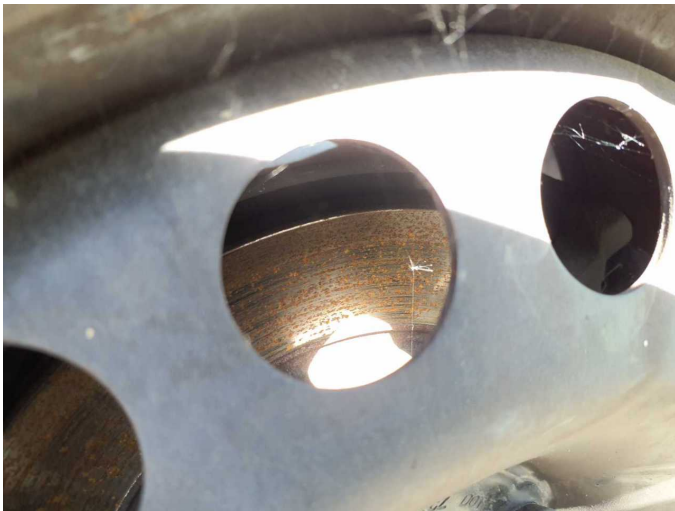
Wear and tear 3: Braking system: Brake discs and pads - rear - Corrosion - No deduction

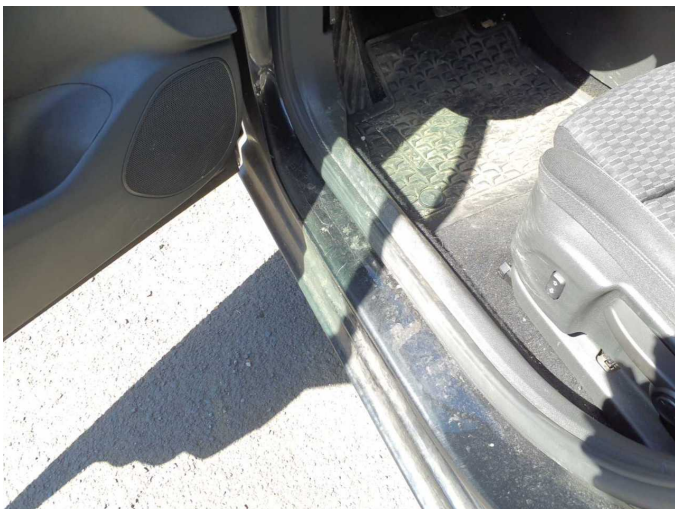
Wear and tear 4: Interior: Interior - Abrasion - No deduction

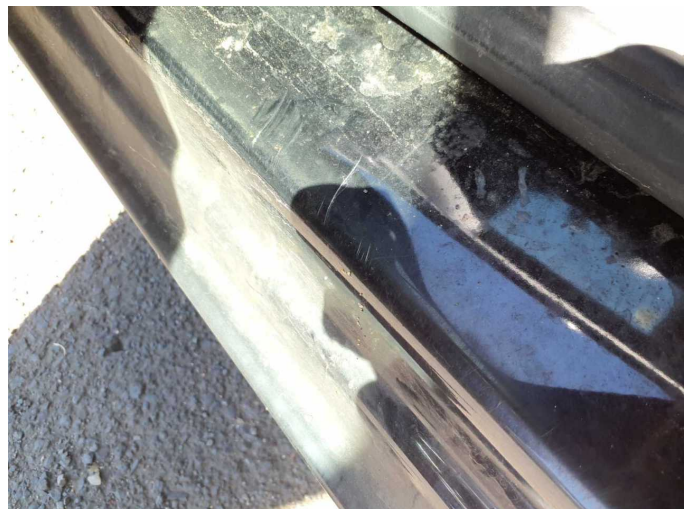
Wear and tear 5: Sill - left side: Sill - Scratch(es) - No deduction
