# MACDAM

## Peugeot 2008 '19

### Vehicle information

Make:	<b>Peugeot</b>	License:	
Gearbox:	<b>Automatic</b>	Body color:	
Model:	<b>2008 '19</b>	VIN:	<b>VR3UKZKXZMJ551876</b>
Fuel type:	<b>Electric</b>	Power:	<b>100 kW</b>
Version:	<b>2008 EV GT Pack 50kWh</b>	First registration	<b>09/06/2021</b>
Mileage:	<b>115761 km</b>	N° of doors:

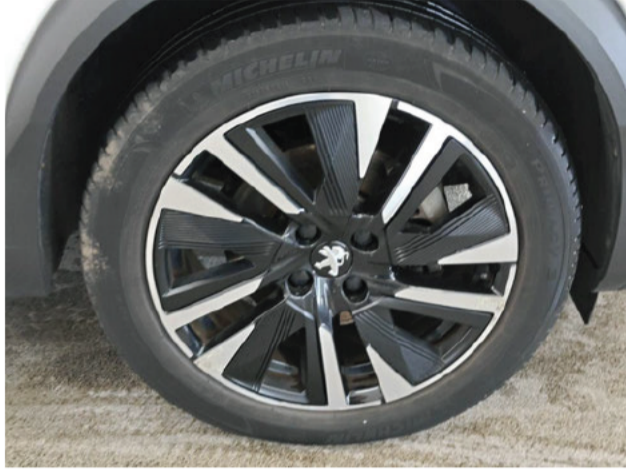
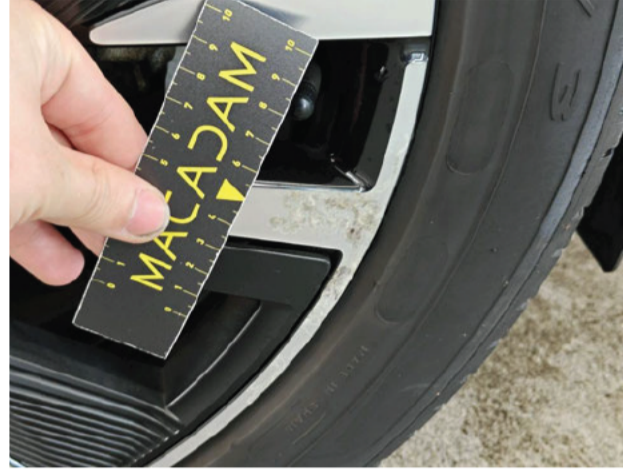
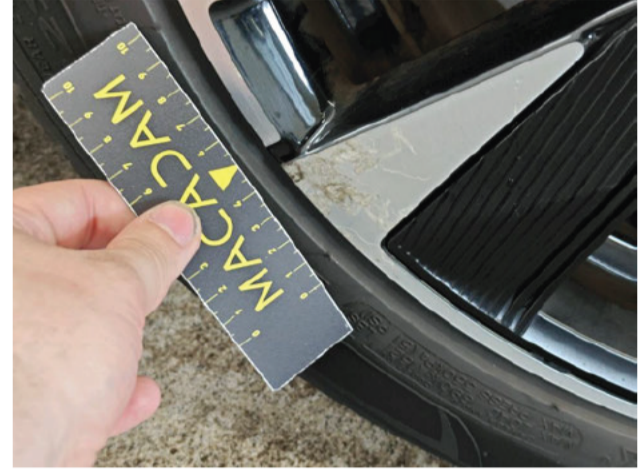
### Alloy rim FR

Rust  
Repair and paint (complete)  
Right

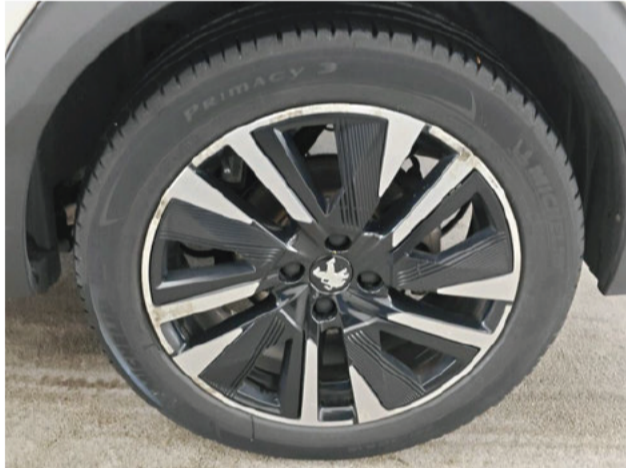
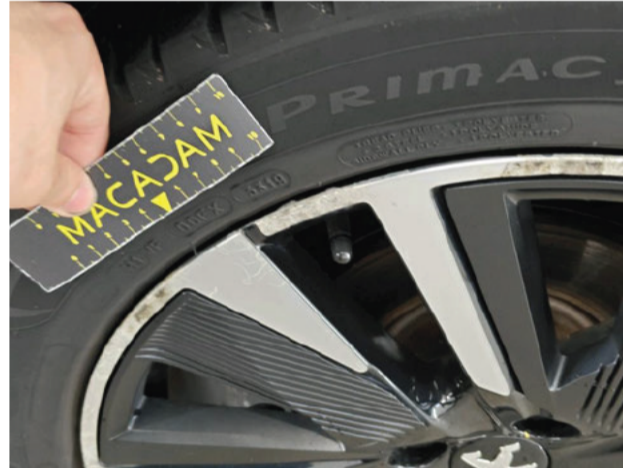
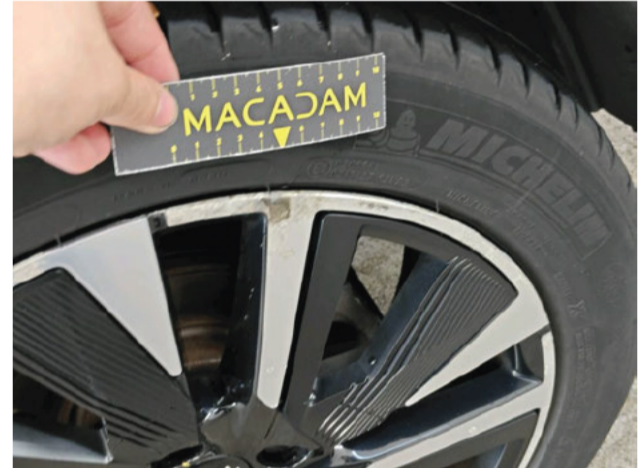
### Alloy rim RL

Rust  
Repair and paint (complete)  
Left

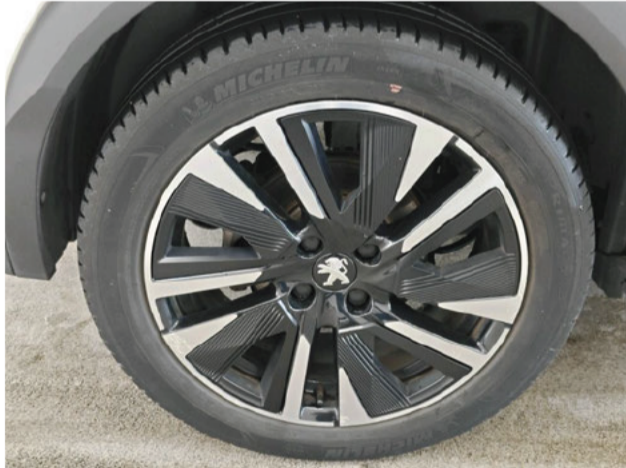
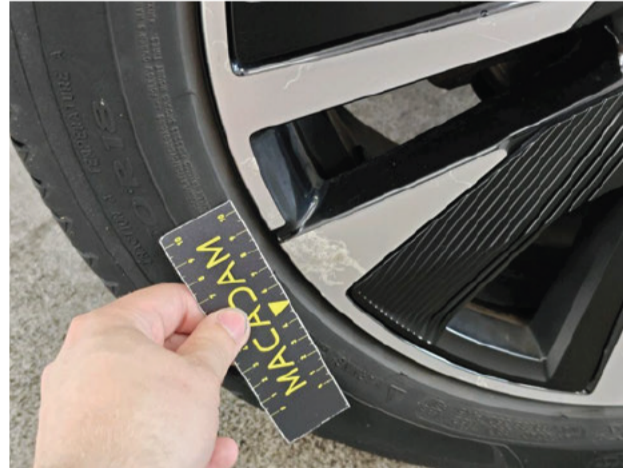
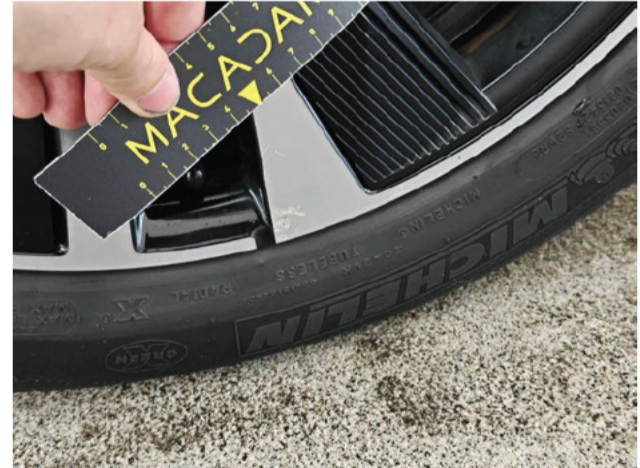
### Alloy rim RR

Rust  
Repair and paint (complete)  
Right

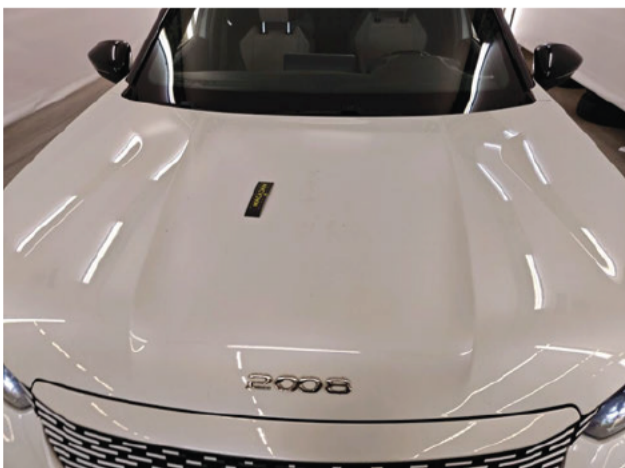
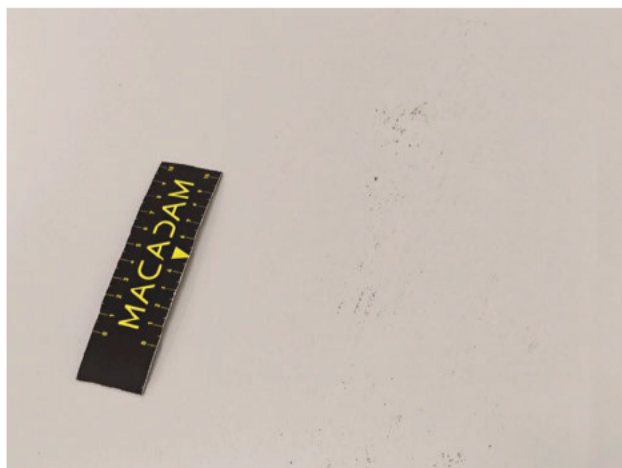
### Bonnet

Chemical polution  
Polish  
Front

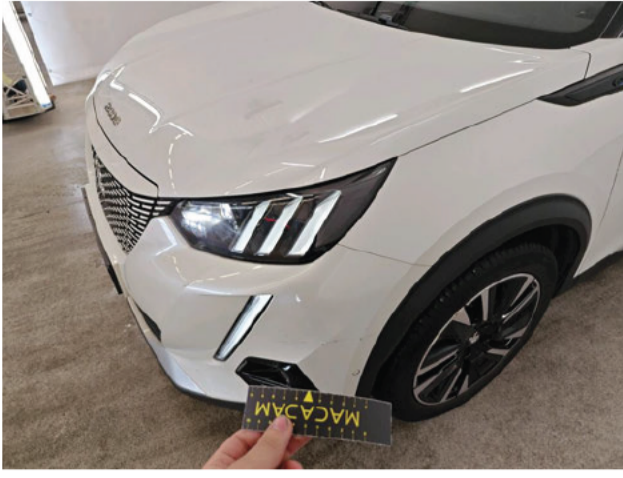
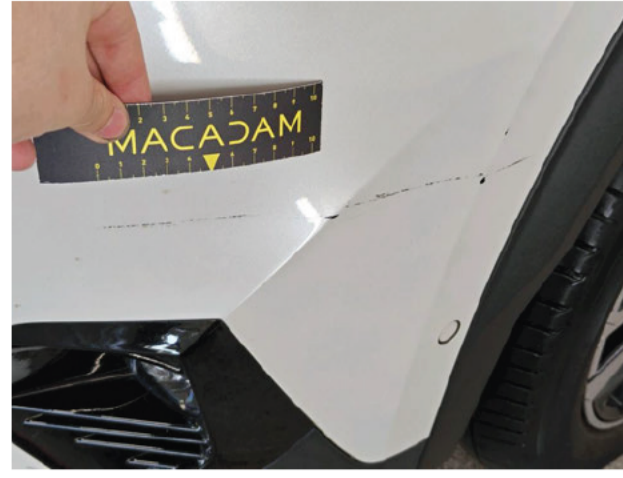
**Bumper F**  
Scratch(es)  
Repair and paint (complete)  
Front

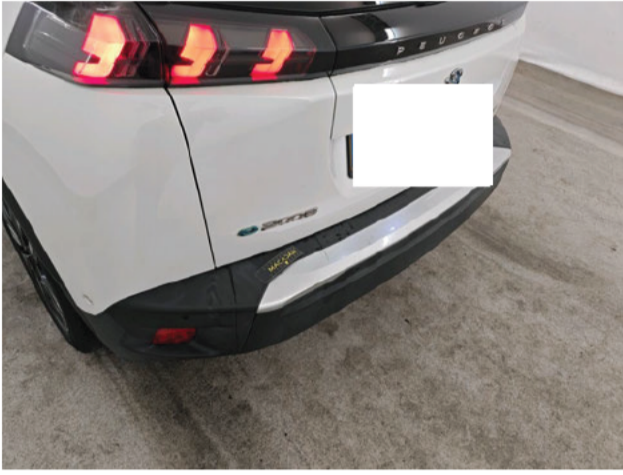
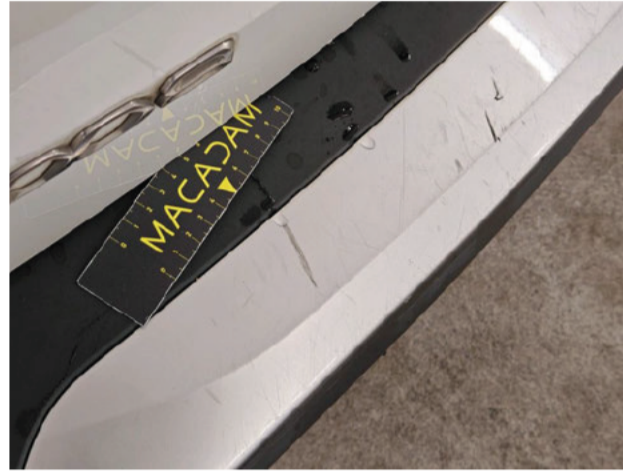
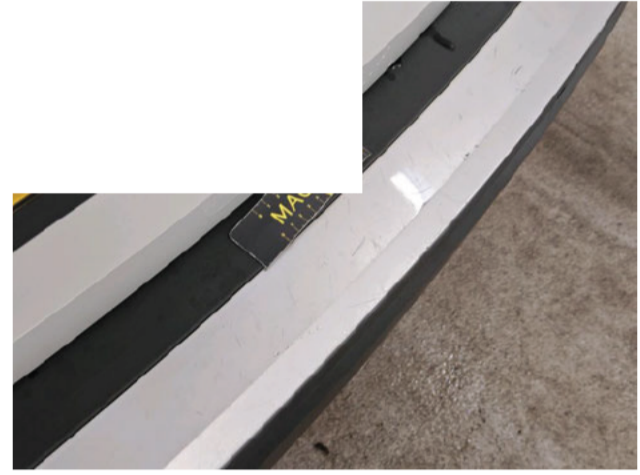
**Bumper moulding R**  
Scratch(es)  
Replace and paint  
Rear

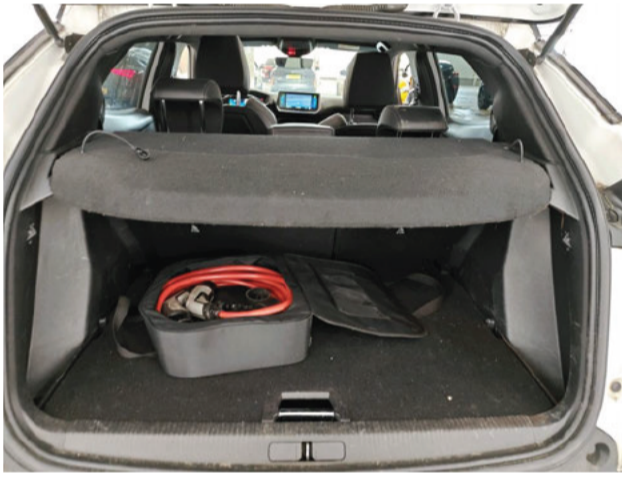
**Charging cable (normal)**  
Missing  
Replace  
Rear

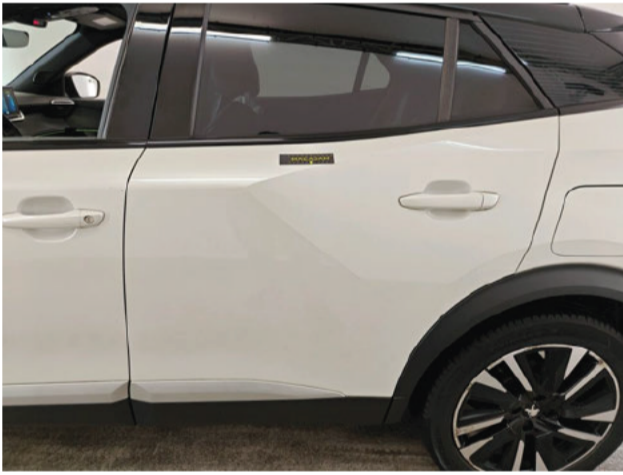
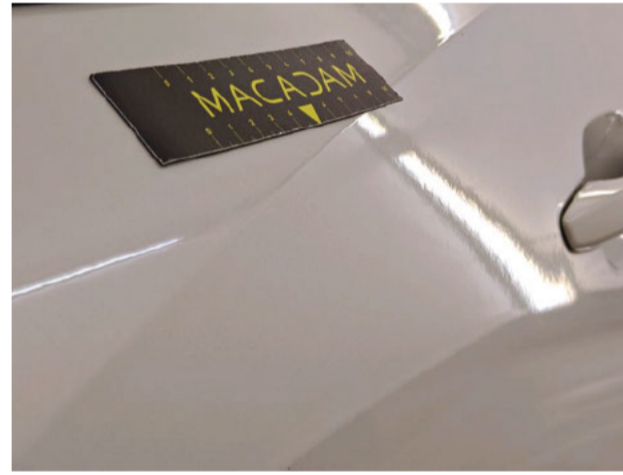
**Door RL**  
Bad repair  
Repair and paint (complete)  
Left

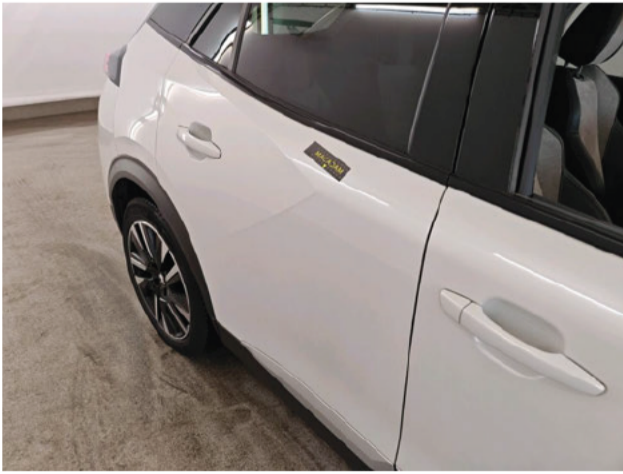
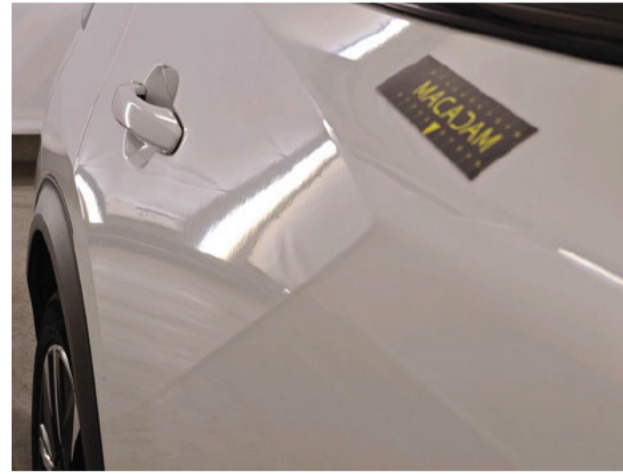
**Door RR**  
Bad repair  
Repair and paint (complete)  
Right

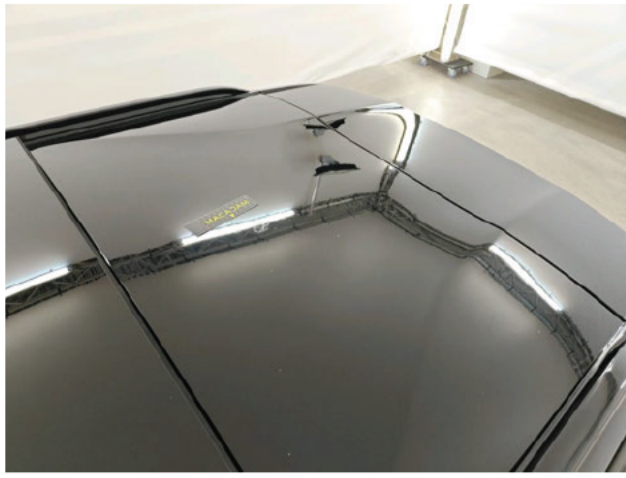
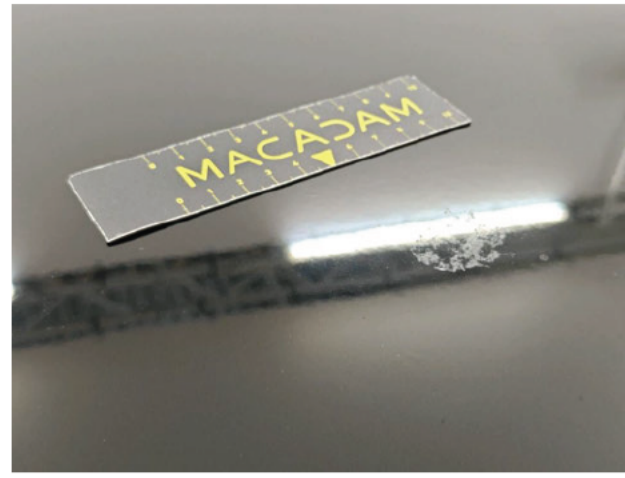
**Roof**  
Chemical polution  
Repair and paint (complete)  
Roof & others

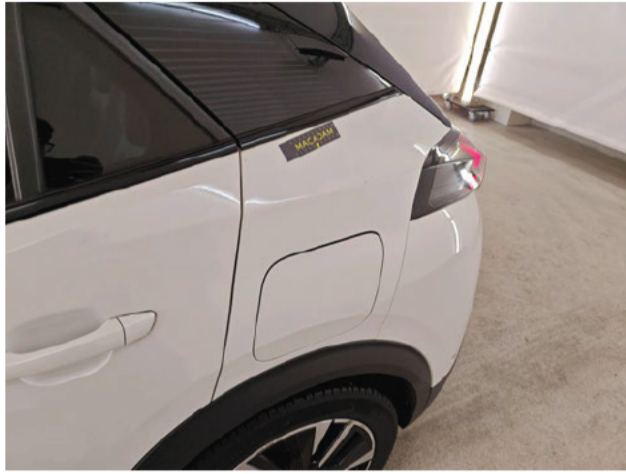
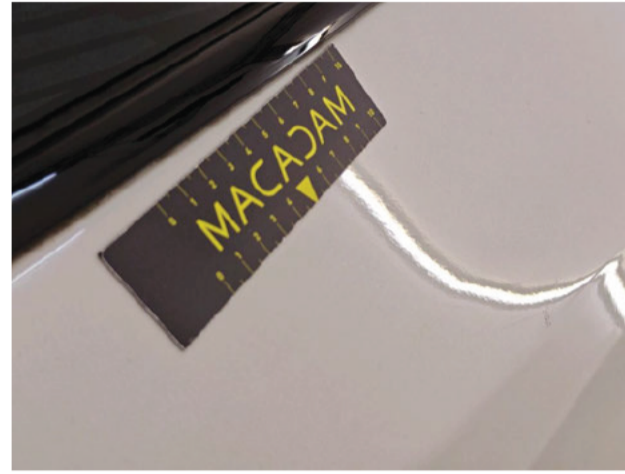
**Wing RL**  
Bad repair  
Repair and paint (complete)  
Left

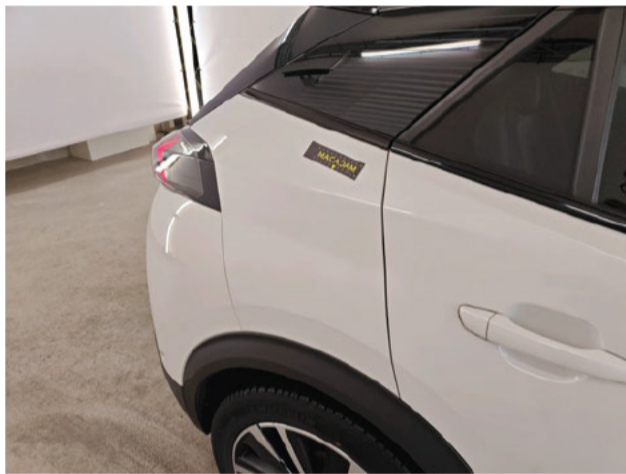
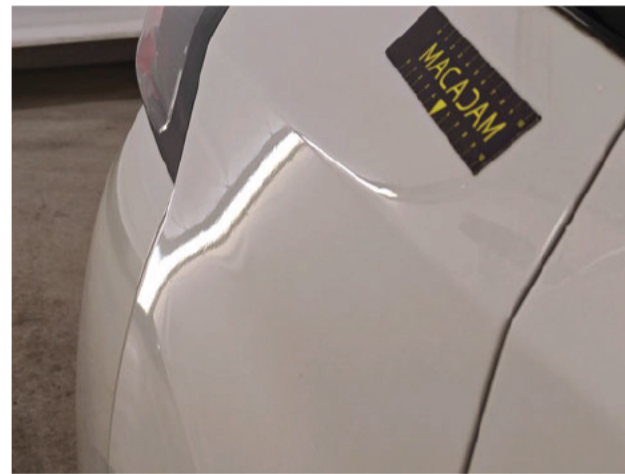
**Wing RR**  
Bad repair  
Repair and paint (complete)  
Right
