Expertise

Protocol number: 46043294
Order No. / Reference: 26153839
Inspection date: 16 Jun 2026

Model: Vito 116 CDI Tourer Lang Aut. PRO

VIN: W1VVLFEZ0T4559223

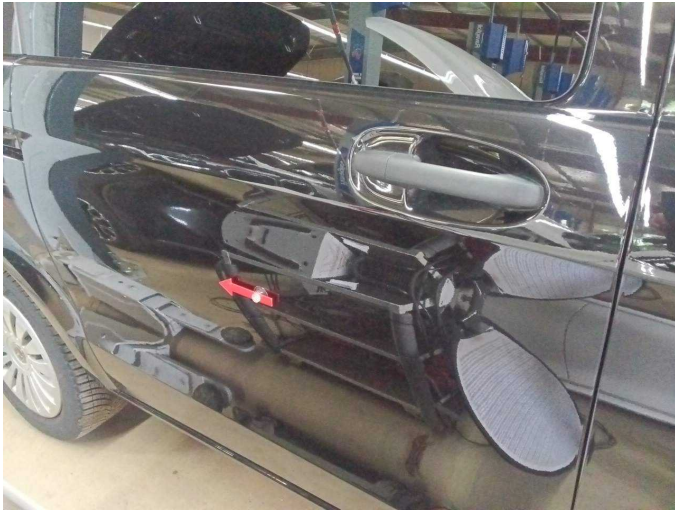
Damage 1: Sliding door, right: Sliding door - dent(s) - Smooth repair work

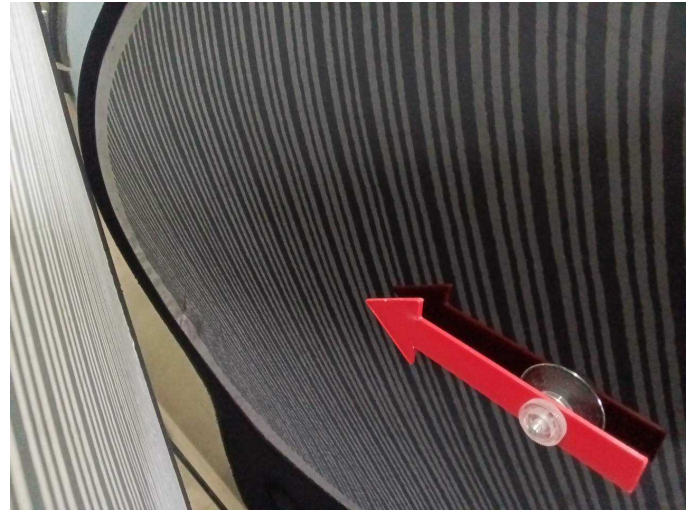
Damage 1: Sliding door, right: Sliding door - dent(s) - Smooth repair work

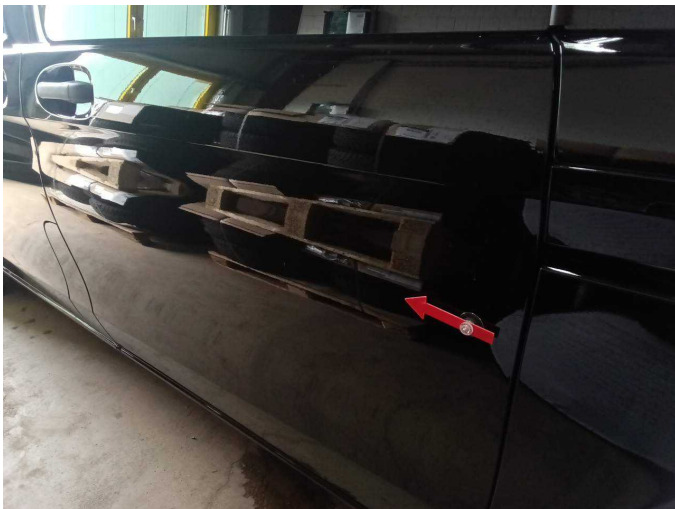
Damage 2: Sliding door - left side: Sliding door - dent(s) - Smooth repair work

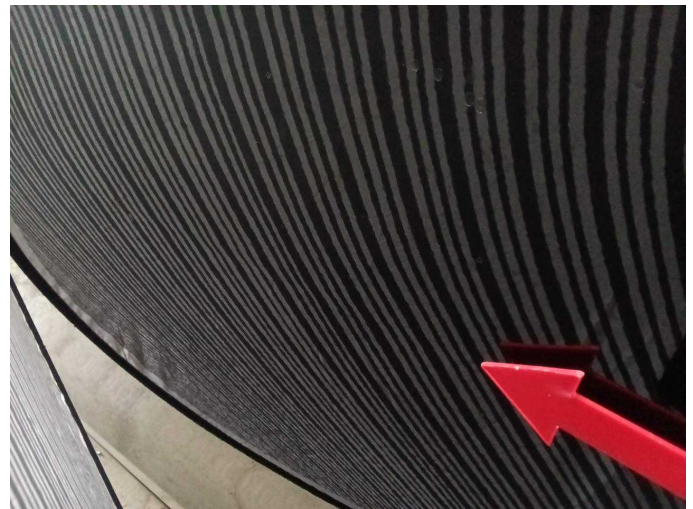
Damage 2: Sliding door - left side: Sliding door - dent(s) - Smooth repair work

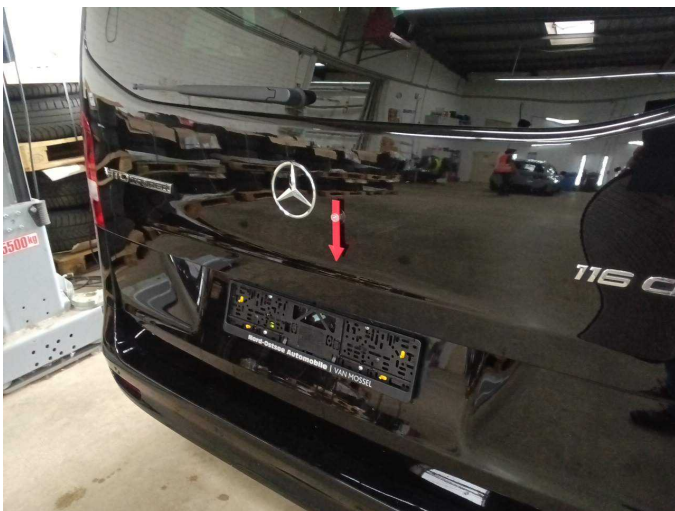
Damage 3: Boot lid / rear door: Boot lid - dent(s) - Smooth repair work

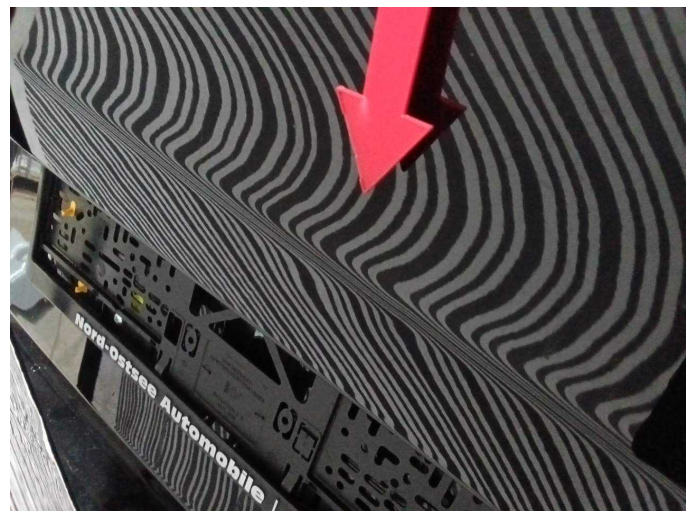
Damage 3: Boot lid / rear door: Boot lid - dent(s) - Smooth repair work

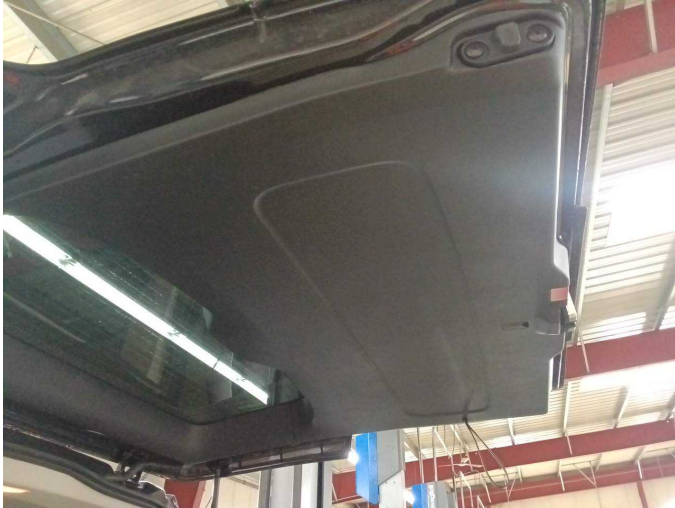
Damage 4: Trim / covers: Boot lid - interior trim - Scratched - Loss in value

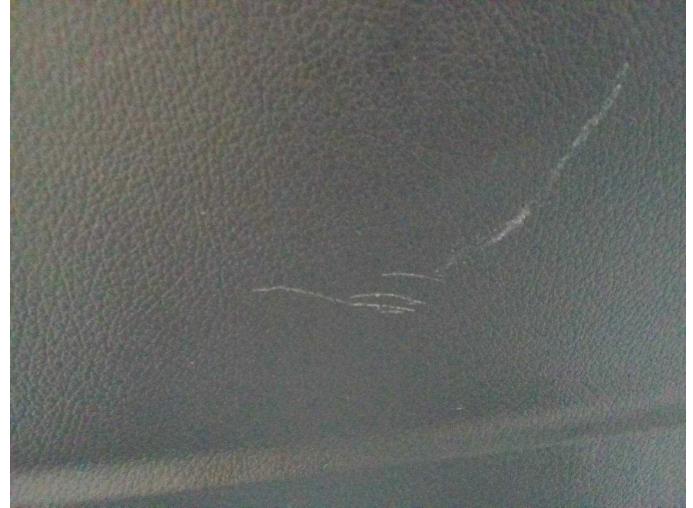
Damage 4: Trim / covers: Boot lid - interior trim - Scratched - Loss in value

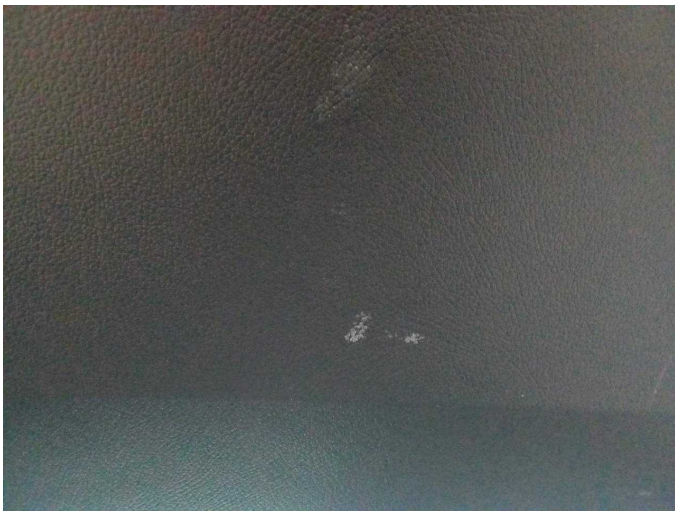
Damage 4: Trim / covers: Boot lid - interior trim - Scratched - Loss in value

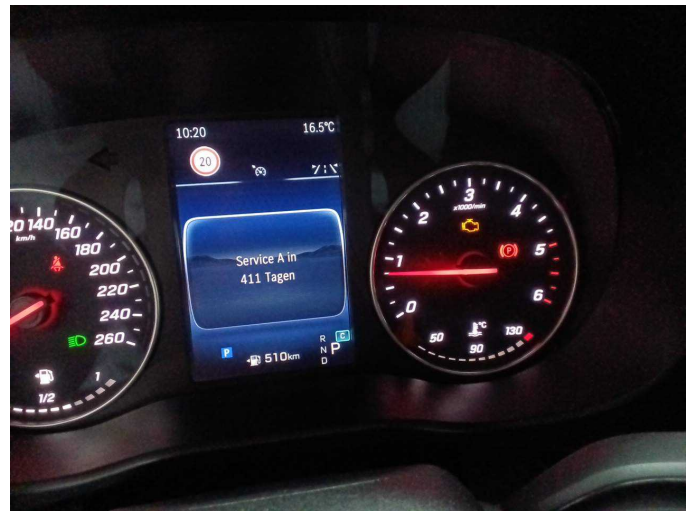
Damage 5: Instrument panel: Indicator light (Motorkontrollleuchte) - on - Perform diagnosis

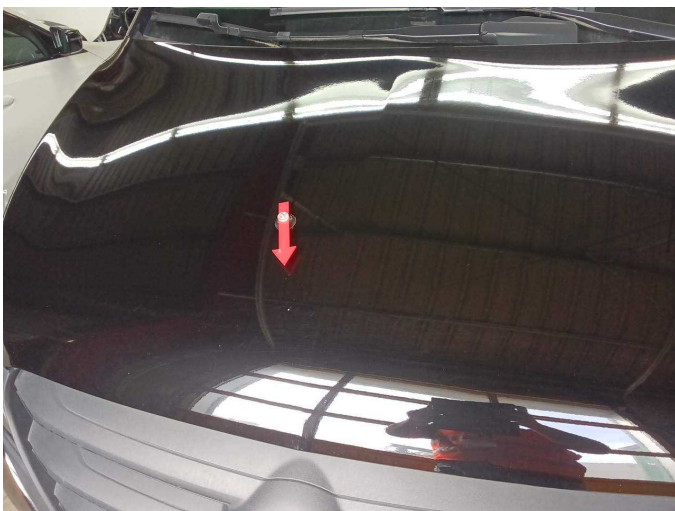
Damage 6: Bonnet: Bonnet - Stone chips - Paint

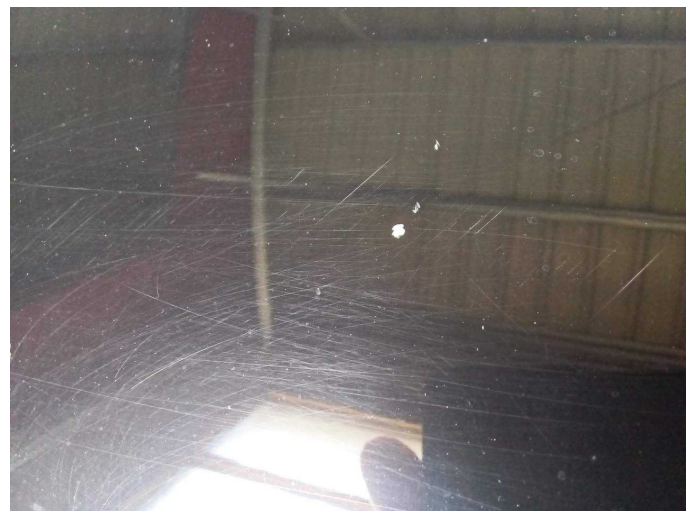
Damage 6: Bonnet: Bonnet - Stone chips - Paint

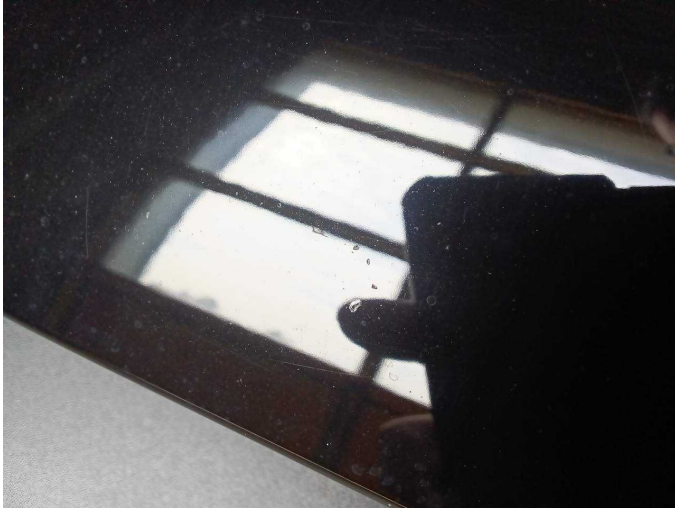
Damage 6: Bonnet: Bonnet - Stone chips - Paint

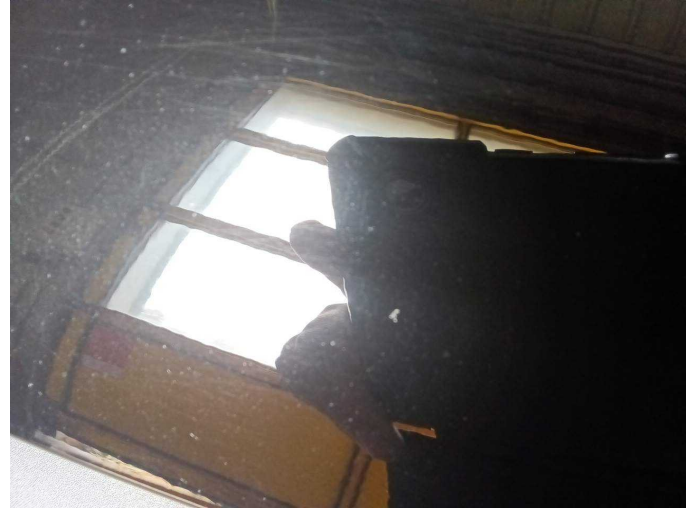
Damage 6: Bonnet: Bonnet - Stone chips - Paint
