## Expertise

Protocol number: 46288007  
Order No. / Reference: 26585955  
Inspection date: 2 Jul 2026

Model: Astra 1.5 D Automatik Business Elegance

VIN: VXKFBYHZTP1021150

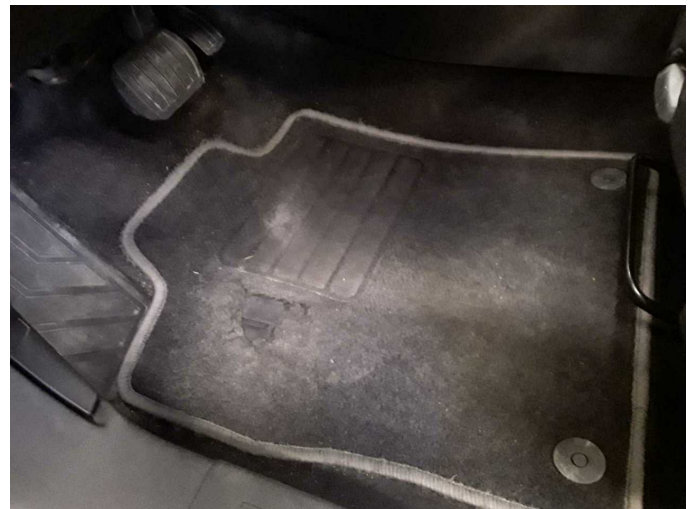
Damage 2: Trim / covers: Floor mats - Broken / torn - Replace

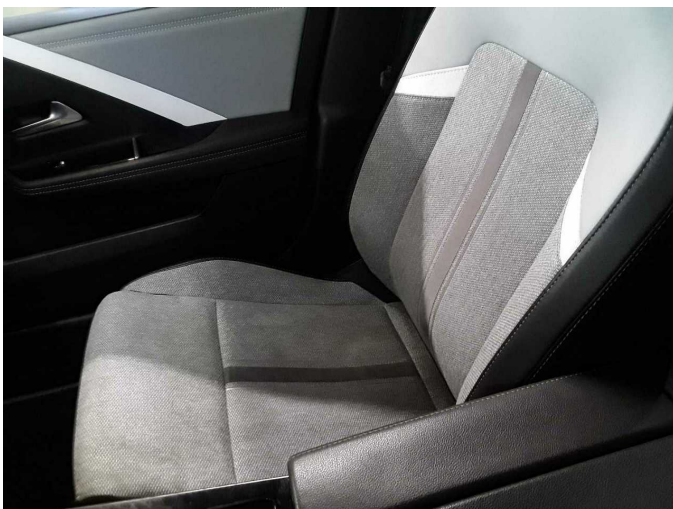
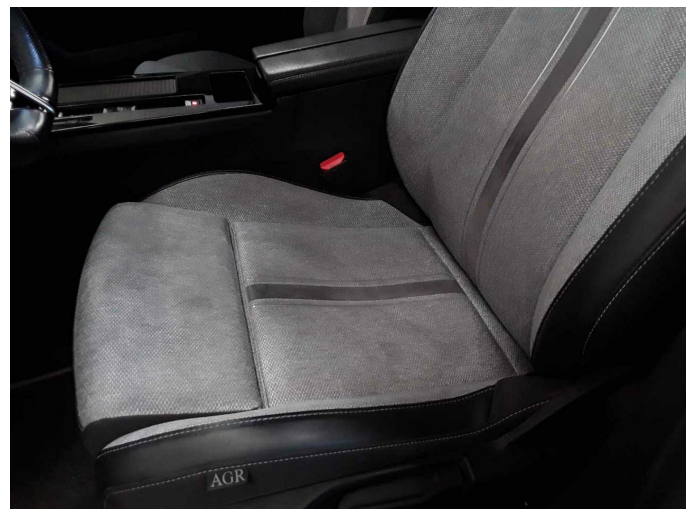
Damage 3: Seat - front: Seat - Soiled - Clean

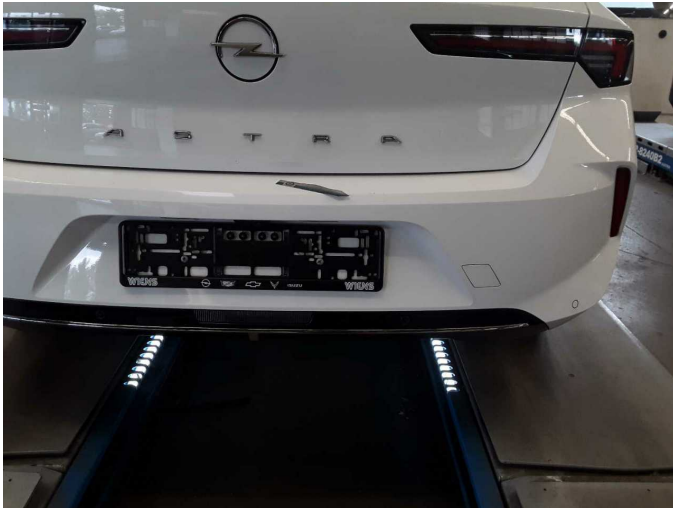
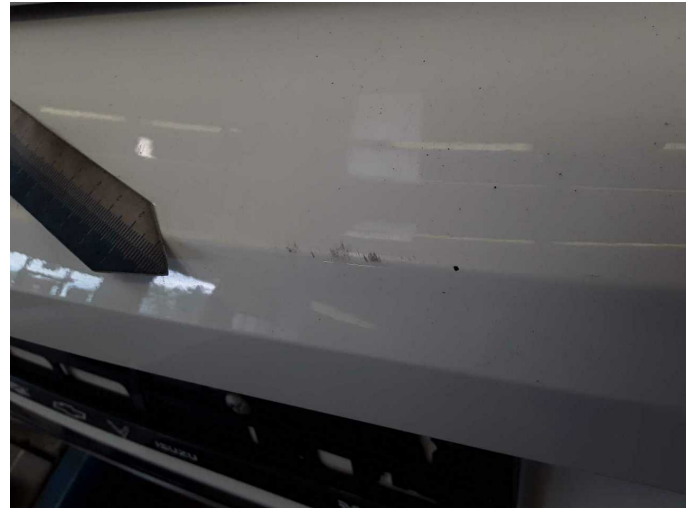
**Damage 4:** Rear bumper: Rear bumper - Scratched - Smart repair

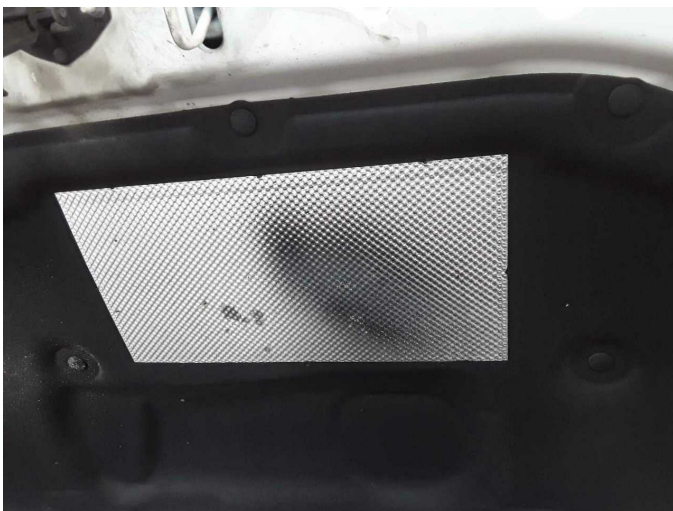
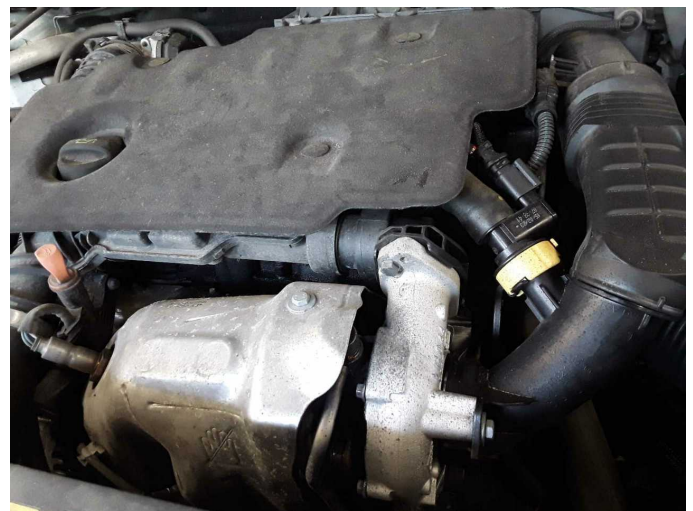
**Damage 5:** Engine: Engine (Mehrkosten möglich) - Leaking - Perform diagnosis

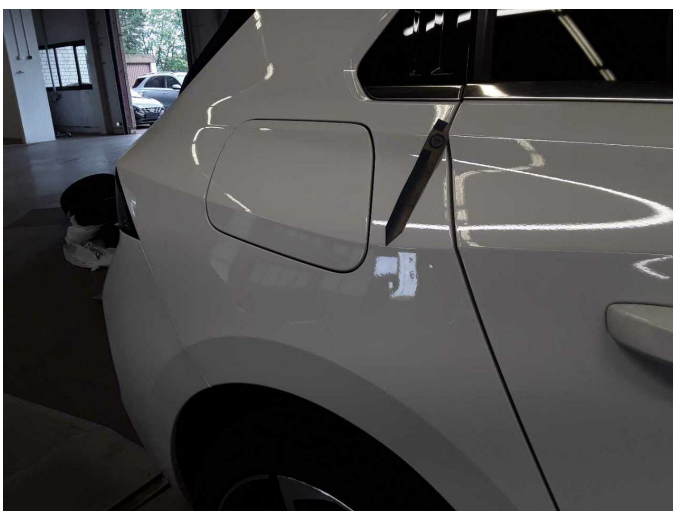
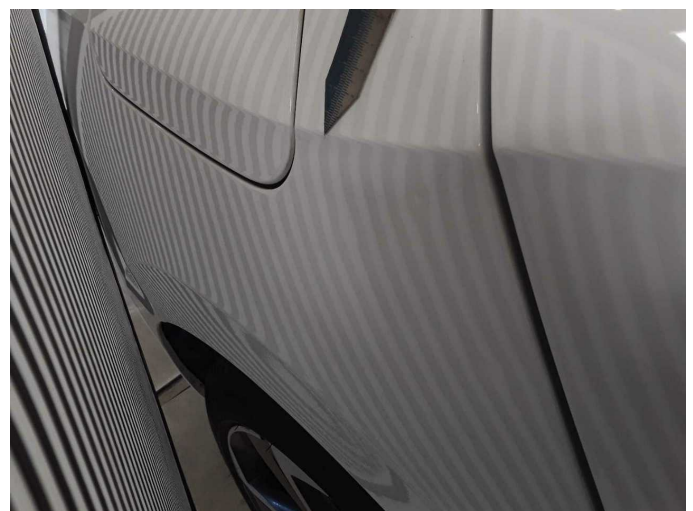
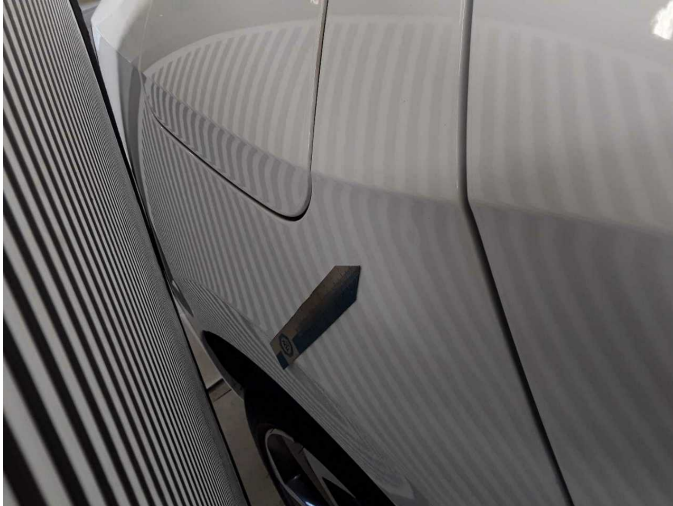
**Damage 6:** Side panel - rear right side: Side panel - dent(s) - Smooth repair work

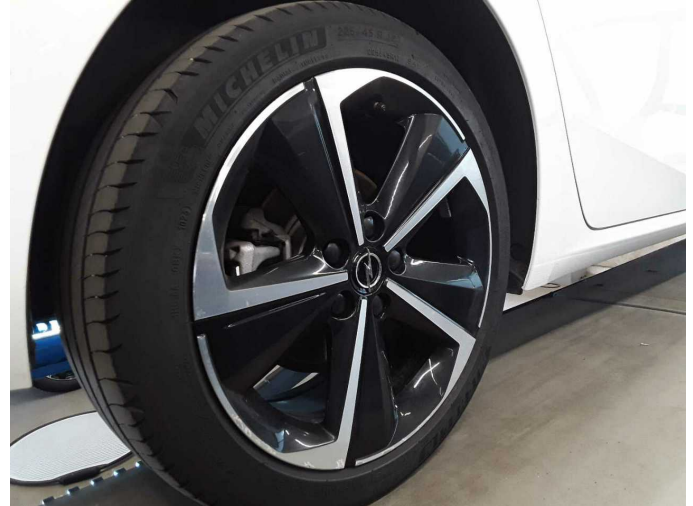
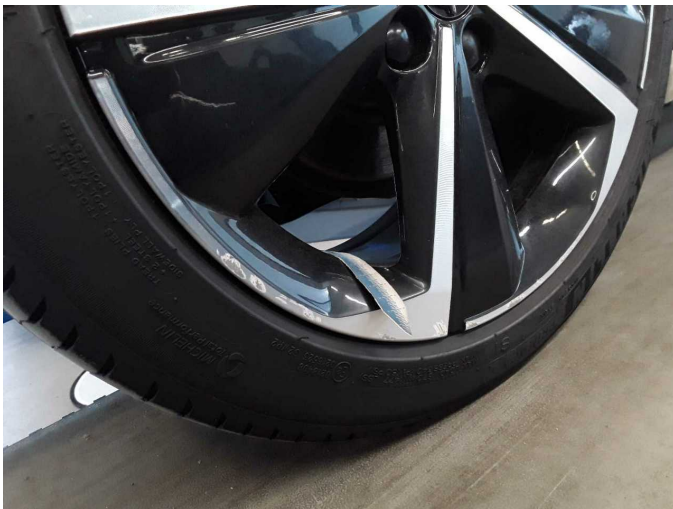
**Damage 7:** Wheel / tyres: Alloy rim - rear right side - Scratched - Loss in value

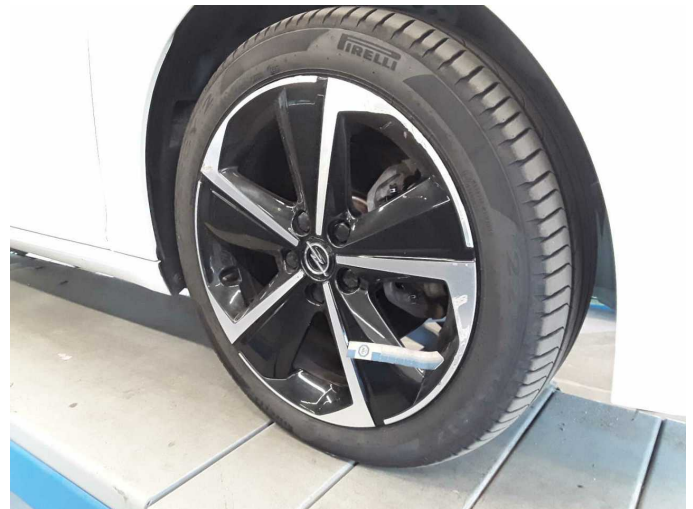
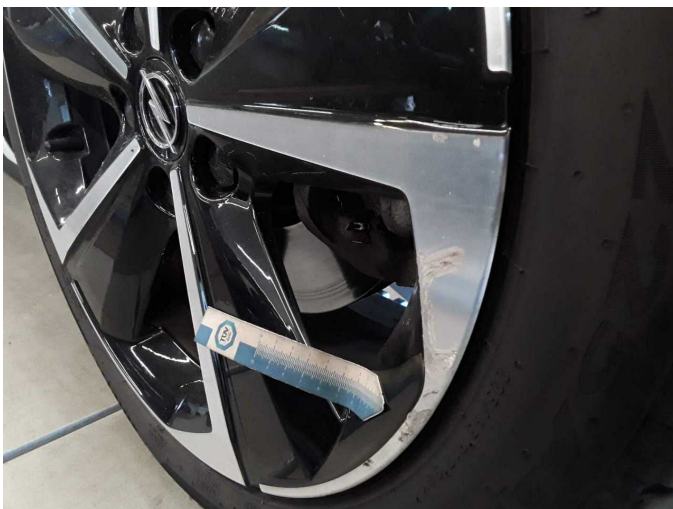
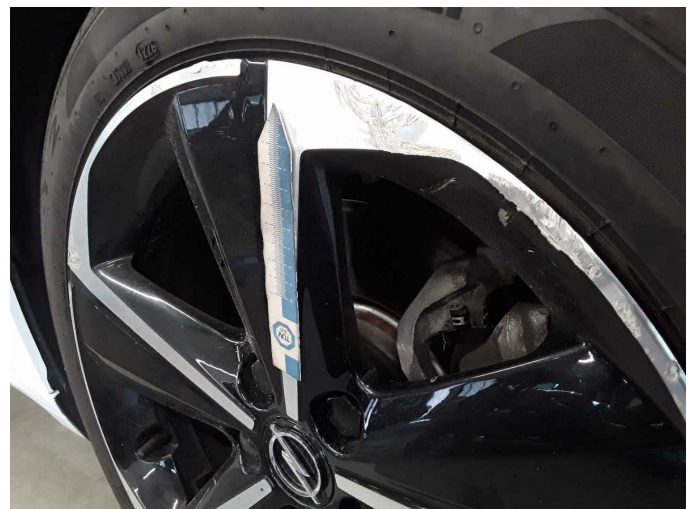
**Damage 9:** Wheel / tyres: Alloy rim - front right side - Scratched - Replace

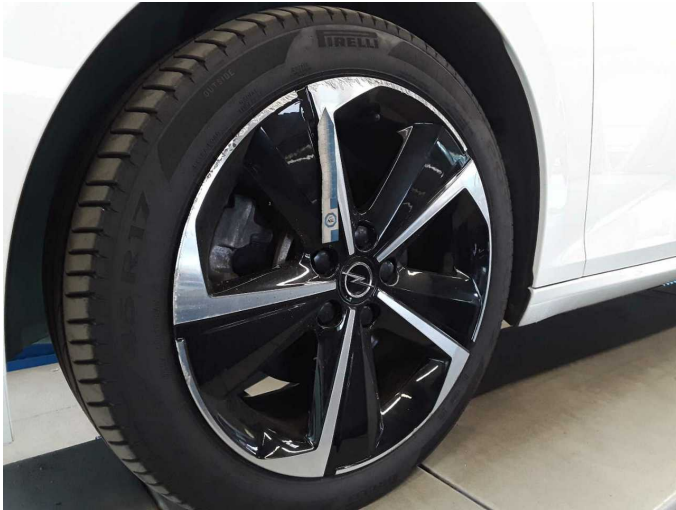
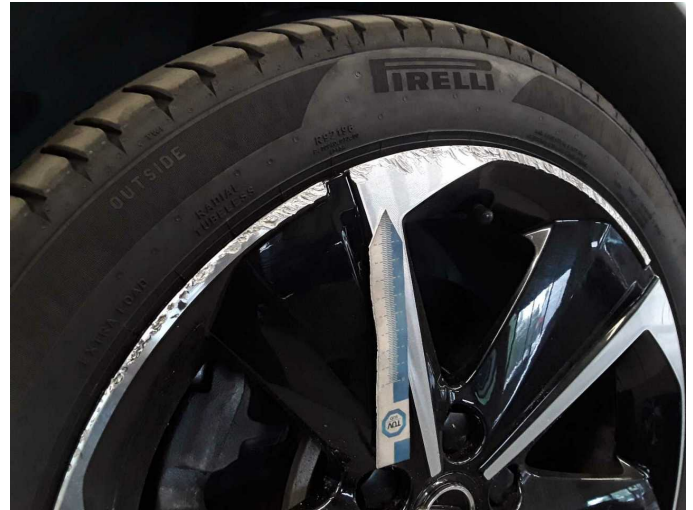
**Damage 10:** Wheel / tyres: Alloy rim - front left side - Scratched - Replace **Damage 10:** Wheel / tyres: Alloy rim - front left side - Scratched - Replace

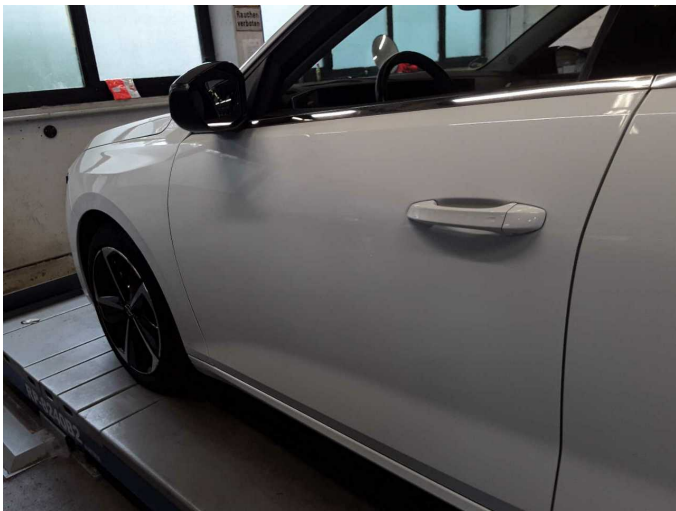
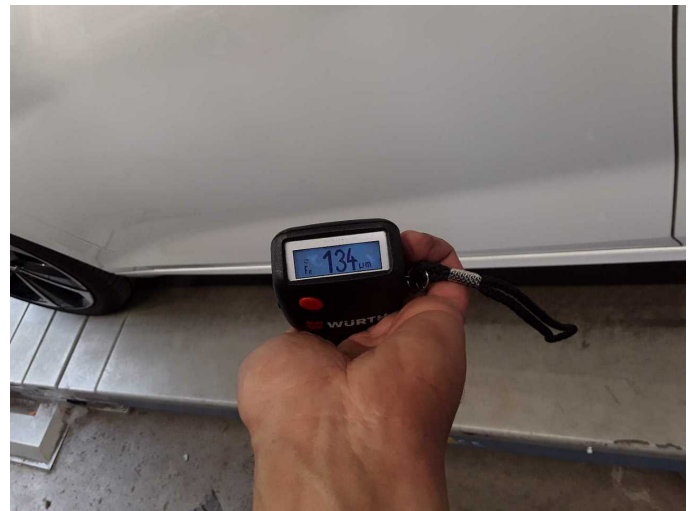
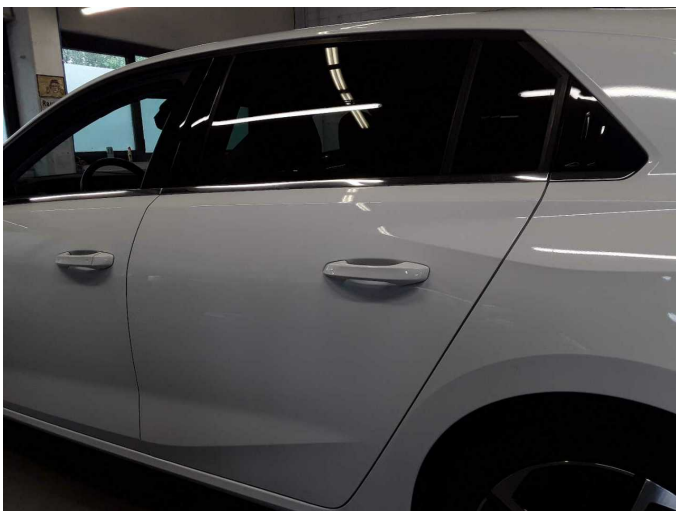
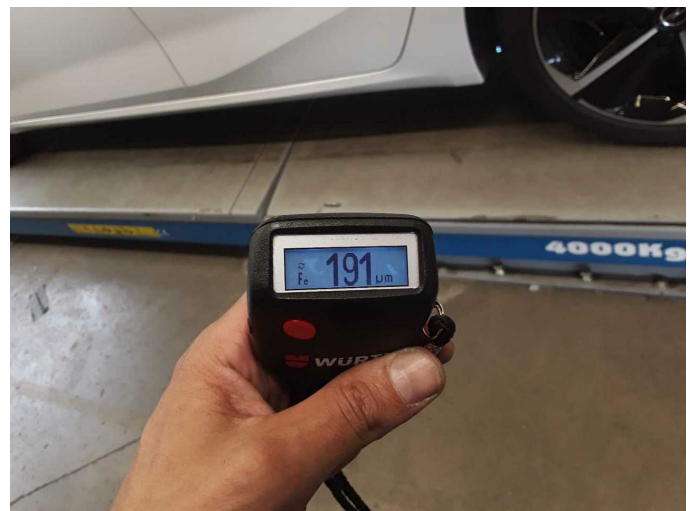
- 1 Door - rear left side, Door - front left side, Professionally carried out, Invoice of repair done Non-existent

**Repainting 1:** Door - rear left side, Door - front left side **Repainting 1:** Door - rear left side, Door - front left side
