Expertise

Protocol number: 46502942  
Order No. / Reference: 26482730  
Inspection date: 14 Jul 2026

Manufacturer: Ford

Model: Tourneo Custom 320 L1H1 VA Trend

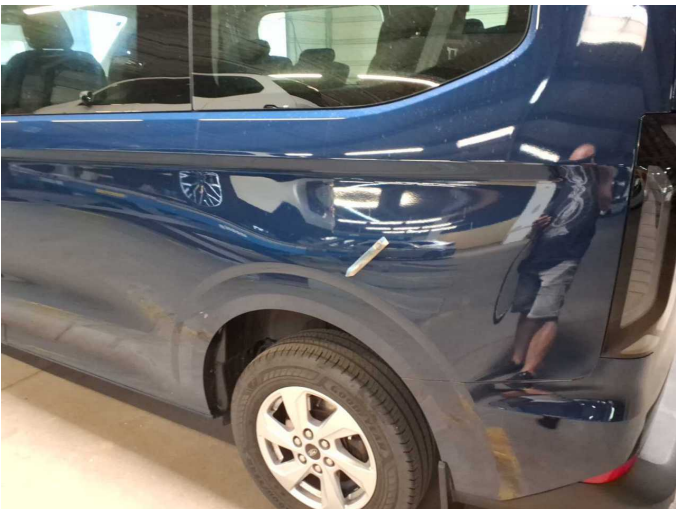
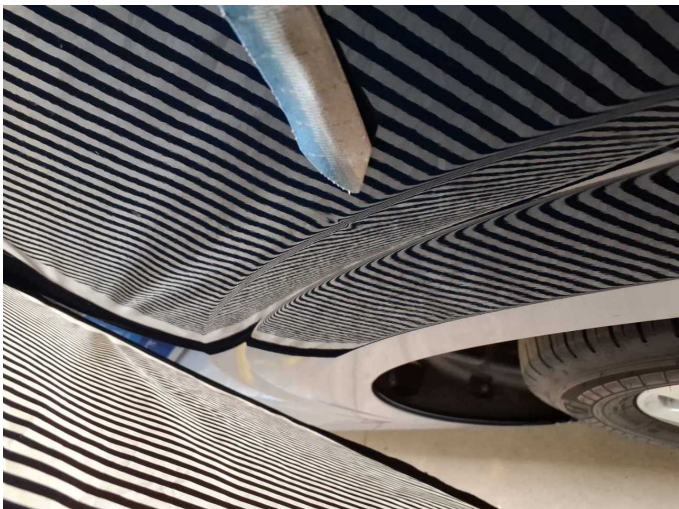
| No. | Component group | Description |
|---|---|---|
| 1 | Side panel - rear left side | Side panel - dent(s) - Smooth repair work |

Damage 1: Side panel - rear left side: Side panel - dent(s) - Smooth repair work

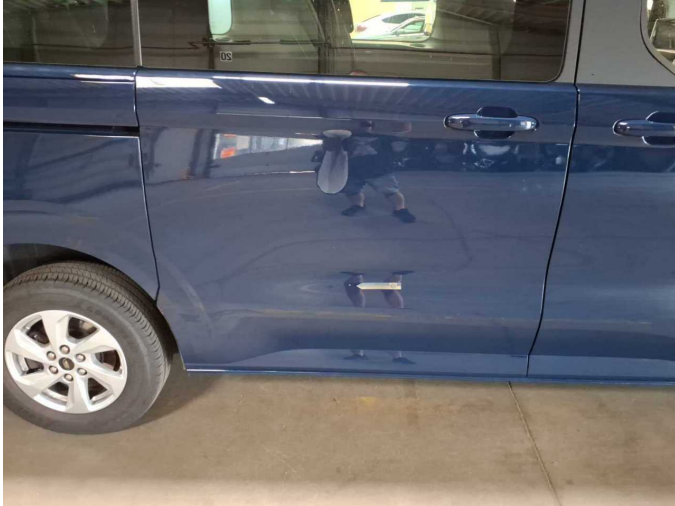
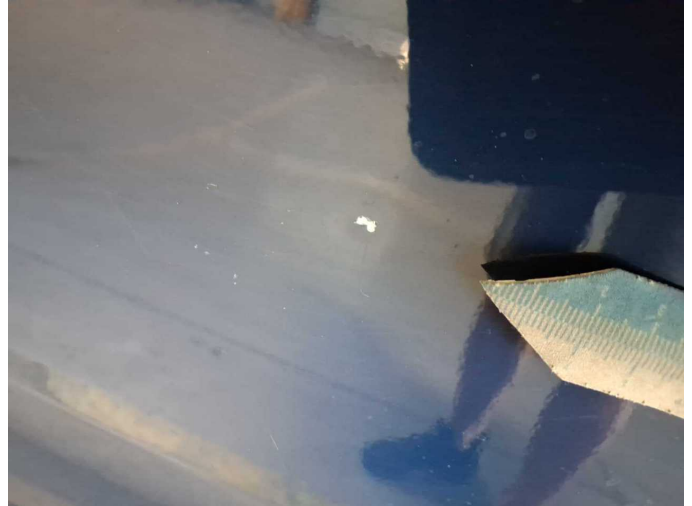
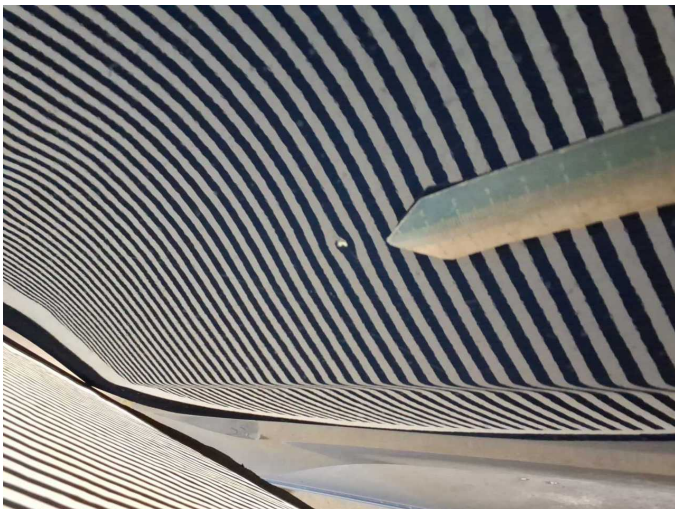
| No. | Component group | Description |
|---|---|---|
| 2 | Sliding door, right | Sliding door with glass panel - Dent / paintcoat damage - Smart repair |

**Damage 2:** Sliding door, right: Sliding door with glass panel - Dent / paintcoat damage - Smart repair

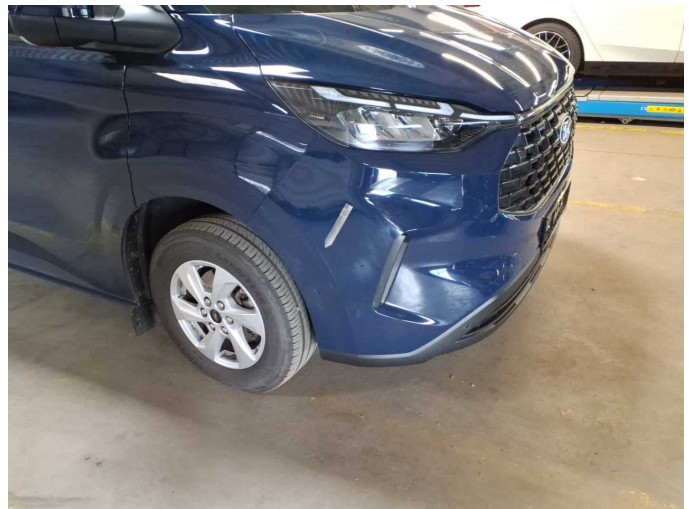
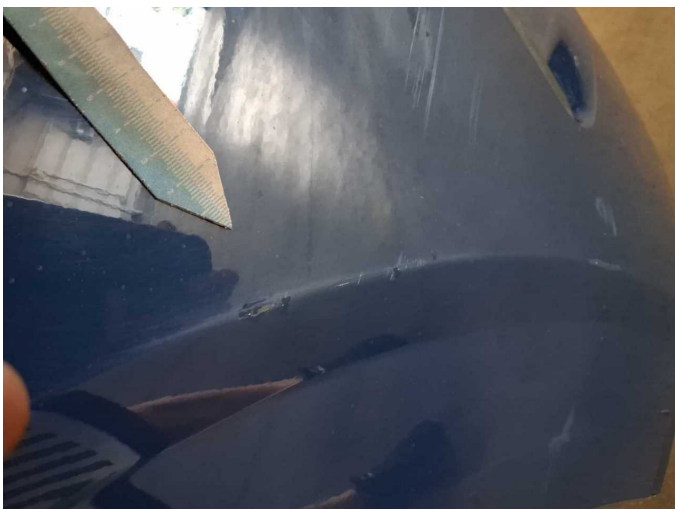
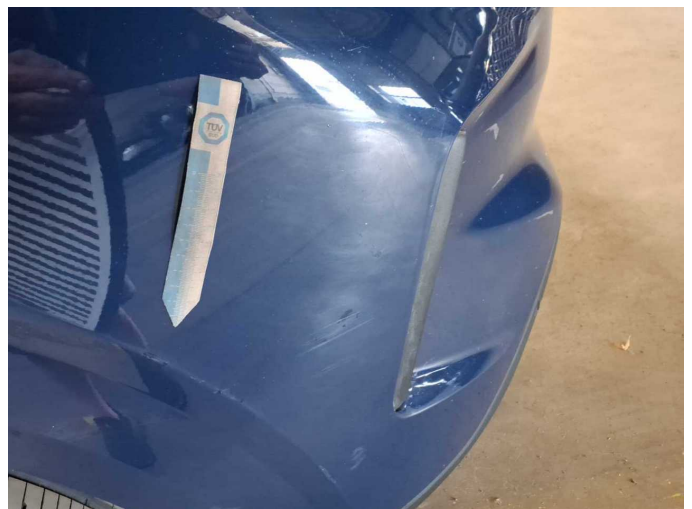
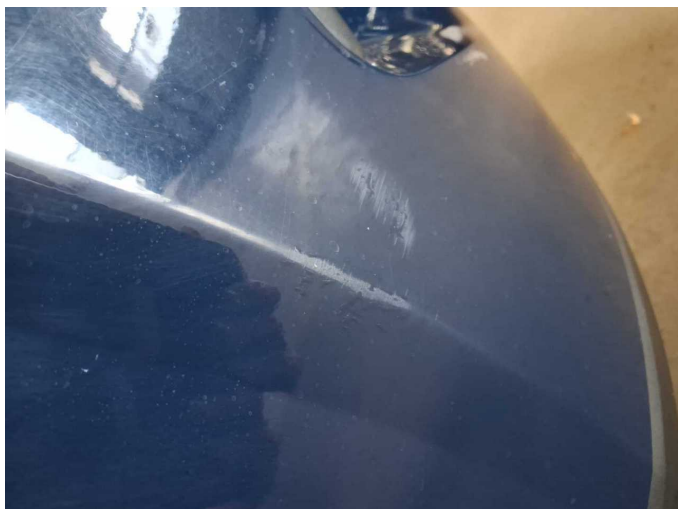
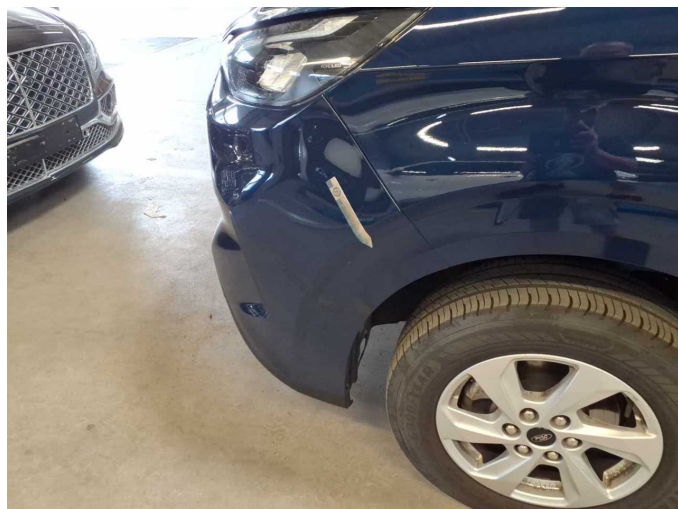
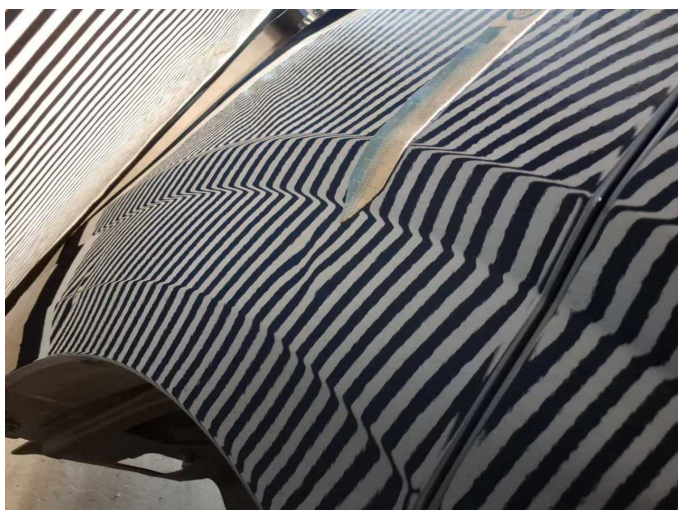
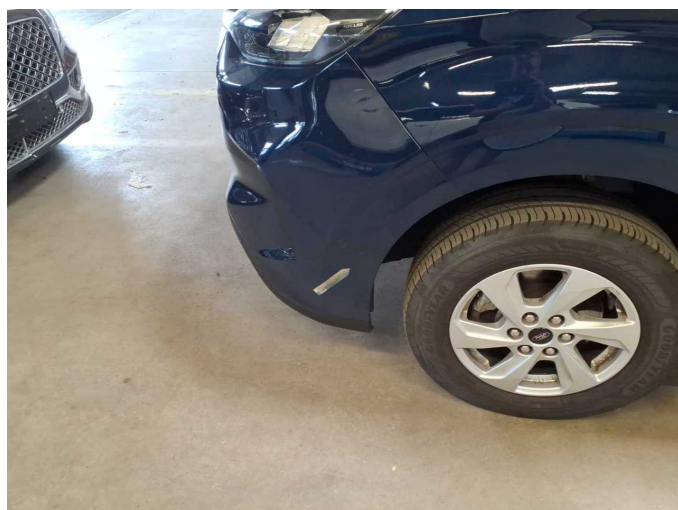
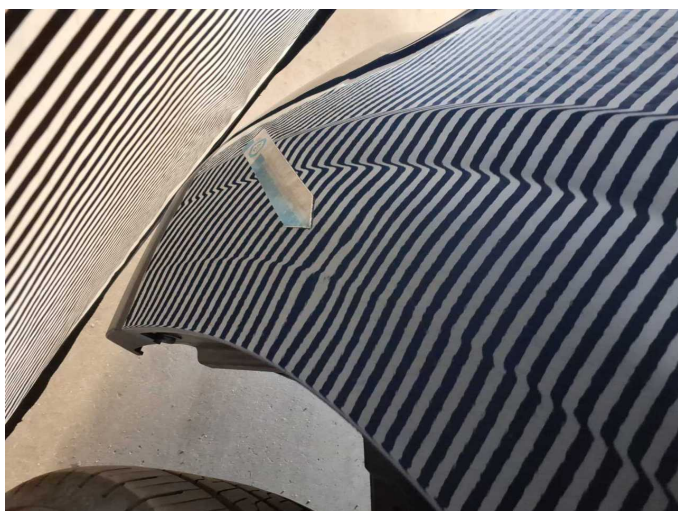
| No. | Component group | Description |
|---|---|---|
| 3 | Front bumper | Front bumper - Damaged - Repair and paint |

**Damage 3:** Front bumper: Front bumper - Damaged - Repair and paint

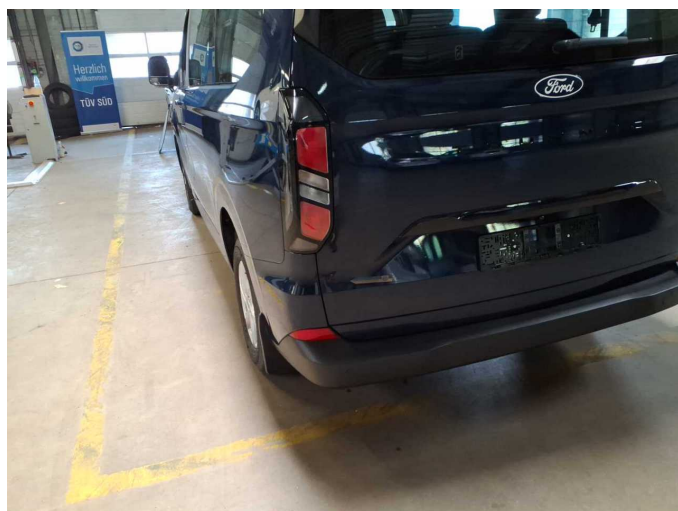
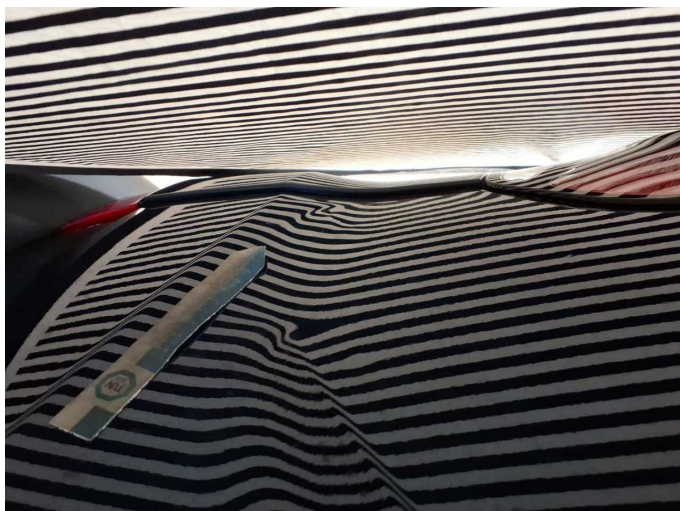
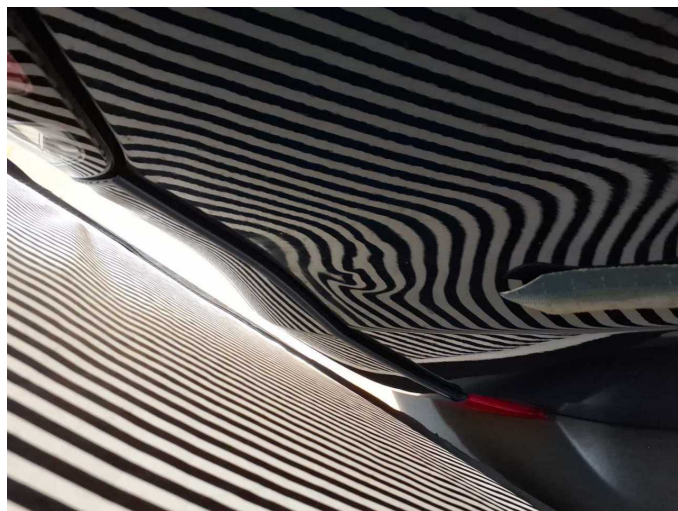
| No. | Component group | Description |
|---|---|---|
| 4 | Boot lid / rear door | Boot lid - Deformed - Repair and paint |

**Damage 4:** Boot lid / rear door: Boot lid - Deformed - Repair and paint

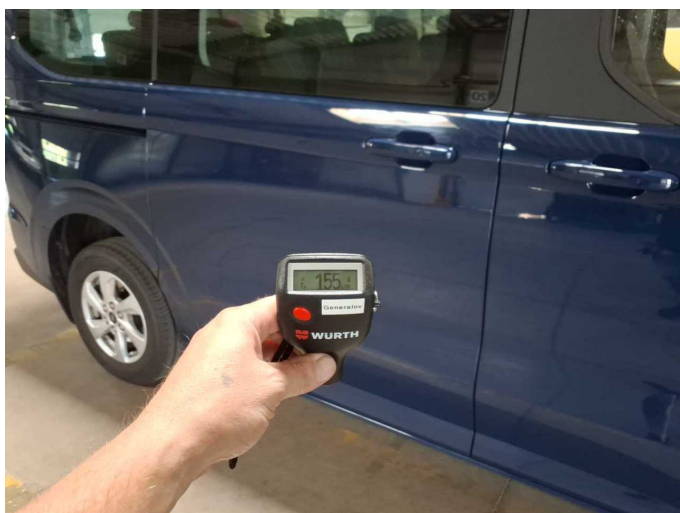
| No. | Repainting |
|---|---|
| 1 | Door - rear right side, Professionally carried out, Invoice of repair done Non-existent |

| Door - rear right side | 155 µm |

**Repainting 1:** Door - rear right side
