## Expertise

Protocol number: 46345793  
Order No. / Reference: 26184159  
Inspection date: 30 Jun 2026

Manufacturer: Mercedes-Benz

Model: Vito 116 CDI Extralang HA Aut. PRO

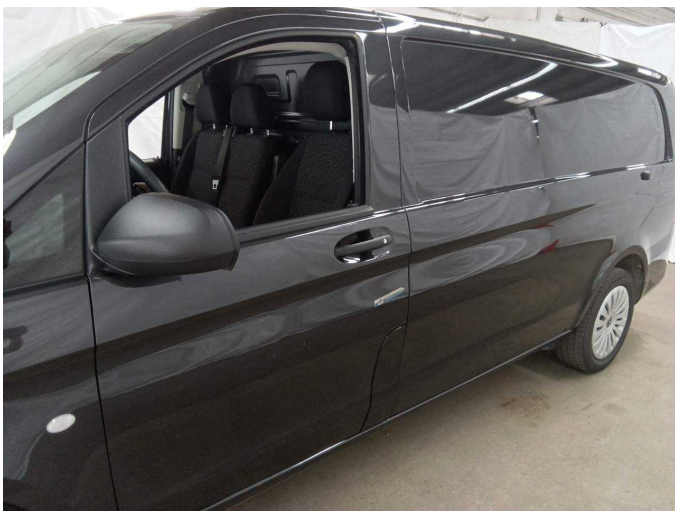
No.	Component group	Description
1	Door - front left side	Door edge - Scratch(es) - Smart repair
2	Wing mirror - right side	Mirror glass - Broken / torn - Replace
3	Body	A-pillar - left side - Scratch(es) - Paint
4	Rear bumper	Rear bumper - Scratch(es) - Paint
5	Boot lid / rear door	Rear door - right side - Scratch(es) - Paint
6	Mudguard - right side	Mudguard - right side - Dent / paintcoat damage - Repair and paint
7	Sliding door, right	Sliding door - Scratch(es) - Paint
8	Side panel - rear left side	Side panel - Scratch(es) - Paint

Damage 1: Door - front left side: Door edge - Scratch(es) - Smart repair

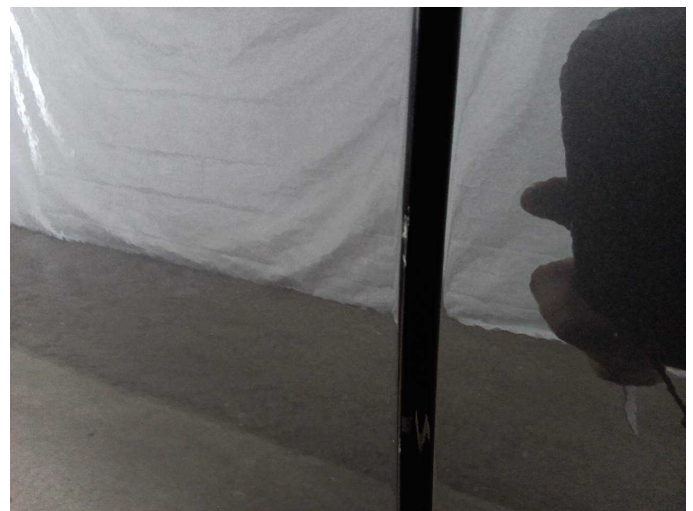
Damage 1: Door - front left side: Door edge - Scratch(es) - Smart repair

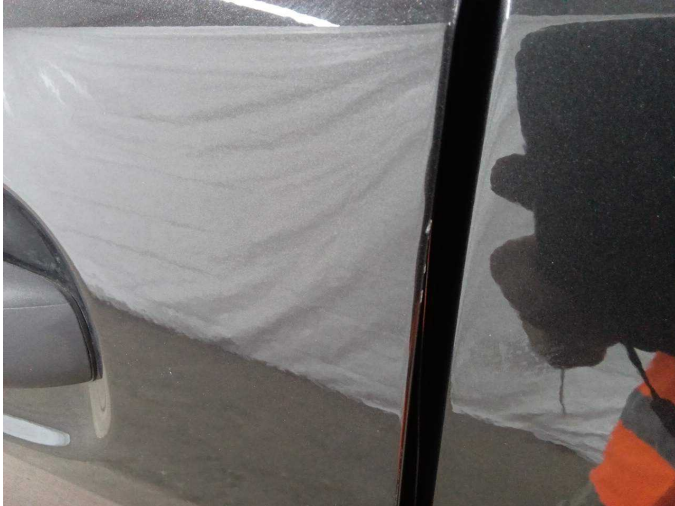
**Damage 1:** Door - front left side: Door edge - Scratch(es) - Smart repair

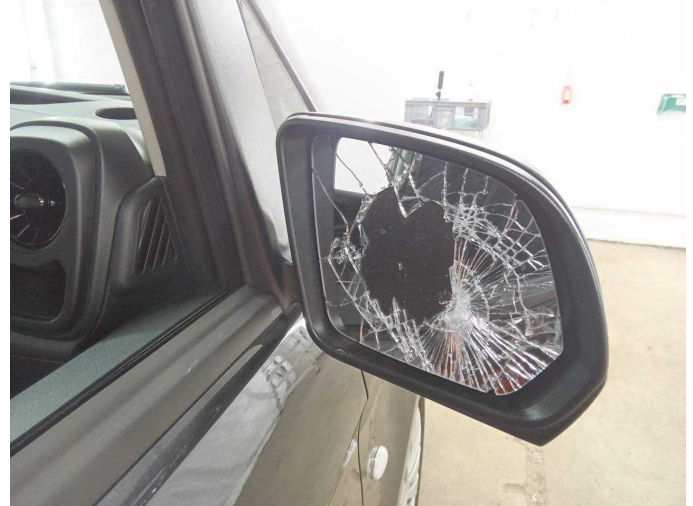
**Damage 2:** Wing mirror - right side: Mirror glass - Broken / torn - Replace

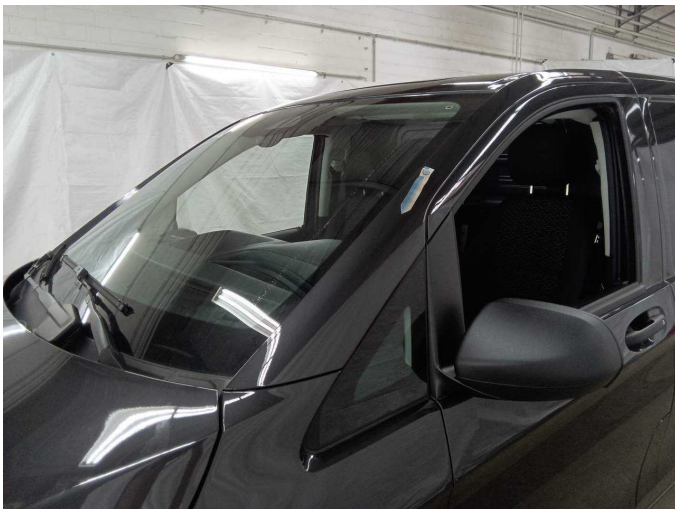
**Damage 3:** Body: A-pillar - left side - Scratch(es) - Paint

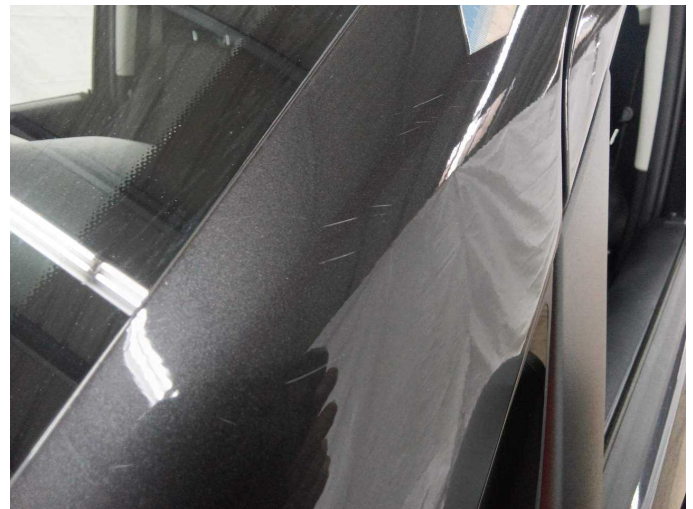
**Damage 3:** Body: A-pillar - left side - Scratch(es) - Paint

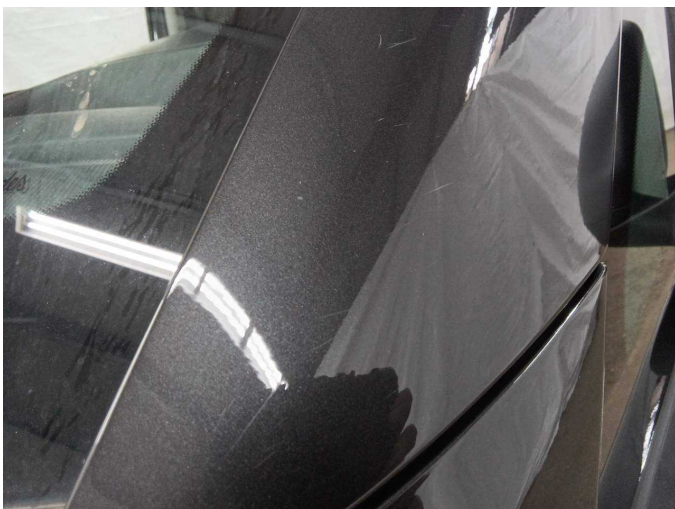
**Damage 3:** Body: A-pillar - left side - Scratch(es) - Paint

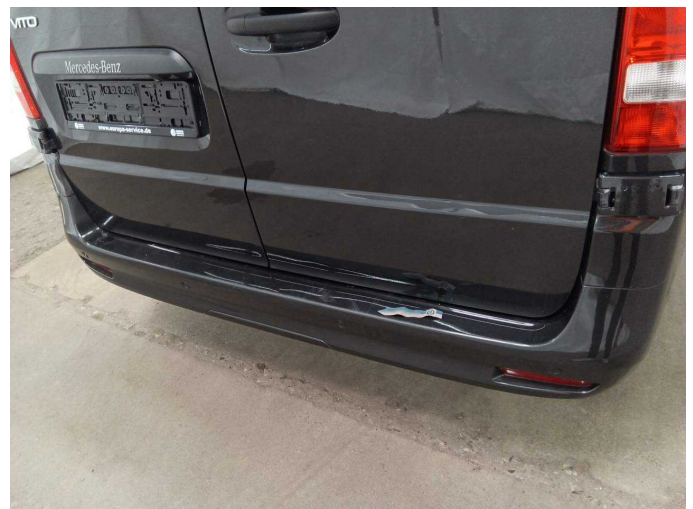
**Damage 4:** Rear bumper: Rear bumper - Scratch(es) - Paint

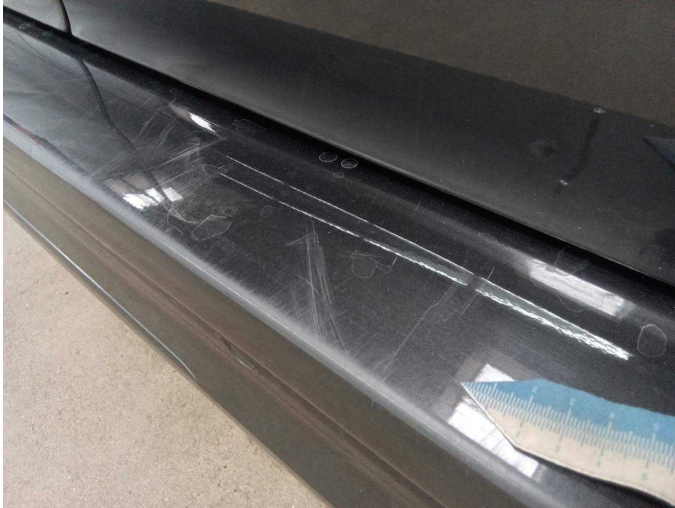
**Damage 4:** Rear bumper: Rear bumper - Scratch(es) - Paint

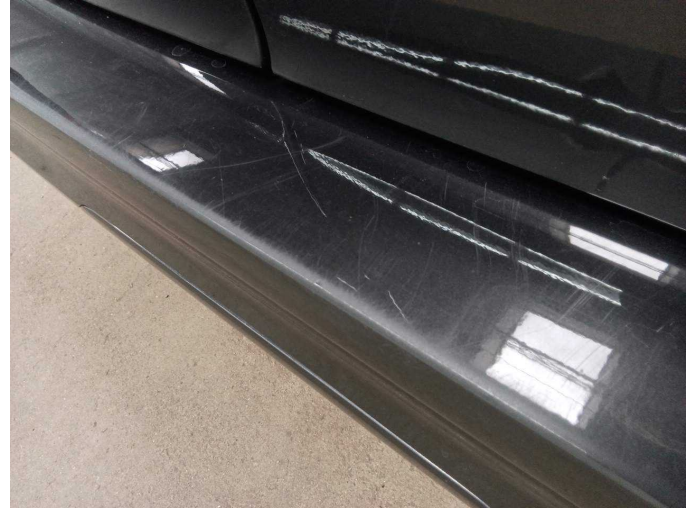
**Damage 4:** Rear bumper: Rear bumper - Scratch(es) - Paint

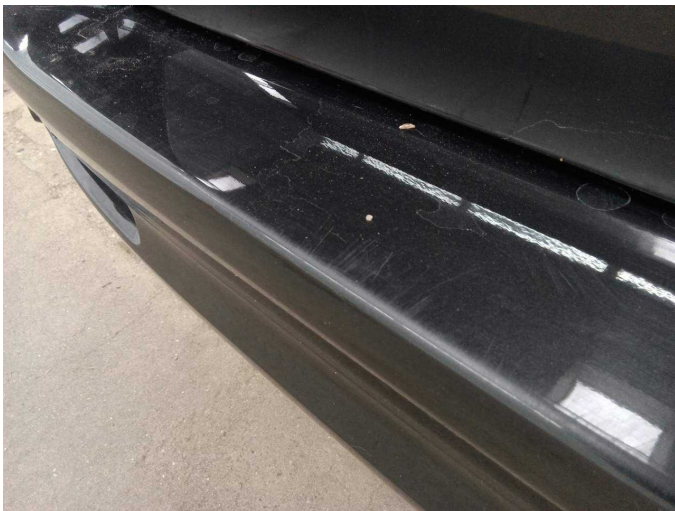
**Damage 4:** Rear bumper: Rear bumper - Scratch(es) - Paint

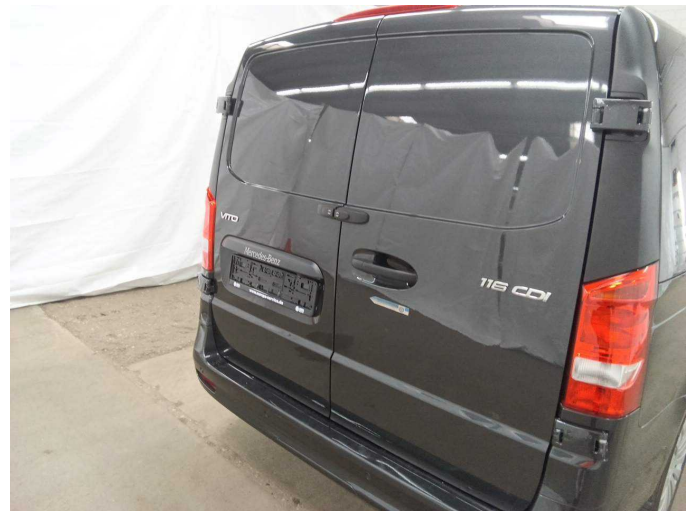
**Damage 5:** Boot lid / rear door: Rear door - right side - Scratch(es) - Paint

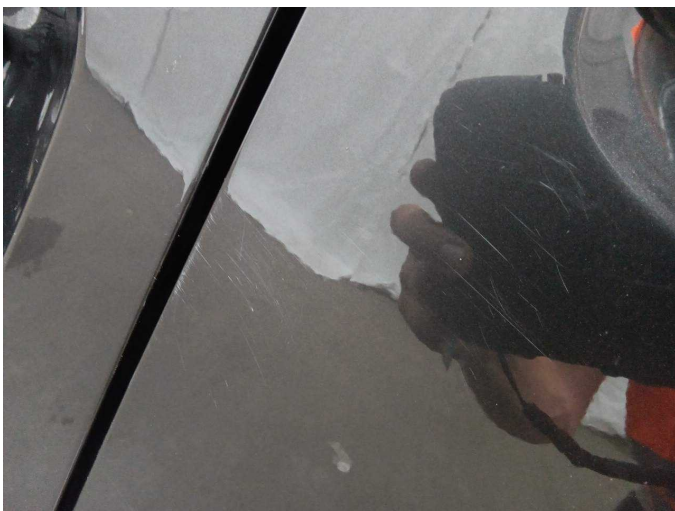
**Damage 5:** Boot lid / rear door: Rear door - right side - Scratch(es) - Paint

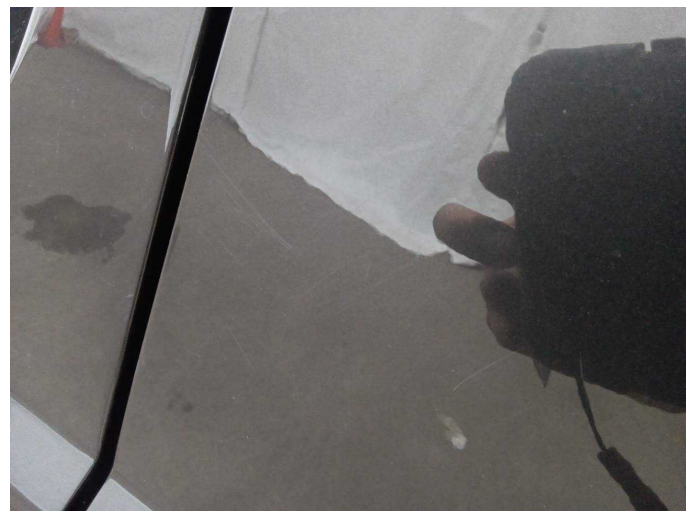
**Damage 5:** Boot lid / rear door: Rear door - right side - Scratch(es) - Paint

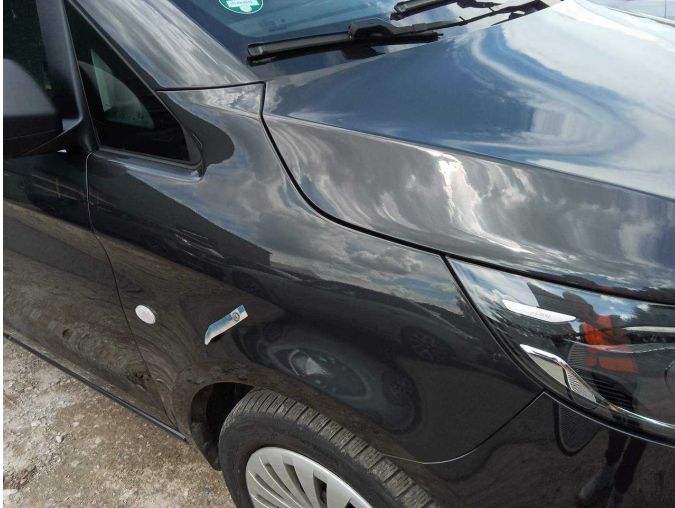
**Damage 6:** Mudguard - right side: Mudguard - right side - Dent / paintcoat damage - Repair and paint

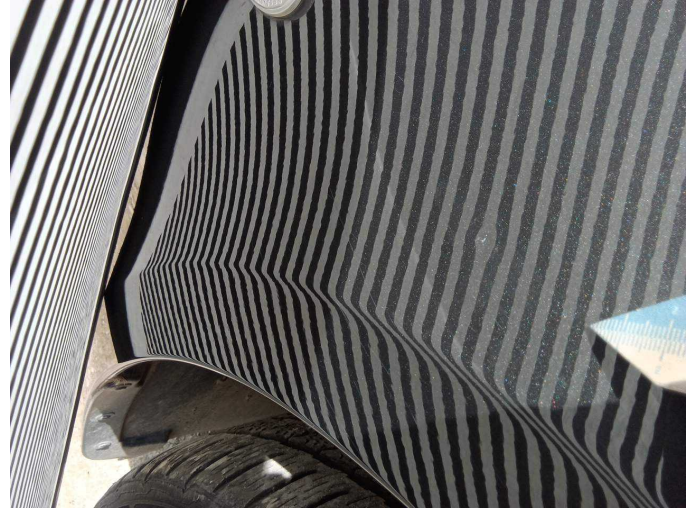
**Damage 6:** Mudguard - right side: Mudguard - right side - Dent / paintcoat damage - Repair and paint

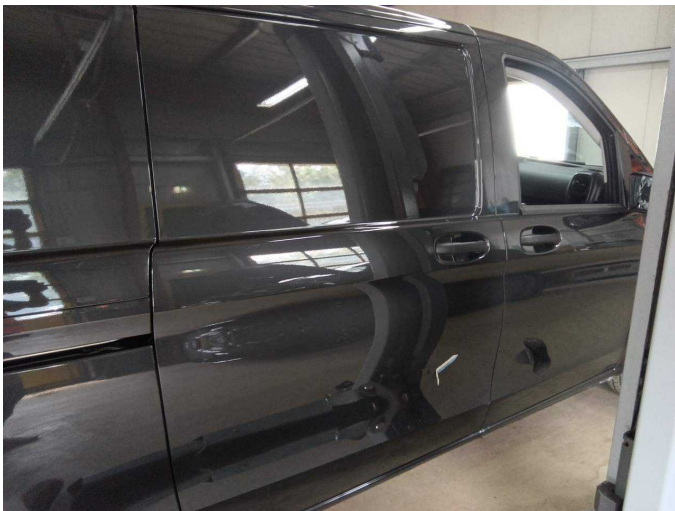
**Damage 7:** Sliding door, right: Sliding door - Scratch(es) - Paint

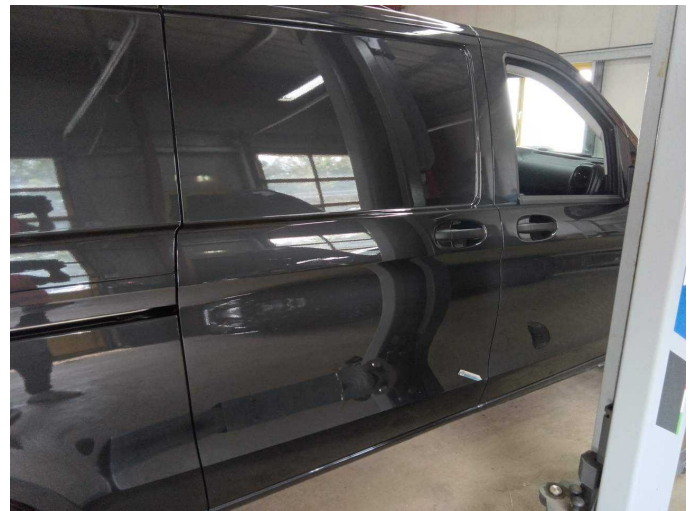
**Damage 7:** Sliding door, right: Sliding door - Scratch(es) - Paint

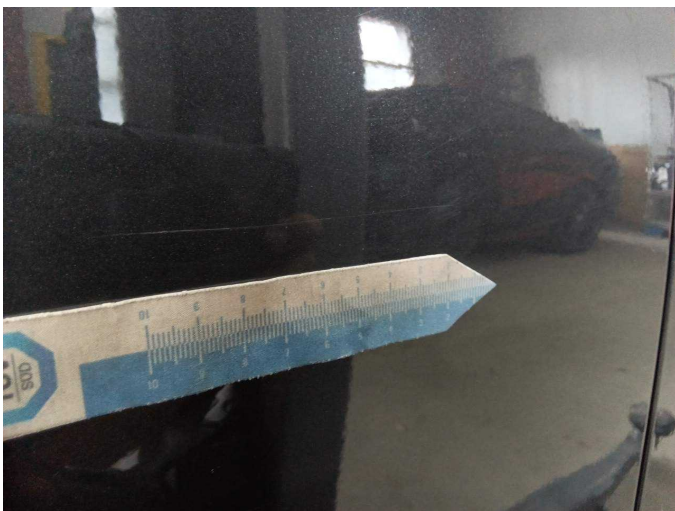
**Damage 7:** Sliding door, right: Sliding door - Scratch(es) - Paint

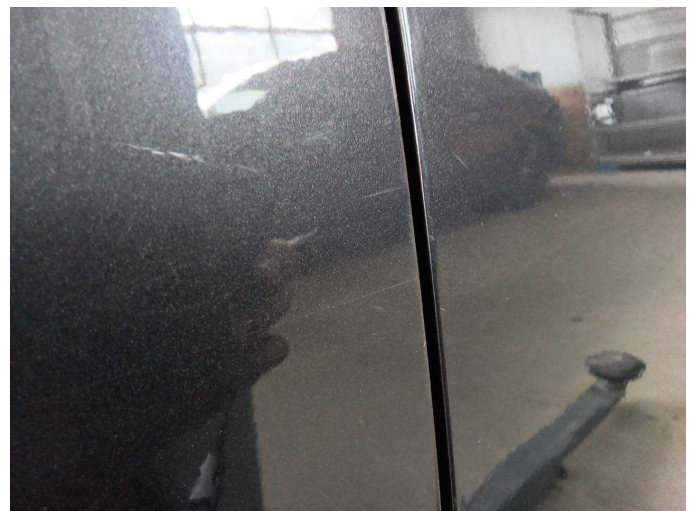
**Damage 7:** Sliding door, right: Sliding door - Scratch(es) - Paint

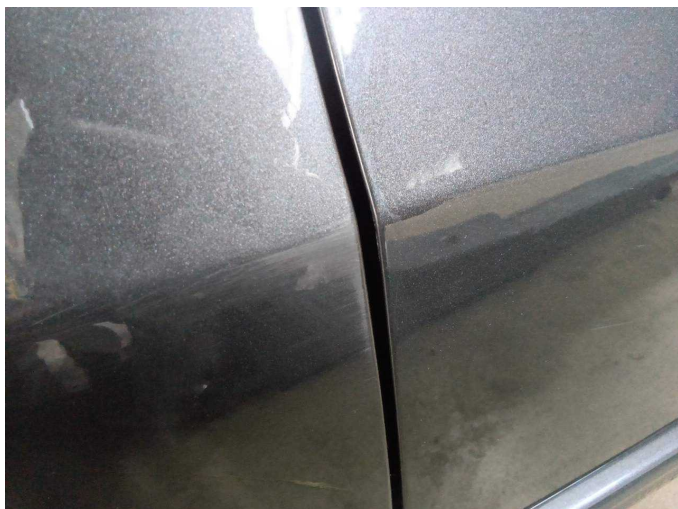
**Damage 7:** Sliding door, right: Sliding door - Scratch(es) - Paint

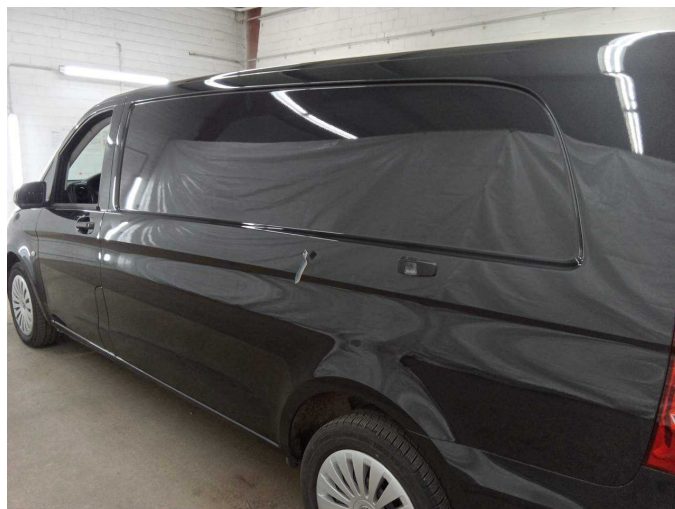
**Damage 8:** Side panel - rear left side: Side panel - Scratch(es) - Paint

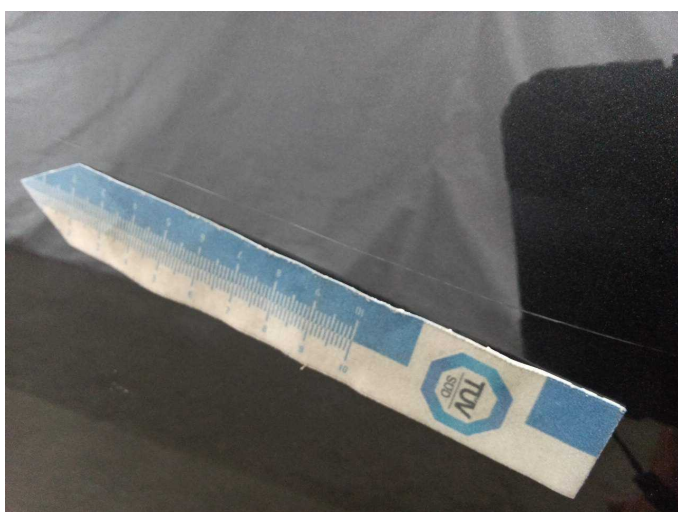
**Damage 8:** Side panel - rear left side: Side panel - Scratch(es) - Paint
