## Expertise

Protocol number: 46294818  
Order No. / Reference: 26611945  
Inspection date: 30 Jun 2026

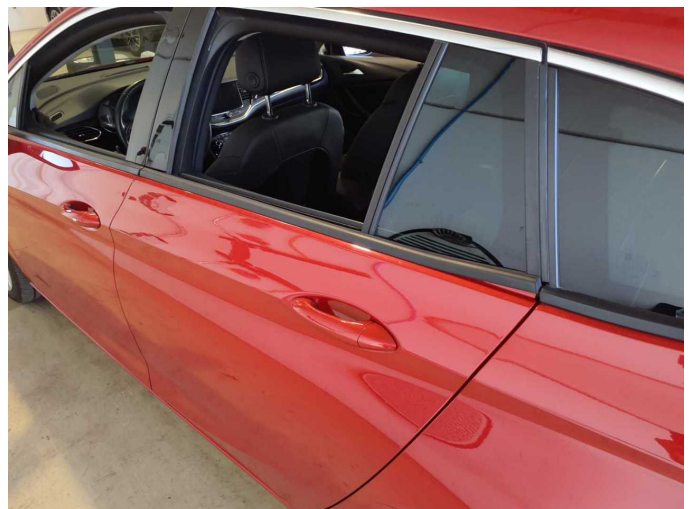
Damage 2: Door - rear left side: Strip - outer - Deformed - Replace

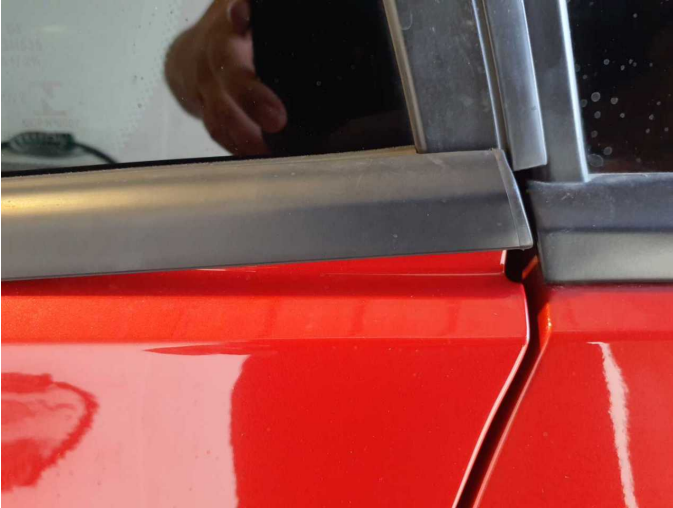
**Damage 2:** Door - rear left side: Strip - outer - Deformed - Replace

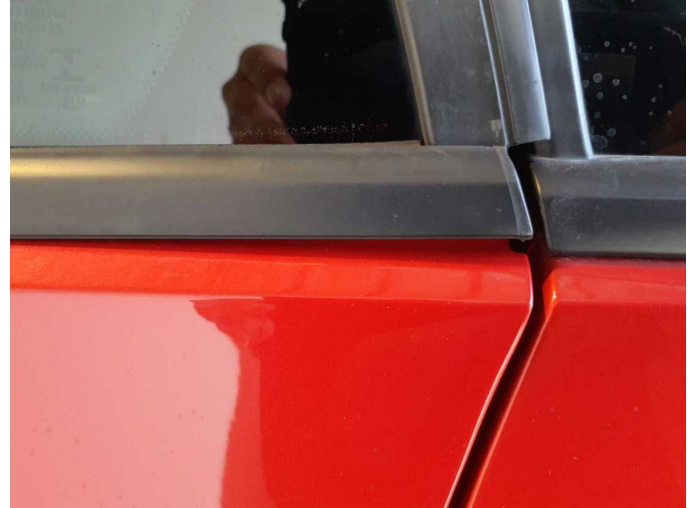
**Damage 2:** Door - rear left side: Strip - outer - Deformed - Replace

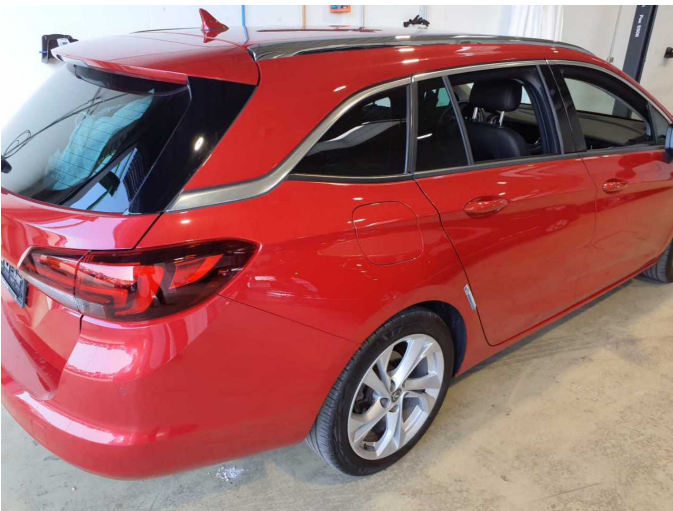
**Damage 3:** Side panel - rear right side: Side panel - dent(s) - Smooth repair work

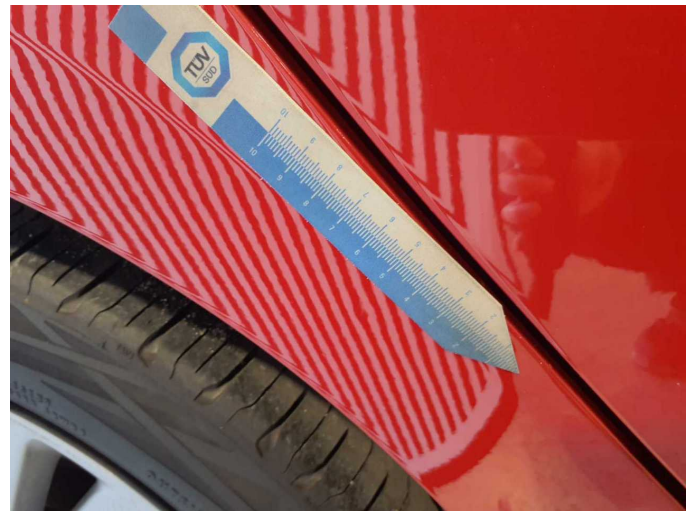
**Damage 3:** Side panel - rear right side: Side panel - dent(s) - Smooth repair work

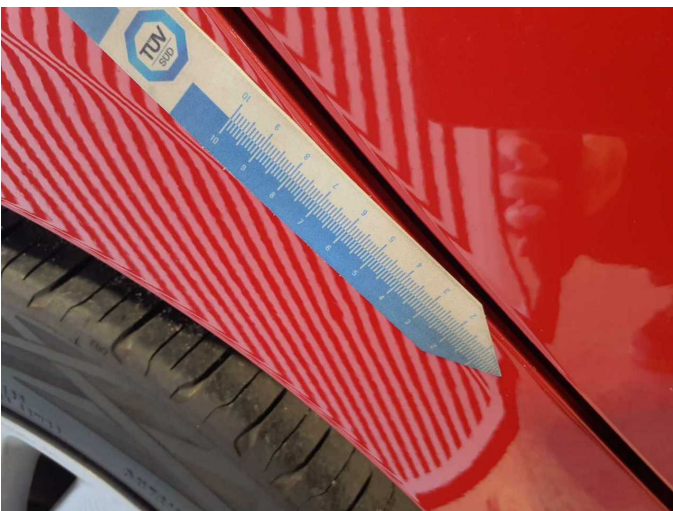
**Damage 3:** Side panel - rear right side: Side panel - dent(s) - Smooth repair work

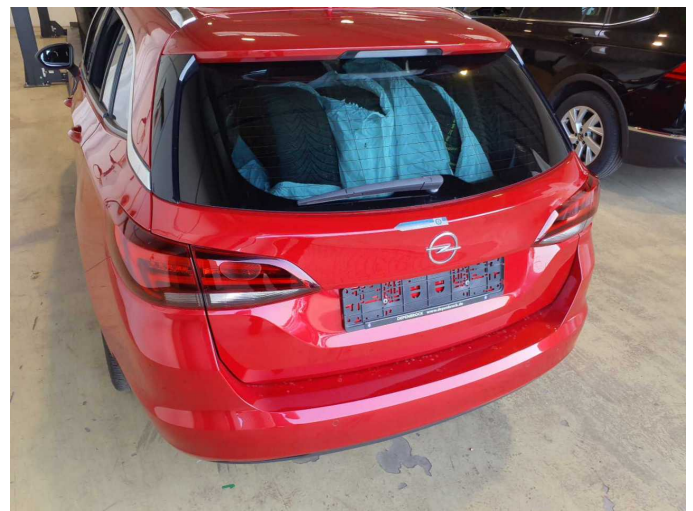
**Damage 4:** Boot lid / rear door: Boot lid - dent(s) - Smooth repair work

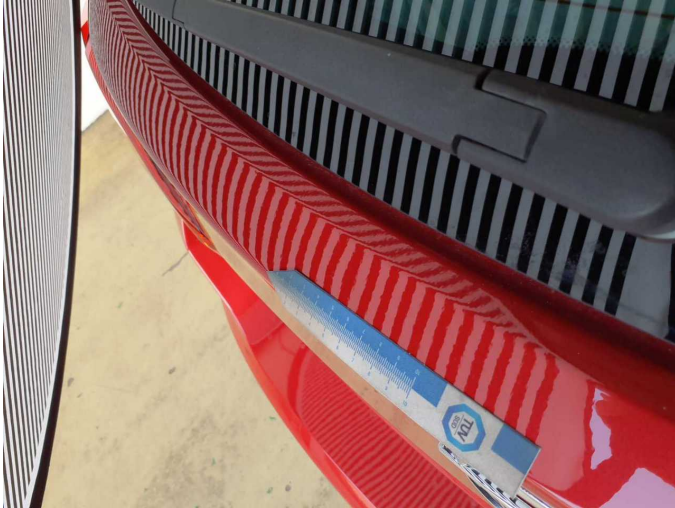
**Damage 4:** Boot lid / rear door: Boot lid - dent(s) - Smooth repair work

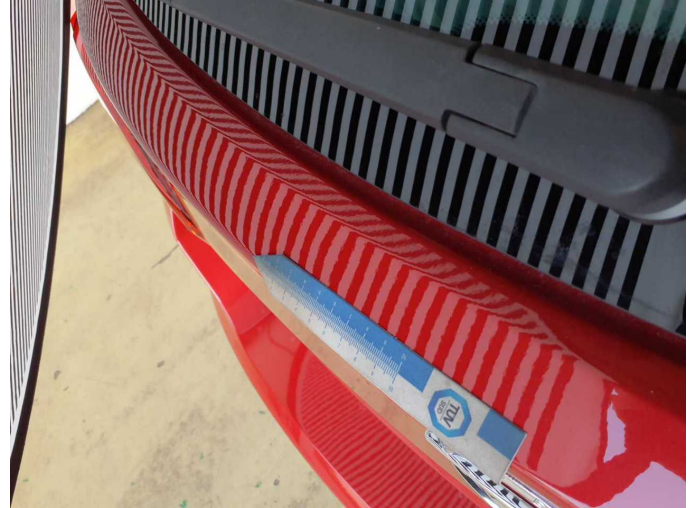
**Damage 4:** Boot lid / rear door: Boot lid - dent(s) - Smooth repair work

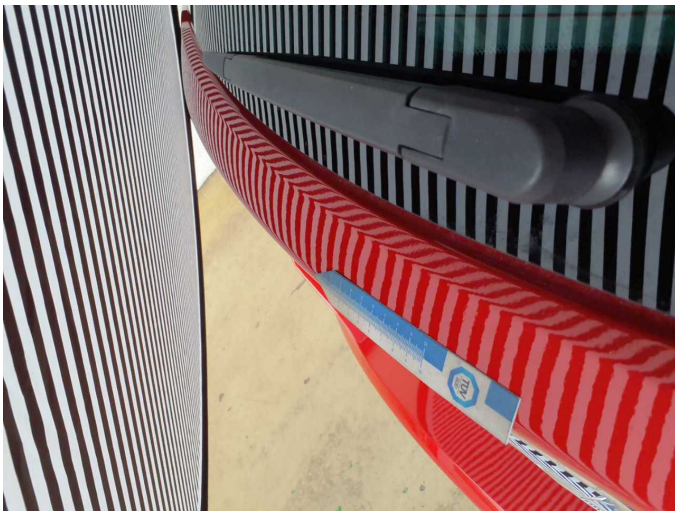
**Damage 4:** Boot lid / rear door: Boot lid - dent(s) - Smooth repair work

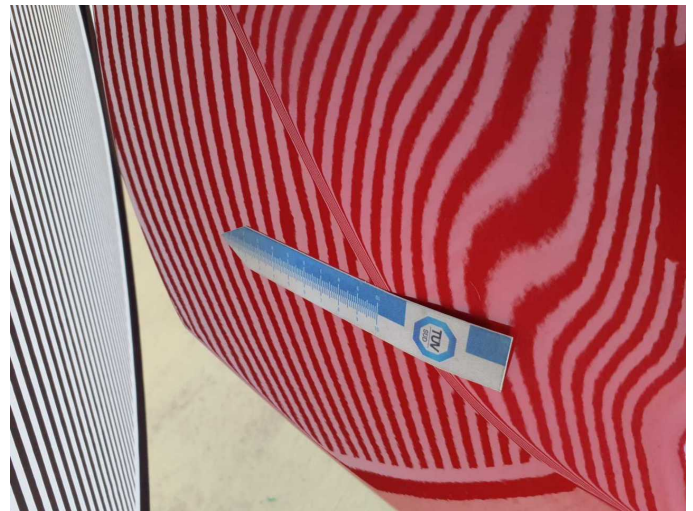
**Damage 4:** Boot lid / rear door: Boot lid - dent(s) - Smooth repair work

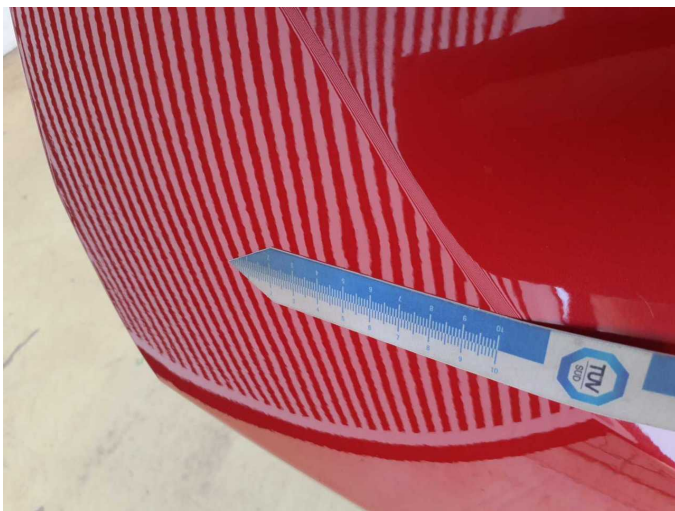
**Damage 4:** Boot lid / rear door: Boot lid - dent(s) - Smooth repair work

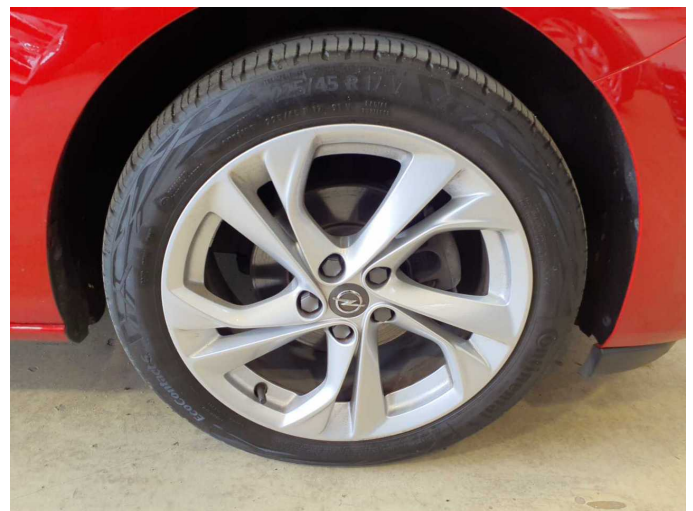
**Damage 5:** Wheel / tyres: Alloy rim - front right side - Scratch(es) - Loss in value

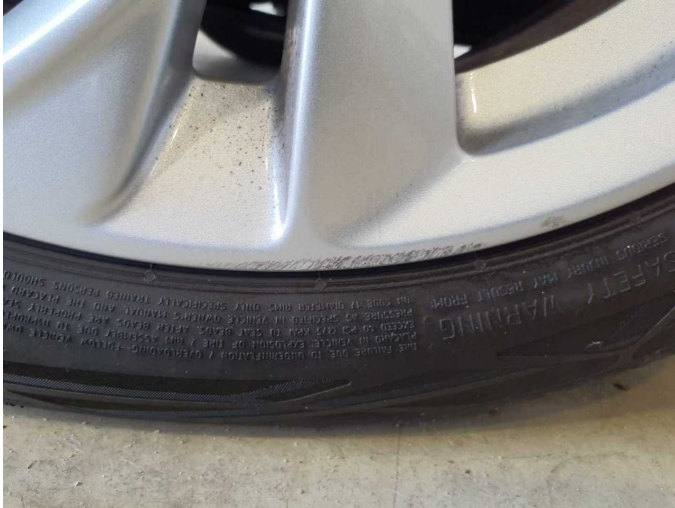
**Damage 5:** Wheel / tyres: Alloy rim - front right side - Scratch(es) - Loss in value

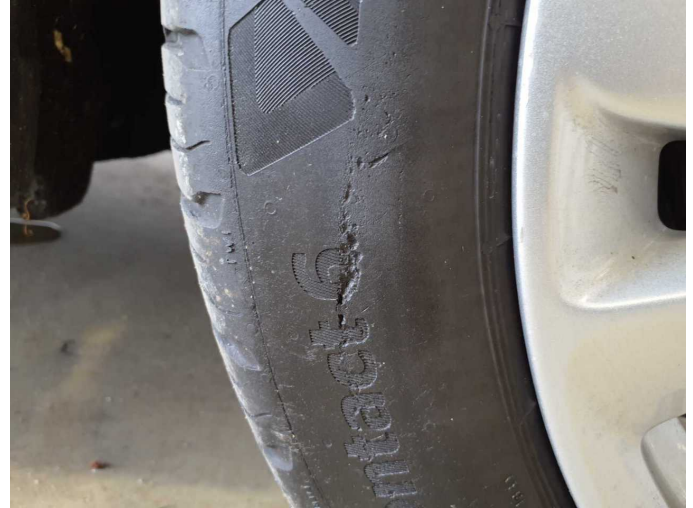
**Damage 6:** Wheel / tyres: Tyre - front right side - Porous / cracked - Replace

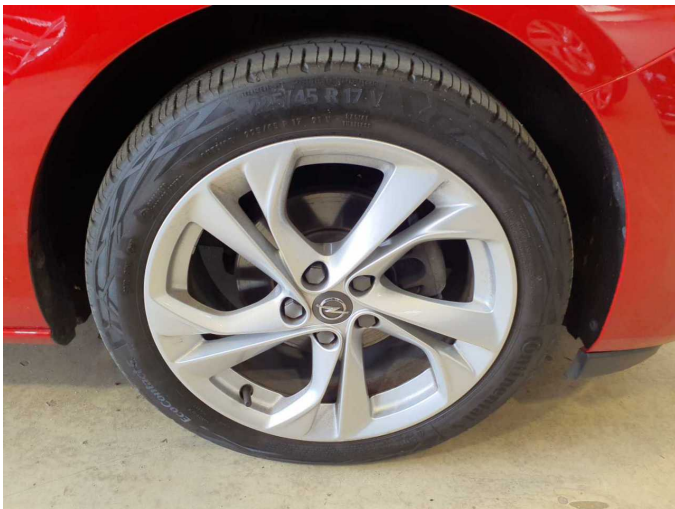
**Damage 6:** Wheel / tyres: Tyre - front right side - Porous / cracked - Replace

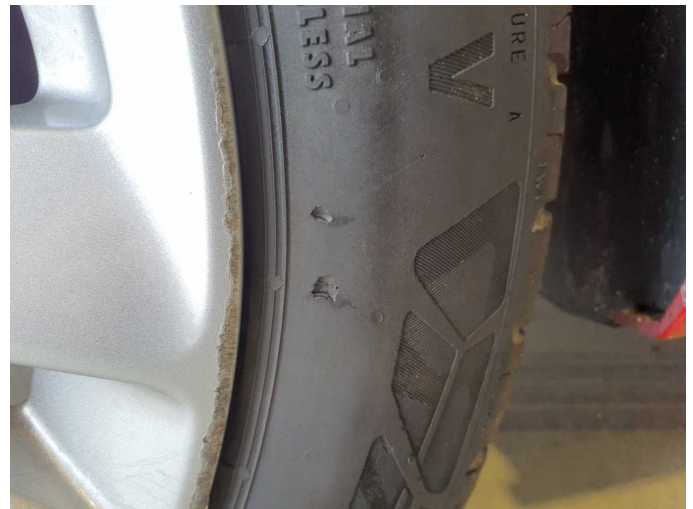
**Damage 7:** Wheel / tyres: Tyre - rear right side - Porous / cracked - Replace

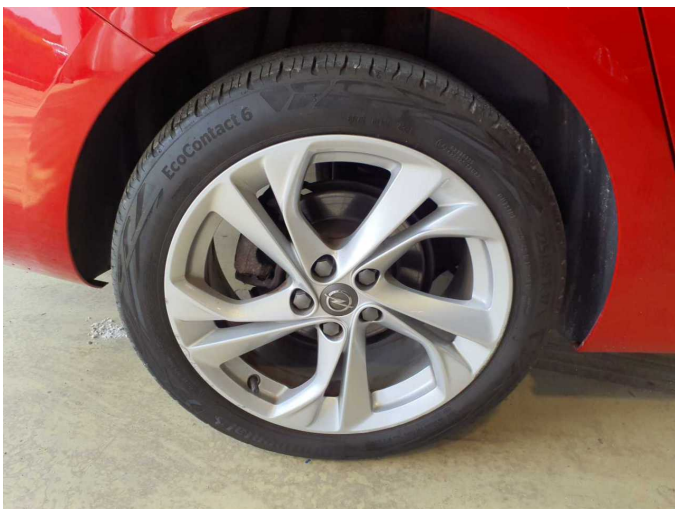
**Damage 7:** Wheel / tyres: Tyre - rear right side - Porous / cracked - Replace

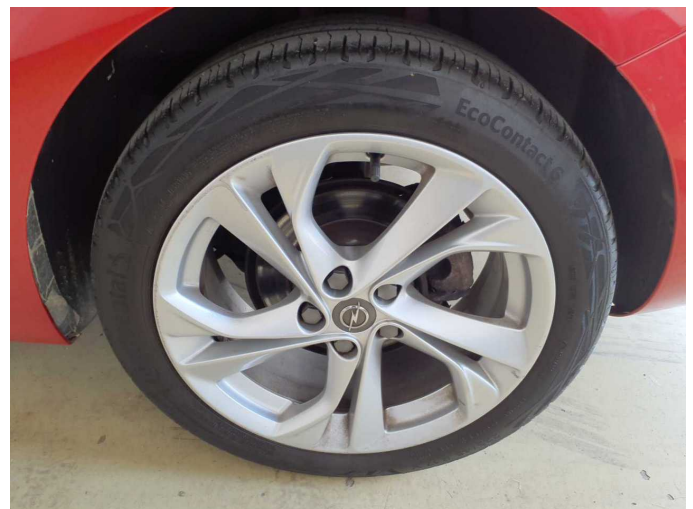
**Damage 8:** Wheel / tyres: Alloy rim - rear left side - Scratched - Replace

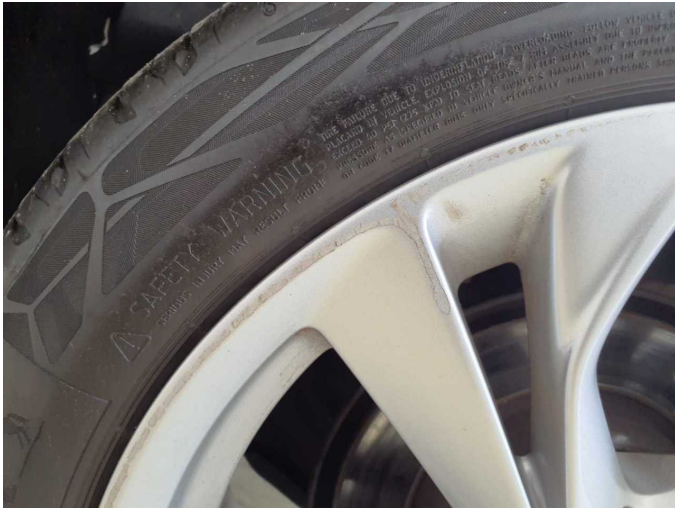
**Damage 8:** Wheel / tyres: Alloy rim - rear left side - Scratched - Replace

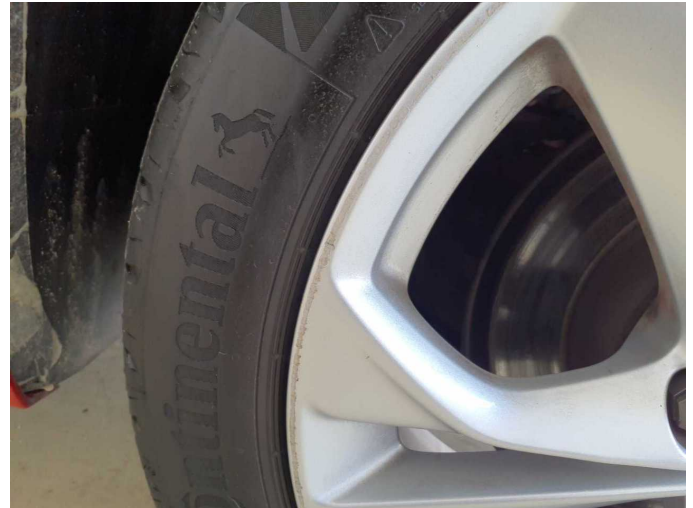
**Damage 8:** Wheel / tyres: Alloy rim - rear left side - Scratched - Replace

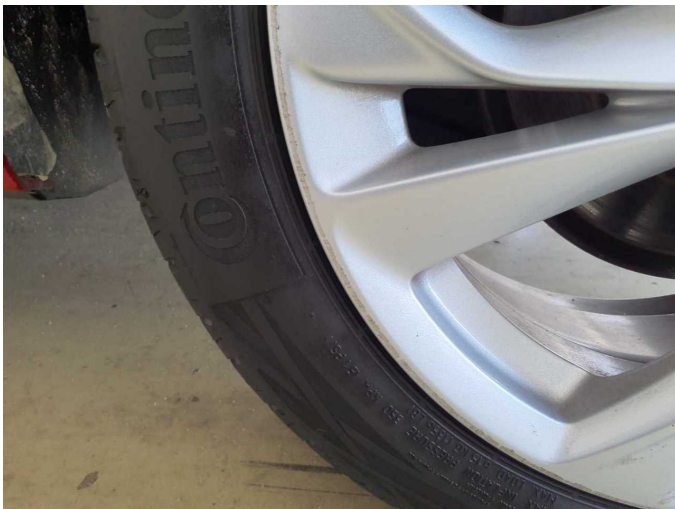
**Damage 8:** Wheel / tyres: Alloy rim - rear left side - Scratched - Replace

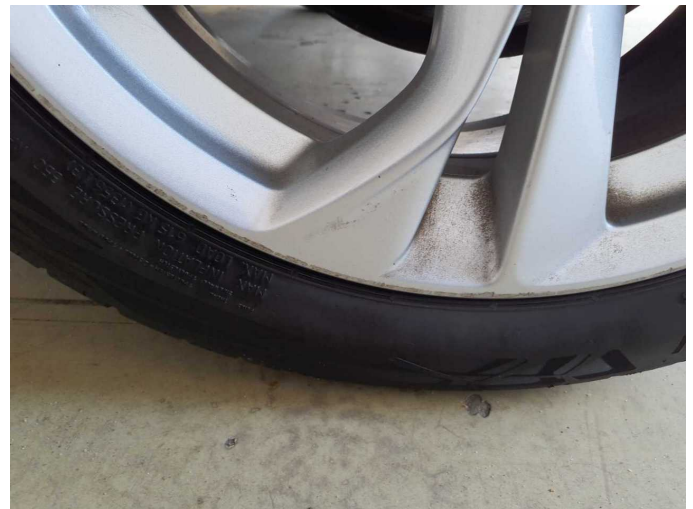
**Damage 8:** Wheel / tyres: Alloy rim - rear left side - Scratched - Replace

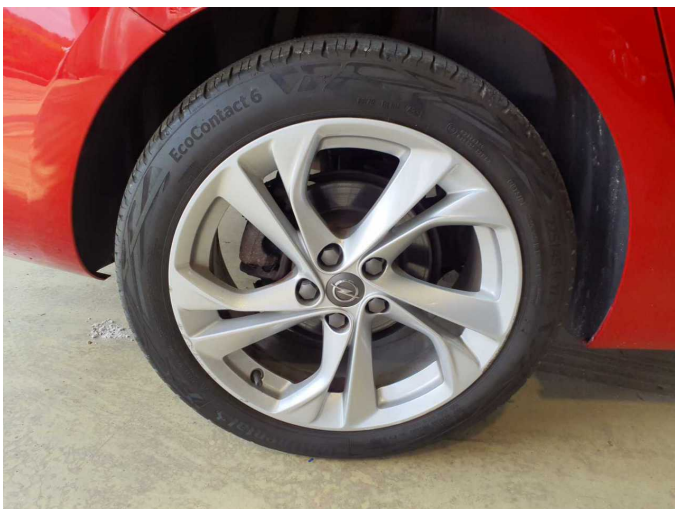
**Damage 9:** Wheel / tyres: Alloy rim - rear right side - Scratched - Replace

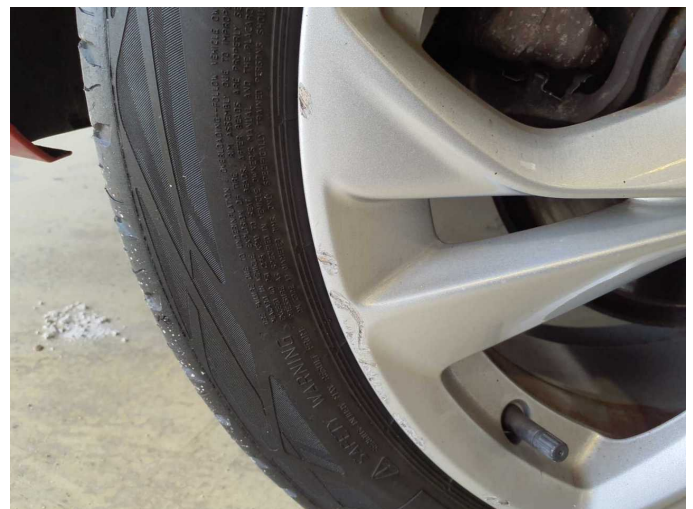
**Damage 9:** Wheel / tyres: Alloy rim - rear right side - Scratched - Replace

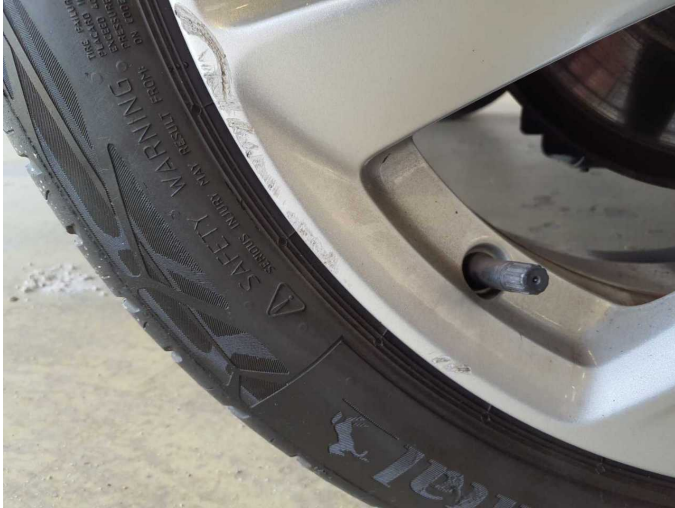
**Damage 9:** Wheel / tyres: Alloy rim - rear right side - Scratched - Replace

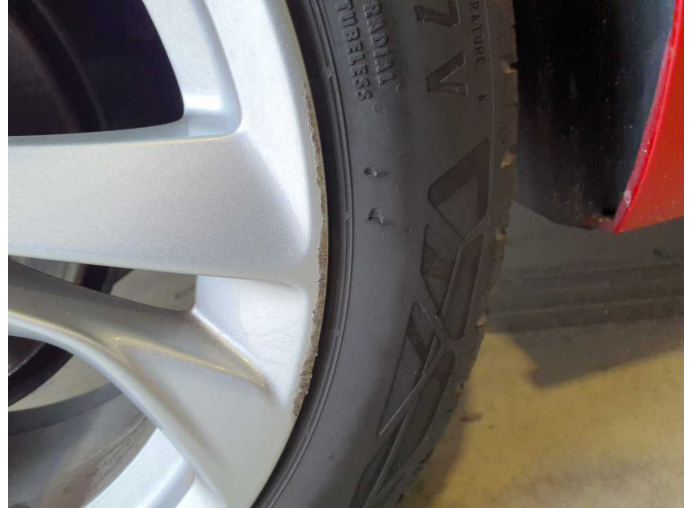
**Damage 9:** Wheel / tyres: Alloy rim - rear right side - Scratched - Replace

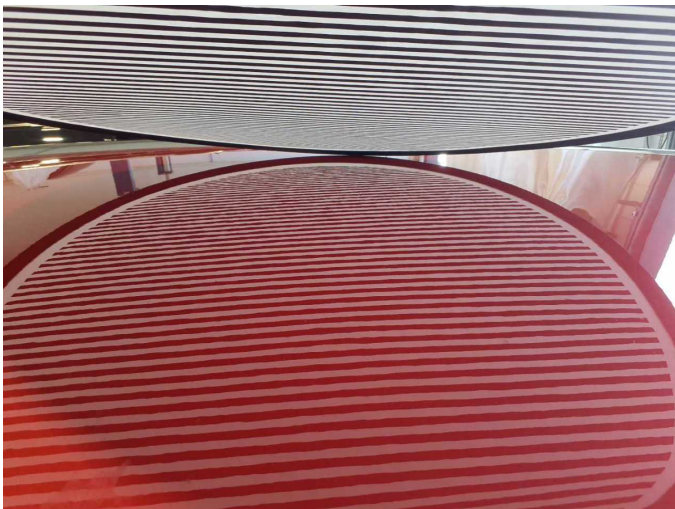
**Damage 10:** Roof: Roof (Wellig) - Unprofessionally repaired - Repair and paint

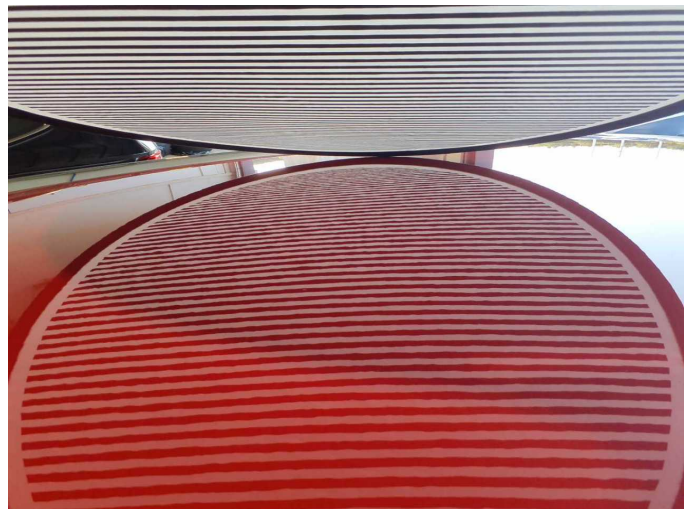
**Damage 10:** Roof: Roof (Wellig) - Unprofessionally repaired - Repair and paint

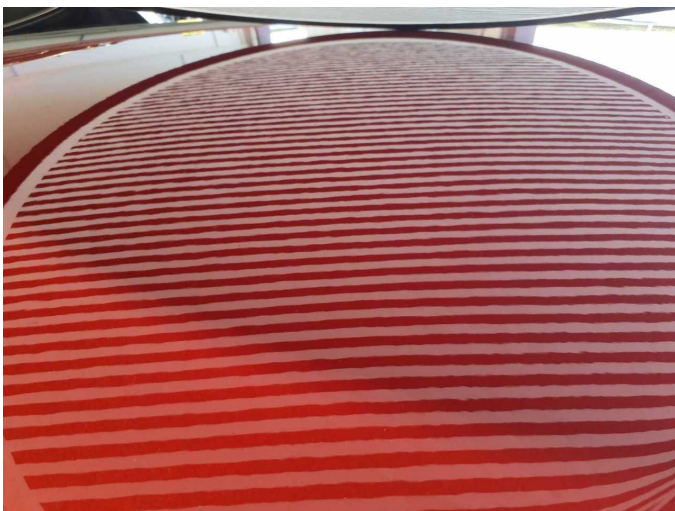
**Damage 10:** Roof: Roof (Wellig) - Unprofessionally repaired - Repair and paint

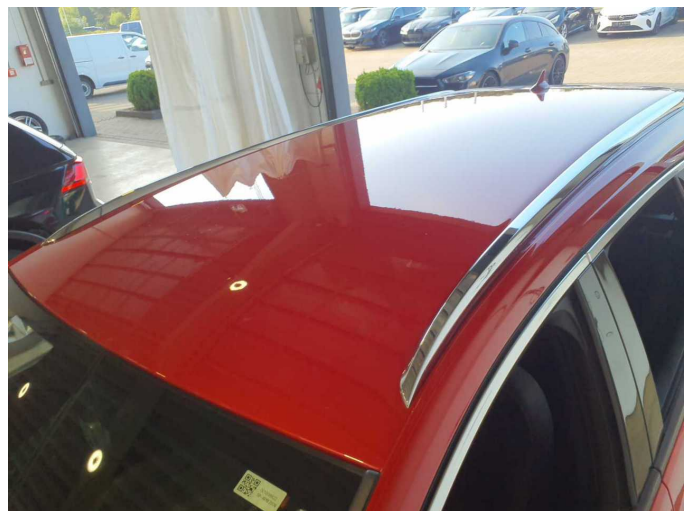
**Damage 10:** Roof: Roof (Wellig) - Unprofessionally repaired - Repair and paint

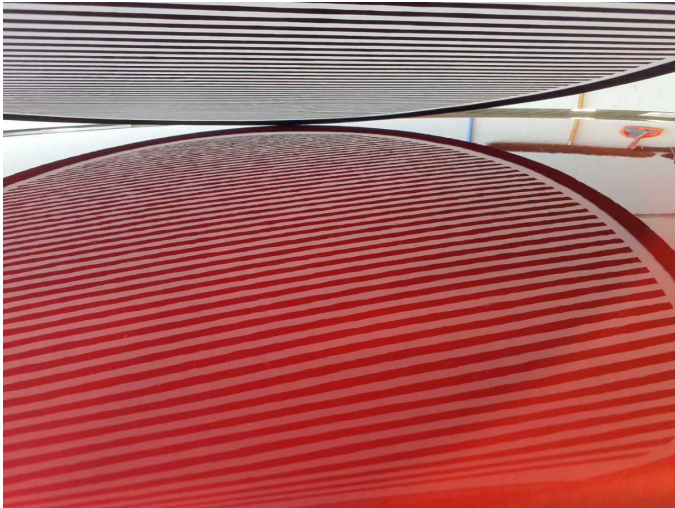
**Damage 10:** Roof: Roof (Wellig) - Unprofessionally repaired - Repair and paint

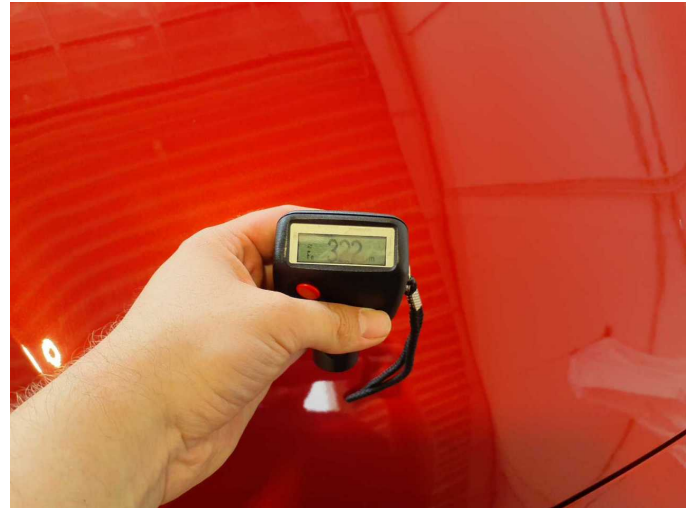
**Repainting 1:** Roof rail - right side, Bonnet, Side panel - rear left side, Door - rear left side
