Expertise

Protocol number: 46462250  
Order No. / Reference: 26545855  
Inspection date: 9 Jul 2026

Manufacturer: Seat

Model: Arona 1.0 TSI OPF Xperience

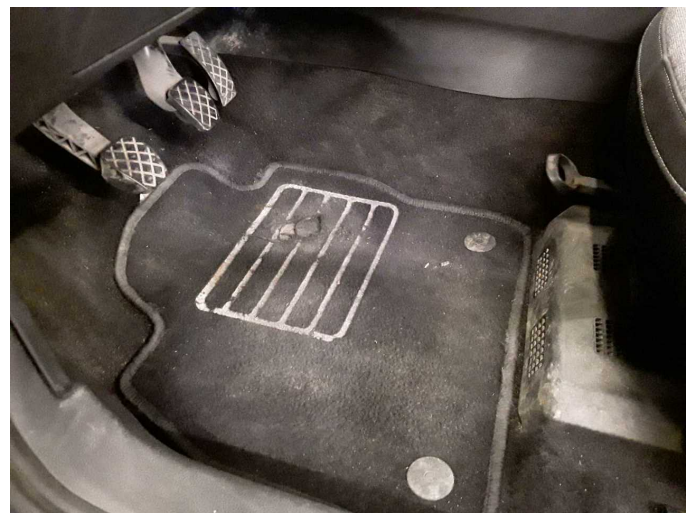
| No. | Component group | Description |
|---|---|---|
| 1 | Trim / covers | Floor mats - Damaged - Replace |

Damage 1: Trim / covers: Floor mats - Damaged - Replace

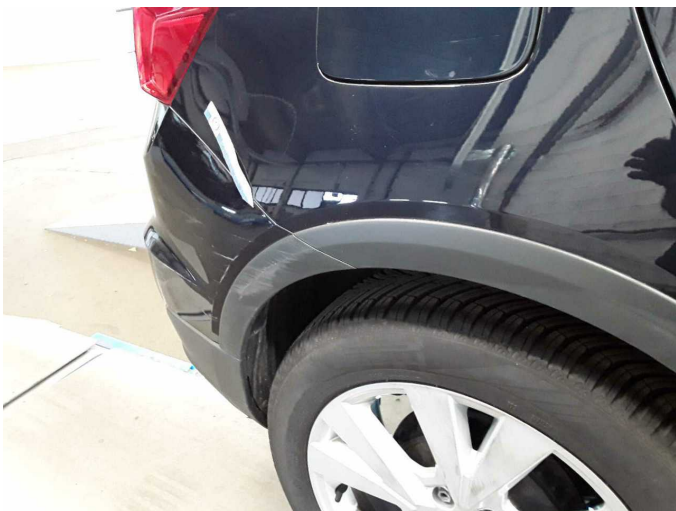
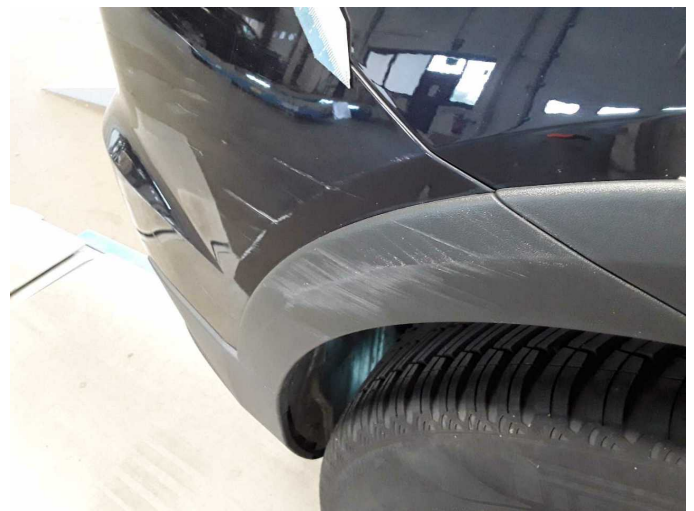
| No. | Component group | Description |
|---|---|---|
| 2 | Side panel - rear right side | Wheel arch - Scratched - Replace |

Damage 2: Side panel - rear right side: Wheel arch - Scratched - Replace

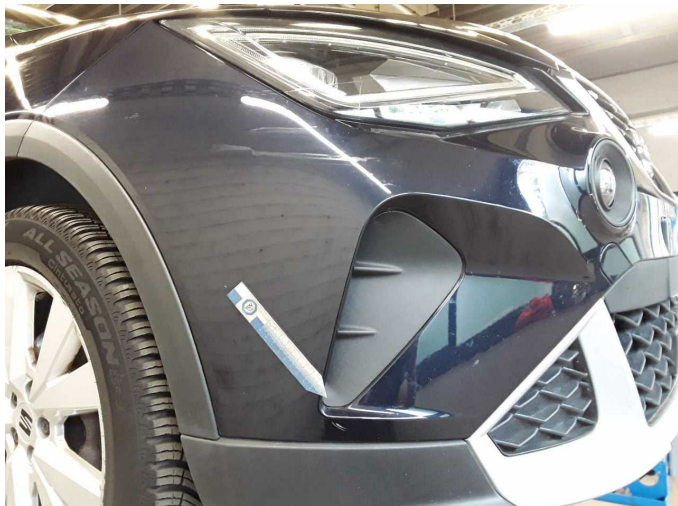
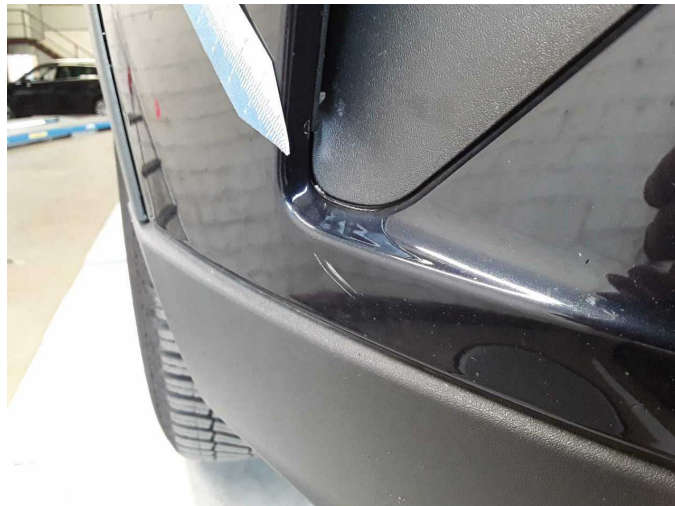
| No. | Component group | Description |
|---|---|---|
| 3 | Front bumper | Front bumper - Scratch(es) - Smart repair |

**Damage 3:** Front bumper: Front bumper - Scratch(es) - Smart repair

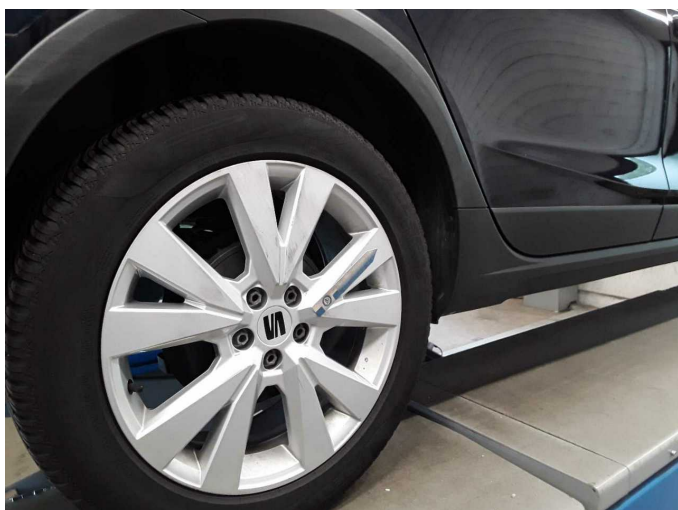
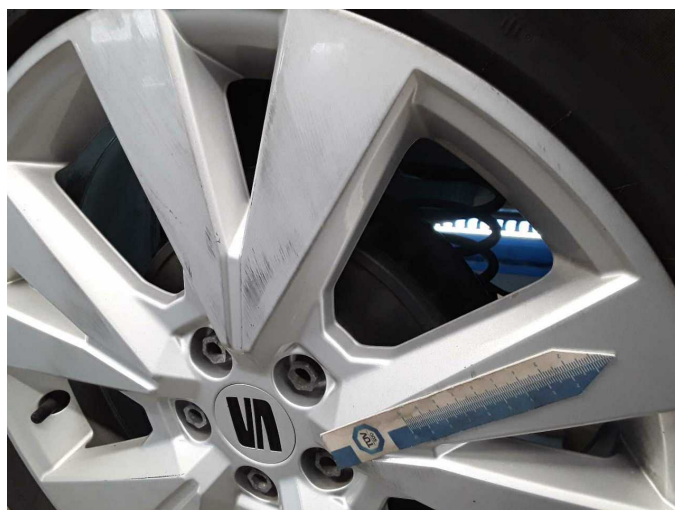
| No. | Component group | Description |
|---|---|---|
| 4 | Wheel / tyres | Alloy rim - rear right side - Scratched - Loss in value |

**Damage 4:** Wheel / tyres: Alloy rim - rear right side - Scratched - Loss in value

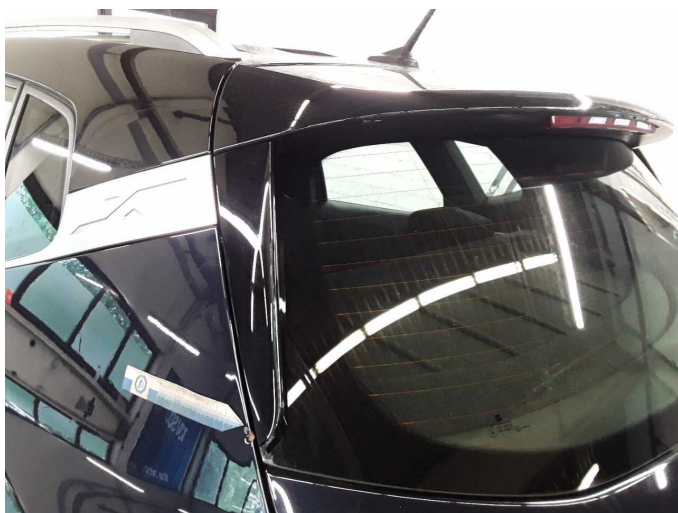
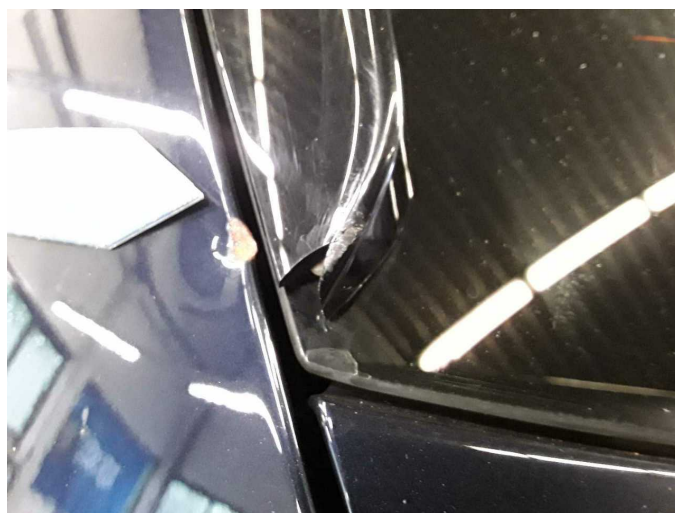
| No. | Component group | Description |
|---|---|---|
| 6 | Boot lid / rear door | Trim - standard - lower - Damaged - Replace |

**Damage 6:** Boot lid / rear door: Trim - standard - lower - Damaged - Replace

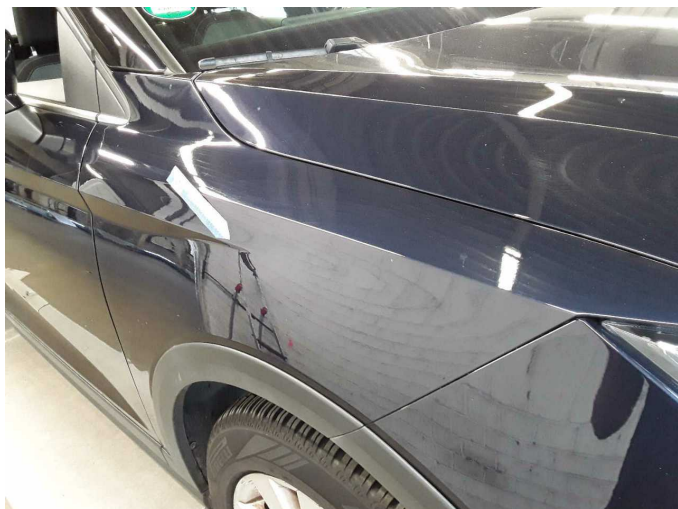
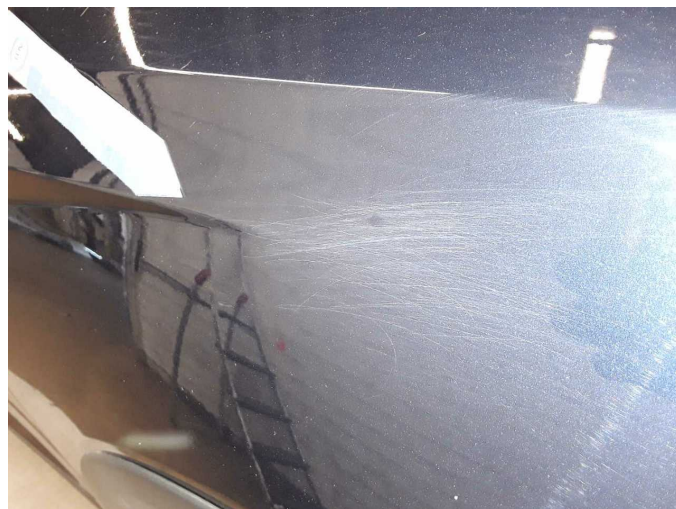
| No. | Component group | Description |
|---|---|---|
| 8 | Mudguard - right side | Mudguard - right side - Scratched - Paint |

**Damage 8:** Mudguard - right side: Mudguard - right side - Scratched - Paint

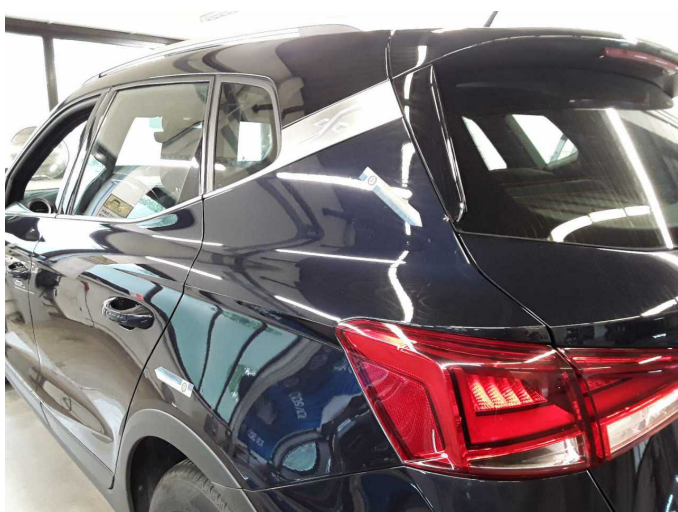
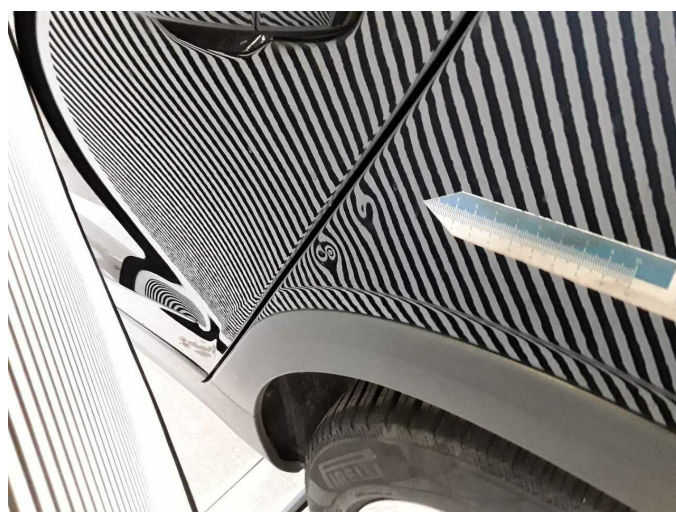
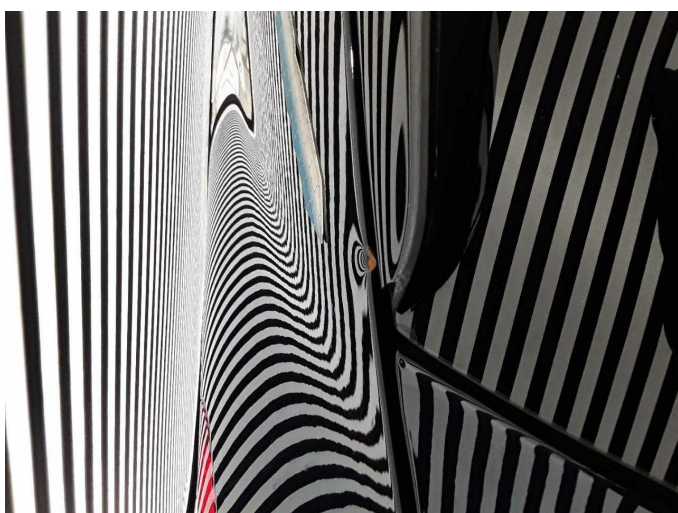
| No. | Component group | Description |
|---|---|---|
| 9 | Side panel - rear left side | Side panel - Dent / paintcoat damage - Repair and paint |

**Damage 9:** Side panel - rear left side: Side panel - Dent / paintcoat damage - Repair and paint

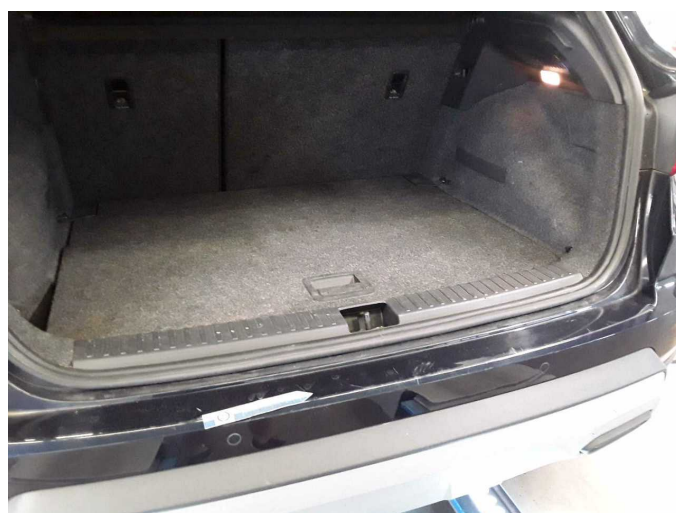
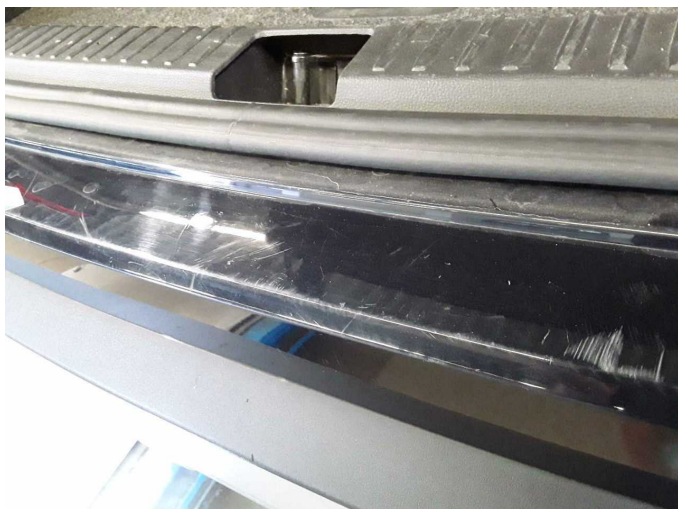
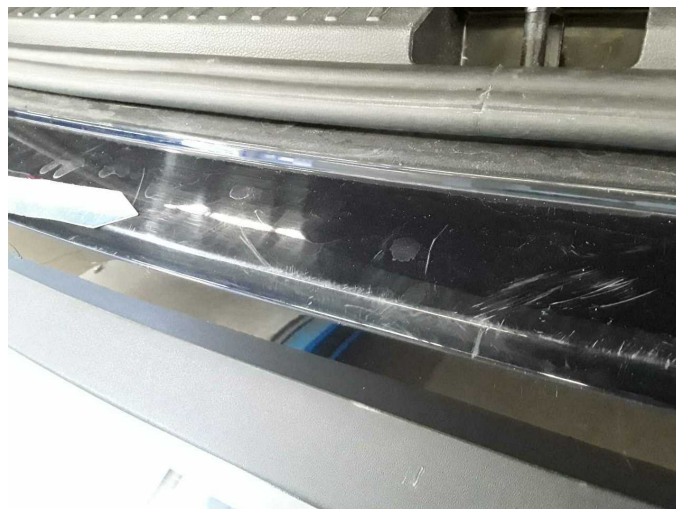
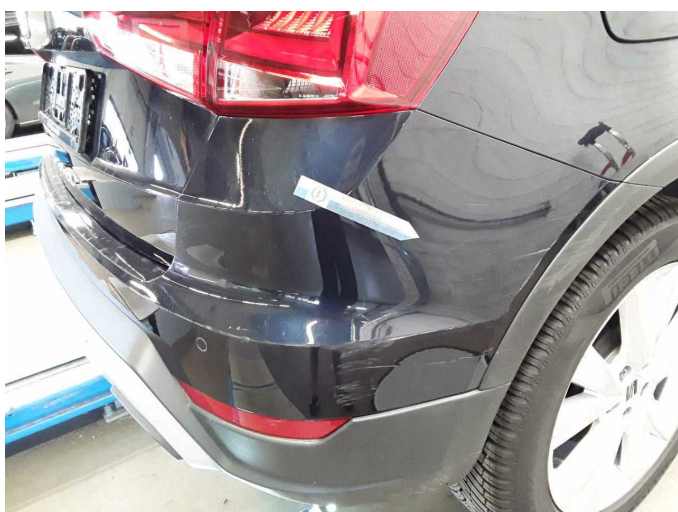
| No. | Component group | Description |
|---|---|---|
| 10 | Rear bumper | Rear bumper - Scratched - Paint |

**Damage 10:** Rear bumper: Rear bumper - Scratched - Paint

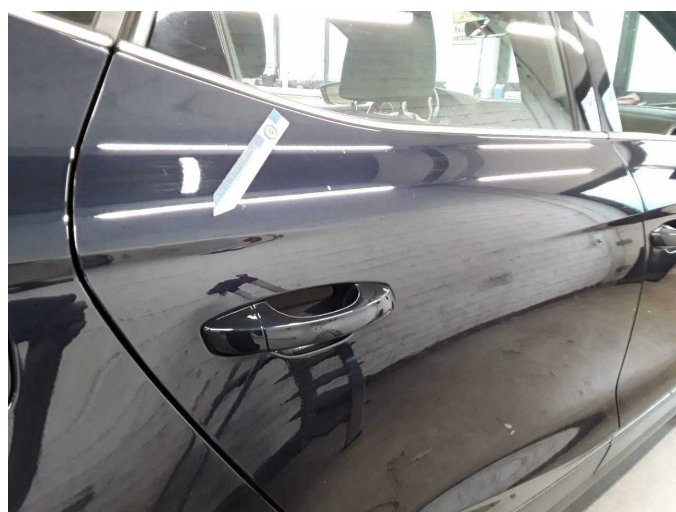
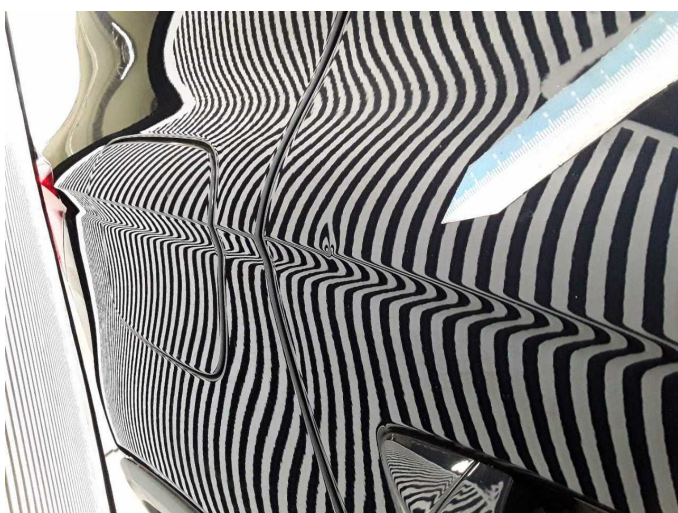
| No. | Component group | Description |
|---|---|---|
| 11 | Door - rear right side | Door - Deformed - Paint |

**Damage 11:** Door - rear right side: Door - Deformed - Paint

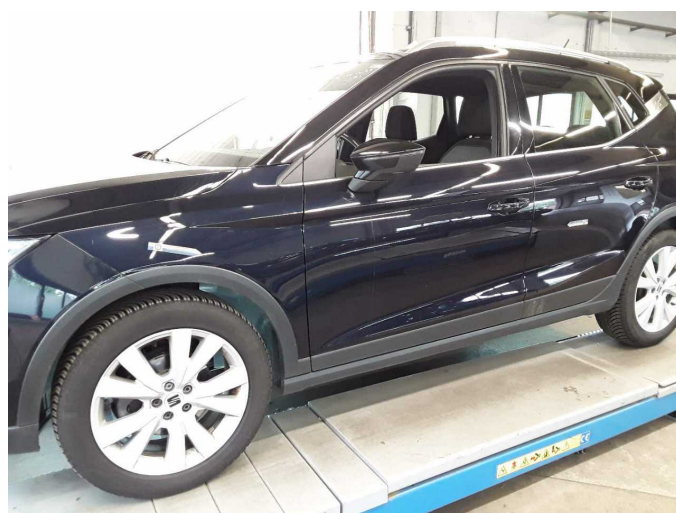
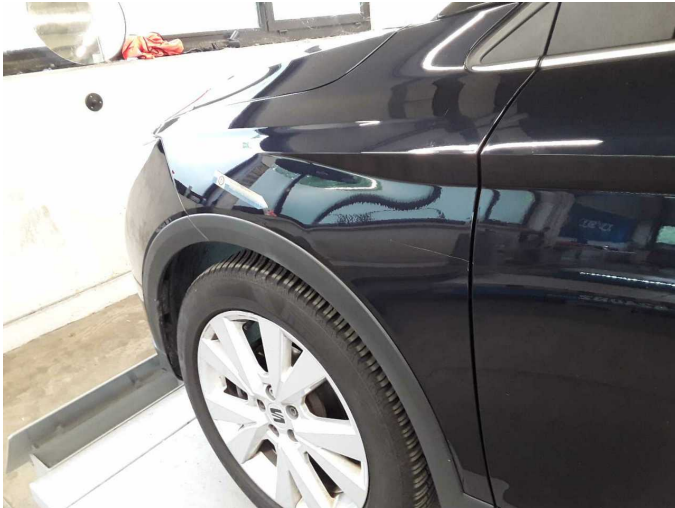
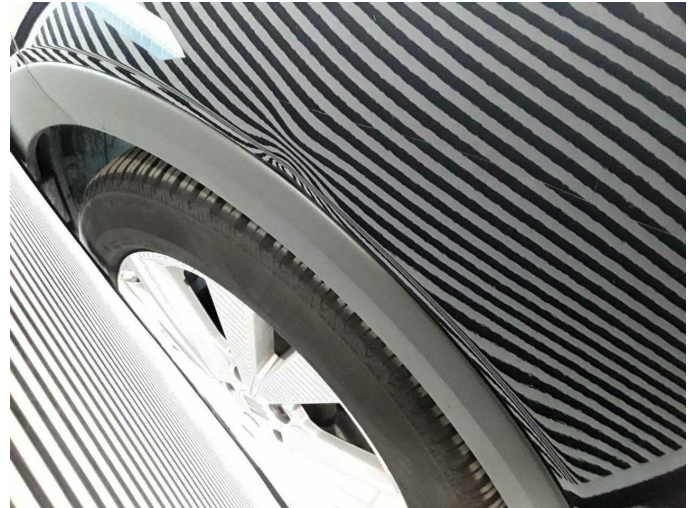
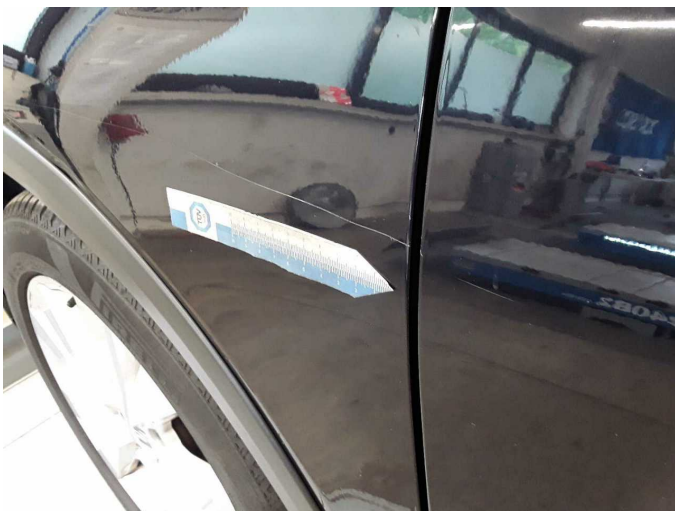
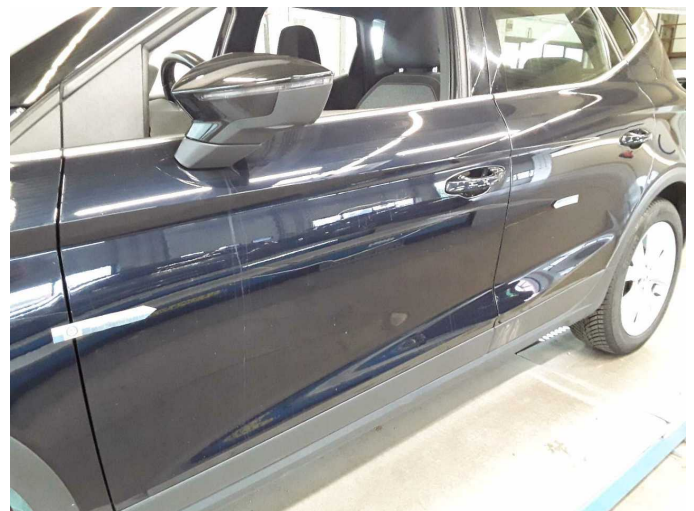
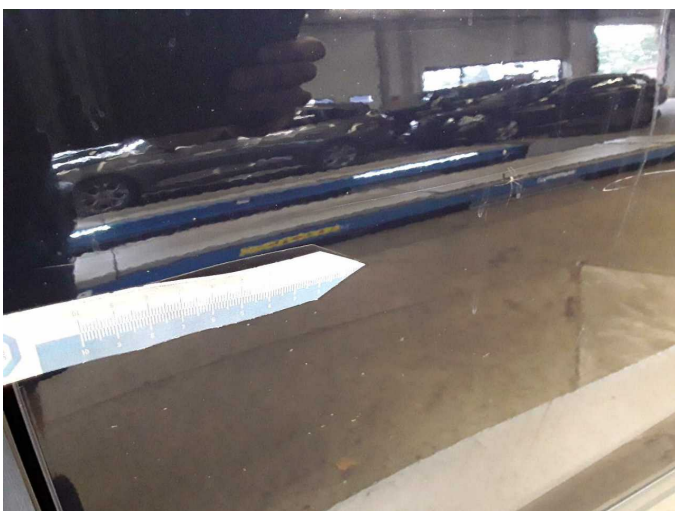
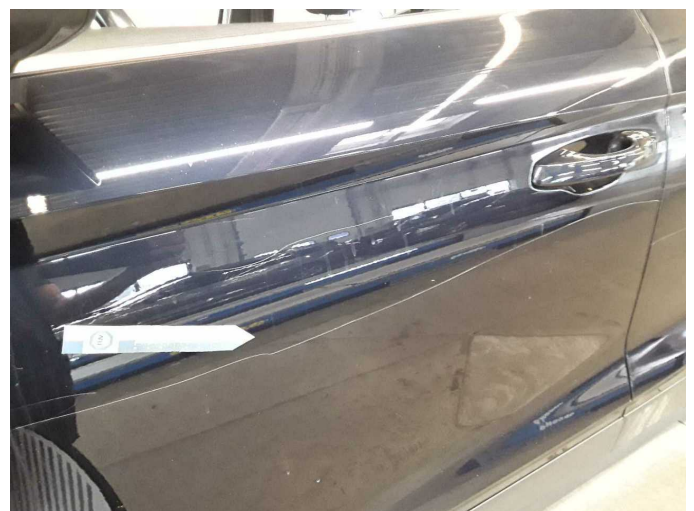
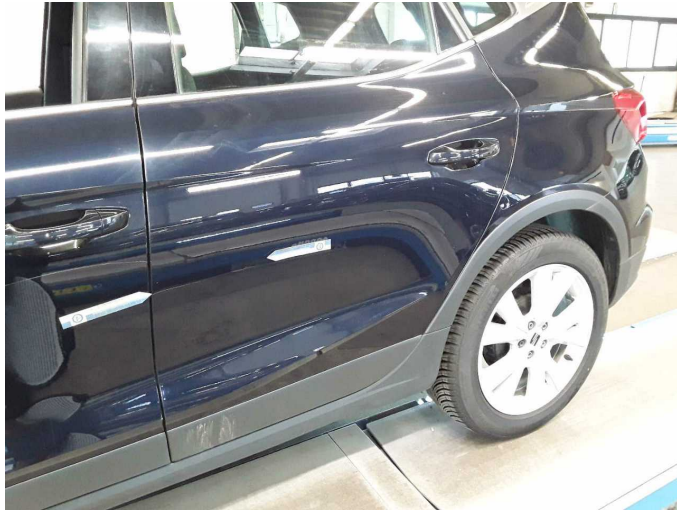
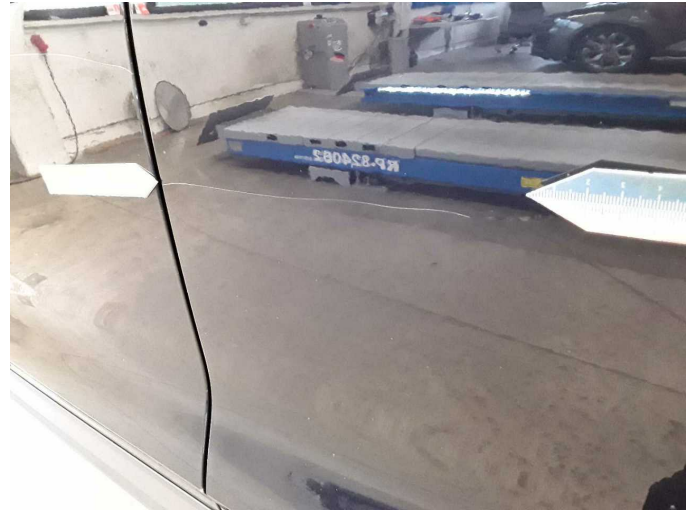
| No. | Accident |
|---|---|
| 1 | Side - left |

**Accident 1:** Side - left

**Accident 1: Side - left**
