Expertise

Protocol number: 45823639
Order No. / Reference: 26154116
Inspection date: 8 Jun 2026

Model: 317 CDI Sprinter Kasten RA 4325 MM 3,5 T, 9G-TRONIC PRO

VIN: W1V3KCFZ5TP845638

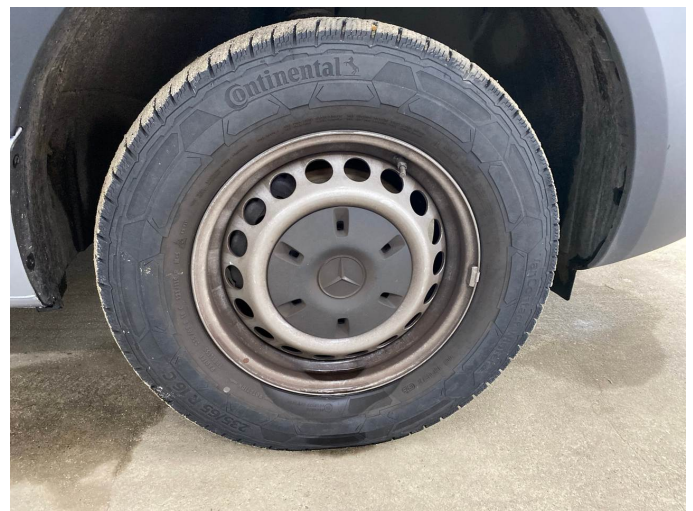
Figure 12: Mounted tyres

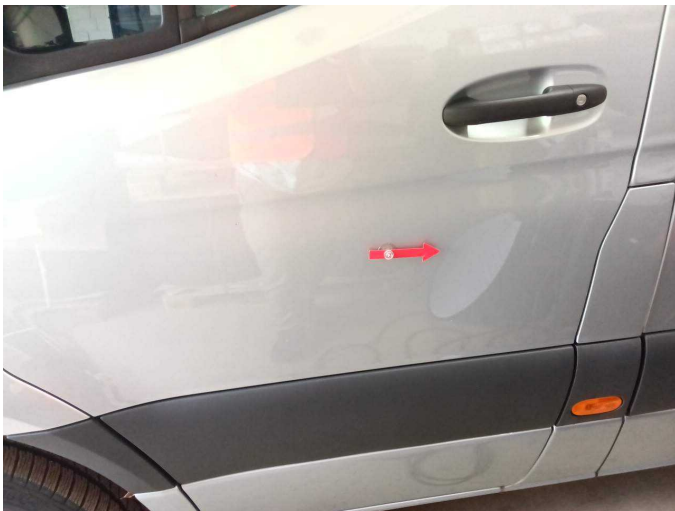
Damage 1: Door - front left side: Door - dent(s) - Smooth repair work

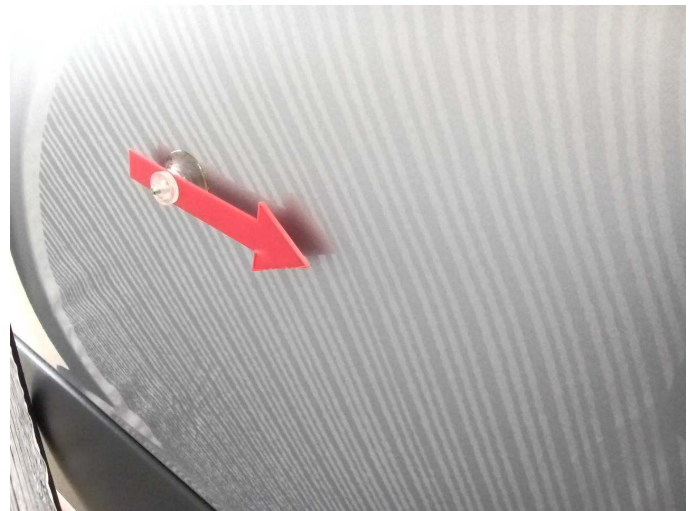
Damage 1: Door - front left side: Door - dent(s) - Smooth repair work

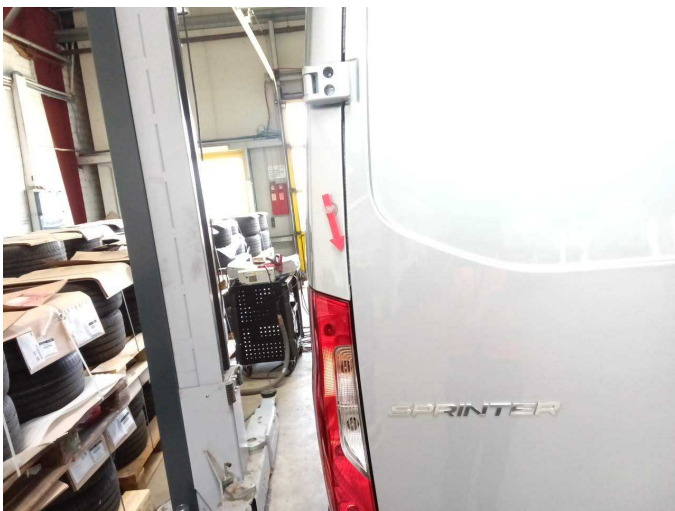
Damage 2: Body: D-pillar - left side - Scratch(es) - Smart repair

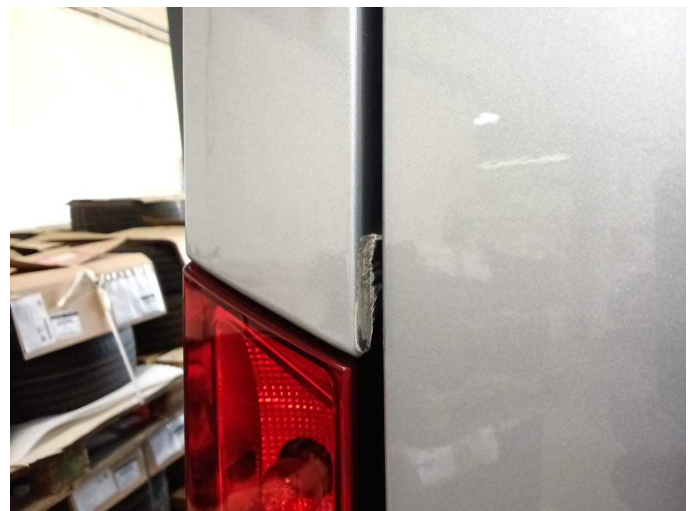
Damage 2: Body: D-pillar - left side - Scratch(es) - Smart repair

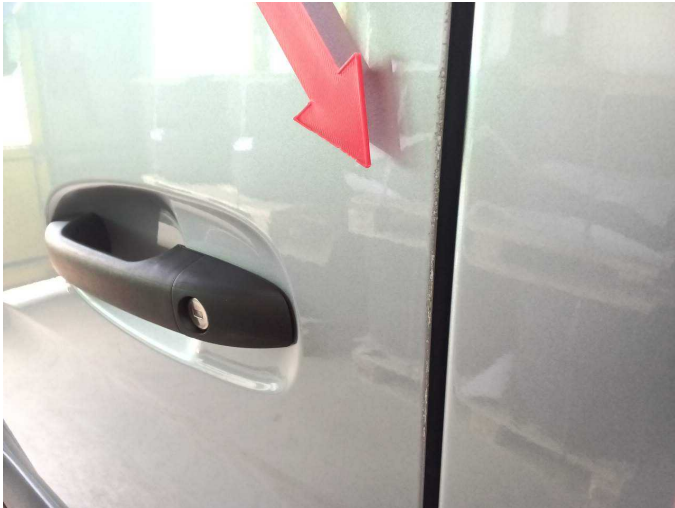
Damage 3: Door - front left side: Door edge - Scratch(es) - Smart repair

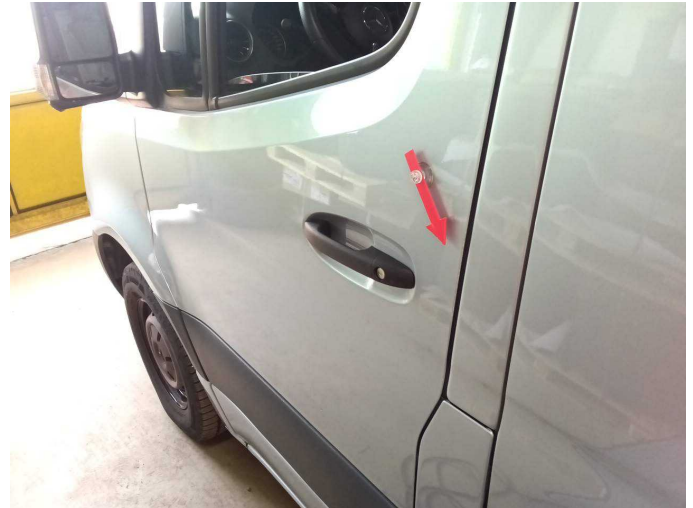
Damage 3: Door - front left side: Door edge - Scratch(es) - Smart repair

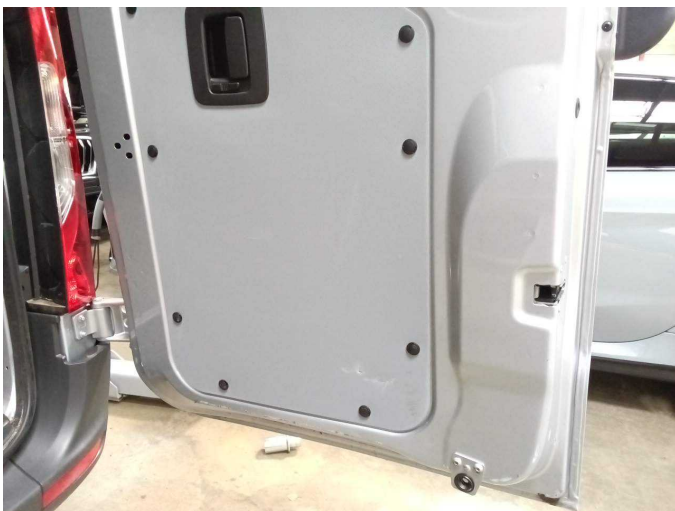
Damage 4: Boot lid / rear door: Rear door - right side - Scratched - Smart repair

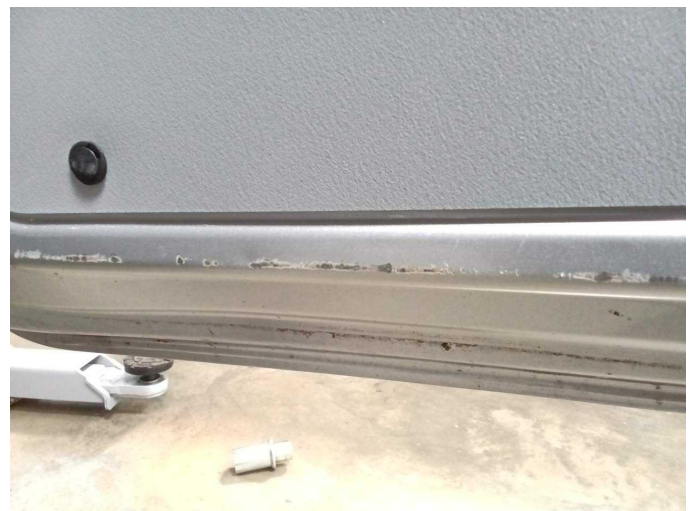
Damage 4: Boot lid / rear door: Rear door - right side - Scratched - Smart repair

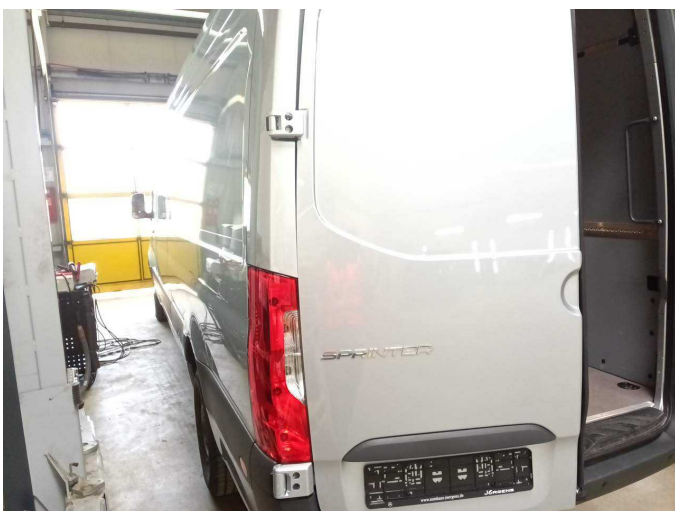
Damage 5: Boot lid / rear door: Rear door - left side - Malposition - Perform diagnosis

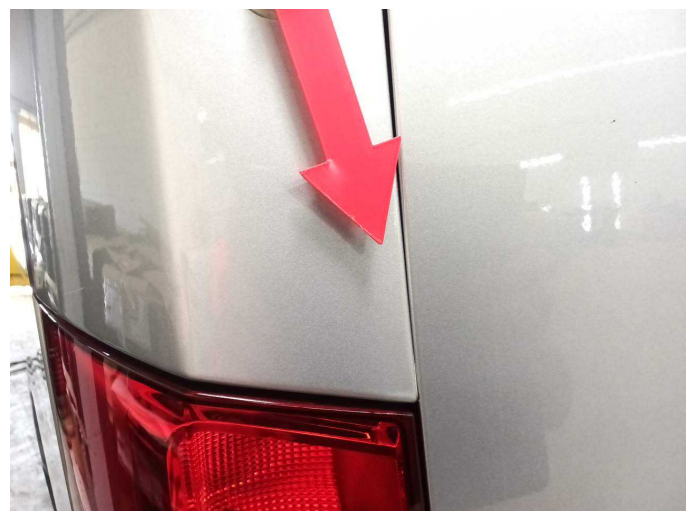
Damage 5: Boot lid / rear door: Rear door - left side - Malposition - Perform diagnosis

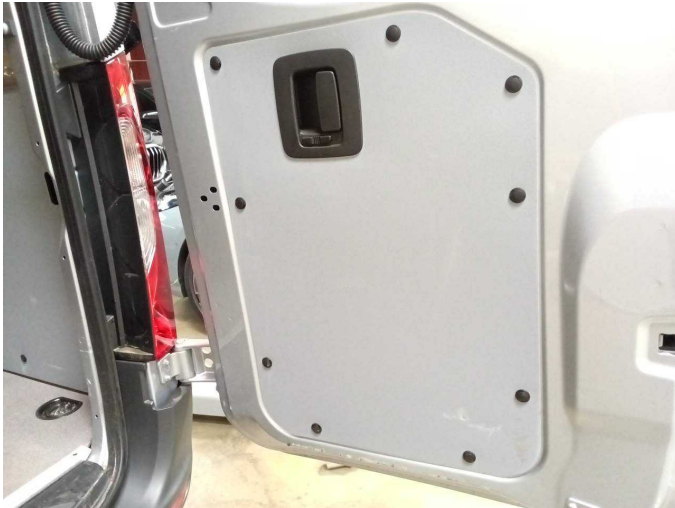
Damage 6: Trim / covers: Boot lid - interior trim - Scratched - Replace

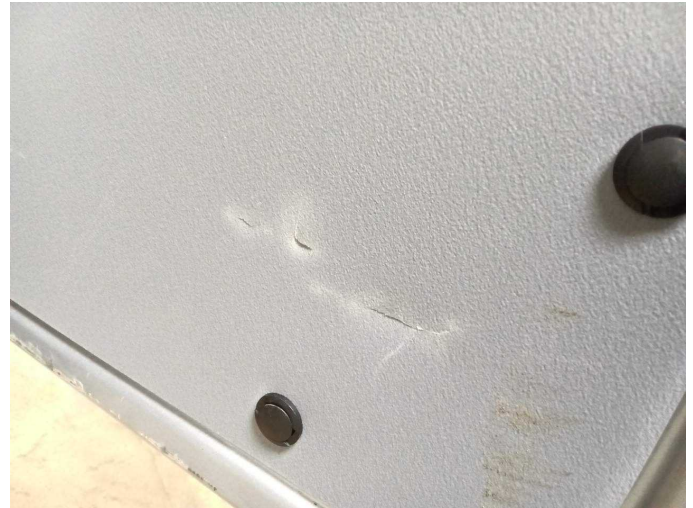
Damage 6: Trim / covers: Boot lid - interior trim - Scratched - Replace

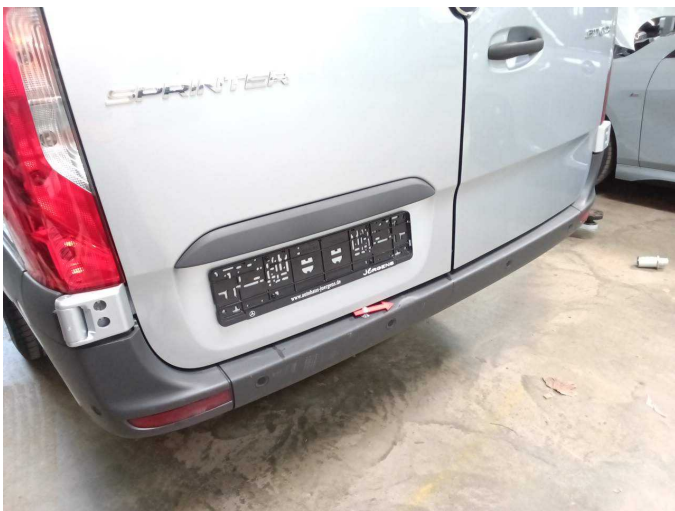
Damage 7: Rear bumper: Rear bumper - Deformed - Replace

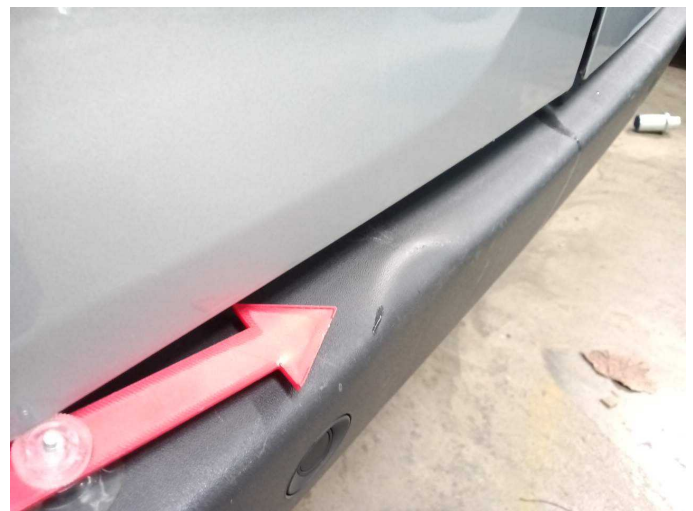
Damage 7: Rear bumper: Rear bumper - Deformed - Replace

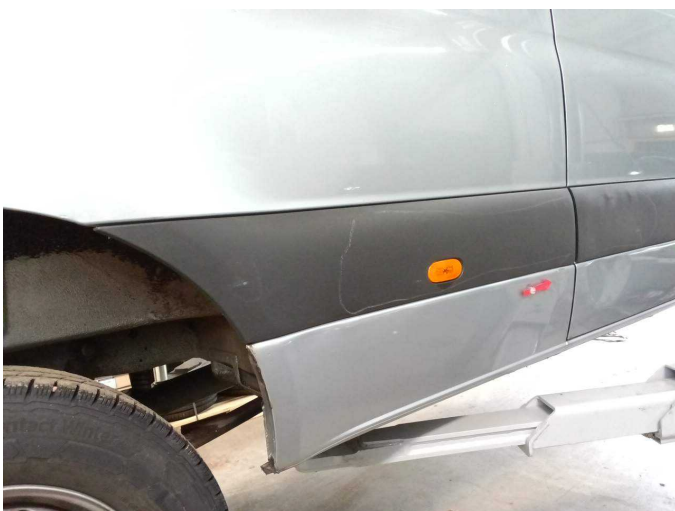
Damage 8: Side panel - rear right side: Side panel - Dent / paintcoat damage - Repair and paint

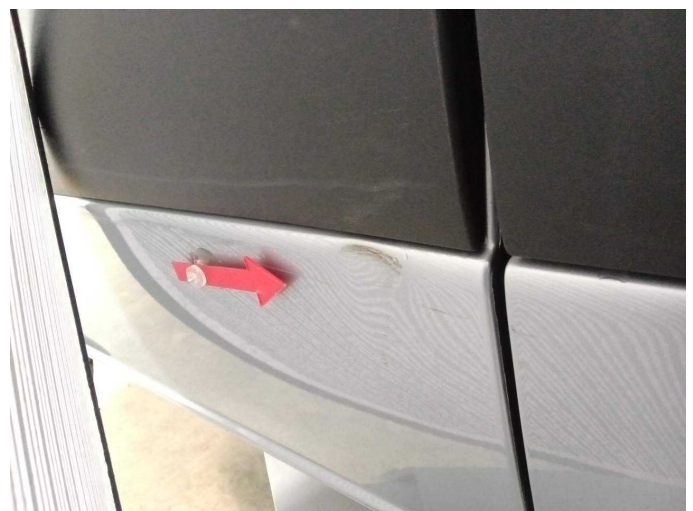
Damage 8: Side panel - rear right side: Side panel - Dent / paintcoat damage - Repair and paint

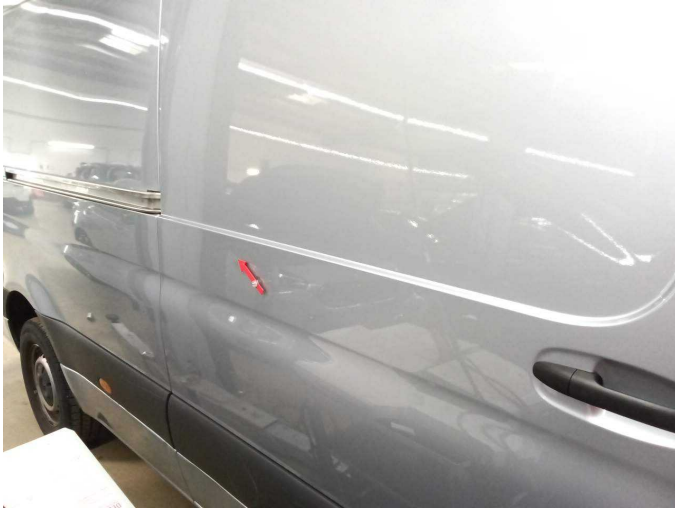
Damage 9: Sliding door, right: Sliding door - Dent / paintcoat damage - Repair and paint

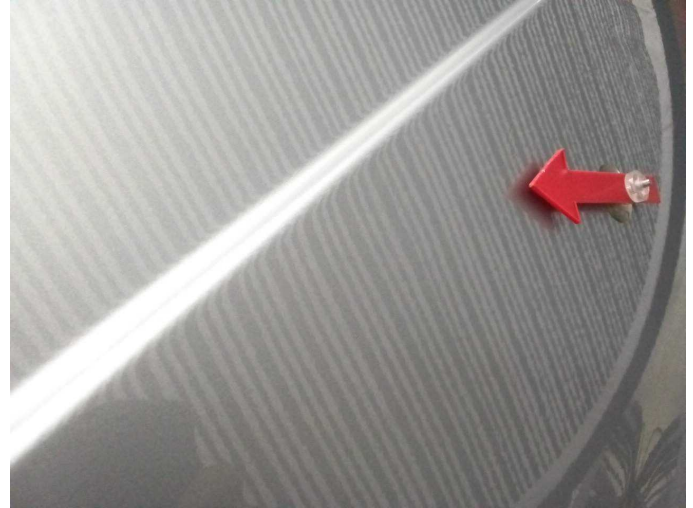
Damage 9: Sliding door, right: Sliding door - Dent / paintcoat damage - Repair and paint

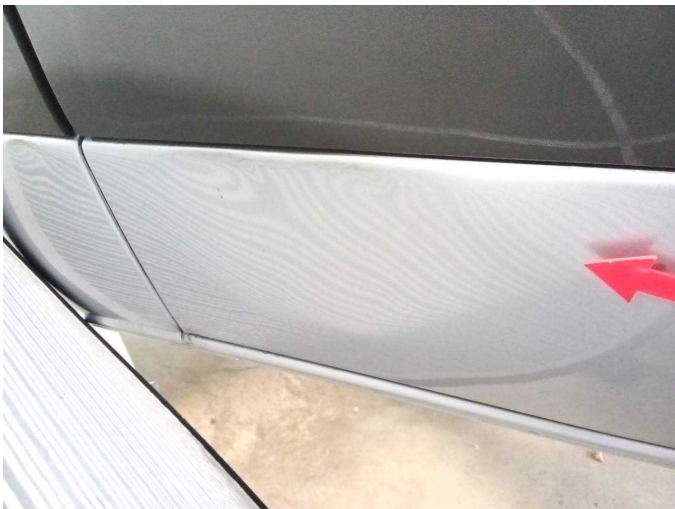
Damage 9: Sliding door, right: Sliding door - Dent / paintcoat damage - Repair and paint

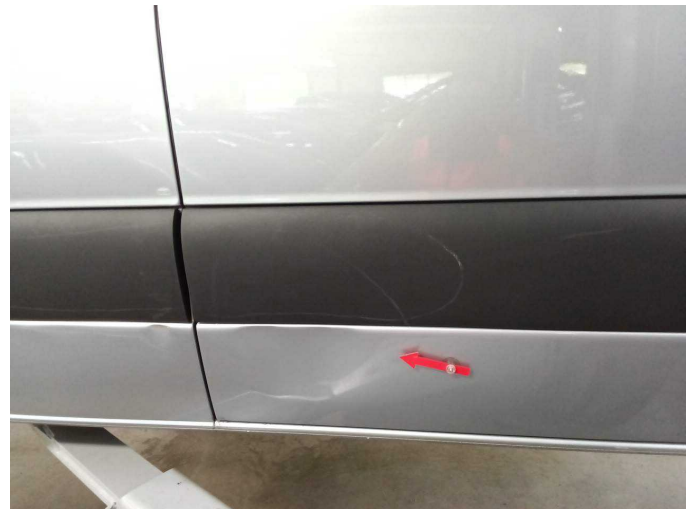
Damage 9: Sliding door, right: Sliding door - Dent / paintcoat damage - Repair and paint

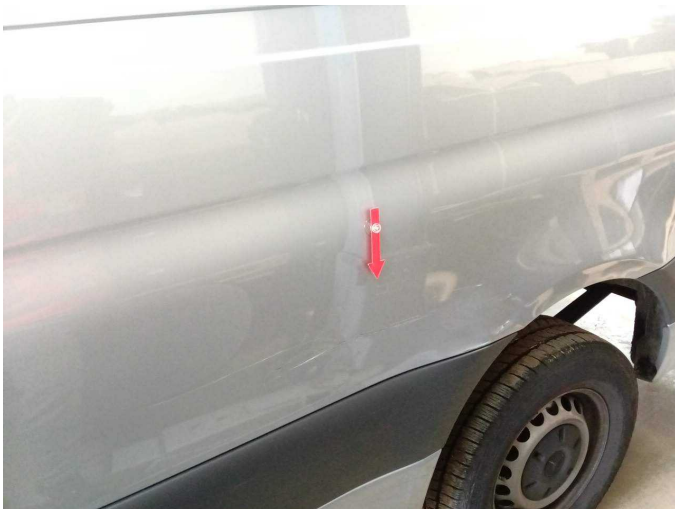
Damage 10: Side panel - rear left side: Side panel - Dent / paintcoat damage - Repair and paint

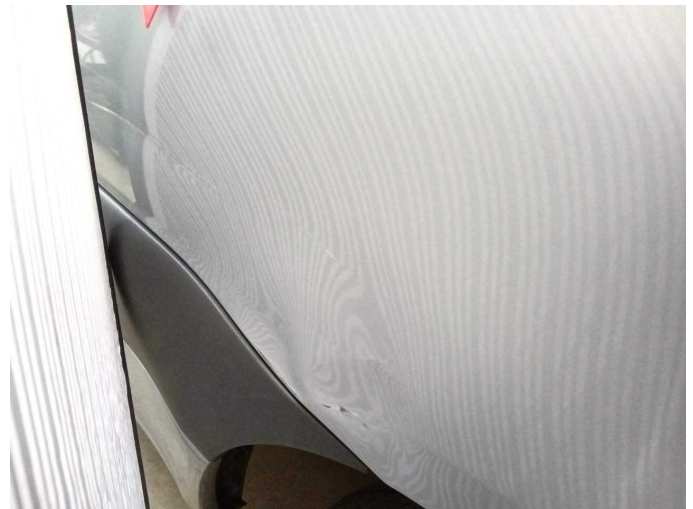
Damage 10: Side panel - rear left side: Side panel - Dent / paintcoat damage - Repair and paint

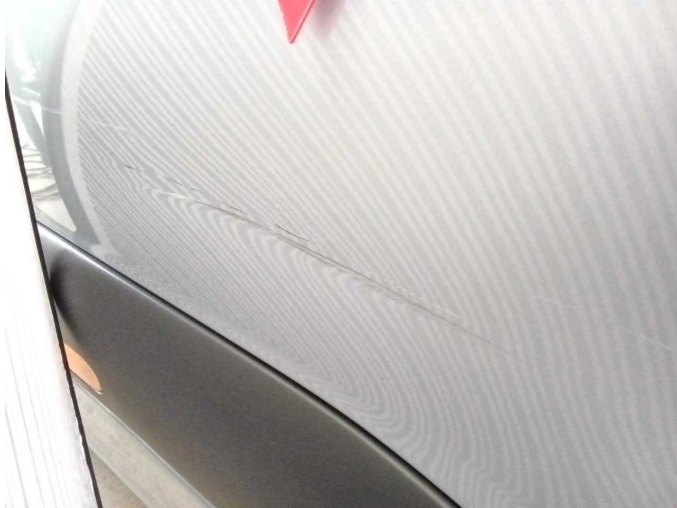
Damage 10: Side panel - rear left side: Side panel - Dent / paintcoat damage - Repair and paint
