## Expertise

Protocol number: 46347990  
Order No. / Reference: 26185550  
Inspection date: 2 Jul 2026

Manufacturer: Mercedes-Benz

Model: Vito 116 CDI Extralang HA Aut. PRO

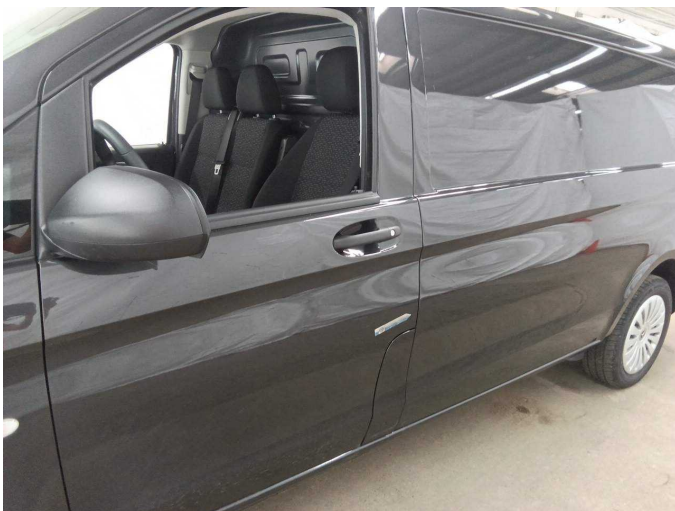
No.	Component group	Description
1	Door - front left side	Door edge - Scratch(es) - Smart repair
2	Boot lid / rear door	Rear door - right side - Scratch(es) - Paint
3	Rear bumper	Rear bumper - Scratch(es) - Paint

Damage 1: Door - front left side: Door edge - Scratch(es) - Smart repair

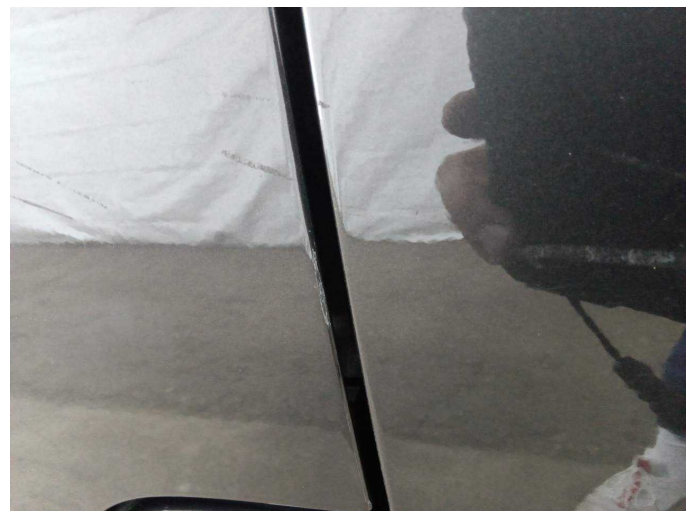
Damage 1: Door - front left side: Door edge - Scratch(es) - Smart repair

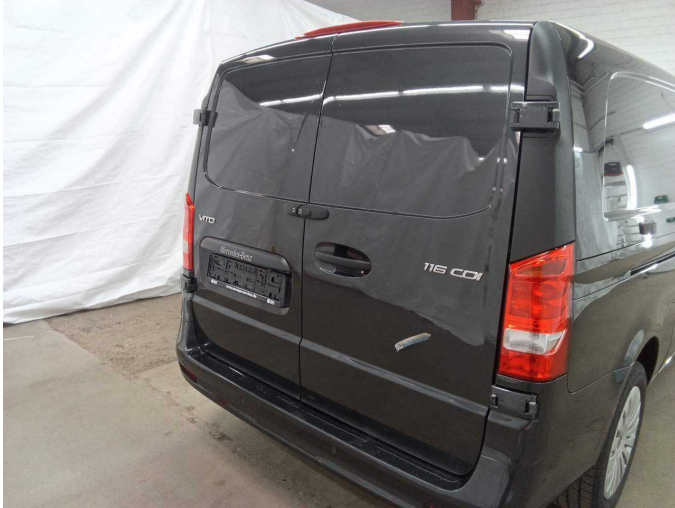
**Damage 2:** Boot lid / rear door: Rear door - right side - Scratch(es) - Paint

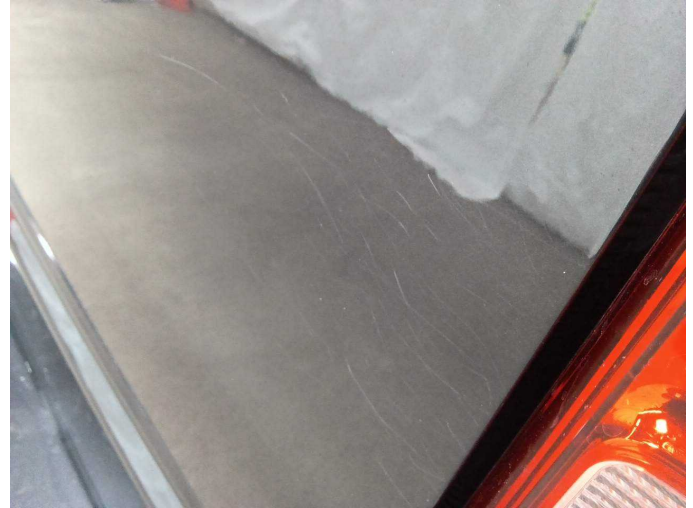
**Damage 2:** Boot lid / rear door: Rear door - right side - Scratch(es) - Paint

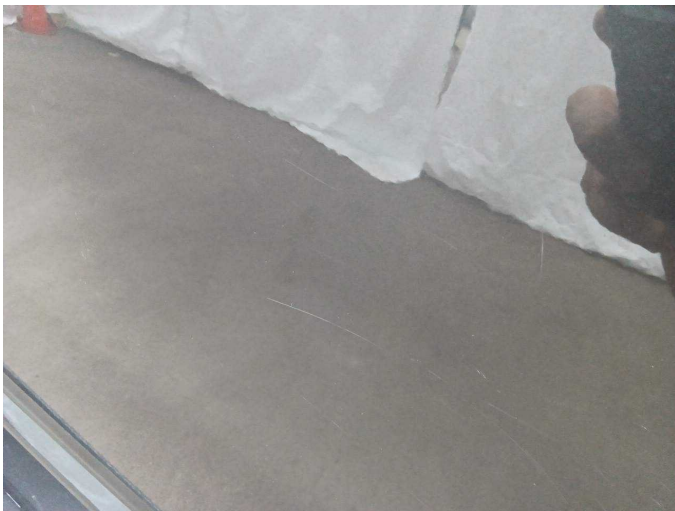
**Damage 2:** Boot lid / rear door: Rear door - right side - Scratch(es) - Paint

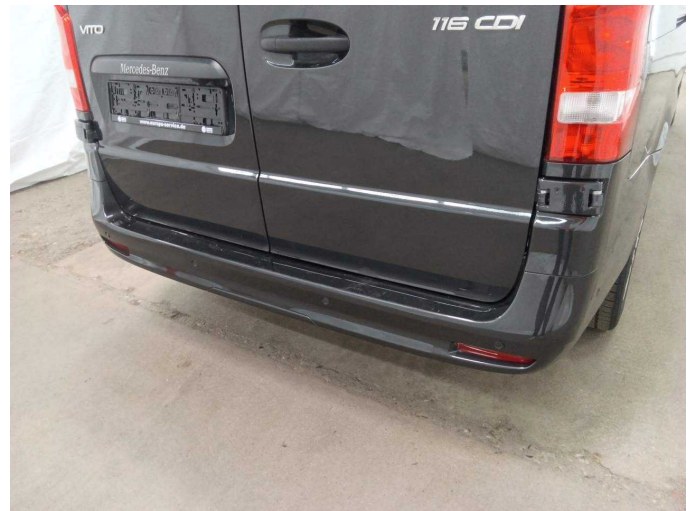
**Damage 3:** Rear bumper: Rear bumper - Scratch(es) - Paint

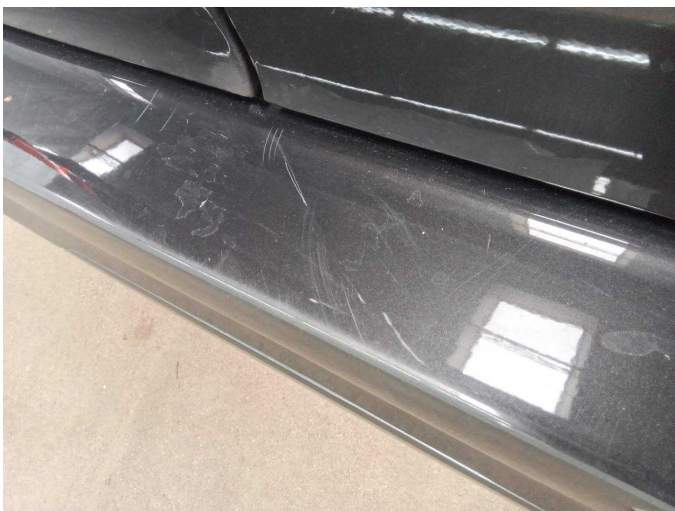
**Damage 3:** Rear bumper: Rear bumper - Scratch(es) - Paint

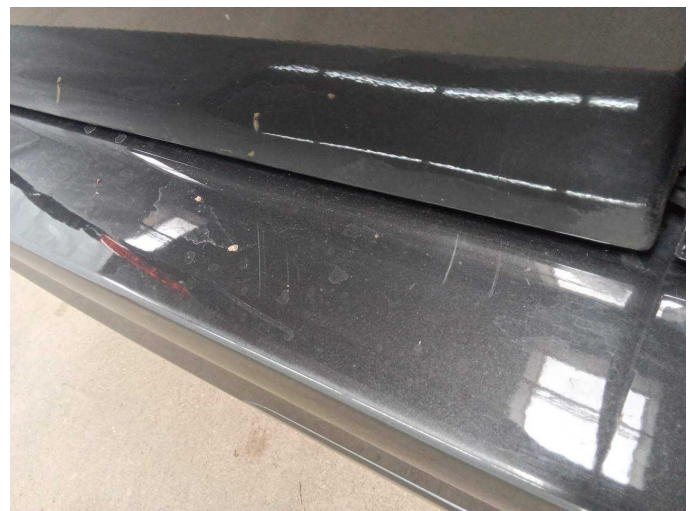
**Damage 3:** Rear bumper: Rear bumper - Scratch(es) - Paint

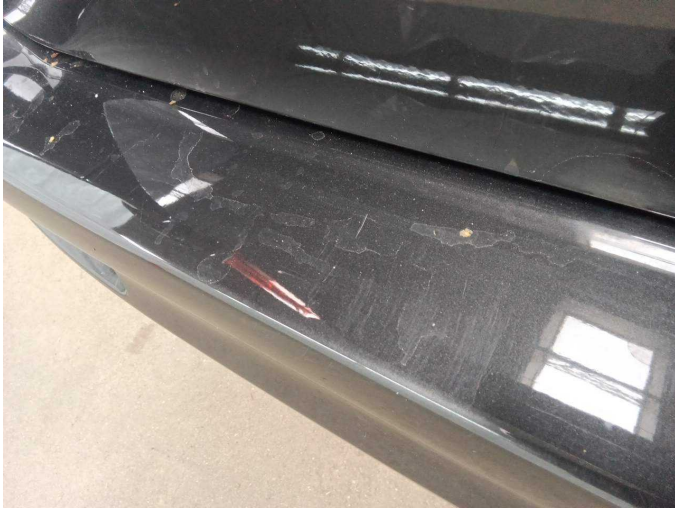
**Damage 3:** Rear bumper: Rear bumper - Scratch(es) - Paint

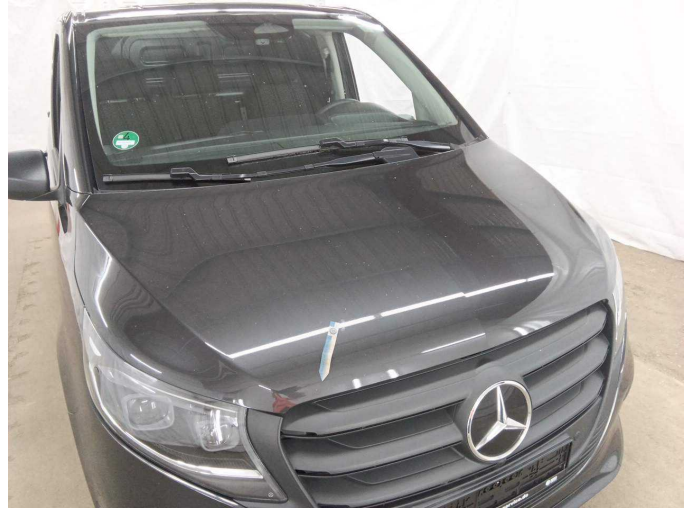
No.	Component group	Description
1	Bonnet	Bonnet - Stone chips - No deduction
2	Wing mirror - right side	Cap - Scratch(es) - No deduction

**Wear and tear 1:** Bonnet: Bonnet - Stone chips - No deduction

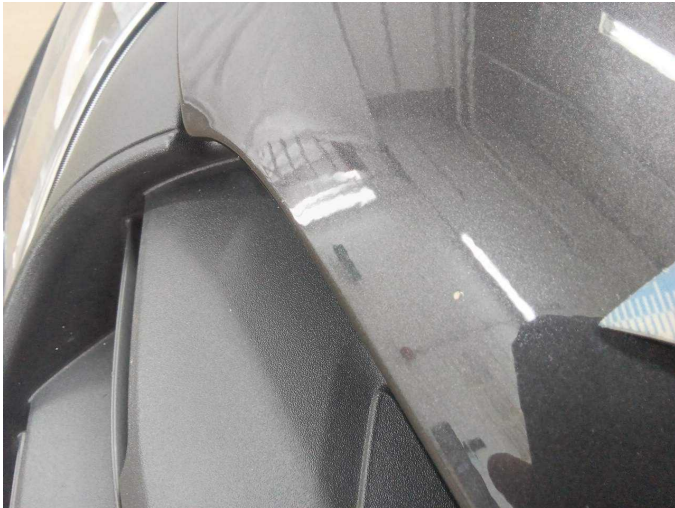
**Wear and tear 1:** Bonnet: Bonnet - Stone chips - No deduction

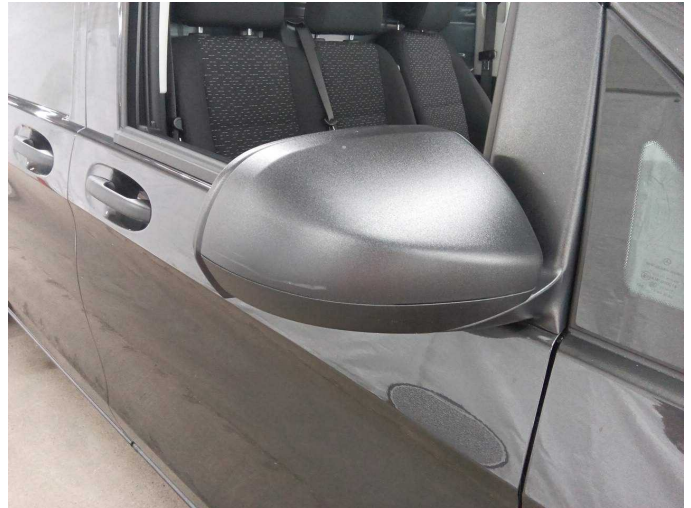
**Wear and tear 2:** Wing mirror - right side: Cap - Scratch(es) - No deduction

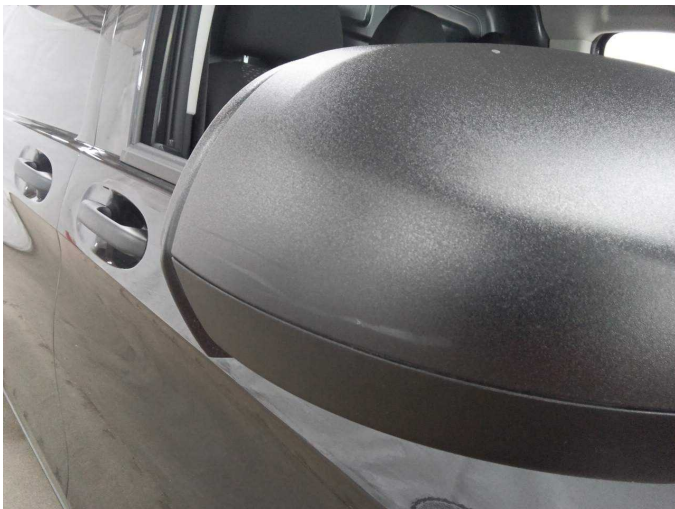
**Wear and tear 2:** Wing mirror - right side: Cap - Scratch(es) - No deduction
