Expertise

Protocol number: 46498395  
Order No. / Reference: 26225910  
Inspection date: 10 Jul 2026

Manufacturer: Mercedes-Benz

Model: Vito 116 CDI Extralang HA PRO

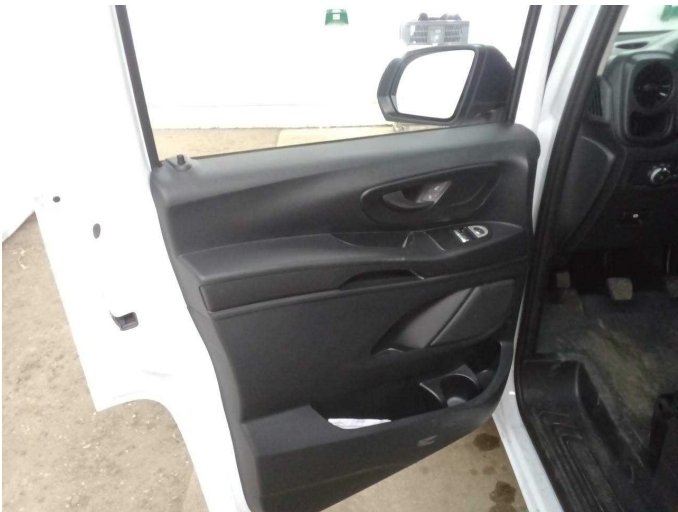
| No. | Component group | Description |
|---|---|---|
| 1 | Trim / covers | Door trim - front left side - Scratch(es) - Loss in value |

Damage 1: Trim / covers: Door trim - front left side - Scratch(es) - Loss in value

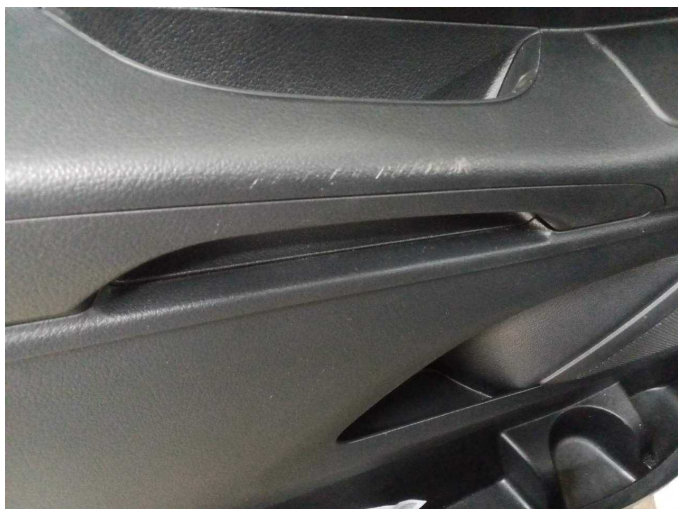
**Damage 1:** Trim / covers: Door trim - front left side - Scratch(es) - Loss in value

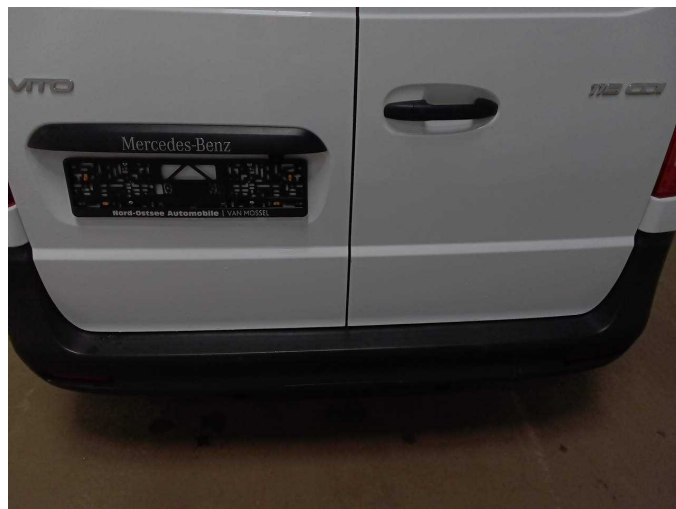
| No. | Component group | Description |
|---|---|---|
| 2 | Rear bumper | Rear bumper - Scratch(es) - Replace |

**Damage 2:** Rear bumper: Rear bumper - Scratch(es) - Replace

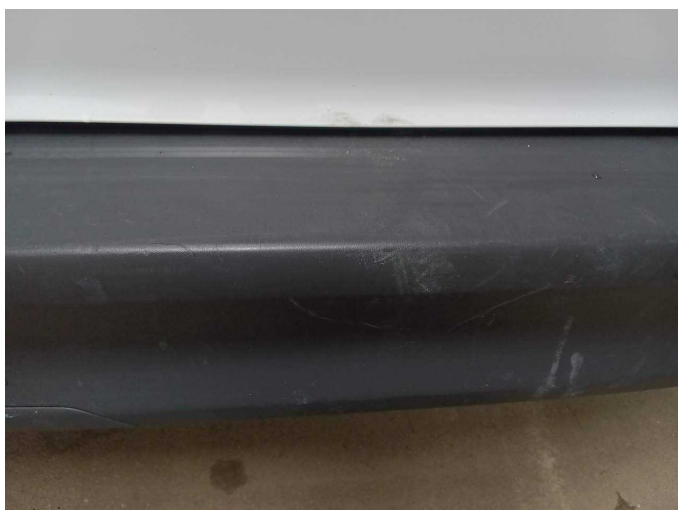
**Damage 2:** Rear bumper: Rear bumper - Scratch(es) - Replace

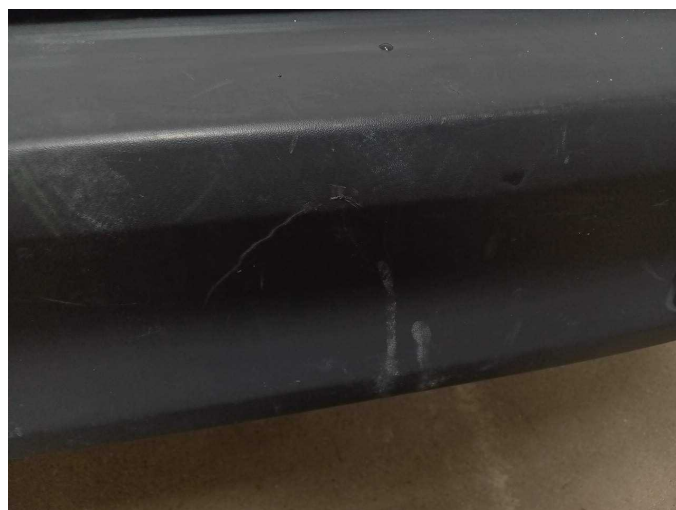
**Damage 2:** Rear bumper: Rear bumper - Scratch(es) - Replace

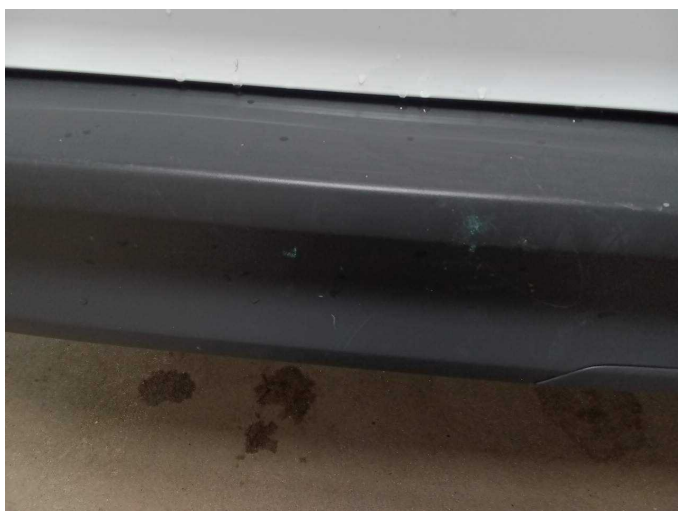
**Damage 2:** Rear bumper: Rear bumper - Scratch(es) - Replace

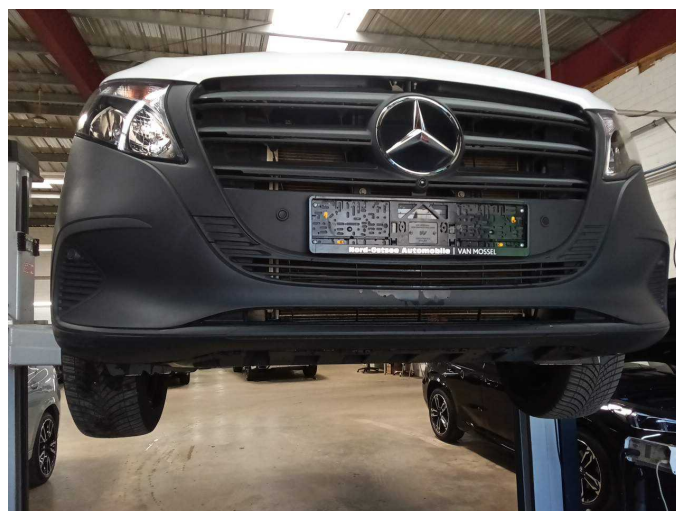
| No. | Component group | Description |
|---|---|---|
| 3 | Front bumper | Front bumper - Scratch(es) - Replace |

**Damage 3:** Front bumper: Front bumper - Scratch(es) - Replace

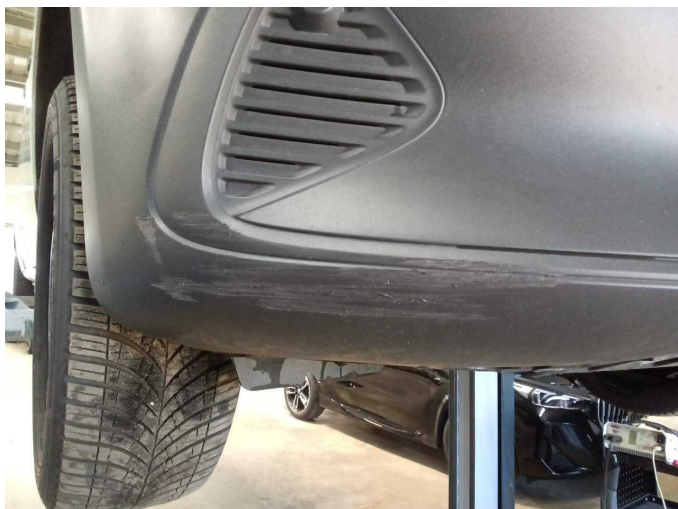
**Damage 3:** Front bumper: Front bumper - Scratch(es) - Replace

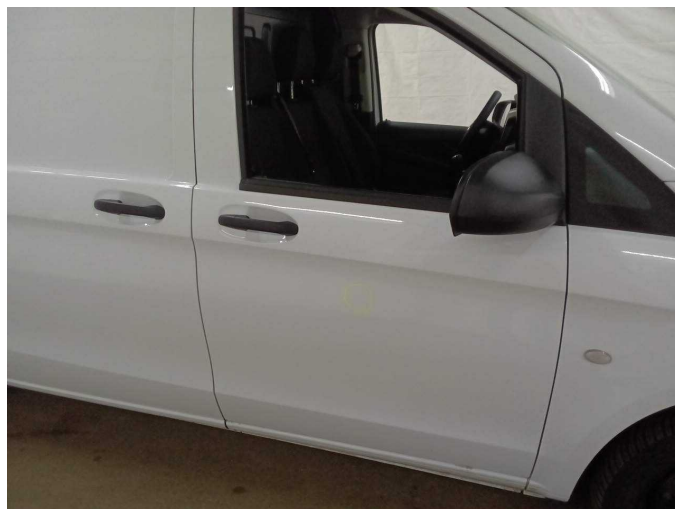
| No. | Component group | Description |
|---|---|---|
| 1 | Door - front right side | Door - dent(s) - No deduction |

**Wear and tear 1:** Door - front right side: Door - dent(s) - No deduction

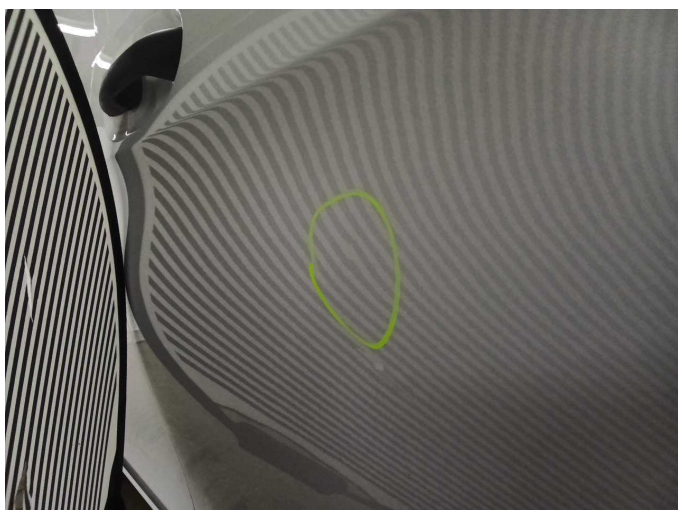
**Wear and tear 1:** Door - front right side: Door - dent(s) - No deduction

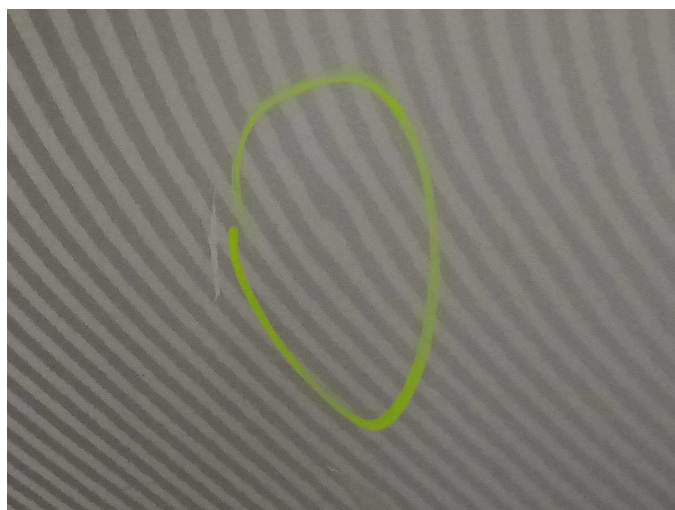
**Wear and tear 1:** Door - front right side: Door - dent(s) - No deduction

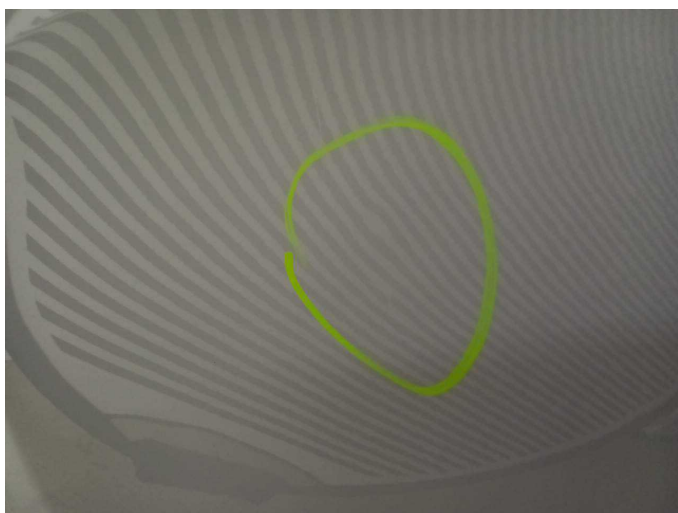
**Wear and tear 1:** Door - front right side: Door - dent(s) - No deduction
